Bridge Inspection Report

03338

**State Highway 28
over
Brush Creek - Scott Co.**

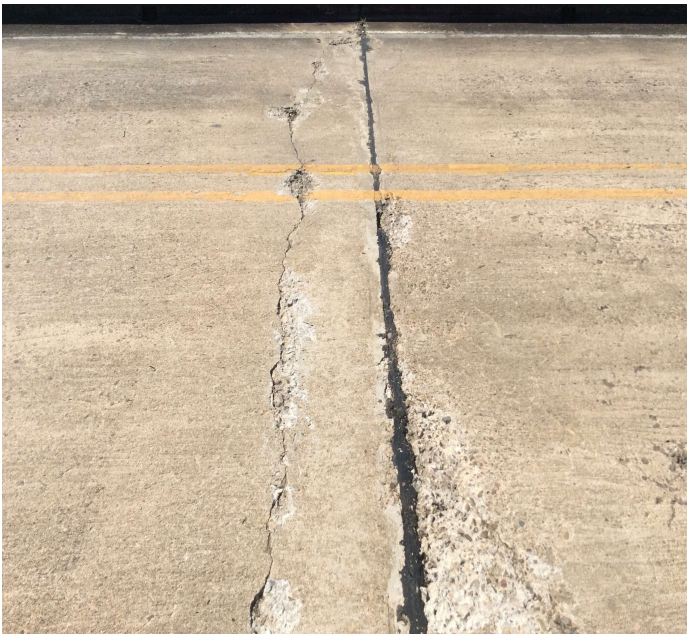
The joint sealant between the spans is deteriorated, leaks water and has a few minor areas that are completely missing.

PHOTO 1 Description The deck joint sealant is deteriorating, leaks water and has a few minor areas where the seal is completely missing.

Work Code: Replace

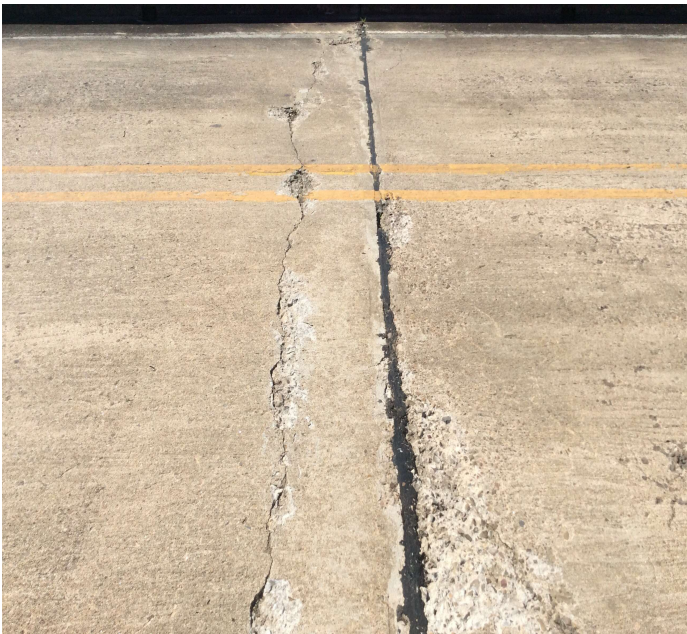
Span # 3 has a transverse crack located approximately 14" from the deck joint over Bent # 4.

PHOTO 1 Description Span # 3 cracking adjacent to the deck joint.

Work Code: Repair

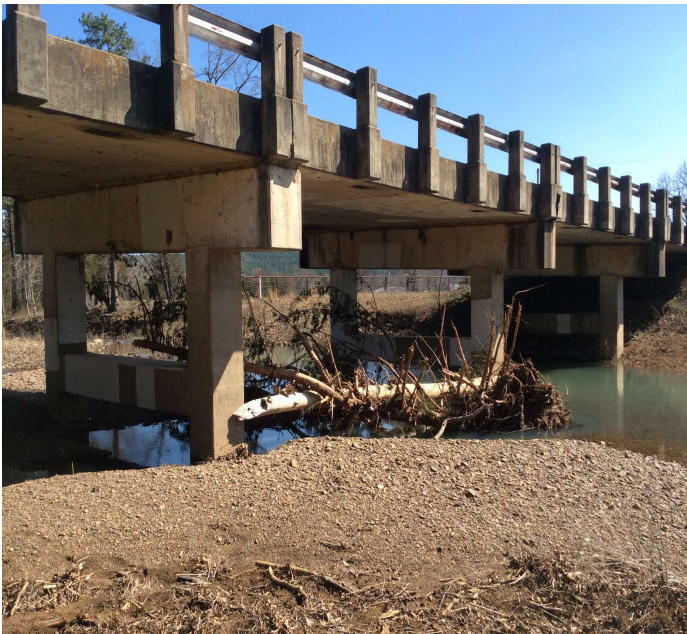
Span # 3 is partially restricted by drift accumulation.

PHOTO 1 Description Span # 3 drift accumulation.
