# Bridge Inspection Report

**03339**  
**SH 28-Scott Co.**  
**over**  
**Sulphur Creek**

Structure Number: 03339

Facility Carried: SH 28-Scott Co.

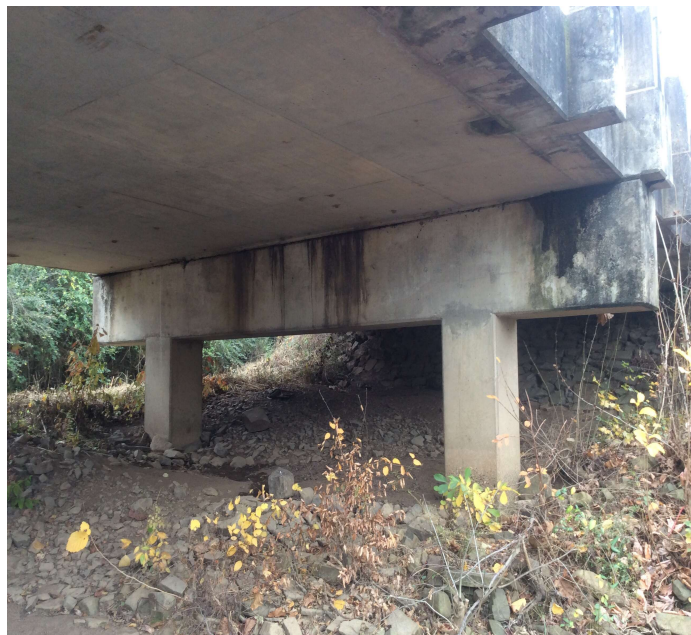
PHOTO 1      Description      Intermediate bent caps have water stains that indicate deck joint leakage.

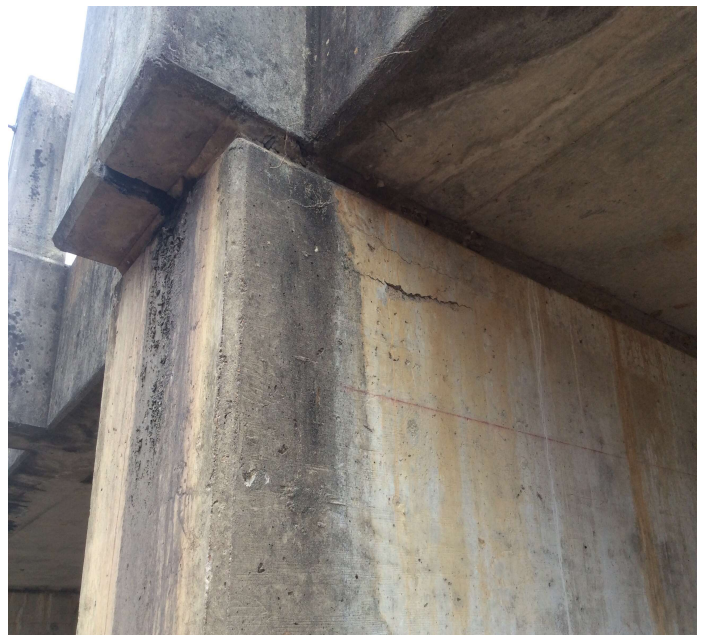
PHOTO 2      Description      The Rt side of Bent 4 has a 12" delaminated area on the Span 4 side of cap.

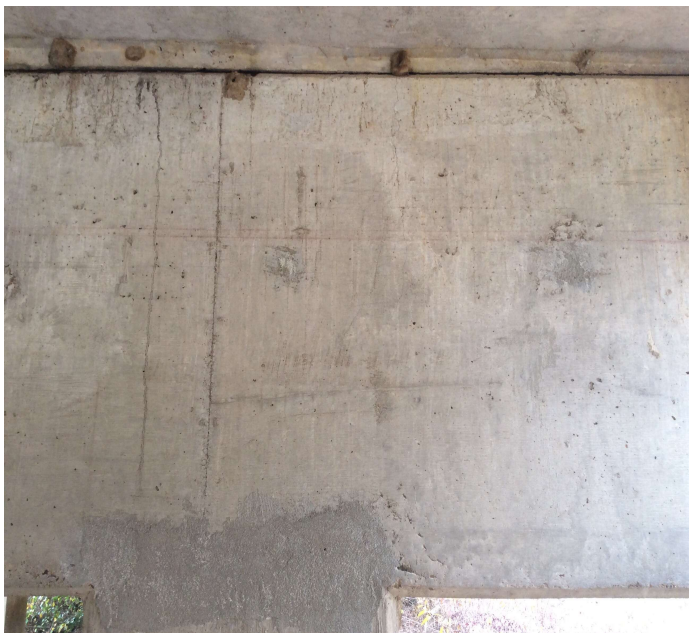
PHOTO 3      Description      Intermediate bent caps have vertical hairline cracks over the exterior face of the columns.

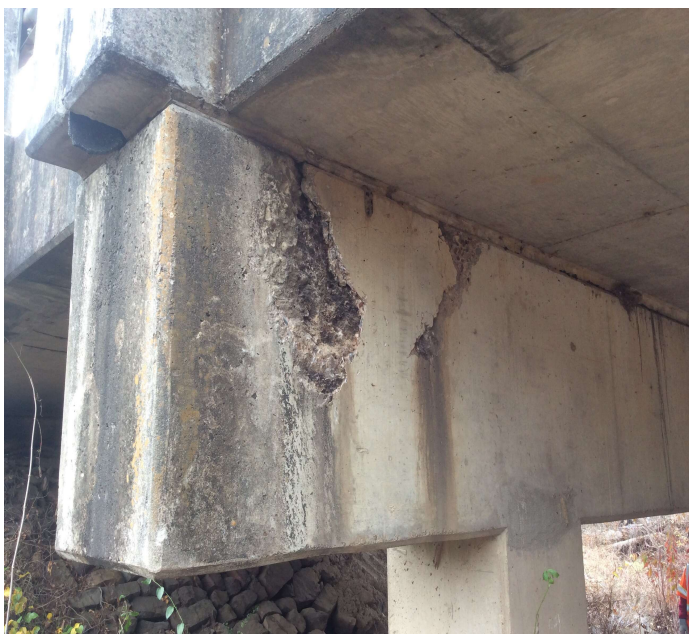
PHOTO 4      Description      The Lt side of Bent 5 has a 36" delaminated area on the Span 4 side of cap.

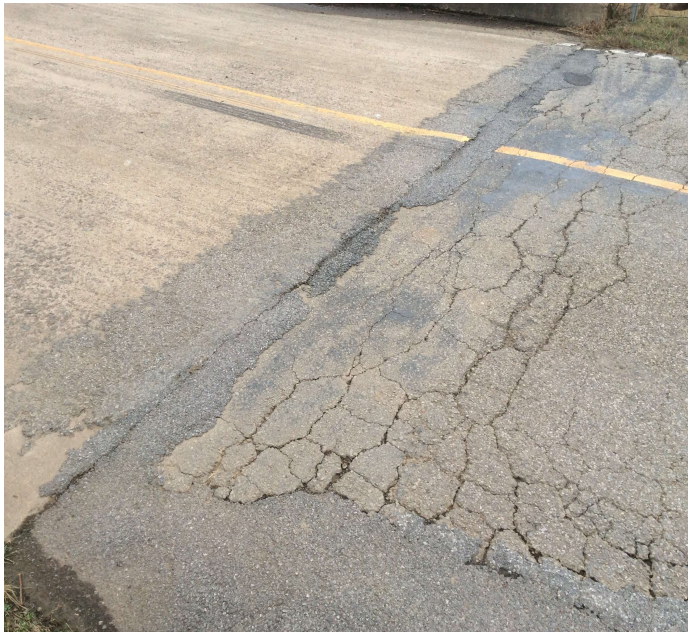
PHOTO 1      Description      The approach roadways have minor asphalt settlement at the bridge ends. Bent 6 (East) bridge end pictured.

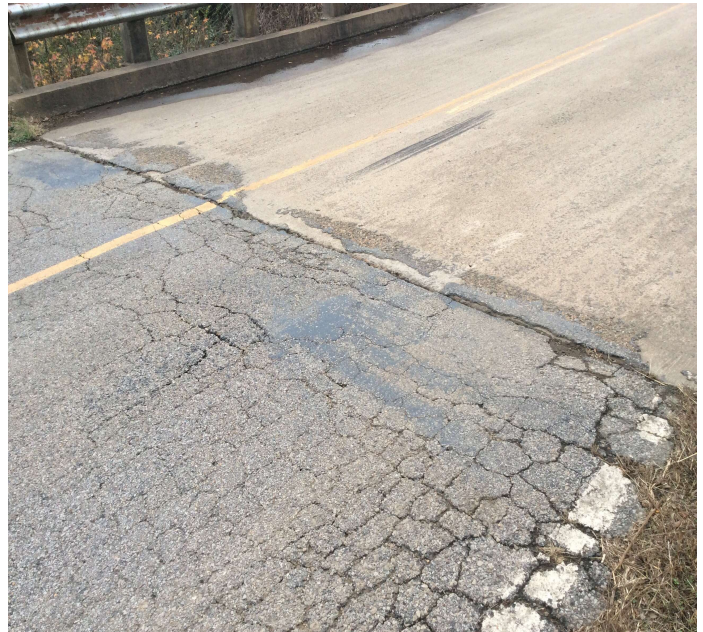
PHOTO 2      Description      The approach roadways have minor asphalt settlement at the bridge ends. Bent 1 (West) bridge end pictured.
