# Bridge Inspection Report

**03340**  
**SH 28-Scott Co.**  
**over**  
**Kelly Creek**

**Executive Summary**

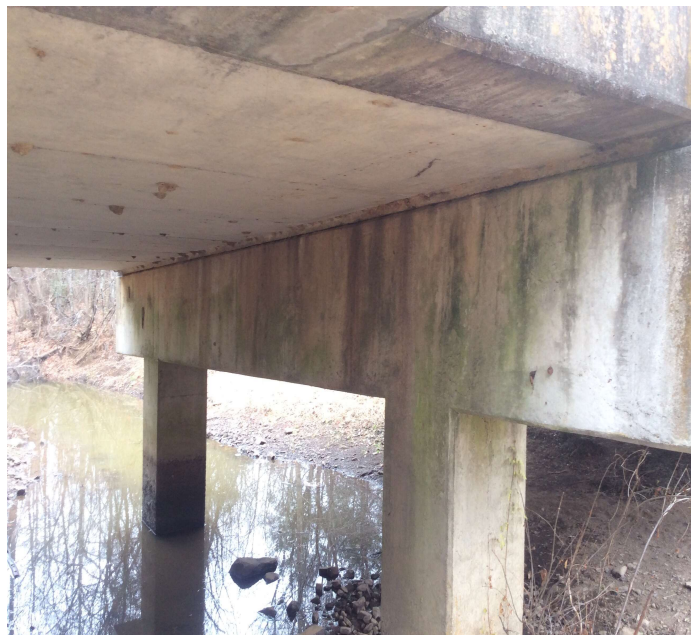
-Substructure caps have efflorescence and water stains that appear to be an indication of leaking expansion joint sealant.

PHOTO 1 Description Substructure caps have efflorescence and water stains that appear to be an indication of leaking expansion joint sealant.

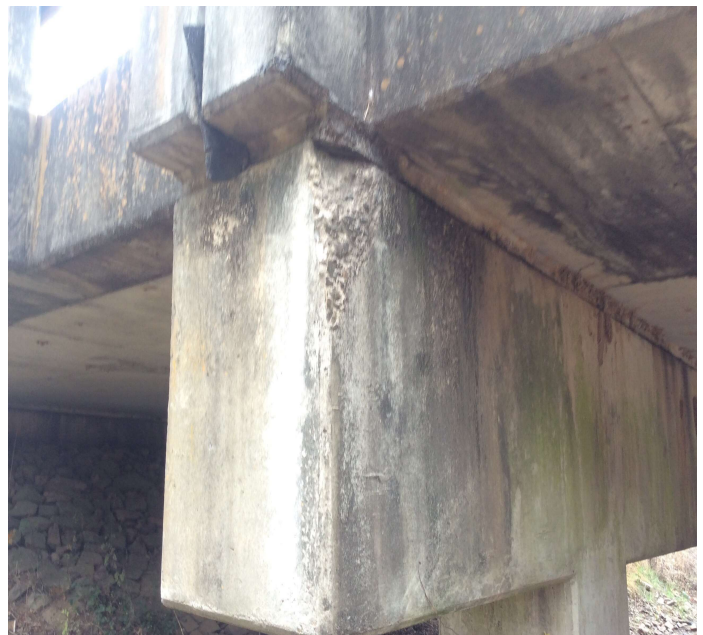
-A 12" spall with no visible reinforcing steel in the Rt side of Bent 2 cap.

PHOTO 2 Description There is a 12" spall with no exposed reinforcing steel at the Rt side of Bent 2 cap.

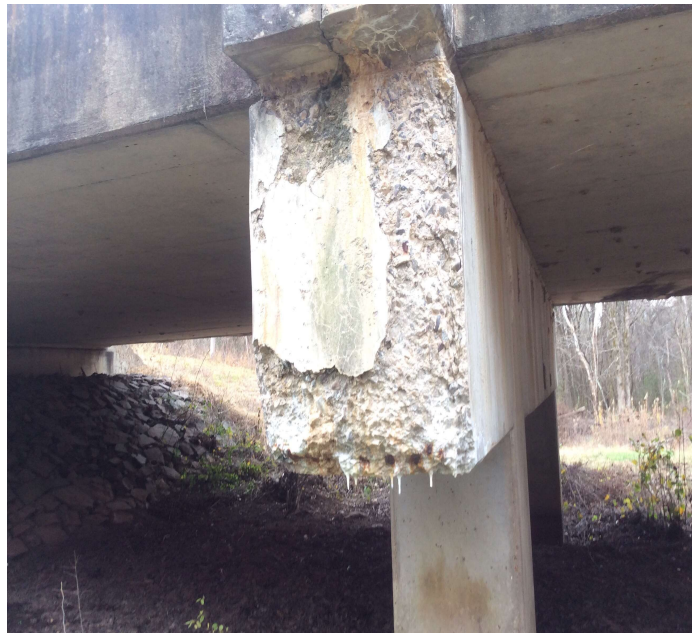
-Map cracking with soft deteriorated concrete, concrete section loss and efflorescence in the Lt end of Bent 3 cap. The ends of two reinforcement bars are visible at the base of cap. No apparent section loss to the exposed reinforcing steel. Area of deterioration is approximately 6" deep.

**PHOTO 3**      Description      The Lt side of Bent 3 has soft deteriorated concrete with up to 4" of concrete section loss at this inspection. The ends of two reinforcement bars are visible at the base of cap. No apparent significant section loss to the exposed reinforcing steel.

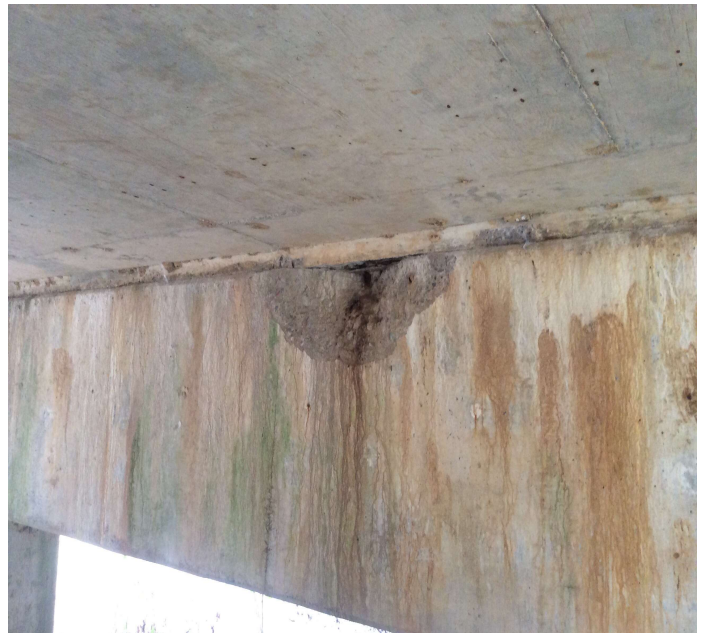
-The Span 3 side of Bent 3 cap has a 24" spall with exposed reinforcing steel near the centerline of cap. No apparent section loss to the exposed reinforcing steel.

**PHOTO 4**      Description      The Span 3 side of Bent 3 cap has a 24" spall with exposed reinforcing steel near the centerline of cap. No apparent section loss to the exposed reinforcing steel.

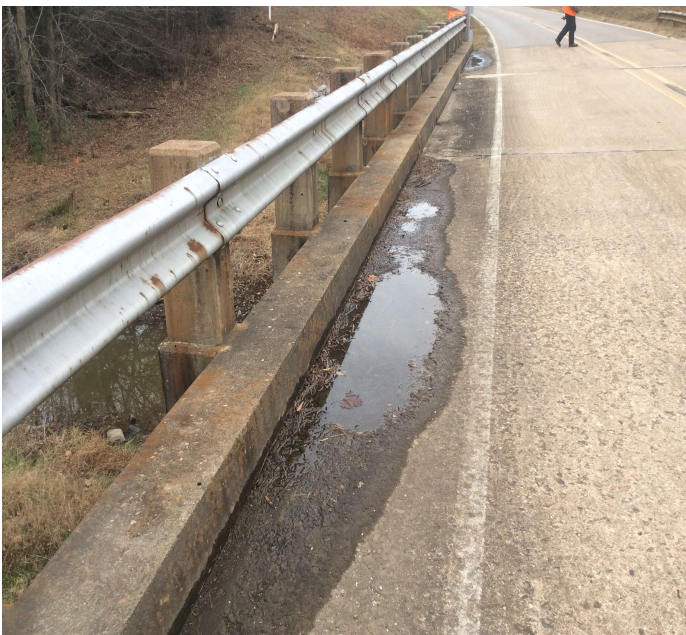
The left gutter has areas with heavy scale.

PHOTO 1      Description      The left gutter has areas with heavy scale.
