Structure Number: 03341

Facility Carried: SH 28-Scott Co.

Bridge Inspection Report

Maintenance Needs

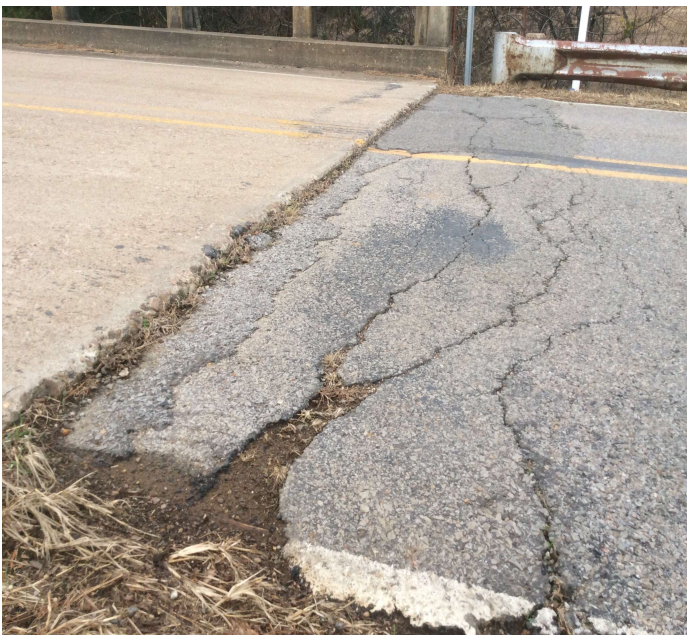
Approach Roadway
Settlement in the East approach.

PHOTO 1 Description Approach Roadway Settlement in the East approach.

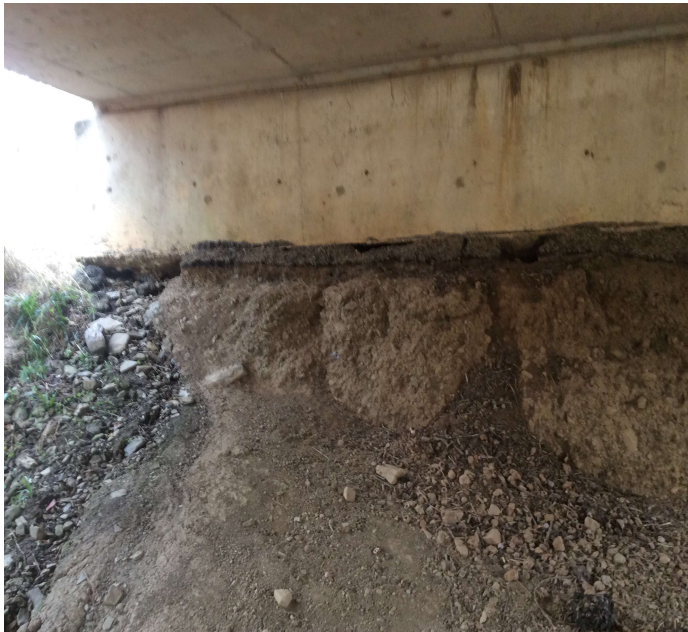
PHOTO 1 Description There is minor earth settlement under the East abutment with asphalt placed in some of the voids as a type of repair.

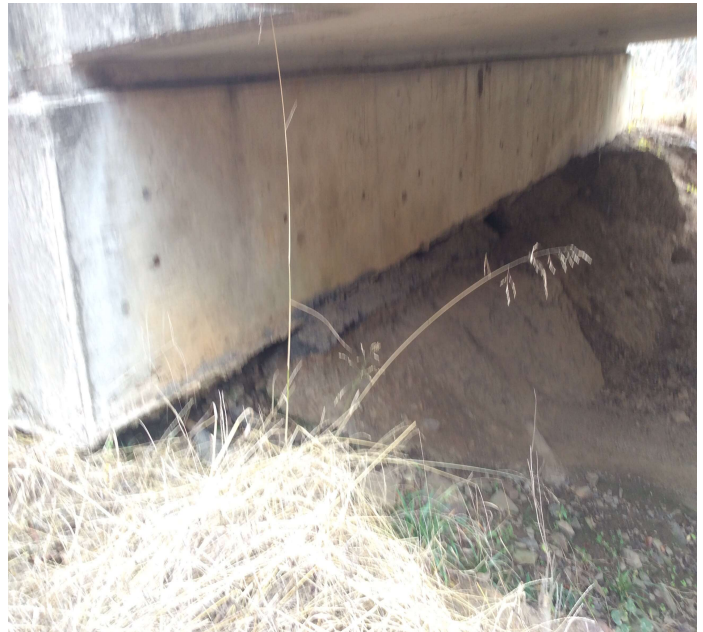
Substructure
Bent # 5 settlement in the compacted embankment.

PHOTO 2 Description Bent 5 settlement in the compacted embankment.

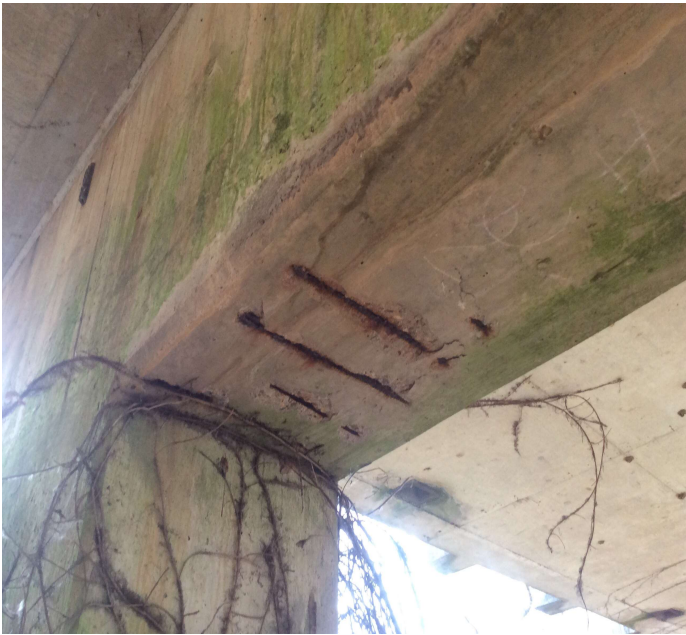
The undersurface of Bent #2 cap has spalling with exposed reinforcing steel.

PHOTO 1	Description	Shallow spalling with exposed reinforcing steel (Stirrups) visible from the undersurface of Bent 2 cap. Exposed reinforcing steel has very little concrete cover from the construction process with initial section loss typical.
---------	-------------	---

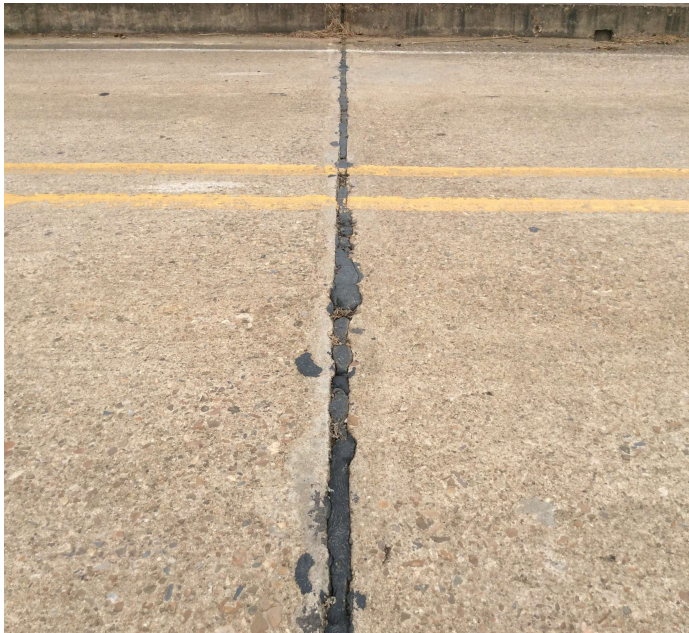
Deck joint sealant has deterioration and leaks water onto the substructure caps.

PHOTO 1 Description Deck joint sealant has deterioration and leaks water onto the substructure caps. Bent 2 pictured.

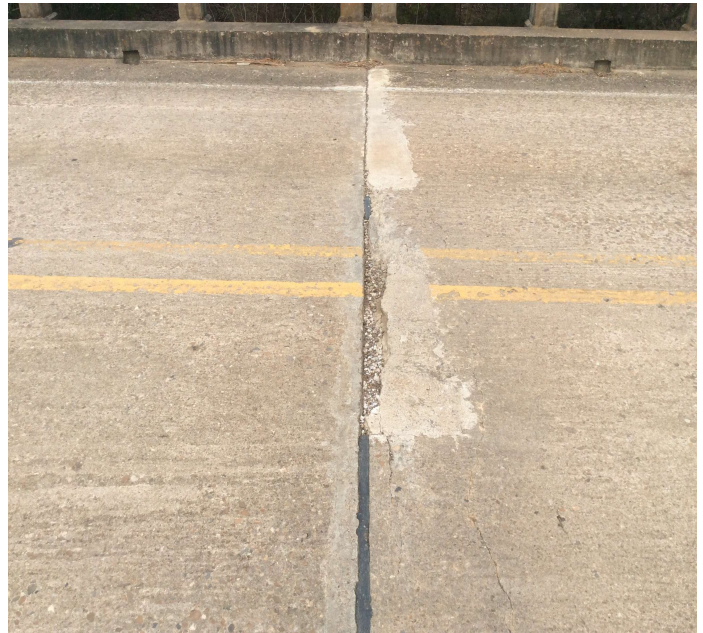
PHOTO 2 Description Deck joint sealant has deterioration and leaks water onto the substructure caps. Bent 3 pictured.

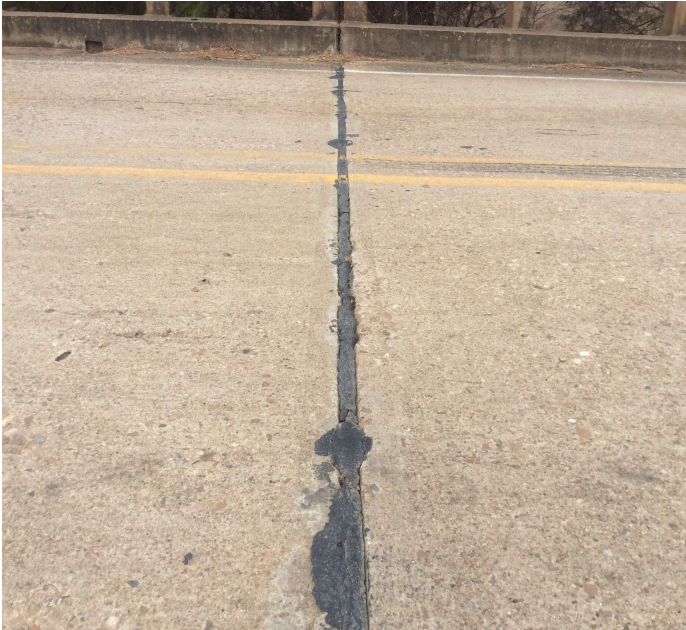
PHOTO 3 Description Deck joint sealant has deterioration and leaks water onto the substructure caps. Bent 4 pictured.
