Bridge Inspection Report

03364
SH 80-Scott Co.
over
Poteau Creek

Structure Number: 03364

Facility Carried: SH 80-Scott Co.

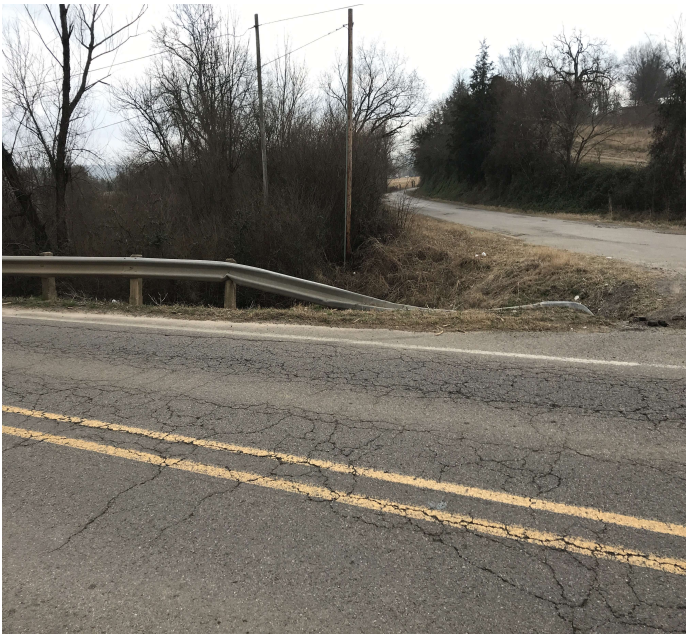
Southwest approach guardrail

The Southwest approach railing has collision damage to the turn down portion of the railing.

PHOTO 1 Description Southwest approach guardrail damage.

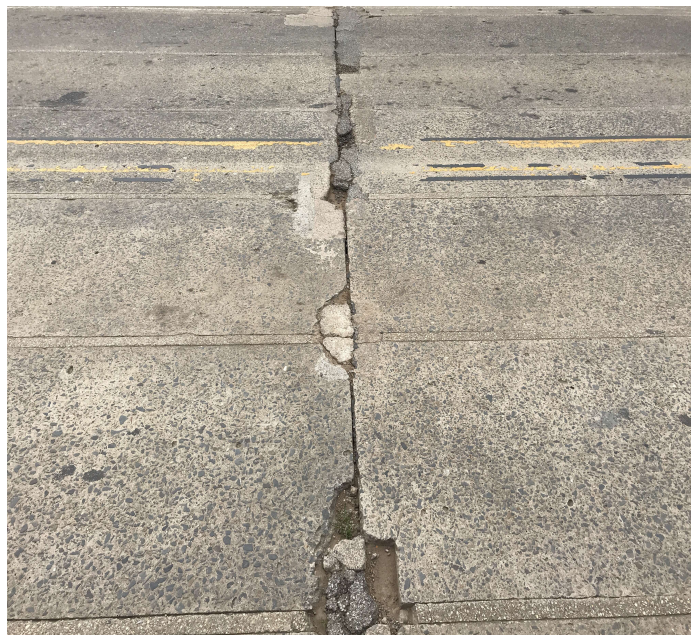
The transverse grouted joints at the ends of the pre-cast channel units over the intermediate bents have grout deterioration that has created potholes in the driving surface.

The transverse joints leak water which appears to be contributing to the significant amount of spalling on the bent caps.

PHOTO 1 Description Typical spalling over the intermediate bents.

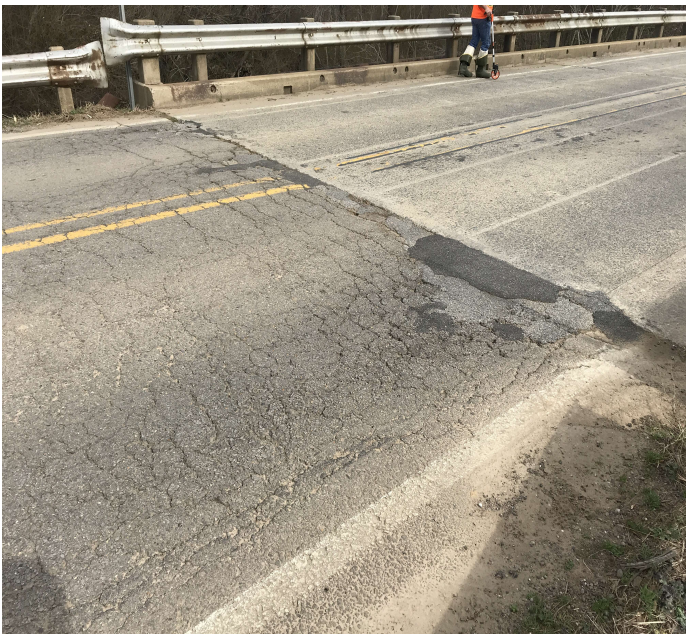
The ACHM driving surface at the east and west approach roadways has settlement and is beginning to break apart with potholes forming adjacent to the bridge ends.

PHOTO 1 Description Achm settlement and break up at the west approach.
