Bridge Inspection Report

05092

**State Highway 80
over
Briscoe Creek -Scott Co.**

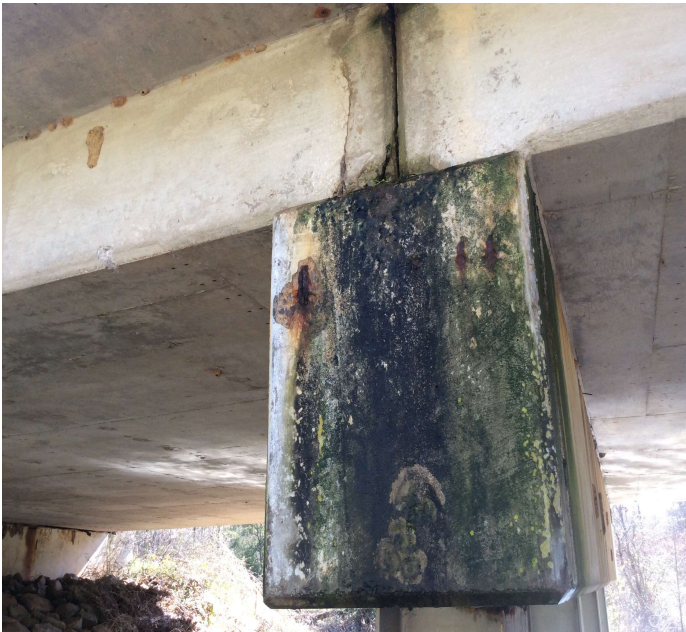
There are spalls with exposed reinforcing steel in the left end of bent number 3 cap.

PHOTO 1 Description North end of Bents 2 & 3 caps have minor golf ball size spalls with exposed reinforcing steel.

02/21/2019 - EJW - Maintenance forces have grout patched the spalling on the undersurface of the cap since the last inspection.

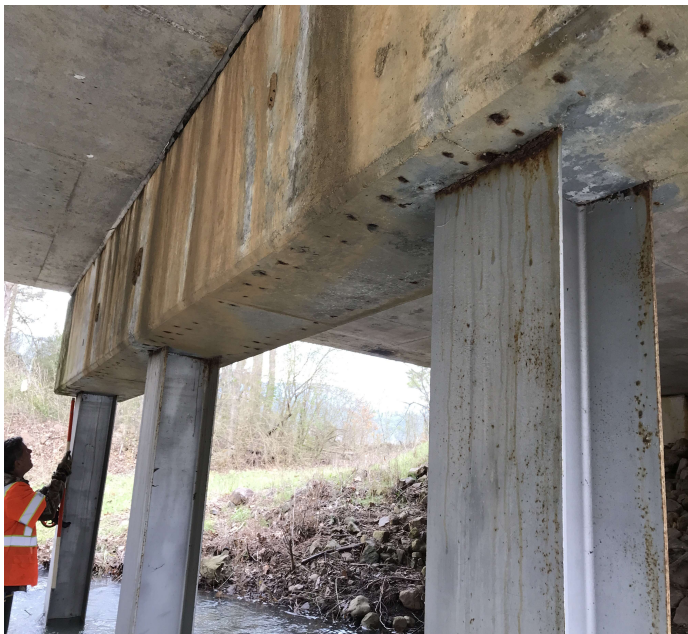
Steel columns have active corrosion with up to approximately 1/8" section loss at the cap juncture, Bent 2 steel piles have active corrosion and pitting on the bottom portion near the water line.

PHOTO 1 Description Bent # 3 active corrosion with minor section loss at the cap juncture.

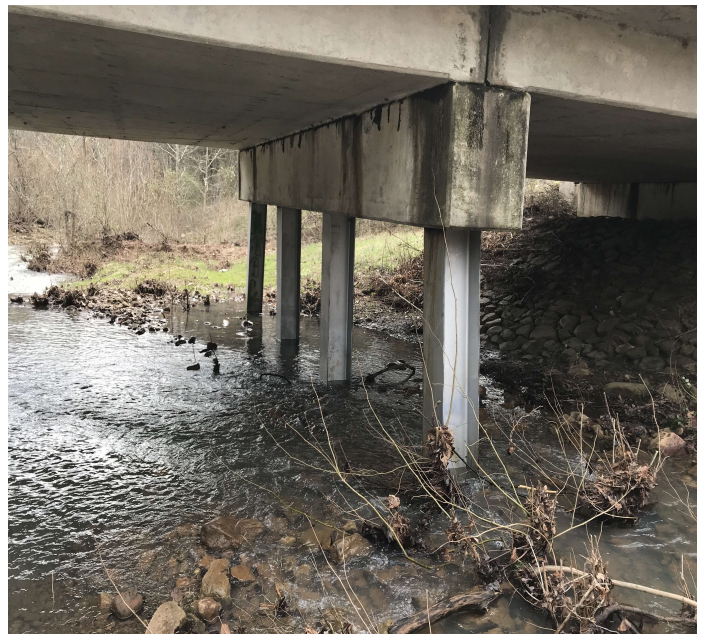
PHOTO 2 Description Typical paint system on the pile.

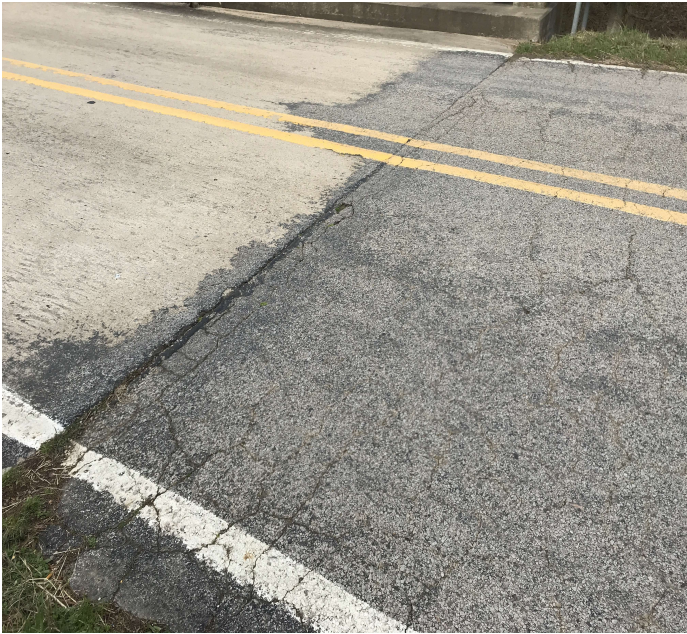
Minor asphalt settlement at the east approach.

PHOTO 1 Description East approach minor achm settlement.

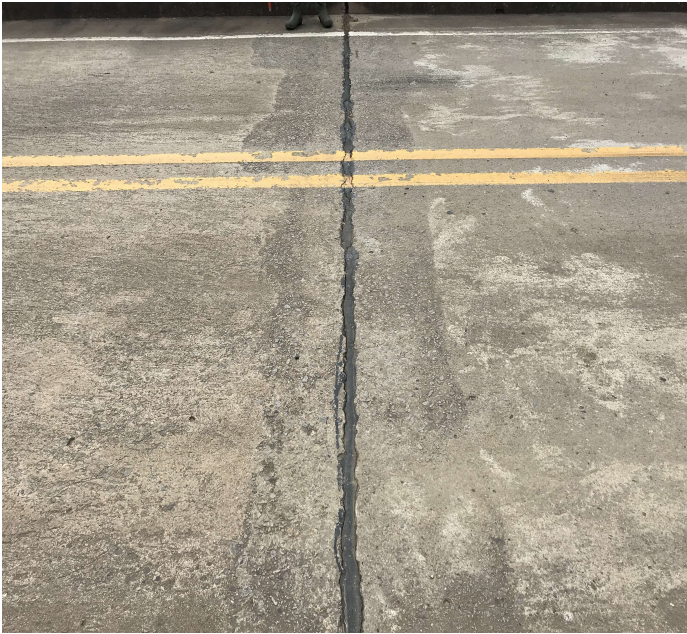
The deck joint seals have adhesion failures and leak water on the substructure.

PHOTO 1 Description Bent # 2 joint seal adhesion failure.
