# Bridge Inspection Report

**05093**  
**SH 80-Scott Co.**  
**over**  
**Dutch Creek**

02/22/2017 JPB & SPC-Routine and Underwater Type 2 Inspections conducted on this date.

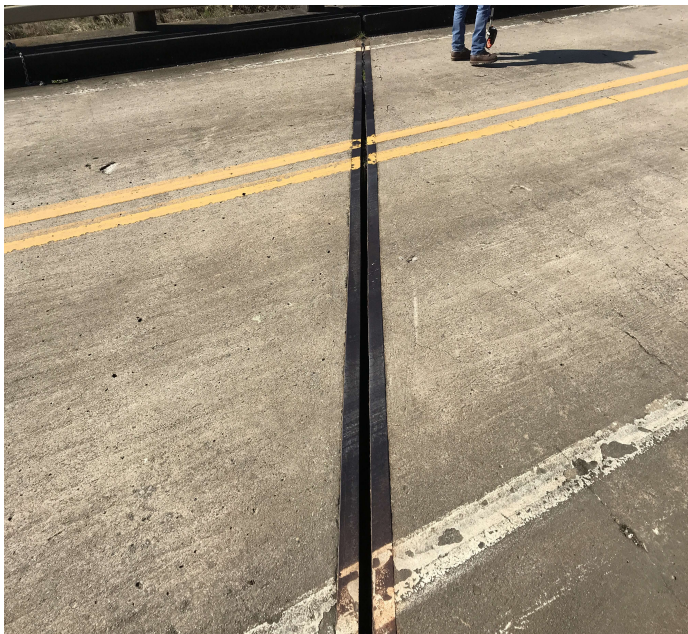
Expansion joint compression seals are deteriorated in all expansion joints. The compression joint seals are sagging in many locations and has dropped down in numerous locations.

PHOTO 1      Description      Bent # 4 joint seal failure.

**Work Code:** Replace

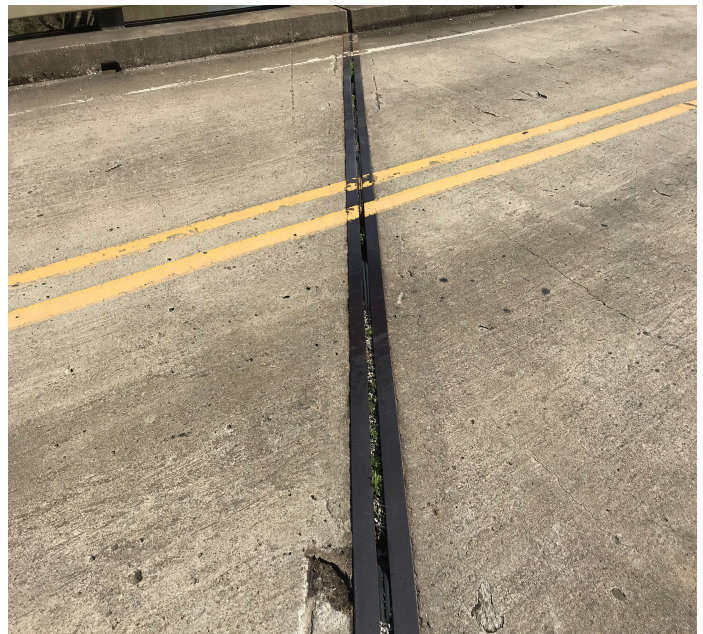
PHOTO 2      Description      Bent # 3 joint seal deterioration.

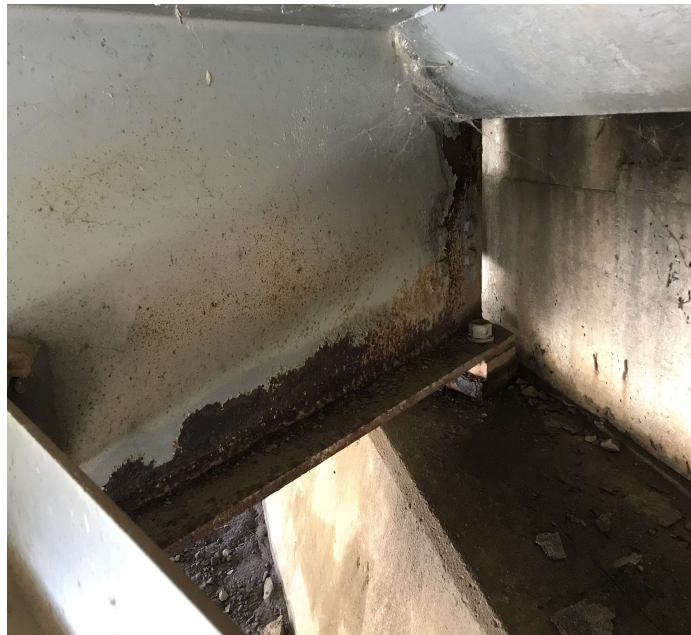
Superstructure has a failing paint system with areas of active corrosion. There is up to 1/8" section loss to the bottom flanges at this inspection. The ends of beams and bearing devices have flaking rust to the bottom flanges of beams and between the sole plates and masonry plates of bearing devices.

PHOTO 1      Description      Active corrosion at the Beam ends typical.

**Work Code:** Repair

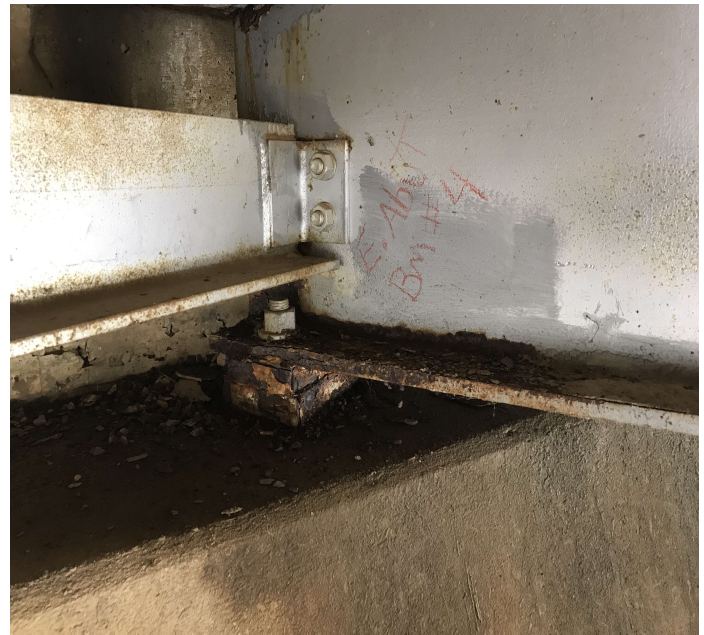
PHOTO 2      Description      Bent # 5 Beam # 4 active corrosion with layers of flaking rust.

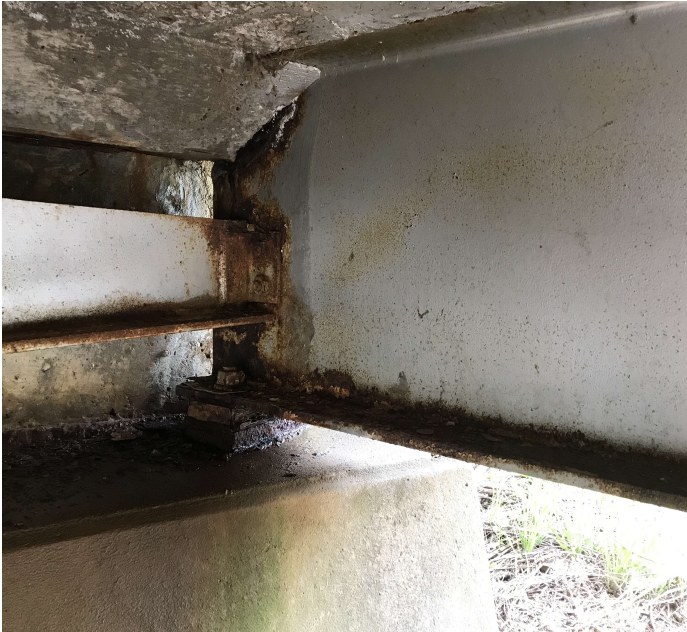
PHOTO 3	Description	Bent # 5 Beam # 5 layers of flaking rust.
---------	-------------	---

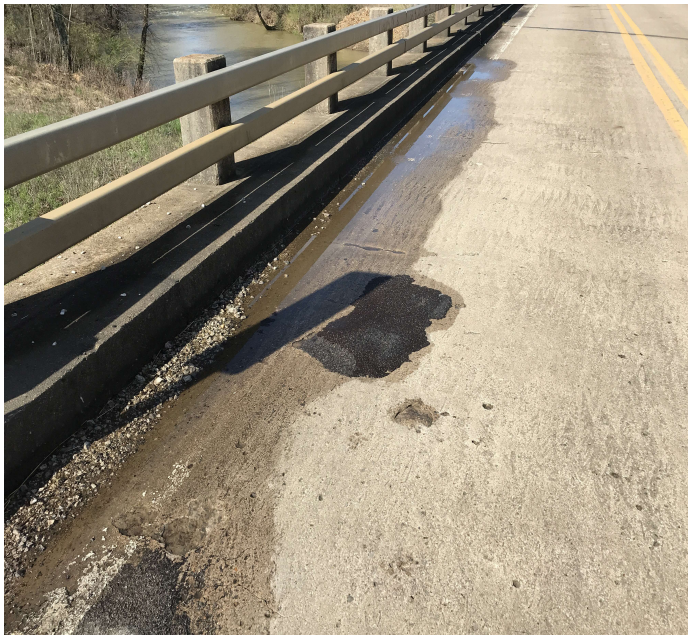
There are sealable deck cracks in all spans. The driving surface of the deck has shallow spalling with exposed reinforcing steel. The gutter on the left side of span # 1 has an area of soft and deteriorated concrete with delaminated areas. The overhang portion of the deck has areas of spalling with exposed reinforcing steel around the deck drains.

PHOTO 1      Description      Span # 4 Rt spalling, delamination and temporary asphalt patches.

Work Code: Repair

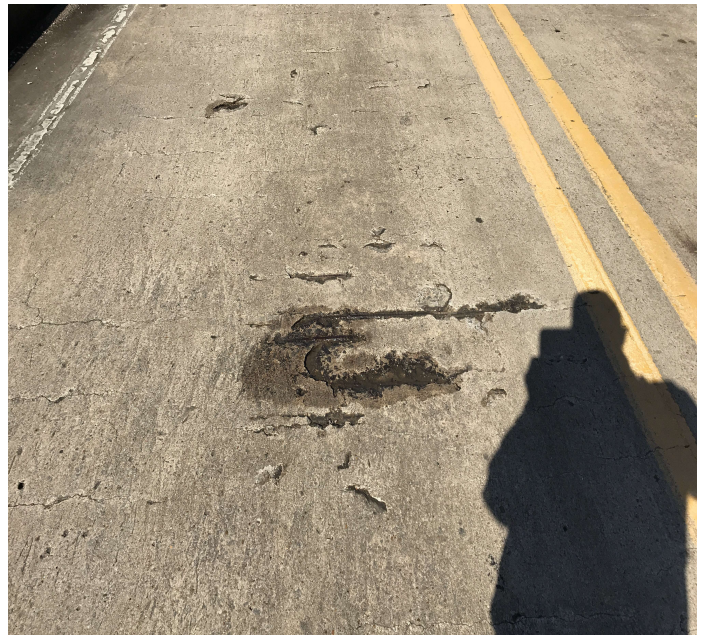
PHOTO 2      Description      Span # 3 Rt spalling with exposed reinforcing steel.

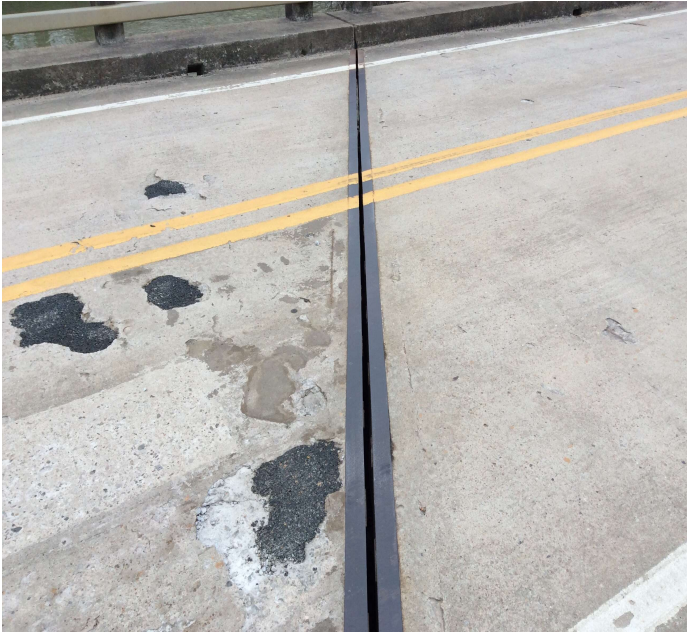
PHOTO 3 Description Bent 2 deck joint seal missing

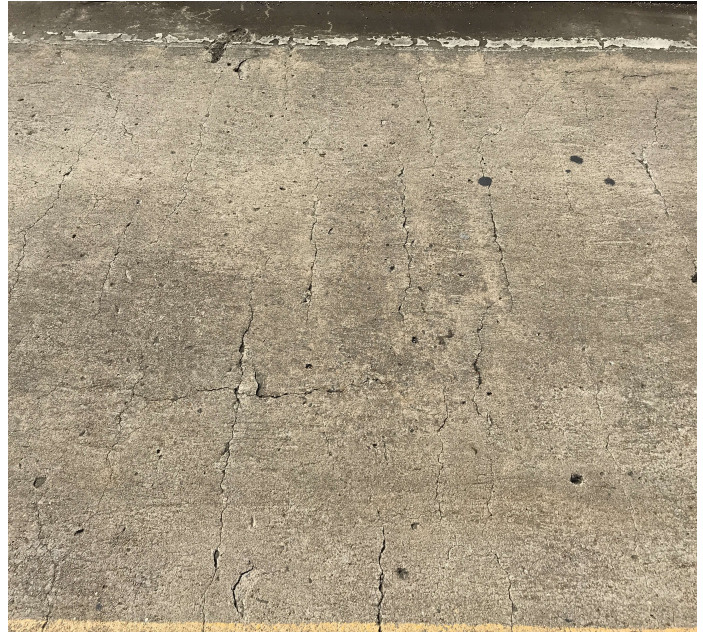
PHOTO 5 Description Sealable deck cracking.

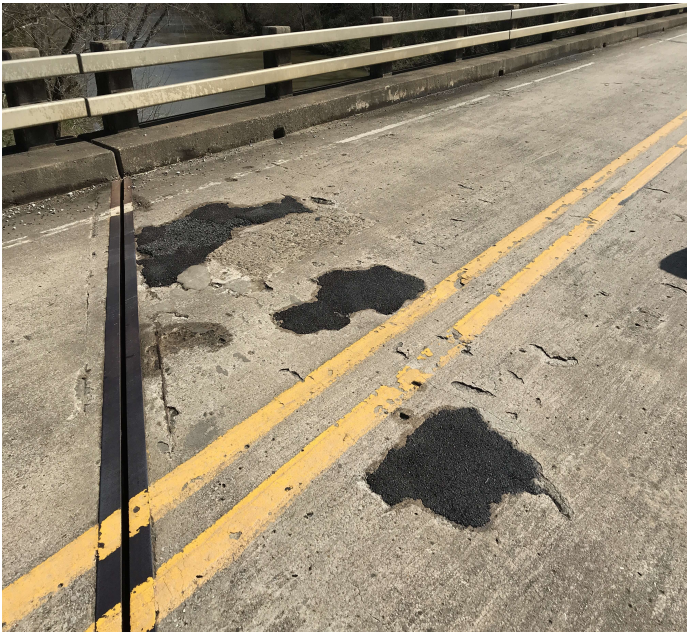
PHOTO 4 Description Span # 2 adjacent to Bent # 2 spalling with exposed reinforcing steel and numerous deteriorating repairs.

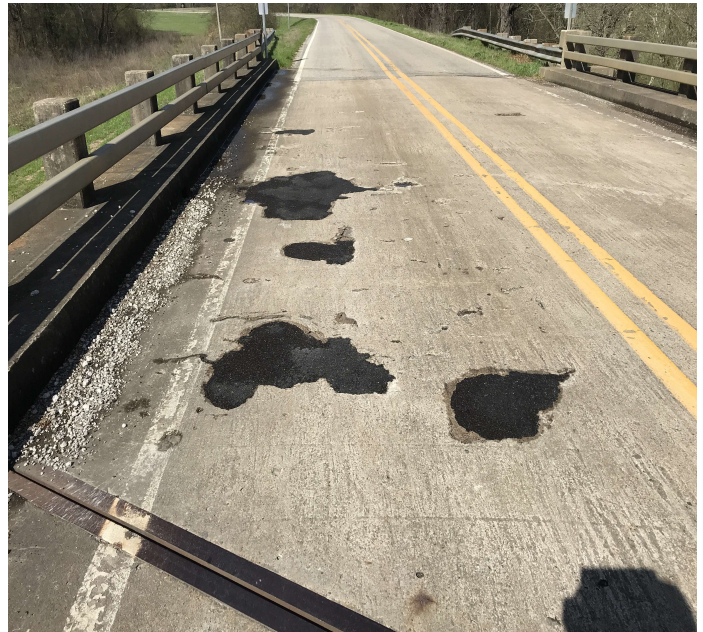
PHOTO 6 Description Span # 1 Rt temporary asphalt patches.

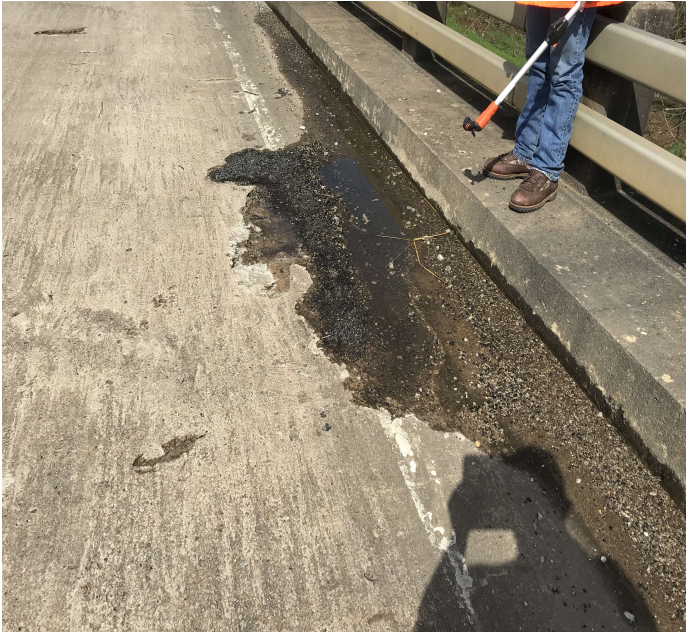
PHOTO 7      Description      Span # 1 Lt spalling in the gutter.

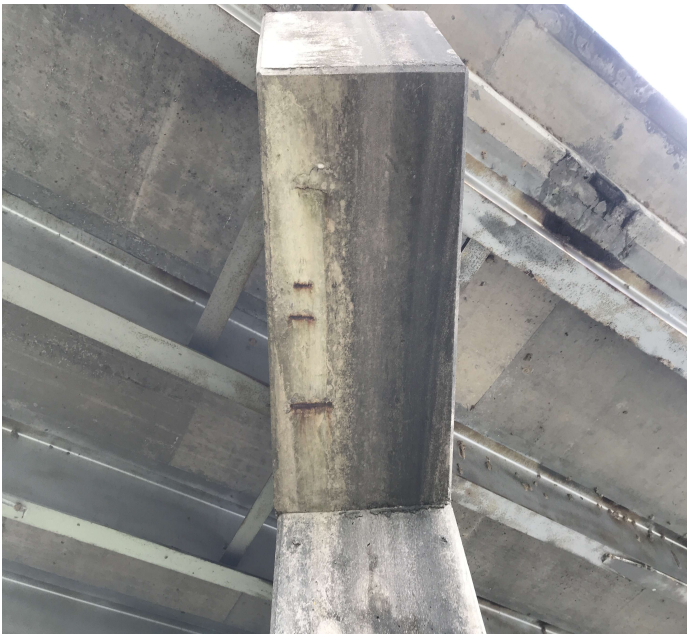
Bent # 2 has shallow spalling with exposed reinforcing steel in the undersurface of the bent cap on the right side.

PHOTO 1      Description      Bent # 2 Rt undersurface of the cap.

**Work Code:** Repair
