Bridge Inspection Report

M1477
SH 80-Scott Co.
over
Freedom Creek

Structure Number: M1477

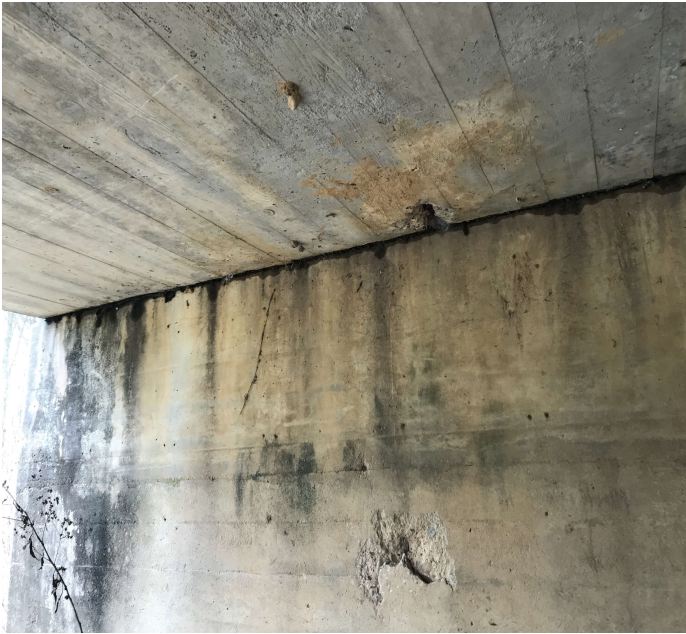
The undersurface of Span # 2 & 3 has an area of shallow spalling with exposed reinforcing steel adjacent to Bent # 2 & 3.

PHOTO 1 Description Span # 2 & 3 shallow spalling with exposed reinforcing steel on the undersurface of the slab.

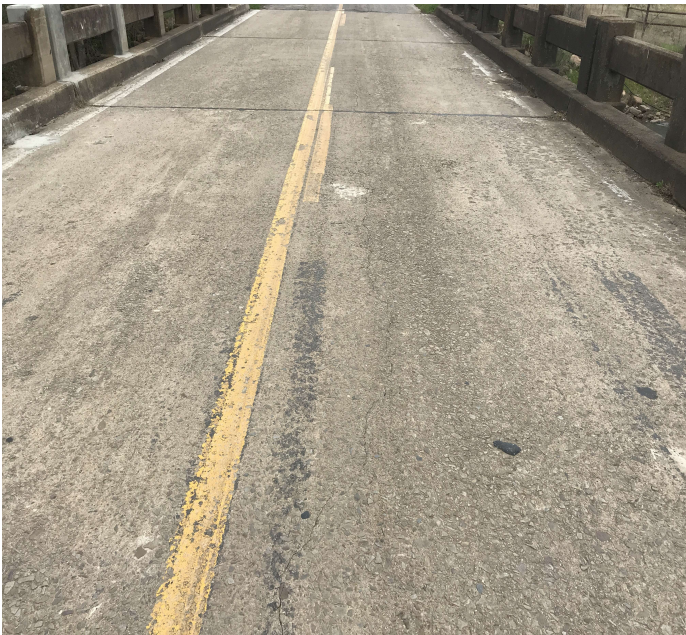
The deck/superstructure has sealable longitudinal cracking in spans # 1 and # 2 that are visible in the driving surface and in the undersurface suggesting full depth cracking. The undersurface has staining along the cracks that indicate corrosion of the reinforcing steel.

PHOTO 1 Description Sealable deck cracking.

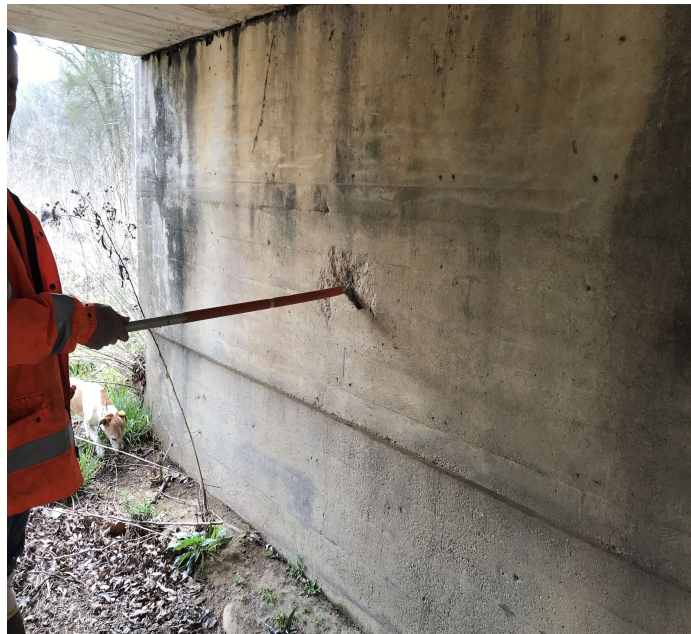
Bents # 2 & 3 pier walls have areas of spalling with exposed reinforcing steel.

PHOTO 1 Description Bent # 2 Span # 2 spalling with exposed reinforcing steel.

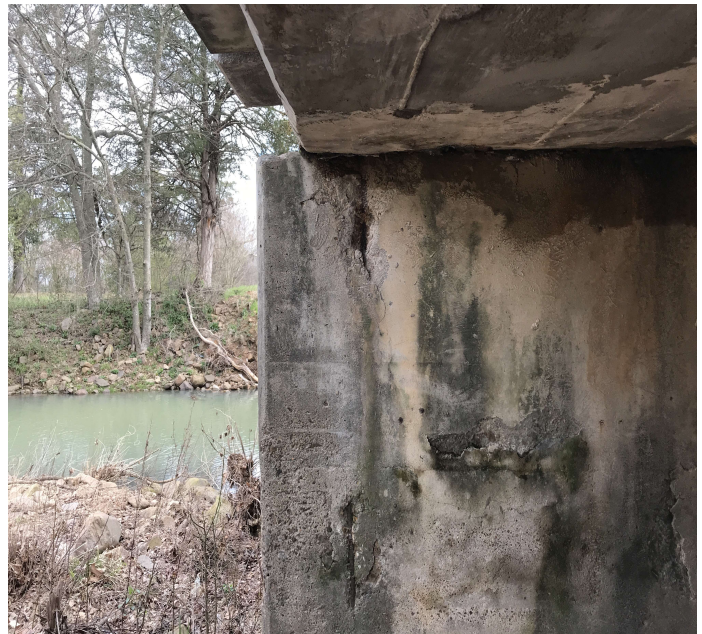
PHOTO 2 Description Bent # 2 Lt spalling with exposed reinforcing steel.

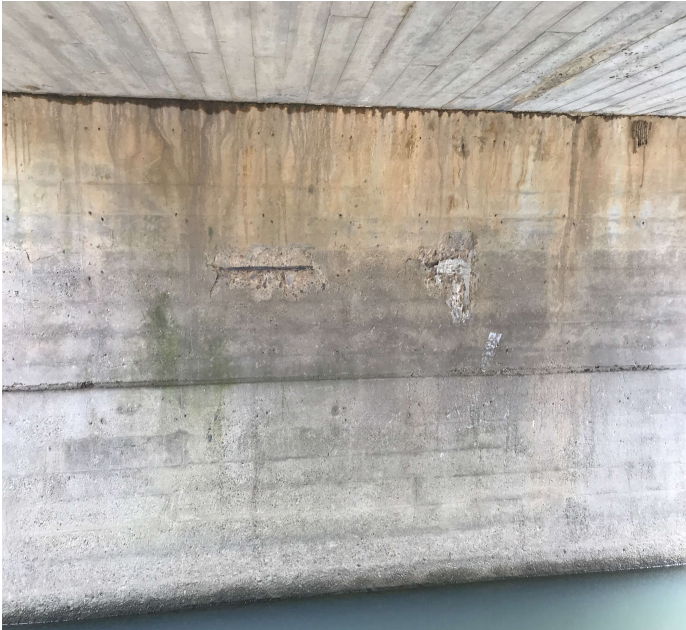
PHOTO 3 Description Bent # 3 Span # 2 spalling with exposed reinforcing steel.

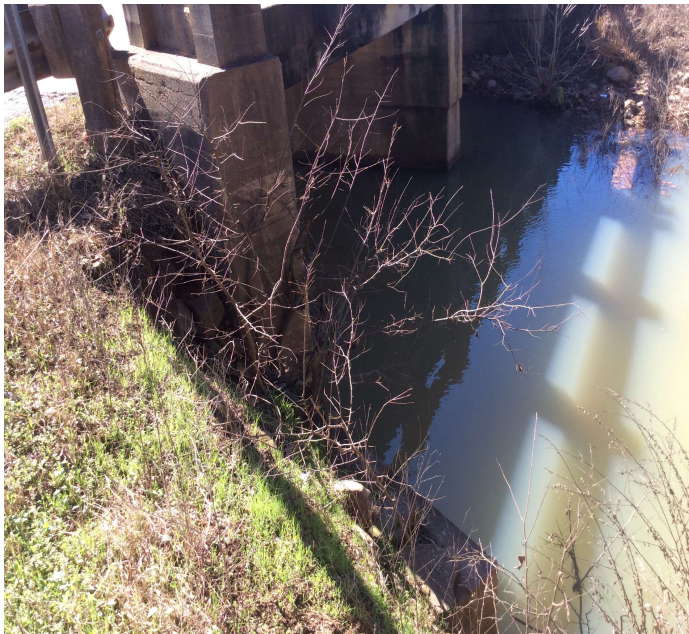
Some erosion with loss of rip-rap adjacent to the wing walls

PHOTO 1 Description Minor erosion at Bent 4, wing walls. Bent 4 Lt pictured.

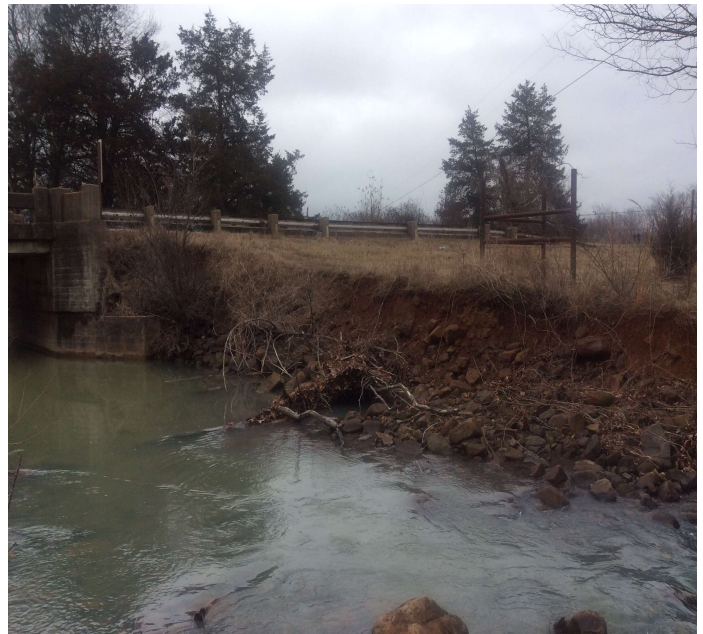
PHOTO 2 Description Some erosion with loss of riprap adjacent to the wingwalls photo of southeast wingwall.

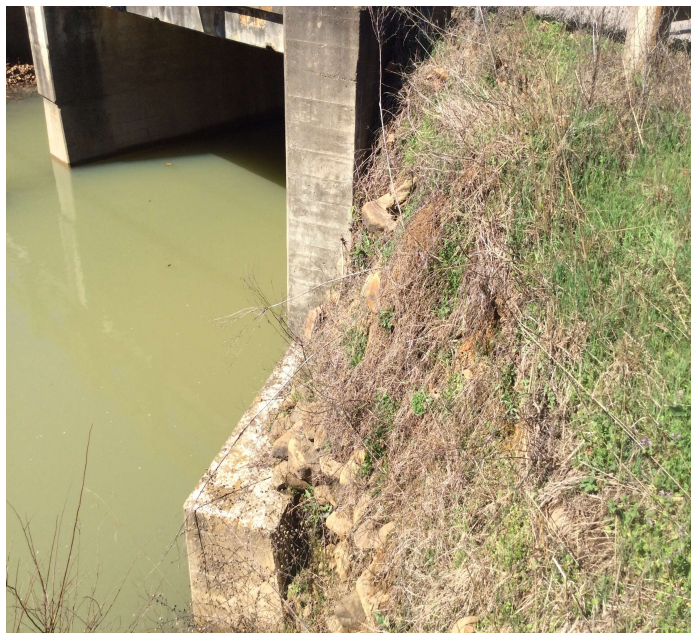
PHOTO 3 Description Minor erosion at Bent 4, wing walls.
Bent 4 Rt pictured.

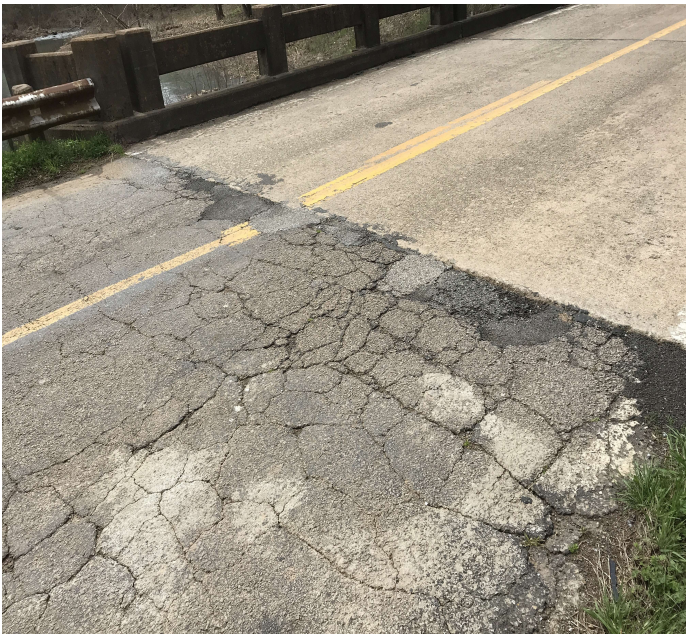
The ACHM at the East approach is breaking apart and has settled adjacent to the end bent.

PHOTO 1 Description Asphalt settlement and deterioration at the east approach.
