Bridge #02012(Routine, Underwater type 2)
State Highway 22 over Dry Fork Branch-Franklin
Location: 8.5 E OF JCT SH 96 & 22

Team Lead: Bob McEntyre Inspection Date: May 13, 2020

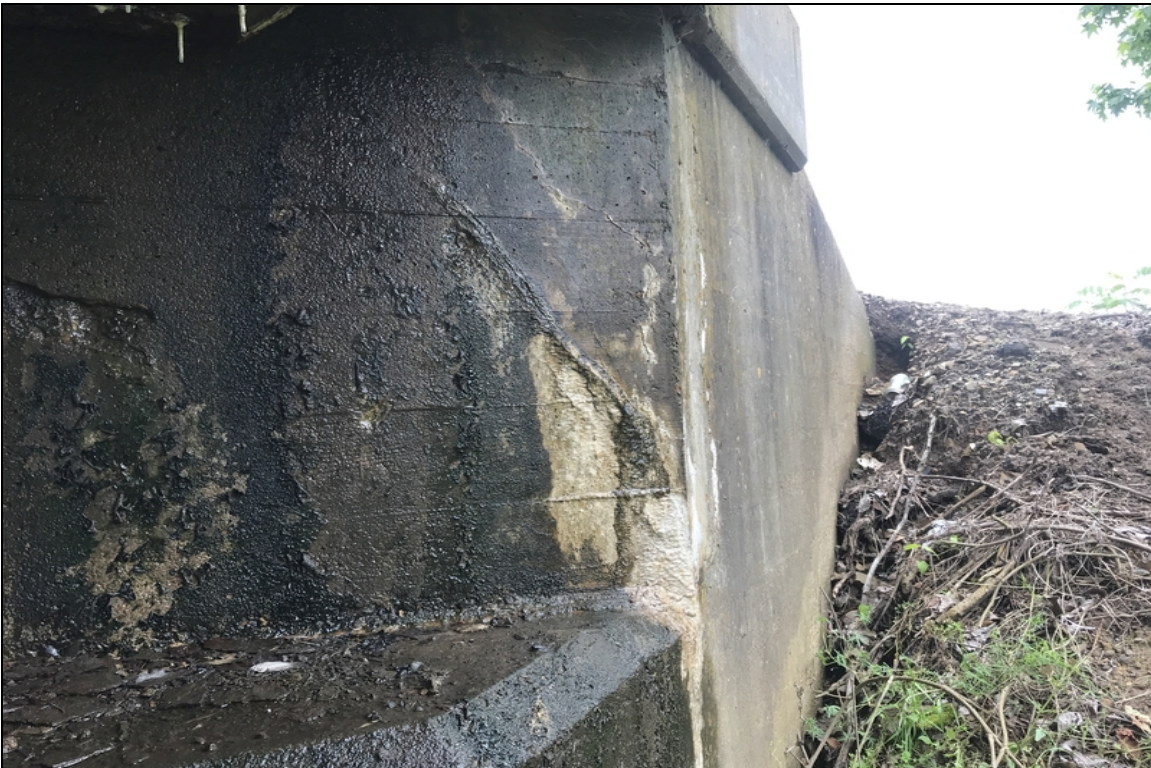
Abutment # 1, left side-Diagonal cracking with efflorescence.

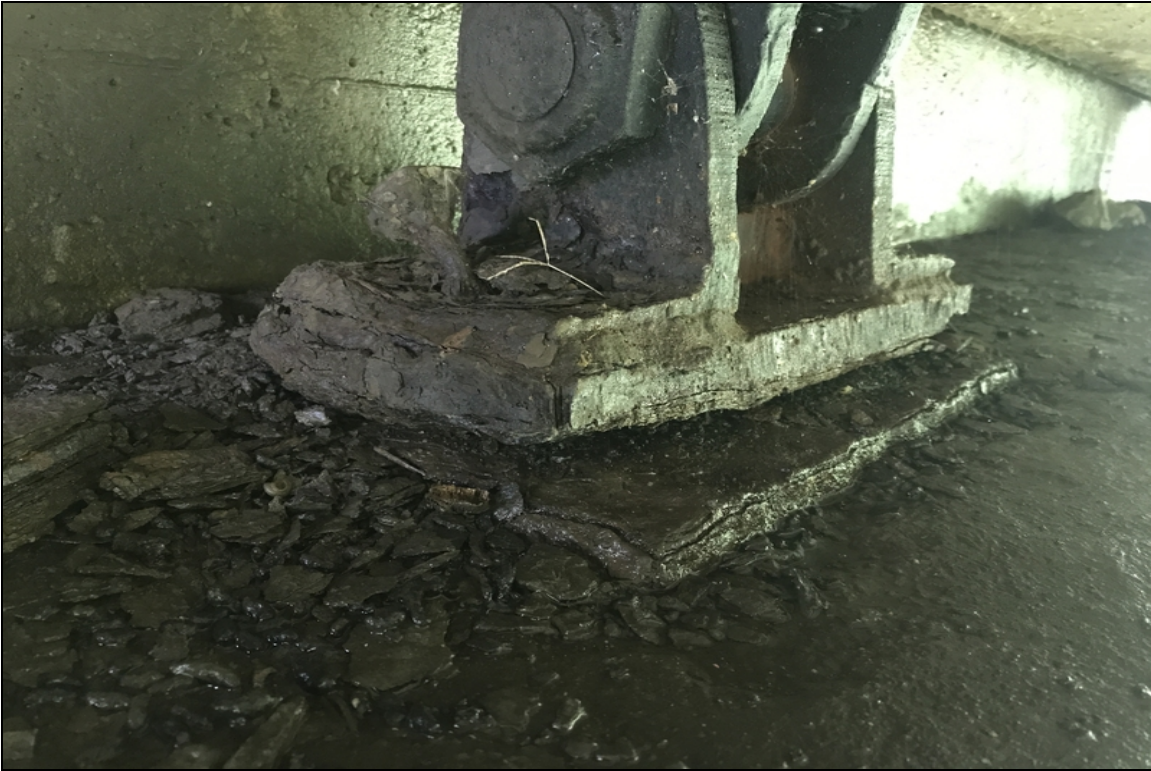
Abutment 1, bearing # 4-Heavy corrosion.

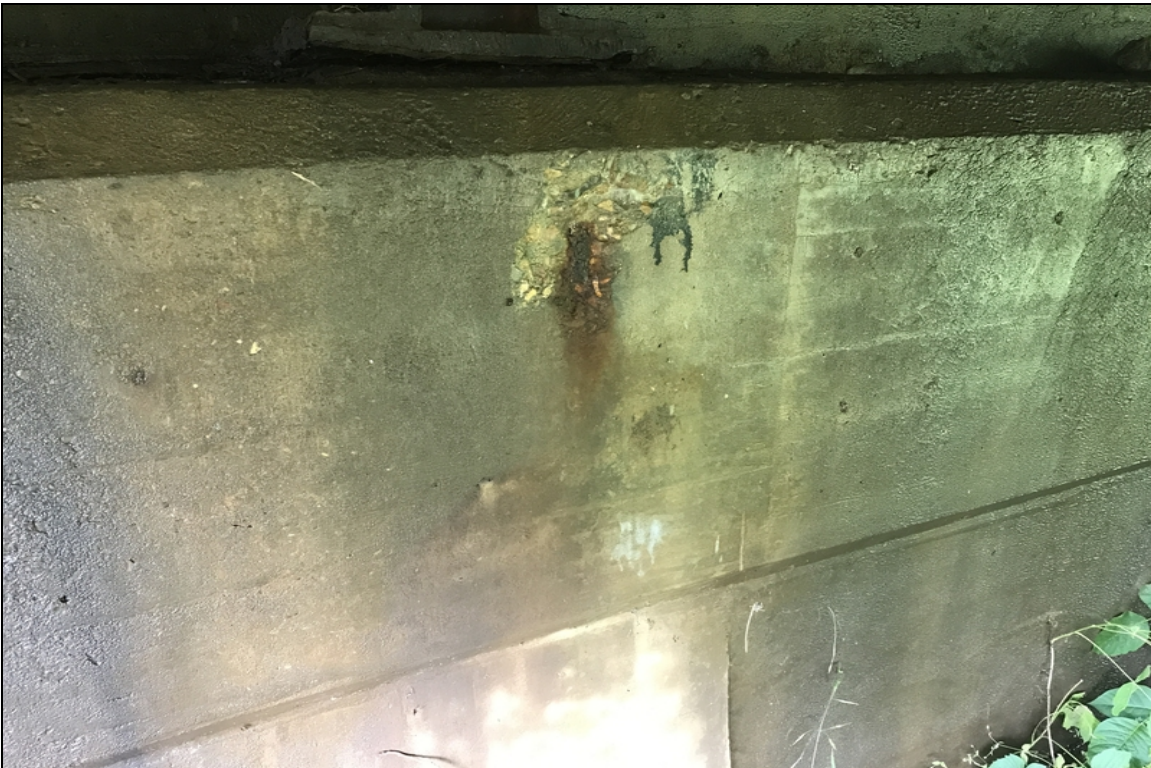
Abutment # 2-Spall with exposed reinforcing steel.

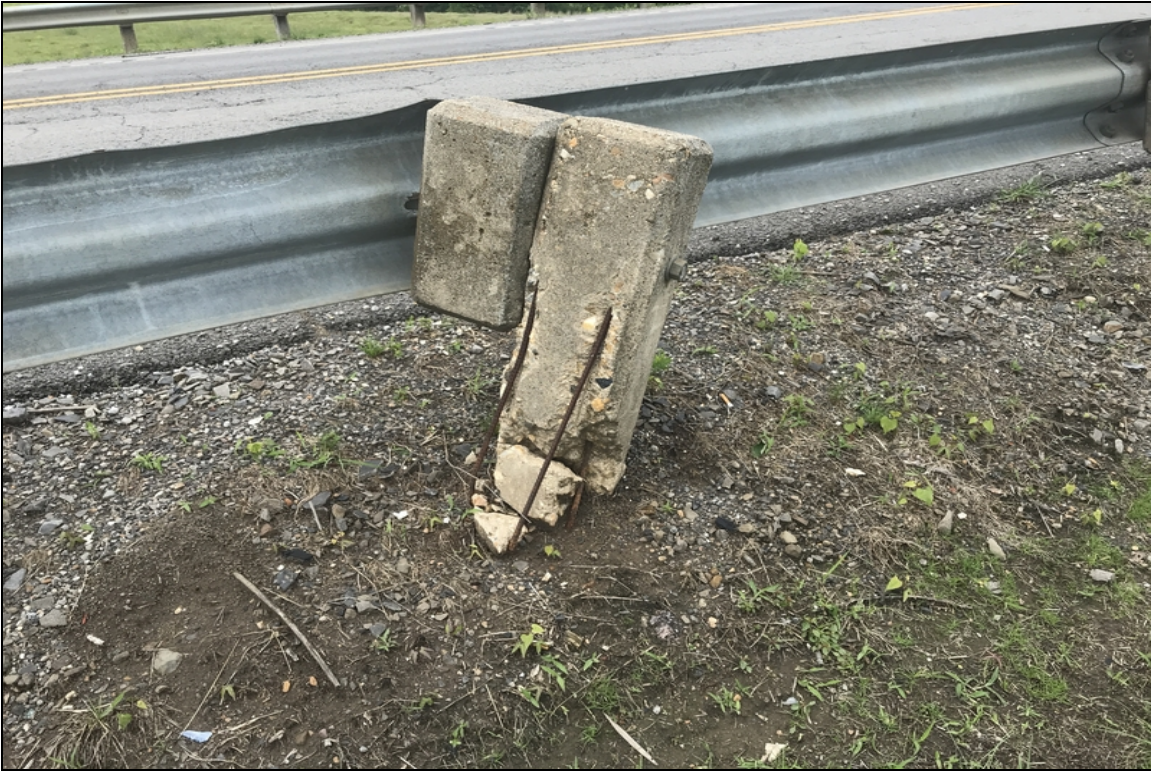
Post # 3 of the Southwest approach railing is broken at the base.

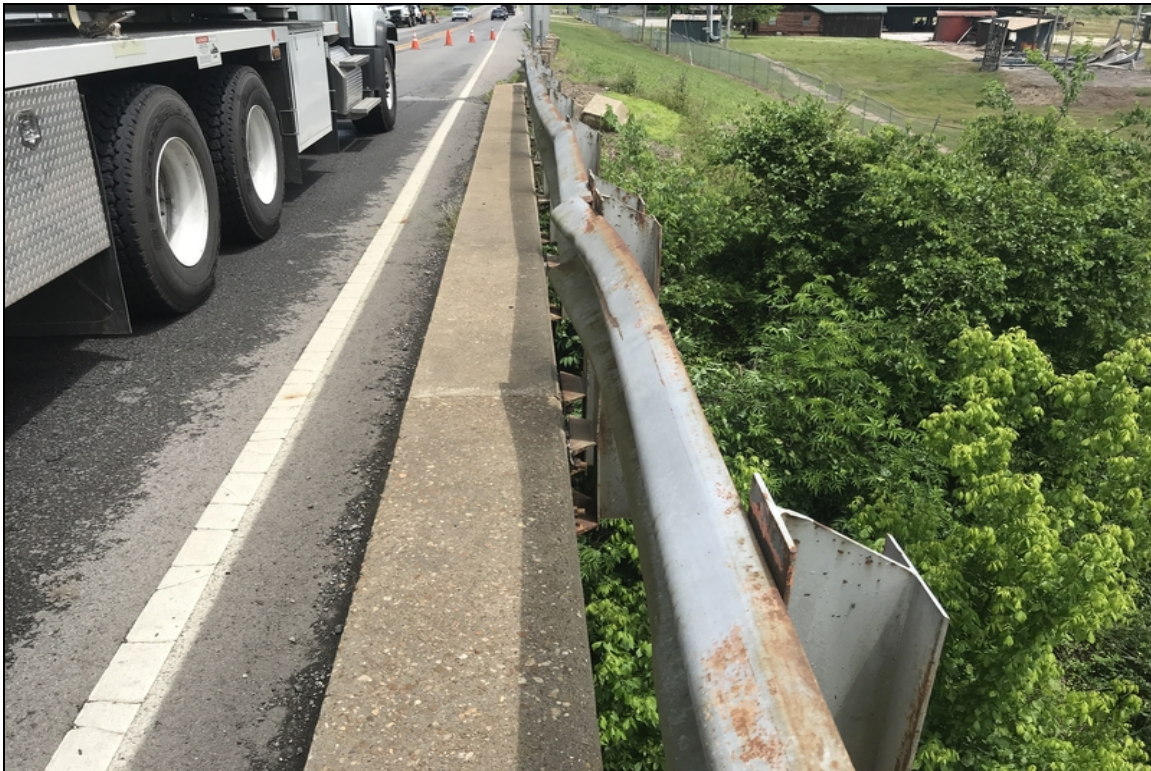
Right bridge railing-Minor collision damage to railing.

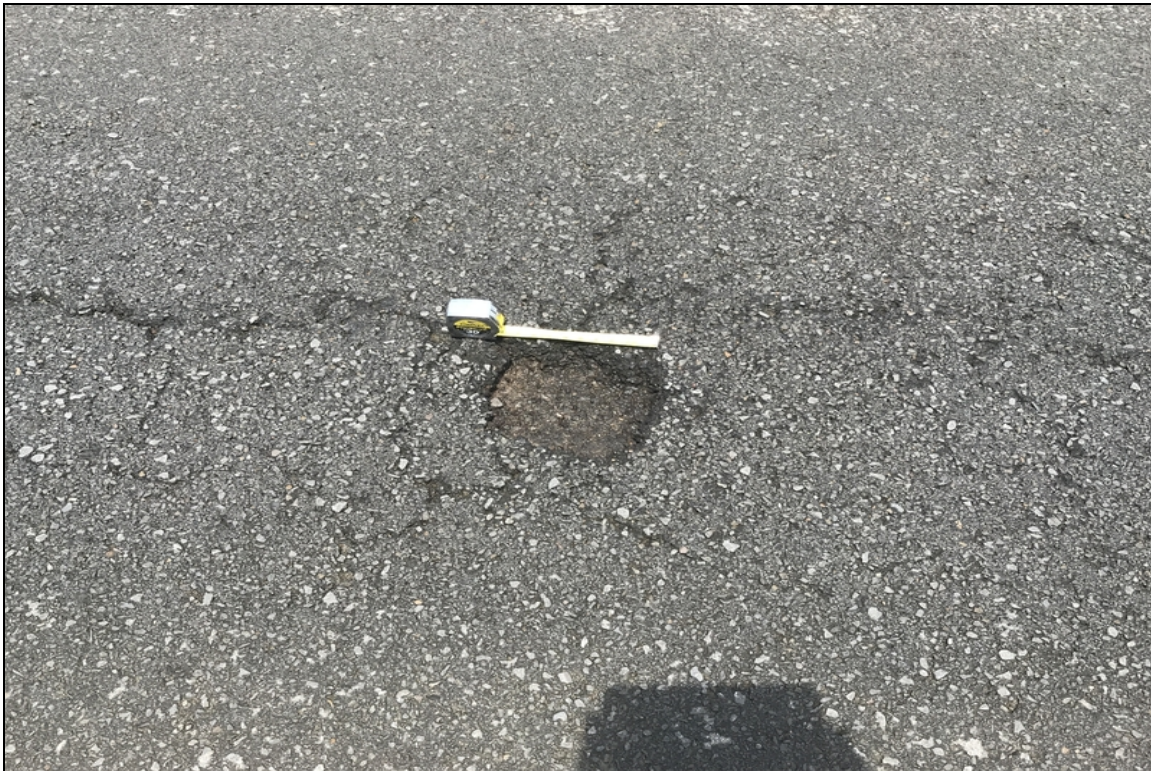
The right lane of span # 2 has an 8" spall in the asphalt driving surface.

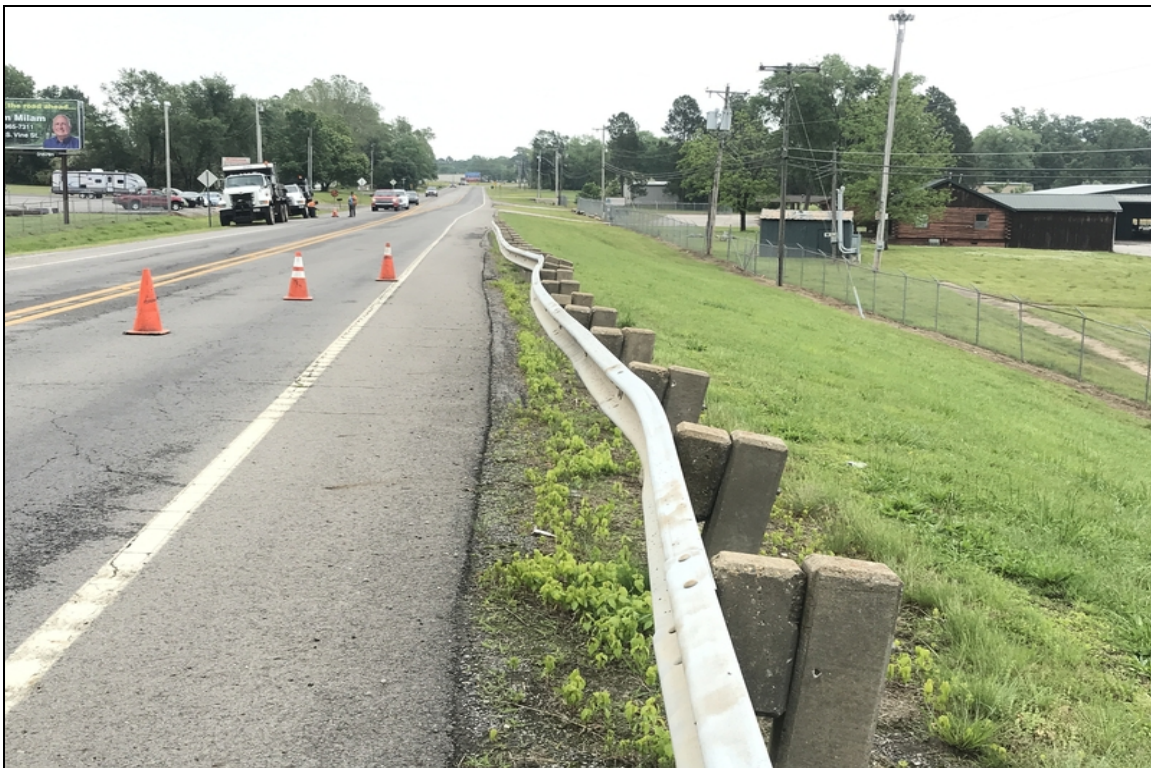
Collision damage to Southeast approach railing.

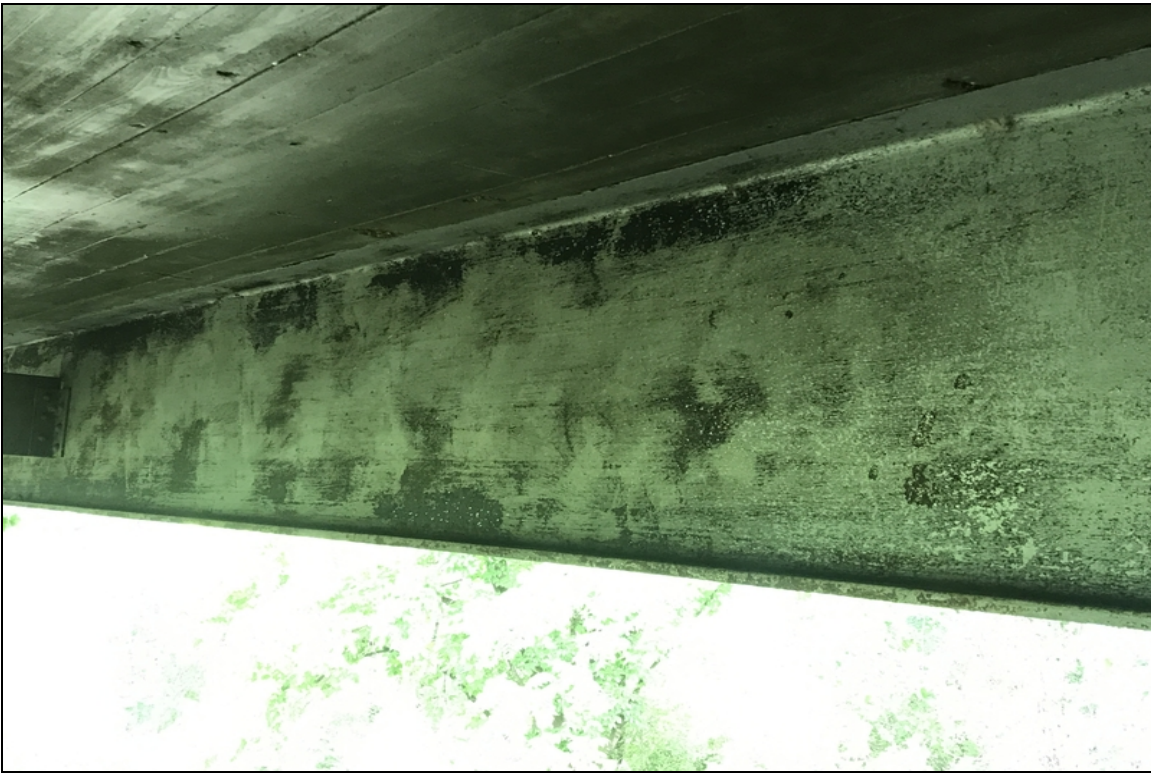
Paint system peeling.

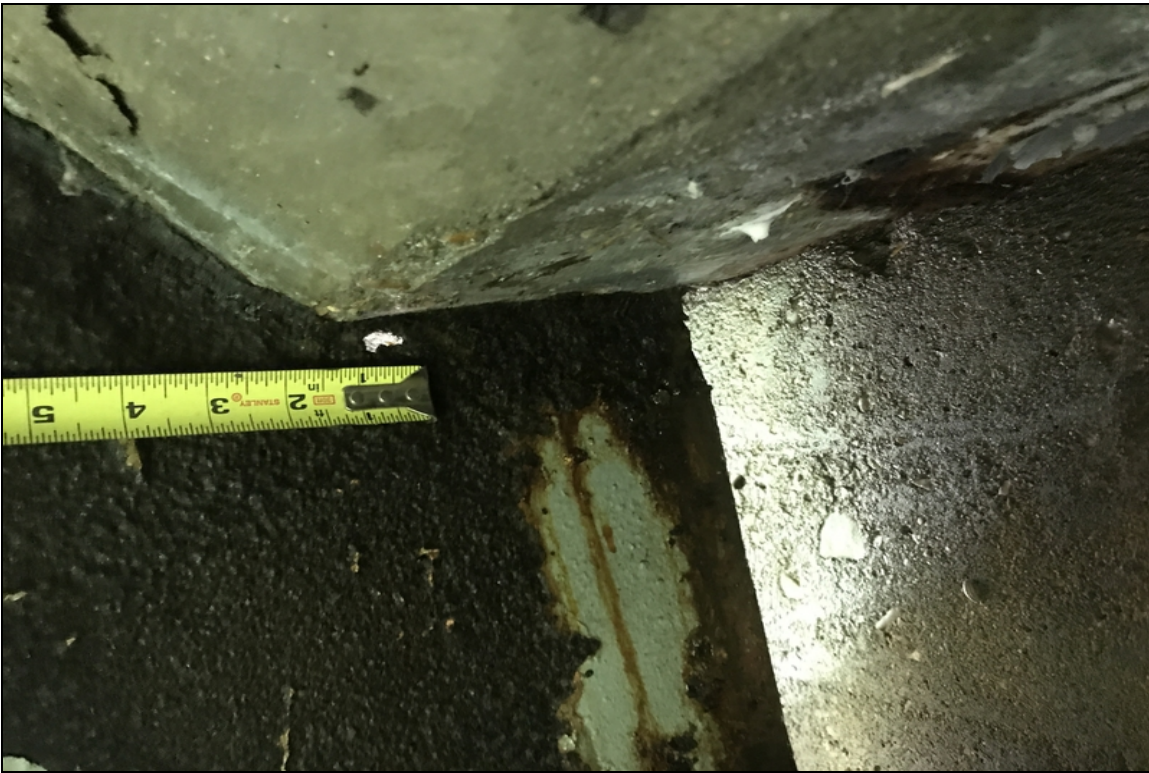
Span # 6, beam # 1 over abutment # 2-Hole rusted through web at expansion dam.

Span # 6, beam # 1 over abutment # 2 has a 1/2" hole rusted through the web at the expansion joint dam juncture. The beam has 1/8" section loss to the bottom flange and up to 3/16" section loss to base of web in the same location.

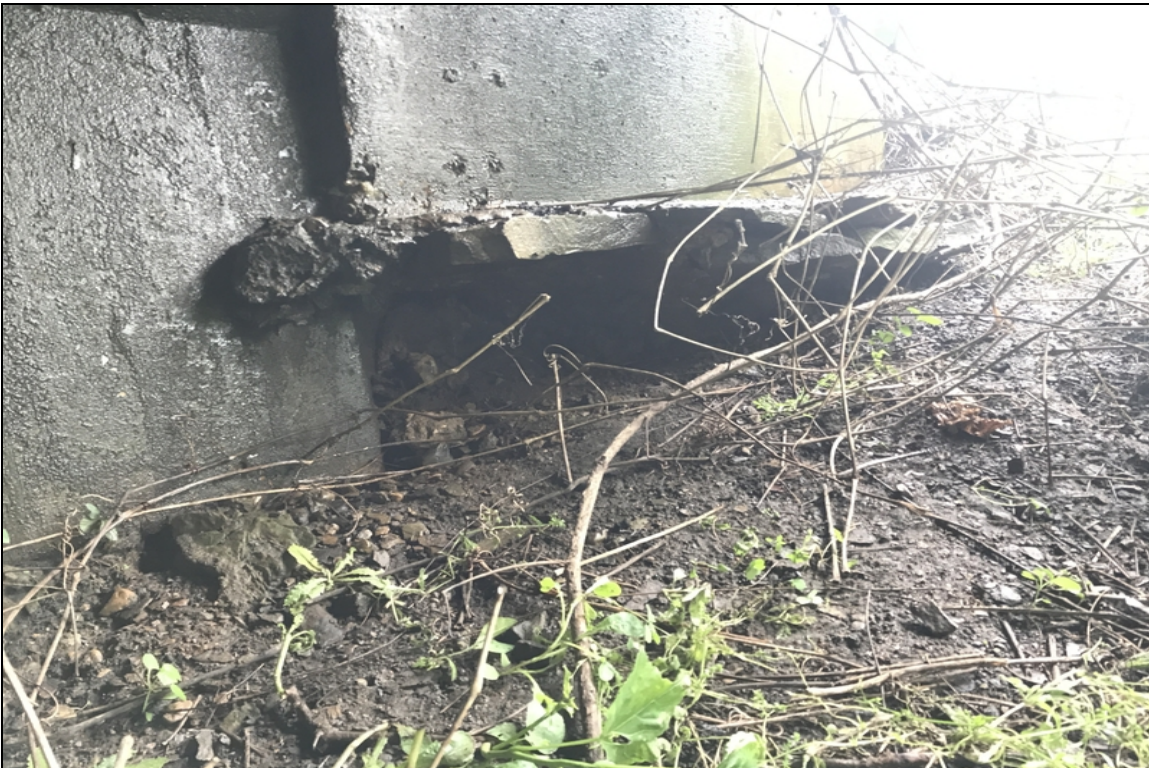
Abutment 2, right side-Minor earth settlement.

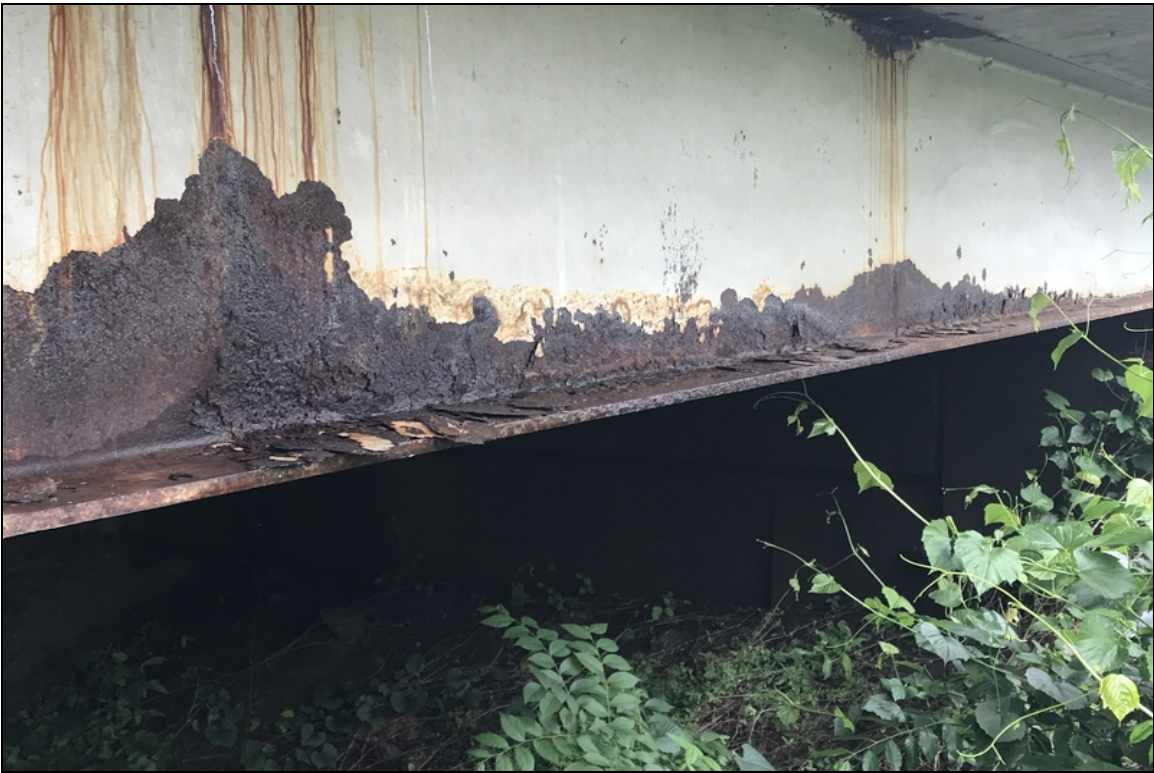
Span # 6, beam # 5-Corroaion.

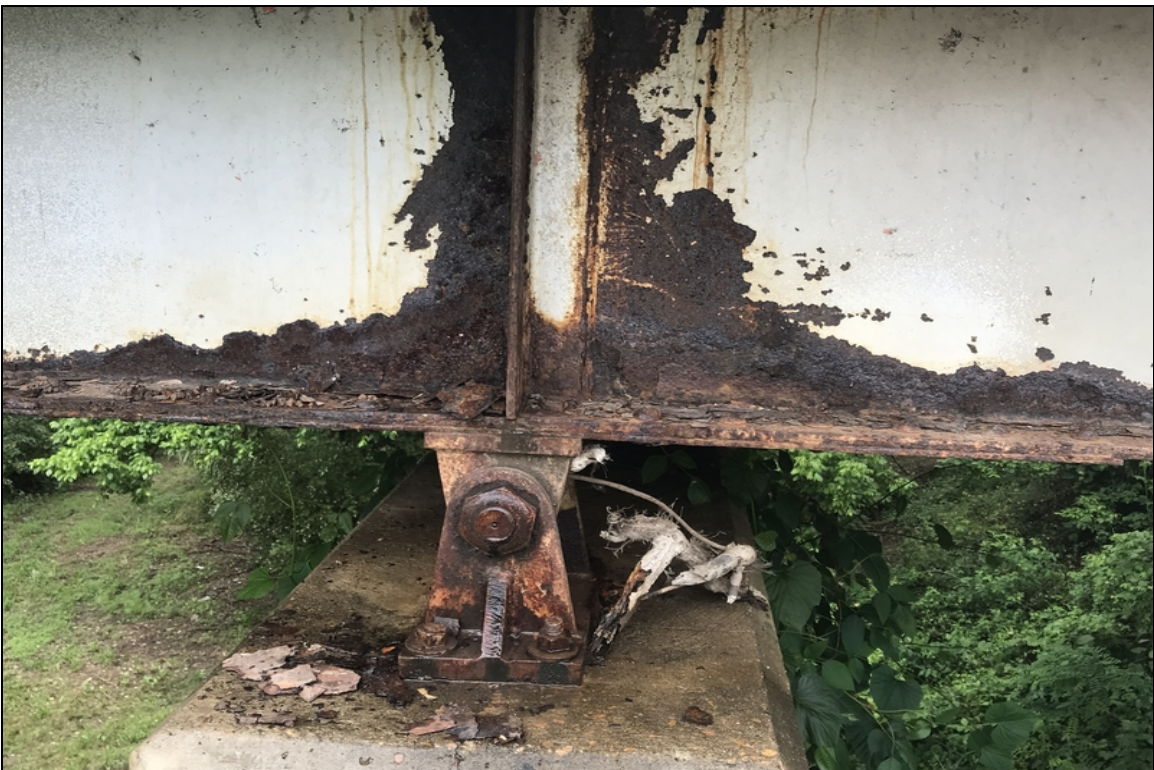
Beam 5 over bent 6-Corrosion.

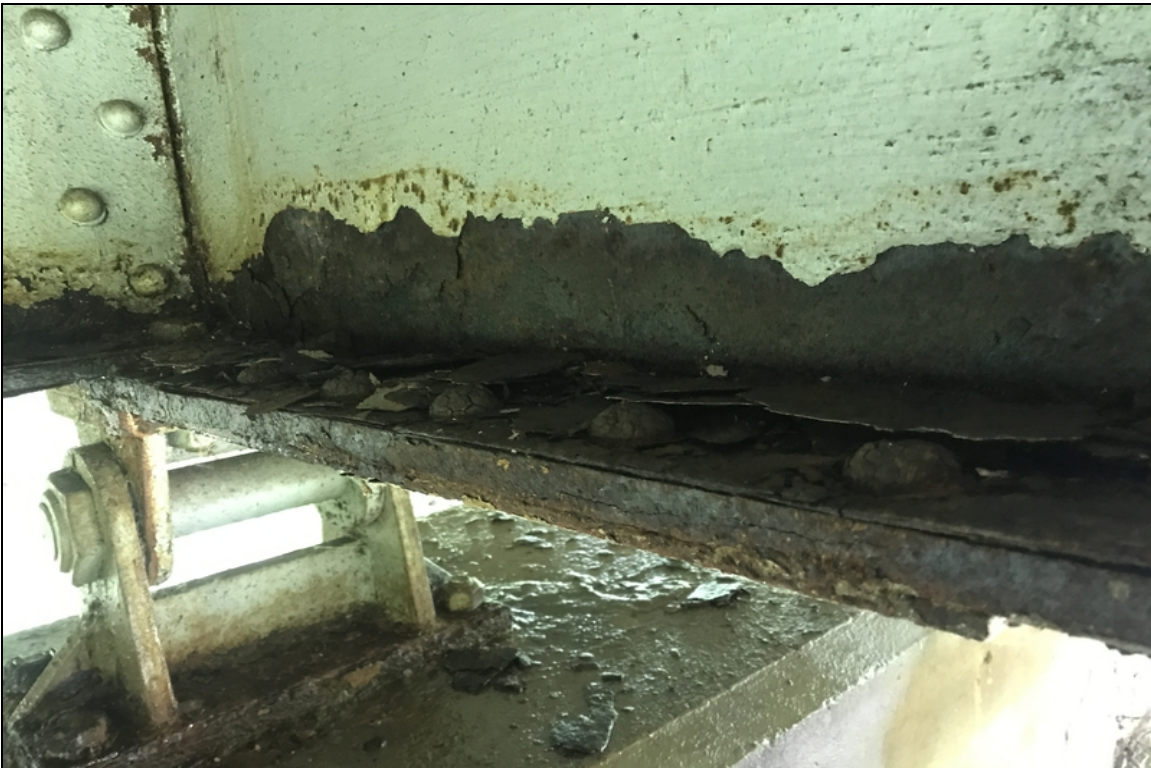
Span 5, beam 3-Corrosion.

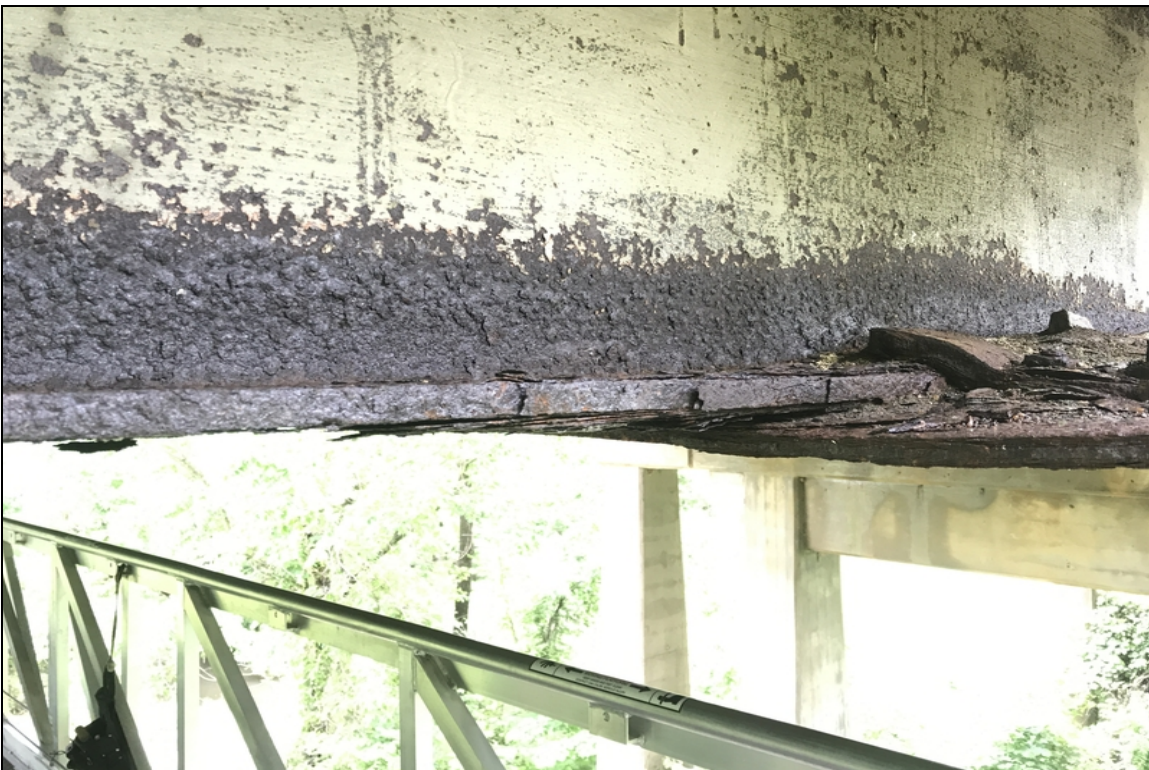
Span 5, beam 1-Corrosion to bottom flange where steel plate is attached.

The steel plate attached to the bottom of beams in span # 5 to deflect locomotive exhaust has heavy dirt and debris accumulation on the left exterior side that has accumulated against the Superstructure. Partial dirt / debris removal revealed significant corrosion with an undetermined amount of section loss to the base of web and bottom flange of beam. Heavy flaking rust is visible along the bottom flange and base of web.

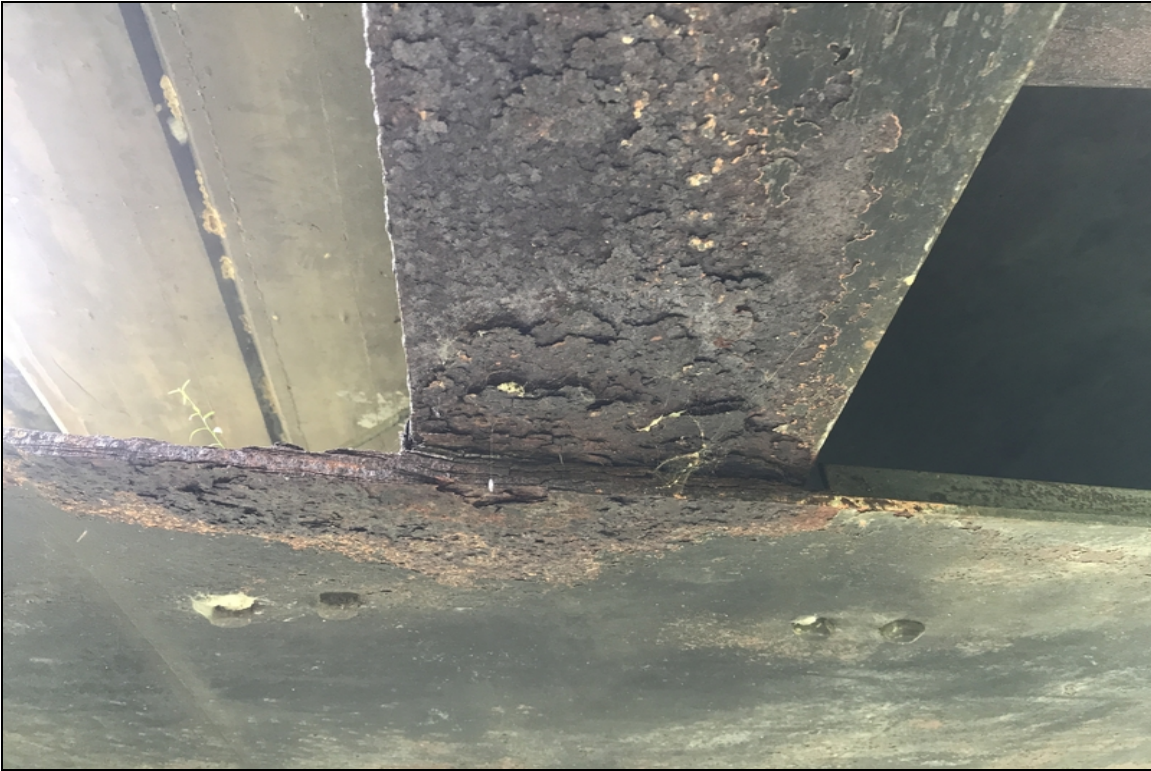
Span 5, beam 1-Corrosion to bottom flange where steel plate is attached.

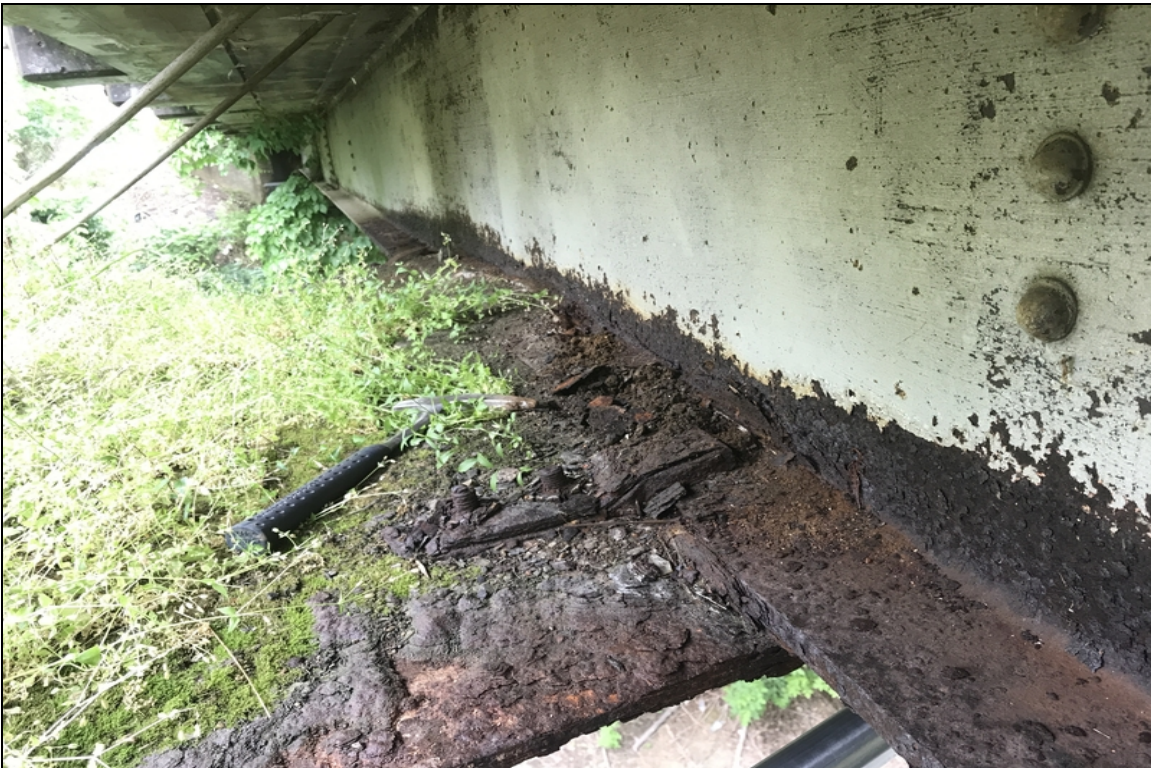
Span 5, beam 1-Heavy corrosion where steel plate is attached To bottom of beams.

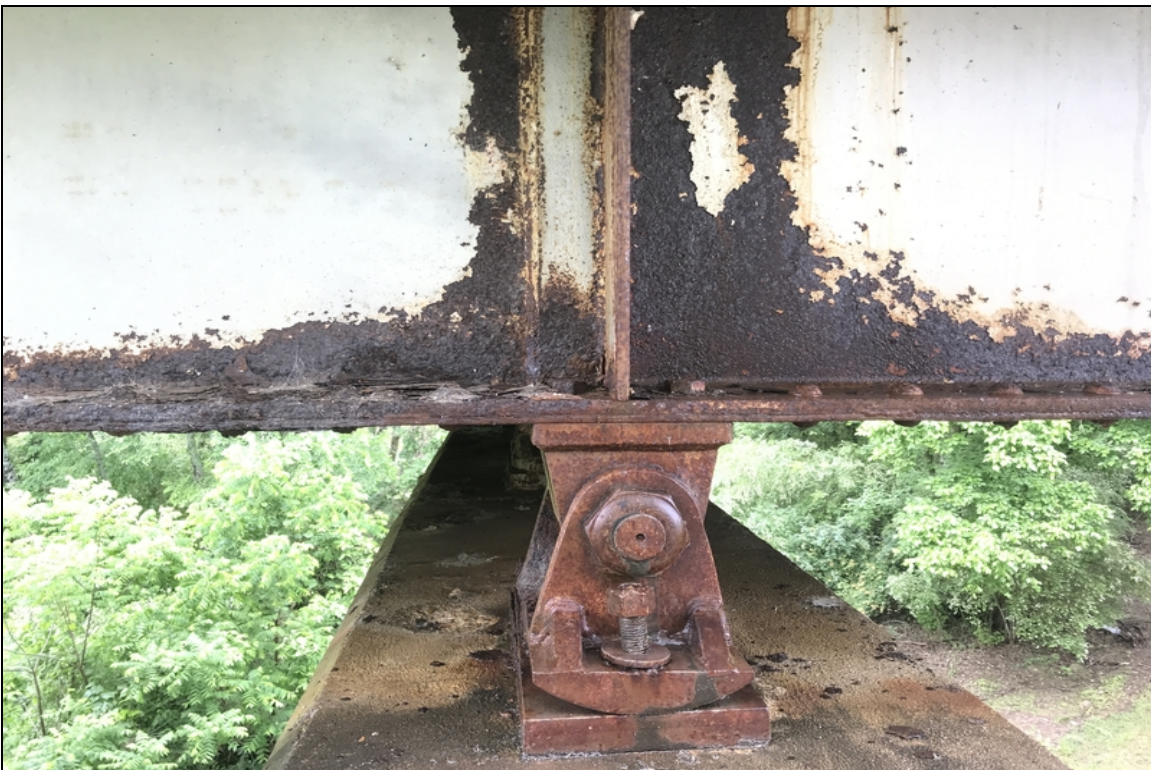
Beam 5 over bent 5-Corrosion.

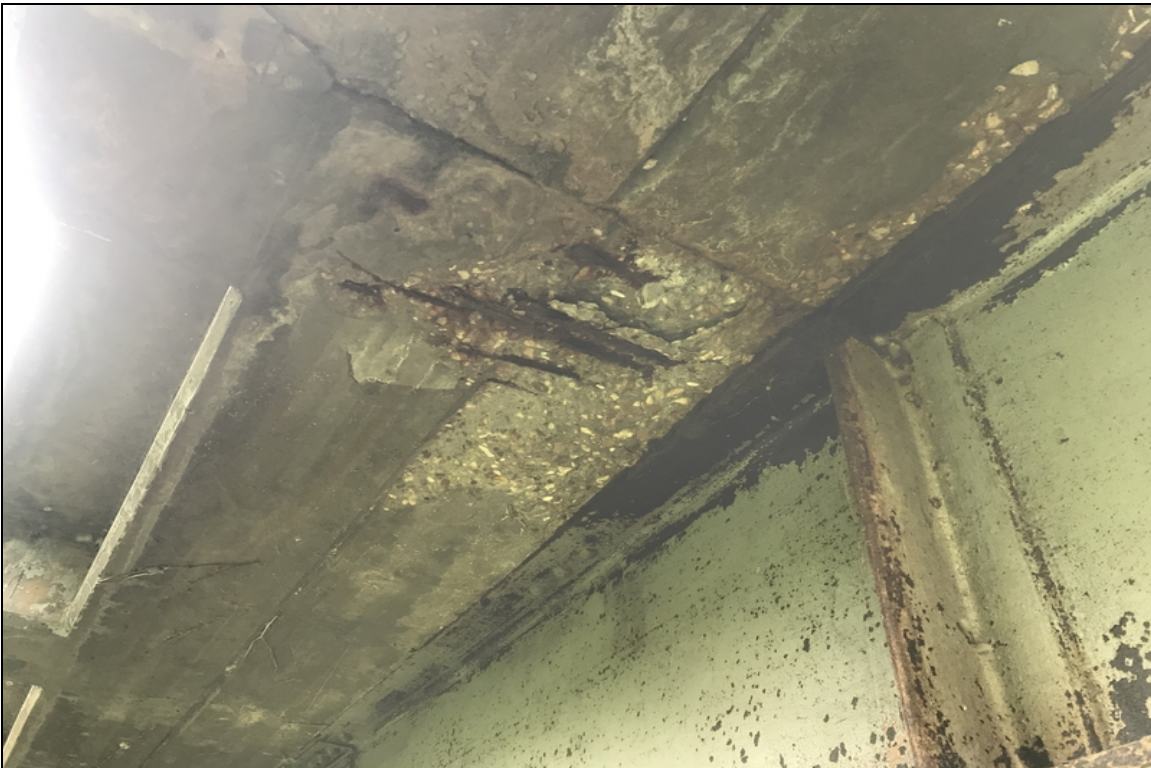
Left deck overhang, span 5 over bent 5-Spalling with exposed reinforcing steel.

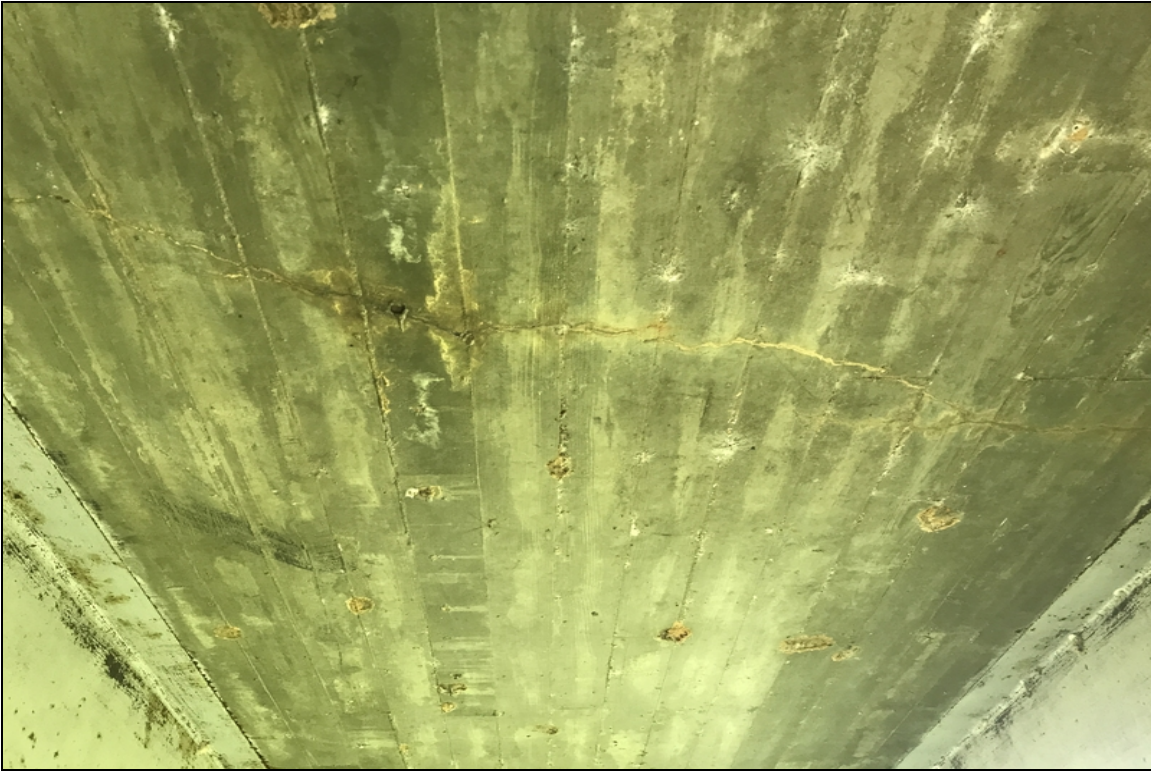
Span 4-Transverse cracking with light efflorescence.

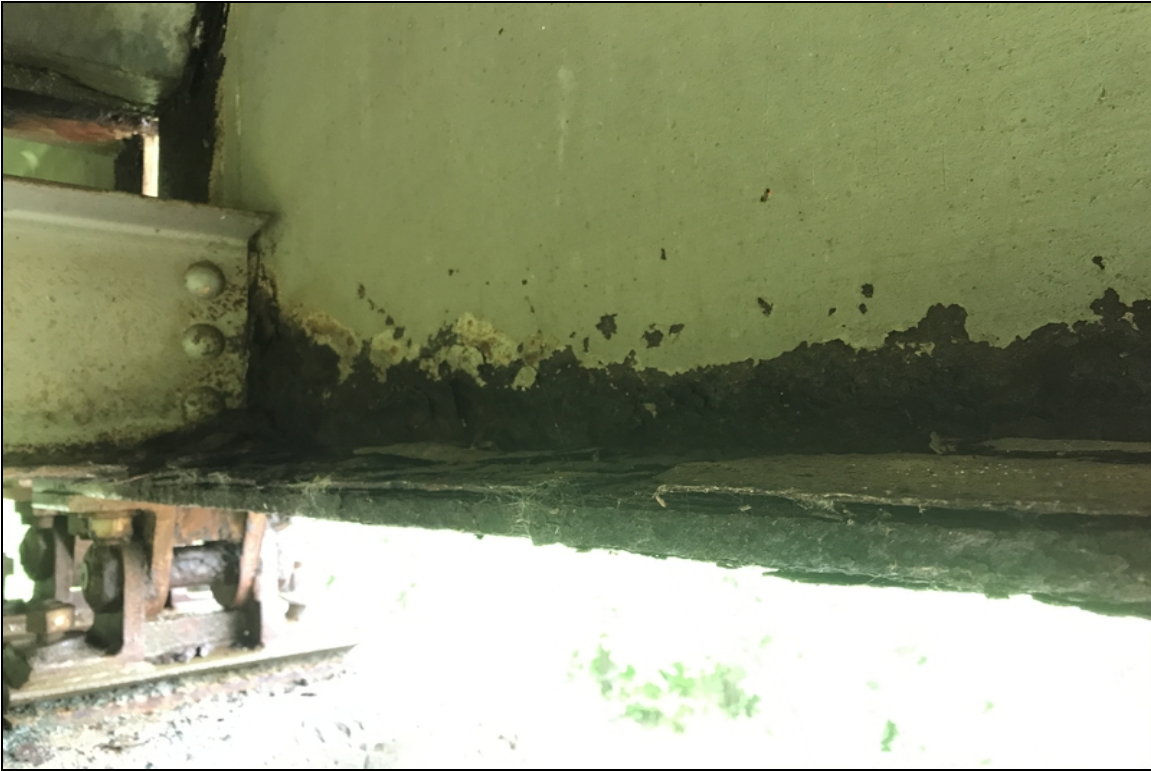
Span 3, beam 5 at bent 4-Corrosion.

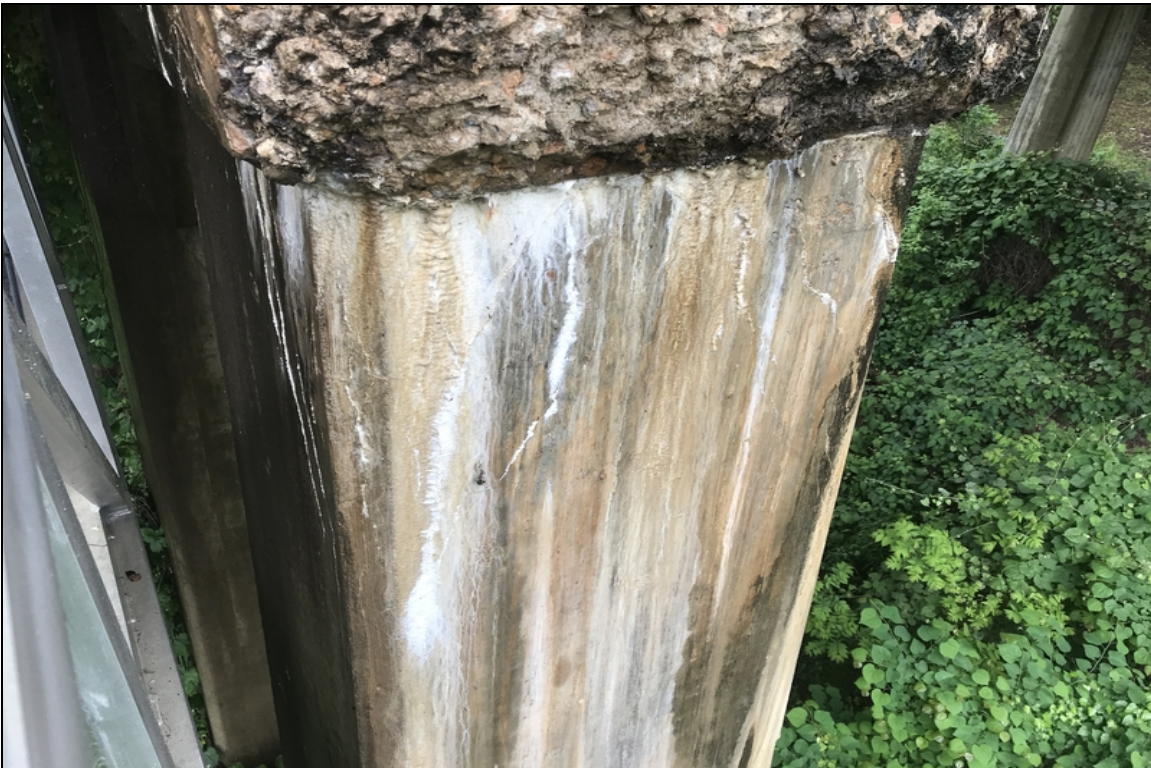
The upper portion of column # 3 of bent # 4 has mapcracking with efflorescence.

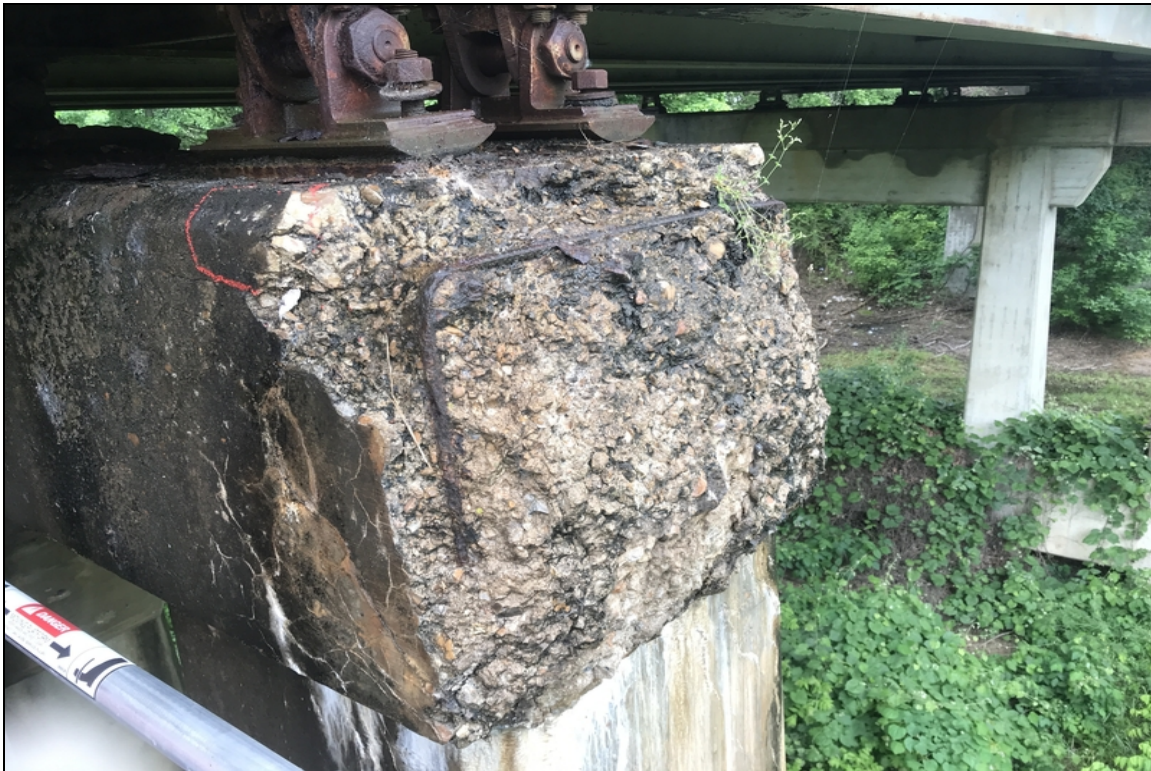
Bent # 4 cap-Concrete deterioration / spalling.

Bent # 4, the Right end of cap has soft deteriorated concrete with approximately 4" of concrete section loss with exposed reinforcing steel. Exposed reinforcing steel has up to initial section loss at this inspection.
The left end of bent # 2 cap has a 20" x 8" spall that has caused a loss of bearing area approximately 2" wide that extends approximately 3" under the exterior side of the masonry plate exposing the bearing anchor bolt. The exposed anchor bolt has an estimated 40% section loss.

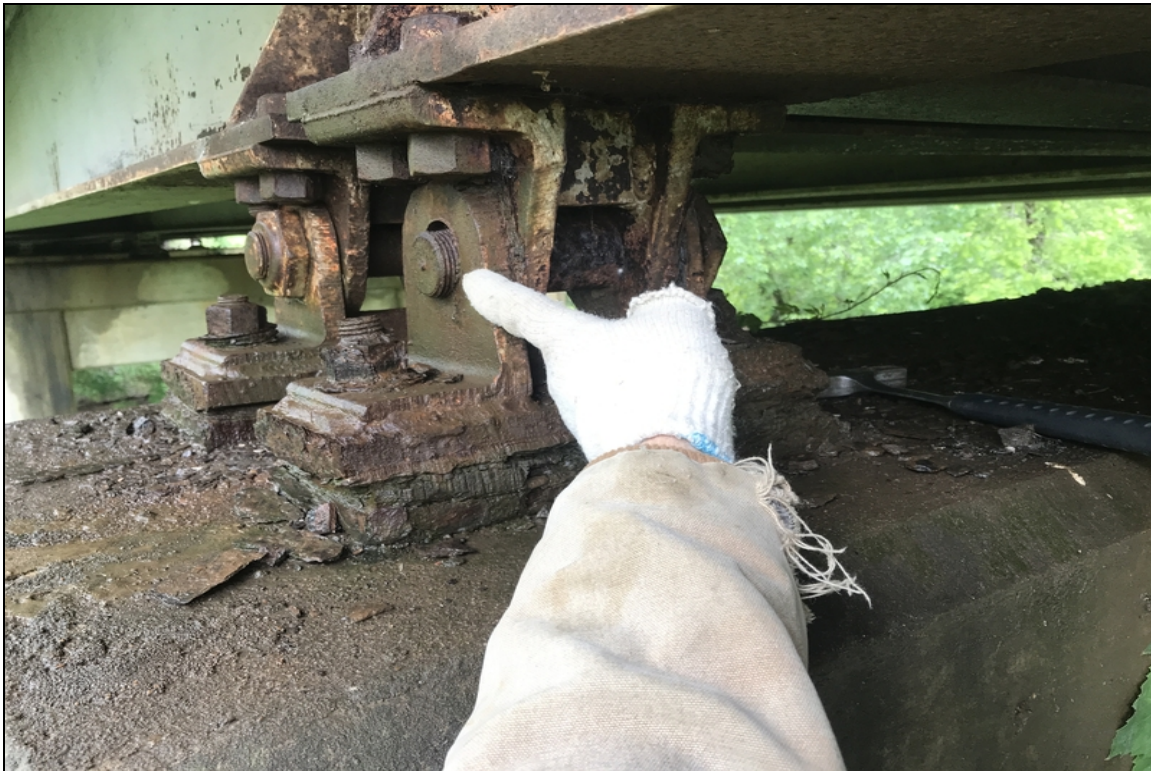
Bearing # 1 of span # 3 over bent # 4 is missing the bearing pin retaining nut.

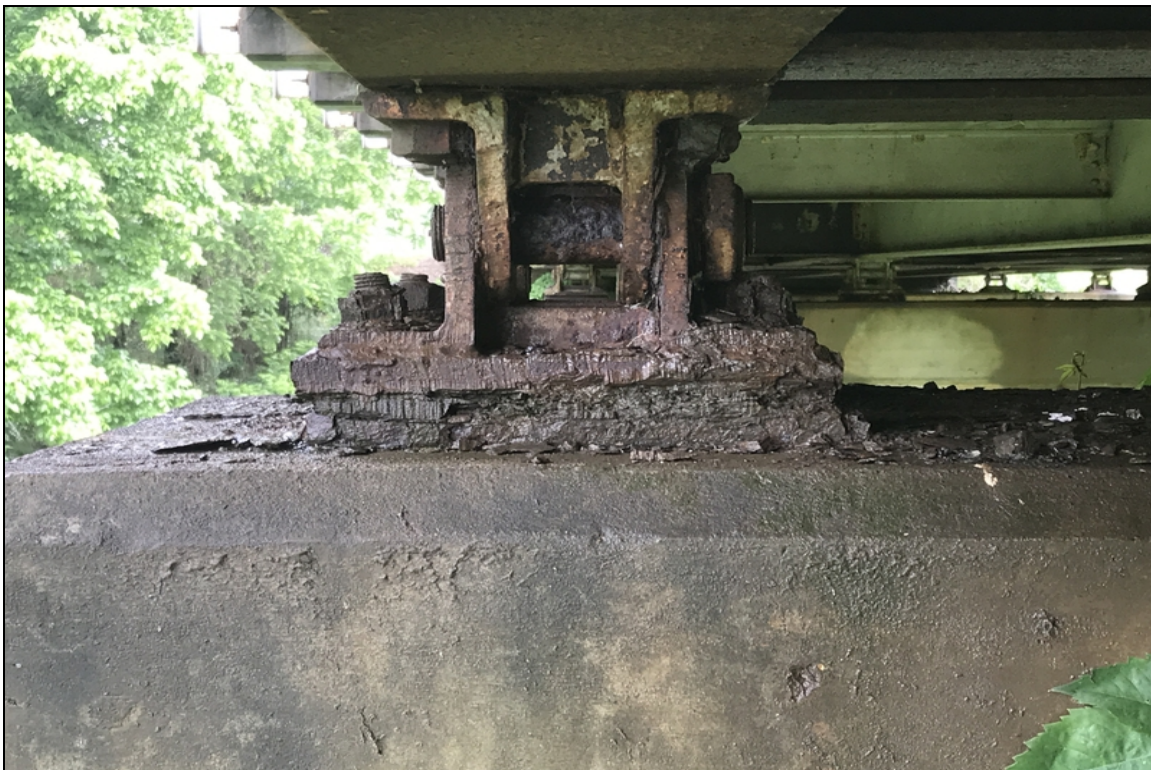
Span 3, bearing 1 over bent 4-Corrosion.

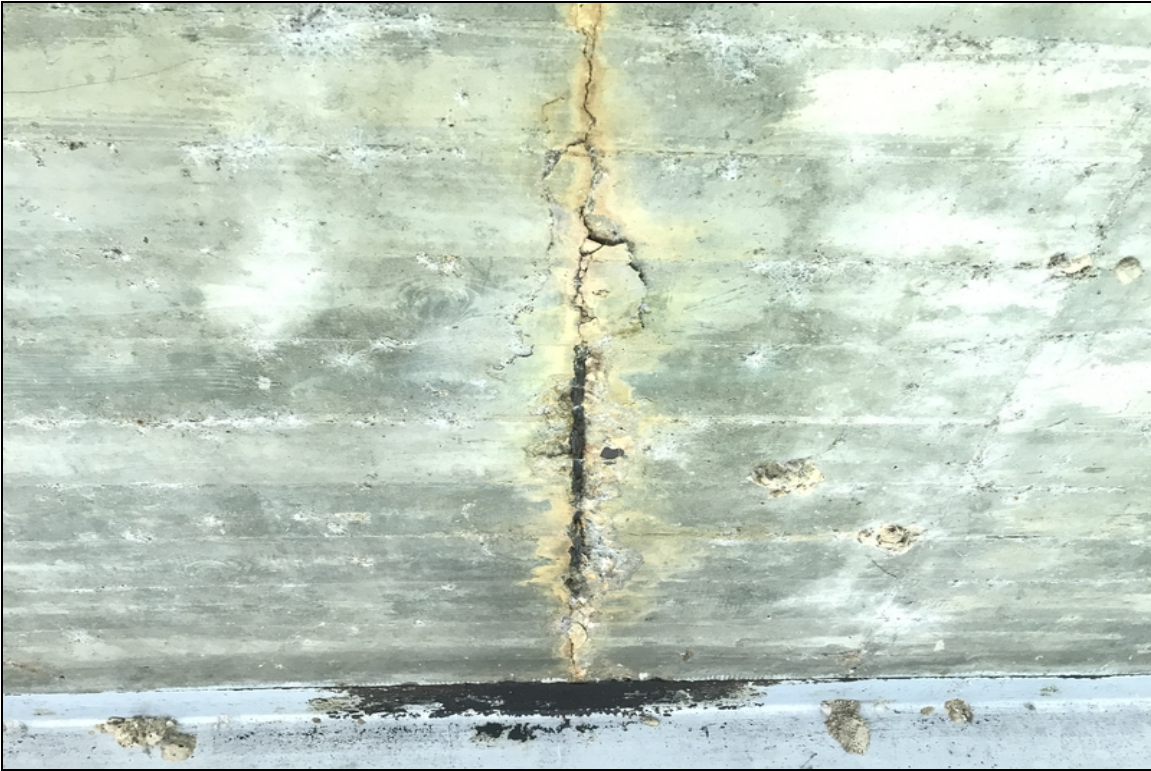
Span # 3, bay # 1-Spalling with exposed reinforcing steel.
