Bridge #02012(Routine, Underwater type 2)
State Highway 22 over Dry Fork Branch-Franklin
Location: 8.5 E OF JCT SH 96 & 22

Team Lead: Bob McEntyre Inspection Date: May 13, 2020

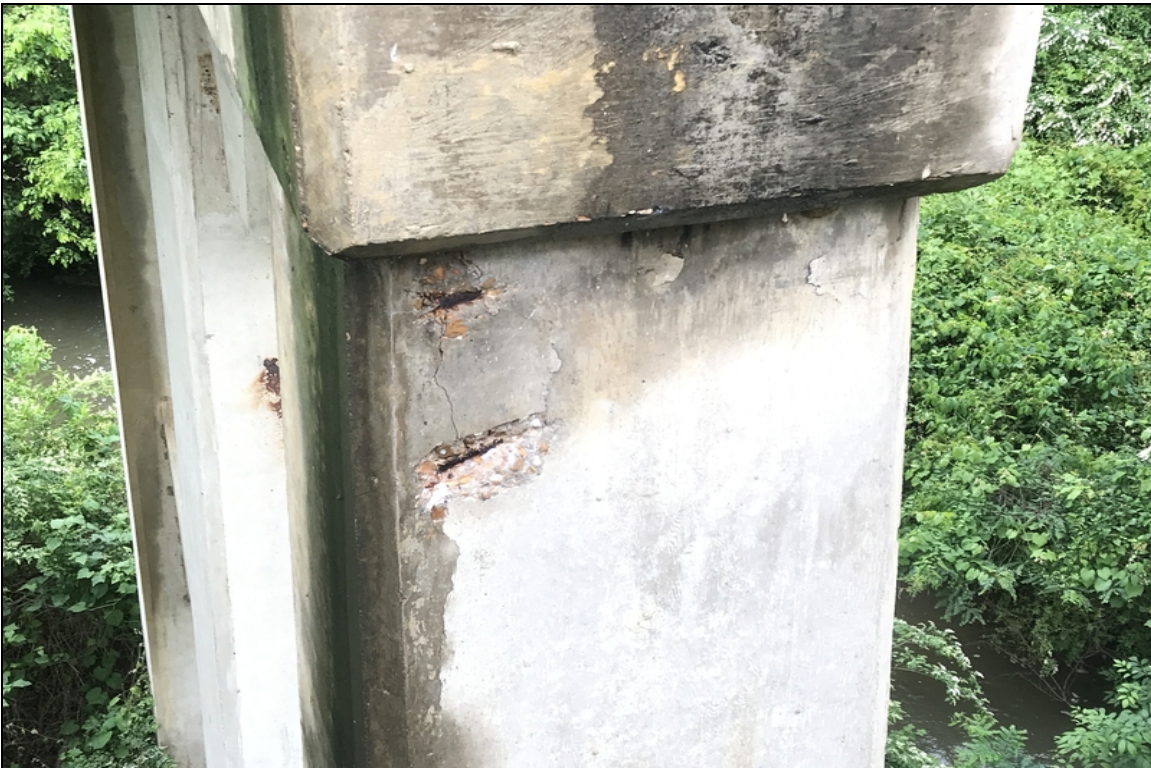
Bent # 3, column # 3 has two 4" spalls with exposed reinforcing steel near cap juncture.

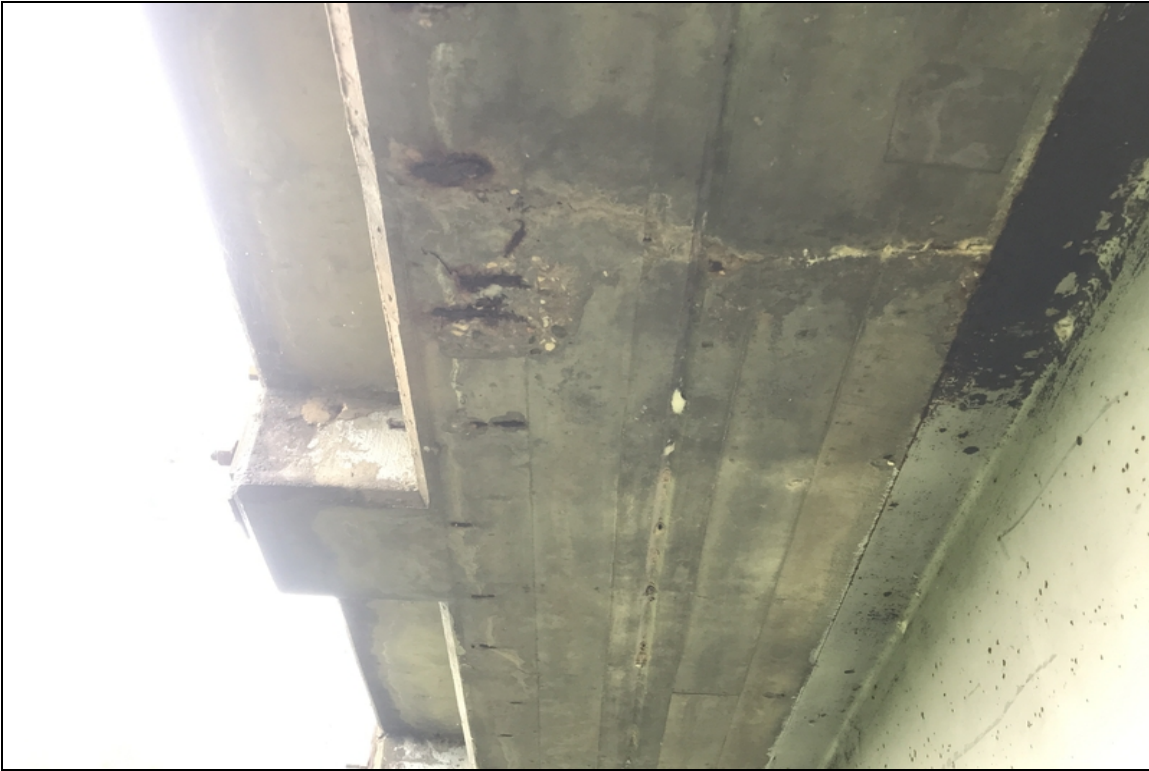
Span 2, left side-Spalling with exposed reinforcing steel in deck overhang.

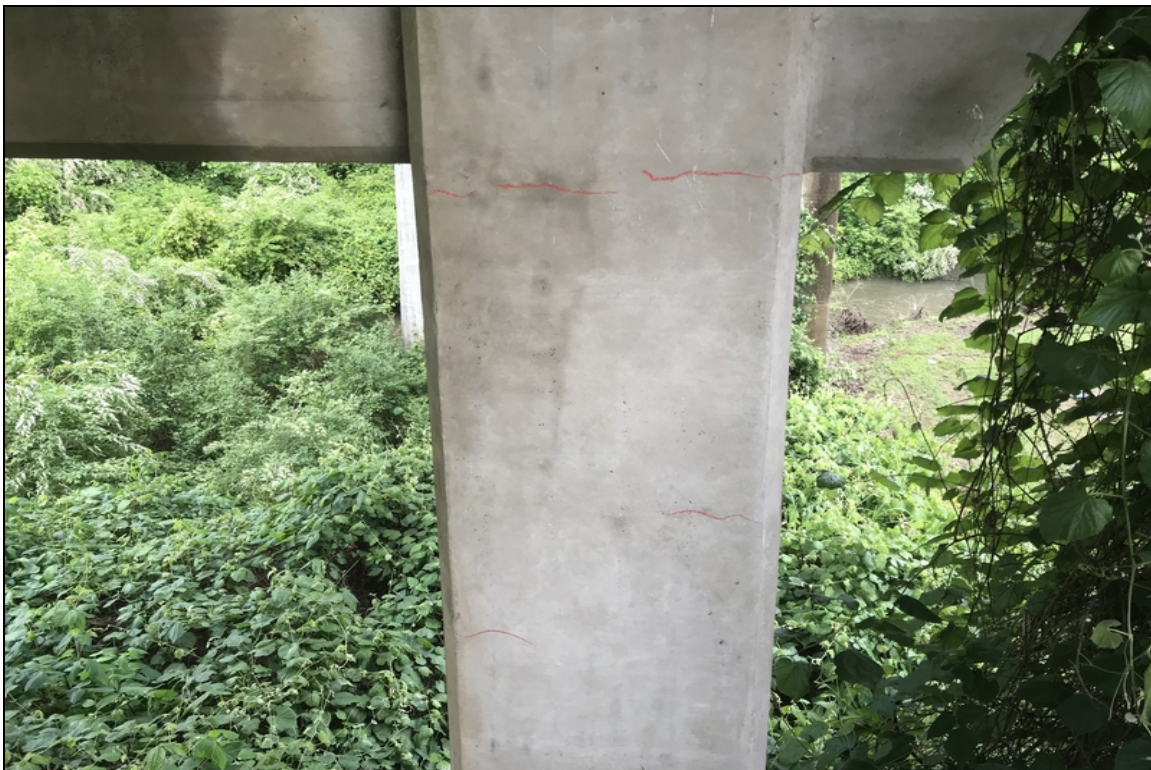
Bent 2, column 2-Hairline horizontal cracks.

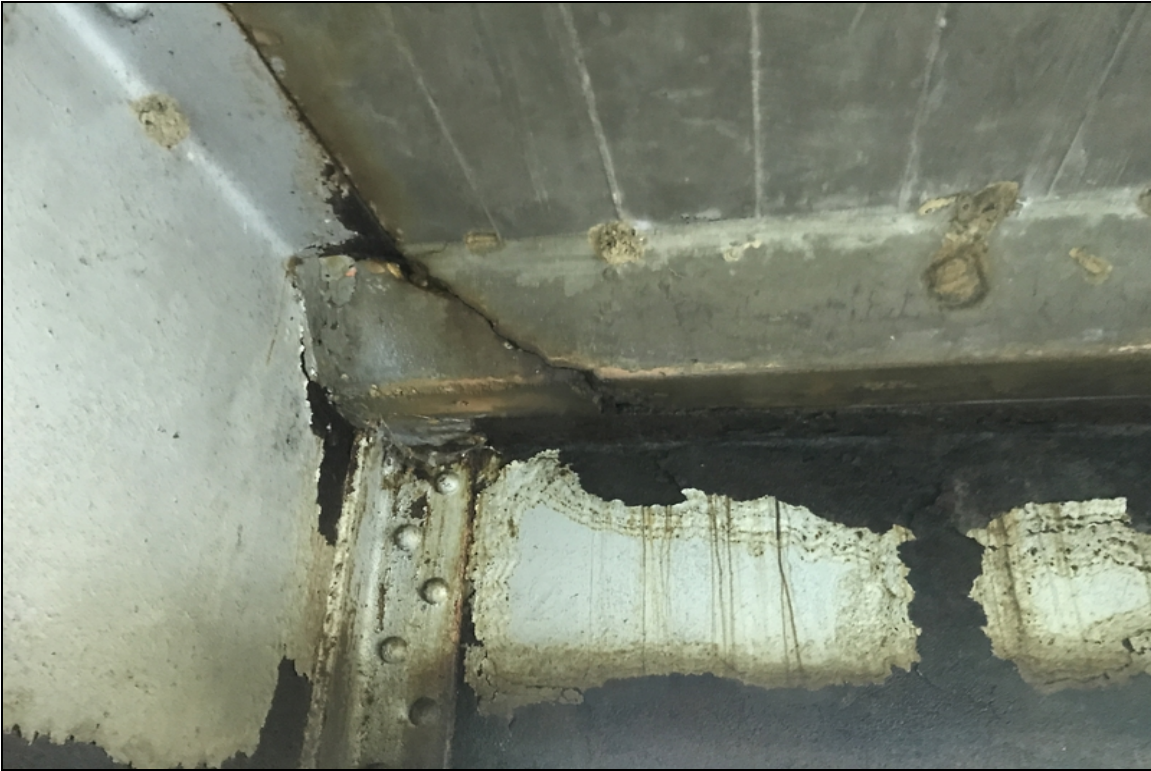
The expansion dams have delaminated areas with wide cracking adjacent to the beams.

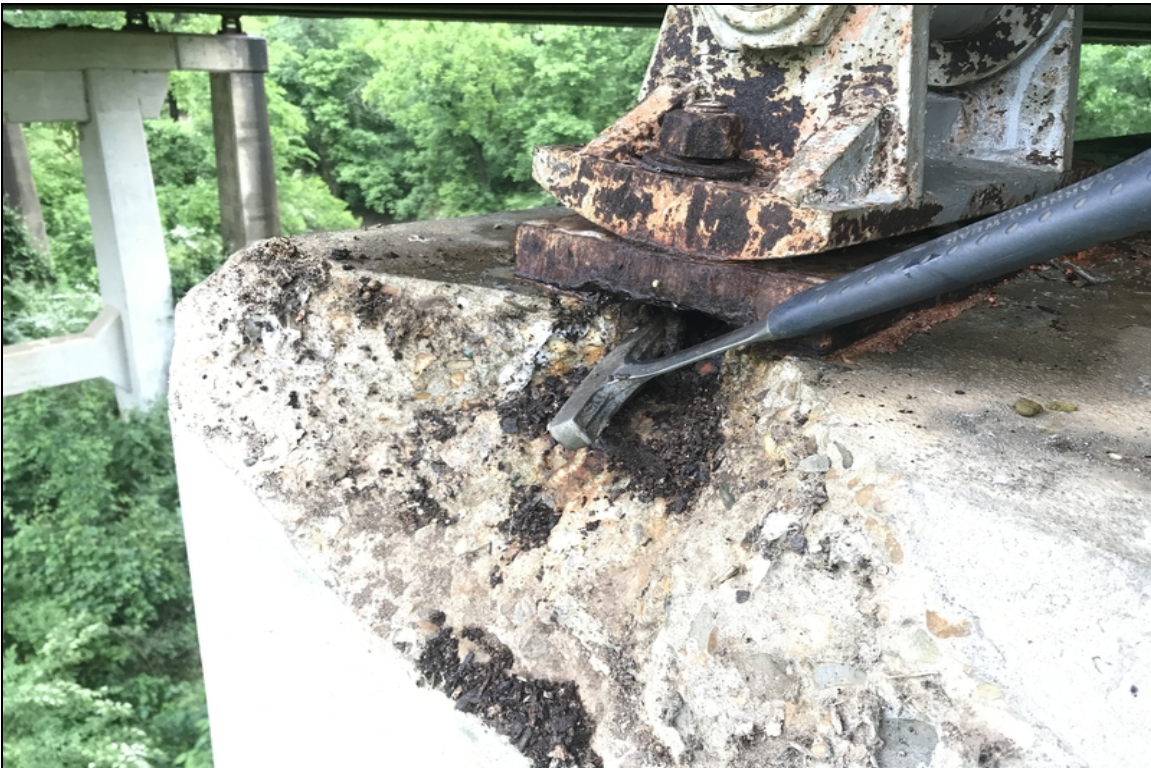
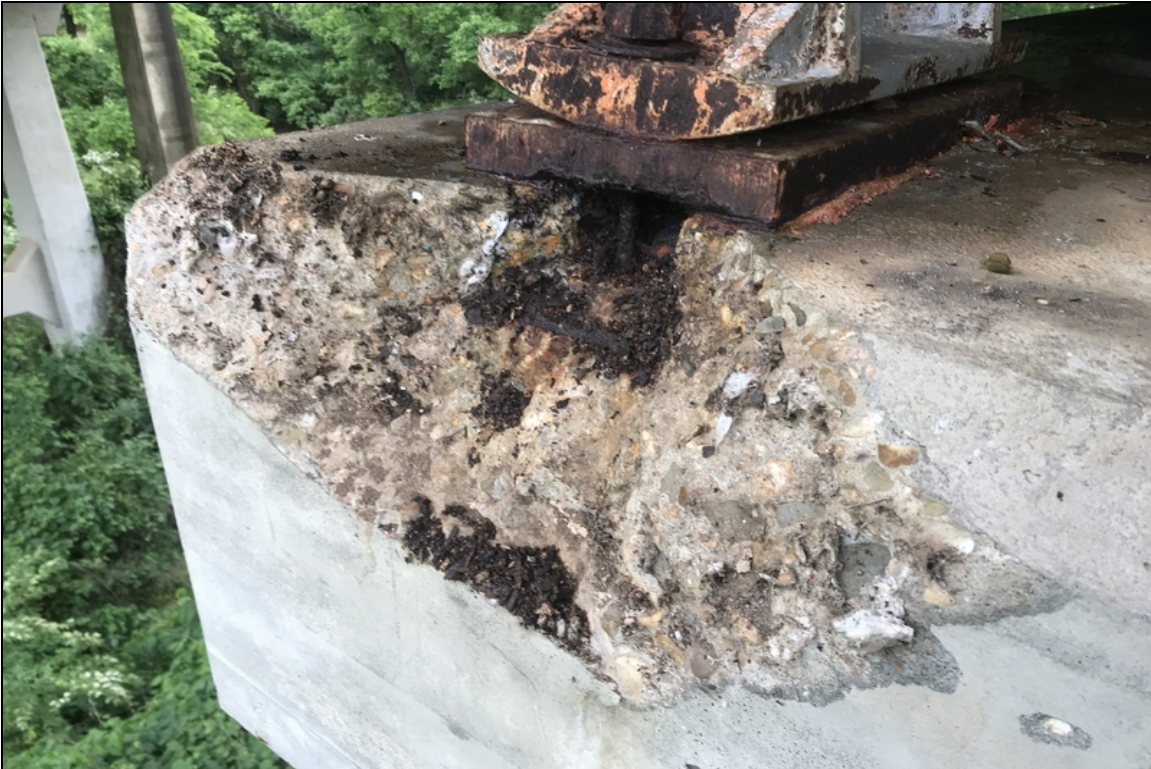
The left end of bent # 2 cap has a 20" x 8" spall that has caused approximately 3" of bearing area loss under the exterior bearing. The bearing anchor bolt is exposed and has approximately 60% section loss.

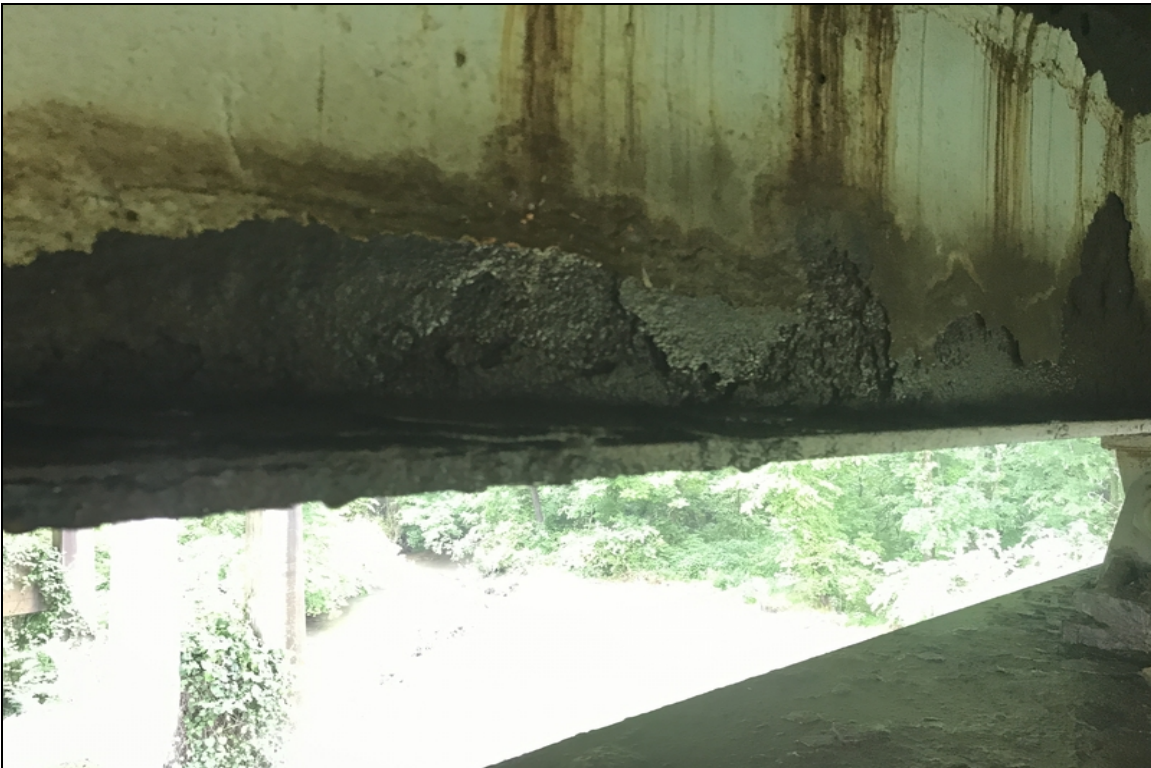
Span 1, bay 1 at bent 2-Corrosion to diaphragm.

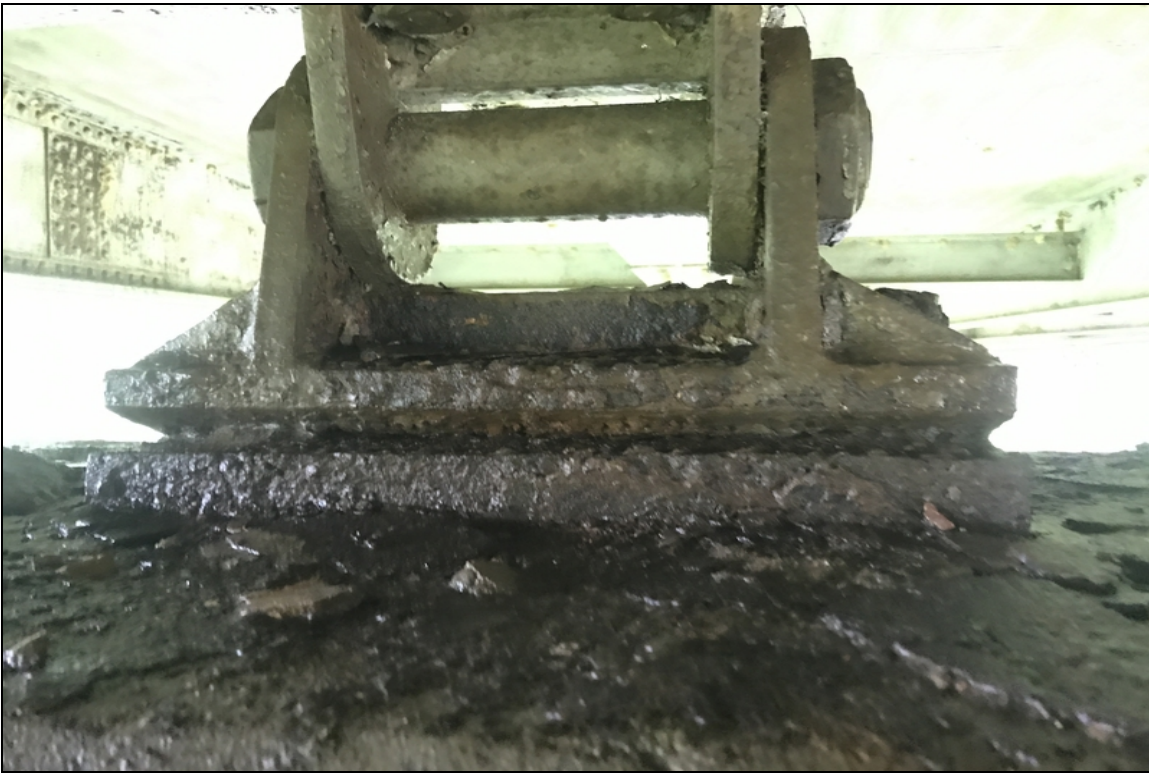
Bent 2, bearing 2-Corrosion.

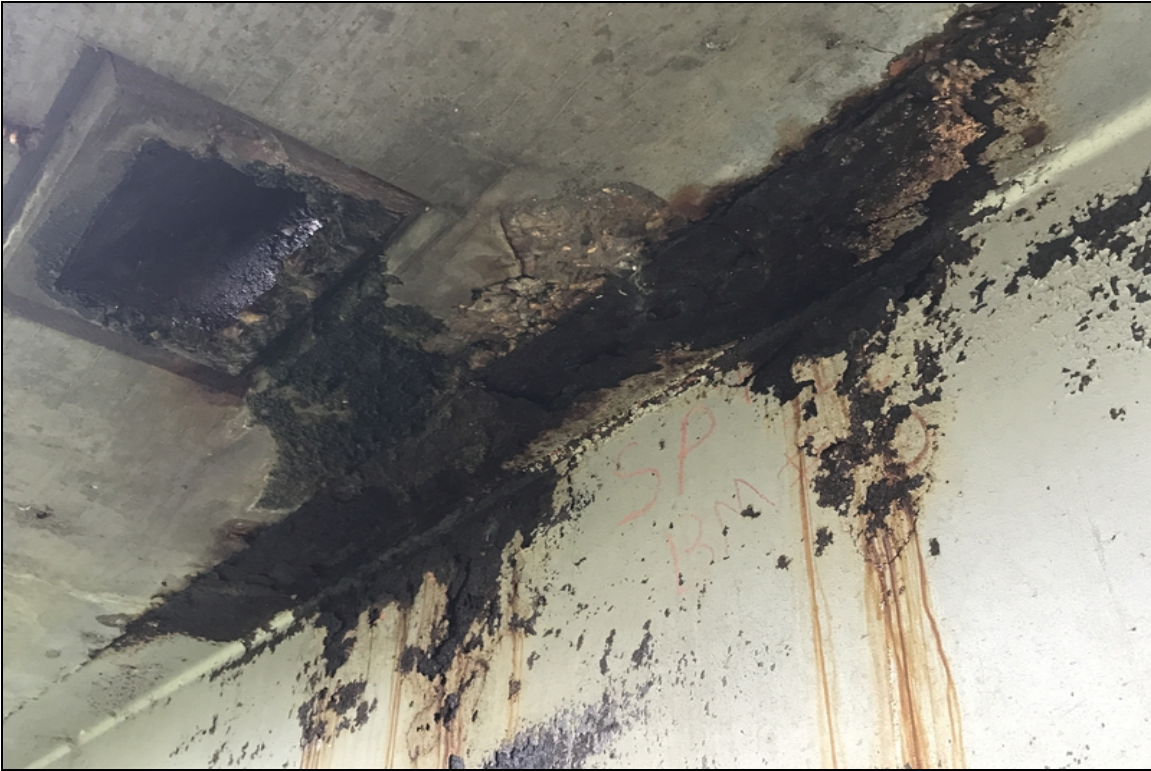
Span 1, beam 5-Corrosion section loss where deck drain discharges water.

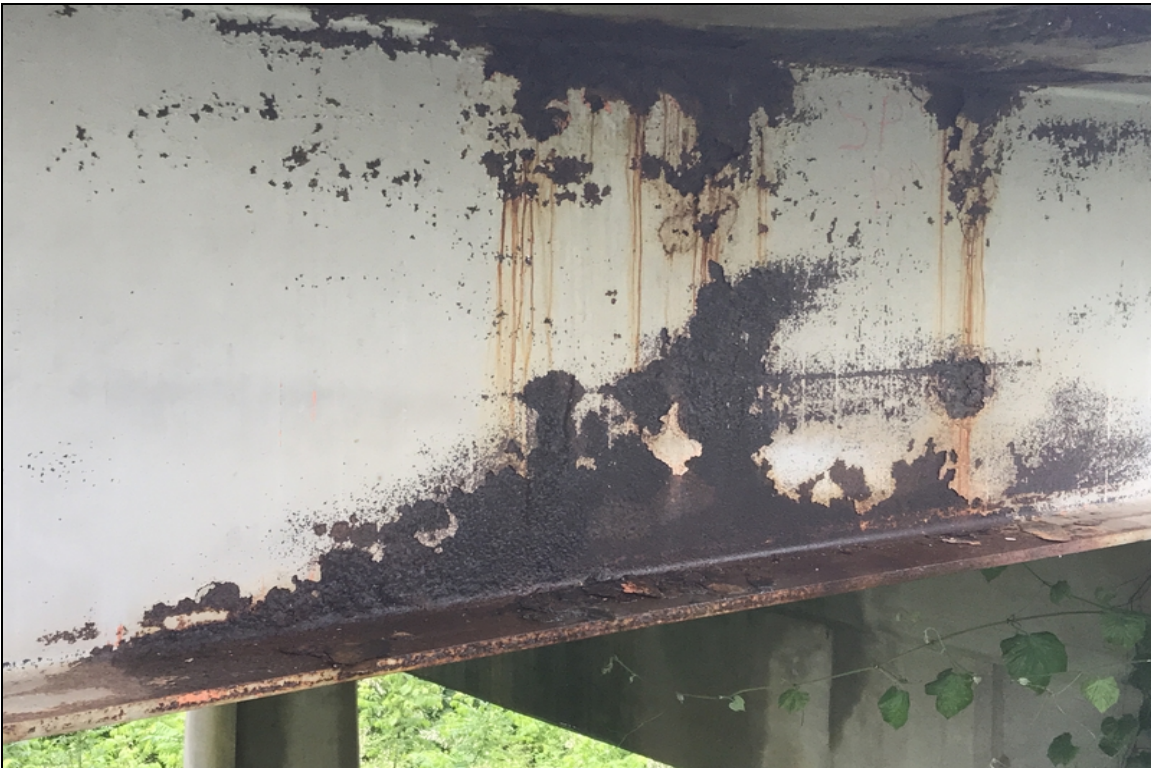
Span 1, beam 5-Corrosion where deck drain discharges water on beam.

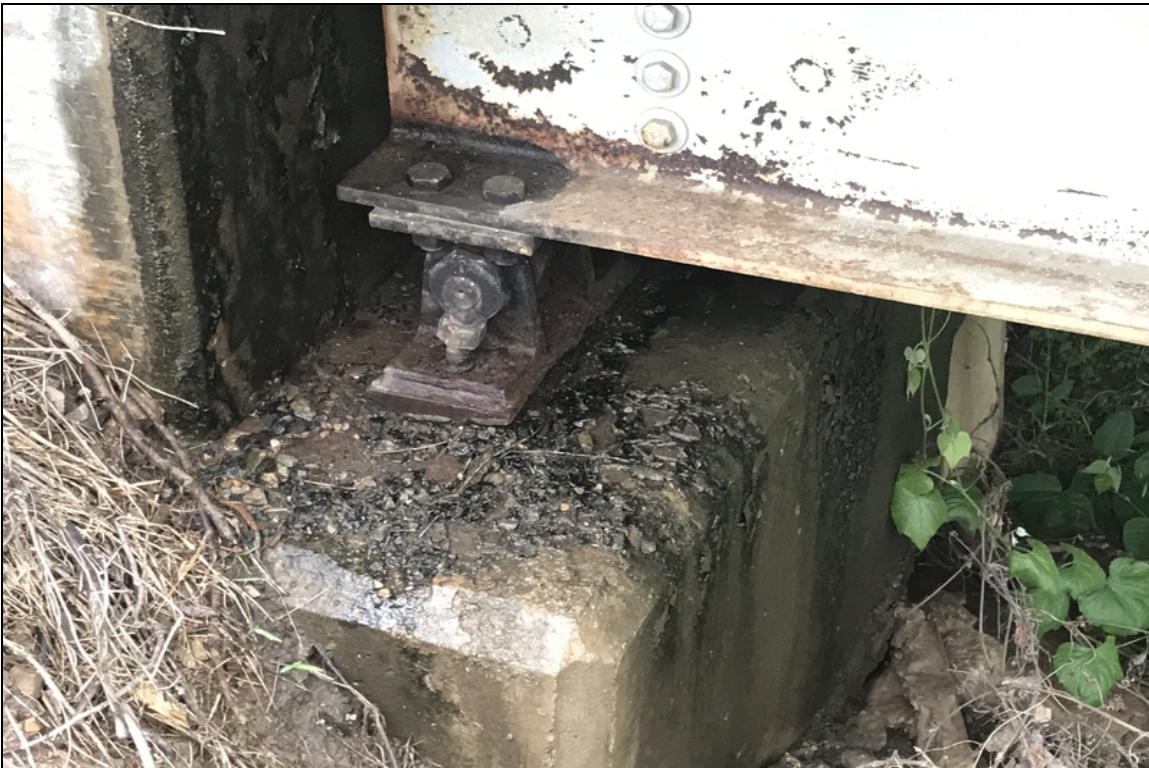
Abutment 1, bearing 5-Corrosion.

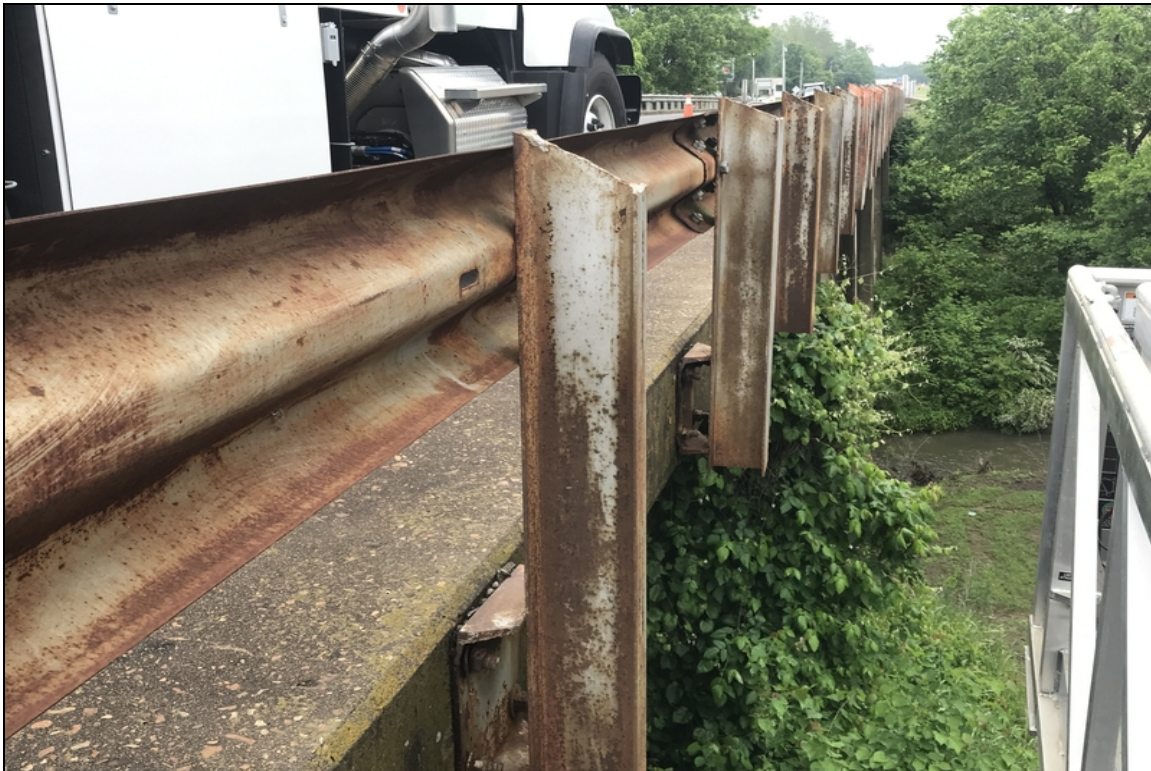
Bridge railing has rust coating.

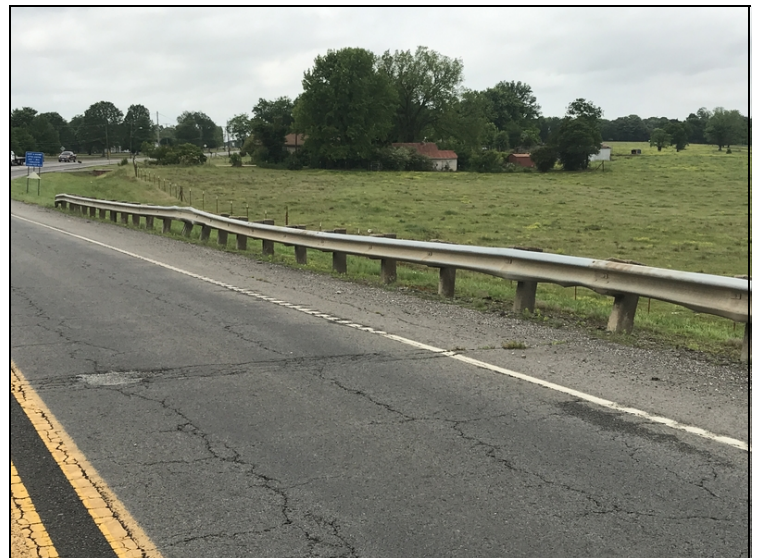
Northwest and Southeast approach guard railing -
The Northwest and Southeast approach guard railing have areas of collision damage.

Collision damage to the Northwest approach railing.

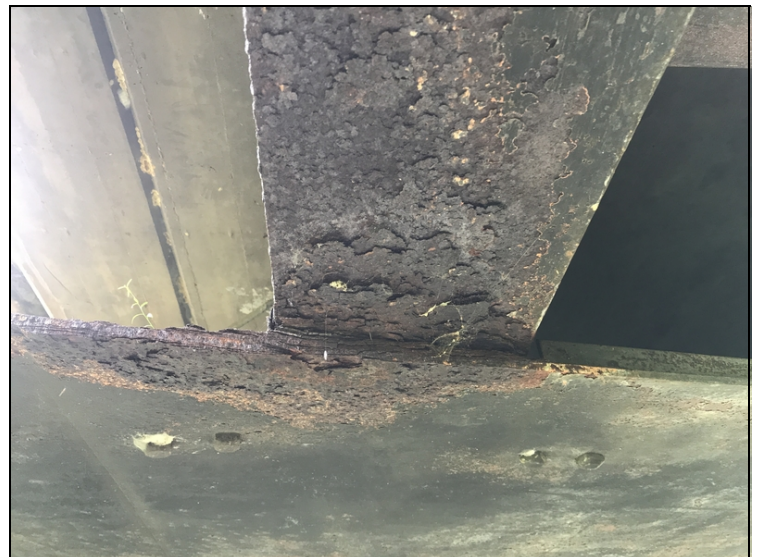
Span 5, beam 1-Corrosion to bottom flange where steel plate is attached.

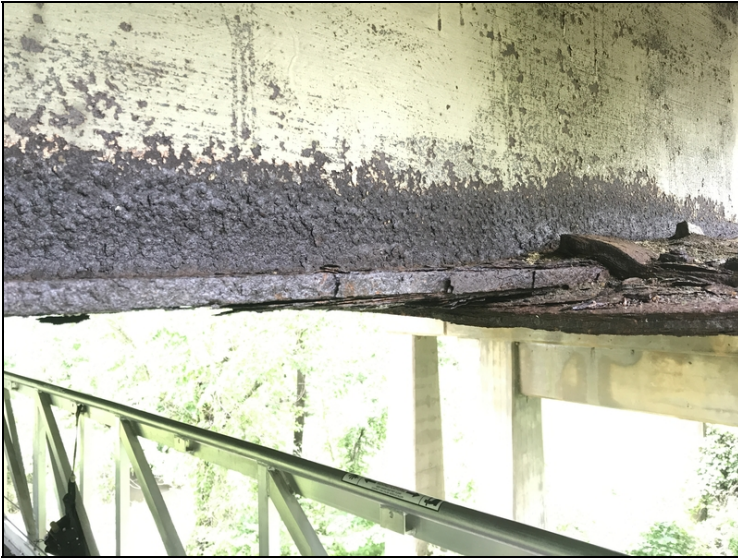
Span 5, beam 1-Corrosion to bottom flange where steel plate is attached.

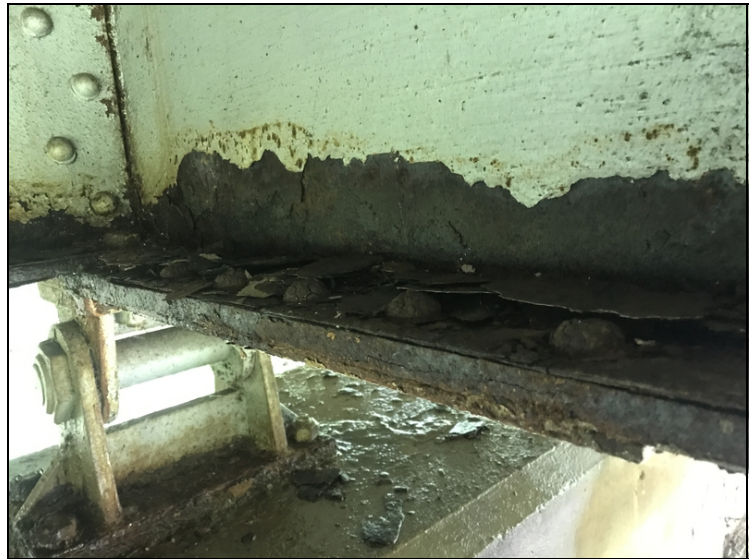
Span 5, beam 3-Corrosion.

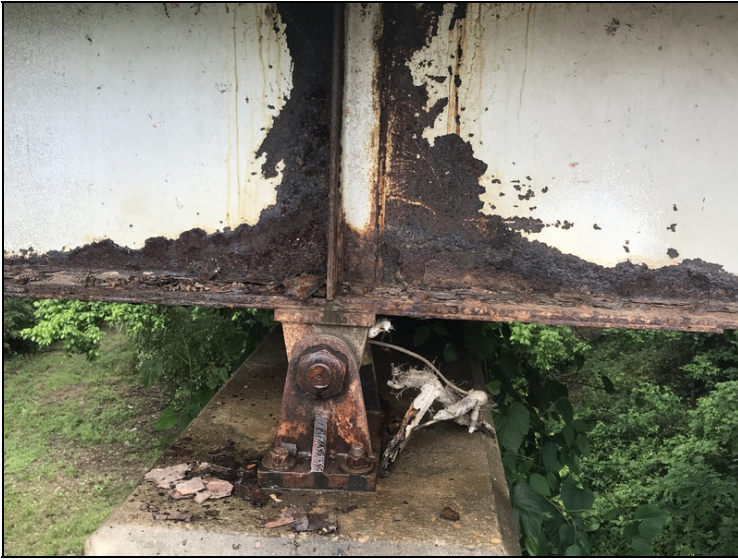
Beam 5 over bent 6-Corrosion.

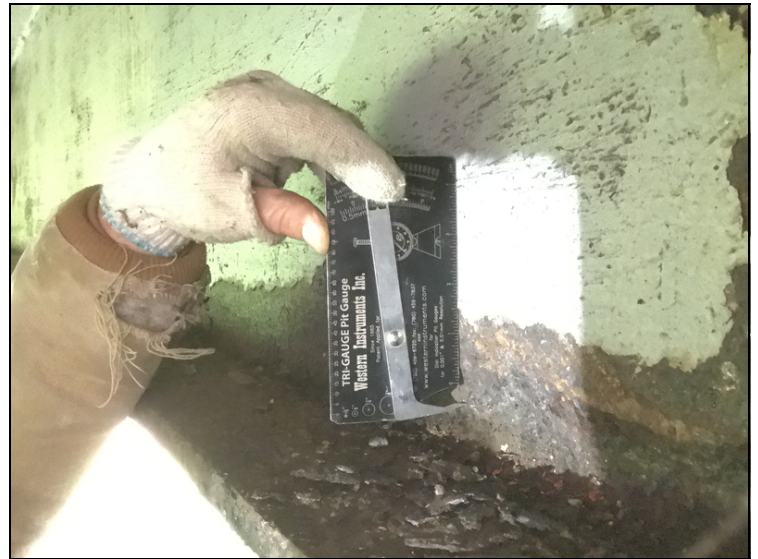
Span # 6, beam 1 over abutment 2-3/16" section loss to base of web.

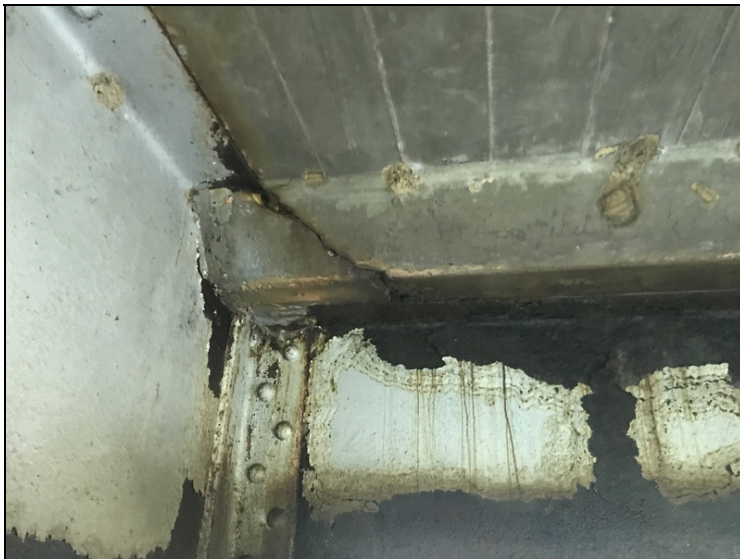
The expansion dams have delaminated and spalled areas with wide cracking adjacent to the beams.

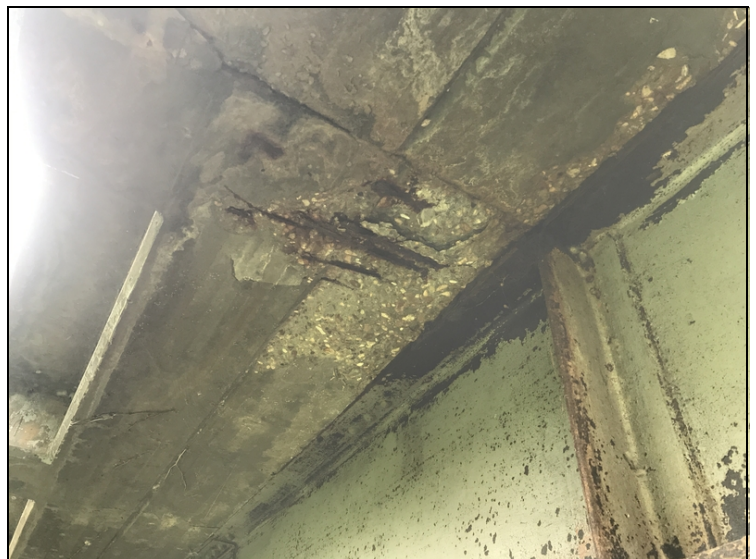
Left deck overhang, span 5 over bent 5-Spalling with exposed reinforcing steel.

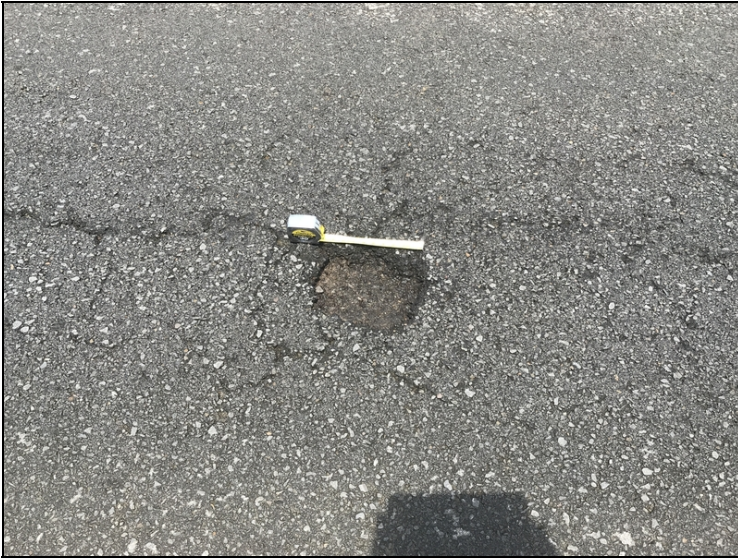
The right lane of span # 2 has an 8" spall in the asphalt driving surface.

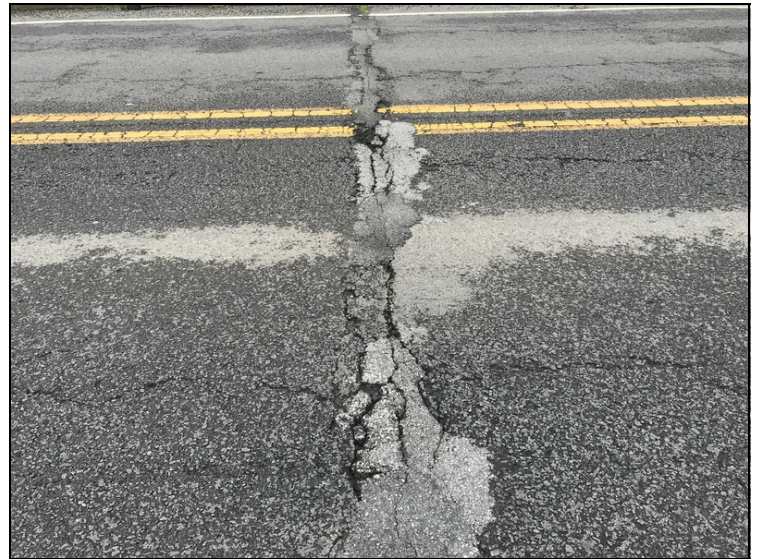
Asphalt breaking apart at expansion joints.

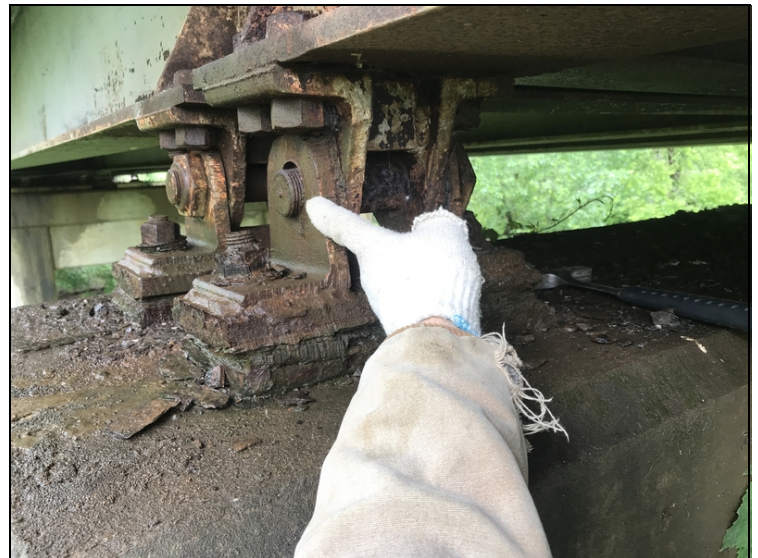
Bearing # 1 of span # 3 over bent # 4 is missing the bearing pin retaining nut.

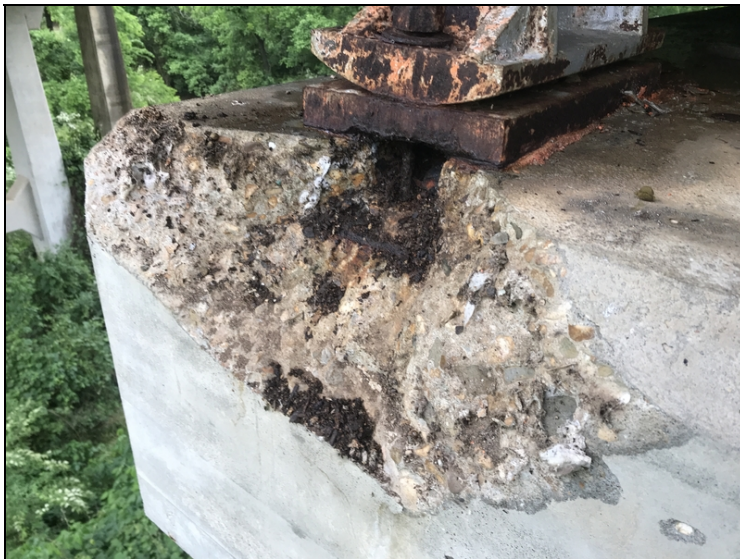
The left end of bent # 2 cap has a 20" x 8" spall that has caused approximately 3" of bearing area loss under the exterior bearing. The bearing anchor bolt is exposed and has approximately 60% section loss.

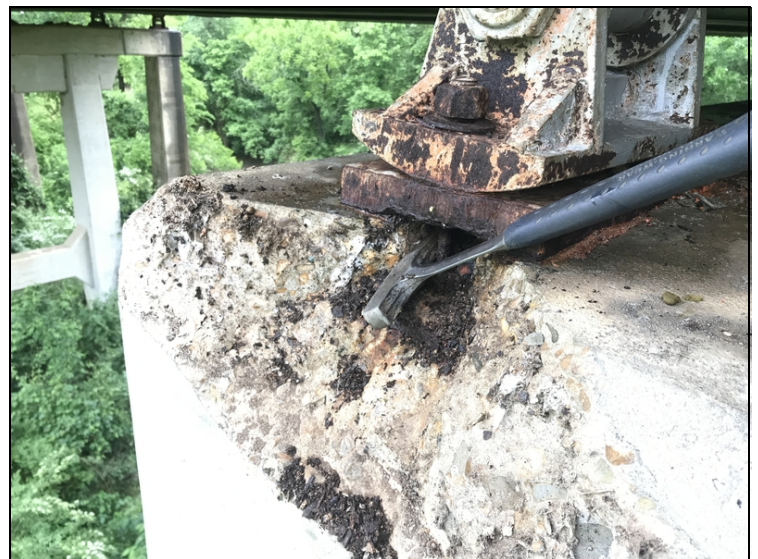
The left end of bent # 2 cap has a 20" x 8" spall that has caused approximately 3" of bearing area loss under the exterior bearing. The bearing anchor bolt is exposed and has approximately 60% section loss.

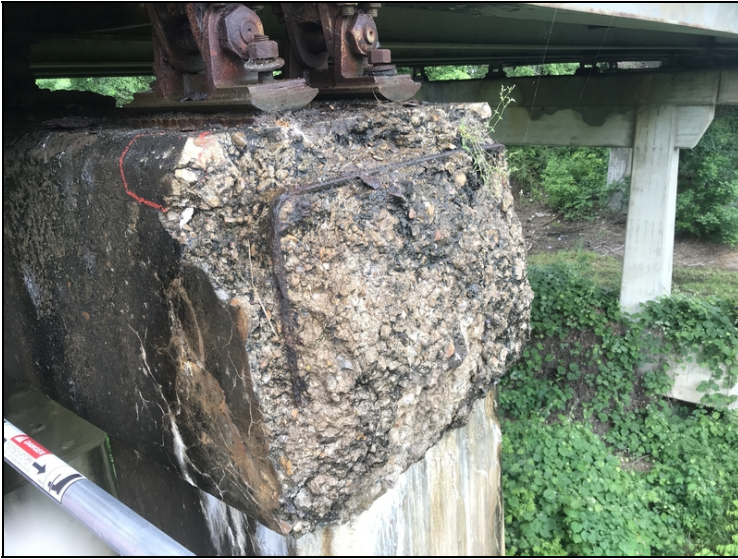
Bent # 4 cap-Concrete deterioration / spalling.

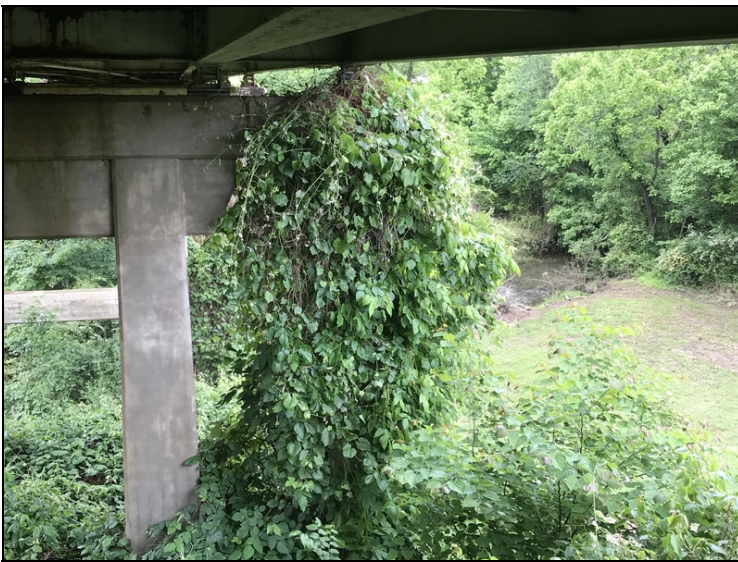
Portions of the substructure are covered with heavy vegetation (poison ivy) and not visible during this inspection.

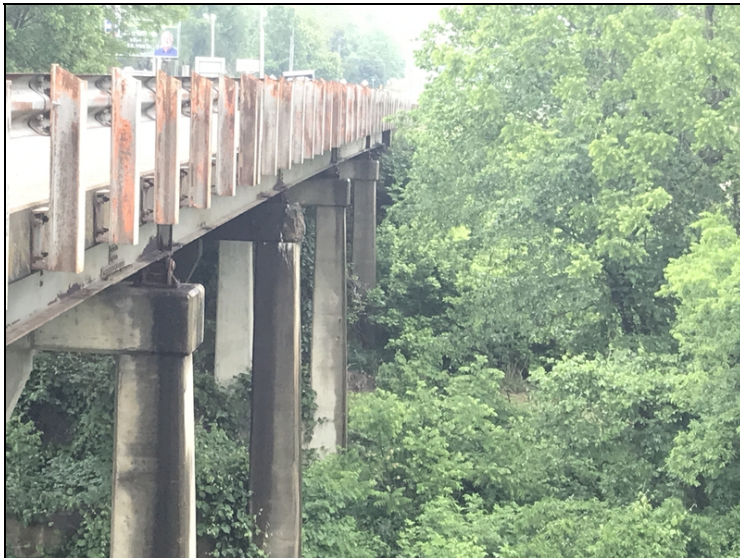
The bridge railing posts have active corrosion in the lower connections to the deck.

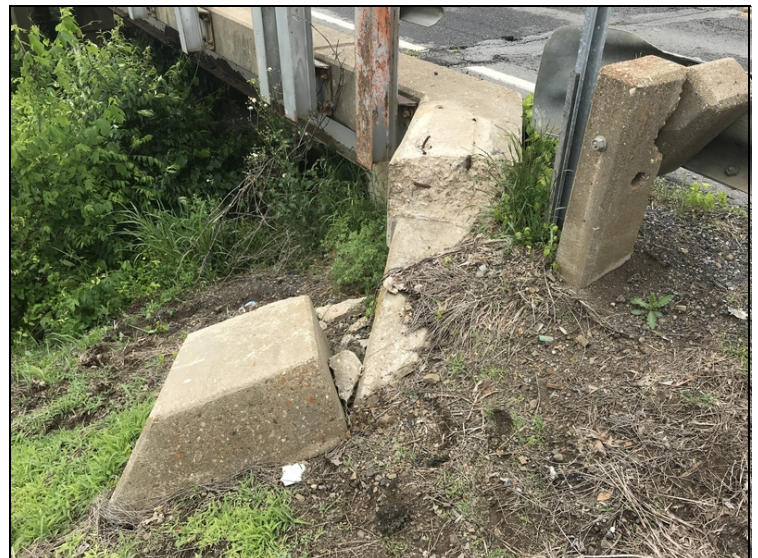
Collision damage has displaced the Southeast end post. The end post is lying on the embankment.

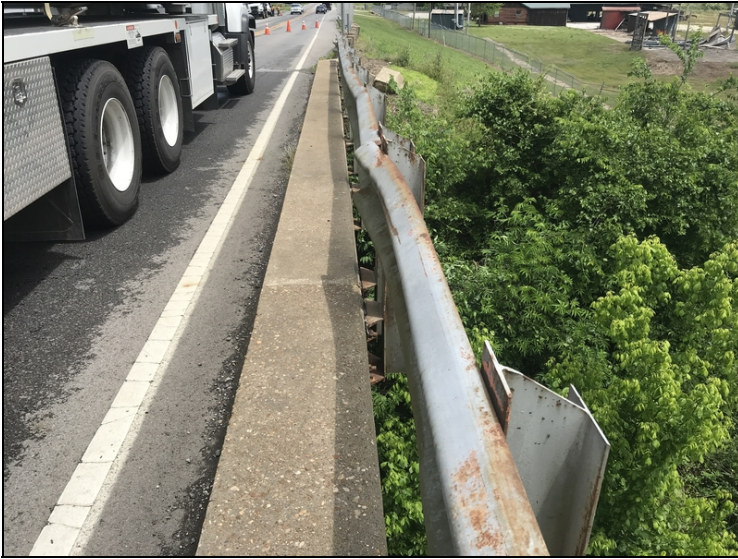
Right bridge railing-Minor collision damage to railing.
