Asset #06114(Routine)

State Highway 96 over Big Creek Seb. Co.

Location: 1.7 MI E SH 255

Team Lead: Jeff Jones, Inspection Date: 04/21/2022

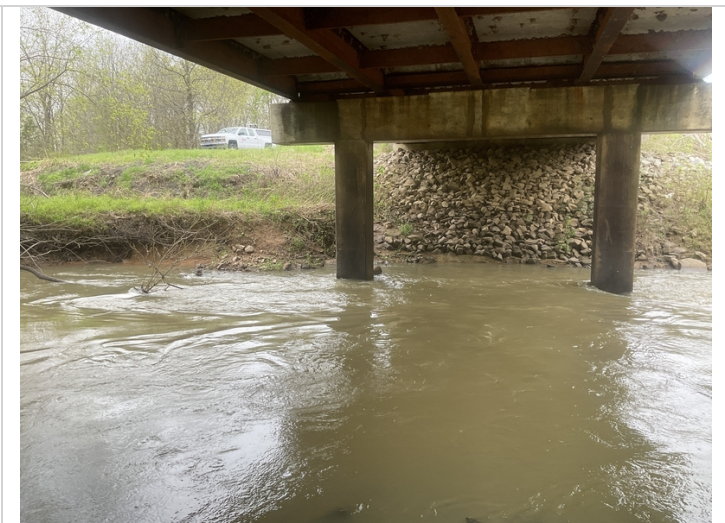
There is embankment erosion with some displacement of rip rap at the West embankment.

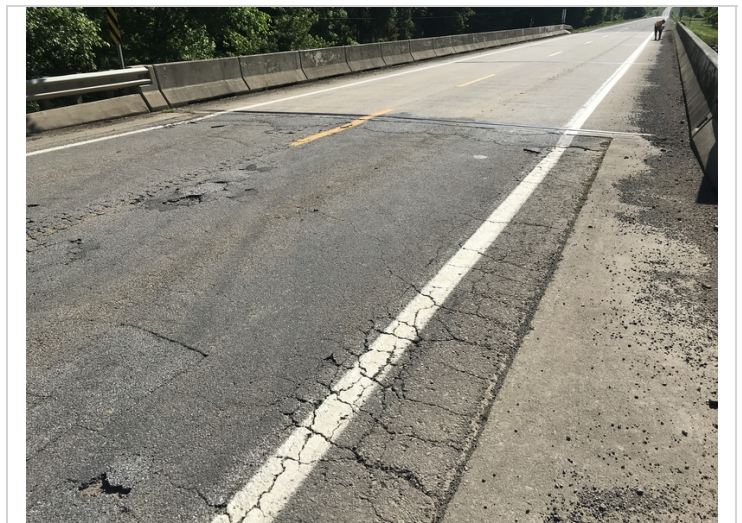
West approach roadway with asphalt deterioration and settlement.

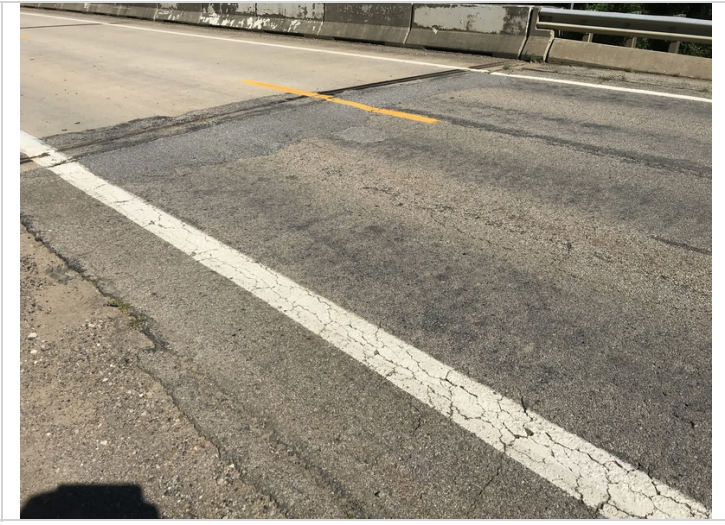
East approach asphalt settlement.

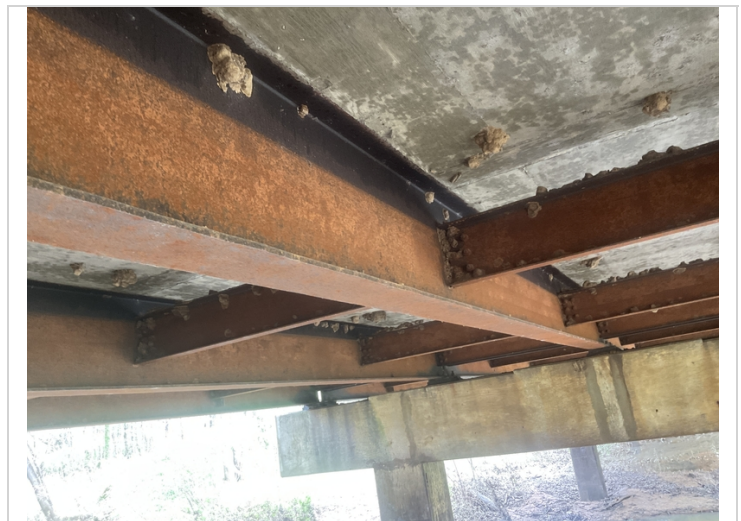
Superstructure has light rust nodes at the base of the beams. High Water elevation marks on the beams indicate that the water has reached the superstructure in the past.

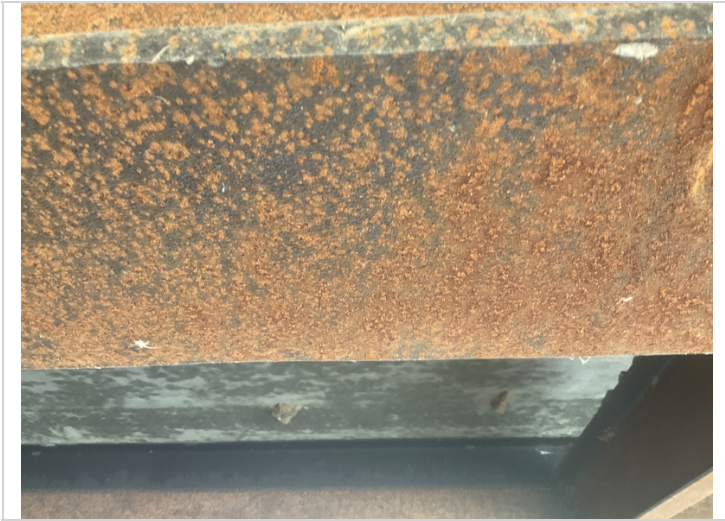
Superstructure has light rust nodes at the base of the beams. High Water elevation marks on the beams indicate that the water has reached the superstructure in the past.

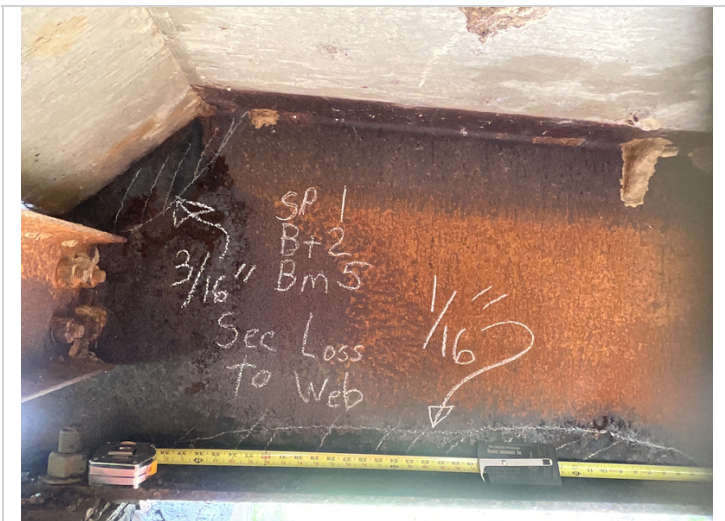
Span # 1. Bent # 2. Beam 5 has 3/16" section loss to the web at the expansion dam juncture. There is a 3' x 4" tall area with up to 1/16" section loss at the base of the web.

-Span # 1. Bent # 2. Beam # 5 has 3/16" section loss to the web at the expansion dam juncture. There is a 3' x 4" tall area with up to 1/16" section loss at the base of the web.

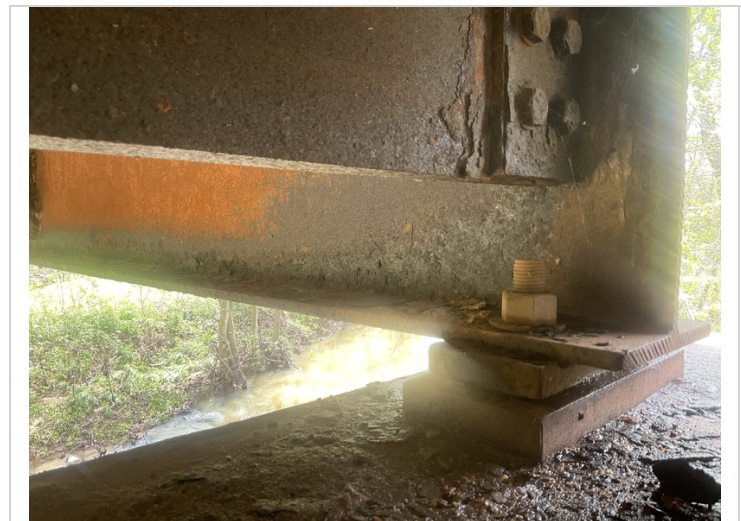
Span # 2. Beam # 5 beam corrosion.

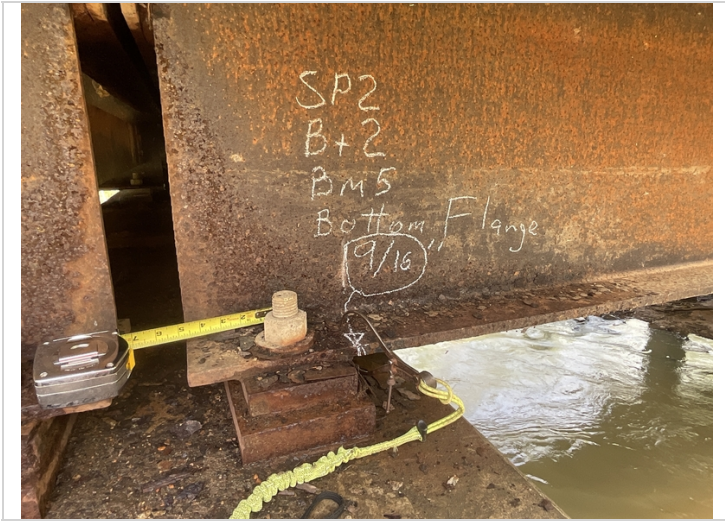
Span # 2. Bent # 2. Beam # 5 bottom flange measures 9/16" remaining section adjacent to the bearing.

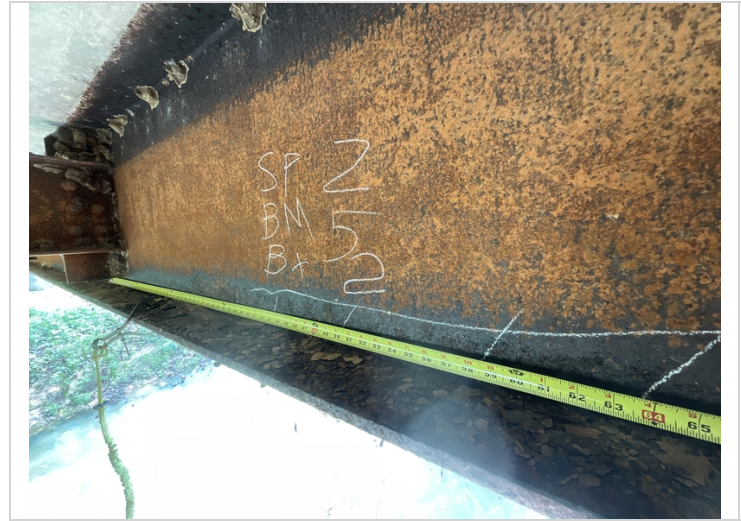
Span # 2. Bent # 2. Beam # 5 bottom flange measures 9/16" remaining section adjacent to the bearing. The remaining base of web and bottom flange has active corrosion with initial section loss.

-Span # 2. Bent # 2. Beam # 5 bottom flange measures 9/16" remaining section adjacent to the bearing. The remaining base of web and bottom flange has active corrosion with initial section loss.

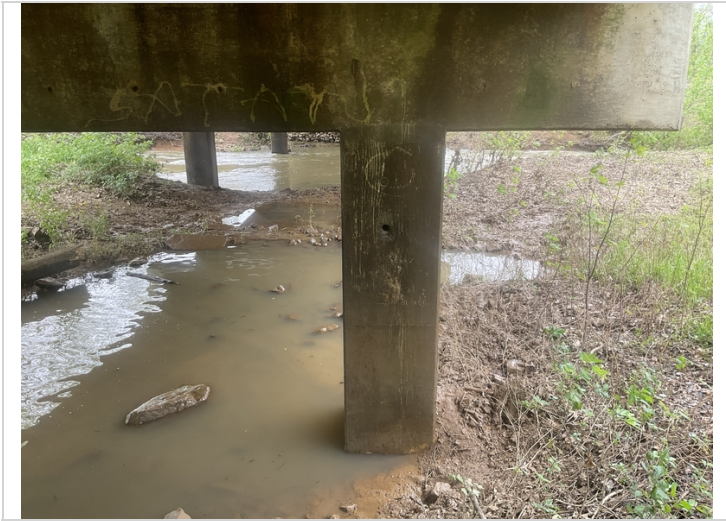
205	Reinforced Concrete Column	EA	6	5	1	0	0
1080	Delamination/Spall/Patched Area	EA	1	0	1	0	0
(205) -The ahead side of Column #1 of Bent # 4 has a shallow baseball sized spall mid-way up the column adjacent to a hole that appears to be from the construction process.							
215	Reinforced Concrete Abutment	LF	78	73	5	0	0
1080	Delamination/Spall/Patched Area	LF	1	0	1	0	0
1130	Cracking (RC and Other)	LF	4	0	4	0	0

Left column of Bent # 4. No apparent change since the last inspection.

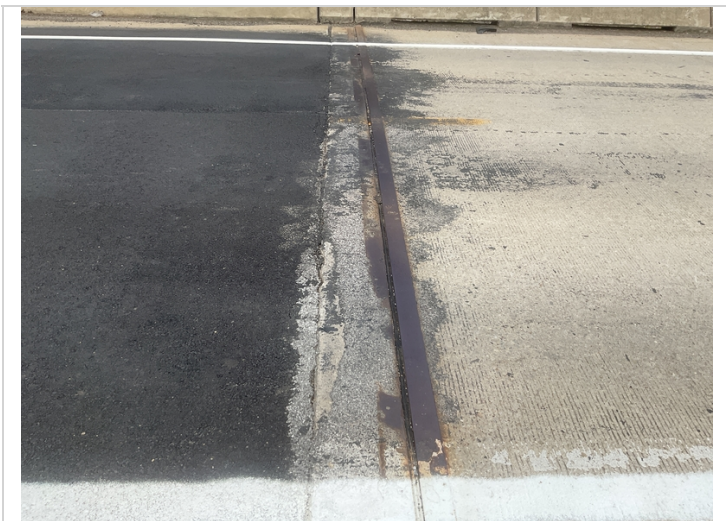
Top of Bent # 1 back wall. Partially covered with asphalt.

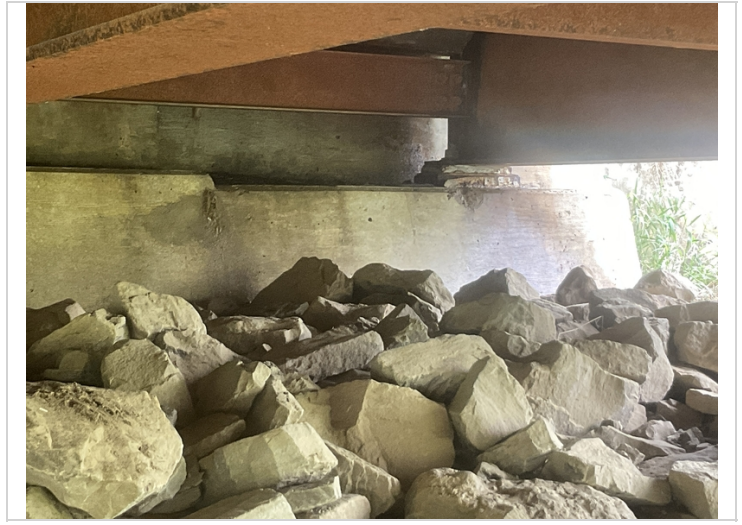
(215) -There are a few isolated vertical hairline shrinkage cracks in the steps in the abutment caps.							
-Top of both abutment back walls are partially covered with asphalt.							
-The Right side of abutment # 2 (Bent # 5) has a shallow baseball sized spall with no exposed reinforcing steel under Beam # 5.							
234	Reinforced Concrete Pier Cap	LF	96	90	6	0	0
1130	Cracking (RC and Other)	LF	6	0	6	0	0

Right side of Bent # 5. East abutment.

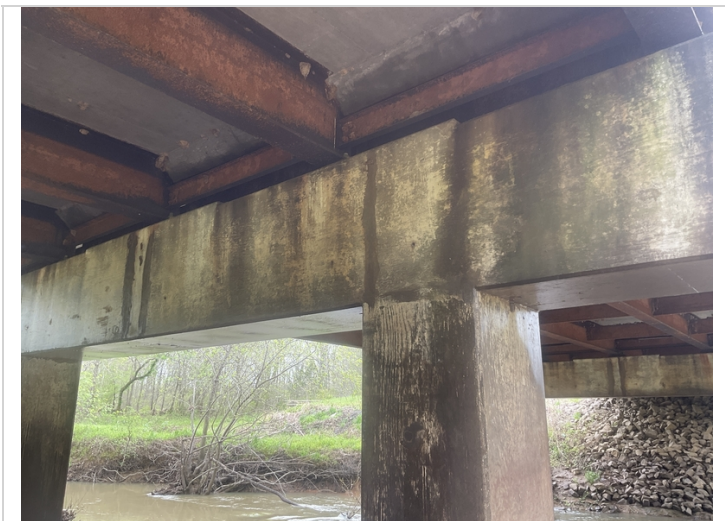
(234) -The bent caps have stains where the deck expansion joint seals leak onto the Substructure.							
-The caps have minor vertical cracks over the exterior edges of the columns in the step of the cap.

Wet substructure caps due to leaking expansion joint seals.
Photo of Bent # 3. Typical.

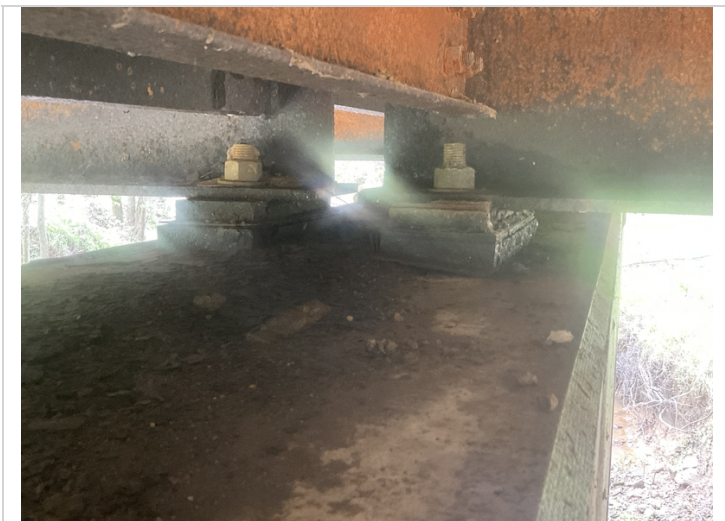
Bent # 2. Beam # 3 bearing corrosion.

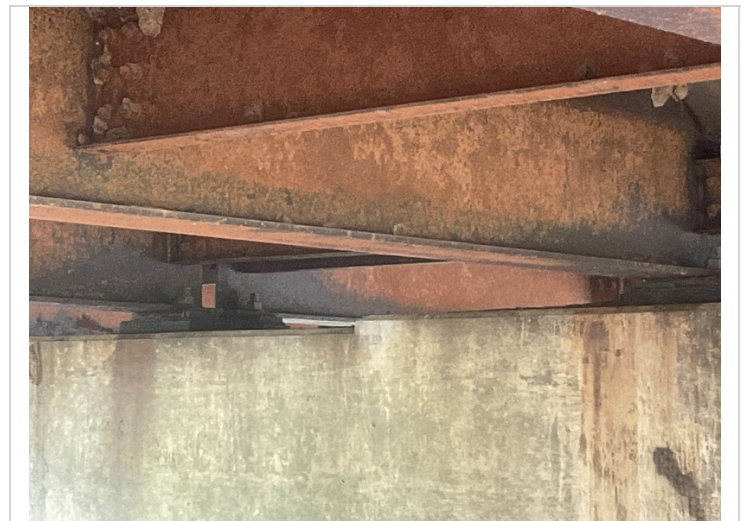
(311) -Bearings at the intermediate bents have active corrosion with flaking rust due to failing expansion joint seals allowing water to leak through onto the bearing devices.							
313	Fixed Bearing	EA	20	0	2	18	0
1000	Corrosion	EA	20	0	2	18	0
515	Steel Protective Coating	SF	20	0	0	0	20
3430	Oxide Film Degradation Color/Texture Adherence(Steel Protective Coatings)	EA	20	0	0	0	20

Bearing corrosion. Typical.

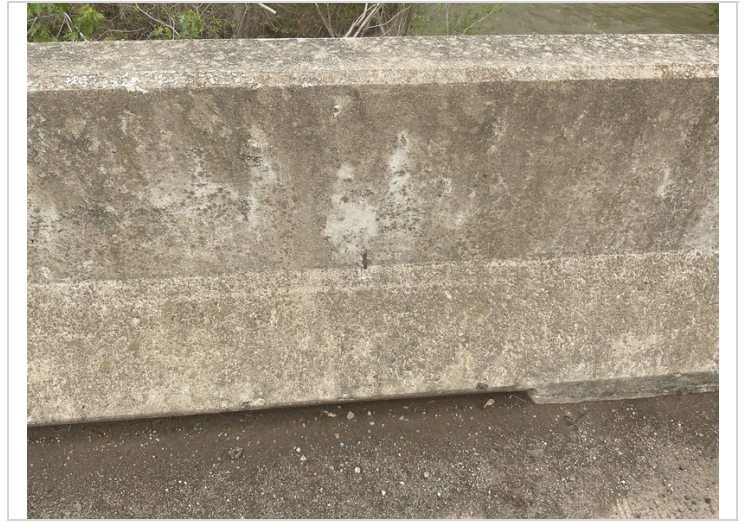
(331) -There are numerous golf ball sized spalls with exposed reinforcing steel in the lower portion of railing.

2" spall with exposed reinforcing steel in the face of the Left parapet wall.

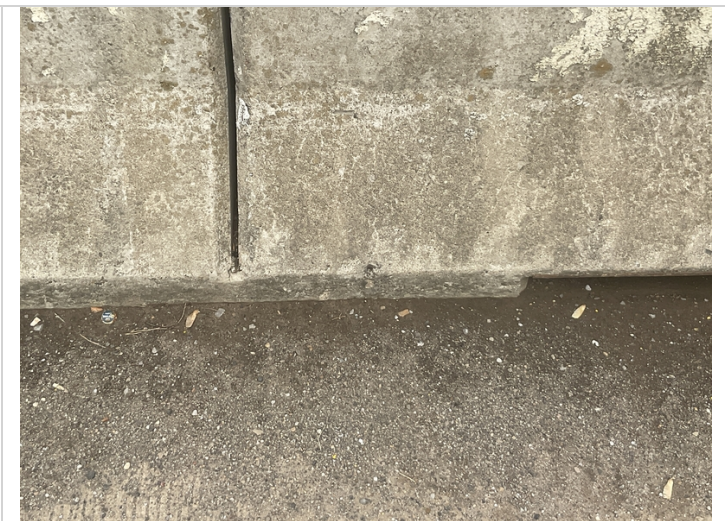
Minor spall in the base of the Left parapet.

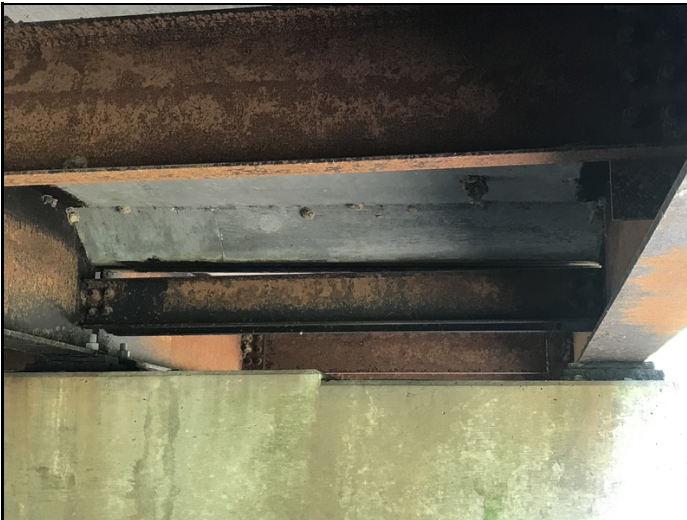
The bearings and the ends of the beams have flaking rust and abnormal weathering due to apparent leakage from the expansion joints.

Bearings have layers of flaking rust that is causing section loss.

Type of Work: Repair (General)

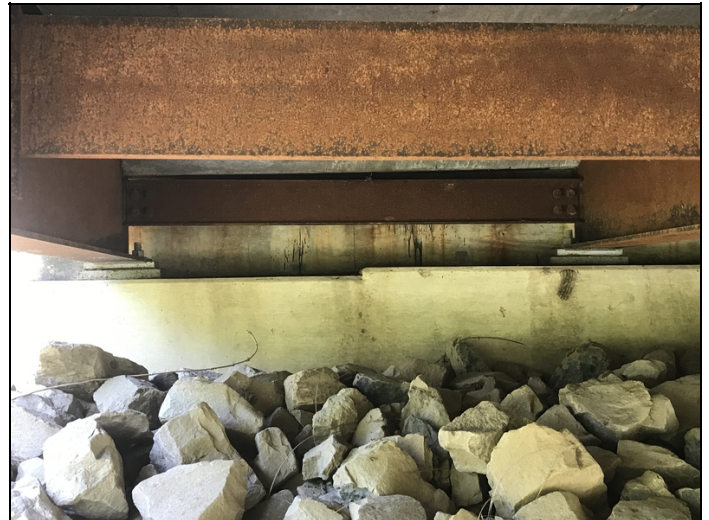
(313) -The bearings at the abutments have been painted. The paint system is failing with rust showing through in several locations. -Bearings have active corrosion with flaking rust where the deck expansion joint seals have failed and is allowing water to leak through onto the bearings.							
331	Reinforced Concrete Bridge Railing	LF	344	306	38	0	0
1090	Exposed Rebar	LF	33	0	33	0	0
1130	Cracking (RC and Other)	LF	5	0	5	0	0

Bent # 1 bearings have been painted in the past with active corrosion under the paint.

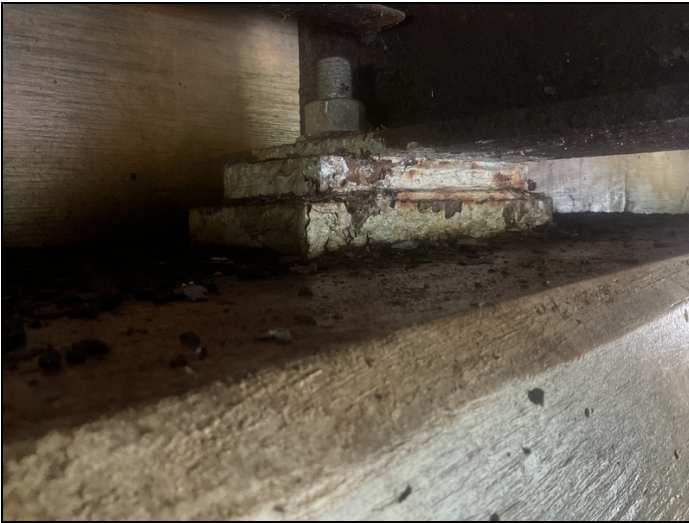
Bent # 1. Beam # 3 bearing corrosion.

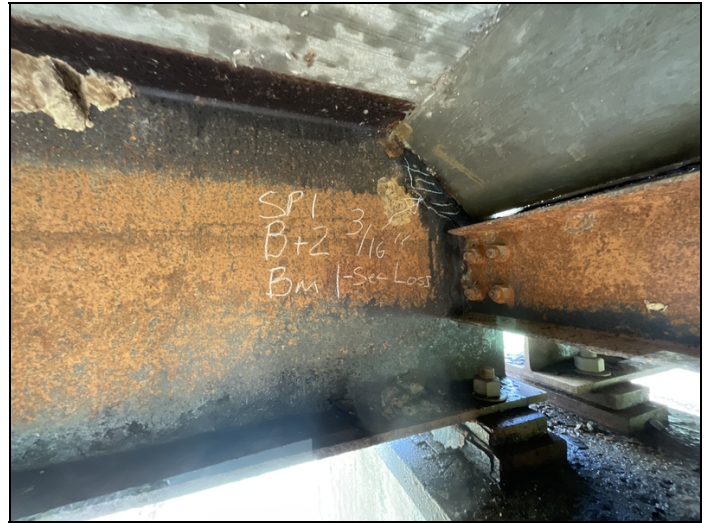
Span # 1. Bent # 2. Beam # 1 has 3/16" section loss to the web at the expansion dam juncture.

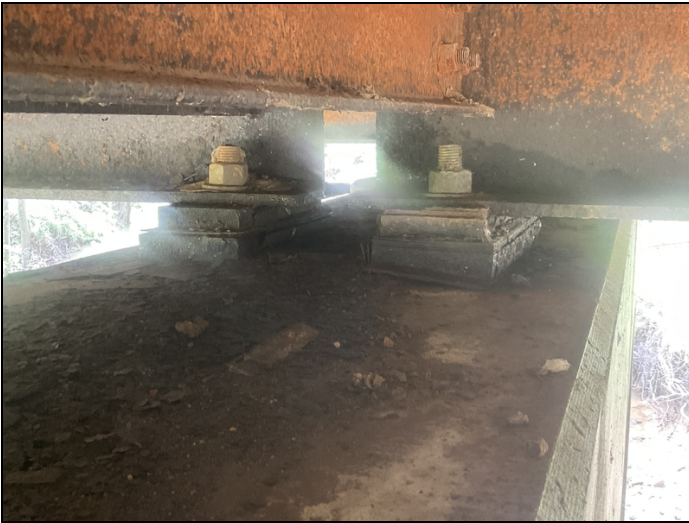
Bent # 2. Beam # 3 Bearing corrosion.

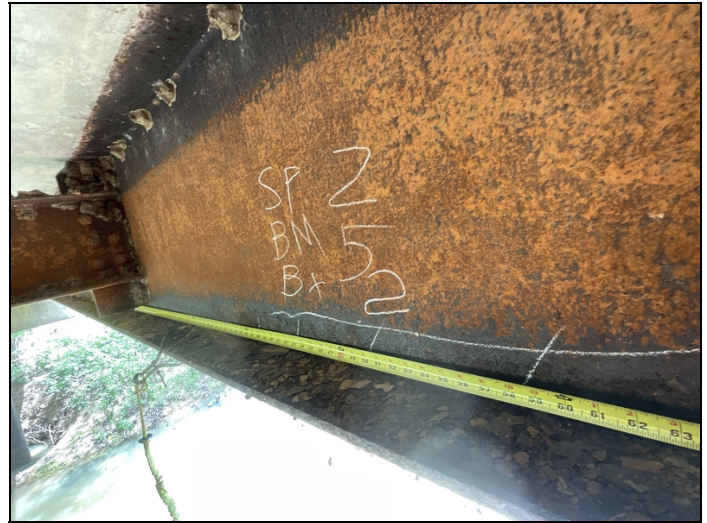
-Span # 2. Bent # 2. Beam # 5 bottom flange measures 9/16" remaining section adjacent to the bearing. The remaining base of web and bottom flange has active corrosion with initial section loss.

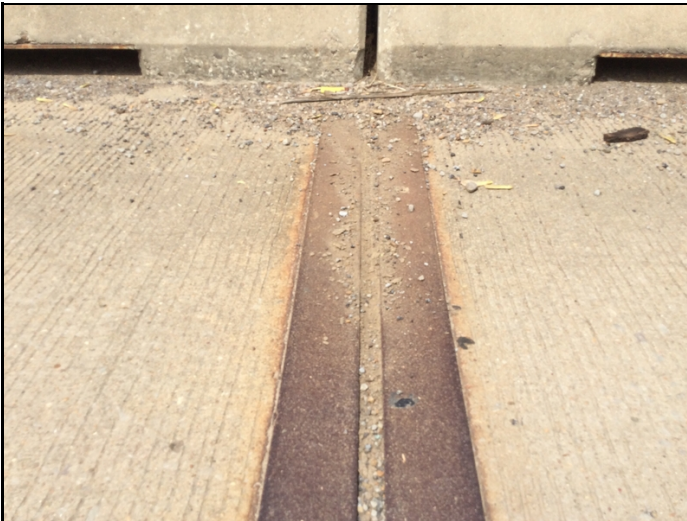
The deck expansion joint seals are deteriorated and leak water on the bearings and superstructure. The expansion joint assemblies have dirt and debris impaction in the gutters.

Dirt and debris impaction in assemblies.

Type of Work: Replace (General)

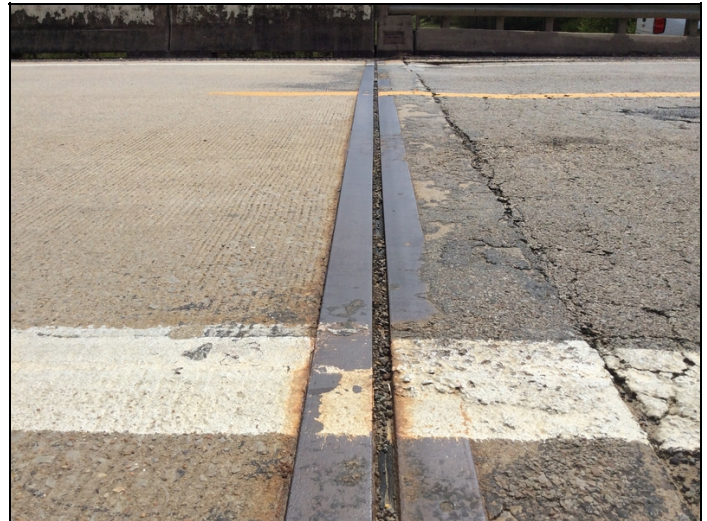
(302) -Expansion joint seals were leaking during the time of inspection. -The compression joint seals are deteriorated with cracking visible in top of seals. -The assemblies have dirt and debris impaction in the gutters. -Joint anchorage was sounded with a hammer during this inspection and appears to solid and functioning as intended, -Stains on the substructure caps and active corrosion with flaking rust to the beams and the bearings are indications that the deck joint seals leak.							
311	Movable Bearing	EA	20	0	0	20	0
1000	Corrosion	EA	20	0	0	20	0
515	Steel Protective Coating	SF	20	0	0	0	20
3430	Oxide Film Degradation Color/Texture Adherence(Steel Protective Coatings)	EA	20	0	0	0	20

Deteriorated expansion joint seals.

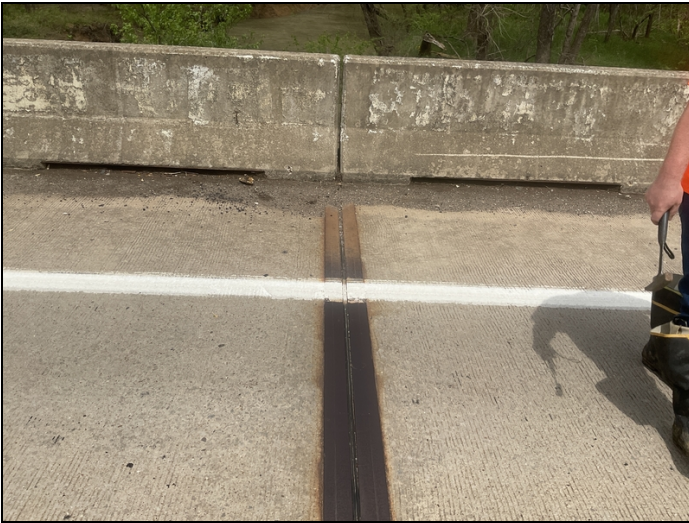
Expansion joint seal over Bent # 3. Typical.

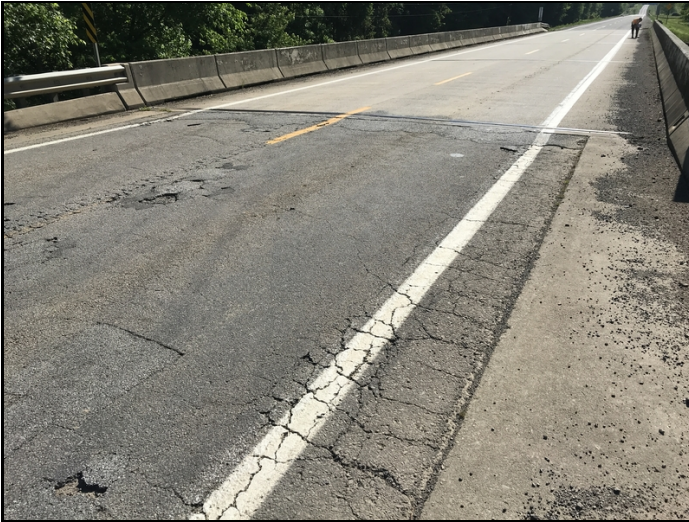
The asphalt driving surface of the West approach roadway is deteriorated and coming apart with numerous potholes forming.

West approach roadway with asphalt deterioration and settlement.

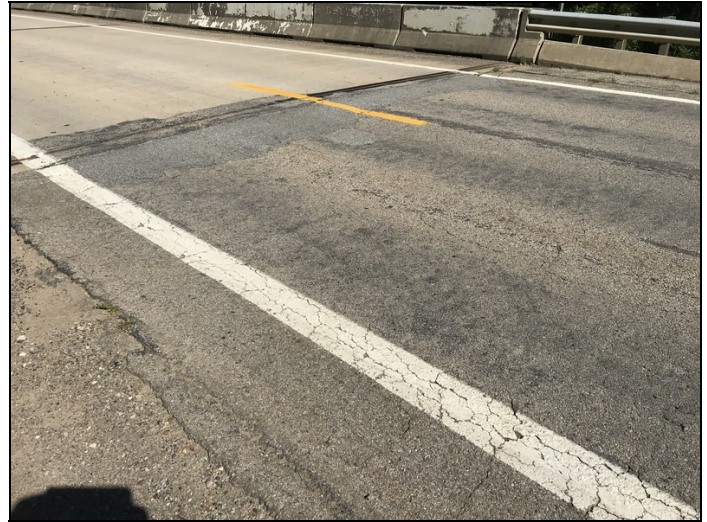
There is settlement in the asphalt adjacent to the abutments.

East approach asphalt settlement.

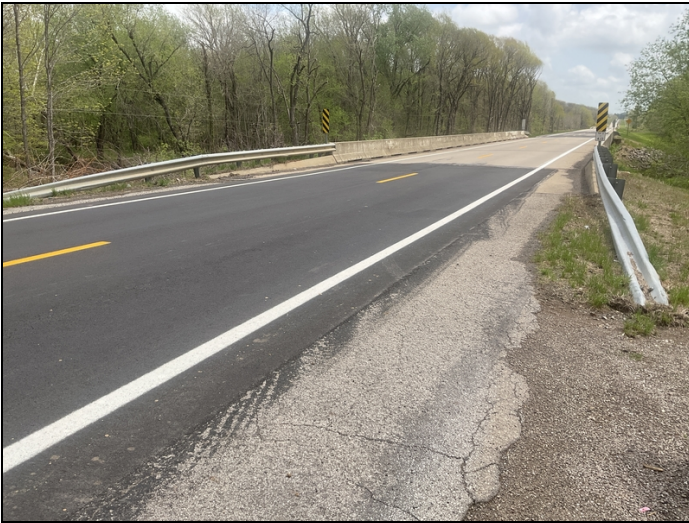
West approach roadway has new asphalt.

04/21/2022 - JCJ & TJL - Both approaches have new asphalt.

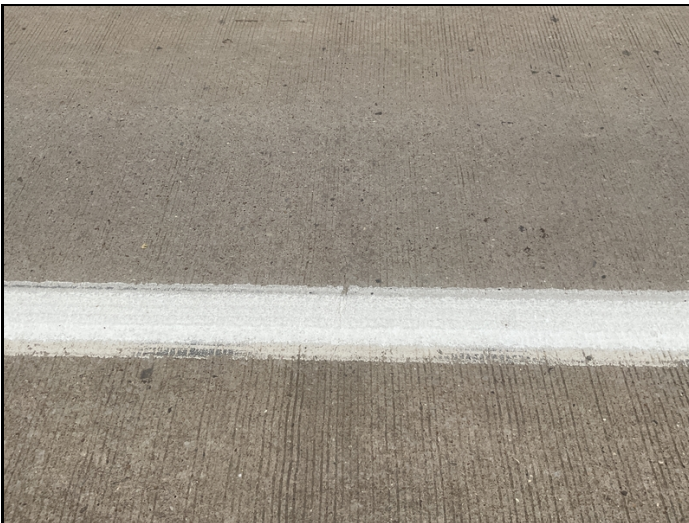
There are a few sealable transverse cracks in the deck.

Sealable cracks in the deck. Span # 2.

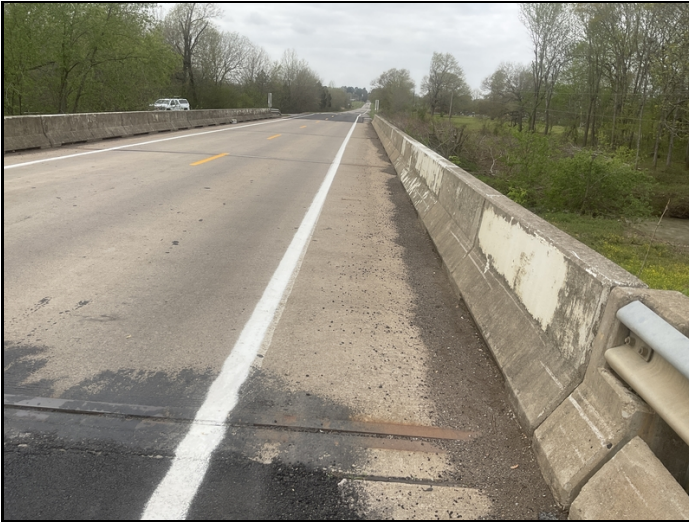
There is debris accumulation in the gutters.

Type of Work: (Inactive) (Inactive) 1 - Clean

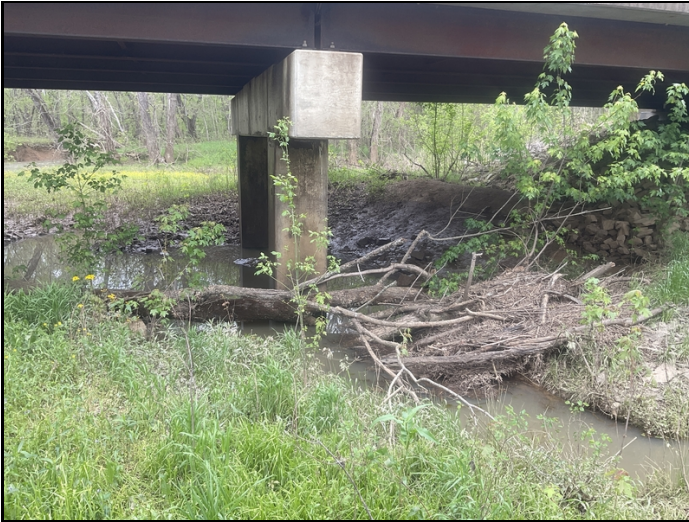
There is drift accumulation at the base of Bent # 4.

Type of Work: (Inactive) (Inactive) 1 - Clean

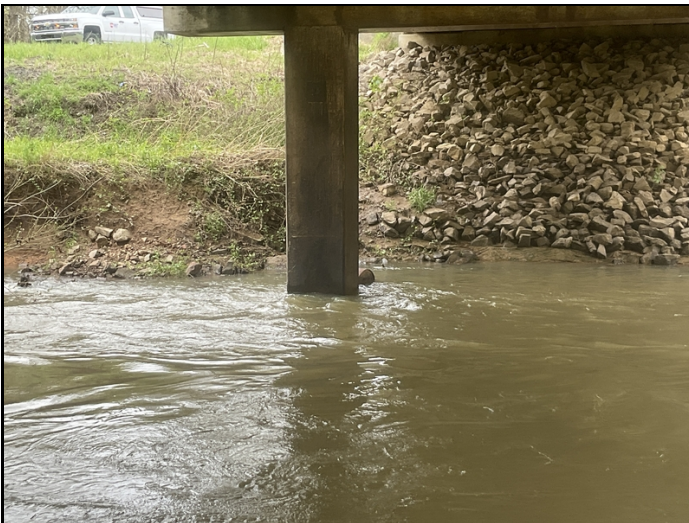
There is embankment erosion with some displacement of rip rap at the West embankment.

Type of Work: Repair (General)
