Asset #06115(Routine)

State Highway 96 over Big Creek Relief

Location: 1.94 MI E SH 255

Team Lead: Jeff Jones, Inspection Date: 04/20/2022

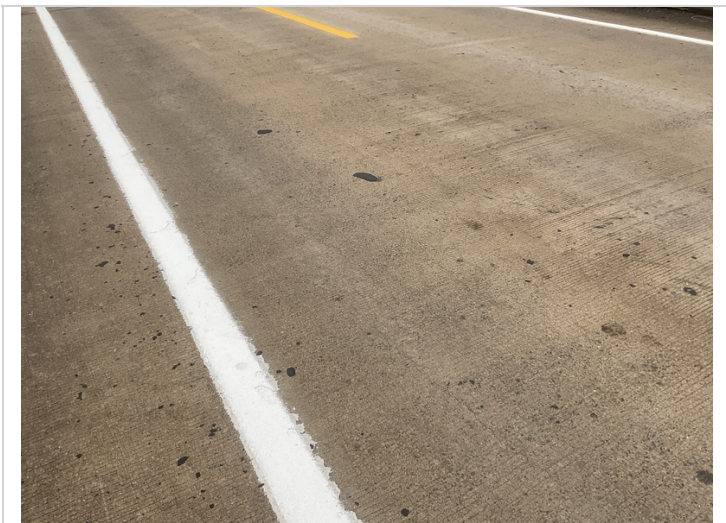
Longitudinal and transverse cracking in Span # 2. Driving surface.

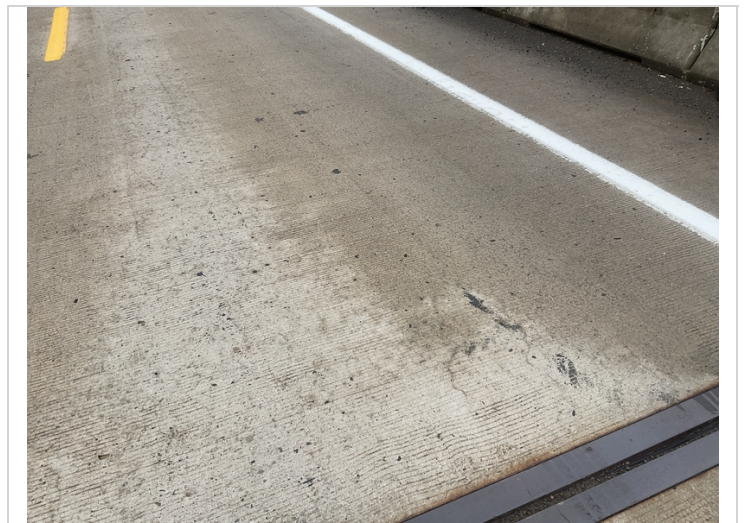
Longitudinal cracking in driving of Span # 1.

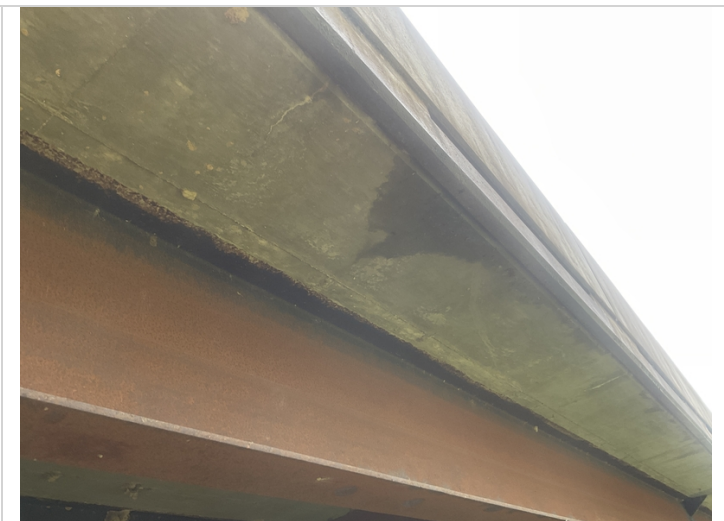
Transverse cracks with efflorescence in the overhang of the deck.

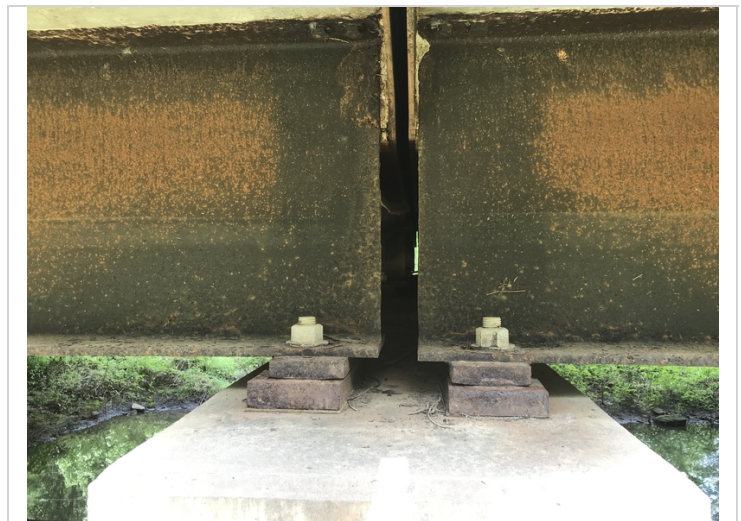
Bent # 2 Beam # 5 active corrosion along the bottom flange and base of the web.

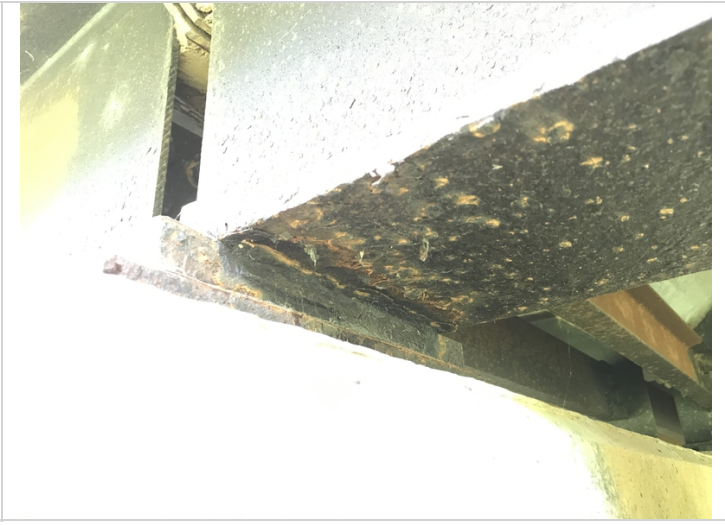
Bent # 3 Beam # 1 with initial section loss along the edge of the sole plate and the bottom surface of the bottom flange.

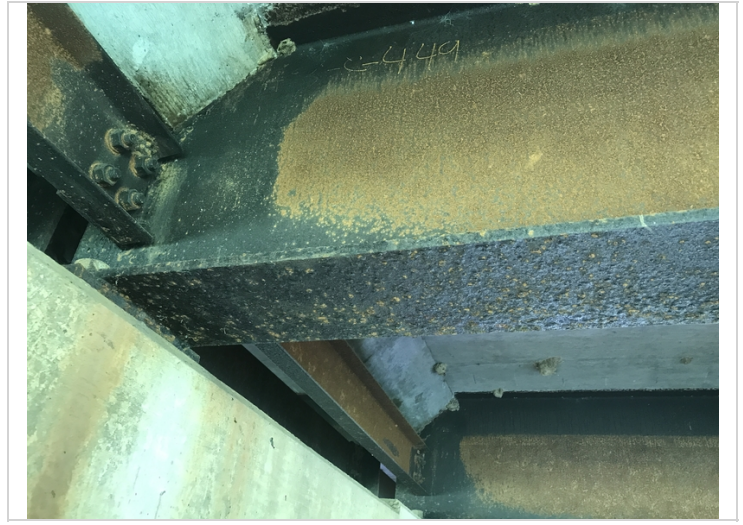
Typical flaking rust at the beam ends.

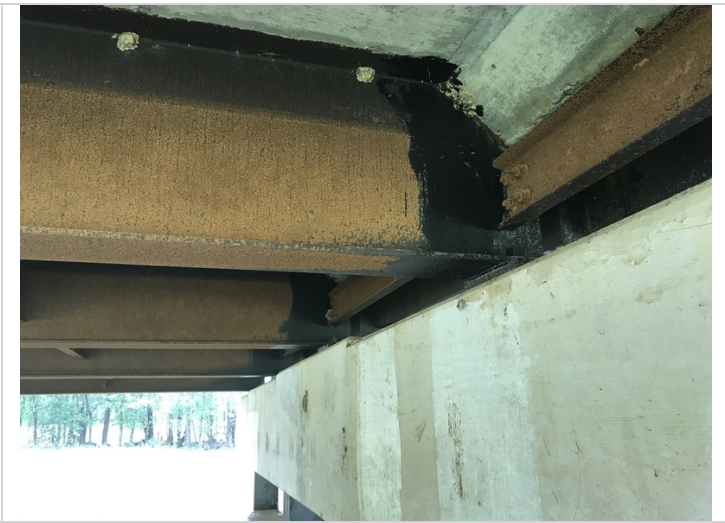
Bridge mate applied to the beam ends in some locations.

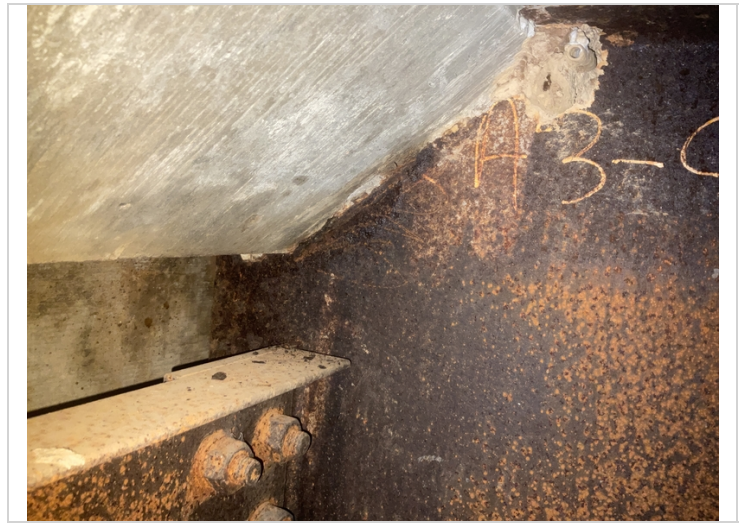
Active corrosion with section loss adjacent to the expansion dam. Beam 4. Bent.

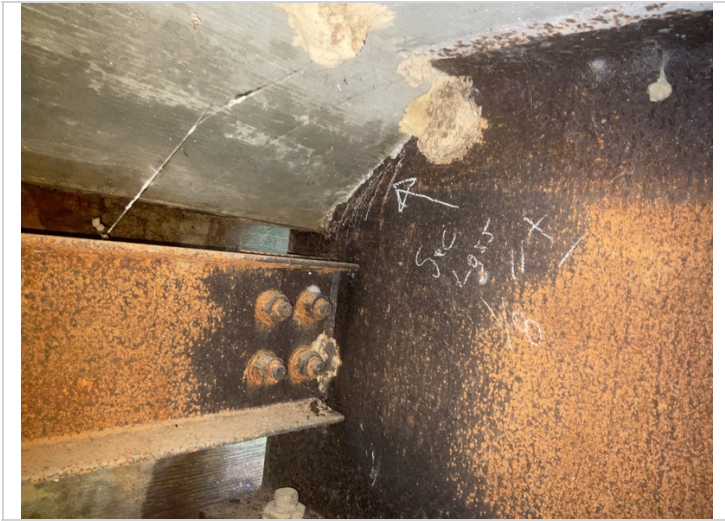
Beam 1. Bent 1. Active corrosion with section loss that measured 1/8" deep during this inspection.

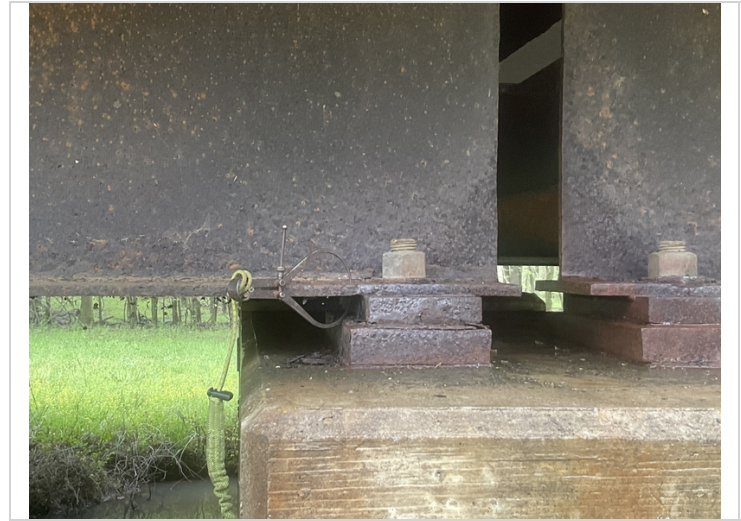
Beam 1. Bent 2. Span 2. There is 1/2" remaining section in the bottom flange thickness.

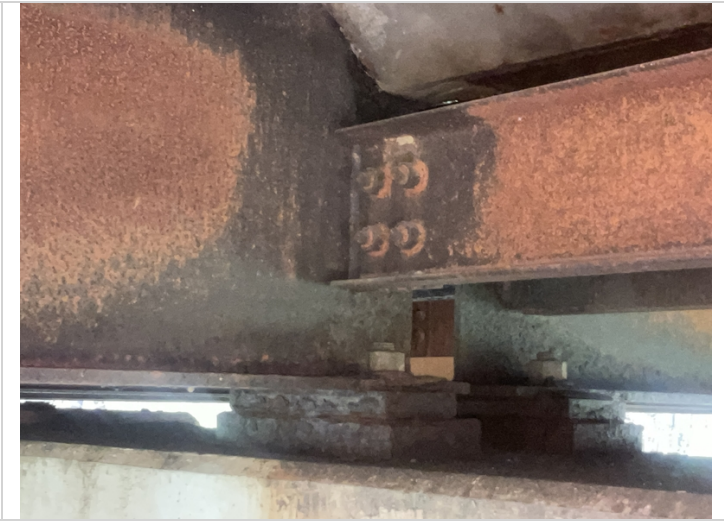
Active corrosion. Beam 2. Over Bent 4.

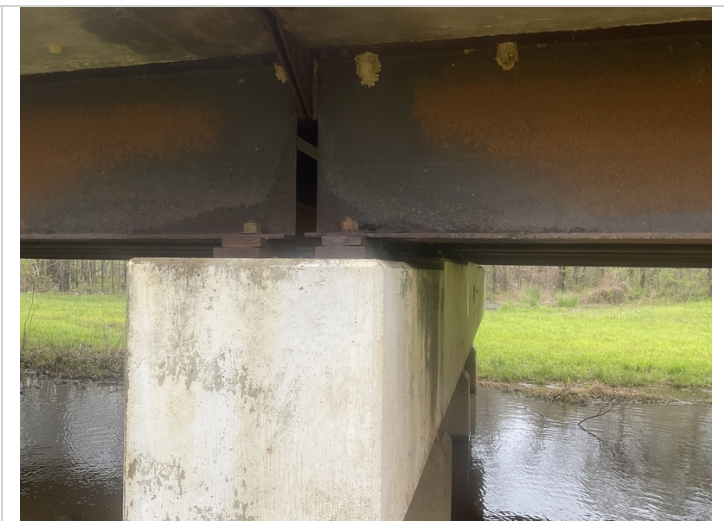
Beam 5. Bent 5. Active corrosion in the beam ends.

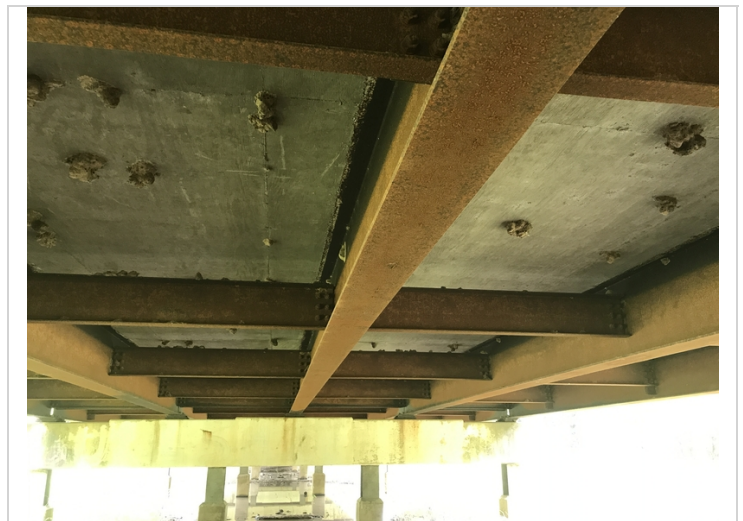
The protective coating has a light orange patina forming on the lower 3/4 of the beams and diaphragms from being inundated by the recent flooding events.

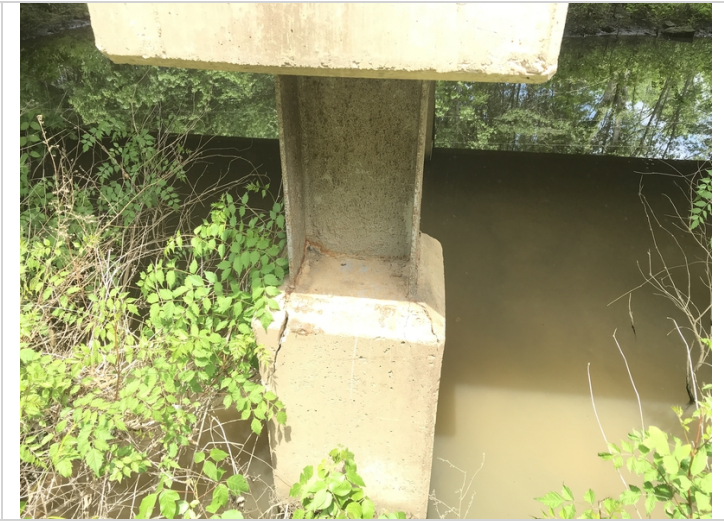
Bent # 2 Column # 4 active corrosion that is cracking the concrete collar at the base of the steel pile.

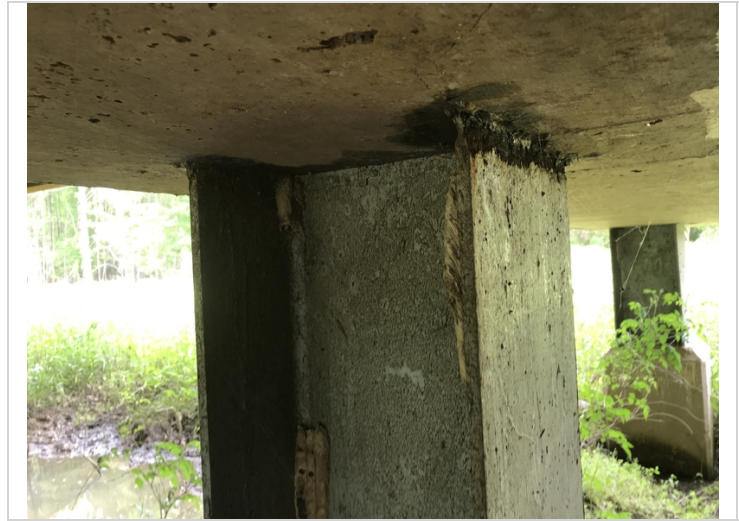
Typical active corrosion along to cap / steel pile interface.

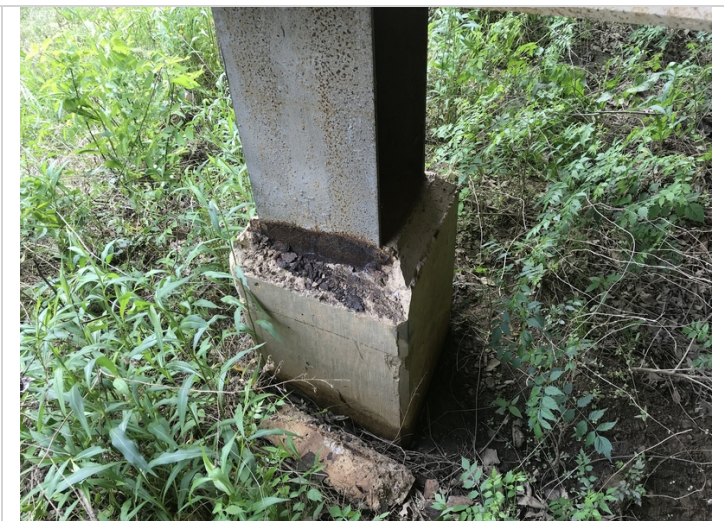
Active corrosion between concrete collar and the steel pile column.

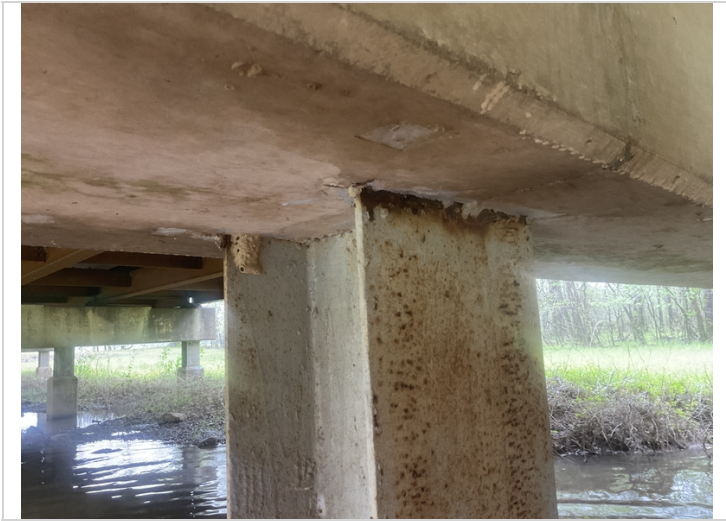
Active corrosion in the steel piles at the cap juncture. Pile # 4. Bent # 2.

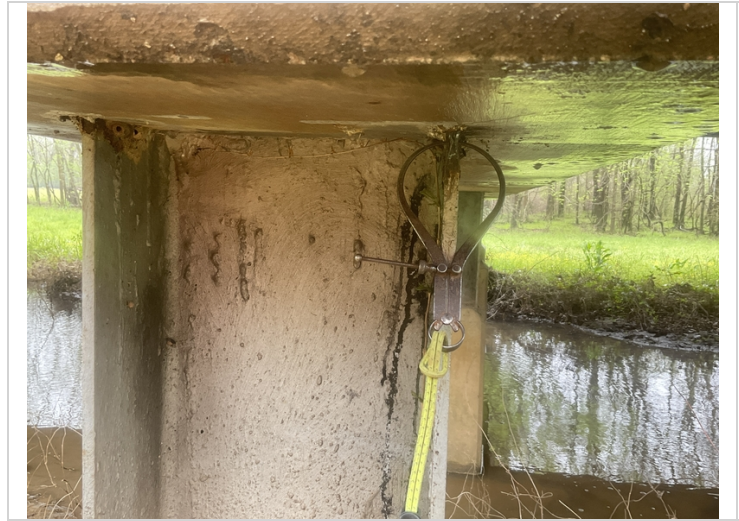
Bent # 4. Pile # 1. Flange edge has been reduced down to 1/8" thickness.

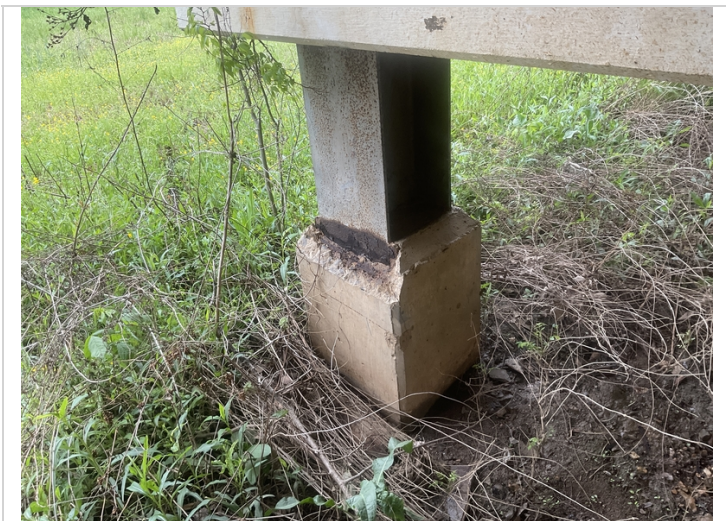
Active corrosion with flaking rust in the steel pile. Spalling with exposed reinforcing steel in the concrete collar. Bent # 7. Pile # 4.

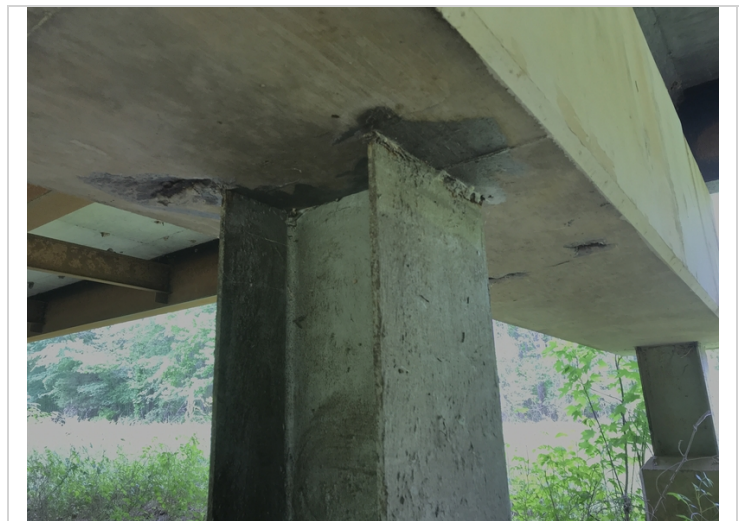
Bent # 3 spalling with exposed reinforcing steel on the undersurface of the cap.

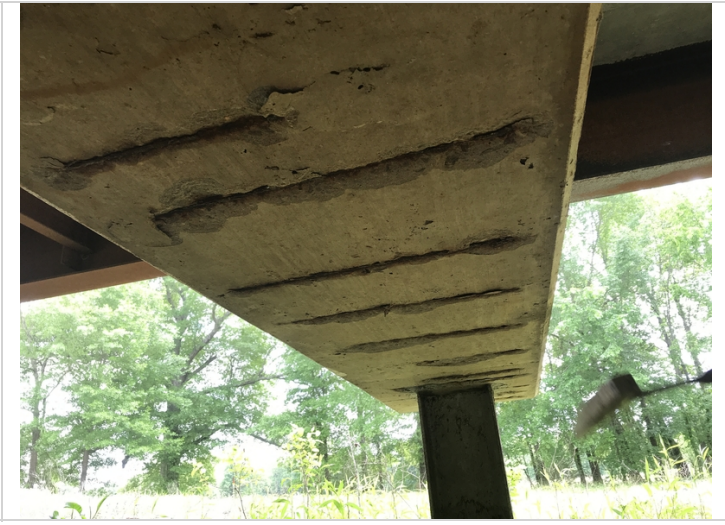
Bent # 7 cap undersurface spalling with exposed reinforcing steel.

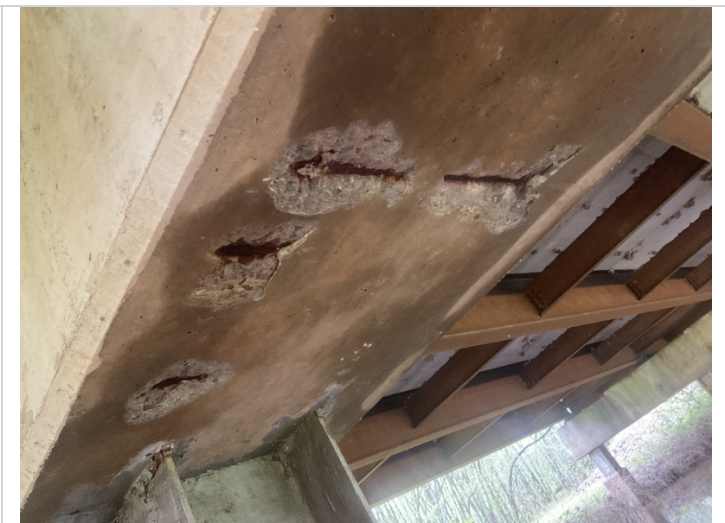
Undersurface of bent # 3. Spalls with exposed reinforcing steel.

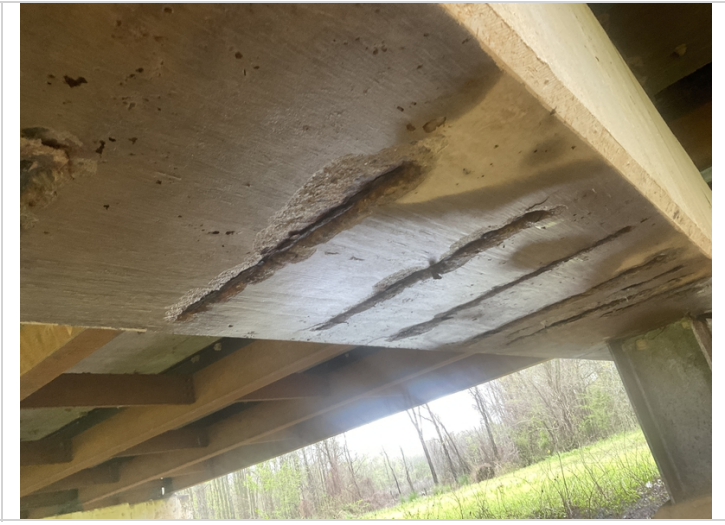
Undersurface of bent # 7. Spalls with exposed reinforcing steel.

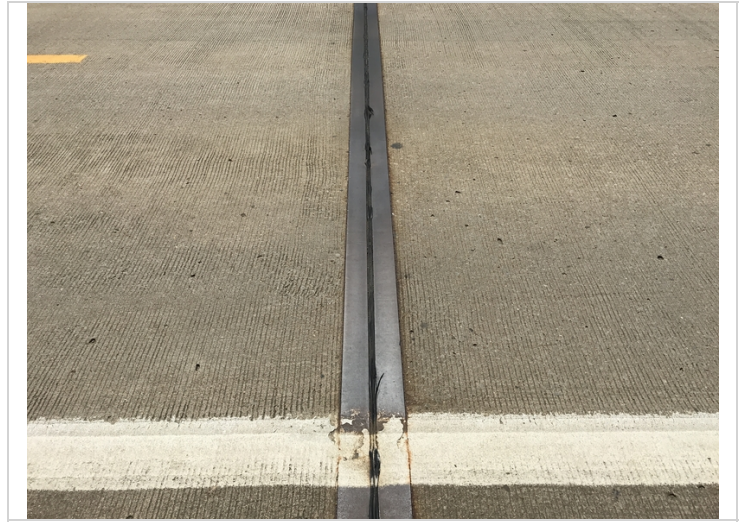
Bent # 4 failing compression joint seal.

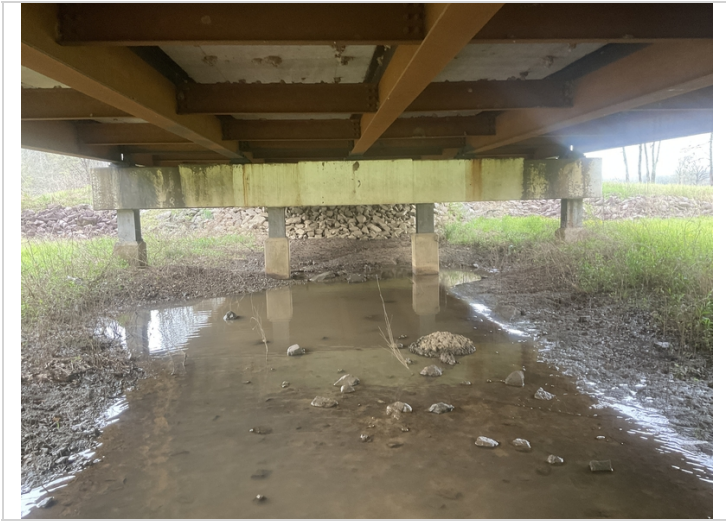
Bent # 7. Stains from apparent joint leakage.

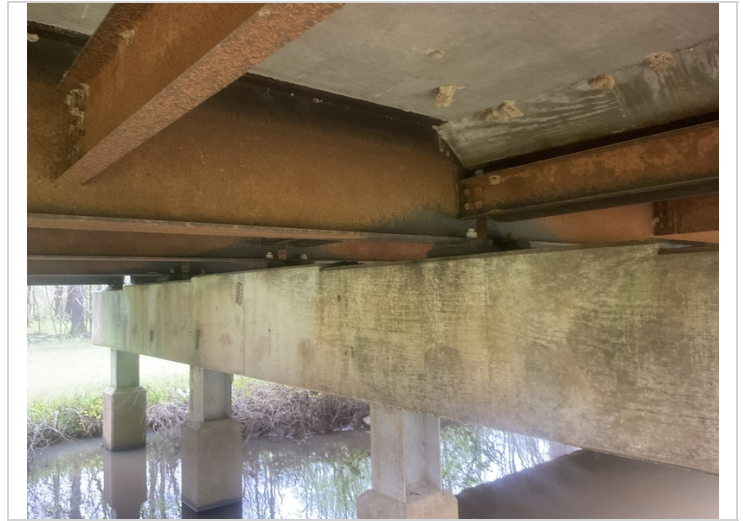
Active corrosion in the bearings.

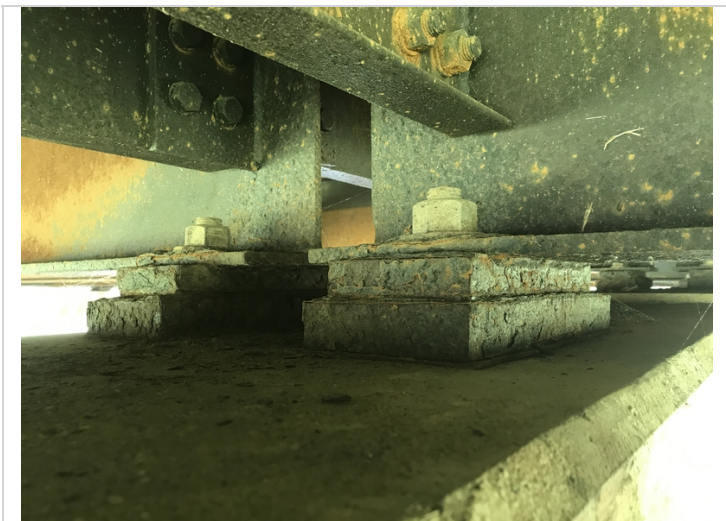
Fixed bearings with active corrosion and layers of flaking rust.

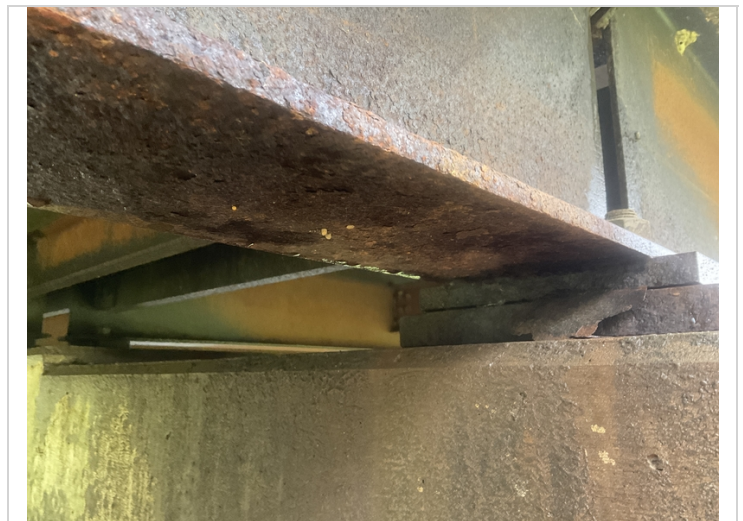
Active corrosion in the bearings.

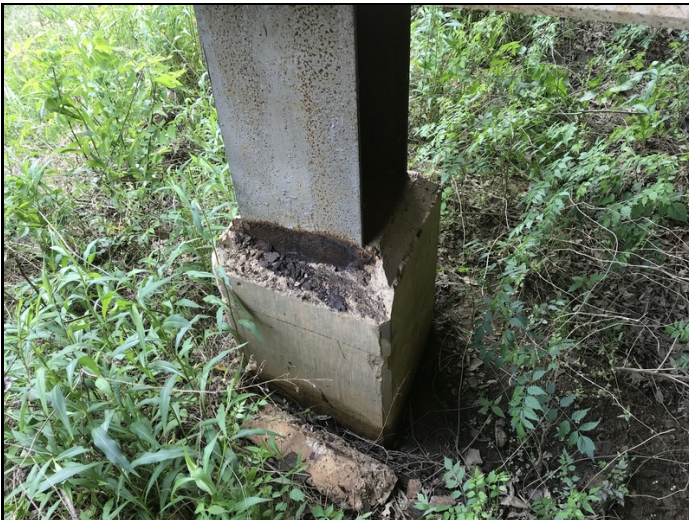
The steel piles have a failing paint system with active corrosion, heavy flaking rust and measurable section loss at the juncture of the concrete caps and concrete encasements. The top of some of the concrete collars have spalling with delaminated areas.

Active corrosion between concrete collar and the steel pile column.

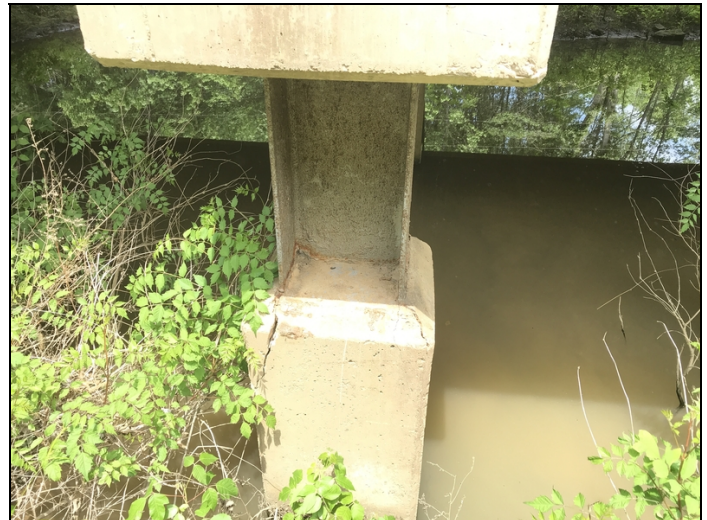
Bent # 2 Column # 4 active corrosion that is cracking the concrete collar at the base of the steel pile.

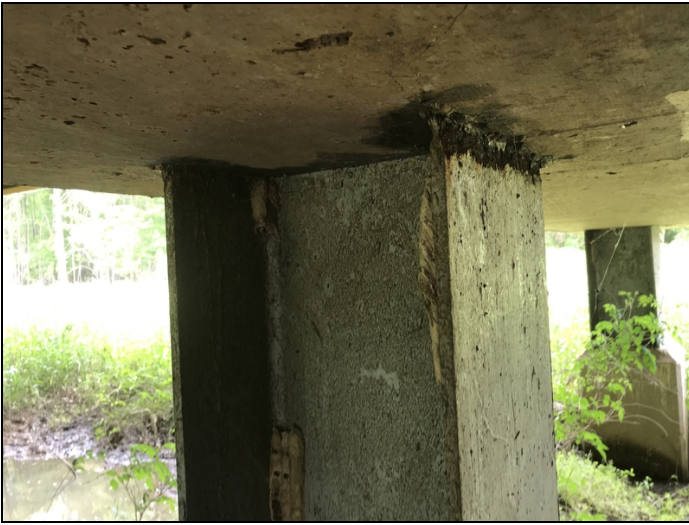
Typical active corrosion along the cap / steel pile interface.

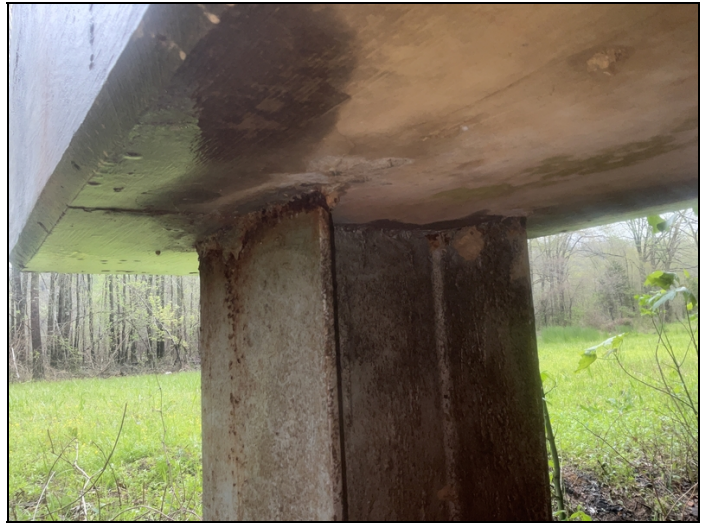
Active corrosion with section loss in the steel piles at the cap juncture. Bent # 2. Pile # 1.

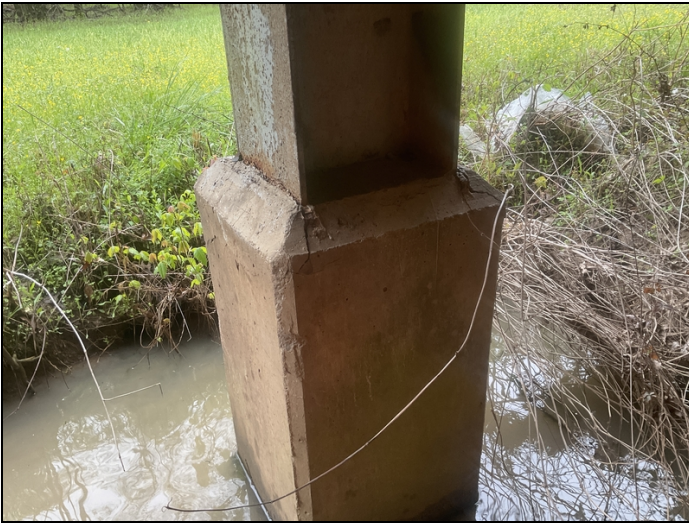
Bent # 2. Pile # 4. Delaminated areas in the top of the concrete collars.

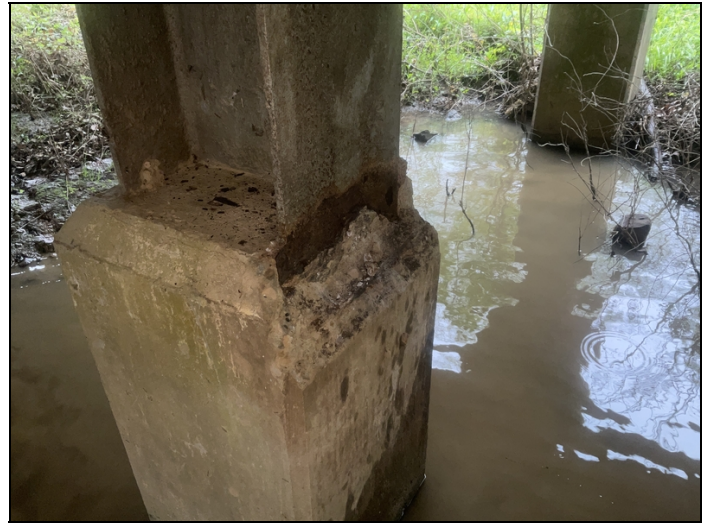
Active corrosion with pack rust. Bent # 3. Pile # 3.

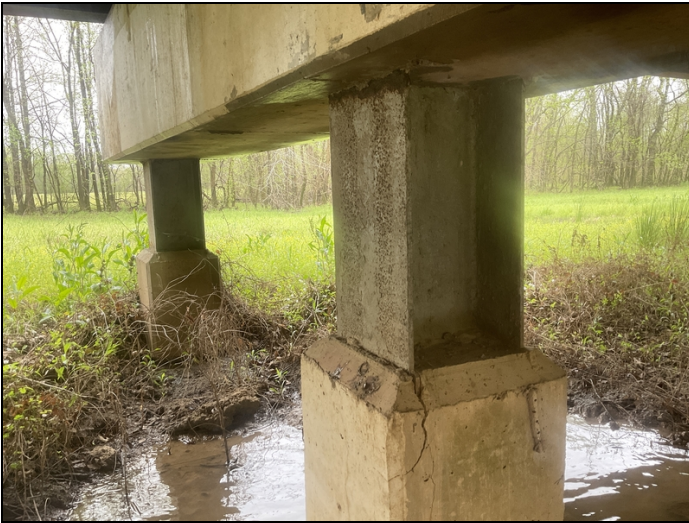
Bent # 6. Pile # 3. Active corrosion with section and delaminated concrete collar.

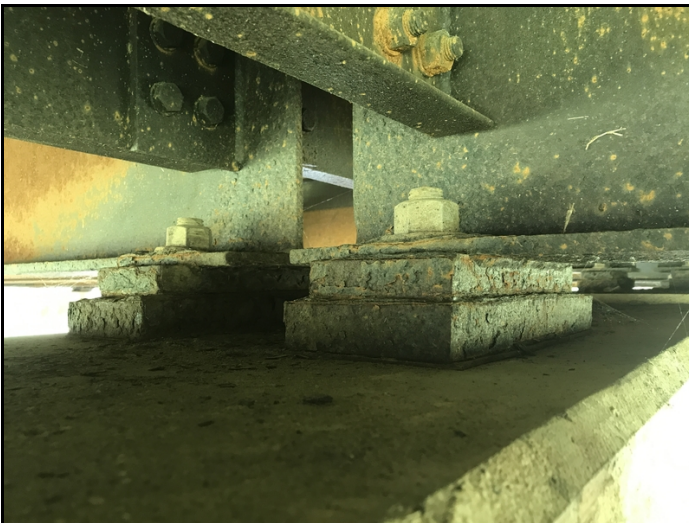
The bearings have heavy pack rust between the sole and masonry plates in several locations.

Fixed bearings with active corrosion and layers of flaking rust.

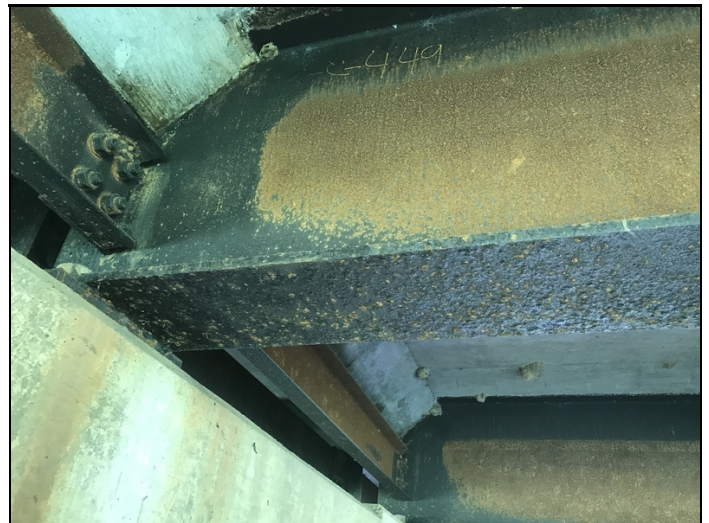
The ends of the beams and the bearings have abnormal weathering with thick flaking rust where the failing expansion joint seals allow water to leak onto the Superstructure.

Typical flaking rust at the beam ends.

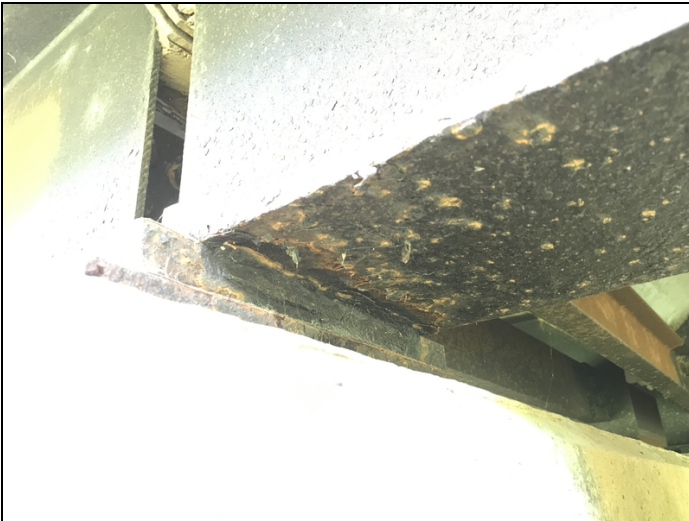
Bent # 3 Beam # 1 with initial section loss along the edge of the sole plate and the bottom surface of the bottom flange.

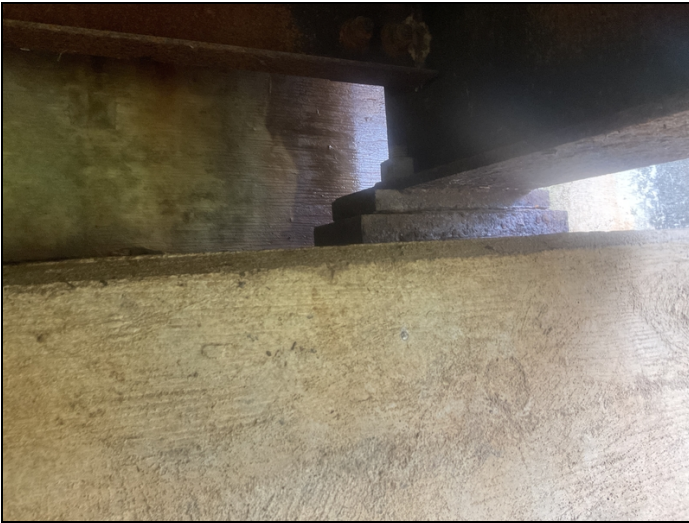
Active corrosion in the bottom flange adjacent to the bearings. Beam # 1. Bent # 1.

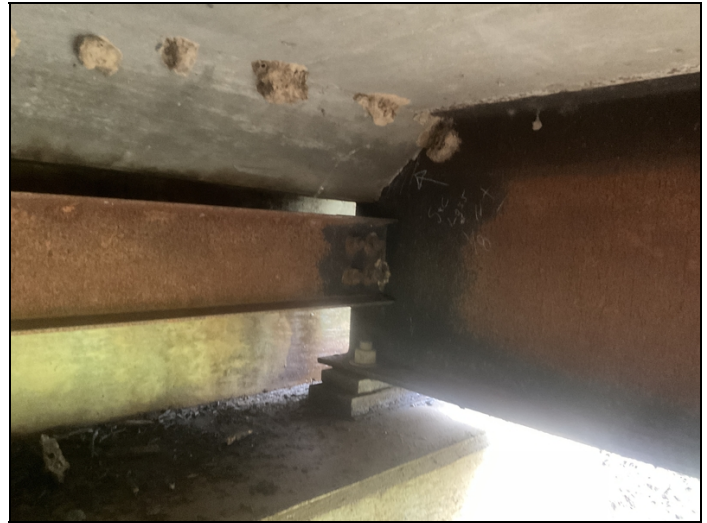
There is active corrosion with section loss at the expansion dam / web juncture that measured up to 1/8" deep.

Active corrosion with section loss adjacent to the expansion dam.

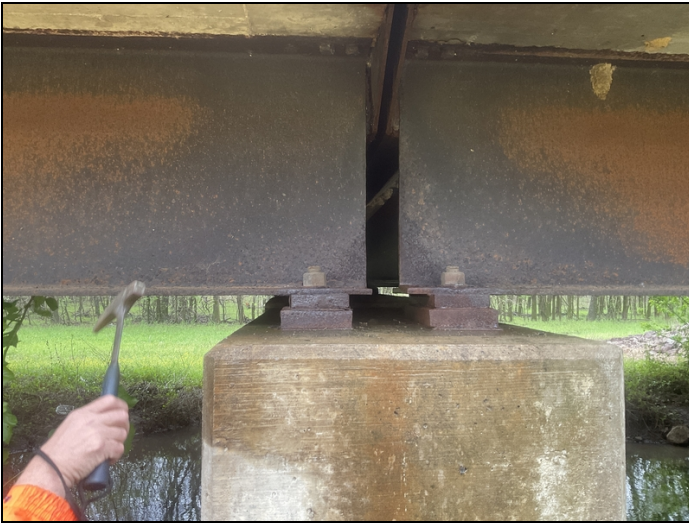
Active corrosion with flaking rust in the beam ends and bearings.

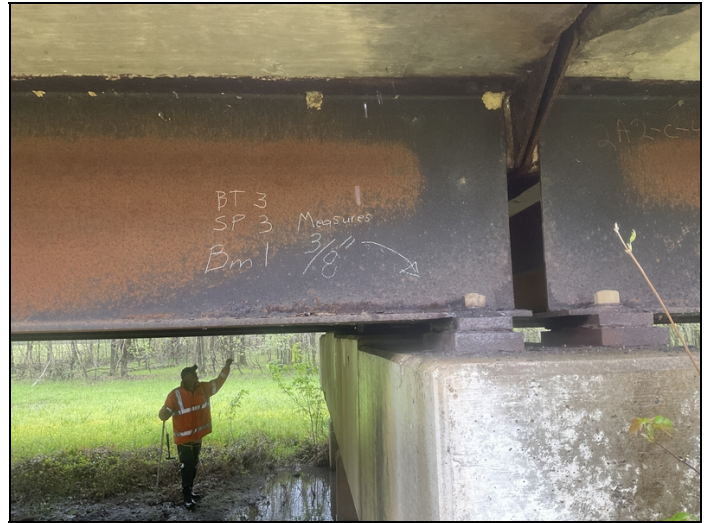
The bottom flanges of the beam ends have been reduced up to 3/8" section adjacent to the sole plates in numerous locations throughout the superstructure.

Span # 3. Beam # 1. Bent # 3. Has been reduced down to 3/8" thickness.

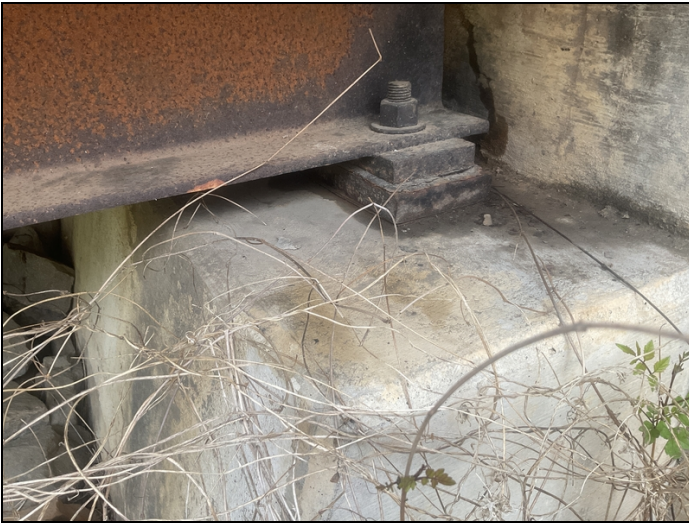
Beam # 5. Bent # 8. Active corrosion in the bearings.

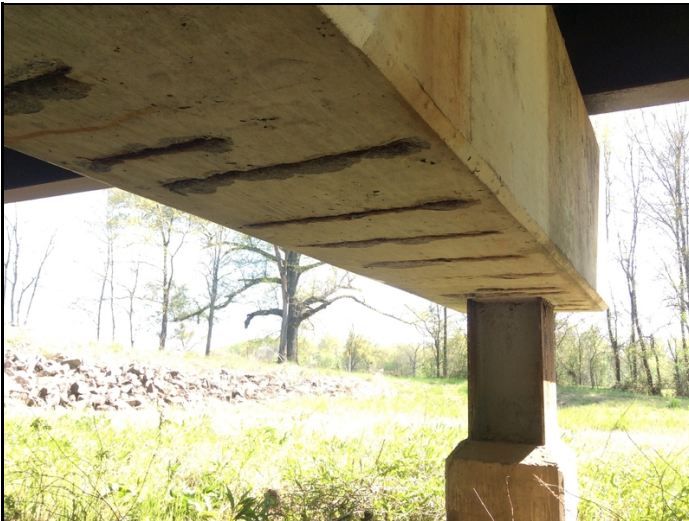
Several bent caps have shallow spalls with exposed reinforcing steel on the undersurface of the bent caps. The exposed reinforcing steel has active corrosion with measurable section loss.

Bent # 7 undersurface of cap exposed reinforcing steel.

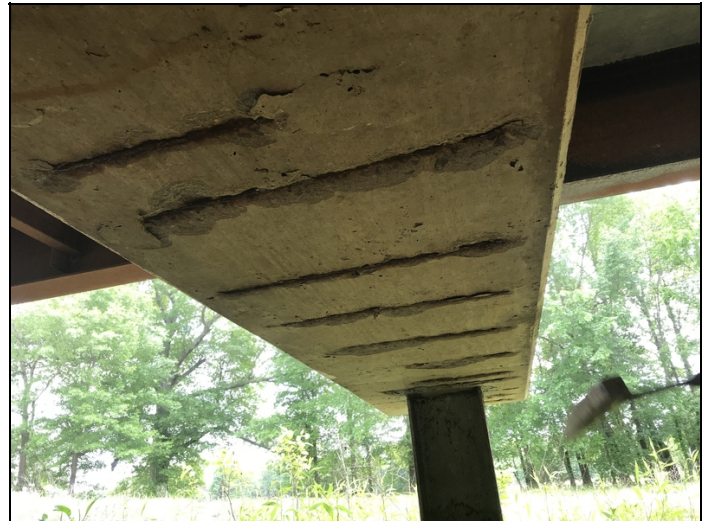
Bent # 7 cap undersurface spalling with exposed reinforcing steel.

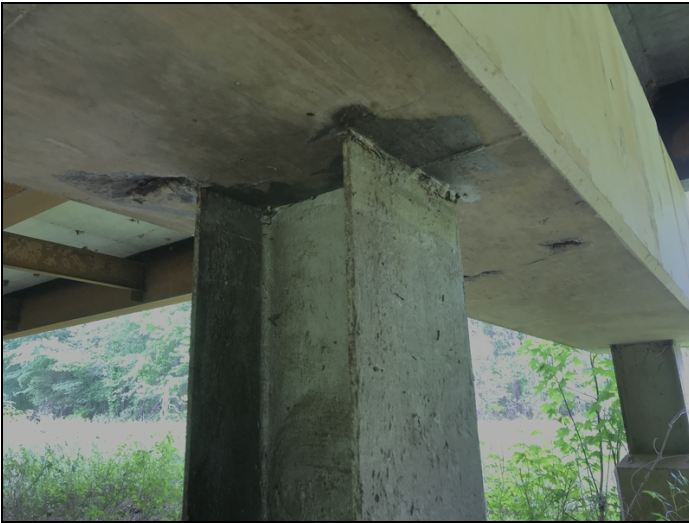
Bent # 3 spalling with exposed reinforcing steel on the undersurface of the cap.

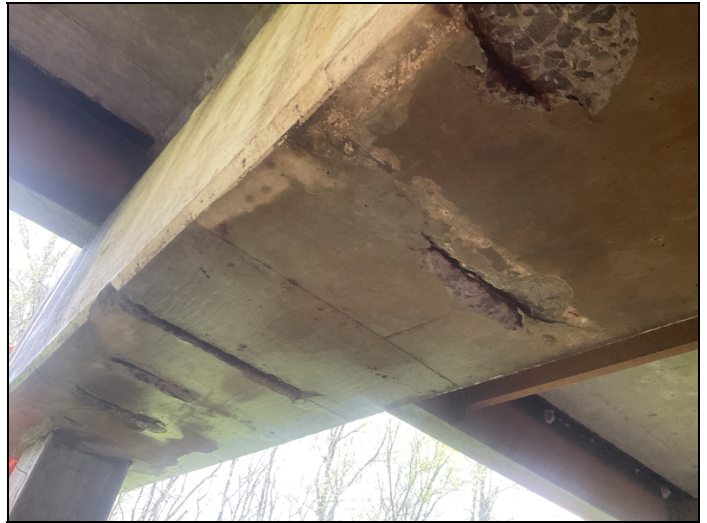
Undersurface of bent # 4. Several spalls with exposed reinforcing.

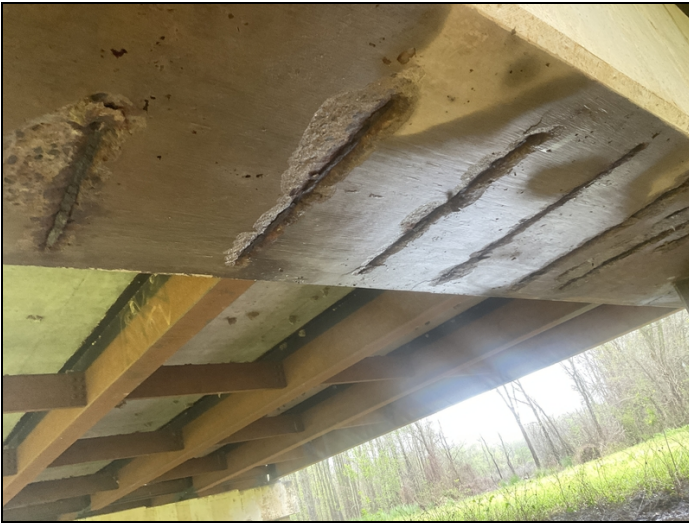
Undersurface of bent # 7. Spalls with exposed reinforcing steel.

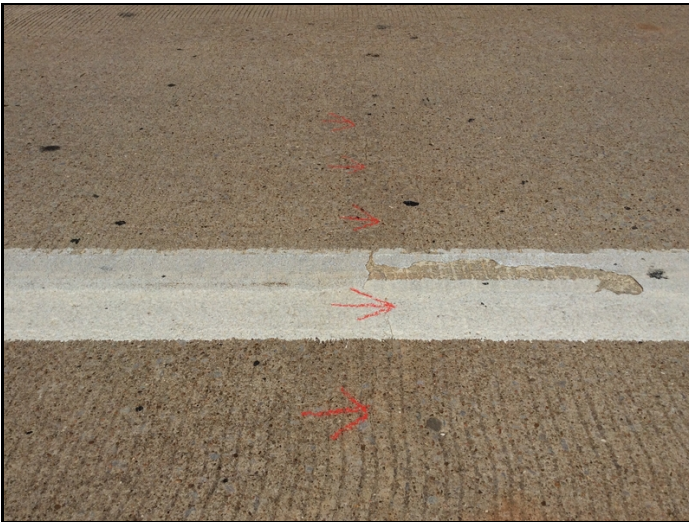
Deck -
The driving surface of the deck has sealable cracking in all spans.

Span # 5, Right lane-Transverse cracking.

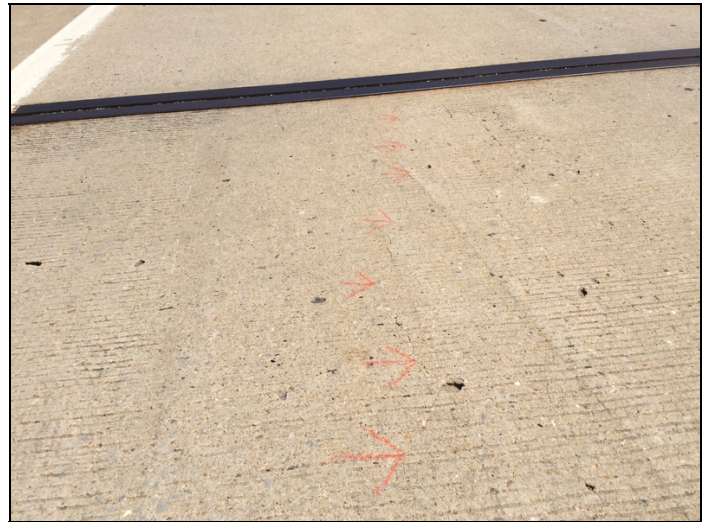
Span # 1, left lane-Longitudinal cracking.

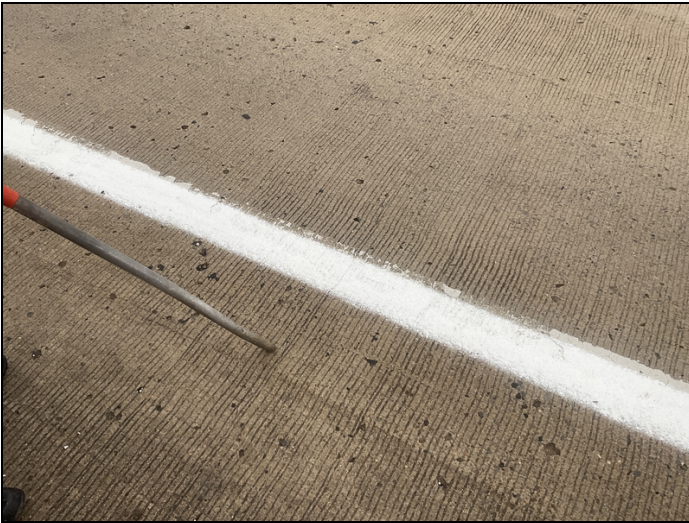
Transverse cracks in the driving surface of the deck.

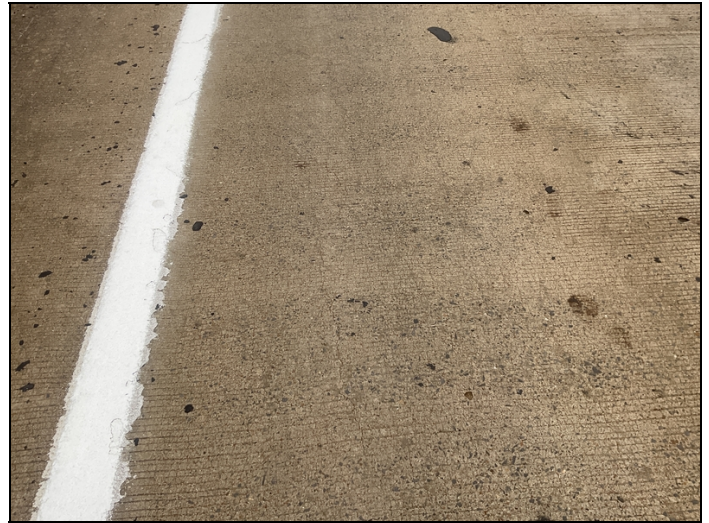
Sealable Longitudinal cracking in span # 2.

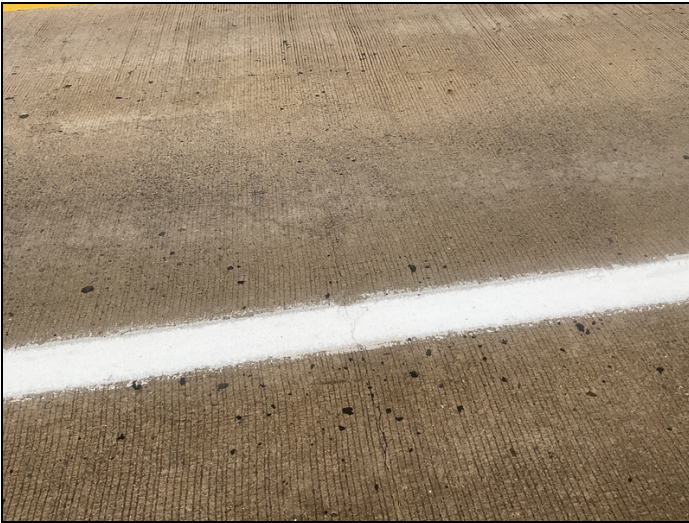
Sealable transverse cracks in the driving surface of the deck.

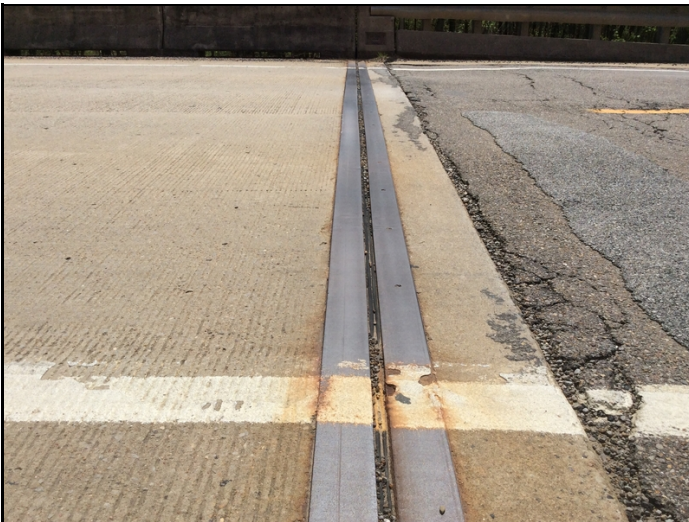
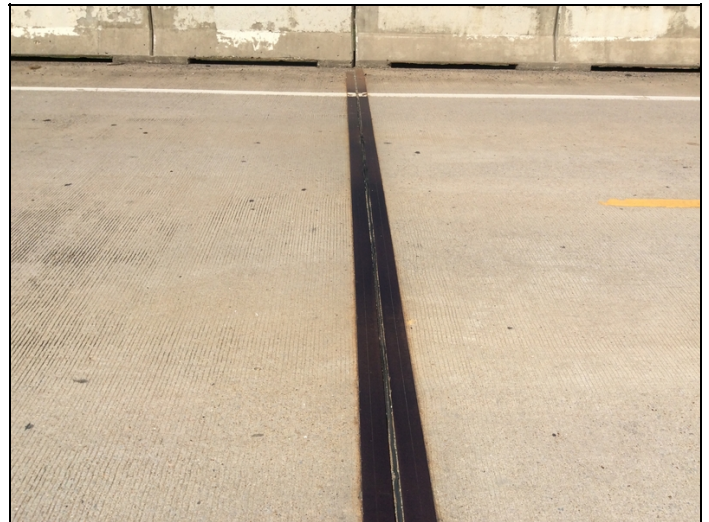
The compression joint seals are deteriorated with cracking visible in the tops of seals. The assemblies have dirt and debris in the gutters with pack rust throughout that has caused the seals to lose adhesion.

Expansion joint seals deteriorated.

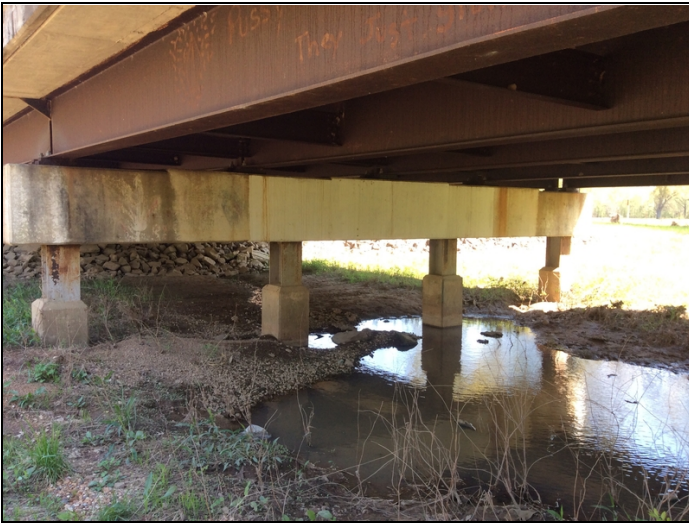
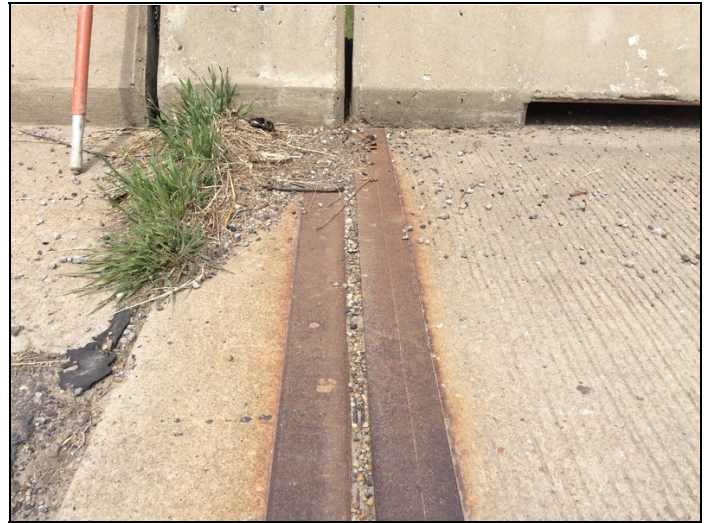
Expansion joints have dirt and debris impaction in the gutters.

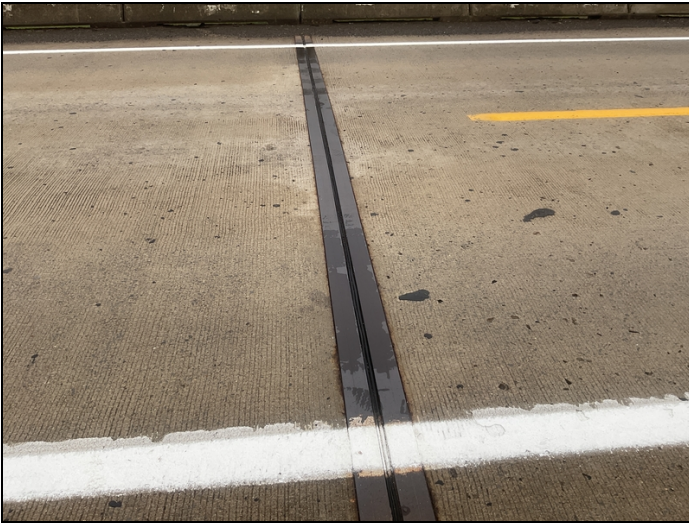
Deteriorated expansion joint seal over bent # 7.
