Asset #06115(Routine)

State Highway 96 over Big Creek Relief

Location: 1.94 MI E SH 255

Team Lead: Jeff Jones, Inspection Date: 04/20/2022

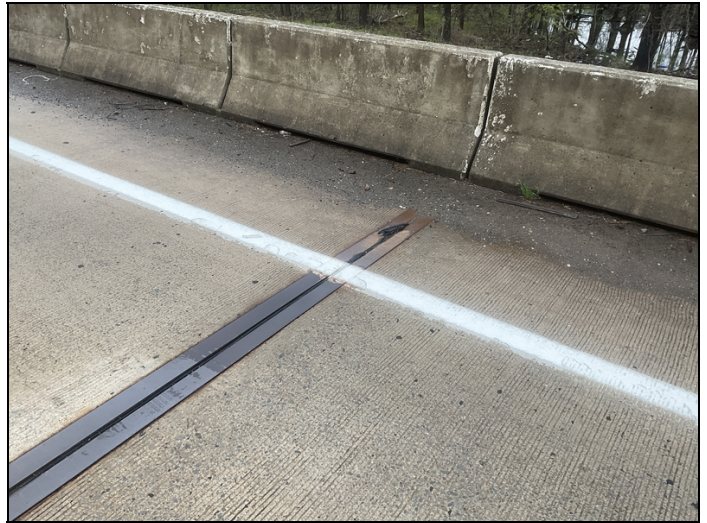
The seals have damaged areas where they stick up above the assemblies in numerous areas throughout the structure.

Damaged compression joint seal over bent # 3. Left.

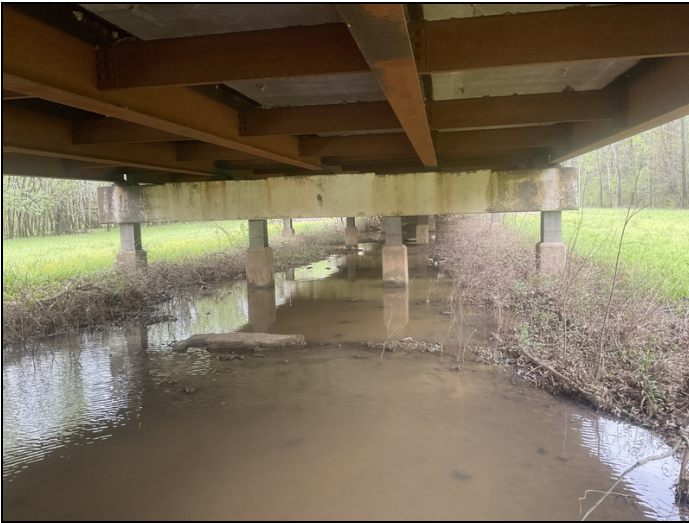
Deck Joint seals leak.

Staining in the bent caps from apparent joint leakage.
