Asset #A0424(Routine)

State Highway 10 over Adamson Creek - Seb. Co.

Location: 0.47 MI E JCT SH 10 SEC 0

Team Lead: Jeff Jones, Inspection Date: 08/31/2023

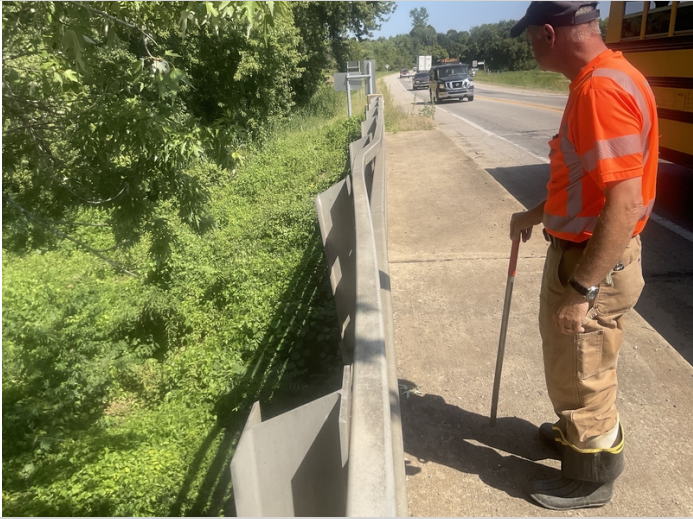
Approximately 15' of collision damage to bridge railing in Spans # 5 & 6 Left.

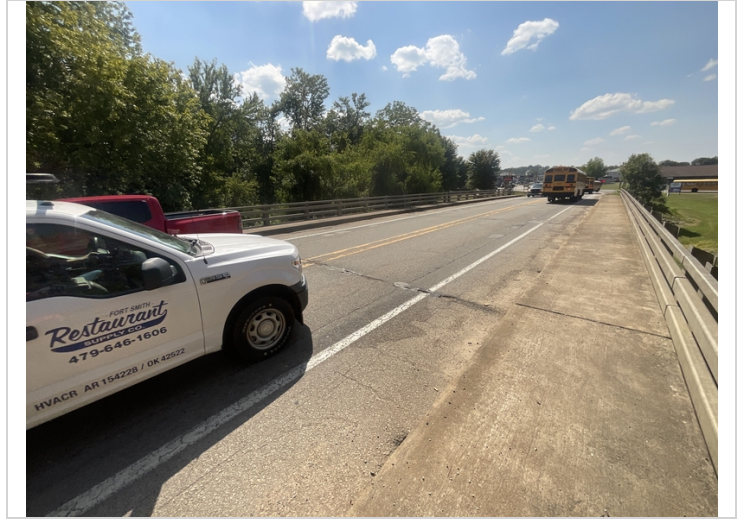
Driving surface of the deck. Typical.

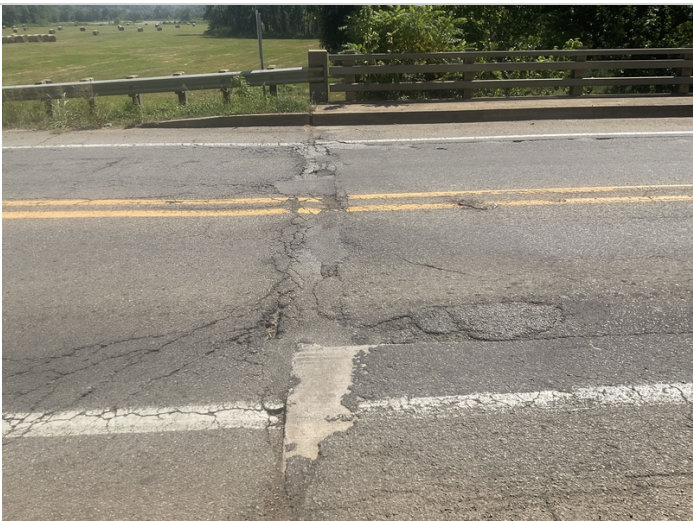
Asphalt driving surface breaking apart over Abutment # 2.

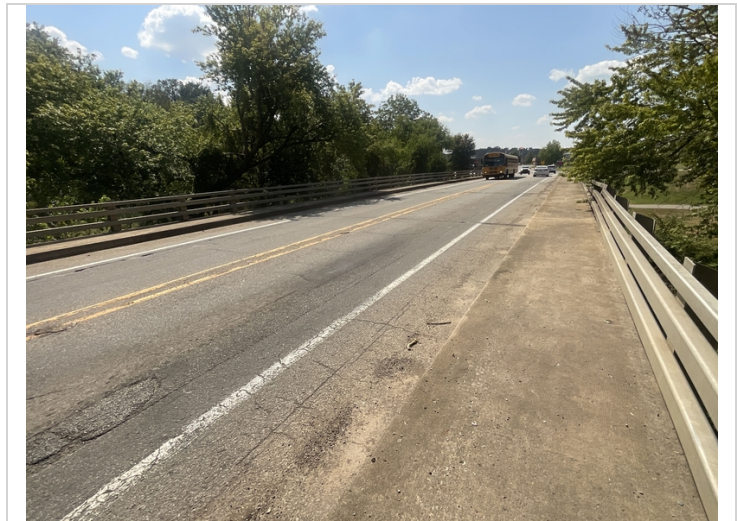
Driving surface of the deck. Typical.

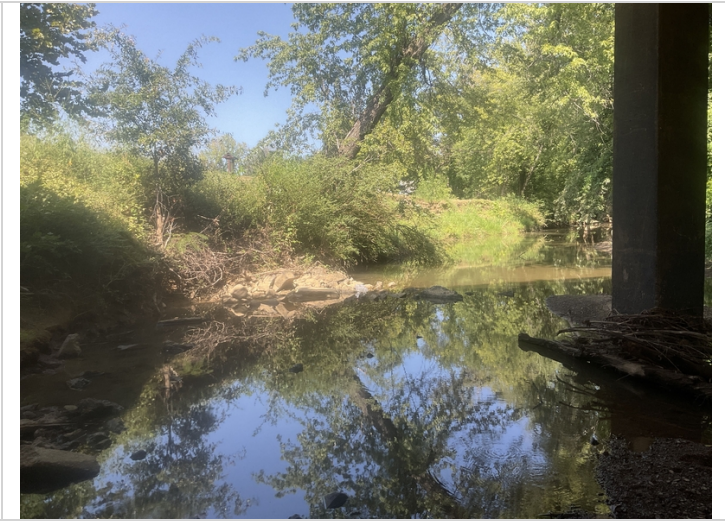
Channel looking downstream.

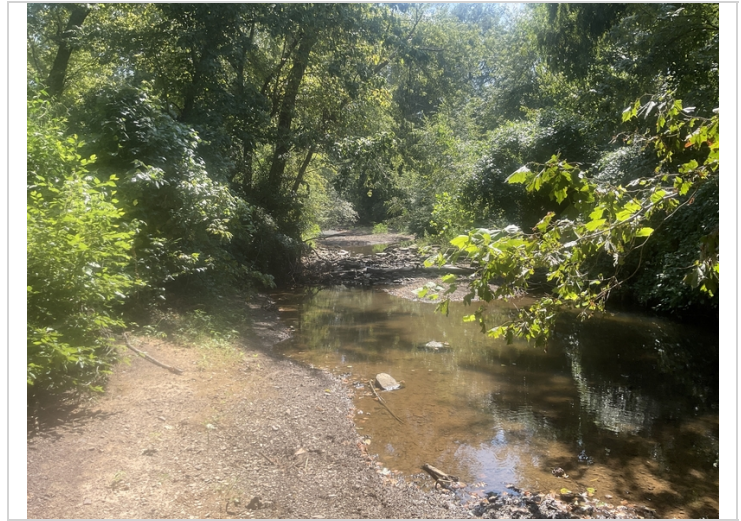
Channel looking upstream.

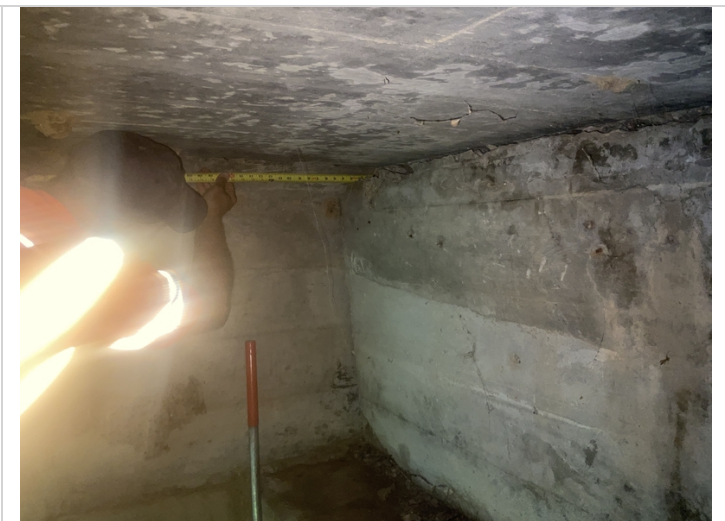
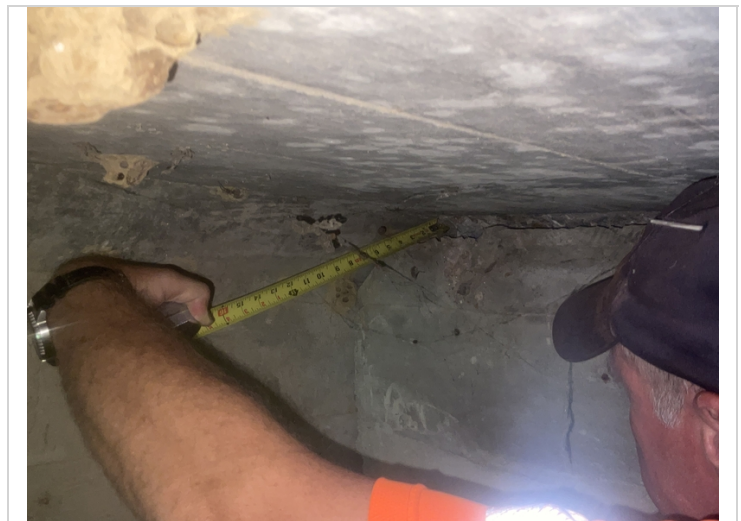
The end diaphragm in Bay # 2 over Abutment # 2 - Top of end diaphragm appears to be rotated towards the channel approximately 3.25" during this inspection.

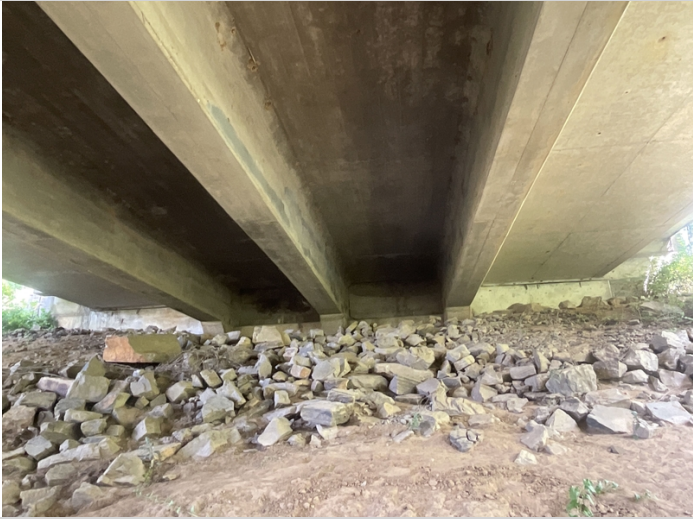
Abutment # 2. Typical.

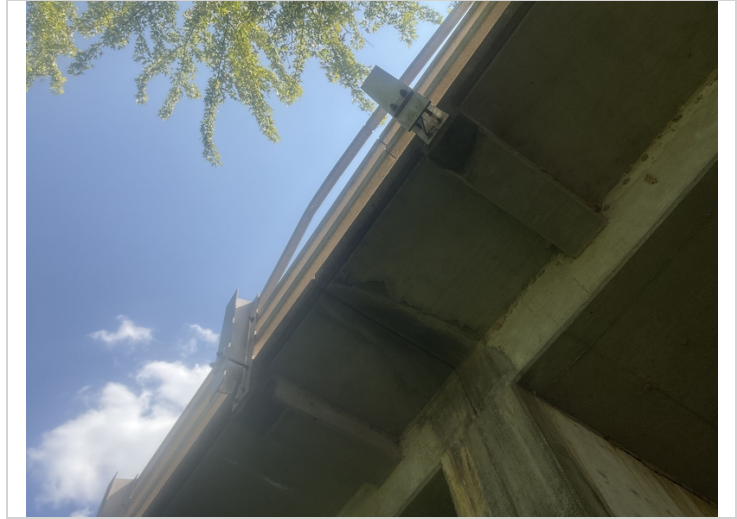
Left side of Span # 5 & 6. Metal rail posts are split from apparent impact damage.

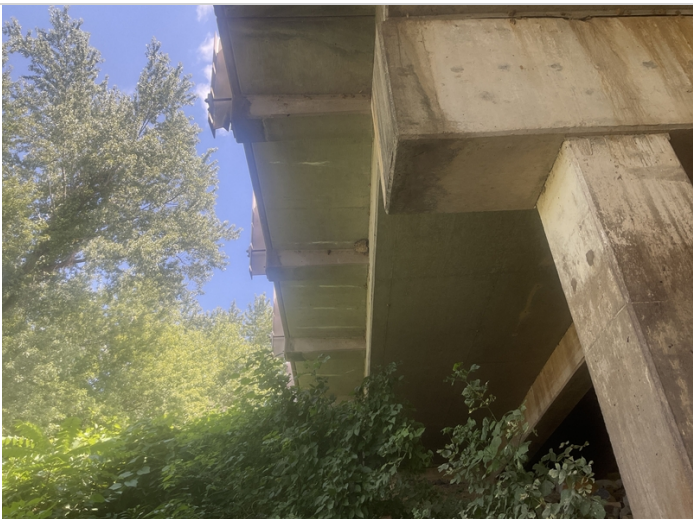
Span # 6. Transverse cracks with efflorescence in the sidewalk portion of structure.

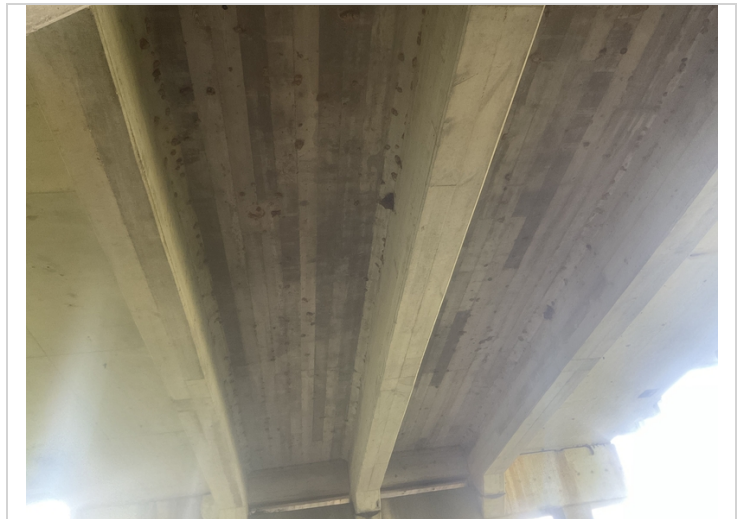
Span # 3. Superstructure. Typical.

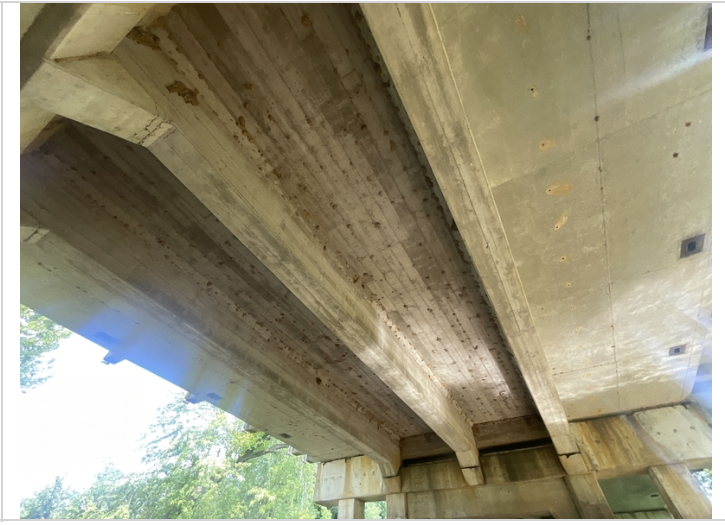
Span # 4. Deck soffit. Typical.

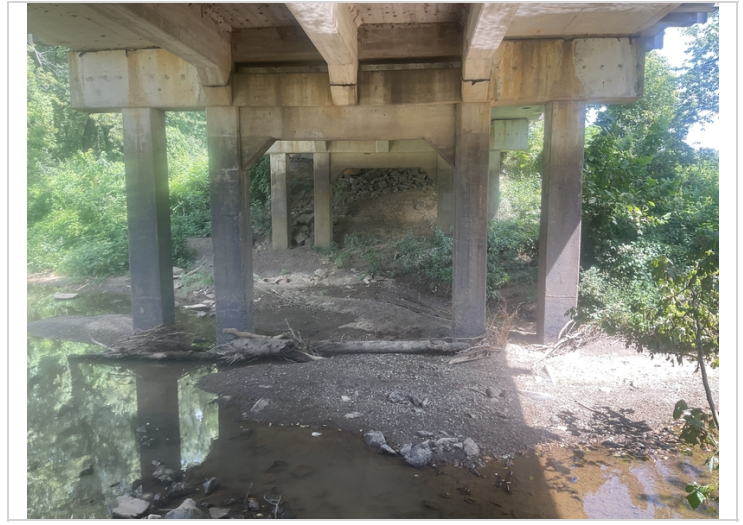
Bent # 5. Typical.

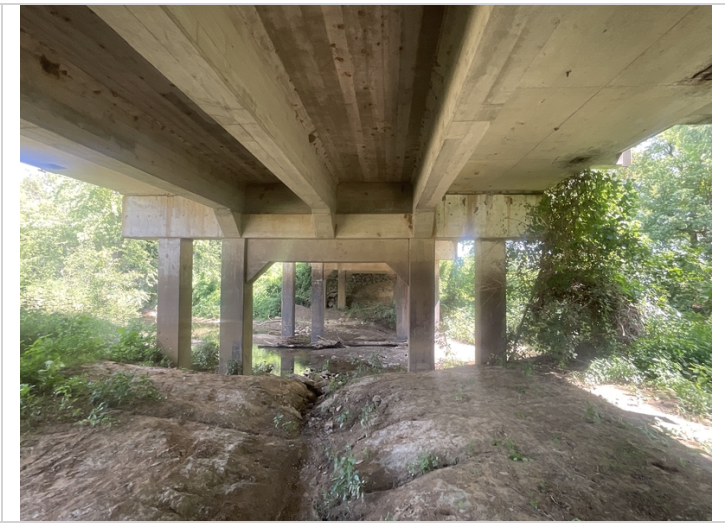
Bent # 4. Typical.

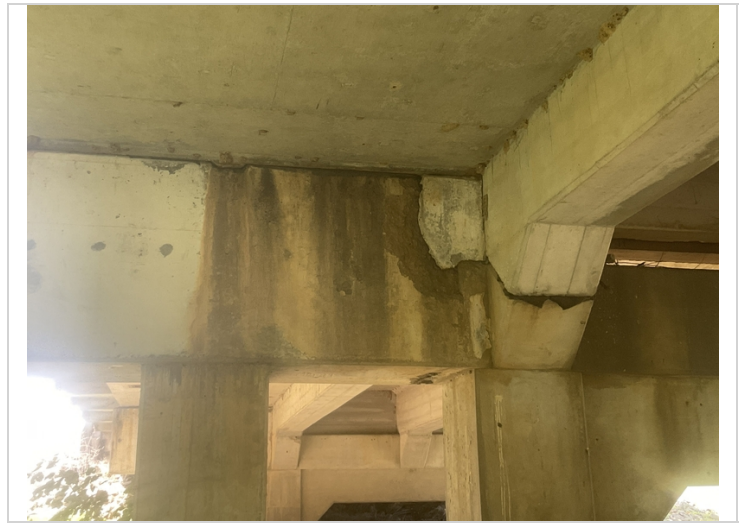
Bent # 3. Ahead face. Spall adjacent to Girder # 3.

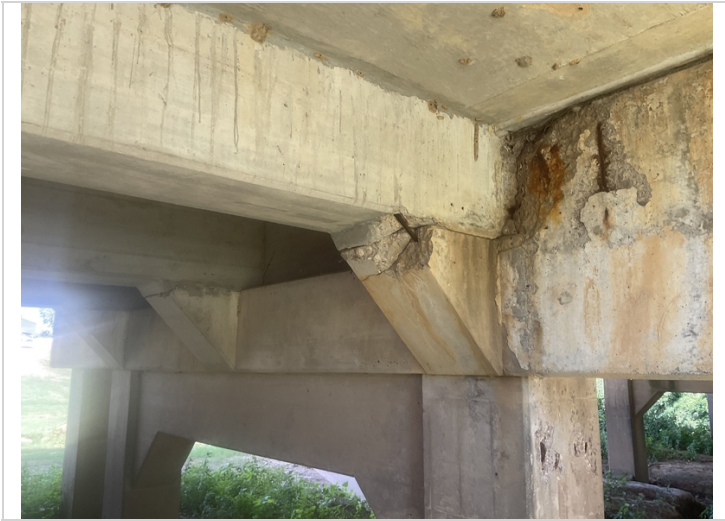
Span # 1. Girder # 3. Fixed end. Spall with exposed reinforcing steel.

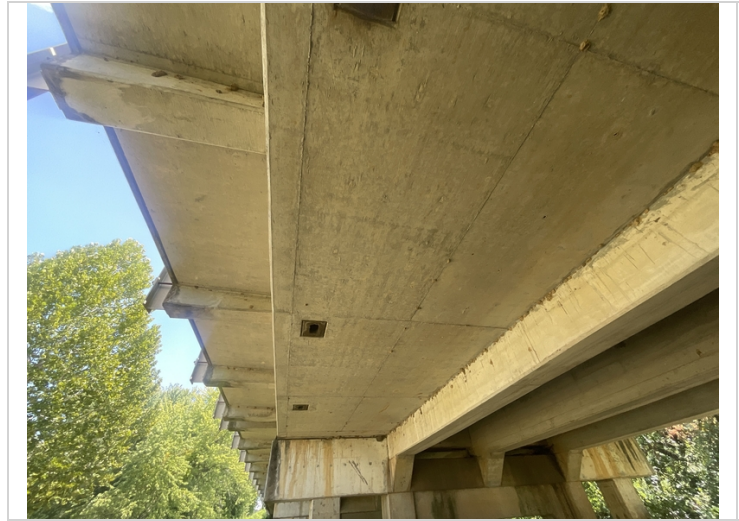
Span # 2. Slab soffit. Typical.

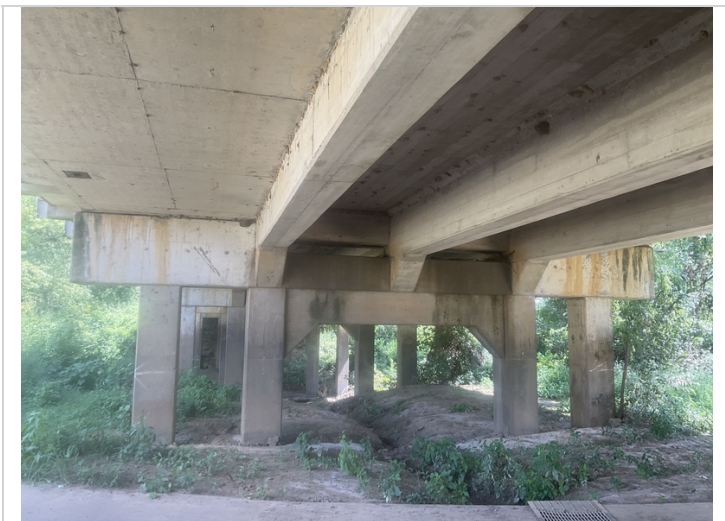
Staining on the substructure indicates that the compression joint seals leak water.

Compression Joint Seals -
Staining on the substructure indicates that the compression joint seals leak water.

A-59 - Joint Repair Needed (Y)

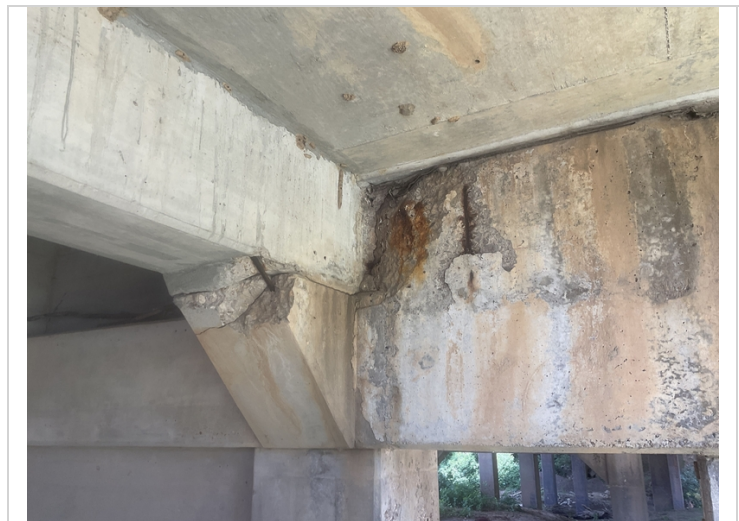
Bent # 2. Spalling with exposed reinforcing under and adjacent to Girder # 3.

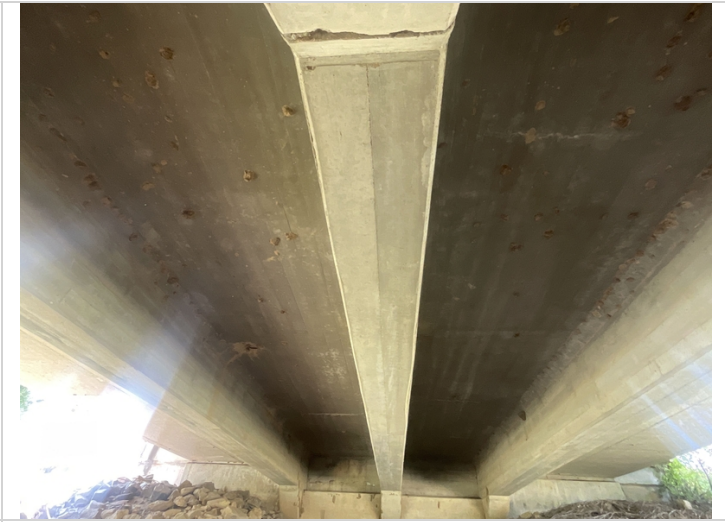
Span # 1. Deck soffit. Typical.

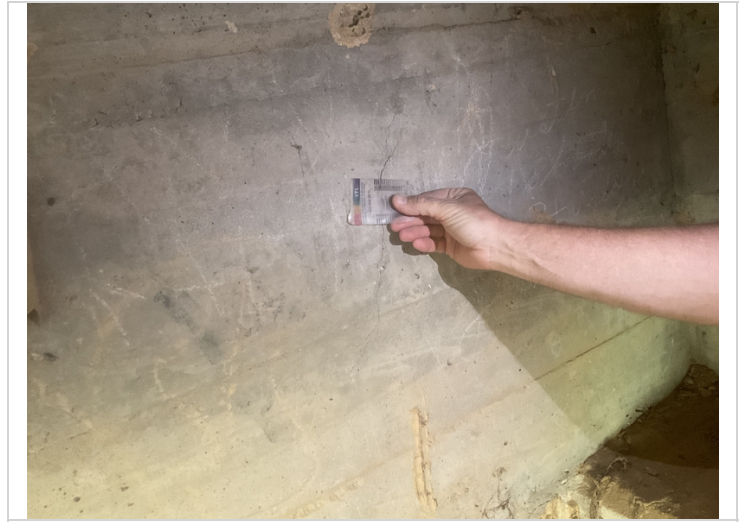
Girder # 3. Bent # 1. Vertical crack measured 0.030".

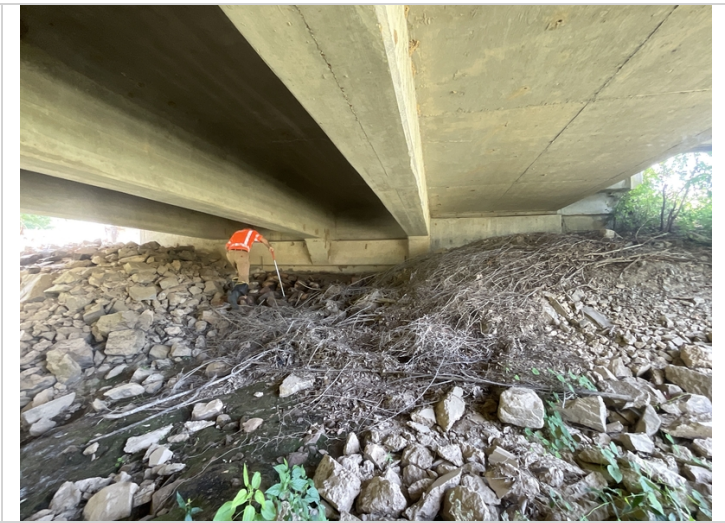
Abutment # 1. Typical.

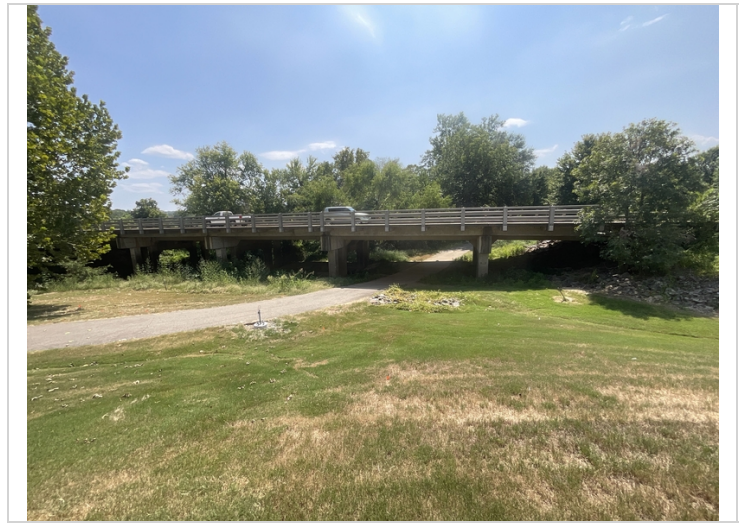
Elevation. Left side of structure.

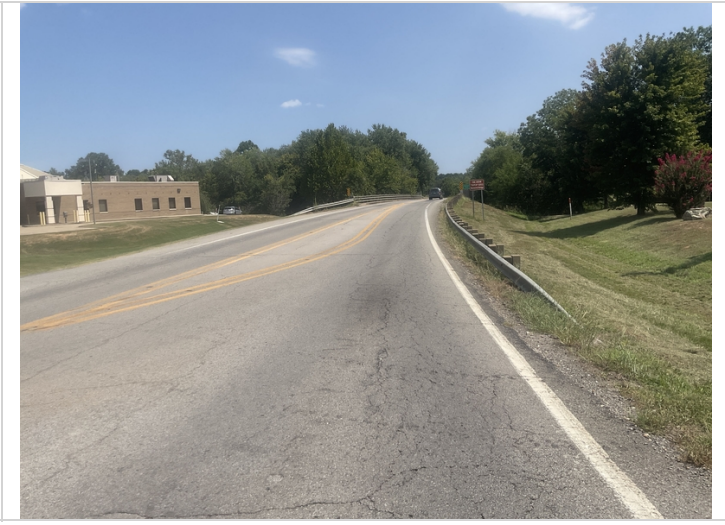
Approach roadway facing East.

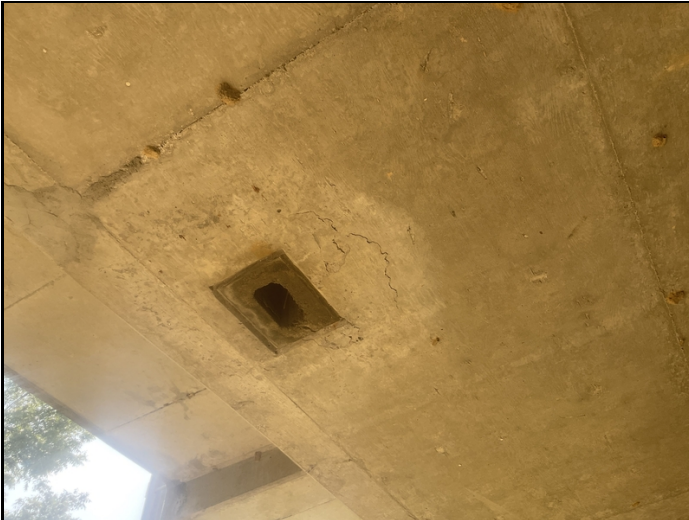
There are delaminated areas in the slab soffit over the pedestrian walkway.

Span # 2. Right. Delaminated areas adjacent to the deck drains over the pedestrian walkway.

Type of Work: Deck Repair

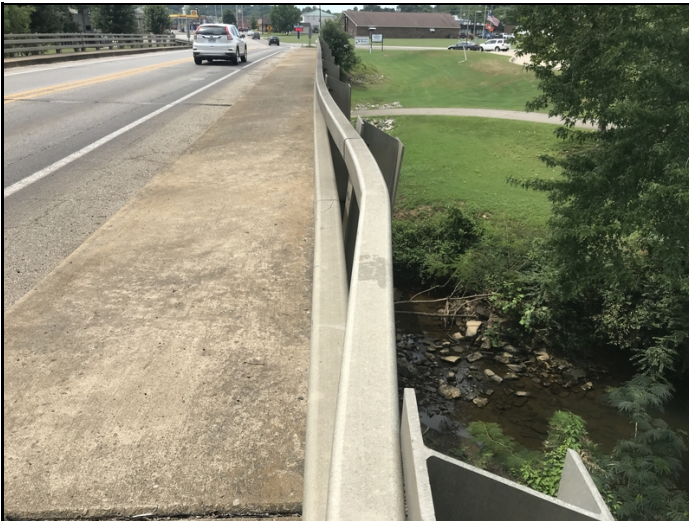
Approximately 15' of collision damage to the bridge railing on the left side of Span # 5 & 6. Two aluminum bridge rail posts are split longitudinally along their webs from crushing.

Span # 5, left-Collision damage to railing.

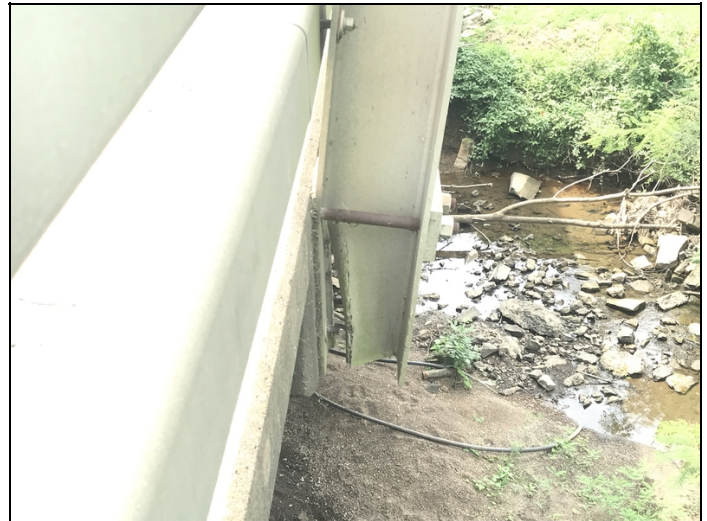
Span # 5, left-Collision damage to railing and post.

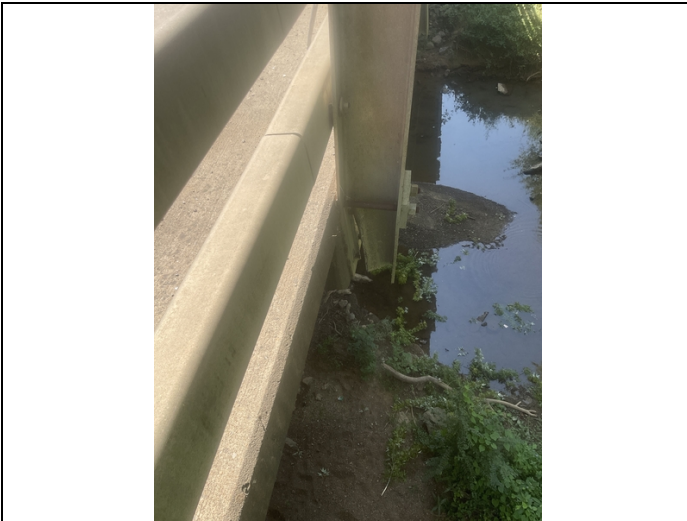
Two aluminum bridge rail posts are split longitudinally along their web / flange juncture from traffic impact.

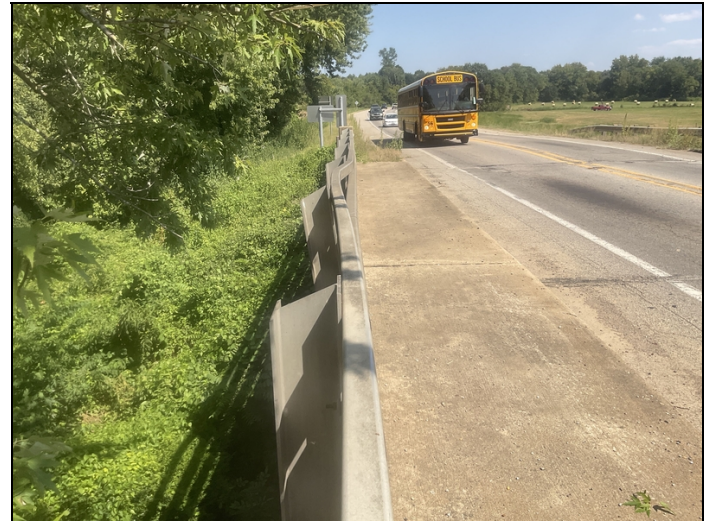
Approximately 15' of collision damage to the bridge railing on the Left side of Span # 5 & 6.

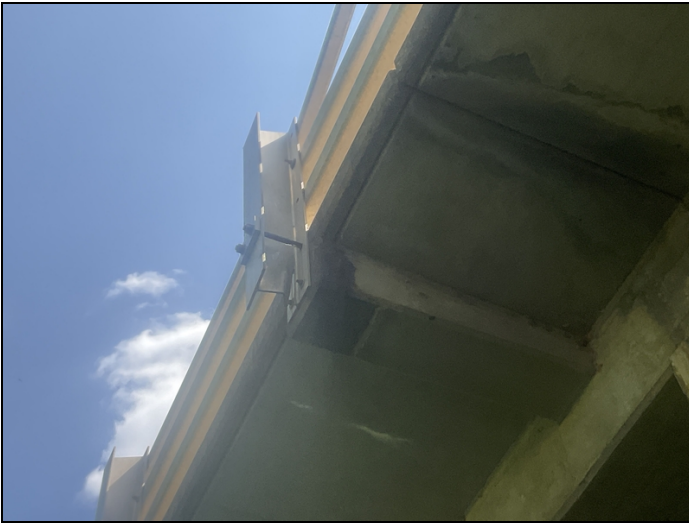
Left side of Span # 5 & 6. Metal rail posts are split from apparent impact damage.

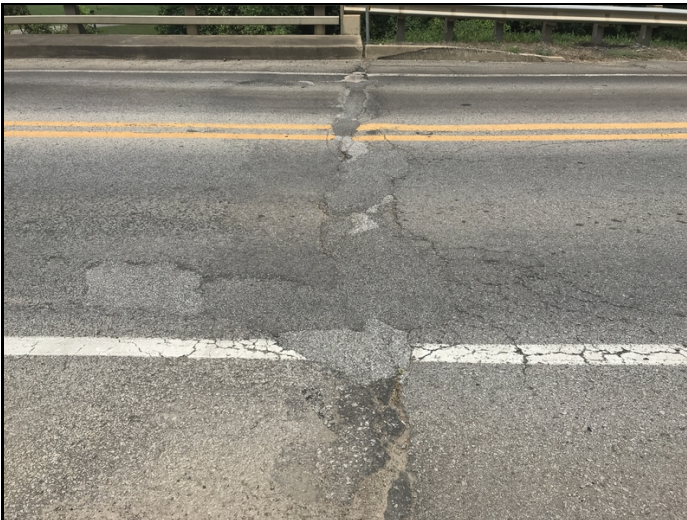
Abutment # 2 expansion joint.

Driving Surface -
Asphalt driving surface is breaking apart over the deck joints.

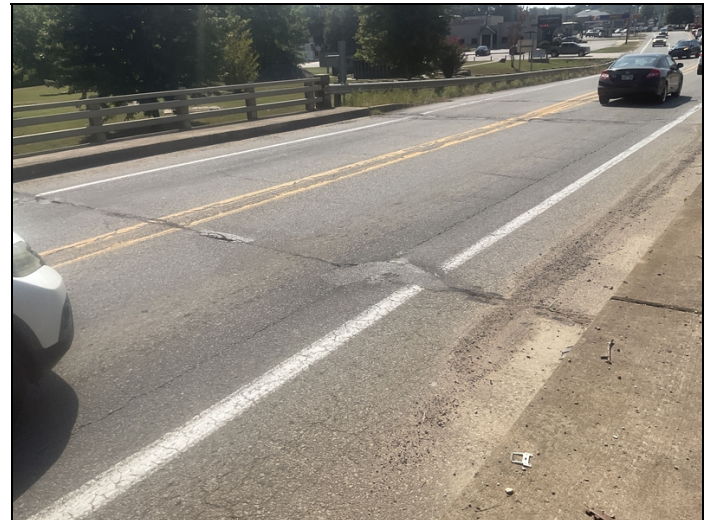
Asphalt driving surface breaking apart over Bent # 2.

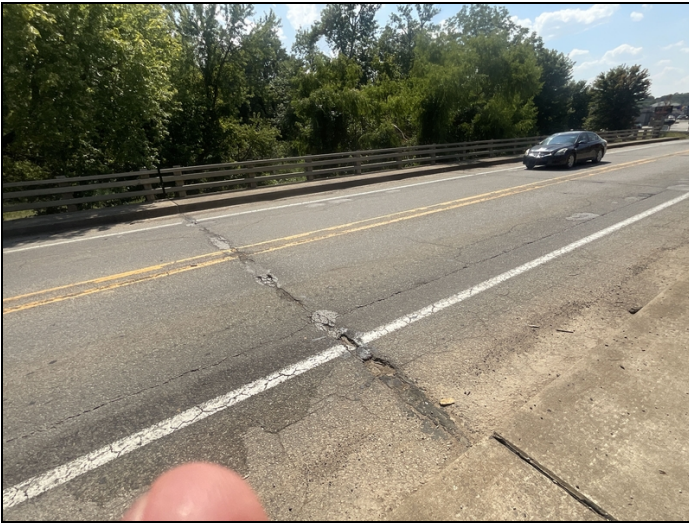
Asphalt driving surface breaking apart over Bent # 5.

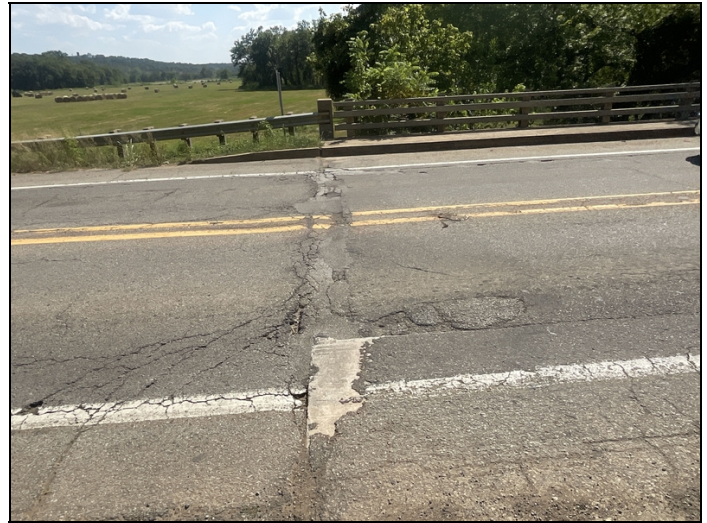
Asphalt driving surface breaking apart over Abutment # 2.

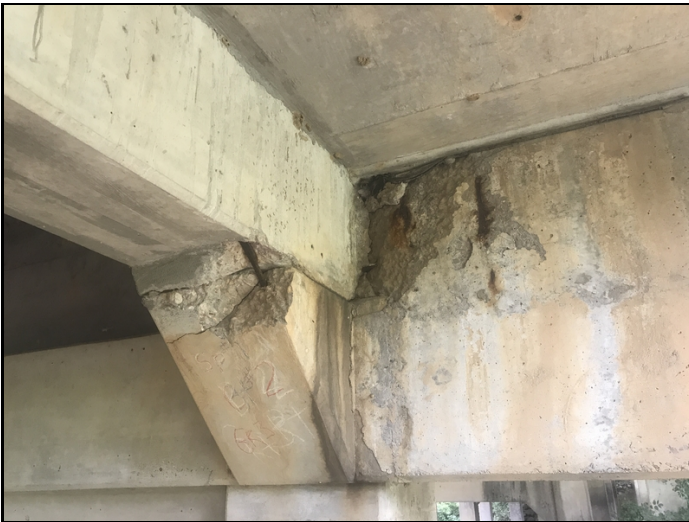
The concrete caps and haunches have cracking and spalling adjacent to the "TEE" beams.

Bent # 2-Spalling with exposed reinforcing steel at girder # 3.

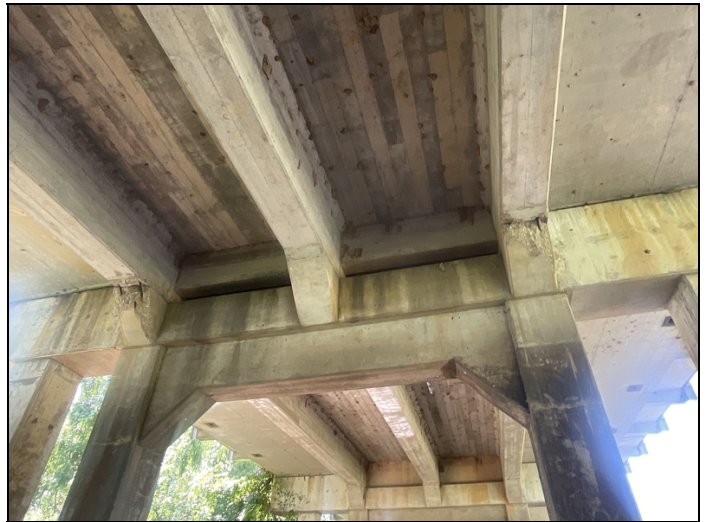
Bent # 5. Spalls with exposed reinforcing steel in the cap haunches.

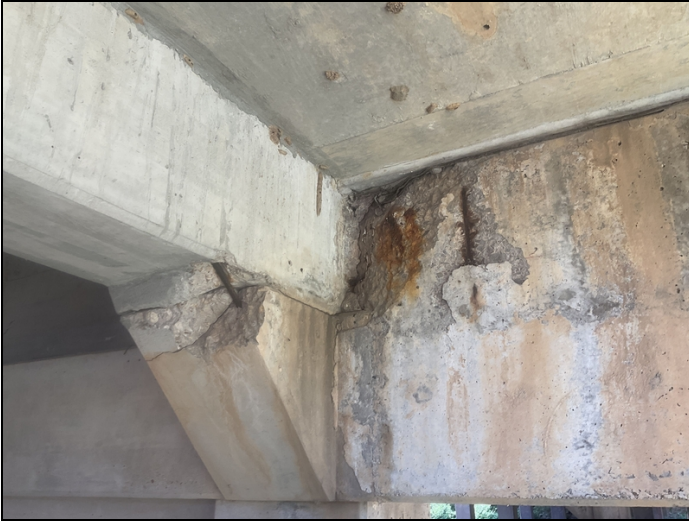
Bent # 2. Spalling with exposed reinforcing steel.

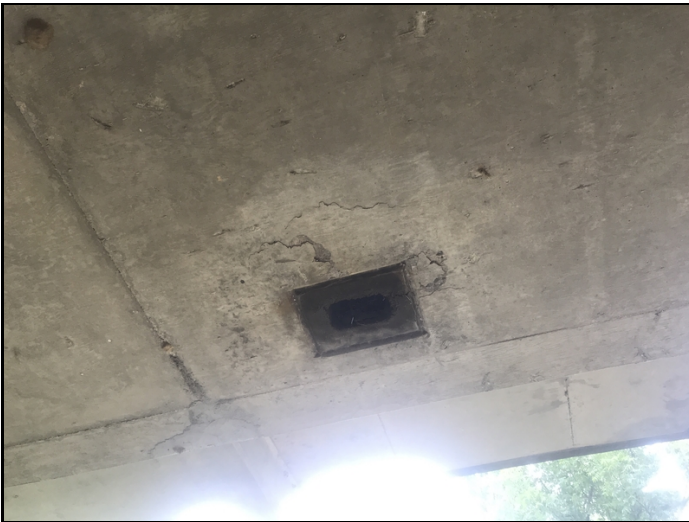
The undersurface of the deck has delaminated areas and spalls with exposed reinforcing steel adjacent to the deck drains.

Span # 2, right side-Delaminated area adjacent to deck drain.

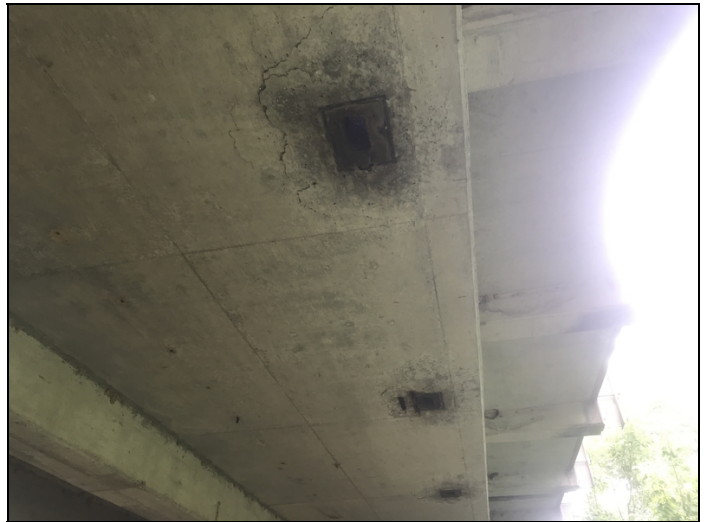
Span # 3, right side-Delaminated and spalled areas with exposed steel adjacent to deck drains.

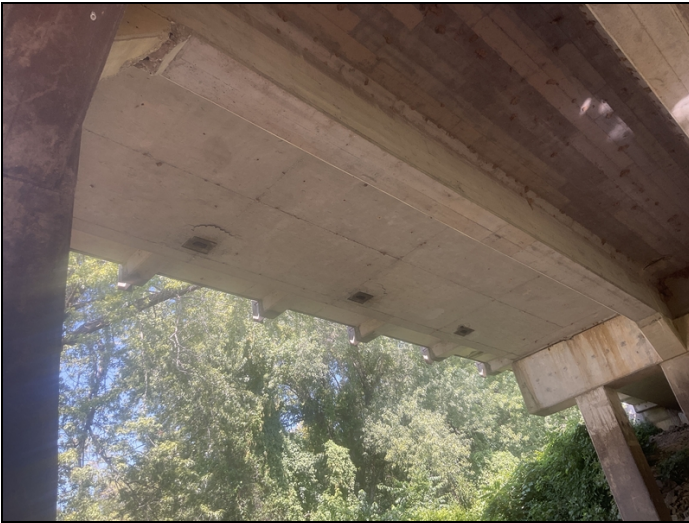
Span # 5. Slab soffit. Delaminated areas adjacent to the deck drains.

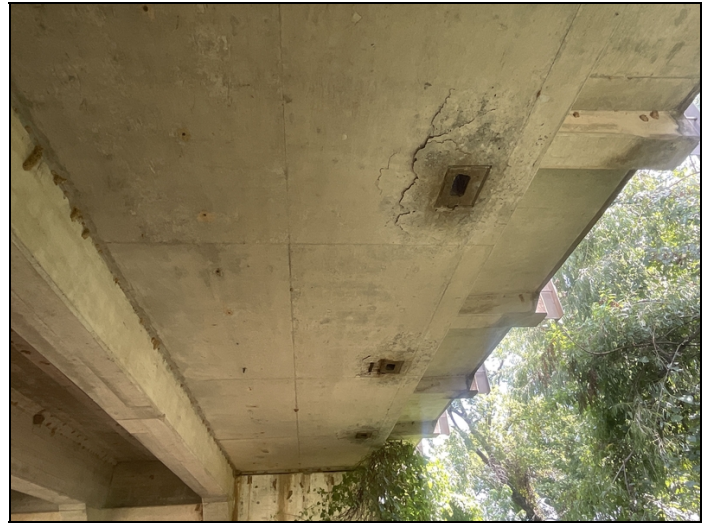
Span # 3. Slab soffit. Spalls with exposed reinforcing steel and delaminated areas.

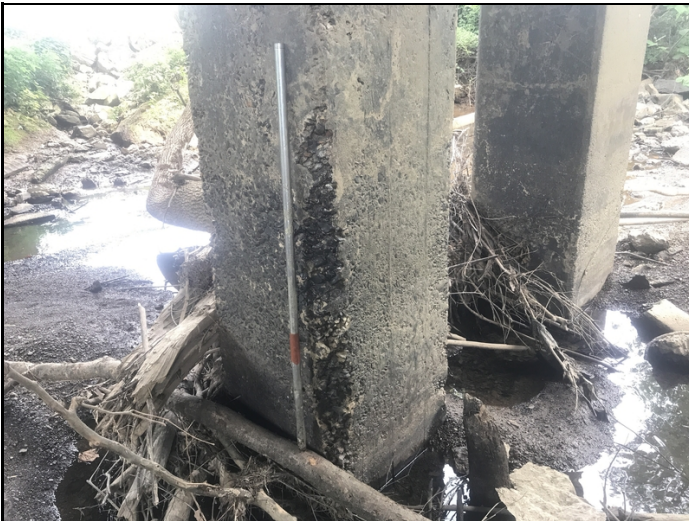
Bent # 5, column # 2-Heavy abrasion / concrete deterioration.

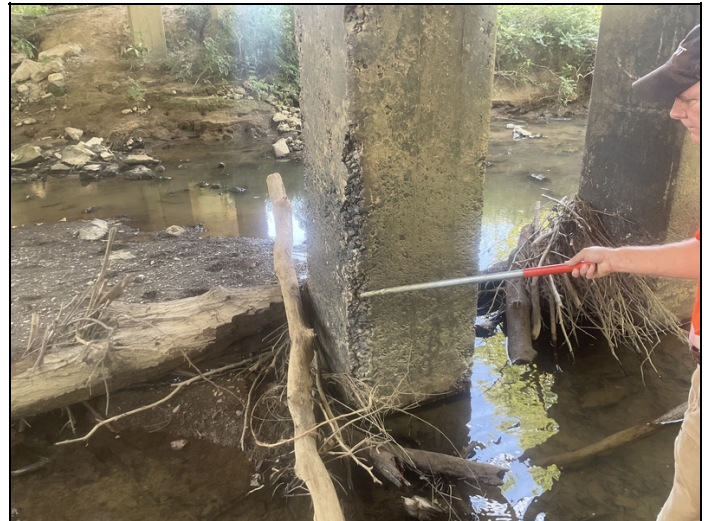
Bent # 5, Column # 2 has concrete deterioration and section loss with no exposed reinforcing steel.

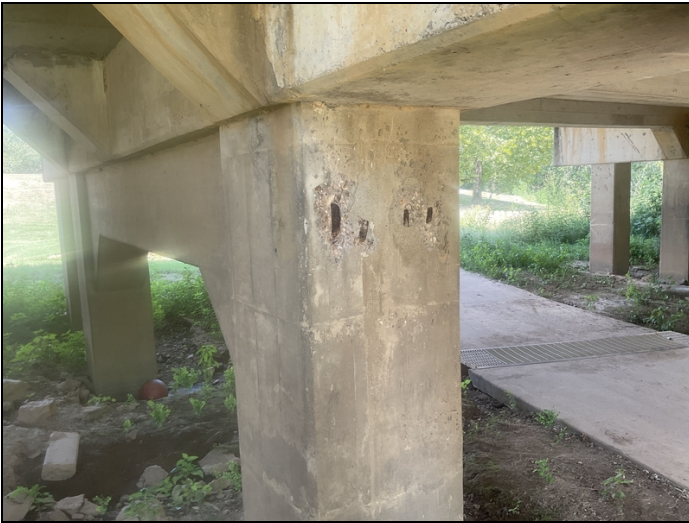
Bent # 2, columns # 2 & 3 have spalls with exposed reinforcing steel.

Bent # 2. Column # 2. Spalls with exposed reinforcing steel.

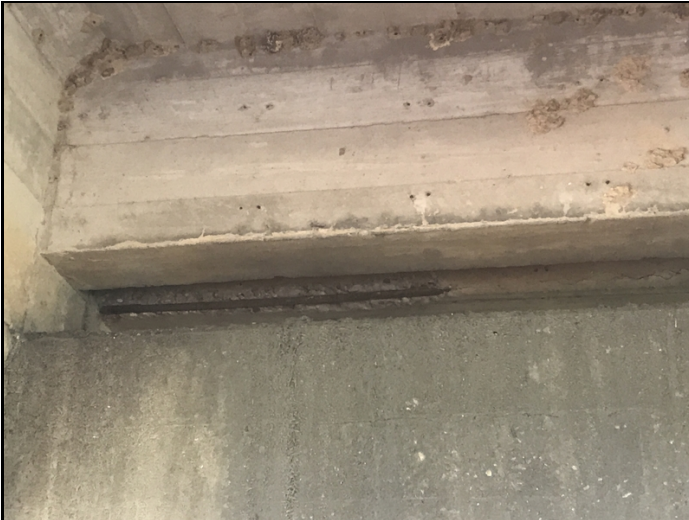
There is spalling with exposed reinforcing steel in the girder haunches adjacent to the substructure caps.

Span # 3 deck haunch over bent # 3-Spalling with exposed reinforcing steel.

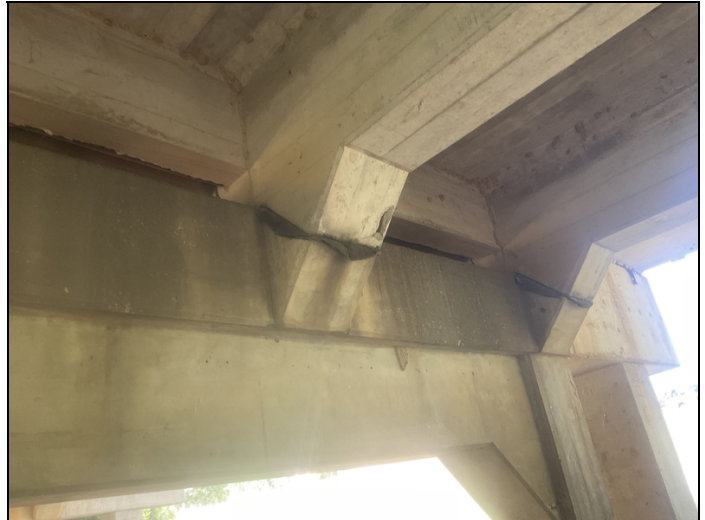
Span # 3. Girder # 2. Spalling with exposed reinforcing steel.

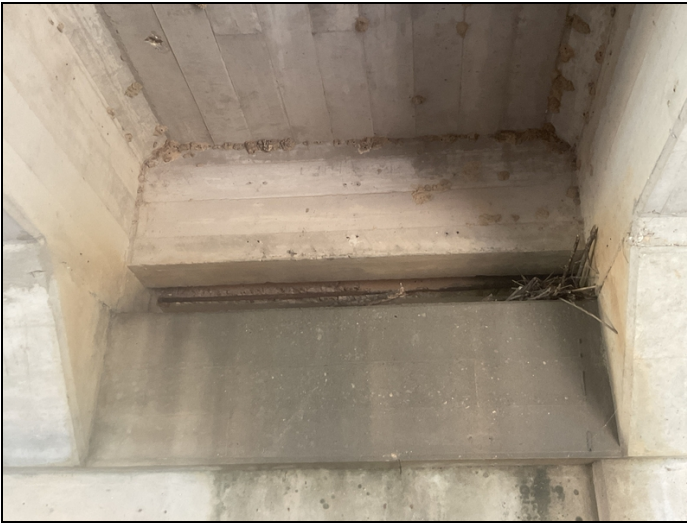
Diaphragms between the deck girders over the intermediate bents have spalls with exposed reinforcing steel and map cracking with efflorescence.

Span # 3. Bent # 3. Spalling with exposed reinforcing steel in the diaphragms.

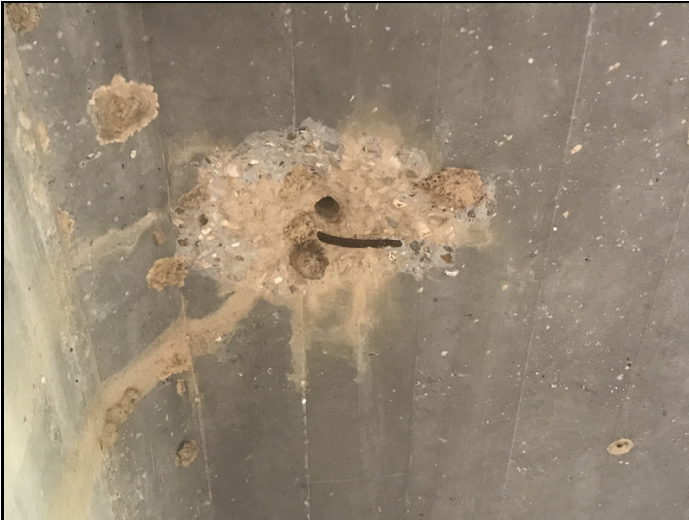
There is a basket ball sized spall with exposed reinforcing steel in the undersurface of span # 1, bay # 2 and span # 2, bay # 1. Span # 5, Bay # 1 adjacent to Bent # 6 has a 16" spall with exposed reinforcing steel visible from the undersurface of the deck. Exposed reinforcing steel has initial section loss.

Span # 1, bay # 2-Spall with exposed reinforcing steel.

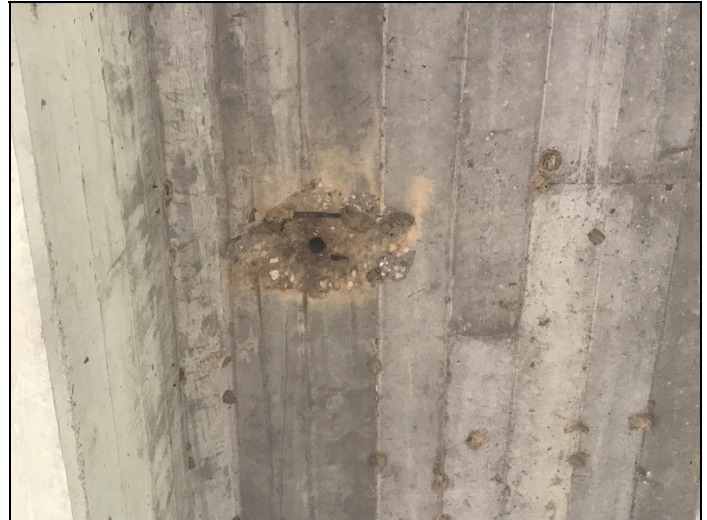
Span # 2, bay # 1-Spalling with exposed reinforcing steel in undersurface of deck.

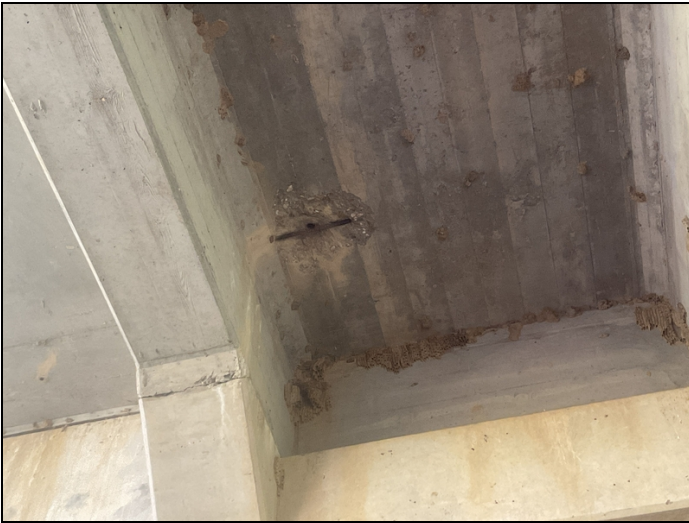
Span # 5. Bay # 1. Spall with exposed reinforcing steel.

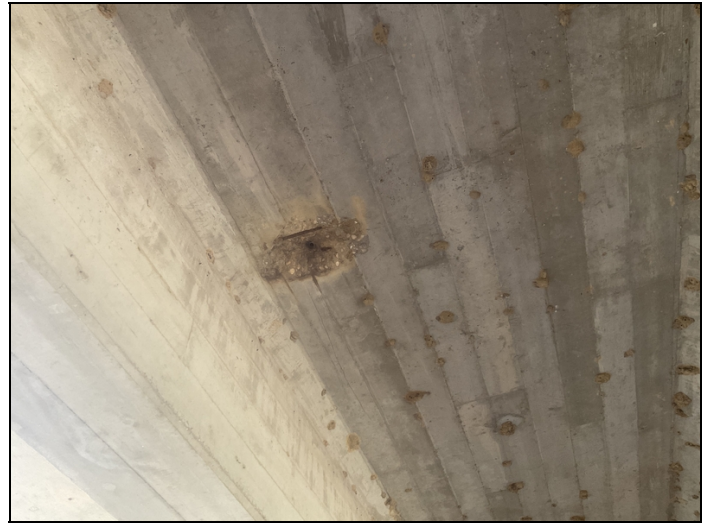
Span # 2. Bay # 1. Spall with exposed reinforcing steel.

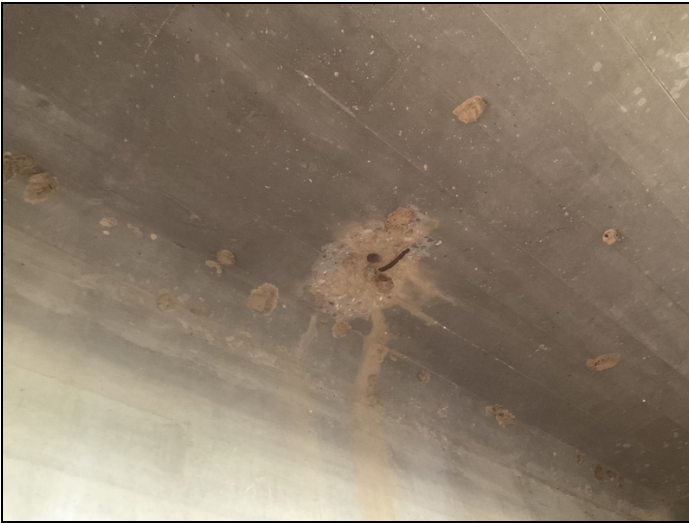
Span # 1. Bay # 2. Spall with exposed reinforcing steel.

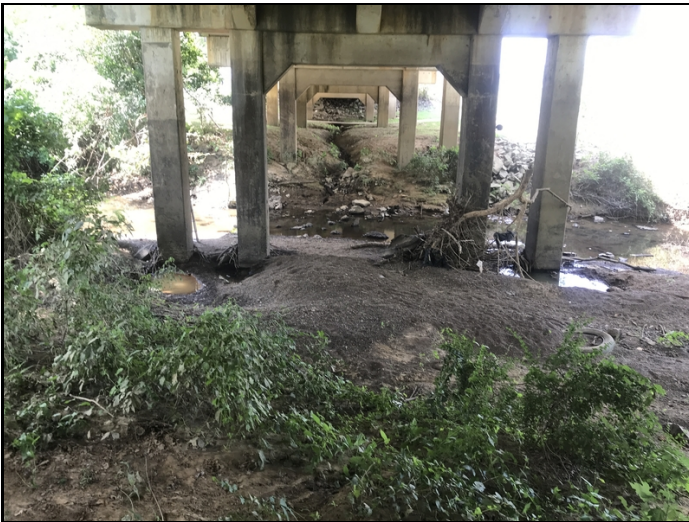
08/30/2021 - EJW - Light drift only. Trees are no longer in place.

Bent #5 light drift accumulation.

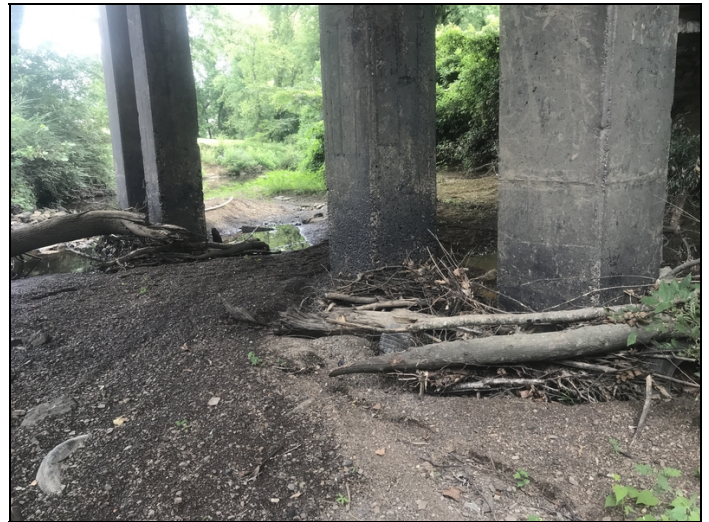
Drift at bent #5.

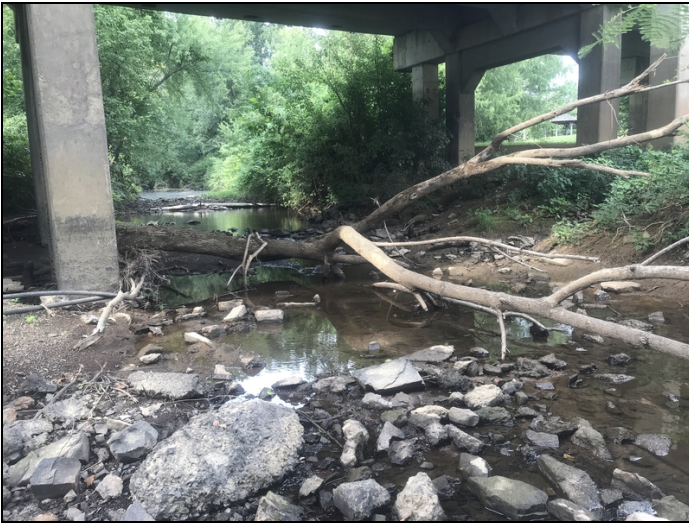
The channel has drift accumulation at bent #5 with a tree wedged against column #2.

The channel has drift accumulation at bent #5.

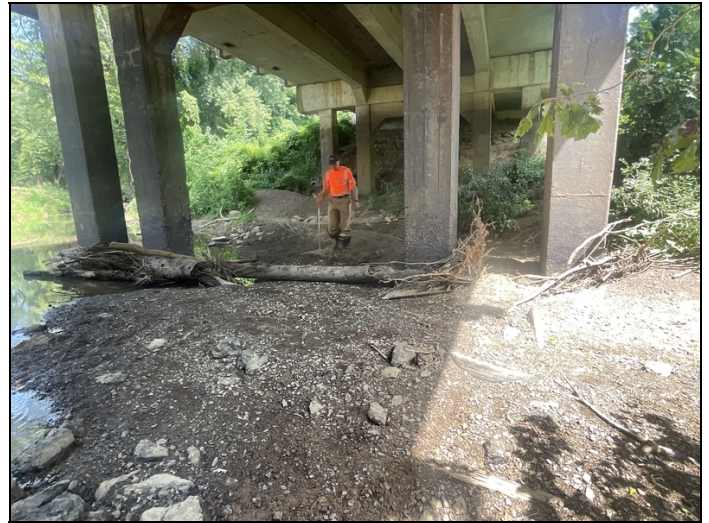
Bent 5. Drift accumulation.
