Asset #A0425(Routine)

SH 10 - Sebastian over Vache Grasse

Location: 0.8 MI E JCT SH 10 SEC 0

Team Lead: Jeff Jones, Inspection Date: 08/31/2023

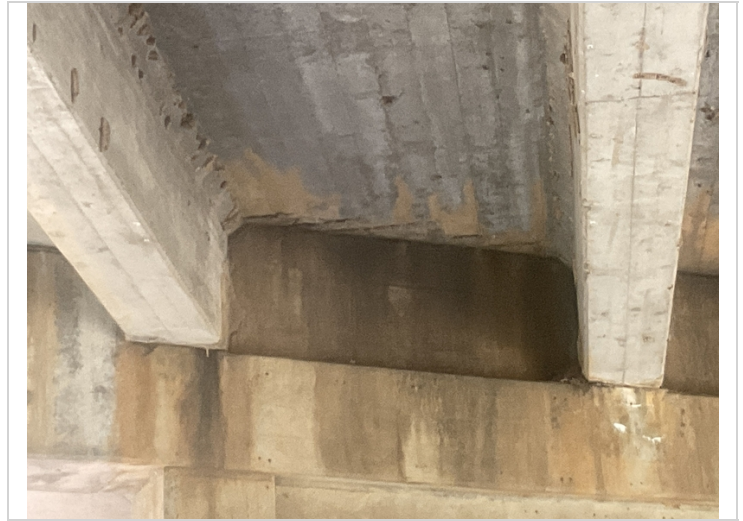
- Span # 2 undersurface in Bays # 1 and 2 adjacent to Bent # 2 has several shallow spalls that have exposed reinforcing steel. The exposed reinforcing steel has initial section loss.
- There are a few isolated transverse cracks with light efflorescence visible from the undersurface of the deck.
- There is an 18" delaminated area adjacent to the Span # 2 deck drain located near the Left end of Bent # 3 cap.

Span # 2. Bay # 2 deck soffit. Spalls with exposed reinforcing steel.

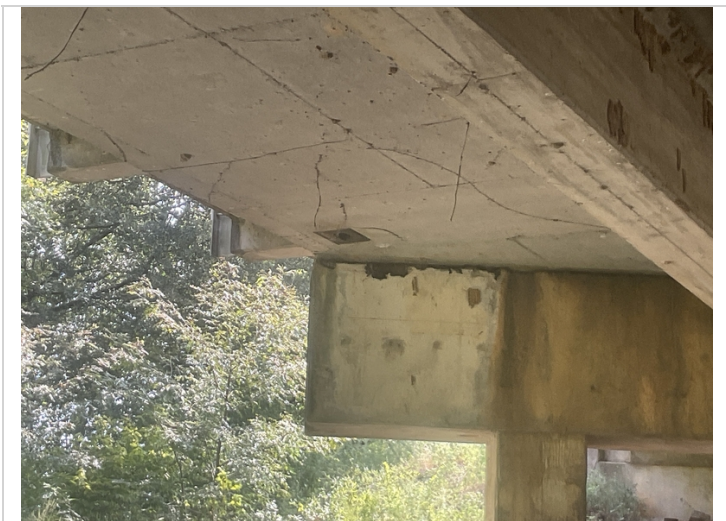
Span # 2 deck soffit: Photo of an 18" delaminated area adjacent to the Span # 2 deck drain located near the Left end of Bent # 3 cap.

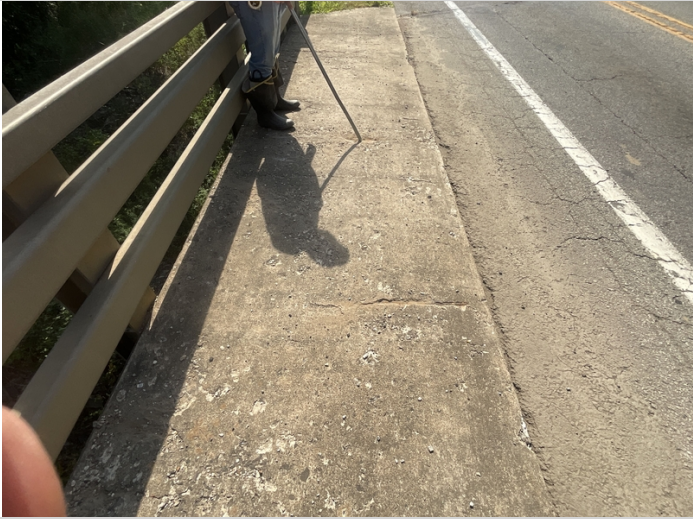
- The Left sidewalk on Spans # 1 and 3 have shallow spalls with exposed reinforcing steel.
- Exposed reinforcing steel has very little concrete cover from the construction process.
- Exposed reinforcing steel has up to initial section loss.
- There are areas with up to medium scale on the sidewalk.

Sidewalk: The Left sidewalk on Spans # 1 and 3 have shallow spalls with exposed reinforcing steel. Exposed reinforcing steel has very little concrete cover from the construction process. Exposed reinforcing steel has up to initial section loss.

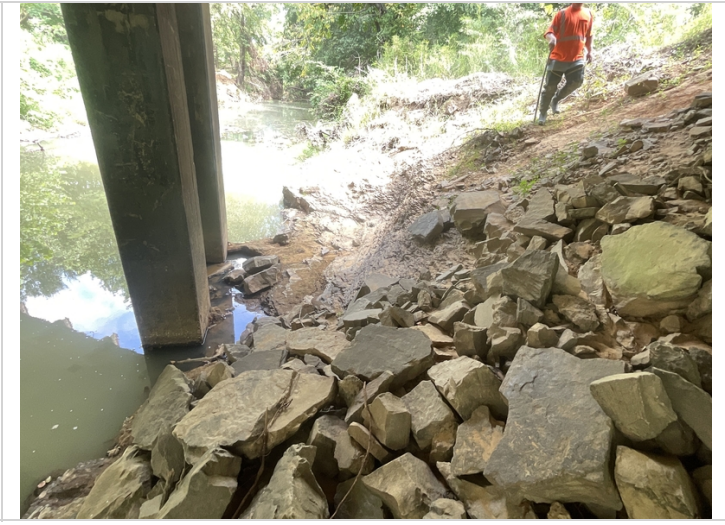
Shale is exposed along the East embankment.

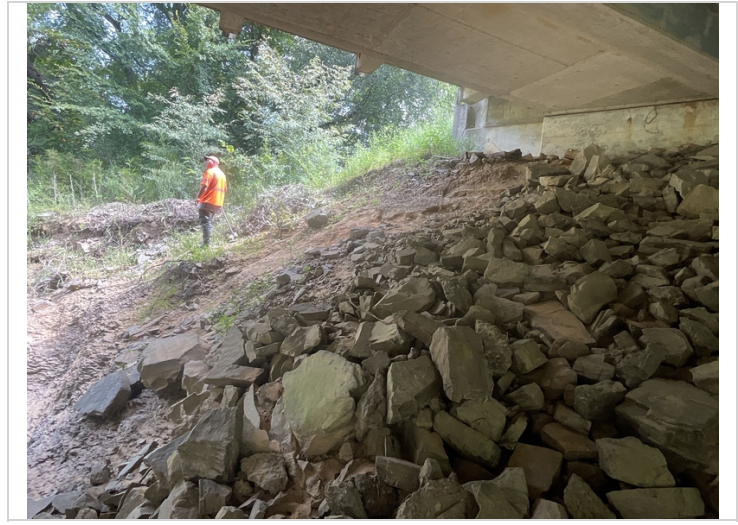
Abutment # 2 has riprap displacement with embankment erosion at the outlet end of the abutment.

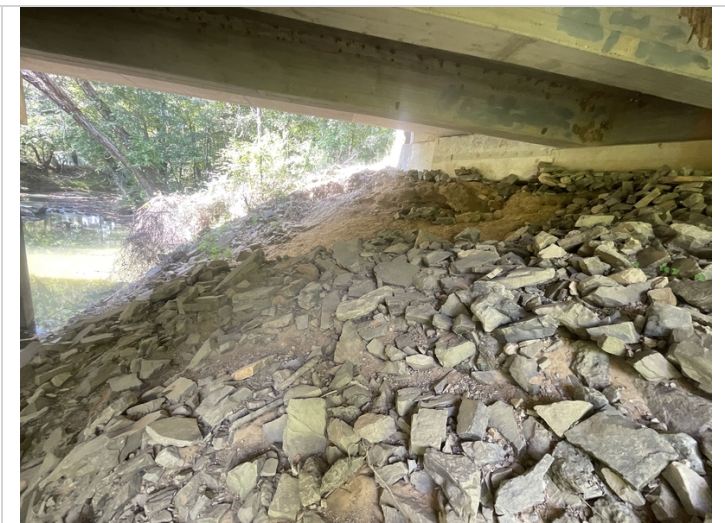
Abutment # 1 has riprap displacement with embankment erosion at the inlet end of the abutment.

There is earth settlement under the Right side of the abutment with voids that penetrate approximately 2' past the face of the abutment.

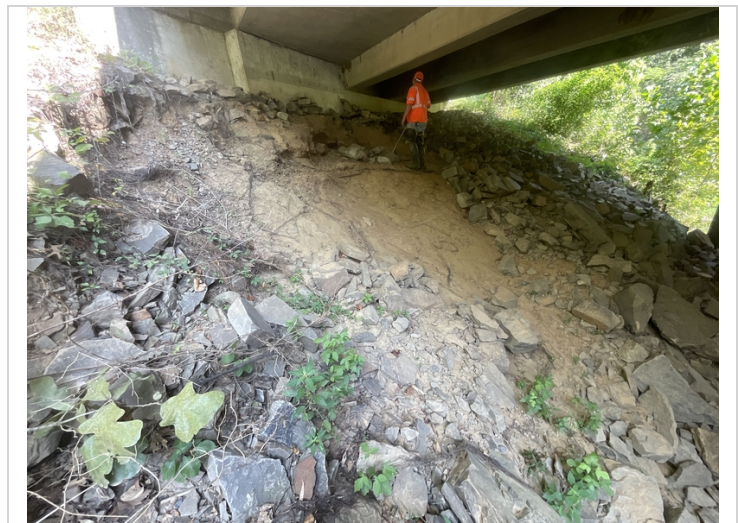
Abutment # 1 has riprap displacement with embankment erosion at the inlet end of the abutment.

There is earth settlement under the Right side of the abutment with voids that penetrate approximately 2' past the face of the abutment.

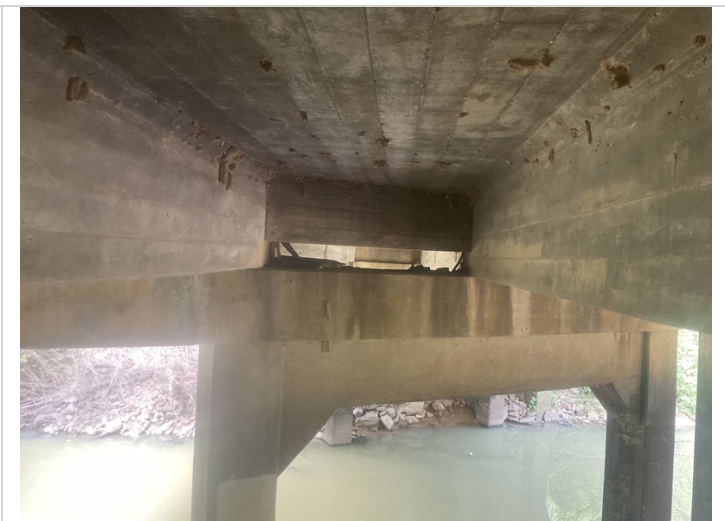
Debris accumulation on Bent # 3 cap.

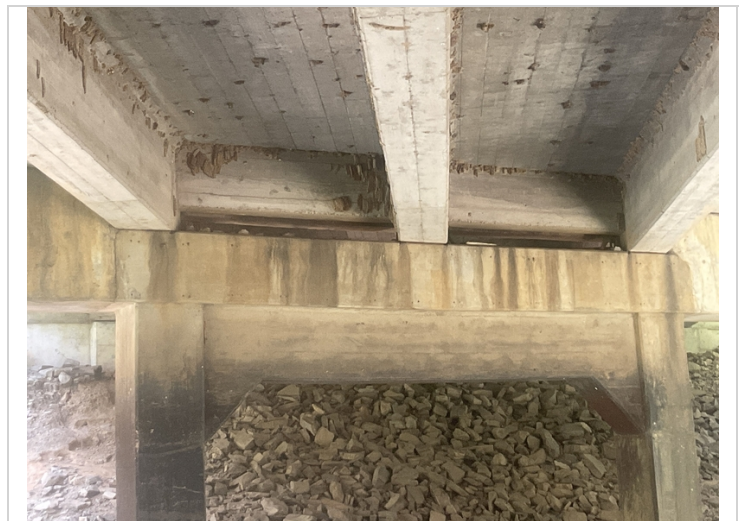
Deck joints leak water and debris on substructure caps and on the diaphragms between the concrete deck girders over the intermediate bents.

Staining due to joint leakage. Photo of Bent # 3. Cap.

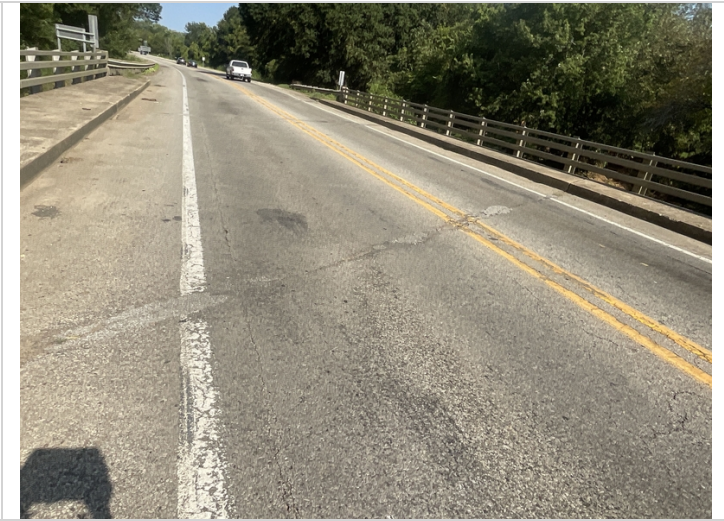
Asphalt has numerous patches over the expansion joint.
Photo of Bent # 3 expansion joint.

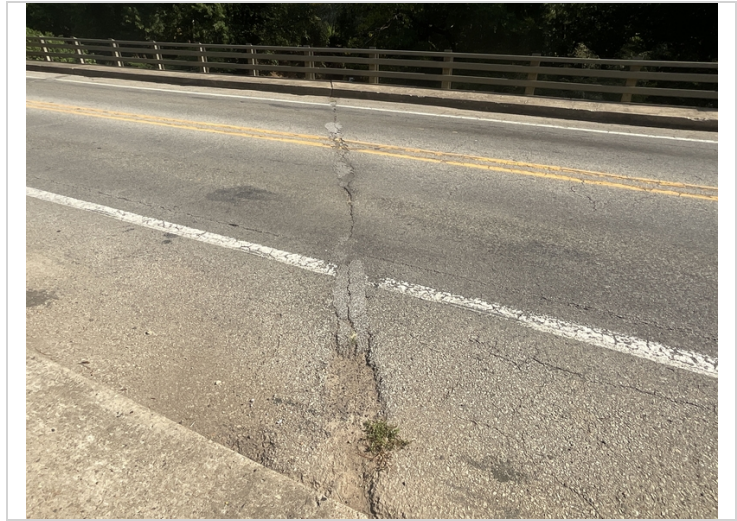
Asphalt has numerous patches over the expansion joint.
Photo of Bent # 3 expansion joint.

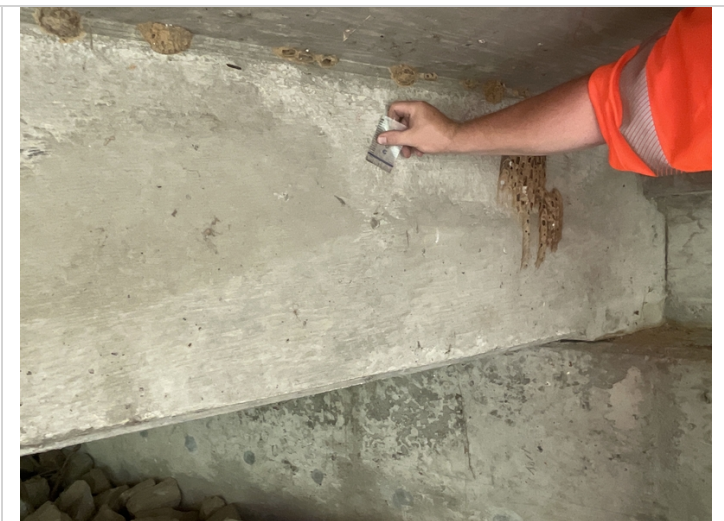
Span # 3, Right side of slab portion of structure has a diagonal crack in undersurface and a shear type crack near abutment # 2 that measures 0.006".

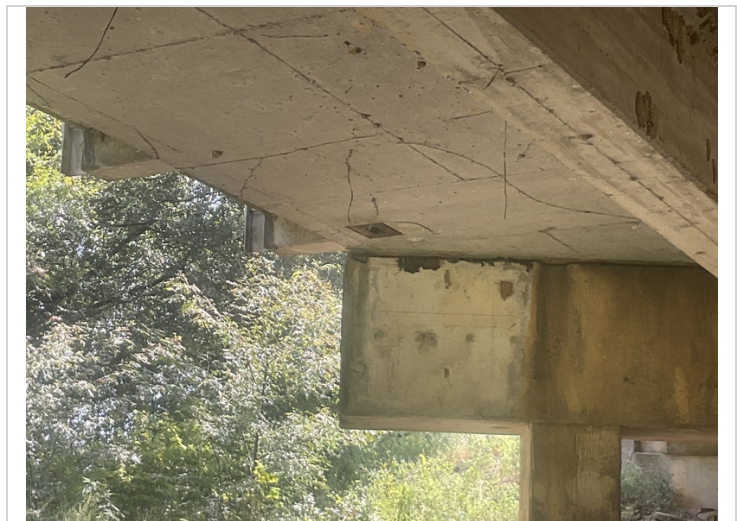
Span # 2 has an 18" delaminated area adjacent to the Span # 2 deck drain located near the Left end of Bent # 3 cap.

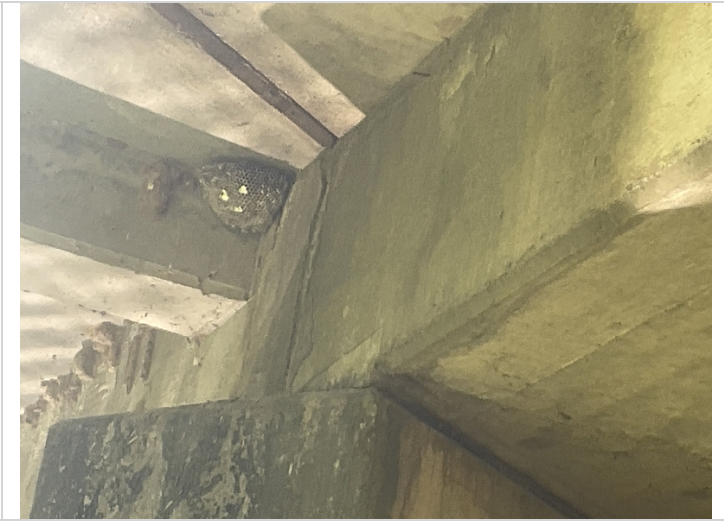
Span # 1, Left vertical face of slab over Bent # 2 has a delaminated area that is up to approximately 2" wide and 22" tall.

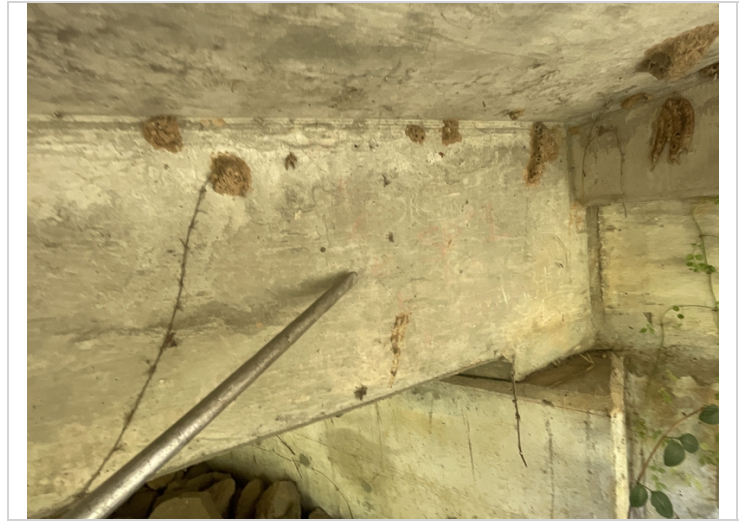
The Left edge of the slab at Abutment # 1 has a hairline shear type crack that measures 0.010" during this inspection.

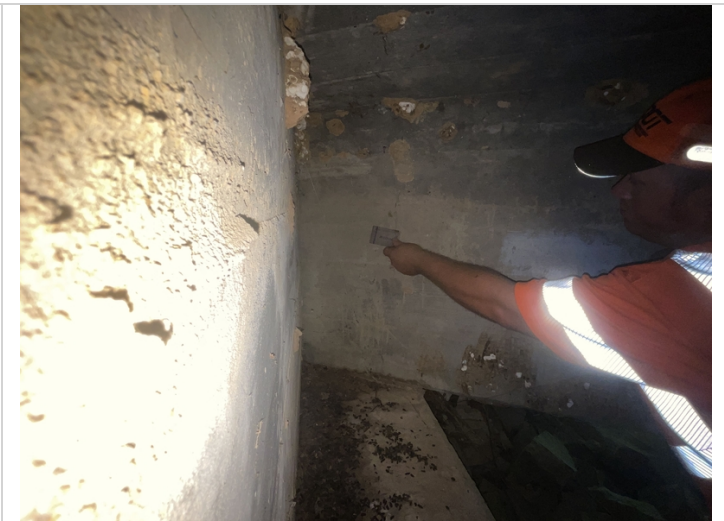
-Span # 3, Girder #3 at Abutment # 2 Left face has a vertical crack approximately 1/16" wide located approximately 1' from the face of the abutment backwall.

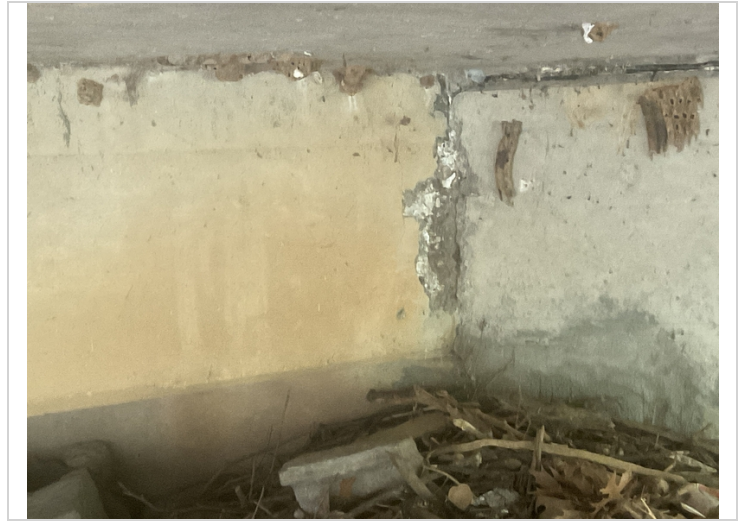
Span # 3, Girder # 3 at Abutment # 2 has a vertical crack and shallow spalling at the abutment interface.

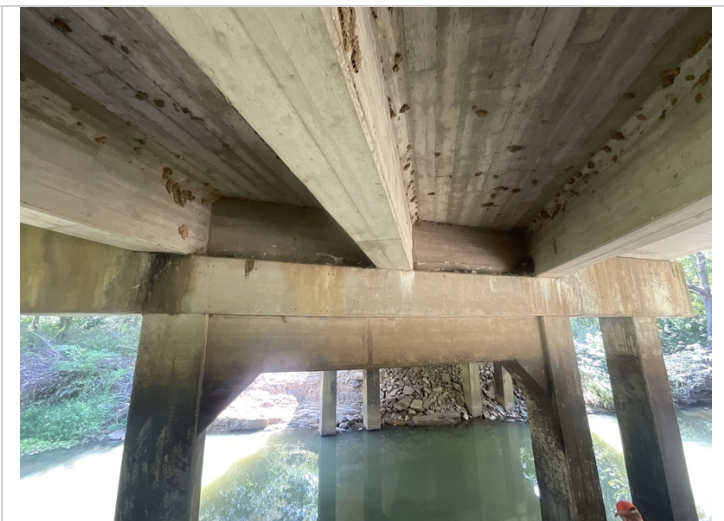
There is map cracking with efflorescence in the end diaphragms between the girders over Bent # 2.

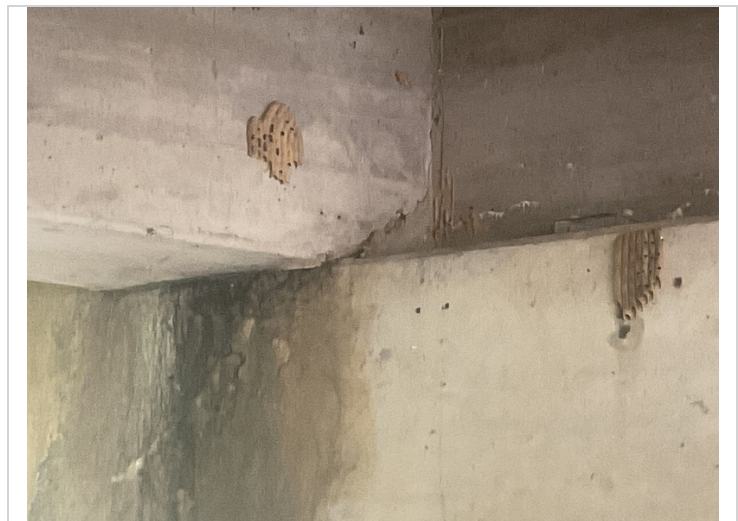
There is a moderate width diagonal crack in the end of Girders # 1 and 2 in Span # 1 at Bent # 2. Diagonal cracks are located at the base of girders and are approximately 14" long. (Not shear type cracks). Photo taken at Girder # 1.

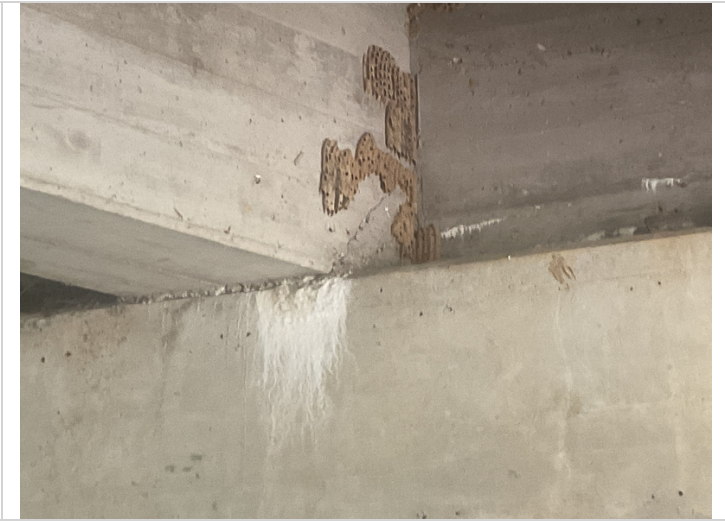
There is a moderate width diagonal crack in the end of Girders # 1 and 2 in Span # 1 at Bent # 2. Diagonal cracks are located at the base of girders and are approximately 14" long. (Not shear type cracks). Photo taken at Girder # 2.

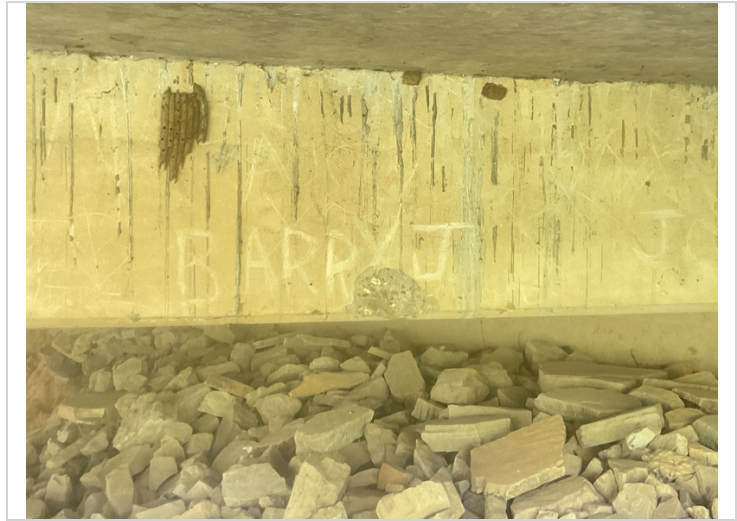
Span # 1, Girder # 1 has a shallow 6" spall with no exposed reinforcing steel in the base of girder located approximately 10' from Abutment # 1.

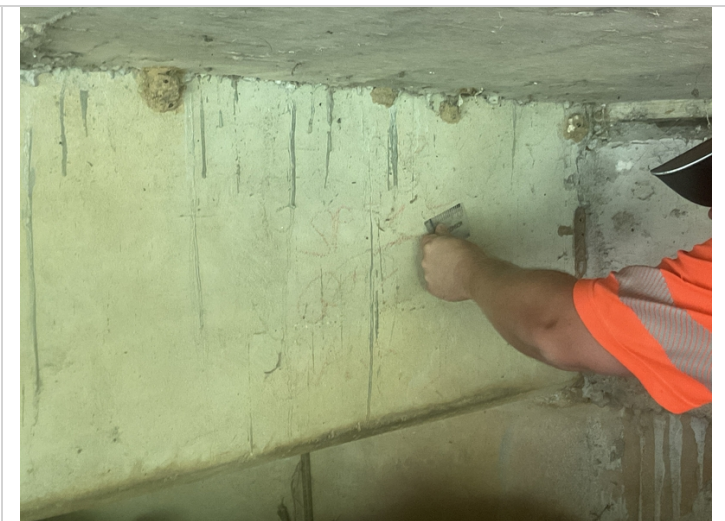
The exterior edge of Girder # 1 has a shear type crack at Abutment # 1 that measures 0.008" during this inspection.

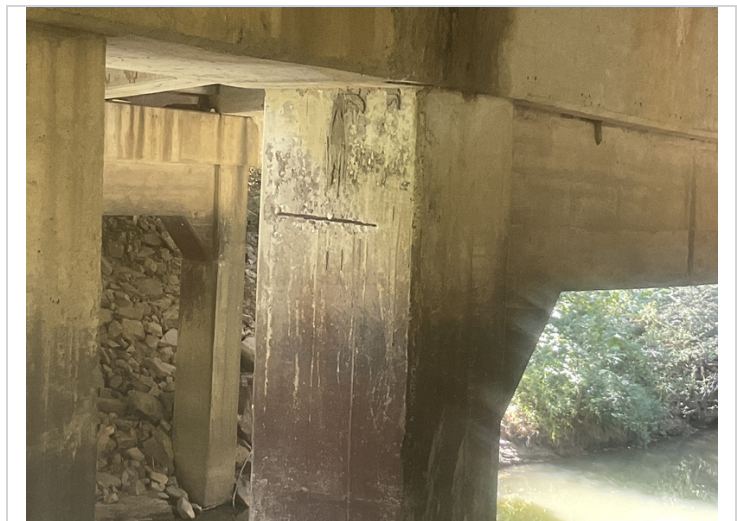
-Bent #2, Column #2 has shallow spalling with exposed reinforcing steel in the upper portion of the column that has very little concrete cover from the construction process. Exposed reinforcing steel has up to initial section loss and appears to be a hoop around the primary vertical reinforcing steel in the column.

Bent # 2, Column # 2 has shallow spalling with exposed reinforcing steel in the upper portion of the column that has very little concrete cover from the construction process. Exposed reinforcing steel has up to initial section loss and appears to be a hoop around the primary vertical reinforcing steel in the column.

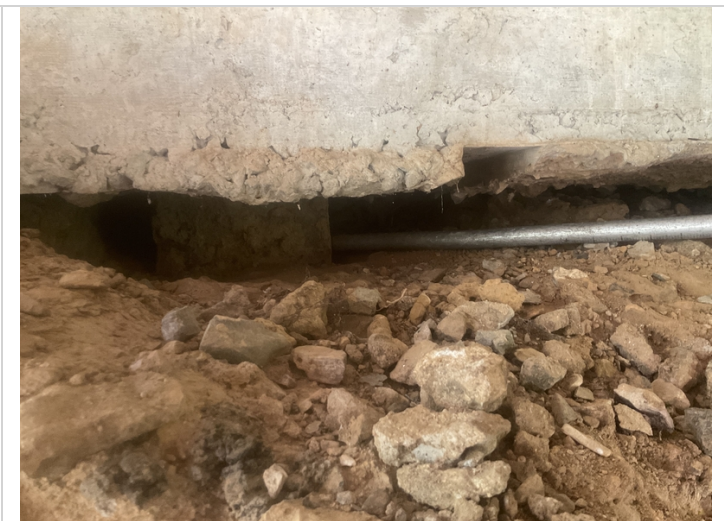
Abutment # 1. Right side has earth settlement with 1 steel pile exposed in the widened portion of the abutment located approximately 4' from Girder # 3.

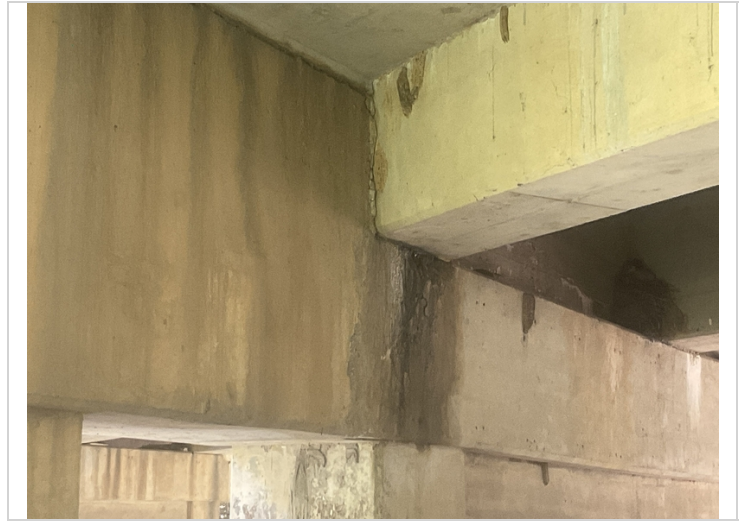
- Bent # 2 cap back face has a 12" shallow spall with no exposed reinforcing steel under Beam # 1.
- The cap has 2" wide delaminated concrete adjacent to the exterior girders in both spans.

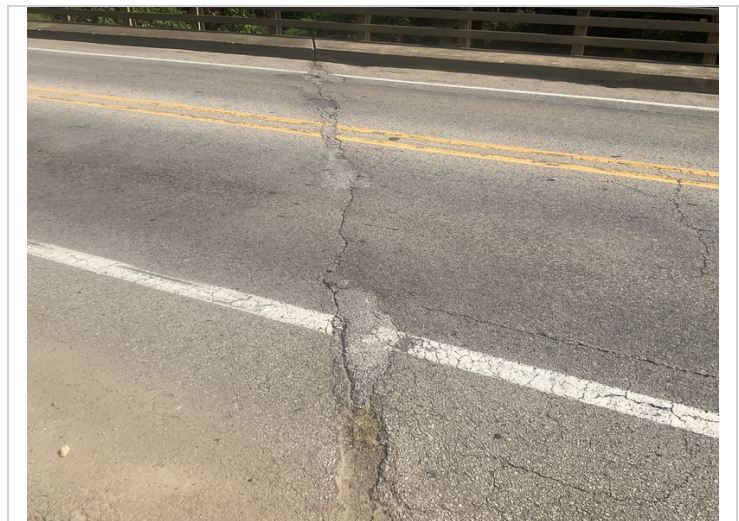
- The asphalt driving surface has numerous patched areas over the expansion joints.
Photo taken over Bent # 2.

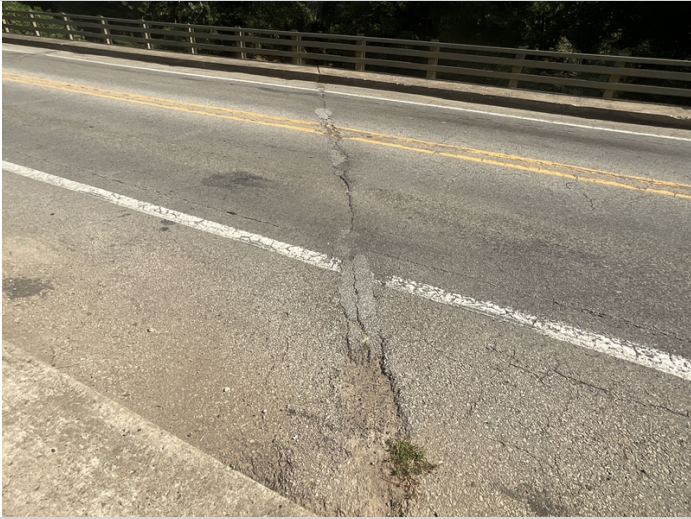
The asphalt driving surface has numerous patched areas over the expansion joints.
Photo taken over Bent # 3.

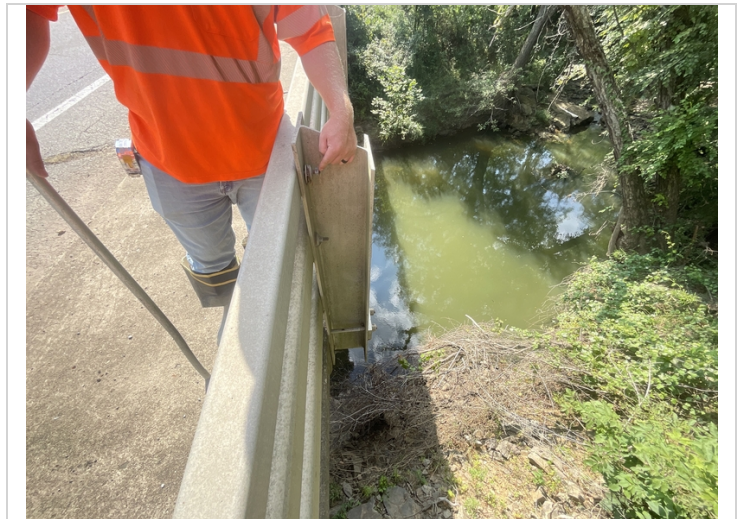
The Right bridge railing in Span # 1 has one loose bolted connection where the top rail is attached to Post # 4.

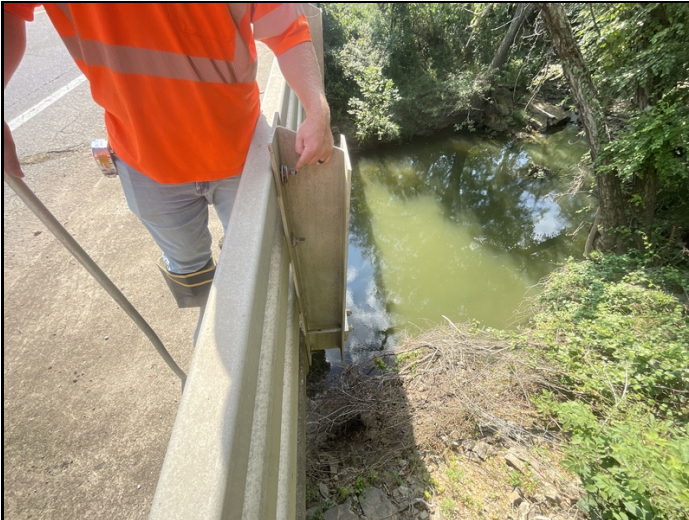
-The Right bridge railing in Span # 1 has one loose bolted connection where the top rail is attached to Post # 4.

The Right bridge railing in Span # 1 has one loose bolted connection where the top rail is attached to Post # 4.

Type of Work: Repair (General)

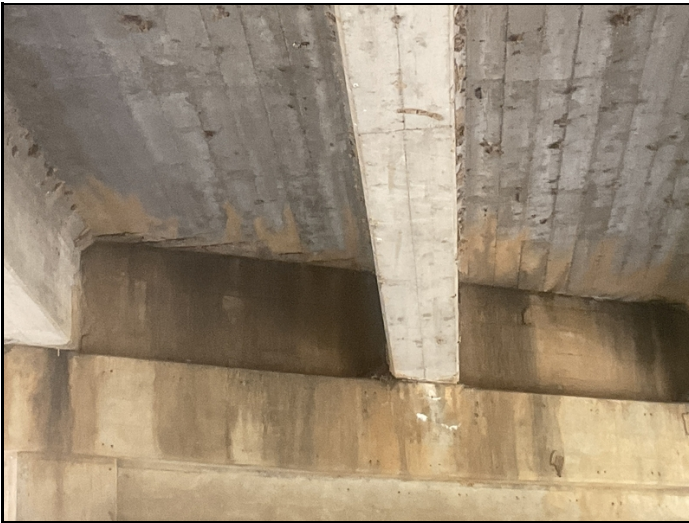
Span # 2 in bays # 1 and # 2 adjacent to bent # 2 has spalls with exposed reinforcing steel in the undersurface of the deck. The exposed reinforcing steel has corrosion with initial section loss.

Span # 2-Spalling with exposed reinforcing steel between Girders # 2 and 3 at Bent # 2.

Type of Work: Deck Repair

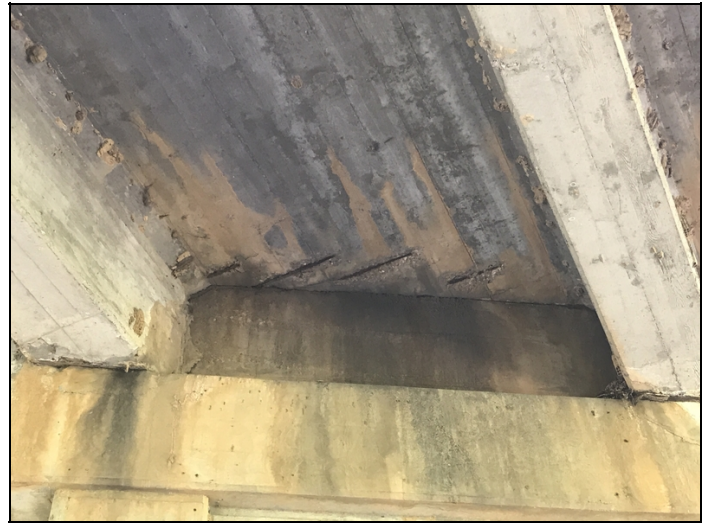
Span # 2-Spalling with exposed reinforcing steel between girders # 2 and 3 at bent # 2.

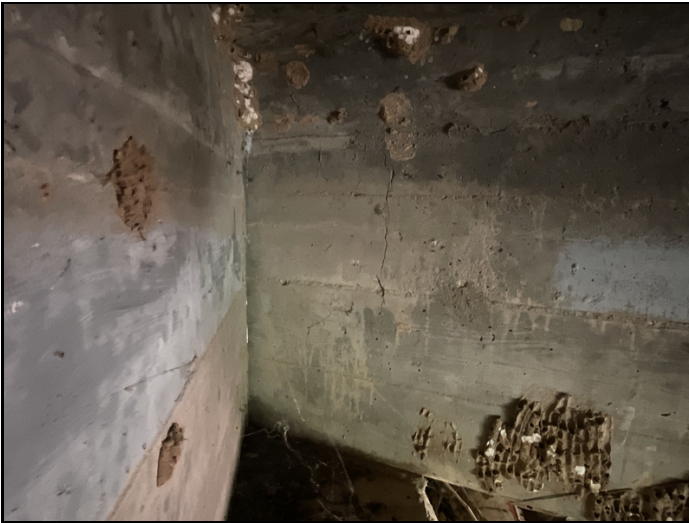
Span # 3, girder # 3 at abutment # 2 Left face has a vertical crack approximately 1/16" wide located approximately 1' from the face of the abutment backwall.

Type of Work: Superstructure Repair

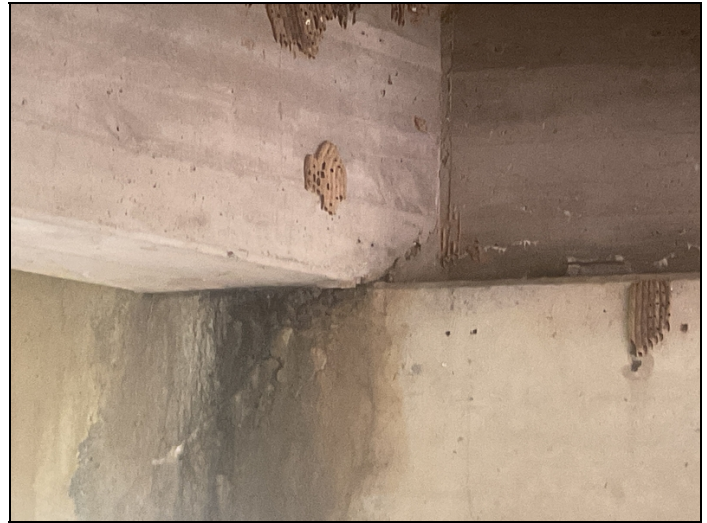
There is a moderate width diagonal crack (Not shear) in the end of girders # 1 and 2 of span # 1 over bent # 2.
Photo taken of Span # 1, Girder # 1 at Bent # 2.

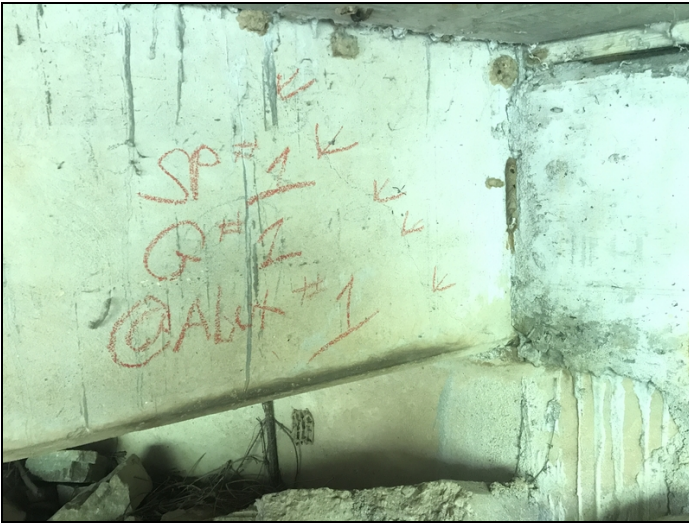
Girder # 1 at abutment # 1 has a hairline shear crack during this inspection.

Span # 1, girder # 1 at abutment # 1-Hairline shear type crack.

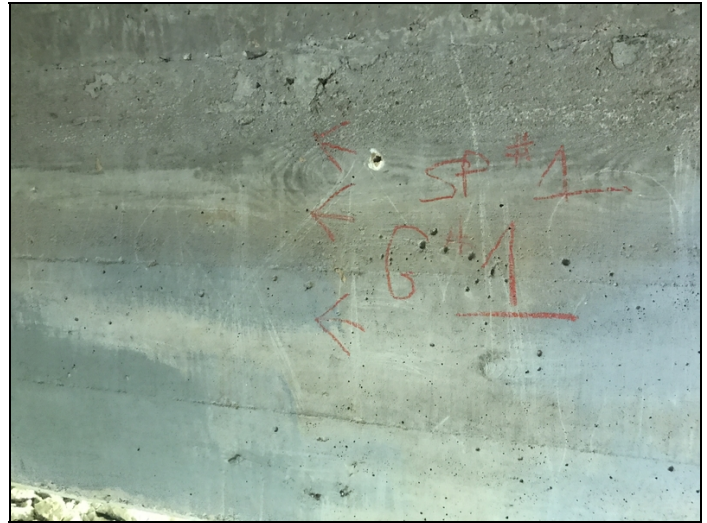
Span # 1, girder # 1-Hairline vertical cracking.

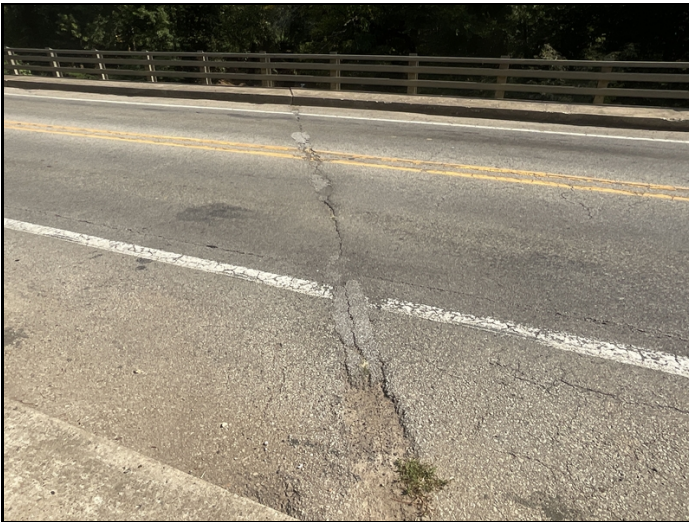
08/31/2023 - JCJ & TJL - The asphalt driving surface has numerous patched areas over the expansion joints.

Type of Work: Repair (General)

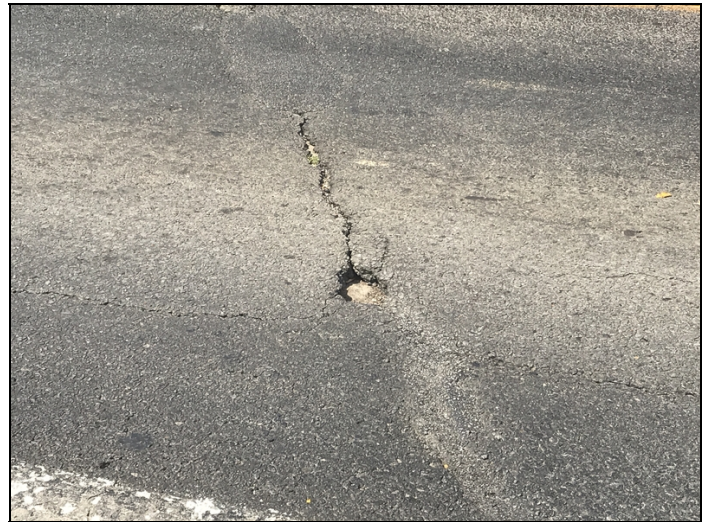
Pothole forming in wearing surface of left lane over bent # 3.

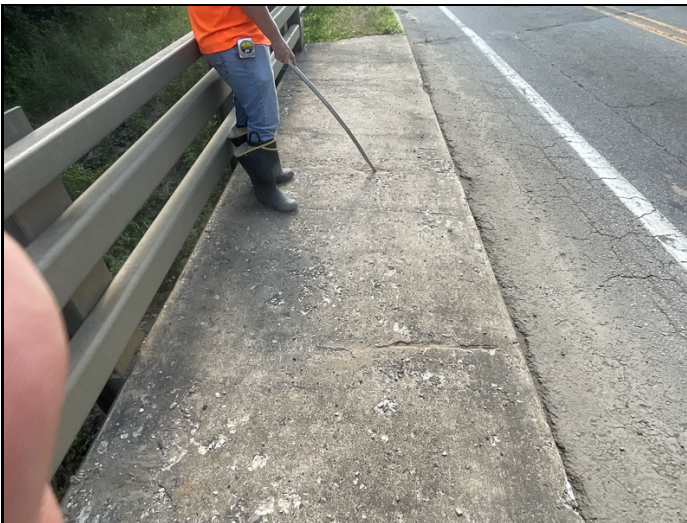
Sidewalk: The Left sidewalk on Spans # 1 and 3 have shallow spalls with exposed reinforcing steel. Exposed reinforcing steel has very little concrete cover from the construction process. Exposed reinforcing steel has up to initial section loss. There are areas with up to medium scale on the sidewalk.

The Left sidewalk on Spans # 1 and 3 have shallow spalls with exposed reinforcing steel. Exposed reinforcing steel has very little concrete cover from the construction process. Exposed reinforcing steel has up to initial section loss. There are areas with up to medium scale on the sidewalk.

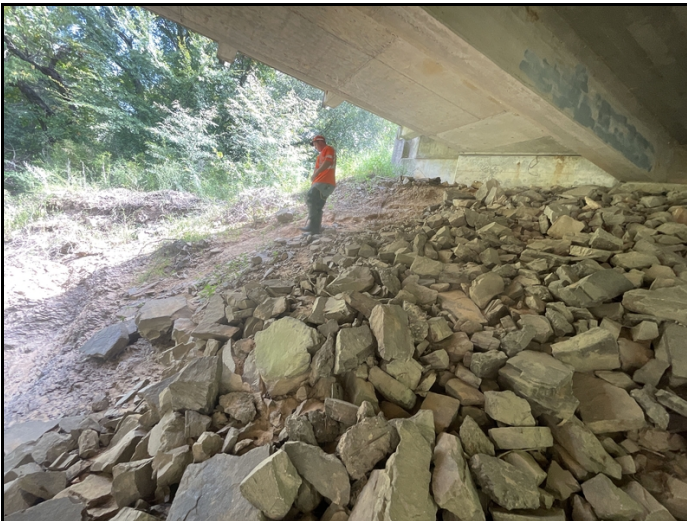
Abutment # 2 has riprap displacement with embankment erosion at the outlet end of the abutment.

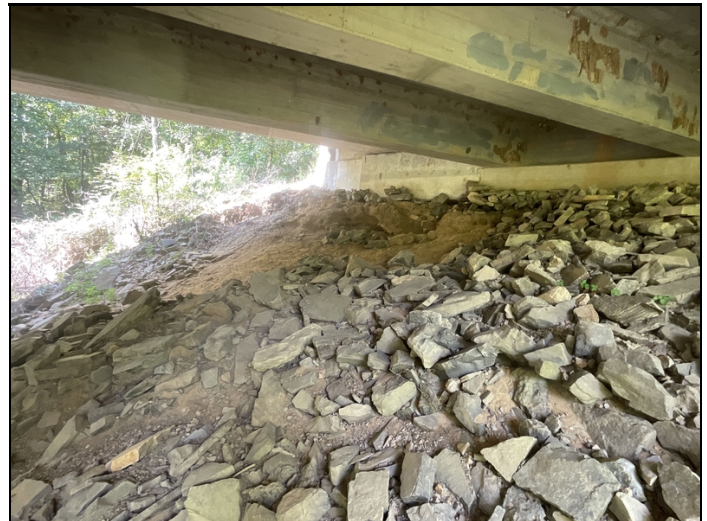
Abutment # 1 has riprap displacement with embankment erosion at the inlet end of the abutment.

There is earth settlement under the Right side of the abutment with voids that penetrate approximately 2' past the face of the abutment.

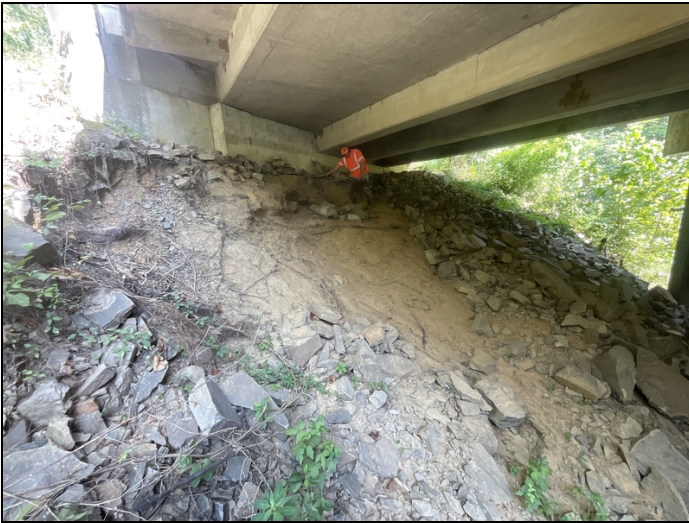
Abutment # 1 has riprap displacement with embankment erosion at the inlet end of the abutment.

There is earth settlement under the Right side of the abutment with voids that penetrate approximately 2' past the face of the abutment.
