Asset #03096(Routine)

State Highway 45 over Barren Fork - Wash. Co.

Location: 1.15 MI E JCT OF SH 59

Team Lead: Eric West Inspection Date: 04/20/2022

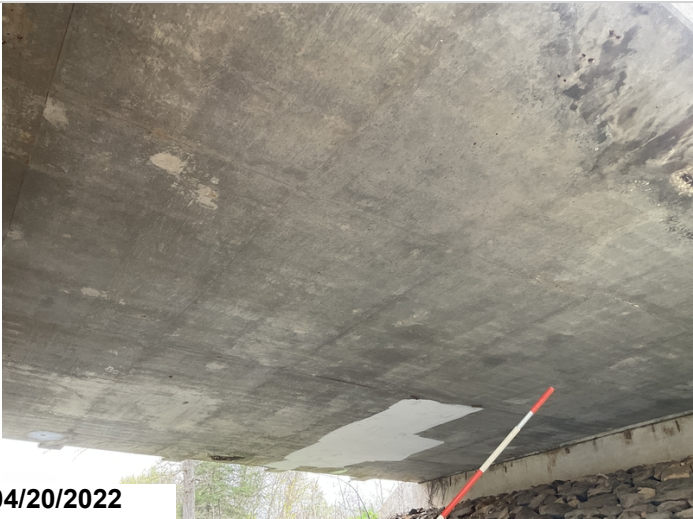
Span #1 typical undersurface of the slab.

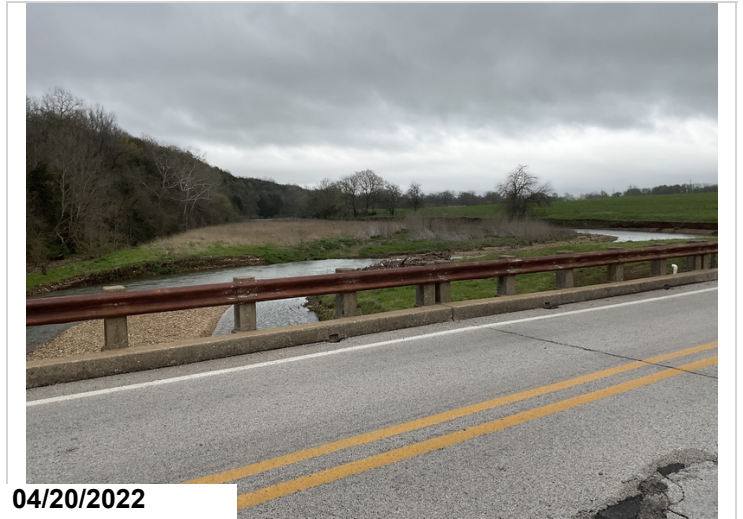
Channel looking upstream.

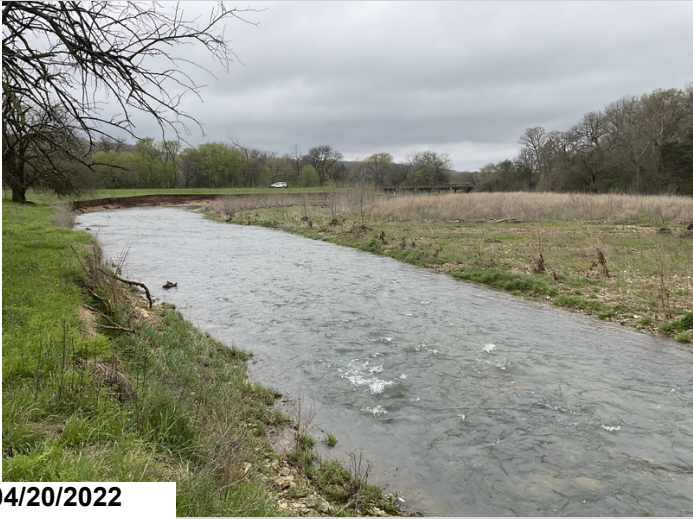
03/27/2019 - JCJ & TJL - There is lateral migration of the channel at the inlet end of structure. Channel alignment is now approximately 300' to the East of the structure and approximately 100' from the edge of the pavement. See images in Google Earth for progression of the lateral migration of the channel.

Channel migration

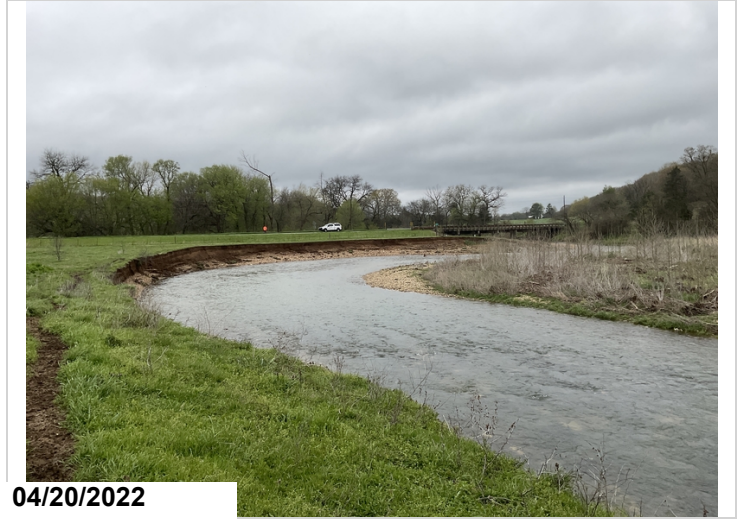
Channel migration.

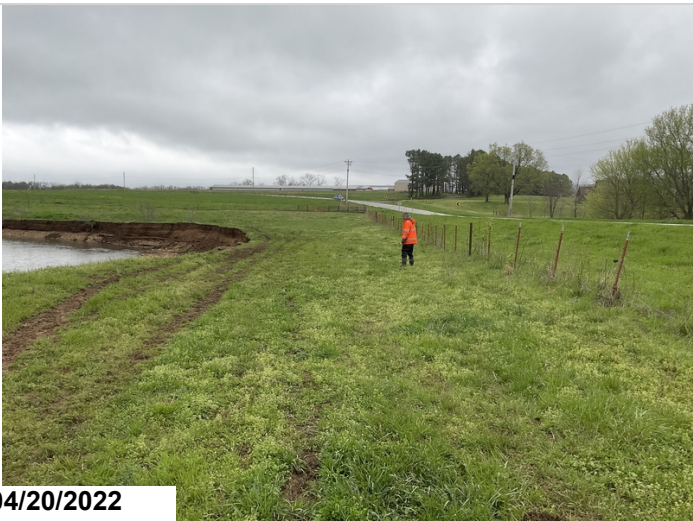
Channel migration has eroded the embankment and is currently 30' from the right of way fence.

The upstream channel has lateral migration. Channel alignment is now approximately 300' to the East of the structure and approximately 66' from the edge of the pavement. See attached Google Earth images for progression of the lateral migration of the channel.

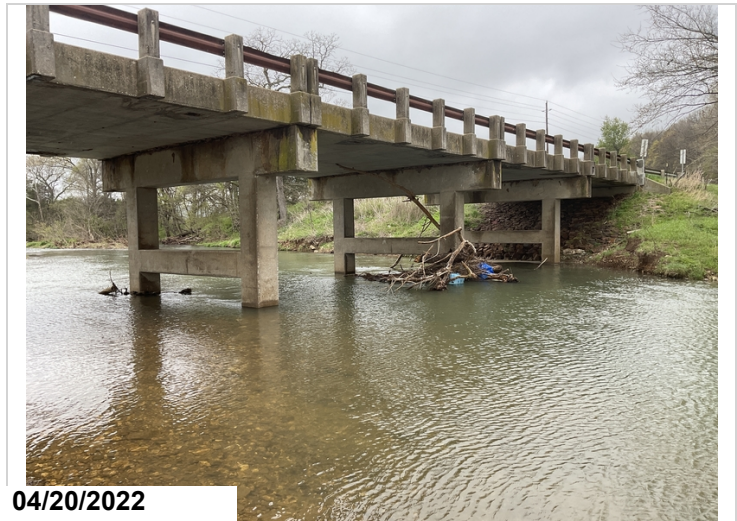
Bent # 2, 3 & 4 drift accumulation.

The channel has drift accumulation at Bent # 3.

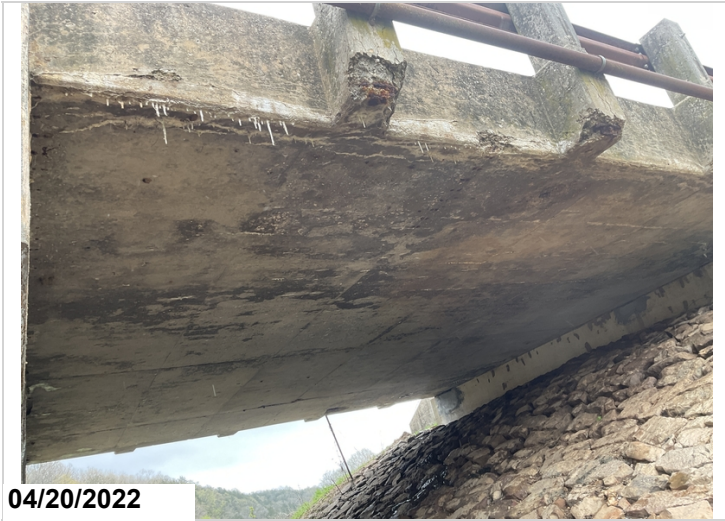
- Span #7 has soft concrete and map cracking with heavy efflorescence that is visible from the undersurface and along the edges of span # 7. Exposed reinforcing steel is primary longitudinal steel with active corrosion and up to approximately 1/8" section loss.

Span #7 has map cracking and efflorescence buildup visible from the undersurface of the slab.

Soft concrete and map cracking with heavy efflorescence is visible from the undersurface and along the edges of Span # 7. Exposed reinforcing steel is primary longitudinal steel with active corrosion and up to approximately 1/8" section loss.

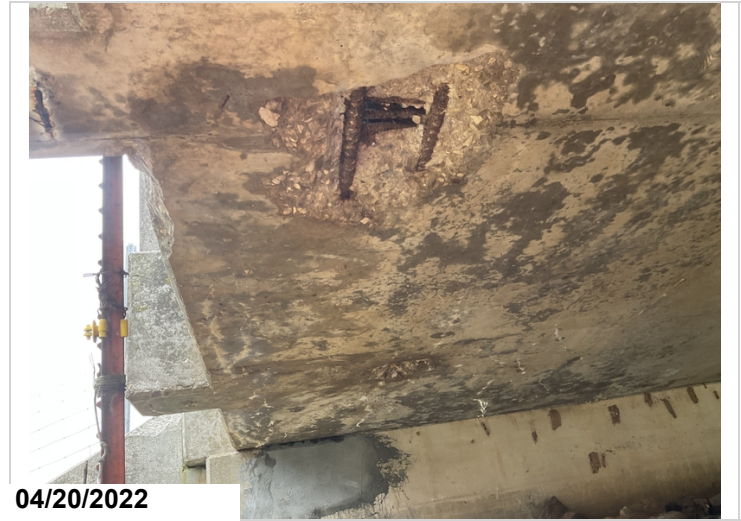
Span #7 Lt spalling with exposed reinforcing steel.

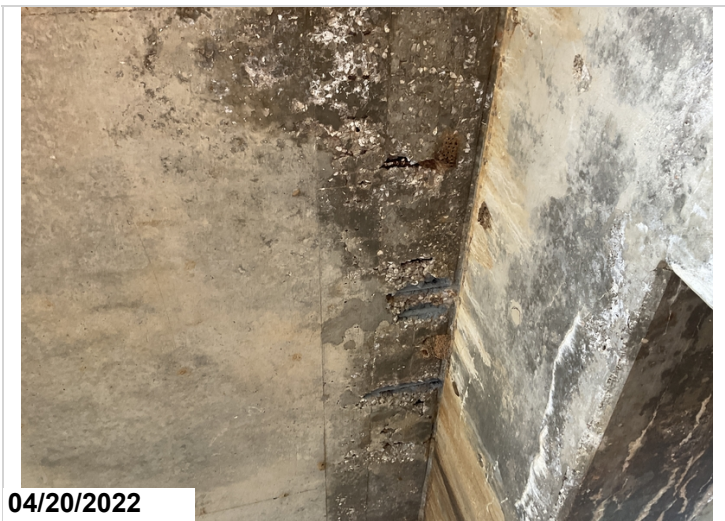
- Spans # 5, 6, and 7 adjacent to Bents # 6 and 7 have soft deteriorated concrete with numerous spalled areas with exposed reinforcing steel with approximately 1/8" section loss visible from the undersurface of slab.

Span #6 adjacent to Bent #7 concrete deterioration with exposed reinforcing steel.

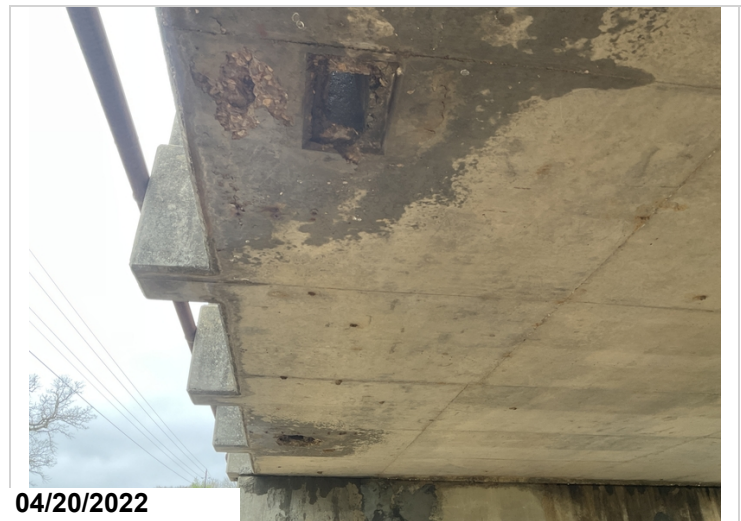
Span #6 Rt spalling with exposed reinforcing steel at the deck drains.

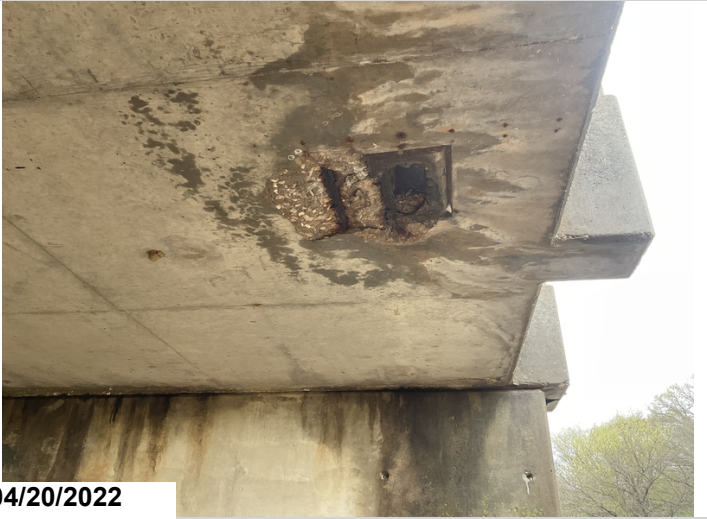
Span #6 Lt spalling with exposed reinforcing steel at the deck drain.

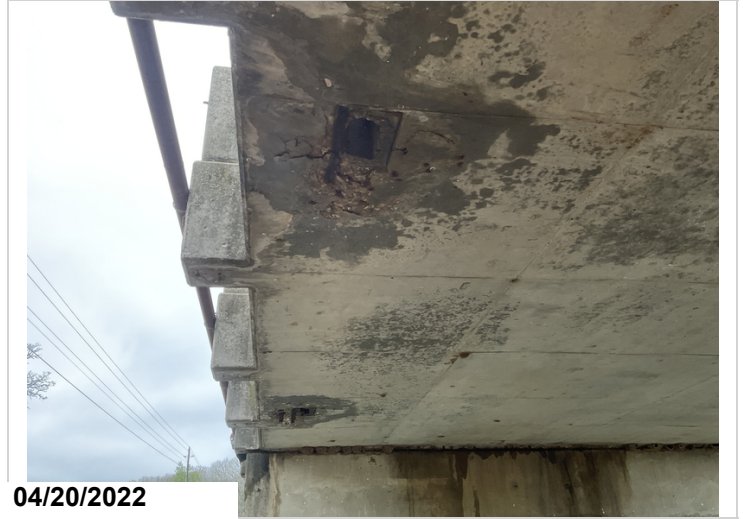
Span #5 Rt spalling with exposed reinforcing steel at the deck drains.

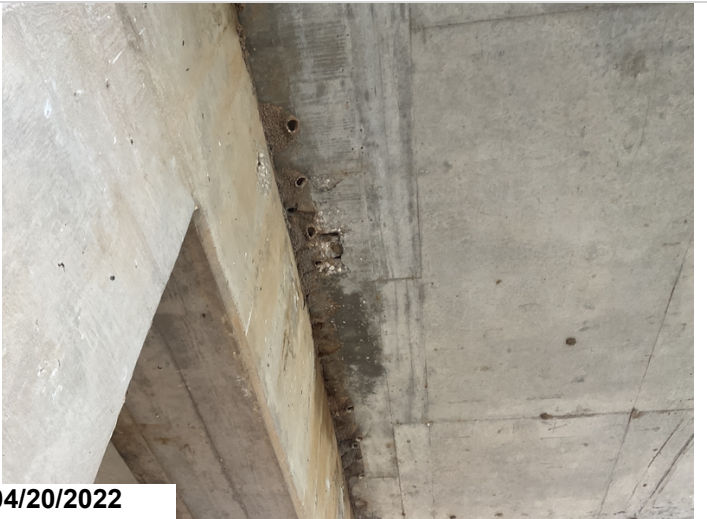
Span #5 bent #6 spalling with exposed reinforcing steel at the cap juncture.

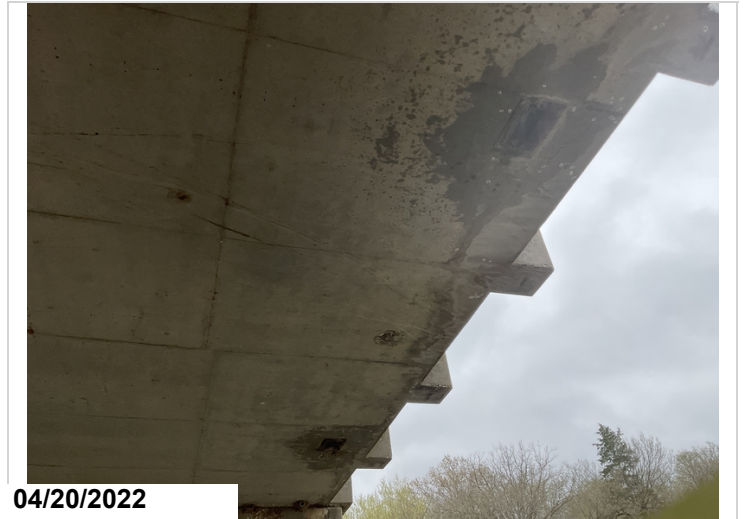
Span #5 Lt spalling with exposed reinforcing steel at the deck drains.

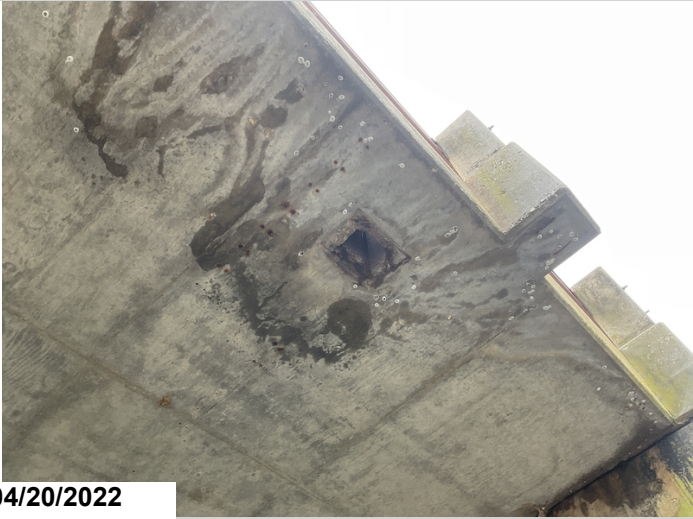
Span #4 Lt exposed reinforcing steel in the deck drain.

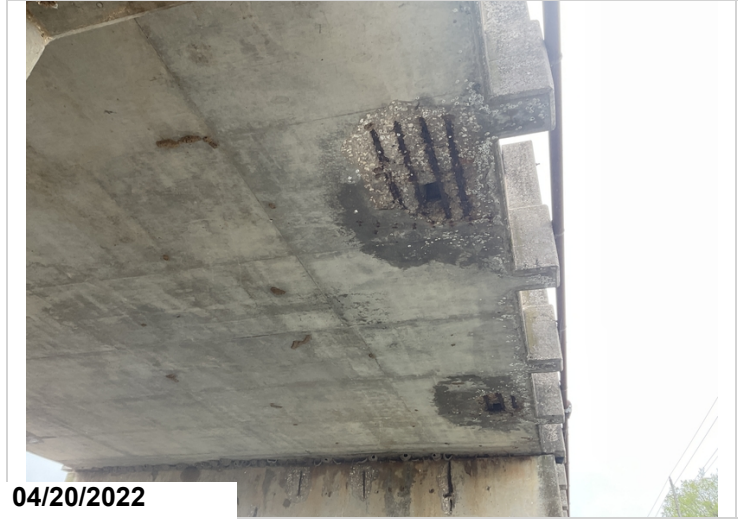
Span #4 Rt spalling with exposed reinforcing steel.

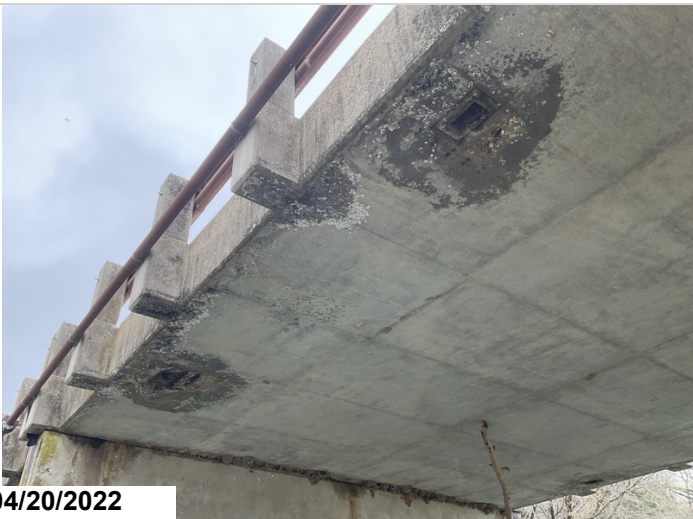
Span #3 Rt concrete spalling with exposed reinforcing steel.

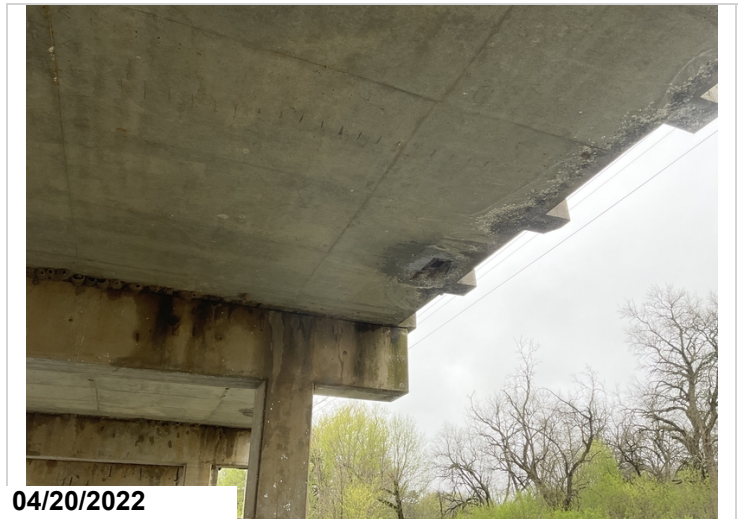
Span #2 Rt spalling with exposed reinforcing steel.

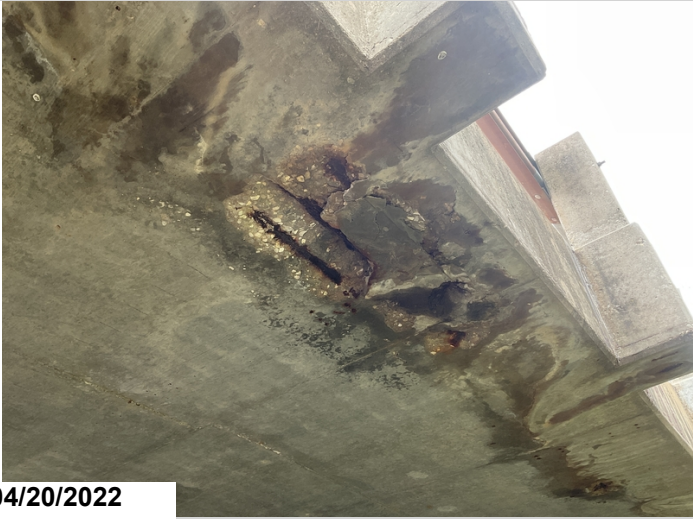
Span #1 Lt concrete spalling with exposed reinforcing steel at the deck drain.

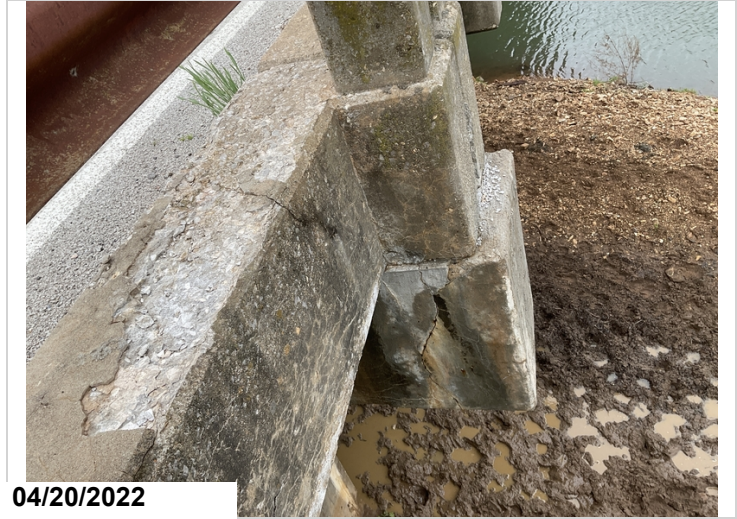
Span #7 Lt at Bent #7 shear type crack exterior edge of the slab.

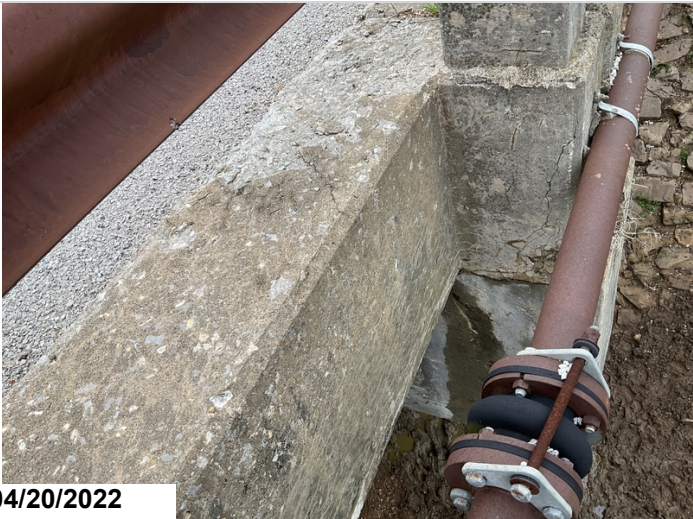
Span #6 Rt at Bent #7 shear type crack exterior edge of the slab.

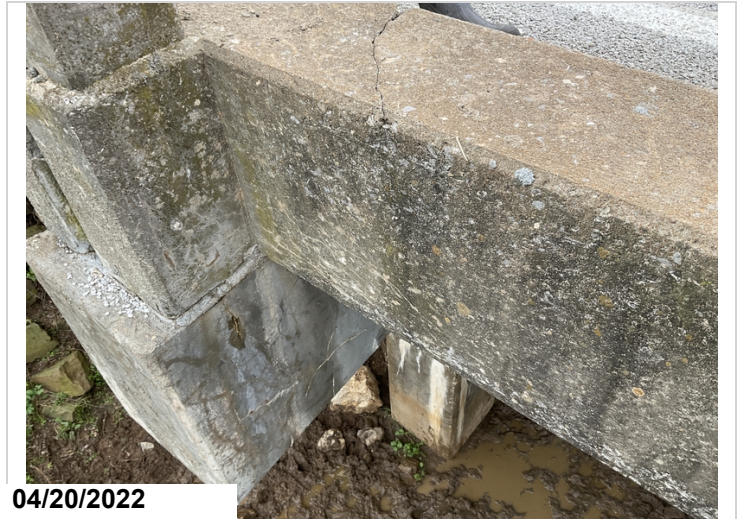
Span #6 Lt at Bent #7 shear type crack exterior edge of the slab.

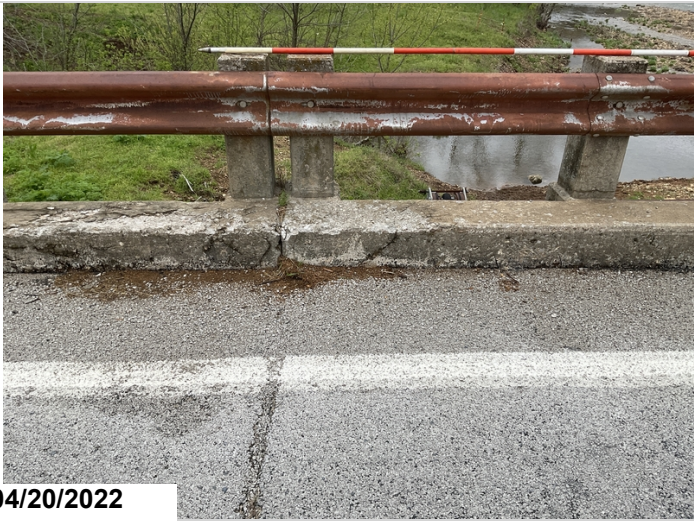
Span #6 Rt at Bent #7 shear type crack.

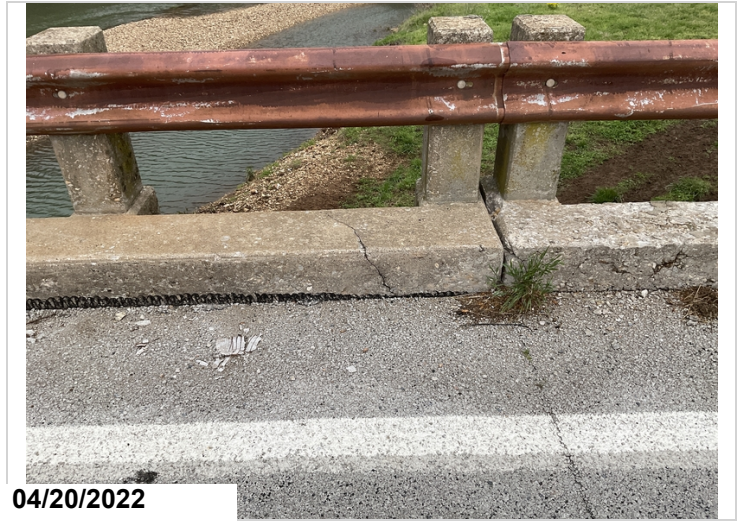
Span #6 Lt at Bent #7 shear type crack.

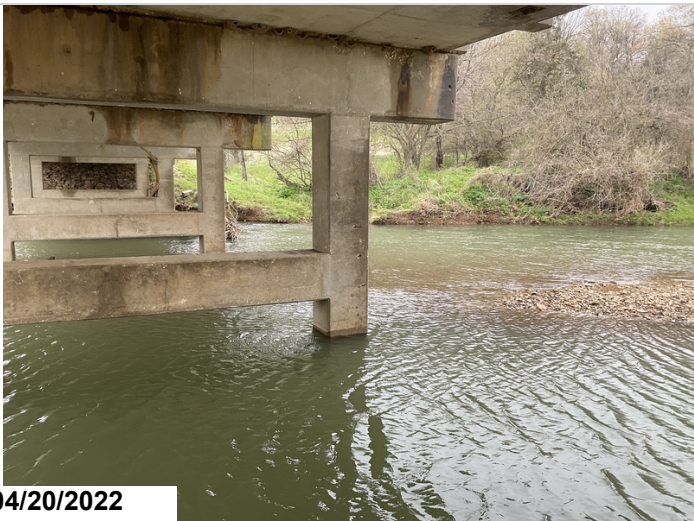
Bent #5 column #1 ahead face spalling with exposed reinforcing steel.

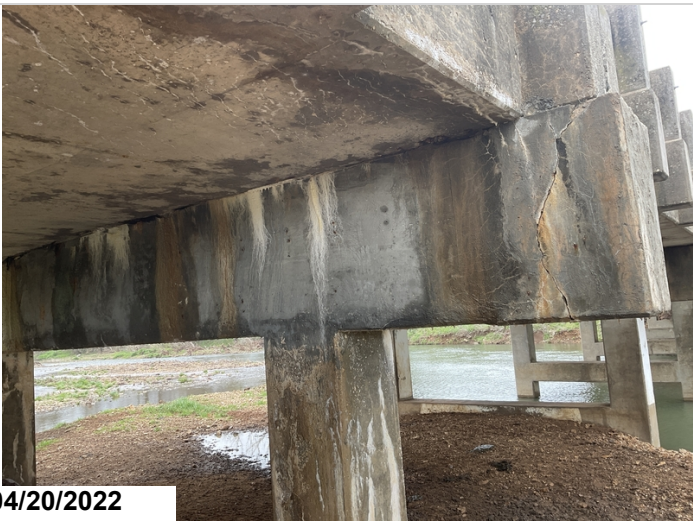
Bent #7 Lt vertical cracking in the Lt end of the cap.

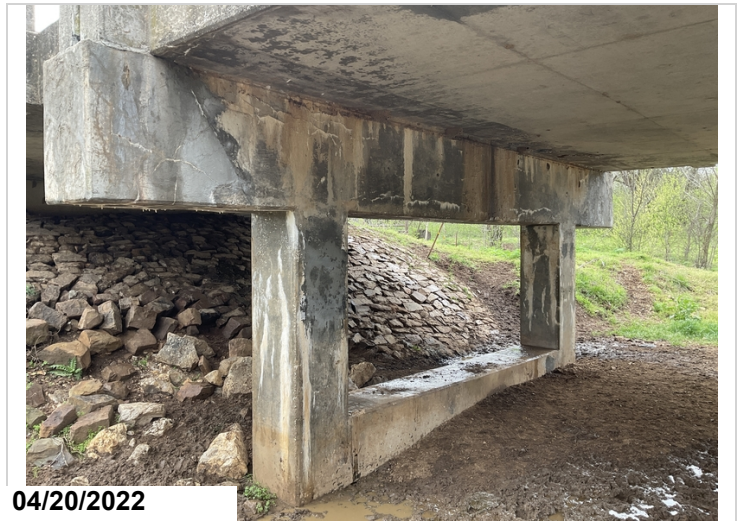
Bent #7 backface map cracking with efflorescence buildup.

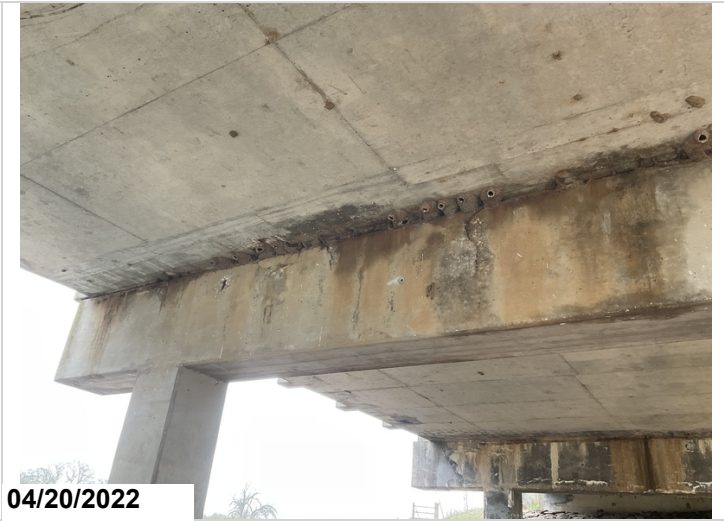
Bent #6 concrete delaminations and spalling with exposed reinforcing steel.

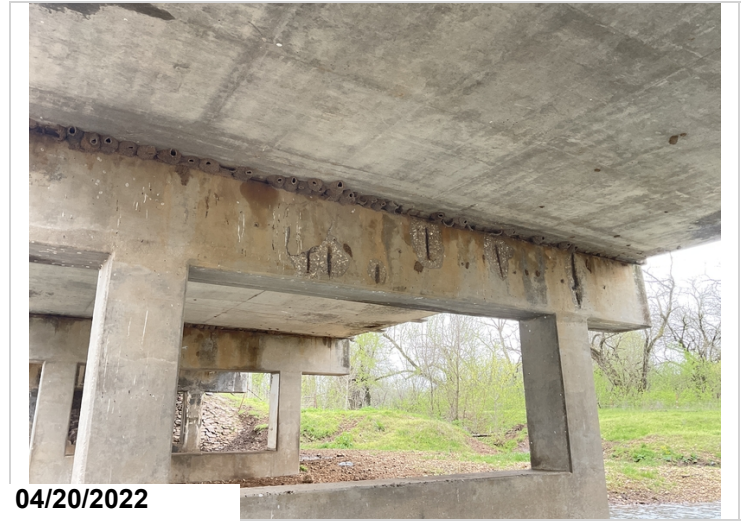
Bent #5 backface spalling with exposed reinforcing steel.

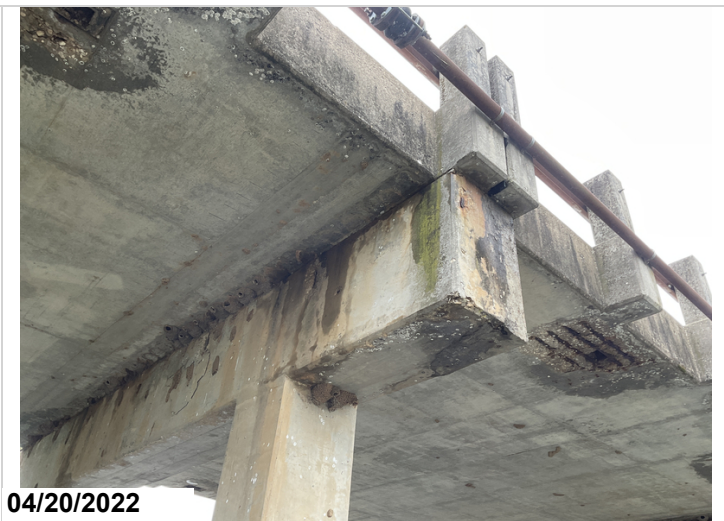
Bent #3 Rt cap with shallow spalling with exposed reinforcing steel.

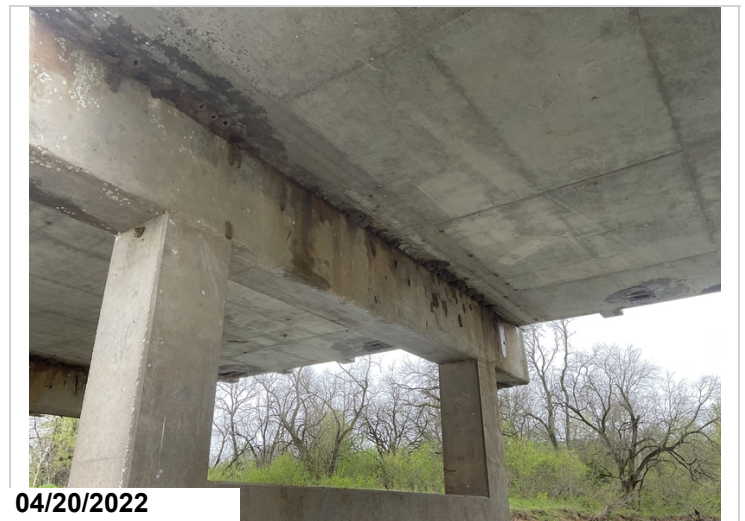
Bent #4 backface large concrete delamination.

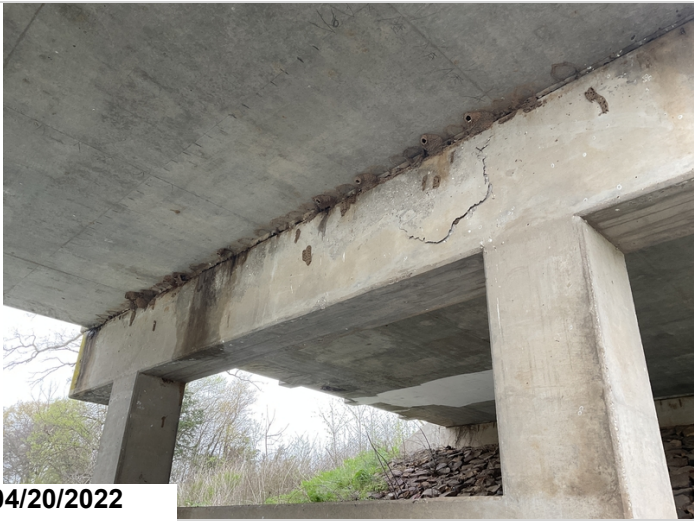
Bent #2 ahead face concrete delamination.

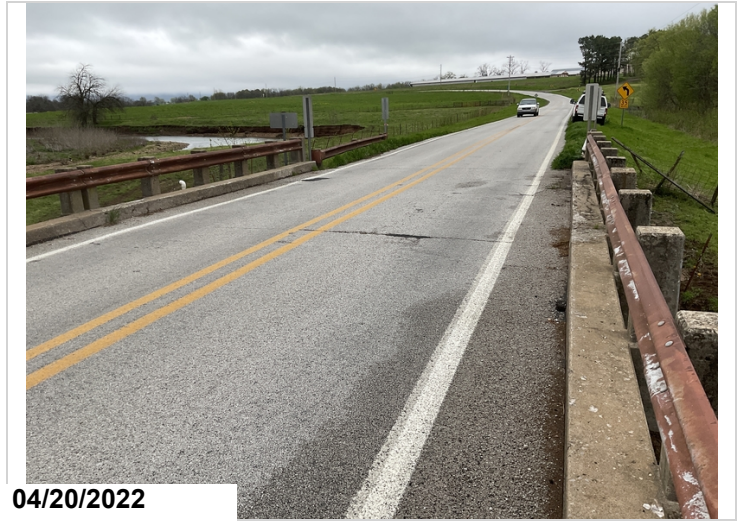
Span #7 curbs with concrete deterioration with section loss.

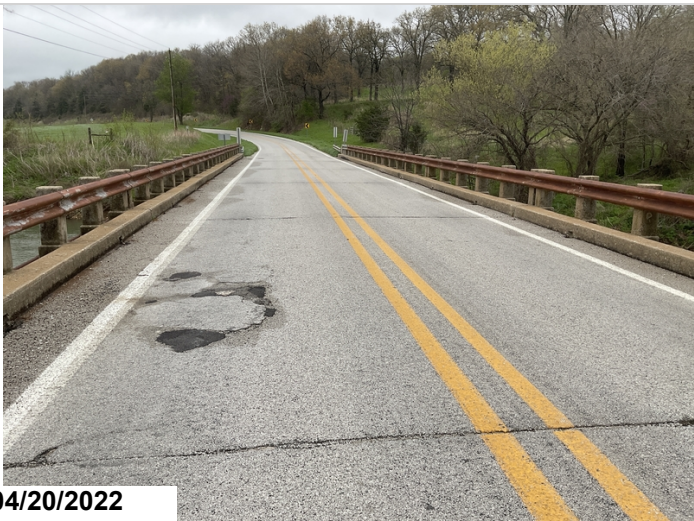
Typical failing paint system on the bridge rail.

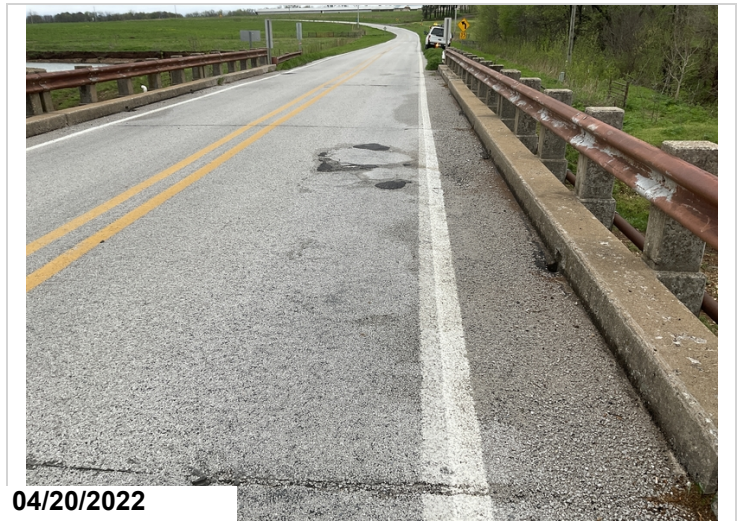
Span # 5, 6 & 7 Rt wearing surface delamination.

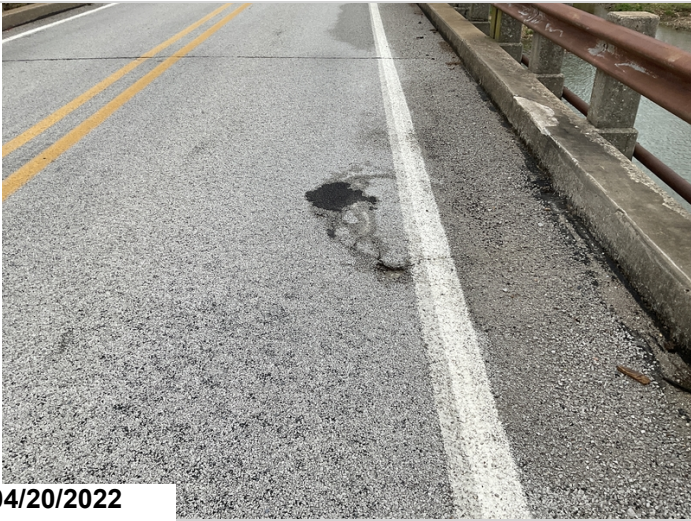
Span #1 Rt delamination of the wearing surface.

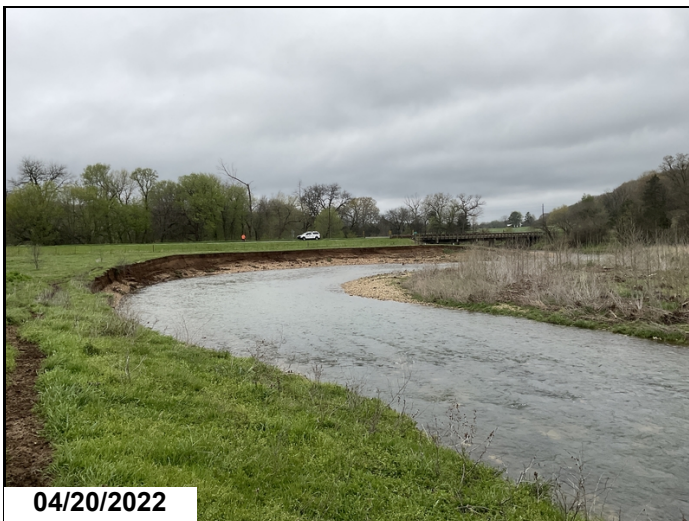
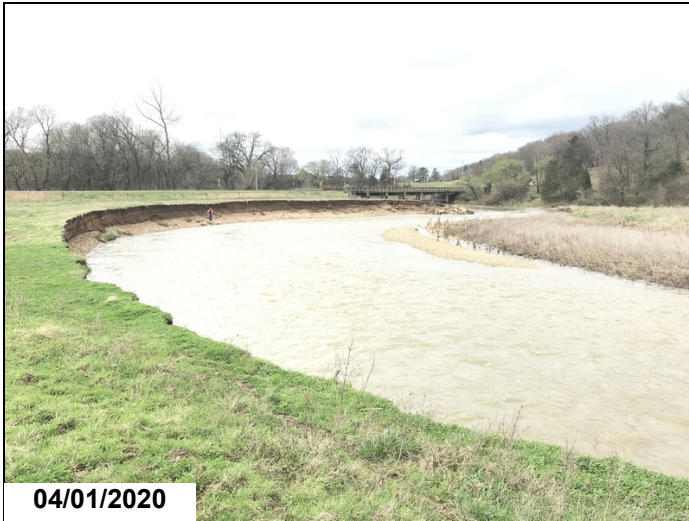
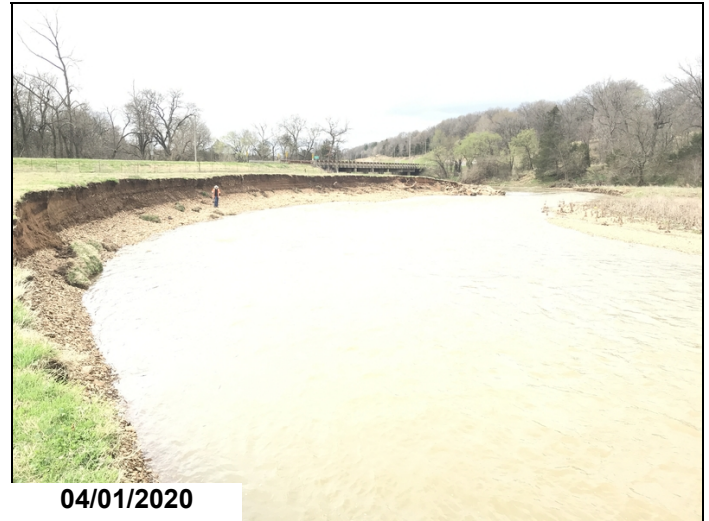
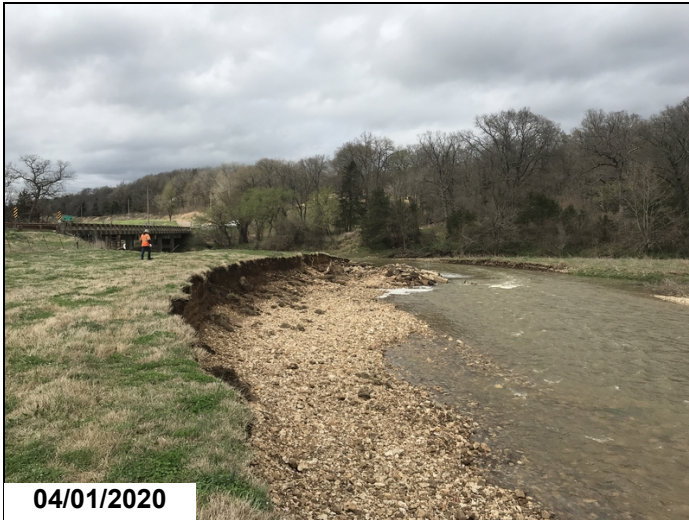
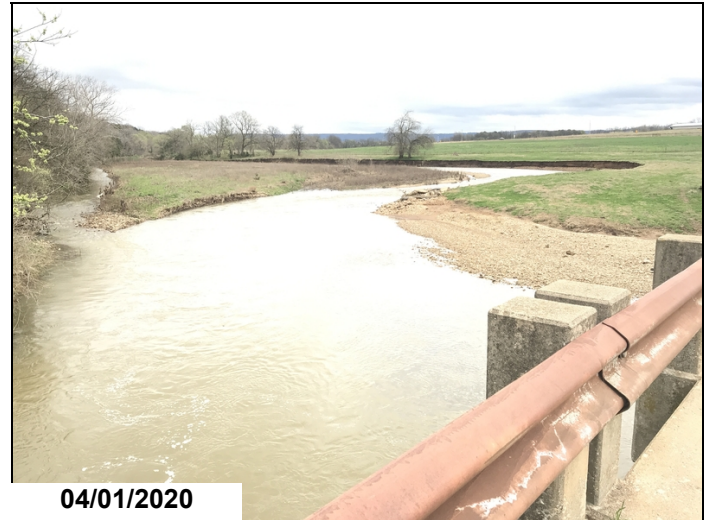
Channel migration.

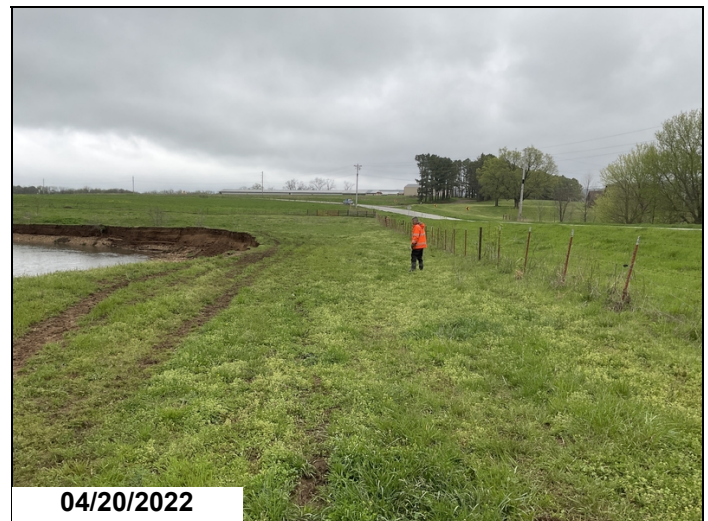
Channel migration has eroded the embankment and is currently 30" from the right of way fence.

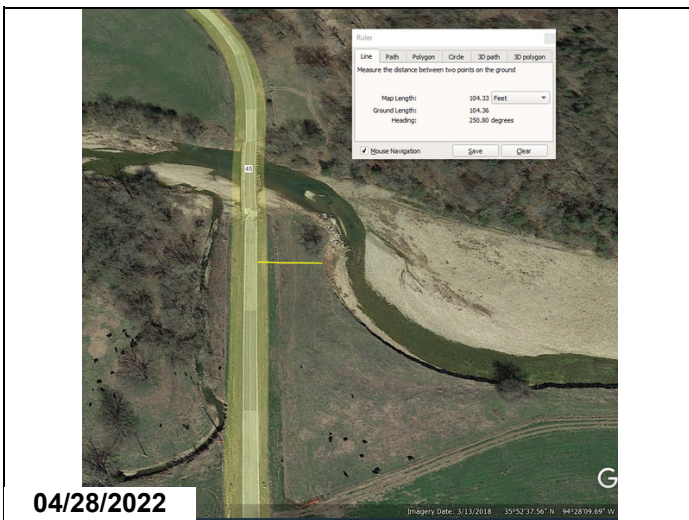
2018 erosion

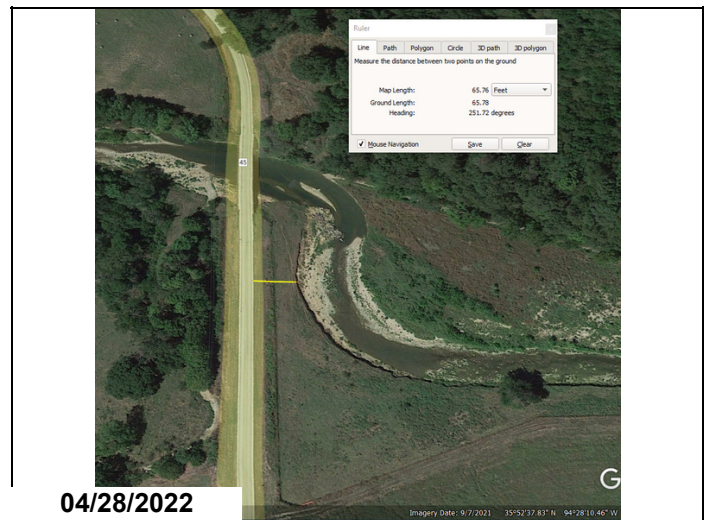
2021 erosion

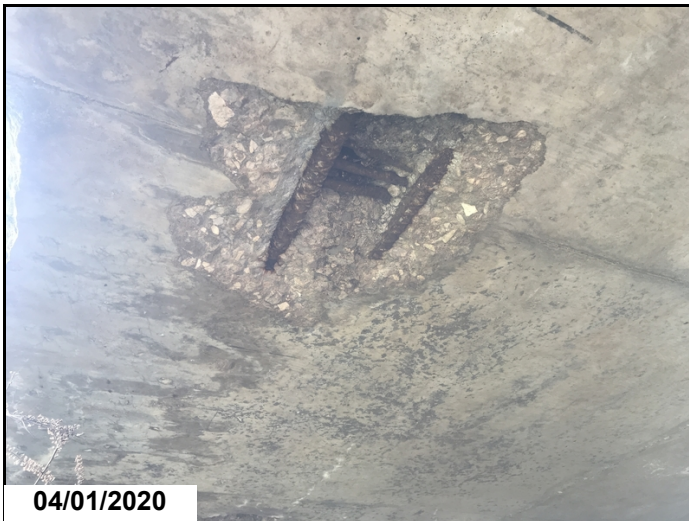
Span 7 undersurface, left side-Spalling with exposed reinforcing steel adjacent to deck drain.

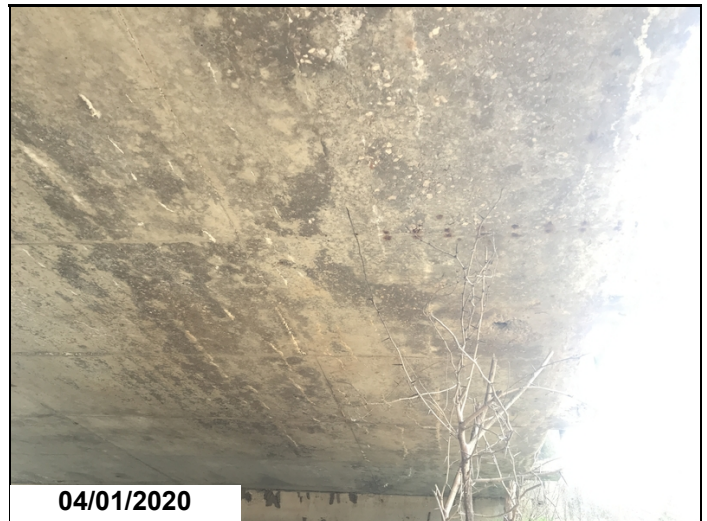
Span 7 undersurface, right side-Mapcracking with efflorescence / concrete deterioration.

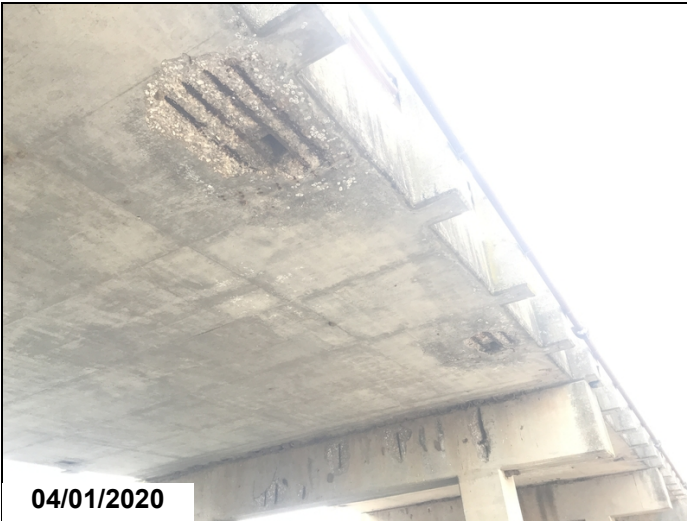
Span 4, right side-Spalling adjacent to deck drains.

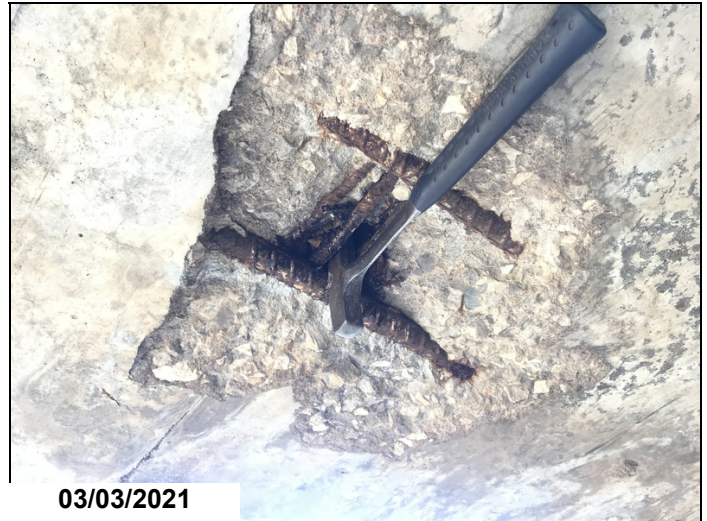
- Span #7 left side has a spall approximately 14" x 14" with two mats of exposed reinforcing steel visible and a 4" diameter area with up to approximately 5" of section loss that appears to be a possible full depth failure due to recent deck repairs

Span # 7, left side has a spall approximately 14" x 14" with two mats of exposed reinforcing steel and a 4" diameter area with up to approximately 5" of section loss that appears to be a possible full depth failure due to recent deck repairs. Photo 1.

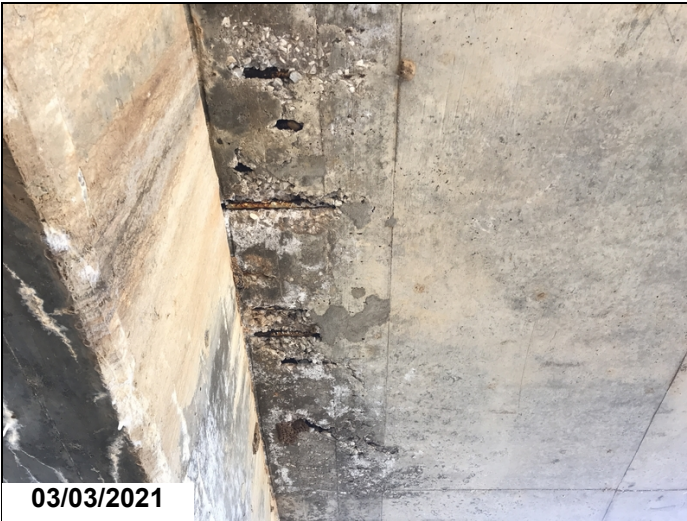
Span 6, at bent 7-Spalling / delaminated areas with exposed reinforcing steel.

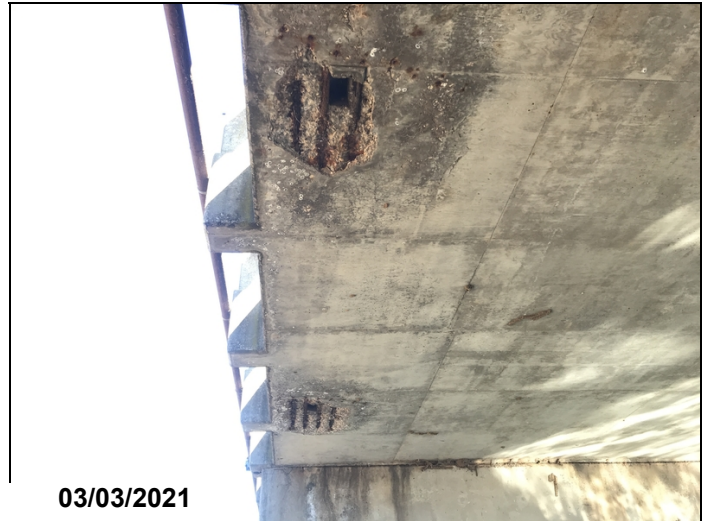
Span 4, right side-Spalling / delaminated areas with exposed reinforcing steel at deck drains.

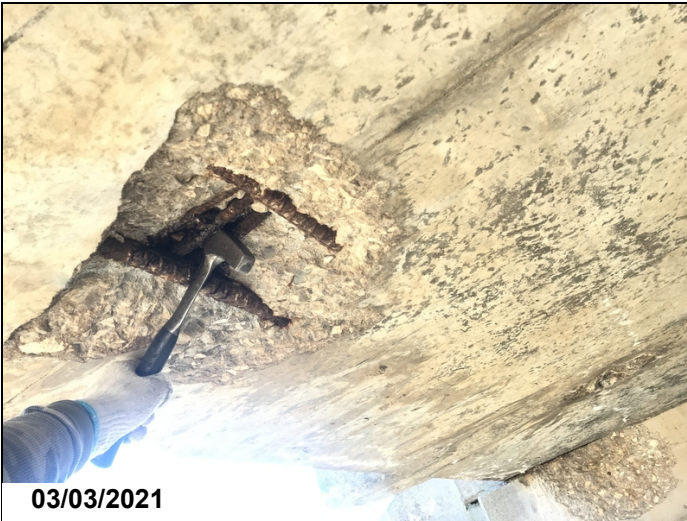
Span # 7, left side has a spall approximately 14" x 14" with two mats of exposed reinforcing steel and a 4" diameter area with up to approximately 5" of section loss that appears to be a possible full depth failure due to recent deck repairs. Photo 2.

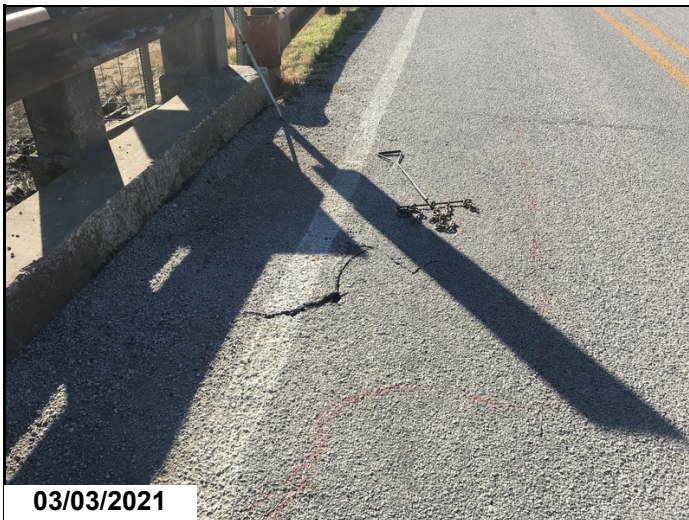
-Span # 7, left lane at abutment # 2 has a 12' long x 6' wide delaminated area with a portion of the failing repair heaved up and beginning to spall.

Span # 7, left lane at abutment # 2 has a 12' x 6' delaminated area with a portion failing repair beginning to spall.

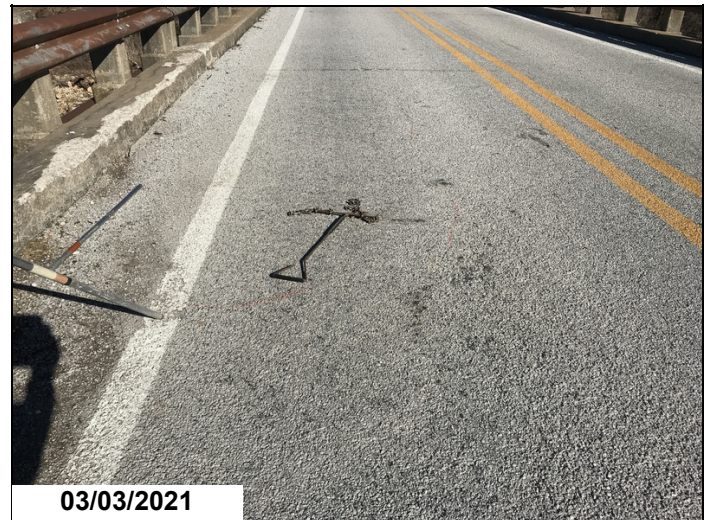
Span # 7, right lane near abutment # 2 has a delaminated area approximately 25' x 6' where previous repairs appear to have failed.

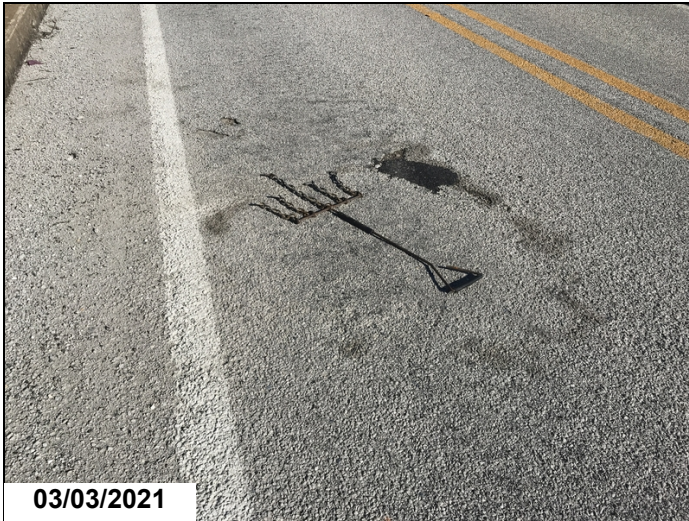
Span 5, right lane has a 12' x 6' delaminated area.

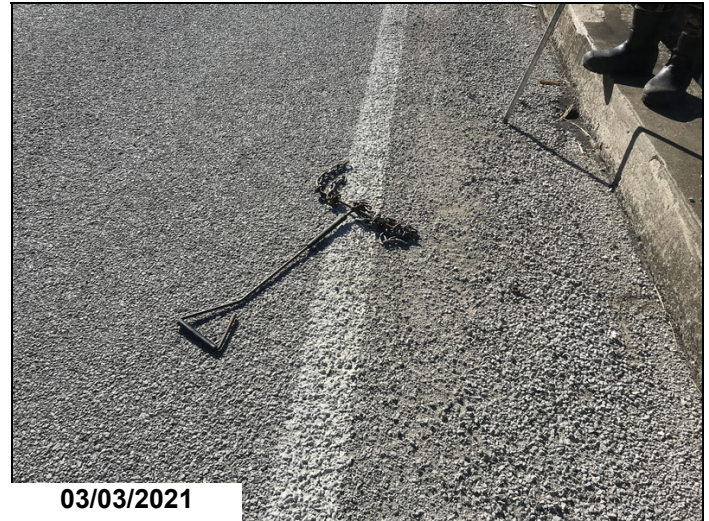
Span # 1 has a delaminated area approximately 5' x 3' along the white line.

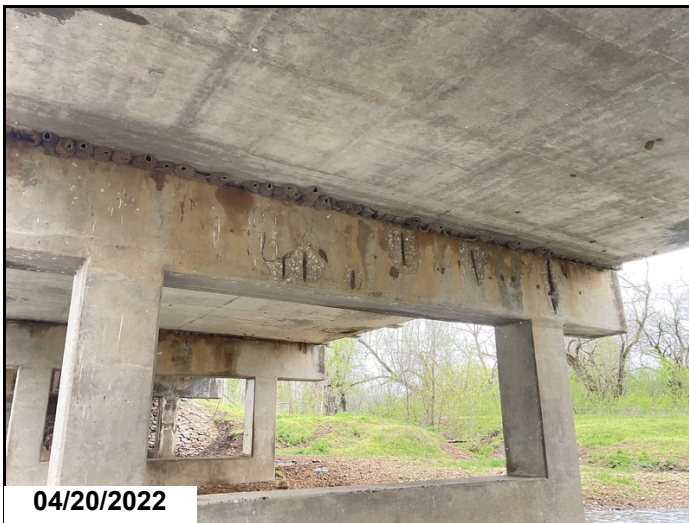
Bent #5 backface spalling with exposed reinforcing steel.

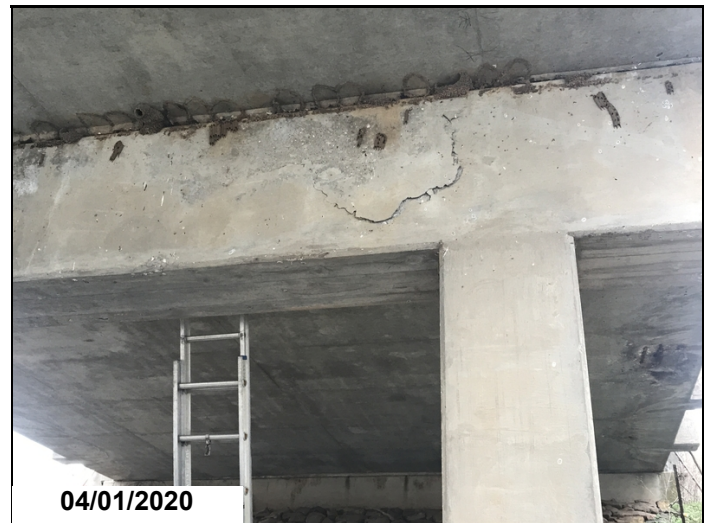
Bent 2 cap, ahead face on left side-Delaminated area.

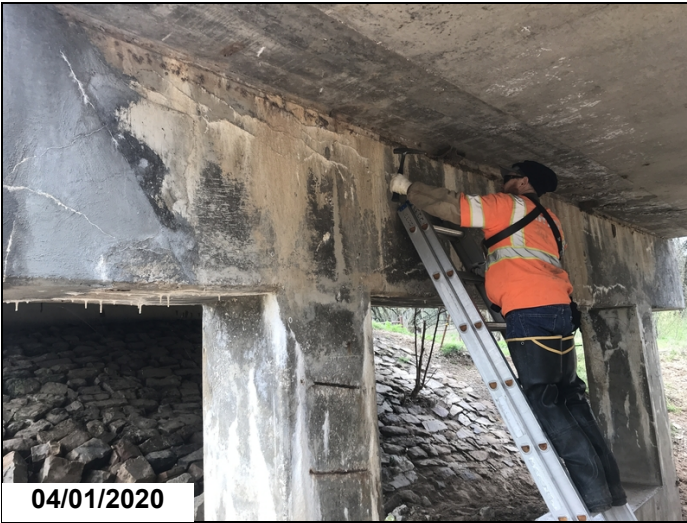
The substructure has areas of delamination and spalling with exposed reinforcing steel in numerous locations. Bent # 7 has chloride contamination with map cracking and efflorescence. The undersurface of bent # 7 cap has several delaminated areas. The left cantilever portion of bent # 7 cap has a moderate width vertical crack in the ahead face outside the bearing area. Repair to the Left end of cap has cracking with efflorescence present.

Bent # 7-Mapcracking / chloride contamination.
