Asset #03096(Routine)

State Highway 45 over Barren Fork - Wash. Co.

Location: 1.15 MI E JCT OF SH 59

Team Lead: Eric West Inspection Date: 04/20/2022

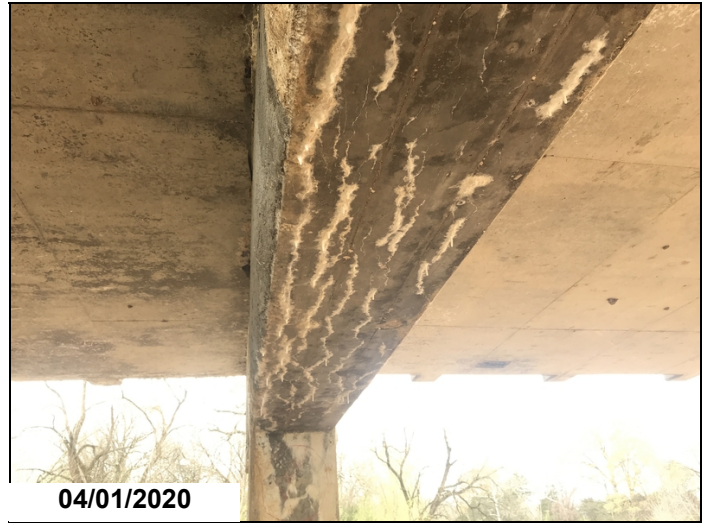
Bent 7 cap undersurface-Mapcracking with delaminated areas.
