Asset #03097(Routine, Underwater type 2)  
State Highway 45 over Fly Creek-Washington Co.  
Location: 1.95 MI E JCT OF SH 59  
Team Lead: Jeff Jones Inspection Date: 10/10/2024

(37) Historical Significance	5 - Bridge is not eligible for
CONDITION	
(58) Deck	4
(59) Superstructure	4
(60) Substructure	4
(61) Channel & Channel Protection	5

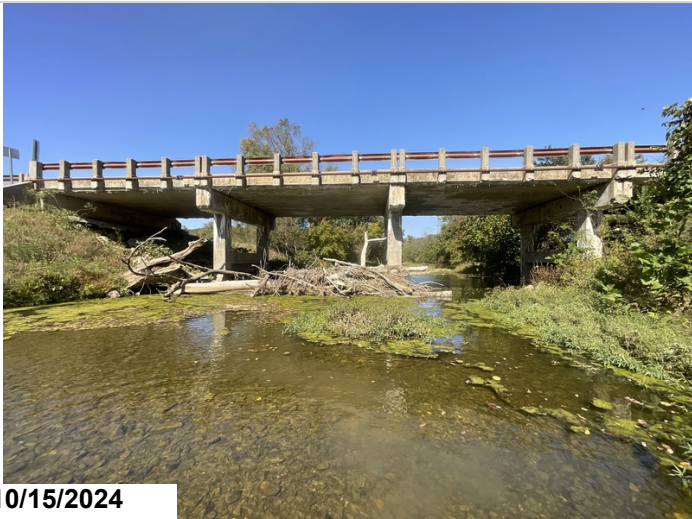
Drift accumulation under Spans 1, 2, & 3.

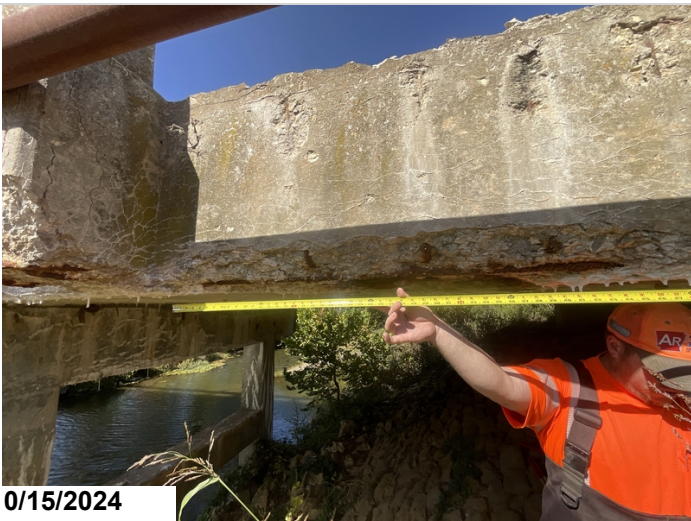
Span 4, Slab undersurface and exterior edge, Right side: 5' long spall with exposed reinforcing steel. 5SF CS3. Up to approximately 1/4" section loss

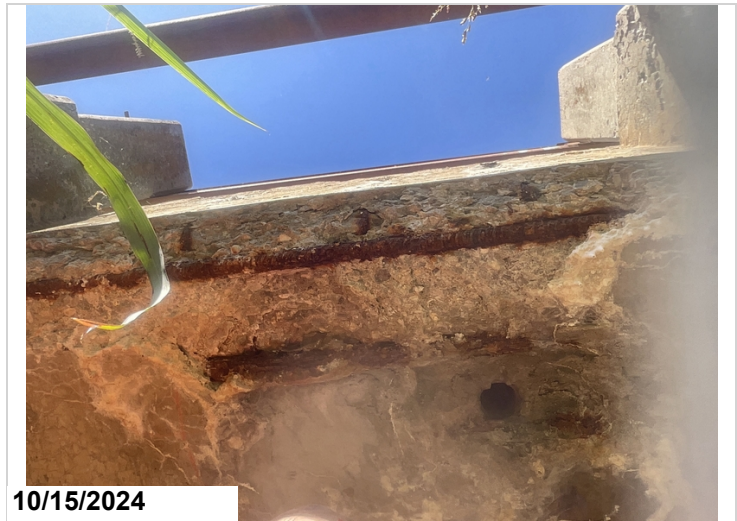
Span 4, undersurface of the slab, right side exposed reinforcing steel.

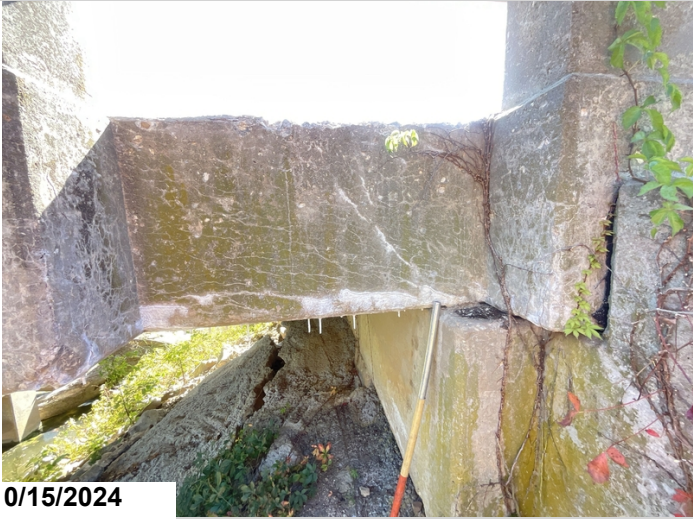
Span 1, Abutment 1, Left side: Diagonal cracks with efflorescence.

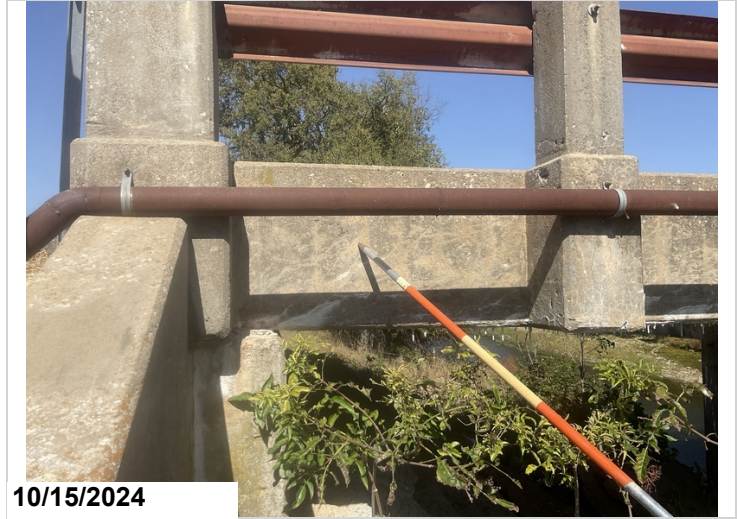
Span 1, Abutment 1, Right side: Diagonal cracks with efflorescence.

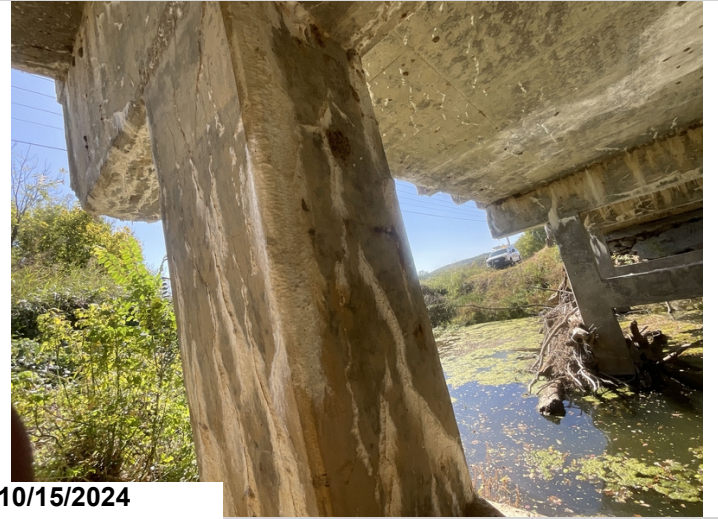
Bent 4, Right column. Spall with exposed reinforcing steel.  
1EA CS3

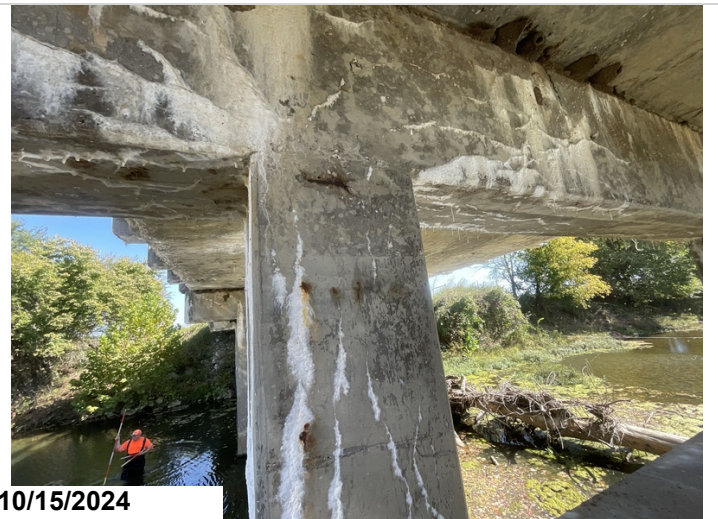
Bent 2, Left column, Back face, spall with exposed  
reinforcing steel.

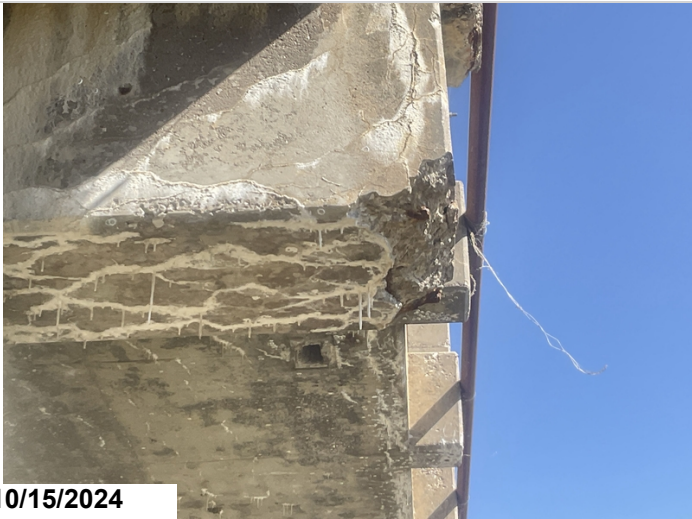
Bent 2 cap, Right end concrete deterioration with exposed reinforcing steel.

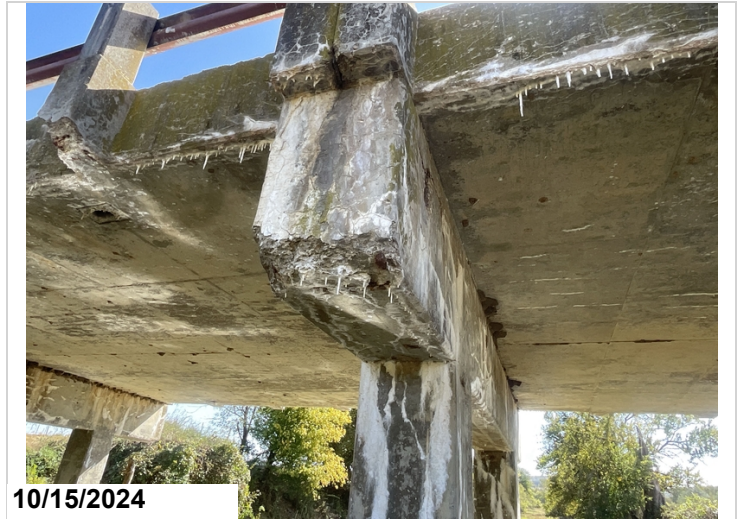
Left end of Bent 2 cap. Concrete deterioration with exposed reinforcing steel.

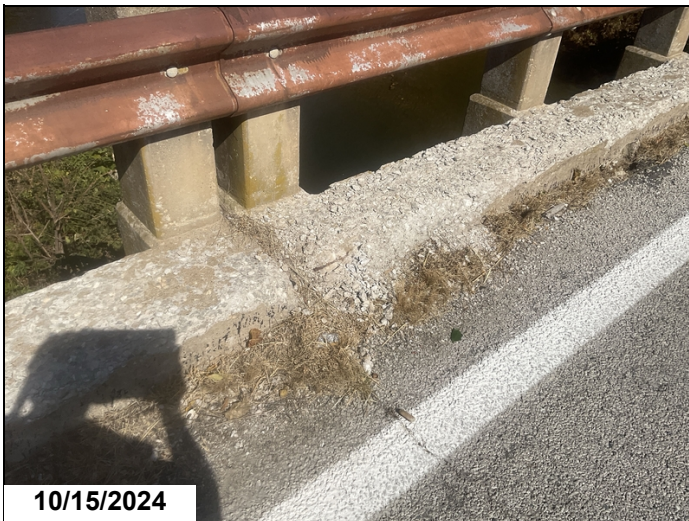
The deck has soft and deteriorated concrete with delaminated areas in the gutters on the left and right sides of structure. The concrete curbs have areas that are soft and deteriorated with heavy scaling. Span 4 right has a large spalled area with exposed reinforcing steel that has initial section loss.

Span 1 curb, Left side: Rotten deteriorated concrete.

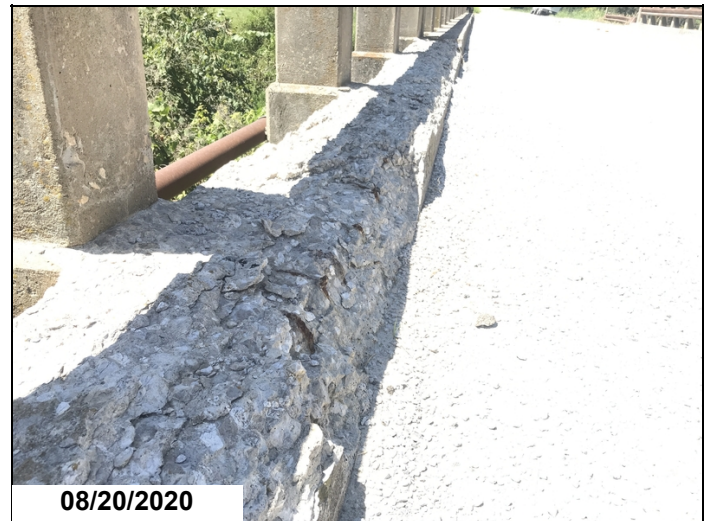
Span 4, right curb-Concrete deterioration.

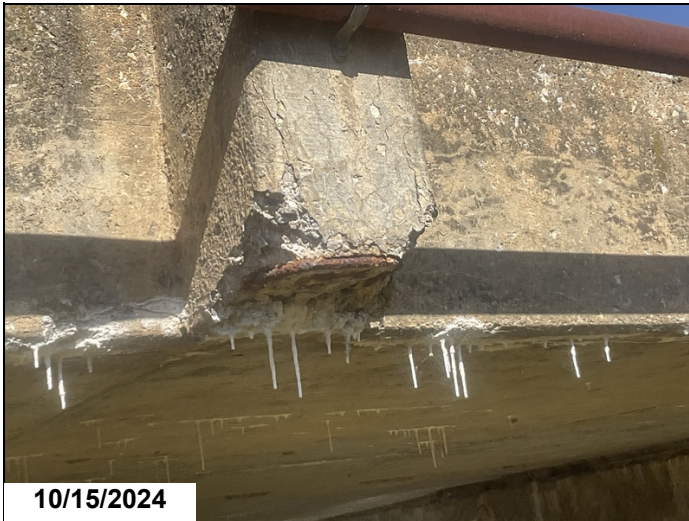
Several posts on both sides of the structure have soft and deteriorated concrete with areas of map cracking with deterioration that exposes reinforcing steel.

Span 1, Right bridge rail post: Soft deteriorated concrete with exposed reinforcing steel.

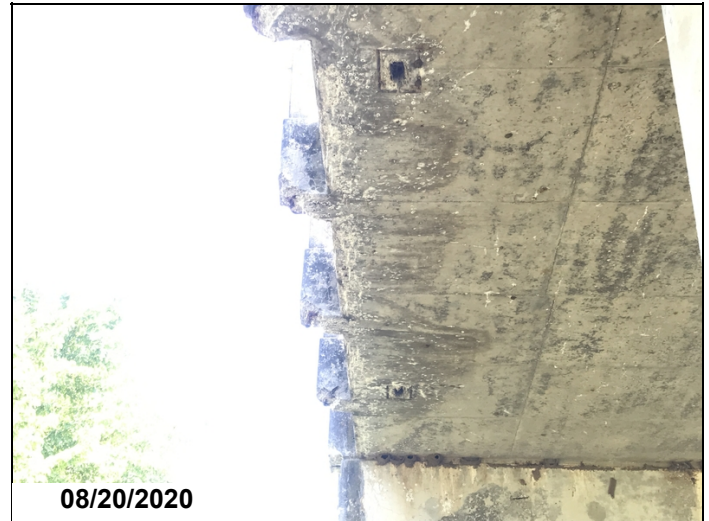
Span 2, left side-Spalling with exposed reinforcing steel to base of bridge railing posts.

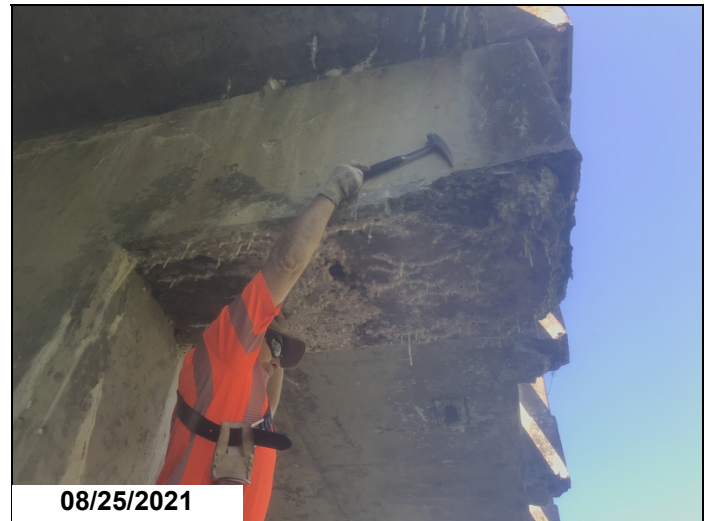
Bent 4 cap-Delaminated areas in left side of ahead face.

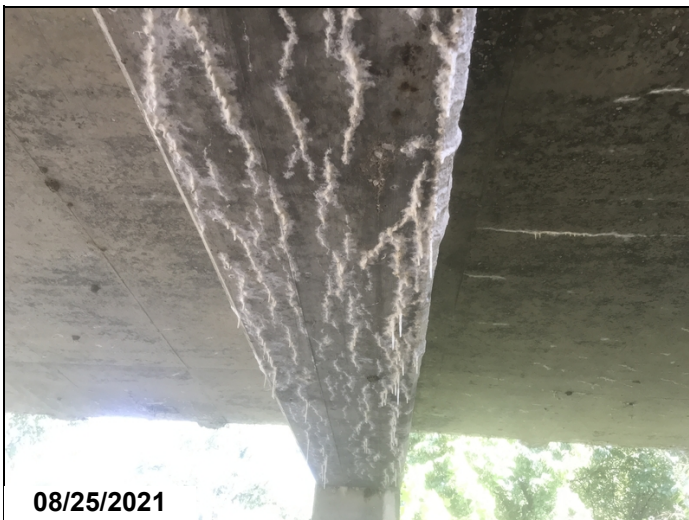
The intermediate bents have heavy map cracking with concrete deterioration and efflorescence throughout. The ends of the intermediate caps have concrete section loss with exposed reinforcing steel and delaminated areas in some locations. Bent 4 is the most extreme case with heavy cracking with efflorescence, delaminated areas, and concrete deterioration that exposes reinforcing steel in the ends of the cap.

Undersurface of bent 4 cap-Concrete deterioration with heavy mapcracking.

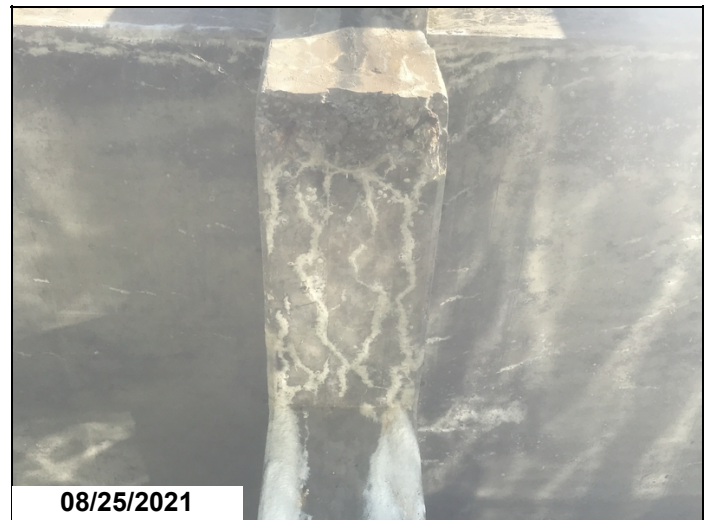
Bent 2 cap, right side-Spalling, concrete deterioration with mapcracking.

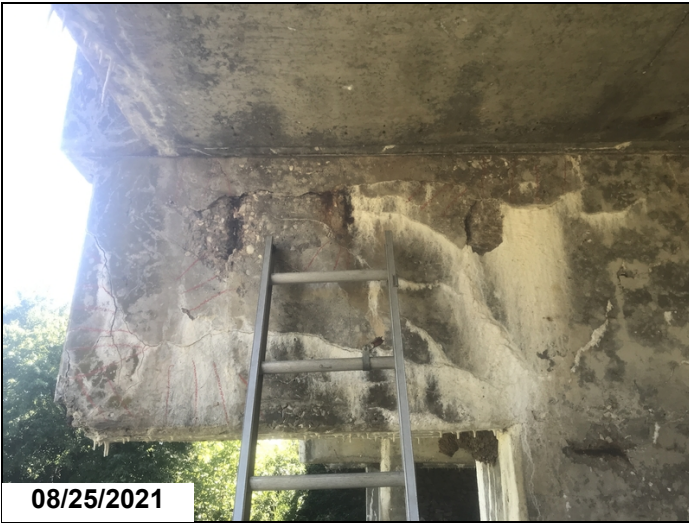
Bent 2 cap, left side-Delaminated areas in backface.

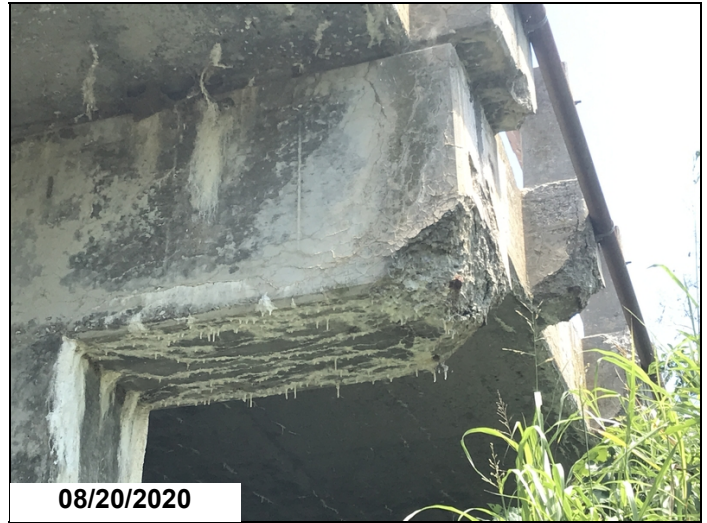
Bent 4 cap, right side-Concrete deterioration / spalling  
with exposed reinforcing steel.

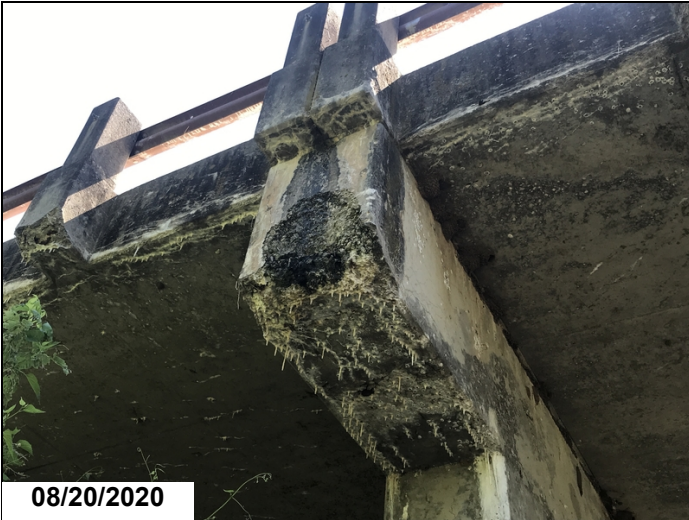
Bent 4 cap, left side-Concrete deterioration / spalling.

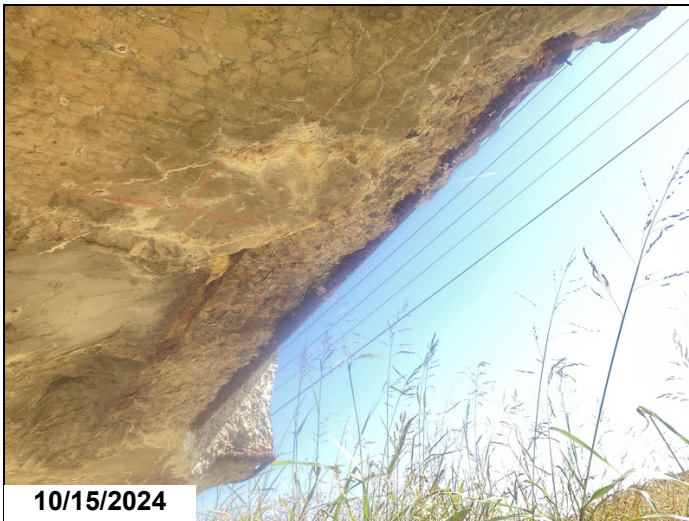
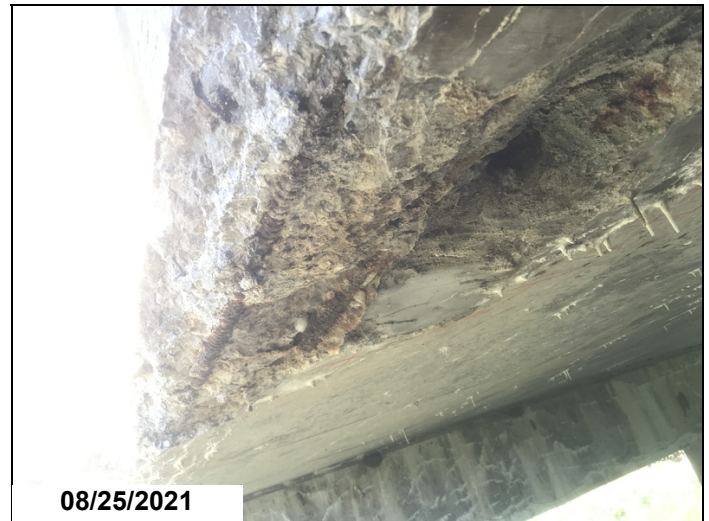
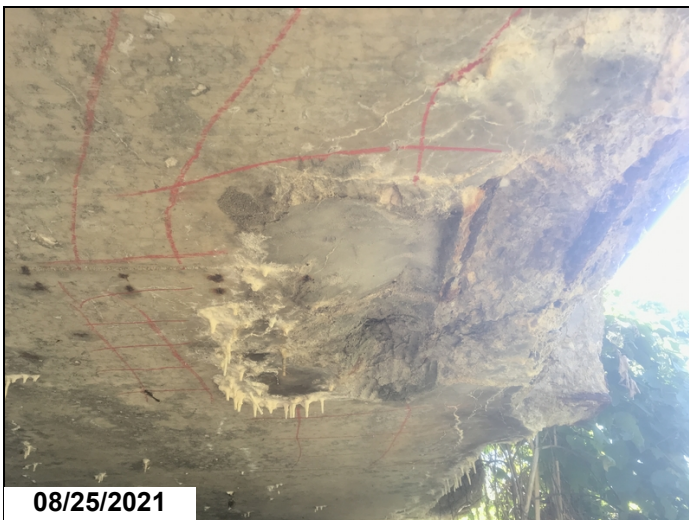
The undersurface of all spans have map cracking with light to heavy efflorescence with delaminated areas along the edges. Span 4 is the worst case during this inspection with soft deteriorated concrete with exposed reinforcing steel visible in the right edge. The area of concrete deterioration adjacent to the deck drain has exposed reinforcing steel with large delaminated areas.

Span 4, right side-Spalling with exposed reinforcing steel and delaminated areas areas.5 SF CS3.

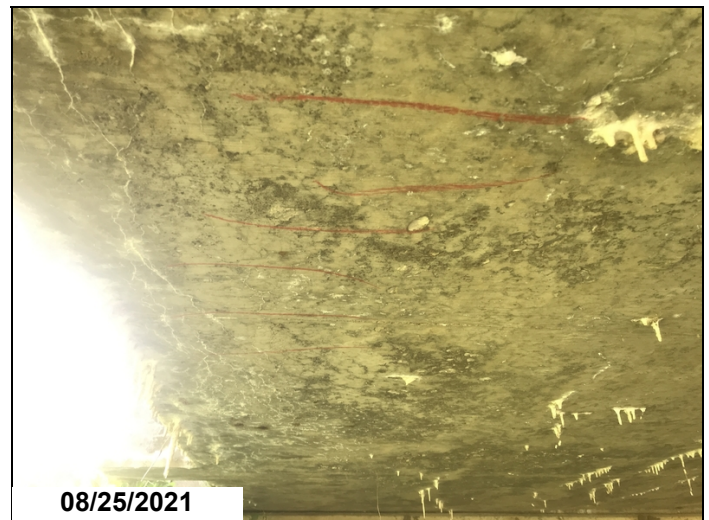
Span 4, left side-Delaminated areas in slab undersurface.

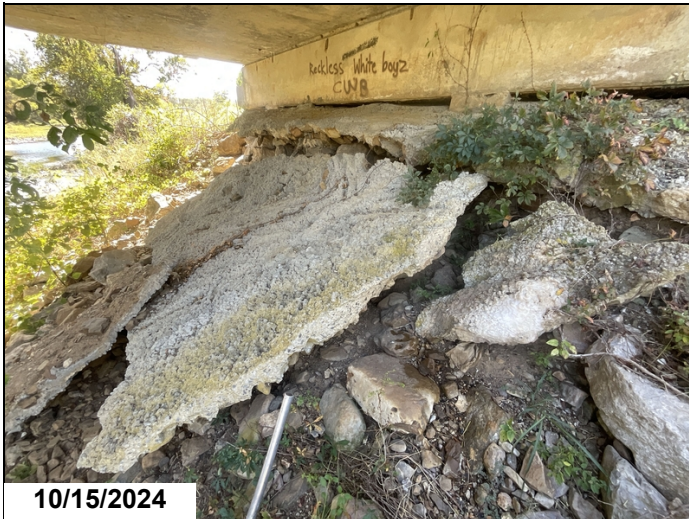
Abutment 1, The dumped rip rap and grouted riprap has displacement and settlement during the time of inspection.

Abutment 1, settlement of grouted riprap.

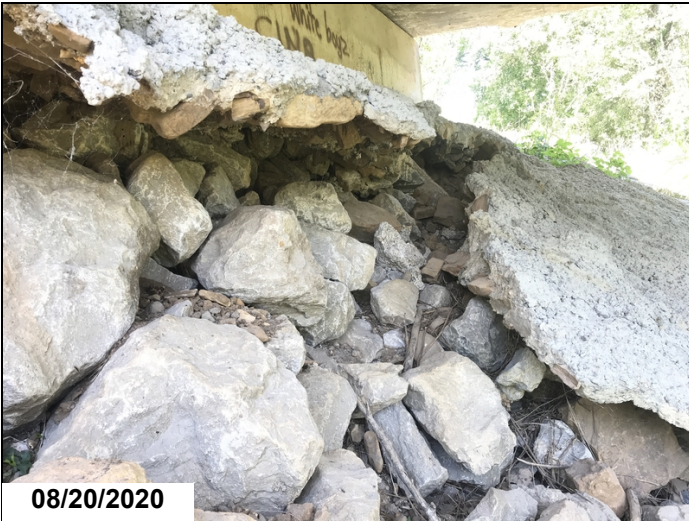
The grouted rip rap adjacent to abutment 1 has fractured and settled with a large portion of the rip rap wedged against column 1 of bent 2. The grouted rip rap still in place is undermined.

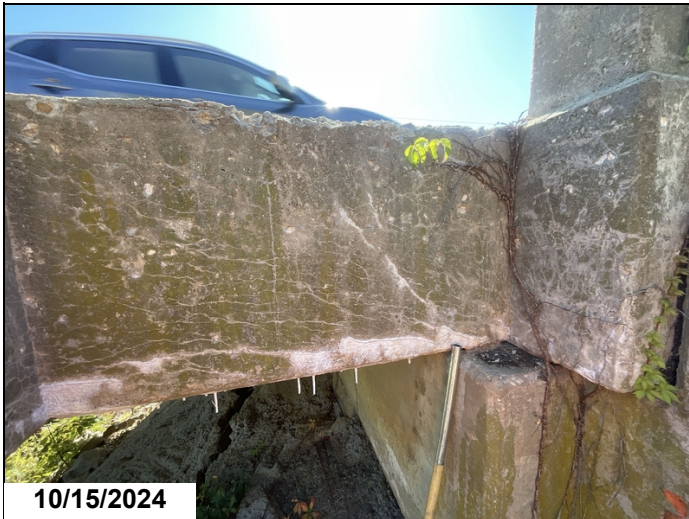
Span 1 has a shear type crack adjacent to abutment 1.

Span 1, Abutment 1, Left side: Shear type crack.

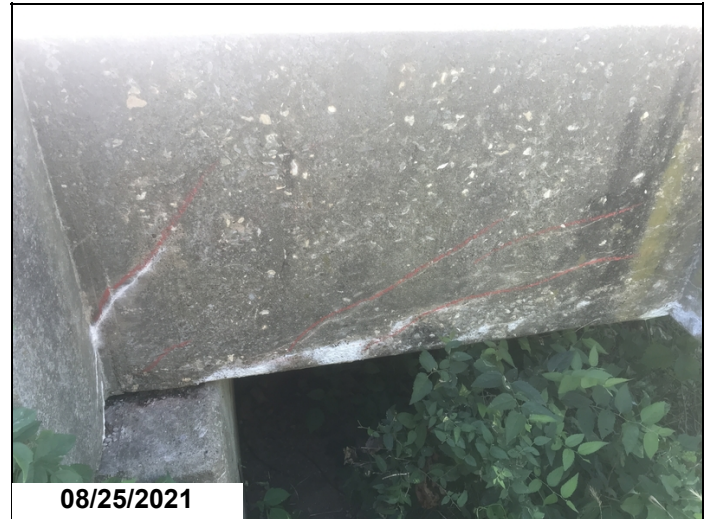
The left and right sides of Span 4 have a shear type crack adjacent to abutment 2.

Span 4, left side-Shear type cracks.

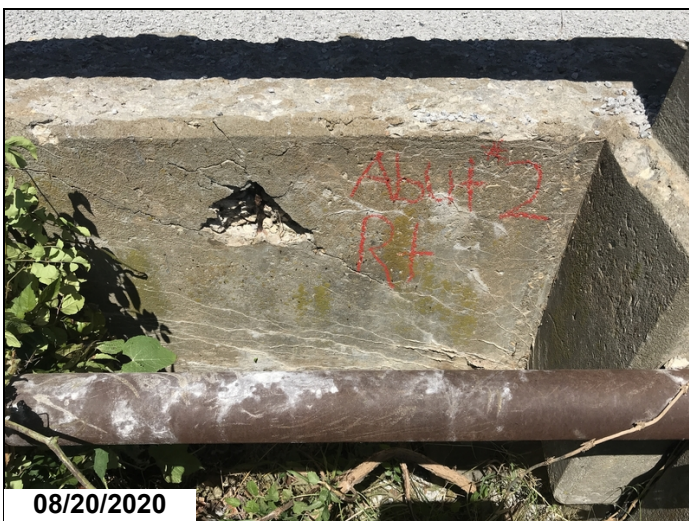
Abutment 2, right side-Shear type crack.
