Asset #A6237 (Routine, Underwater type 2)
I-49 Southbound over Ravine-Washington Co.

Location: 11.4 MI N. OF WASH.CO.LN

Team Lead: Eric West, Inspection Date: 12/12/2022

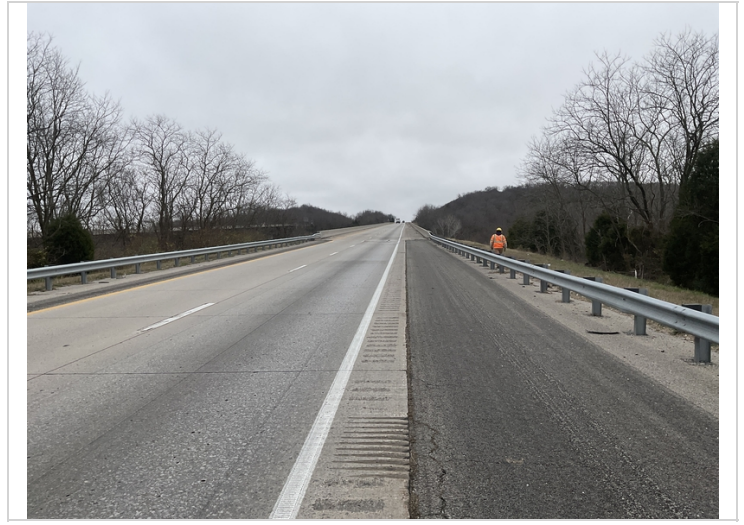
Driving surface of the deck. Typical.

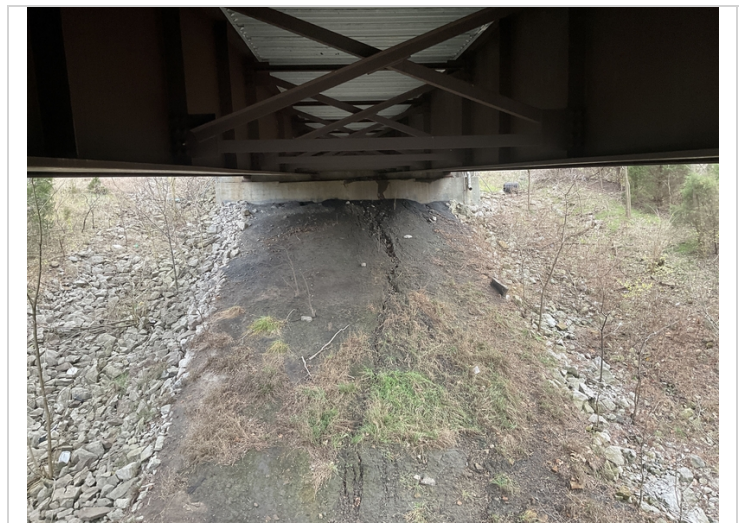
Abutment #1 typical.

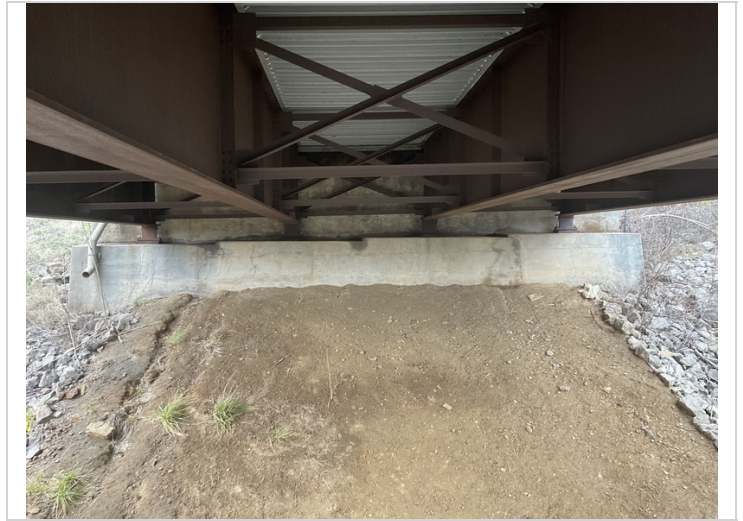
Abutment #2 typical.

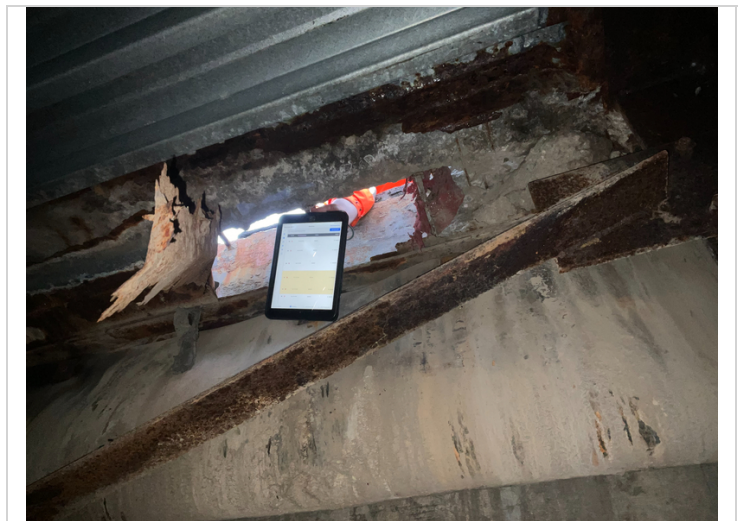
Abutment # 1 rubberized expansion dam.

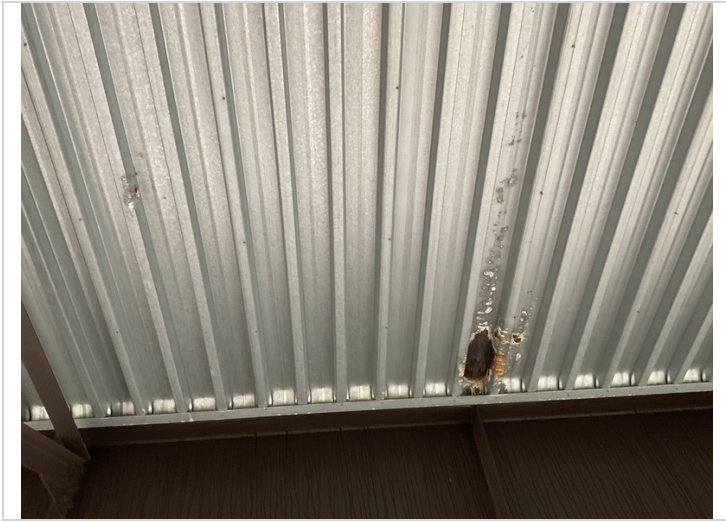
Span #3 bay #1 active corrosion in the stay in place forms.

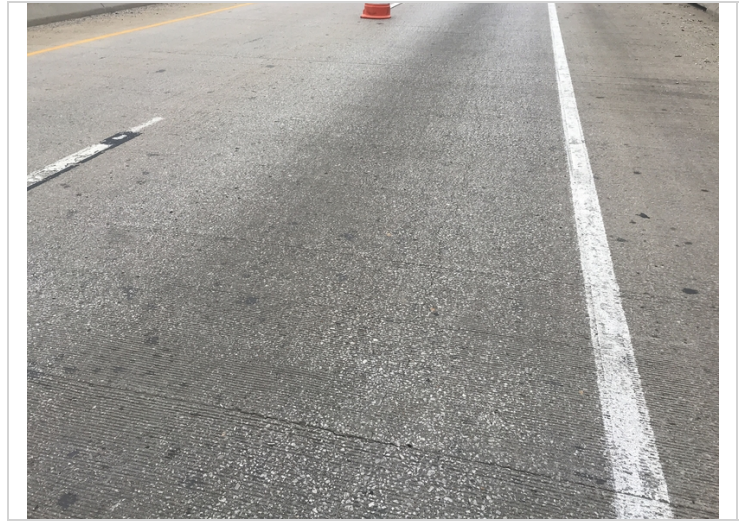
Sealable longitudinal cracking in driving surface of span 6.

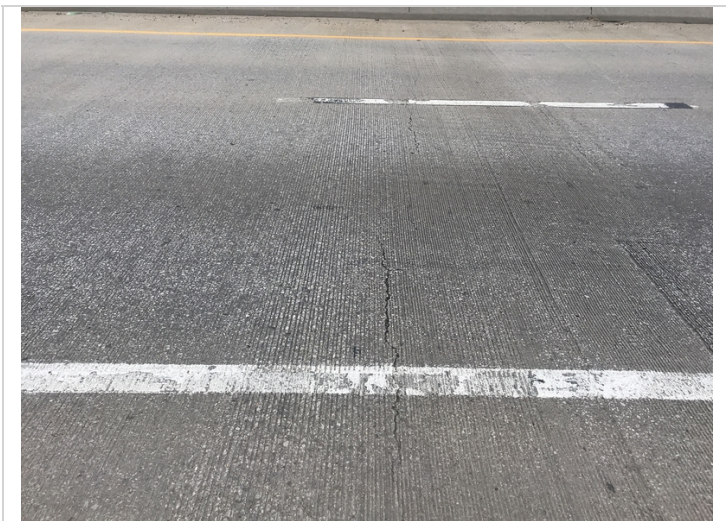
Wide transverse cracking in the driving surface of span 3.

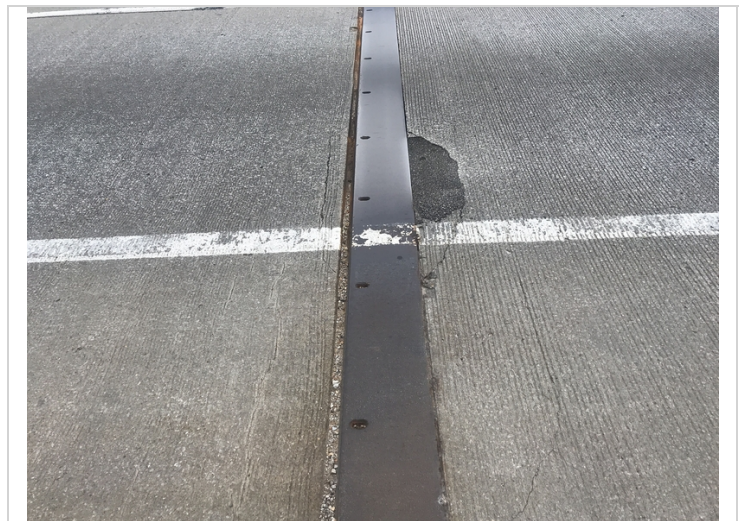
Expansion joint over Bent 3. Circular cracking adjacent to joint.

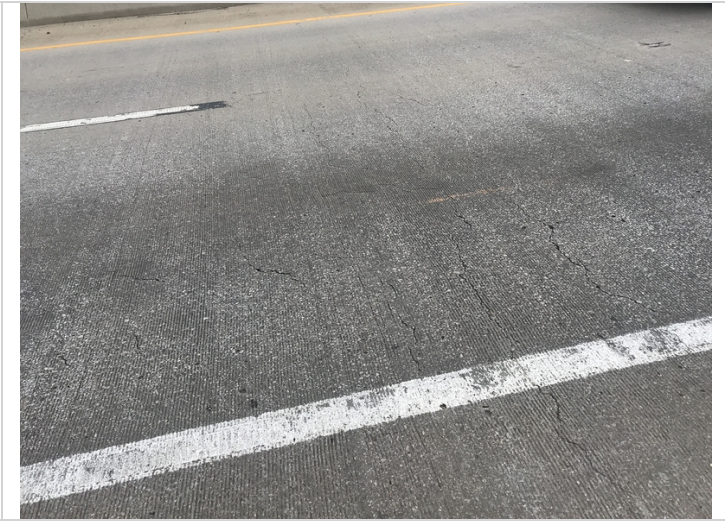
Span 1. Wide transverse and longitudinal cracks.

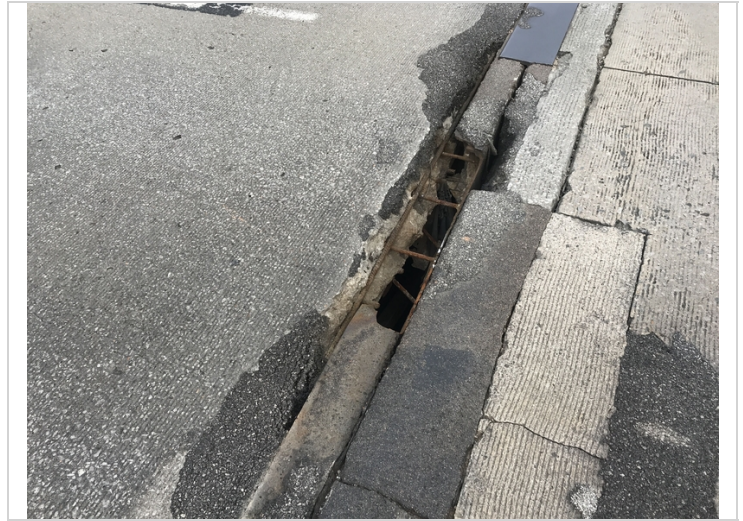
Spalling with exposed reinforcing steel adjacent to the south abutment.

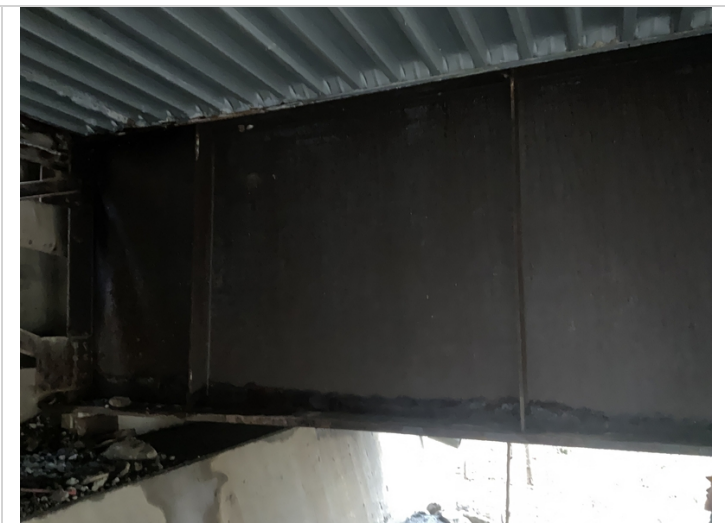
Span #1 girder #2 active corrosion with pack rust along the base of the web.

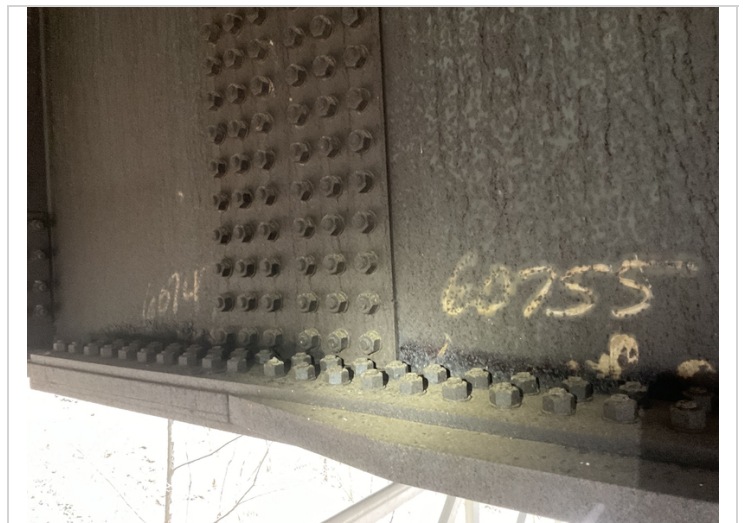
Span #1 girder #2 active corrosion with pack rust along the base of the web.

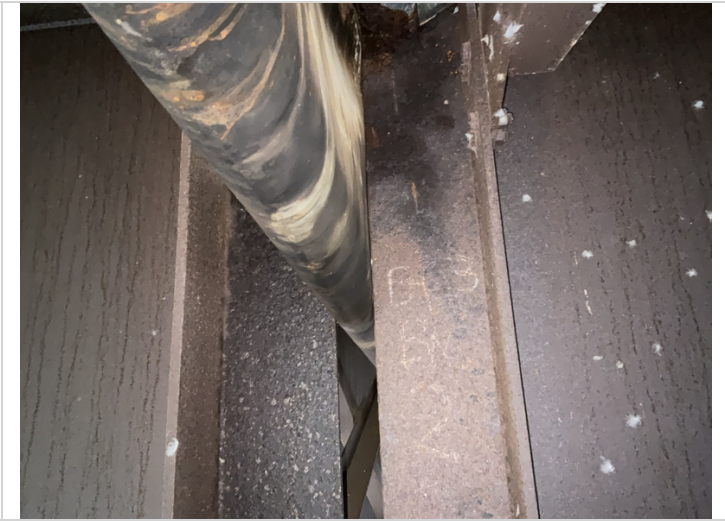
Bent #3 beam #2 active corrosion with flaking rust at the top of the web.

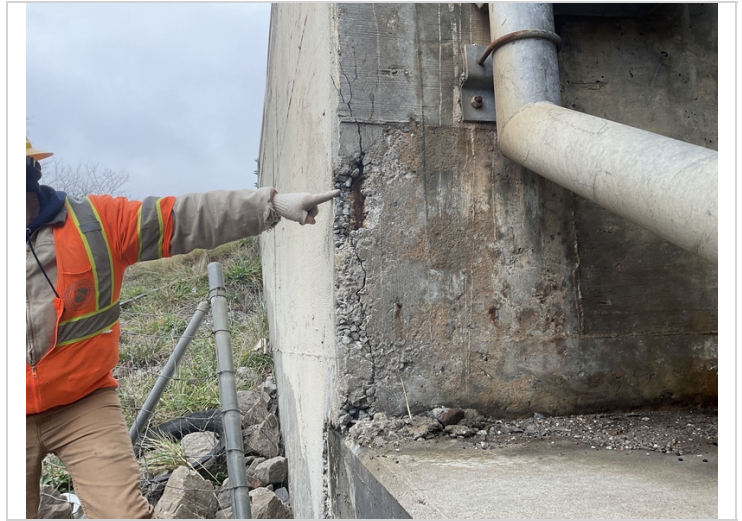
Abutment #2 Lt spalling with exposed reinforcing steel.

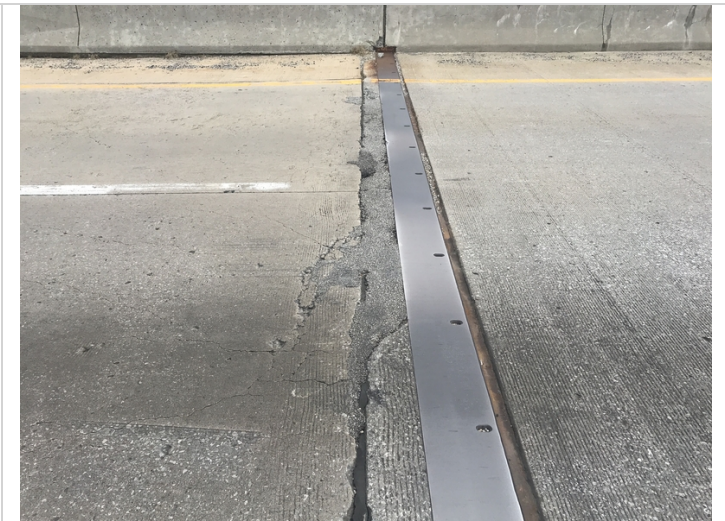
Abutment 2. Top of backwall. Spalling with temporary asphalt repairs.

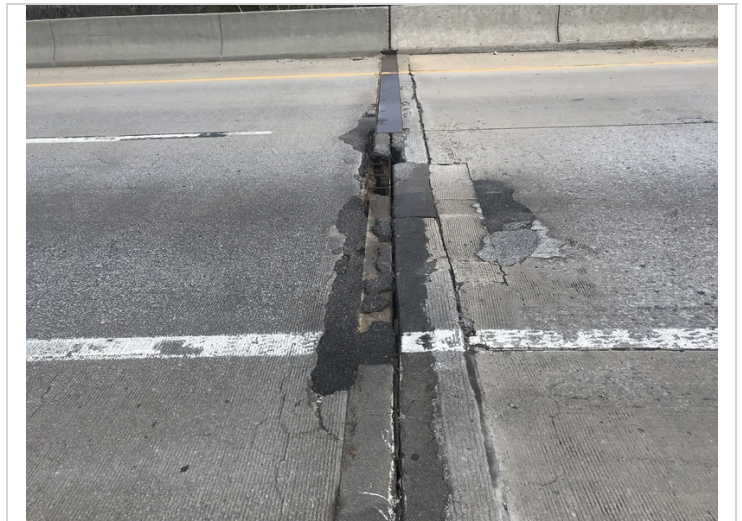
Bent 1. Top of backwall. Failing repairs.

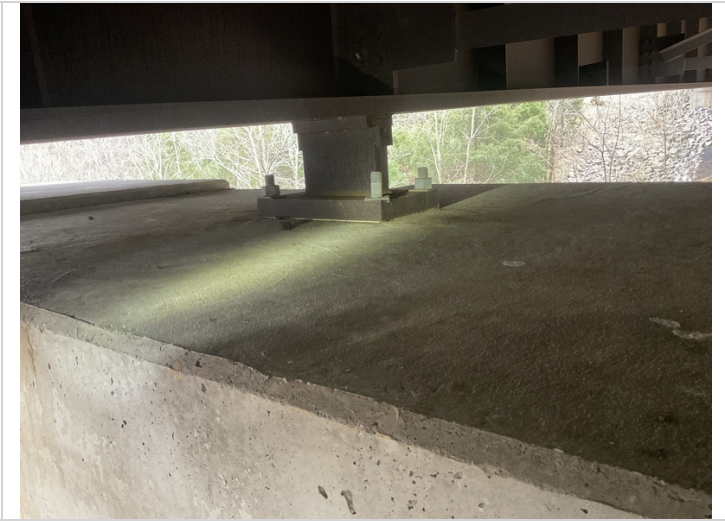
Bent #2 missing anchor bolt nuts.

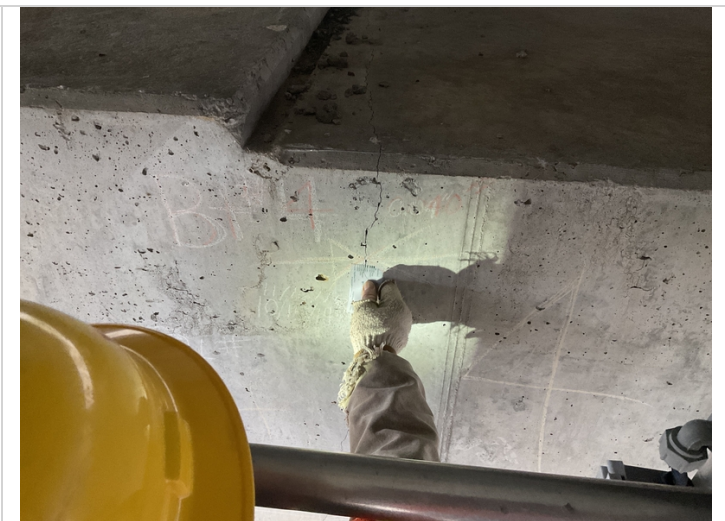
Bent #4 cap cracking.

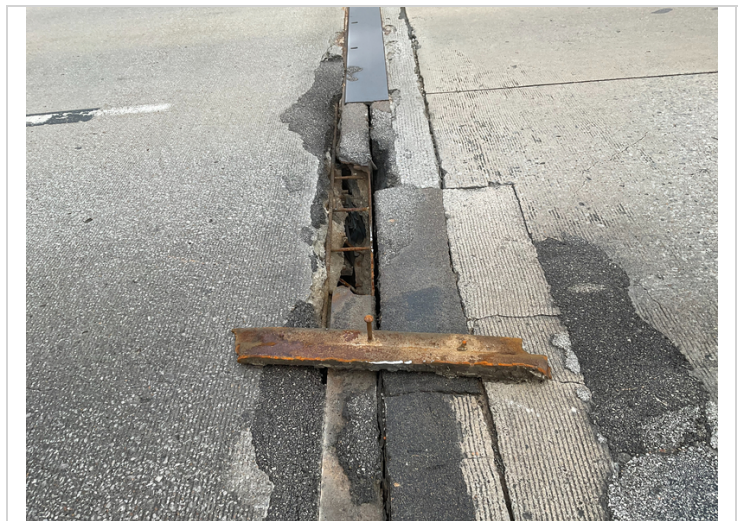
Abutment # 1 section of the road iron fractured.

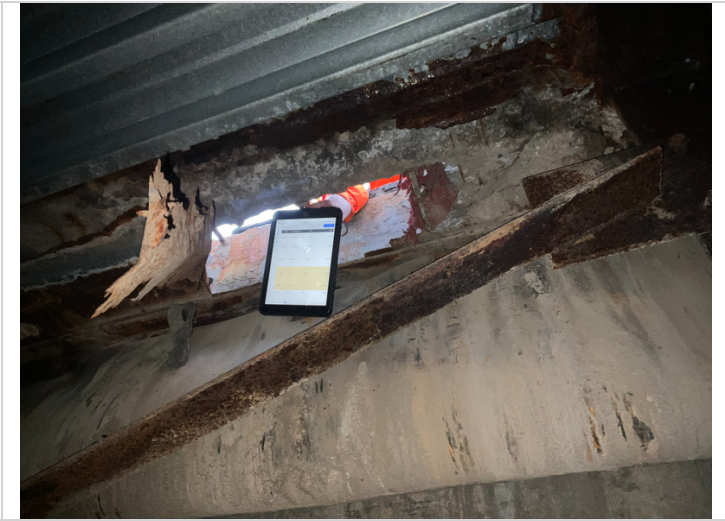
Abutment # 1 rubbelized expansion dam.

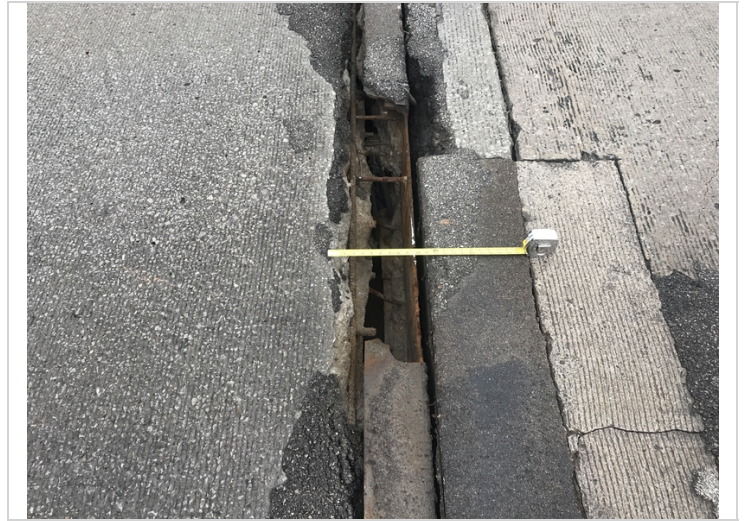
The expansion joint anchorage at bent 1 has fractured and is no longer supported by the deck for several feet.

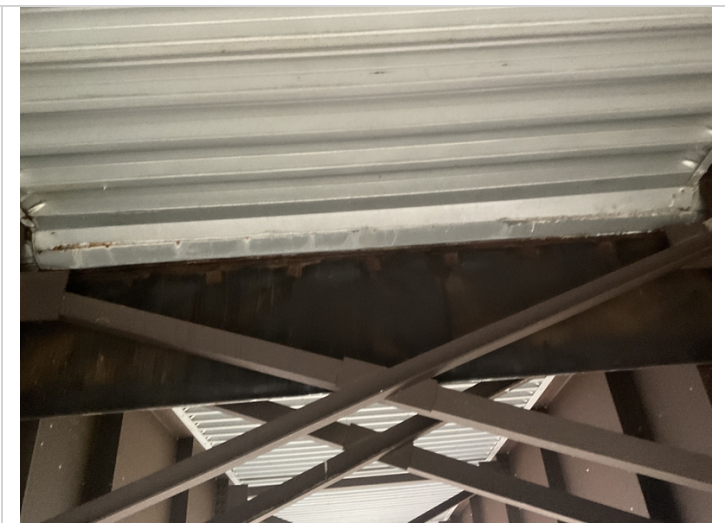
Bent #3 expansion dam with active corrosion and flaking rust.

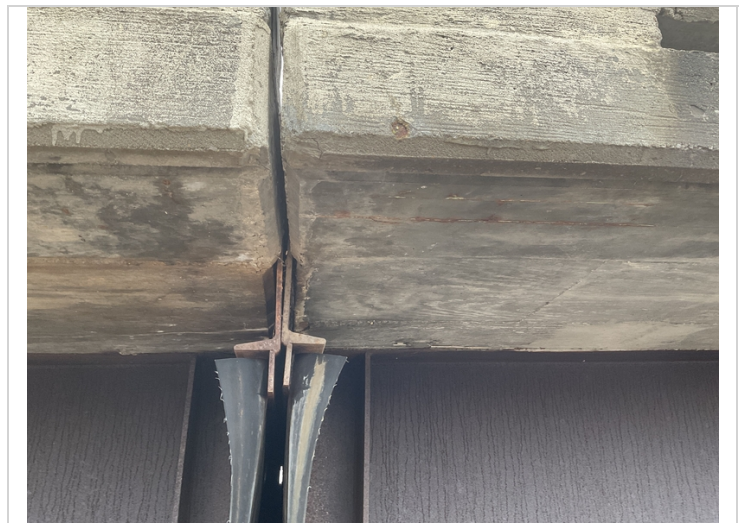
Bent #3 Lt expansion joint jammed together and touching.

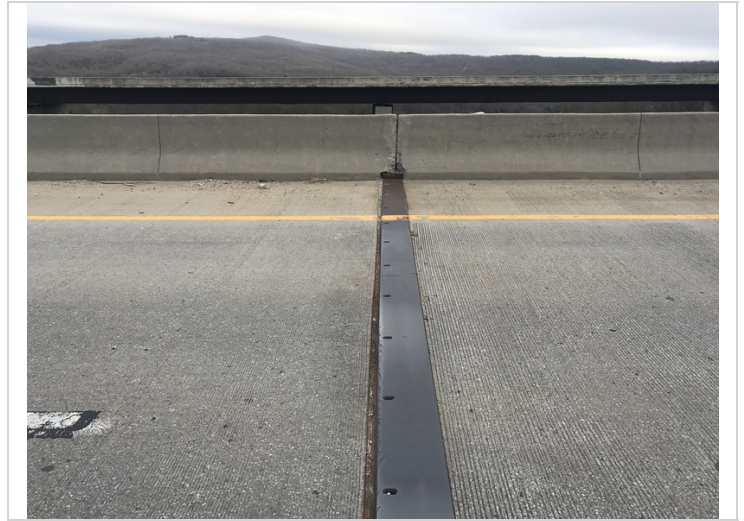
Bent 3. Right side of expansion joint is closed.

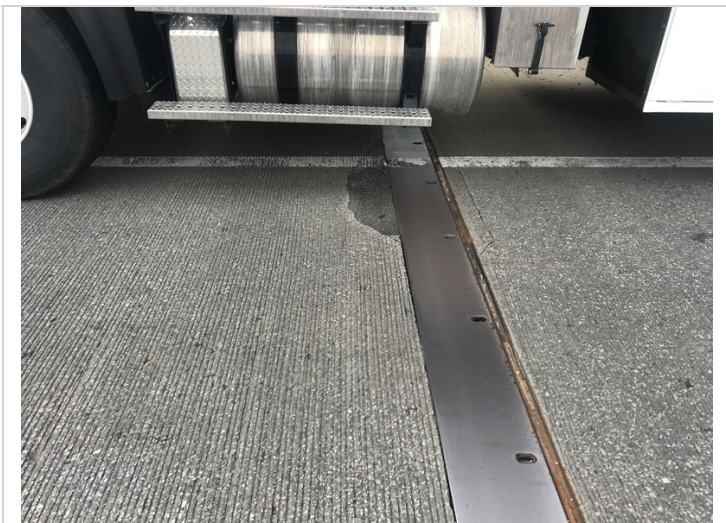
Bent 3. Circular cracking with spalling adjacent to the expansion joint assembly.

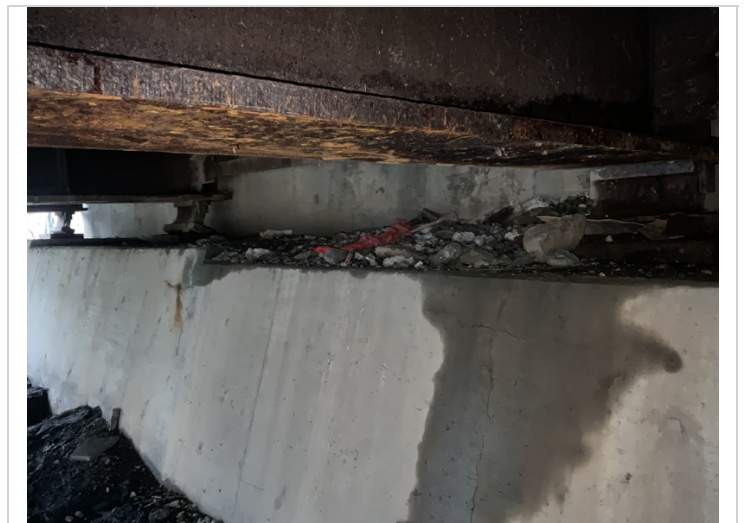
Abutment #1 bearings fully expanded.

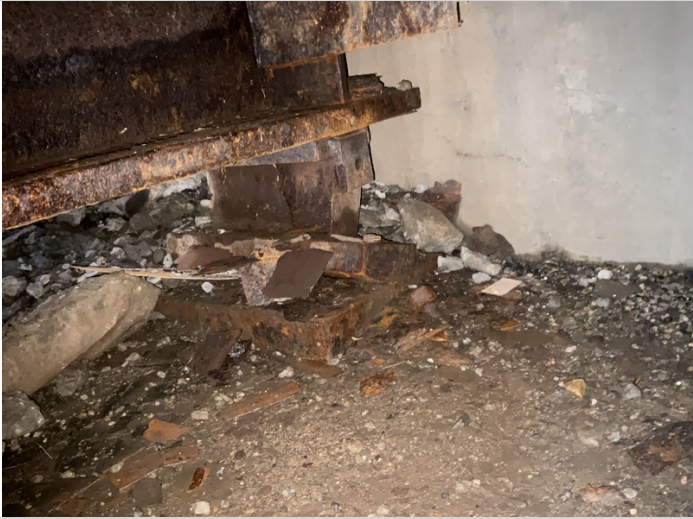
Abutment #1 bearing #2 missing anchor bolt.

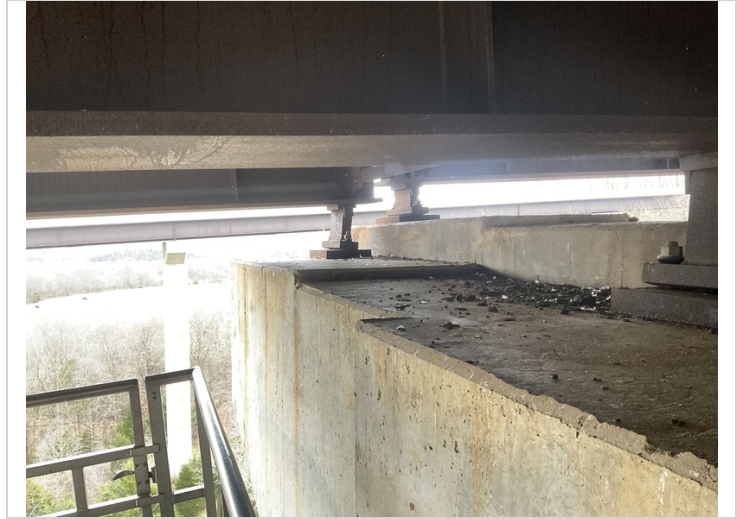
Bent #3 bearing #4 active corrosion with flaking rust.

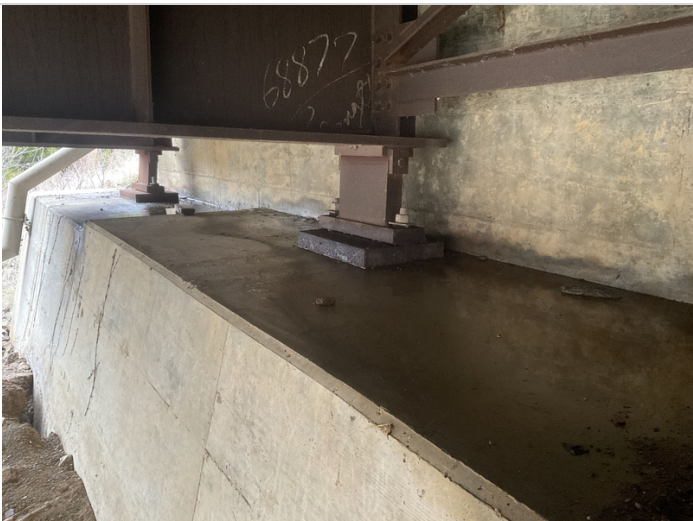
Abutment #2 active corrosion with pack rust.

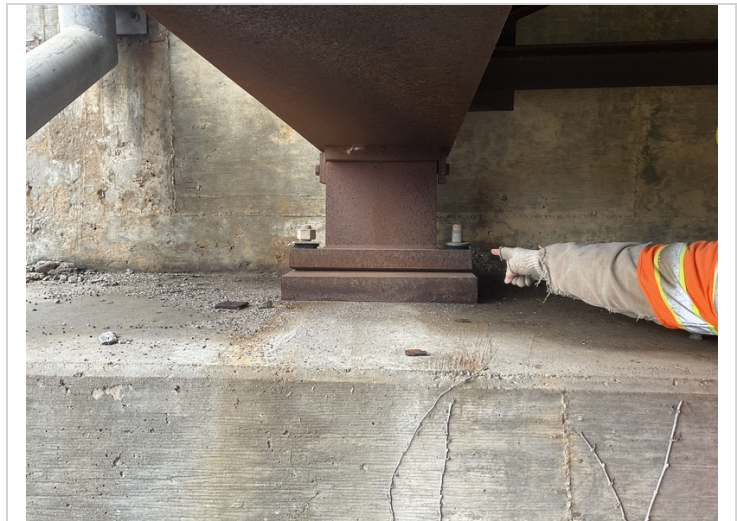
Abutment #2 girder #1 missing anchor bolt nut.

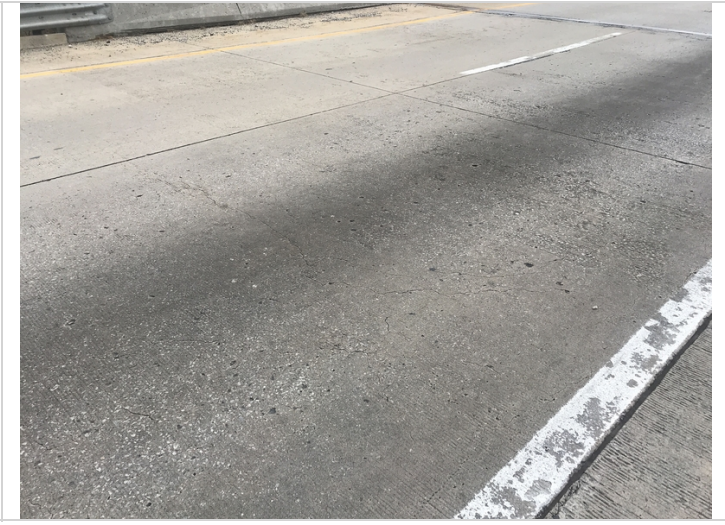
North approach slab. Sealable map cracking.

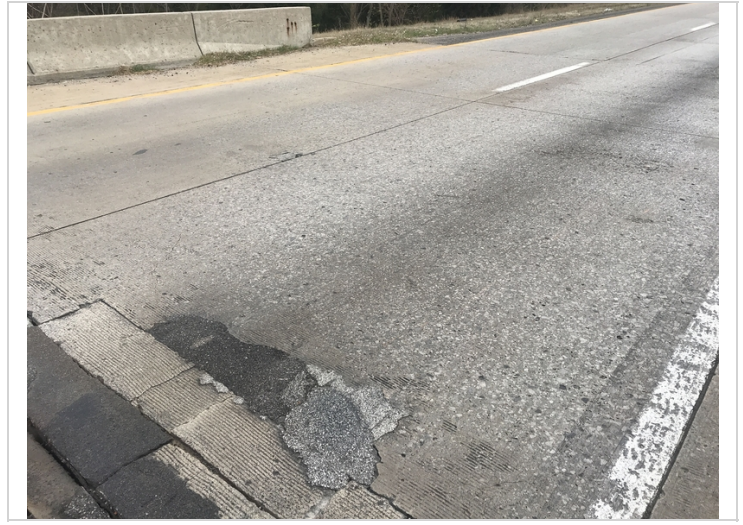
South approach slab. Temporary asphalt repairs.

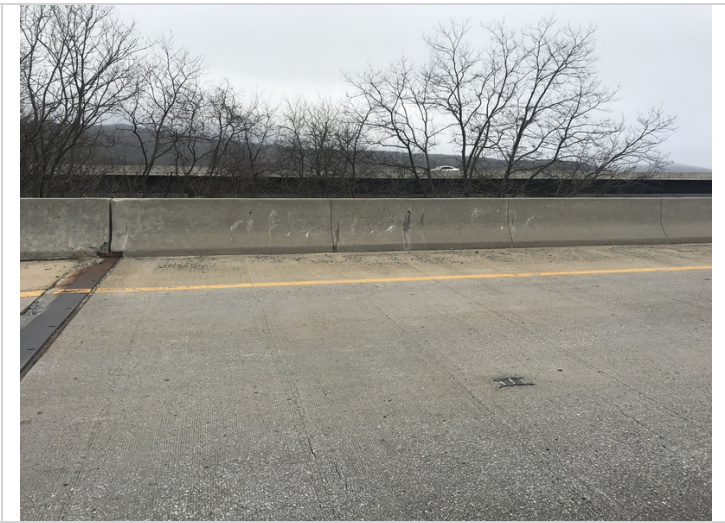
Right parapet. Map cracking with efflorescence adjacent to the north abutment.

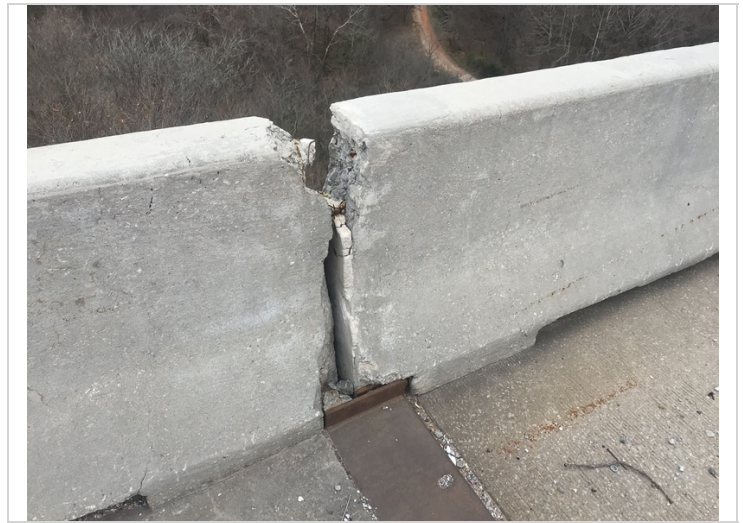
Spans 2 & 3. Spalling with exposed reinforcing in the left parapet over bent 3.

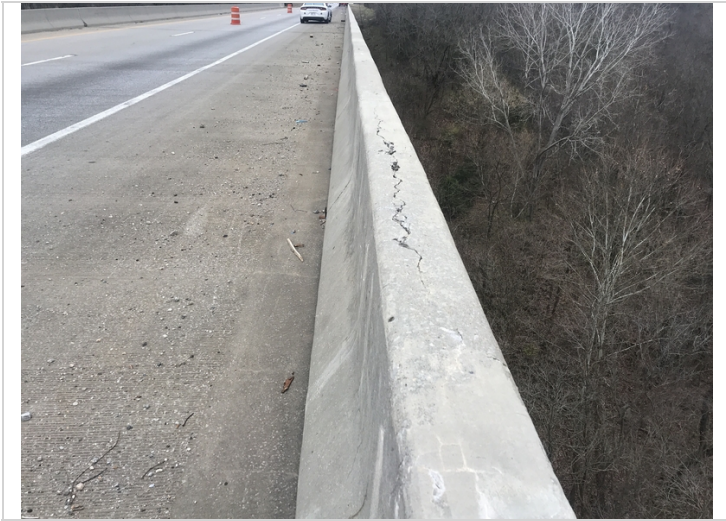
Wide longitudinal cracking in the top of the left parapet.
Span 3.

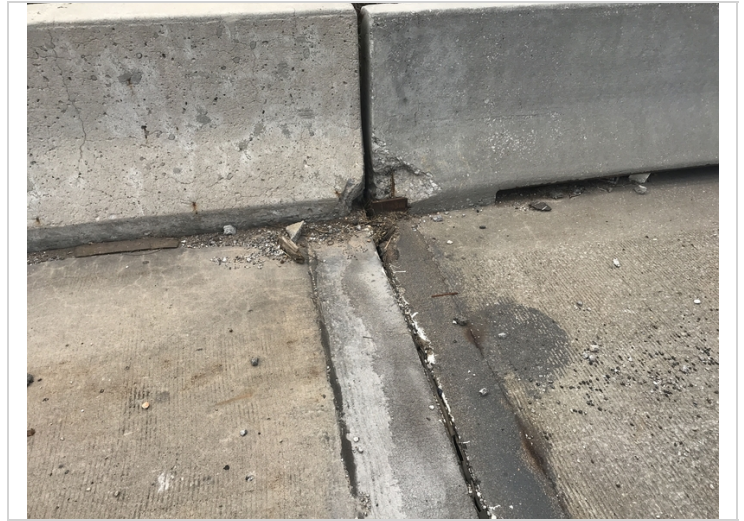
Spall with exposed reinforcing steel in the left parapet over
bent 1.

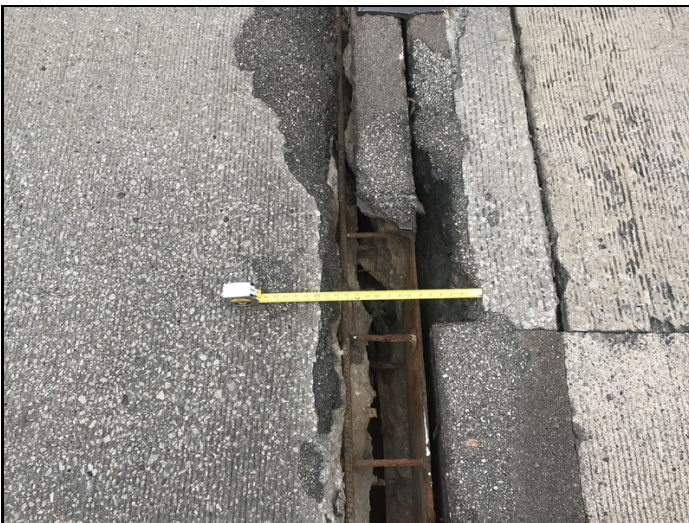
There is a full depth failure at the south end of span 1 in the left lane adjacent to the south abutment. The expansion joint anchorage in the left lane at abutment 1 has fractured and is no longer supported by the adjacent deck, approximately 3' section of the road iron is missing. There is an approximately 16" gap from the concrete on the deck to the concrete in the abutment backwall.

There is a full depth failure at the south end of span 1 in the left lane adjacent to the south abutment. The expansion joint anchorage in the left lane at abutment 1 has fractured and is no longer supported by the adjacent deck. There is an approximately 16" gap from the concrete on the deck to the concrete in the backwall.

12/12/2022 - EJW - Marcus Rainwater notified at approximately 4:15pm on this date, lane closure left in place until repairs are completed.

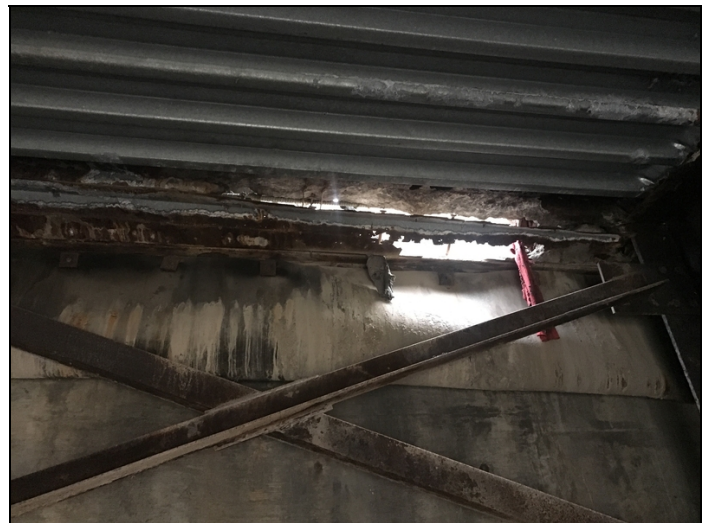
Undersurface of the full depth failure in span 1. Bay 2.

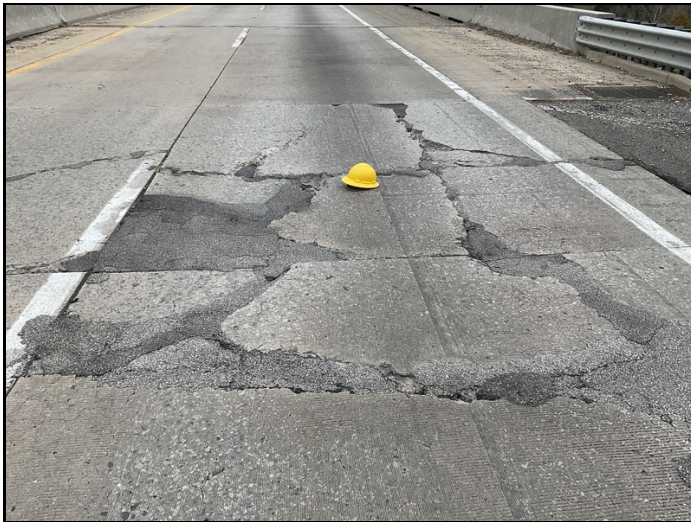
North approach roadway concrete breaking apart and settlement.

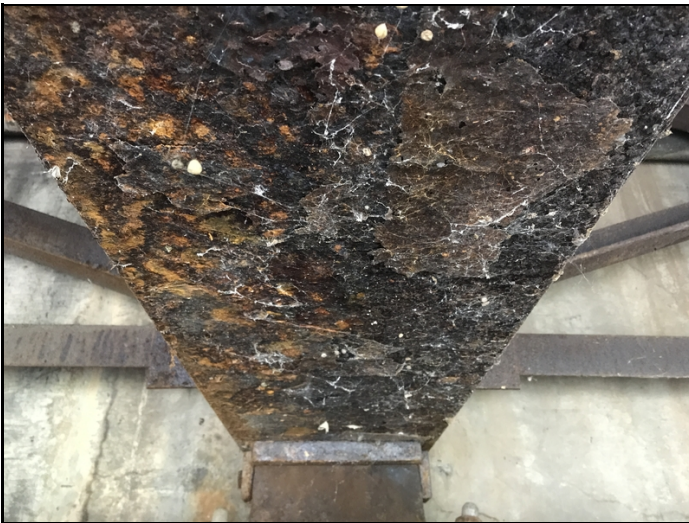
The ends of the girders at Bents # 1, 3, & 7 are weathering abnormally and have layers of flaking rust forming. Span # 1, girder # 2 at bent # 1 appears to be the most extreme case which has corrosion with flaking rust to base of web and bottom flange with up to approximately 1/16" section loss to base of web. The bearings have corrosion with flaking rust in some locations. Leaking expansion joint seals appear to be discharging water on the ends of the the girders and bearings.

Span 1, girder 2 at bent # 1-Corrosion with flaking rust to bottom flange undersurface.

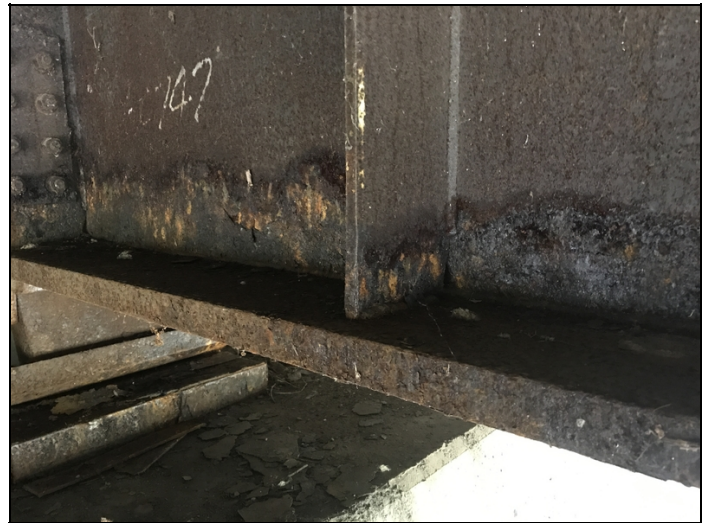
Span 1, girder # 2 at bent # 1-Corrosion with flaking rust.

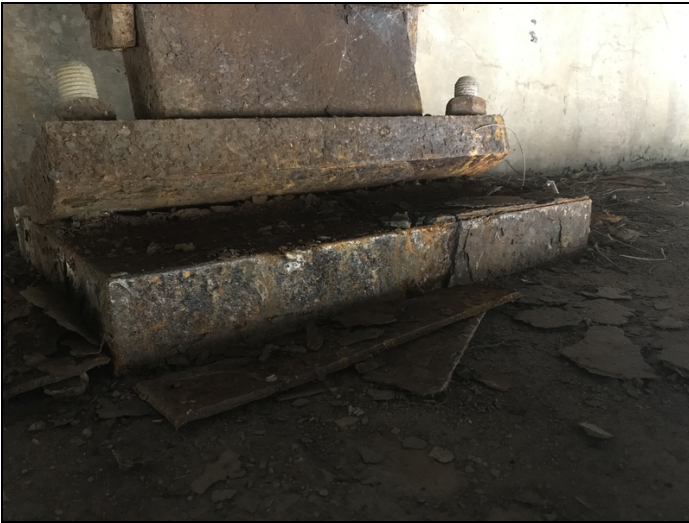
Abutment 1-Bearing 2-Corrosion.

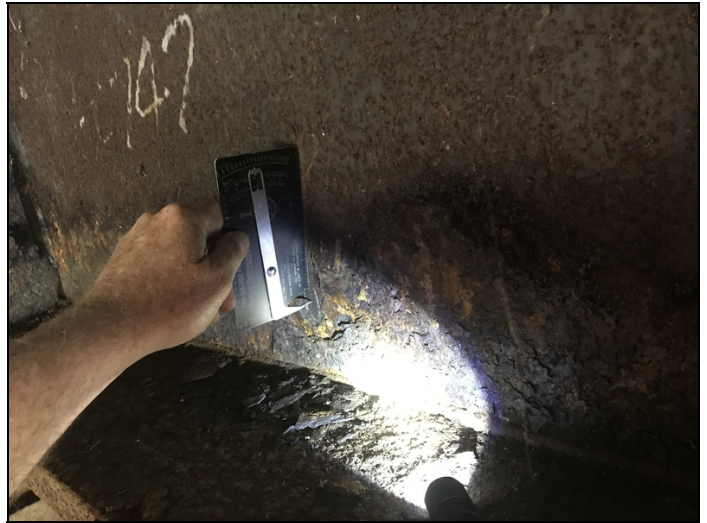
Span # 1, girder # 2 at bent # 1 has corrosion with flaking rust to base of web and bottom flange with up to approximately 1/16" section loss to base of web.

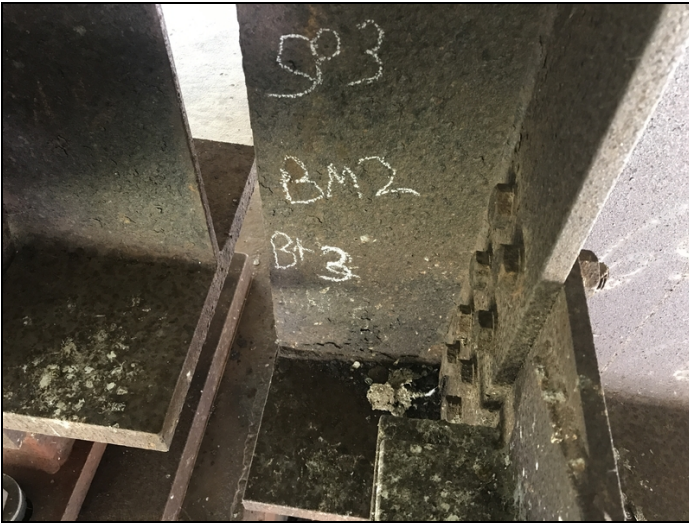
Span 2, Girder 2 at bent 3-Corrosion with flaking rust.

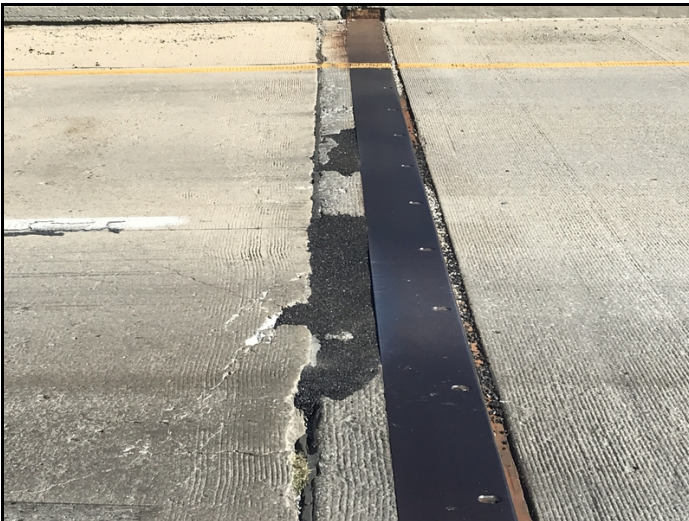
There is spalling with delaminated areas in the top of the back walls of the both abutments. Abutment # 2 backwall has a 5' long spall in the outside lane and a 10' spall in the inside lane.

Abutment 2-Spalling in backwall with asphalt patches.

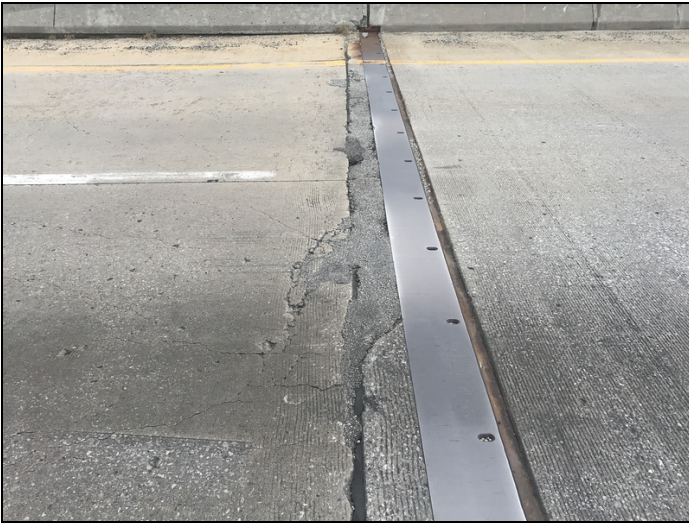
Spalls in the top of the backwall. Abutment 2.

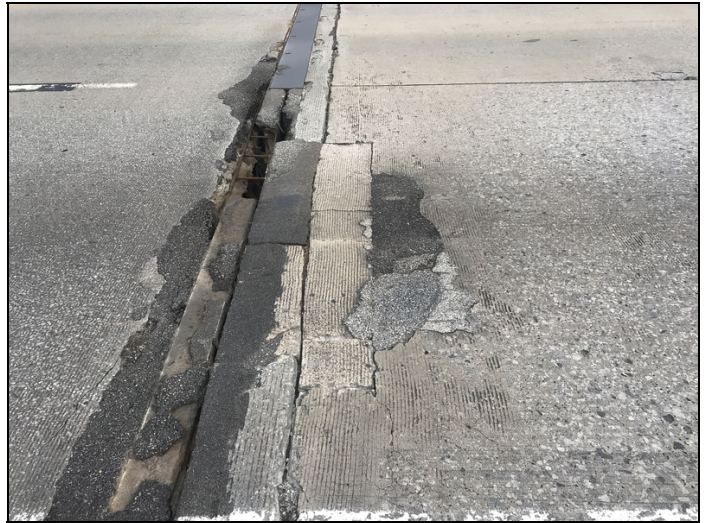
The South approach slab has spalled areas adjacent to deteriorated repairs with temporary asphalt patches.

South approach slab. Deteriorating repairs.

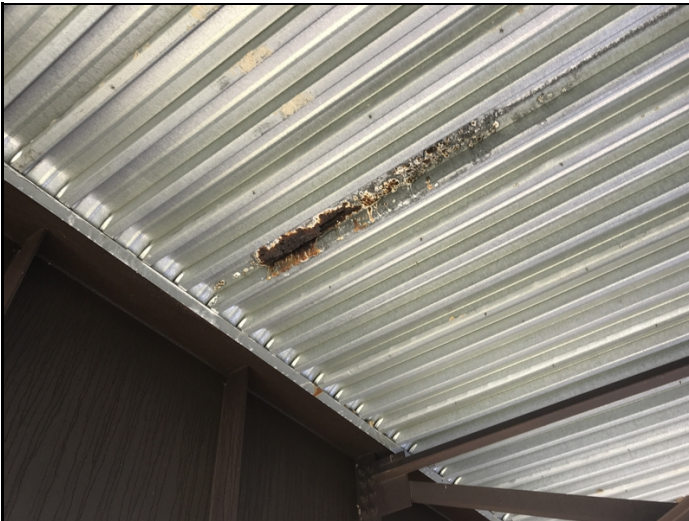
Span 2, bay 3-Corrosion in SIP forms.

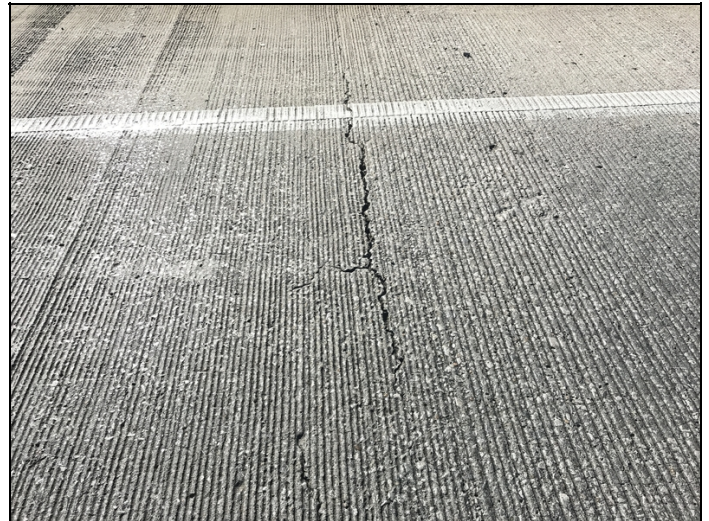
Span 3, left lane-Wide transverse cracking.

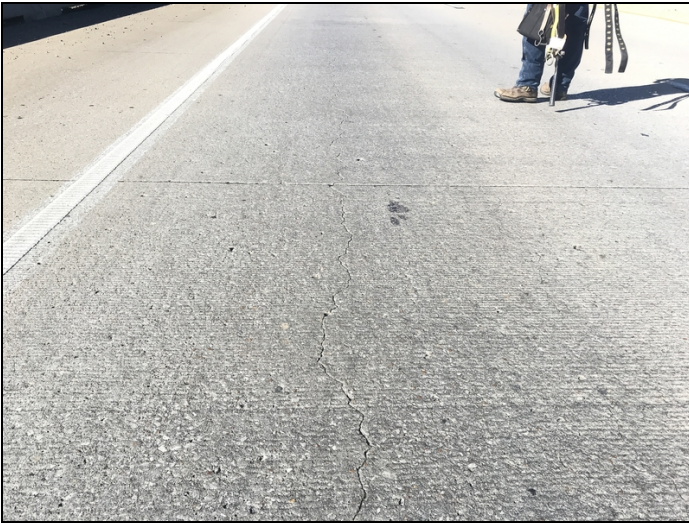
Span 4, left lane-Longitudinal cracking.

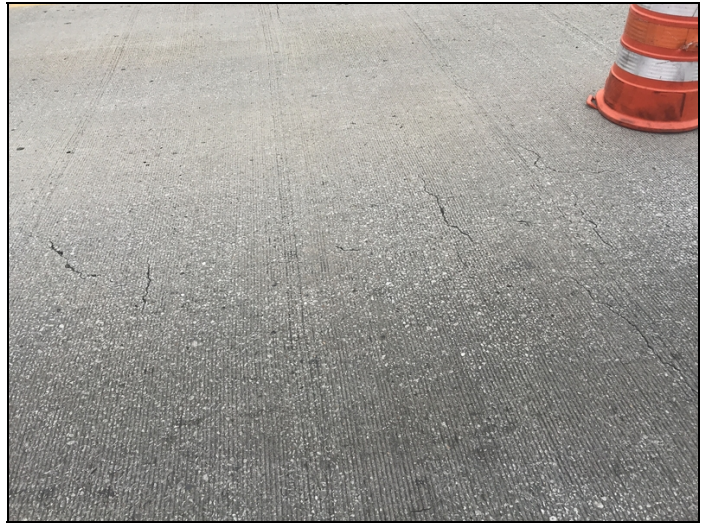
Sealable longitudinal and transverse cracks in the driving surface of the deck.

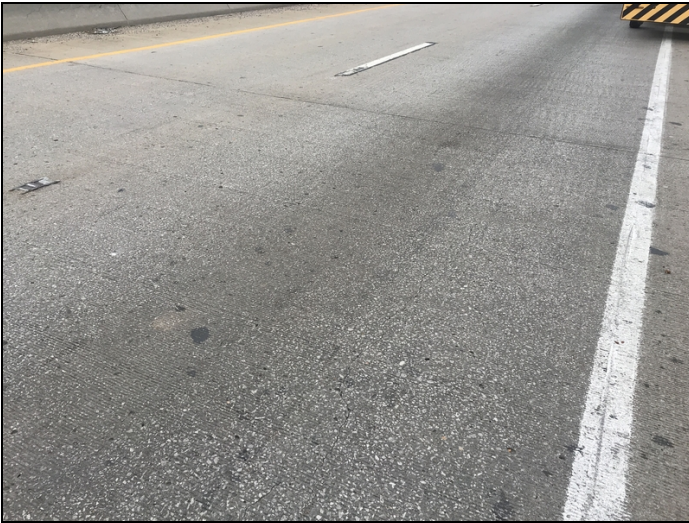
Sealable longitudinal cracking in the driving surface of span 5.

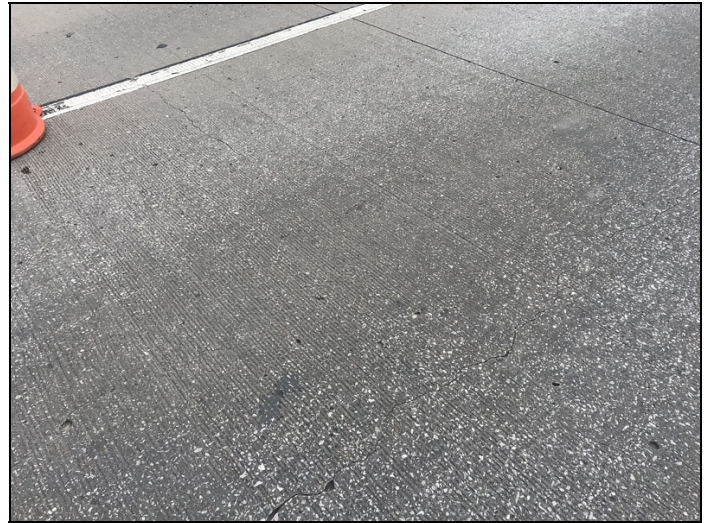
Span 1. Sealable longitudinal and transverse cracking in the driving surface of the deck.

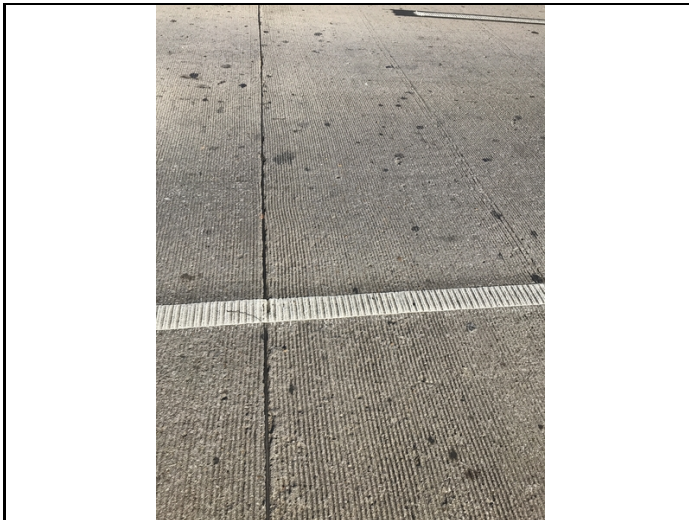
The sawn joint sealant is deteriorated and missing in locations.

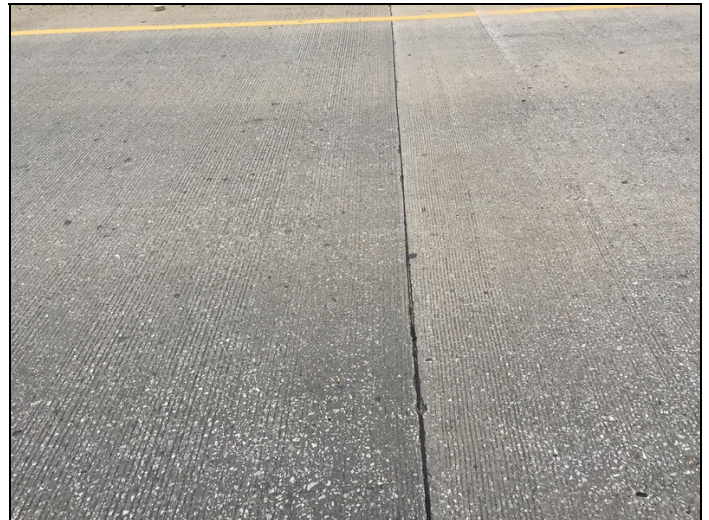
Saw joint sealant is deteriorated and missing in areas.

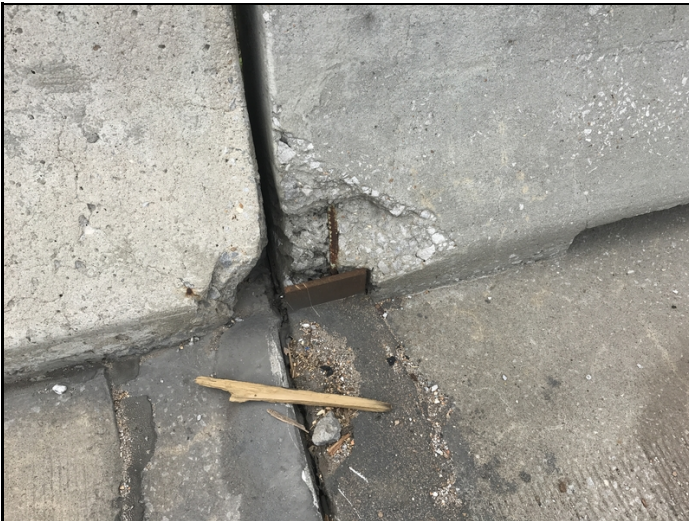
There is concrete spalling on the left side of Bents # 1 & 3 where the parapet wall appears to be making contact at the expansion joints. The upper portion of the left bridge railing at bent # 3 has apparent collision damage with spalling.

Left parapet at span 1-Spalling.

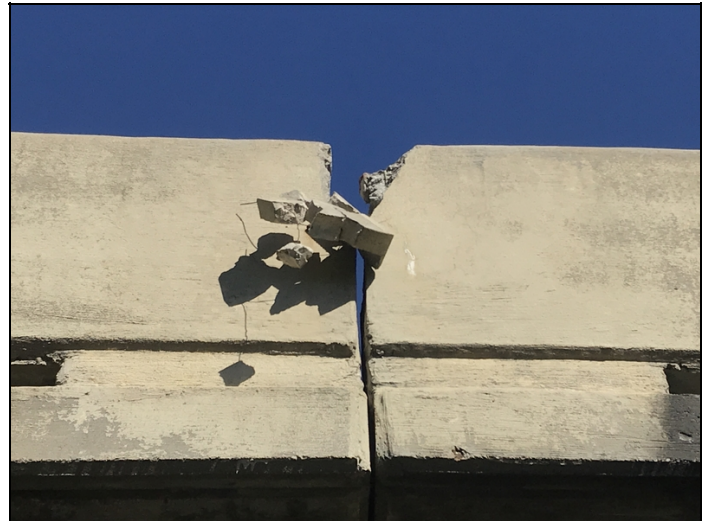
Left parapet over bent 3-Collision damage.

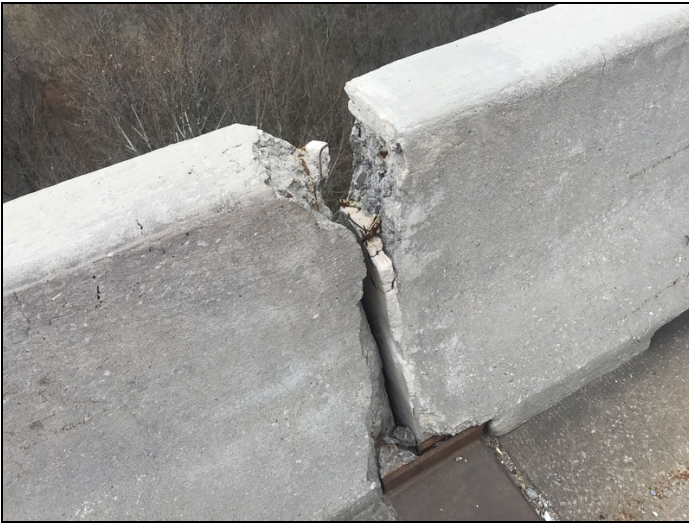
Spalls with exposed reinforcing steel in the left parapet over bent 3.
