Asset #A6237 (Routine, Underwater type 2)
I-49 Southbound over Ravine-Washington Co.

Location: 11.4 MI N. OF WASH.CO.LN

Team Lead: Eric West, Inspection Date: 12/12/2022

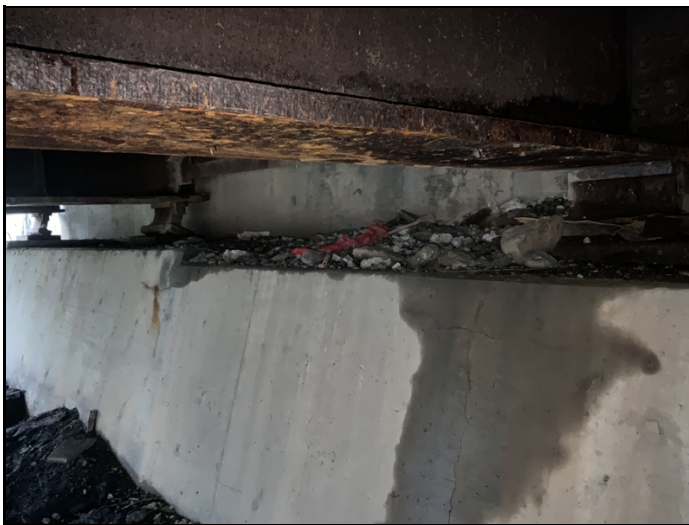
The ambient temperature is approximately 80 degrees Fahrenheit during this inspection. It appears that this structure does not have adequate room for expansion. Abutment # 1 bearings appear to be fully expanded. Spalling in the deck, backwall, and approach slab at the South bridge end indicate there is contact. The Bent # 3 expansion joint is fully closed with radial cracking in the deck over Girder # 2 and spalling in the parapet walls. Bent # 7, North abutment, has spalling in the top of the back wall adjacent to the approach slab.

Abutment #1 bearings fully expanded.

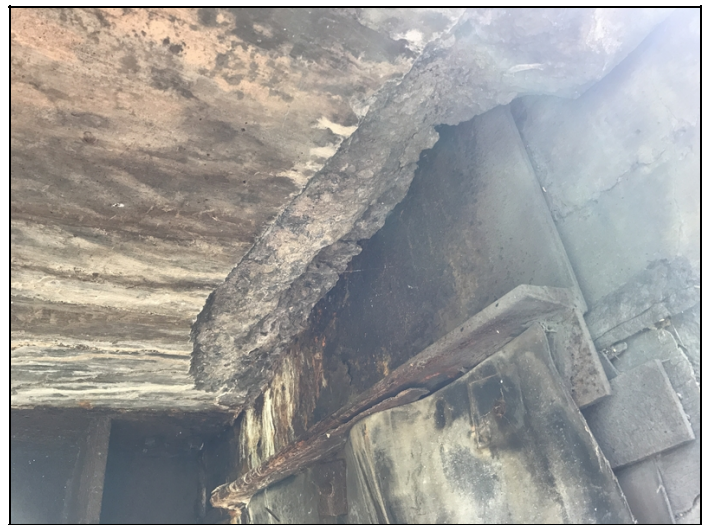
Span 1, left side at abutment 1-Spalling in deck undersurface.

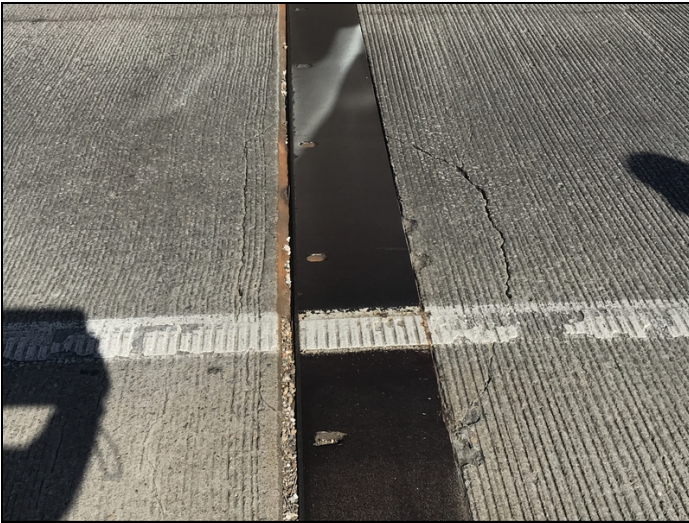
Bent 3, left lane-Wide cracking adjacent to sliding plate assembly.

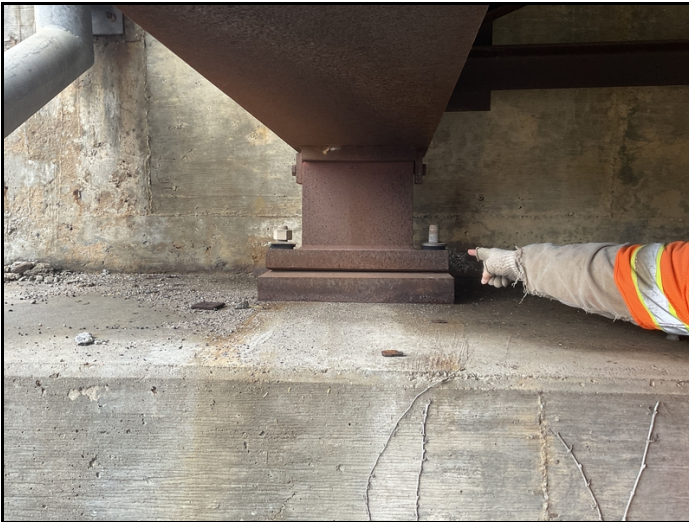
The bearings at abutment # 2 and bent # 2 have several missing anchor bolt nuts.

Abutment #2 girder #1 missing anchor bolt nut.

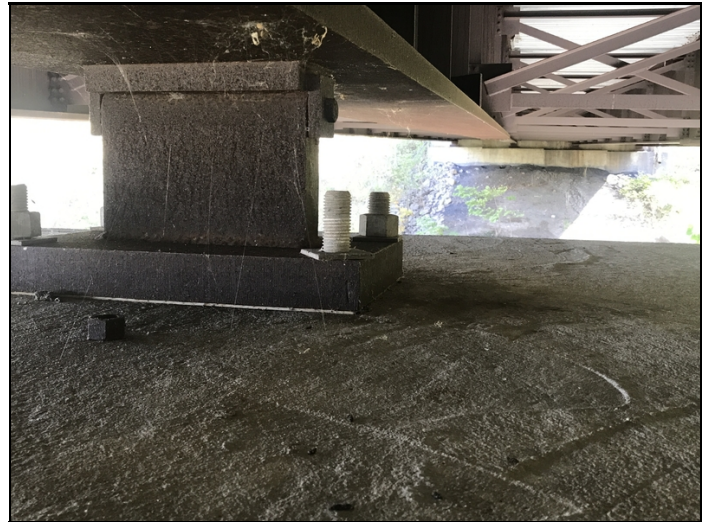
One anchor bolt nut is missing at bearings # 2 and # 3 over bent # 2.

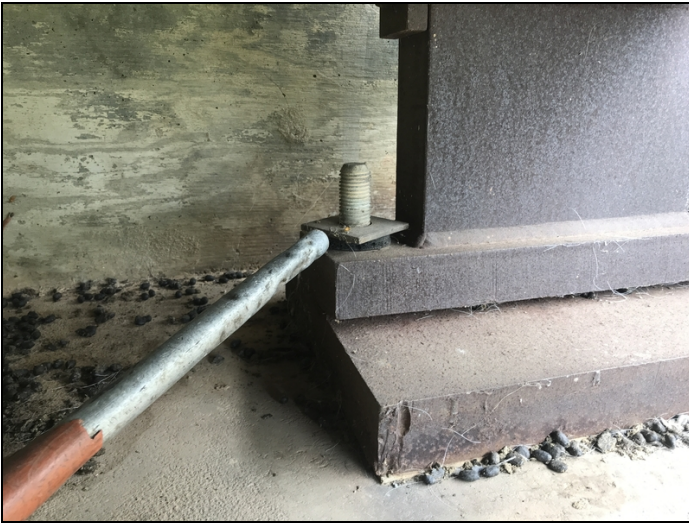
Bearings # 1, 3 and 4 at abutment # 2 are missing one anchor bolt nut.
