**Asset #B6237** (Routine, Underwater type 2)  
**I-49 Northbound over Ravine-Washington Co.**

**Location: 11.4 N. OF WASH CO LINE**

**Team Lead: Eric West, Inspection Date: 12/12/2022**

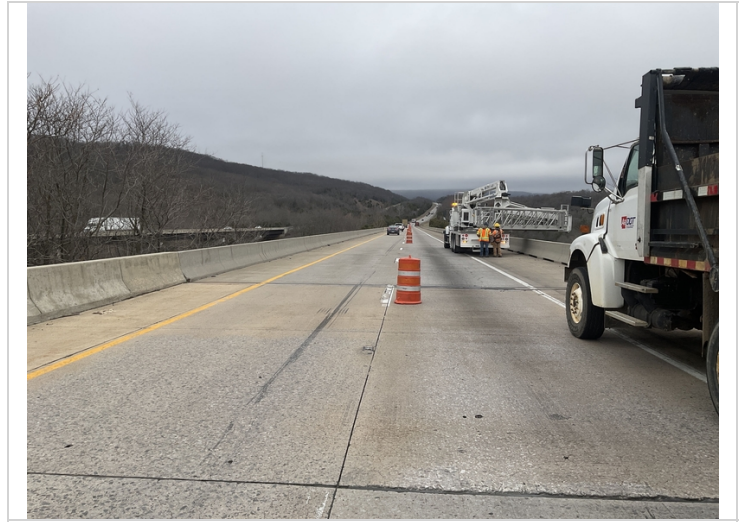
Typical driving surface of the deck. Span # 1

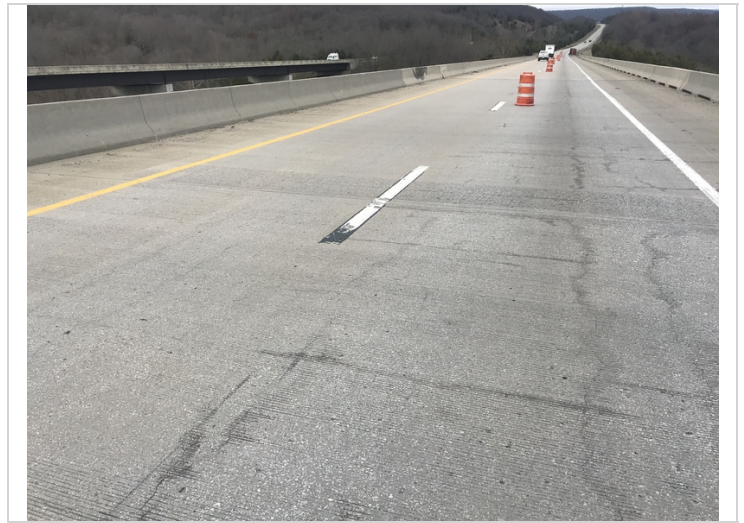
Typical driving surface of the deck. Span # 3.

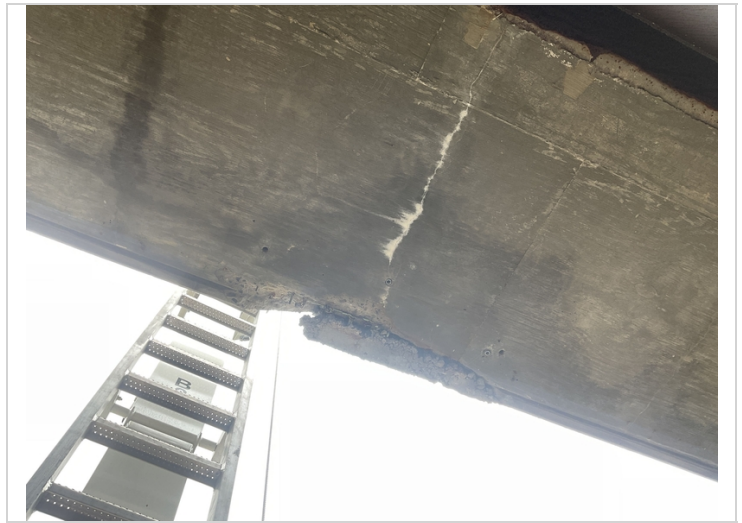
Span # 3 repair with honeycomb and exposed reinforcing steel.

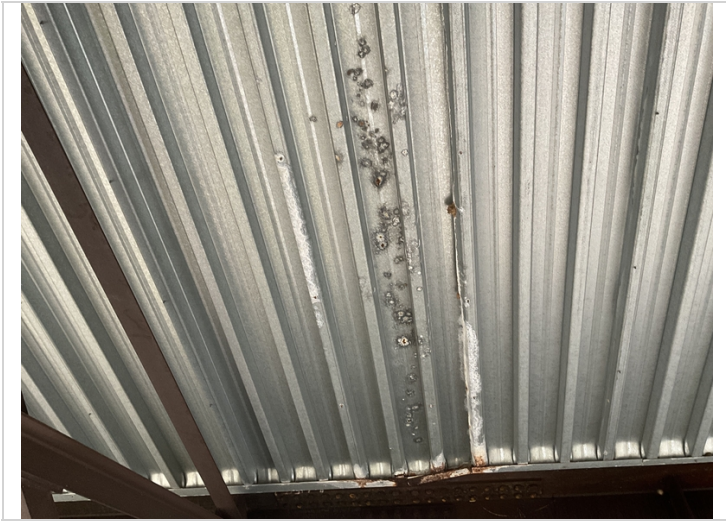
Span # 2 splice #1 bay# 2 active corrosion in the stay in place.

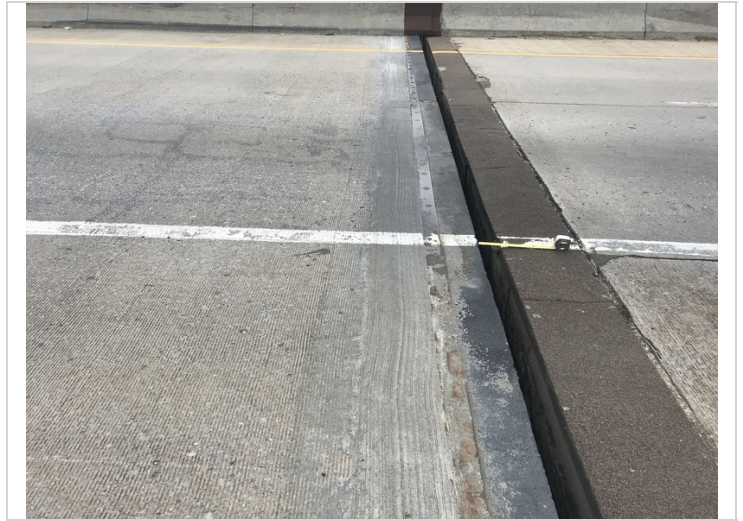
Grouted repairs adjacent to the north abutment.

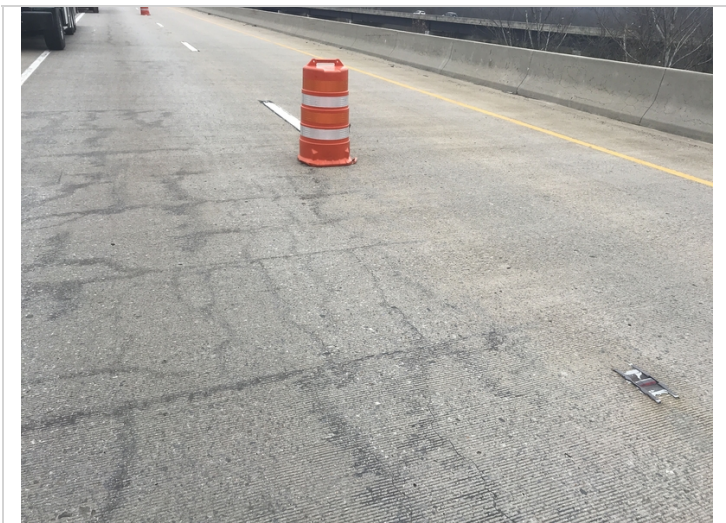
Span # 7 sealable cracking in the deck.

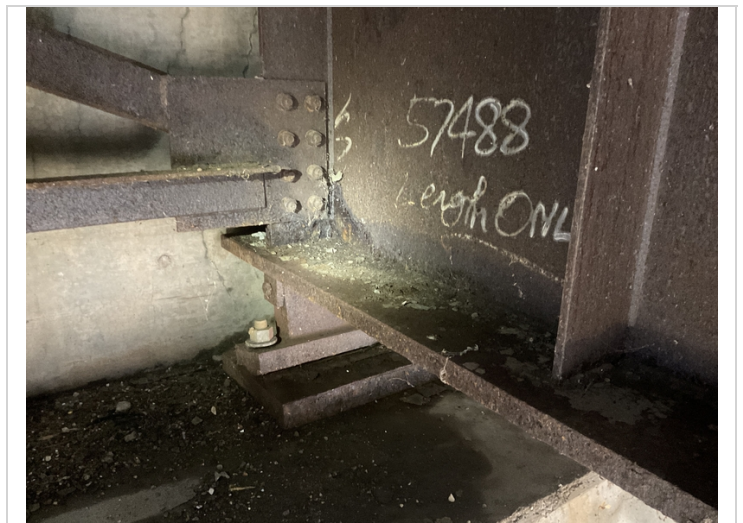
Abutment # 1 girder #2 active corrosion with pack rust over the bearing.

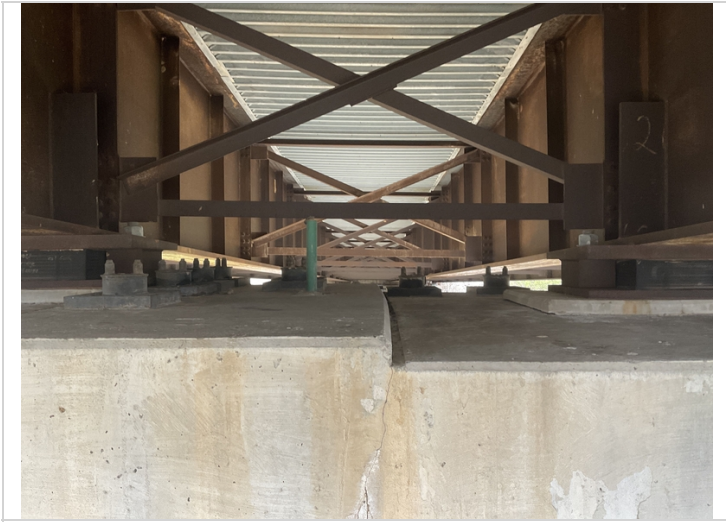
Bent # 7 repair appears to still be holding.

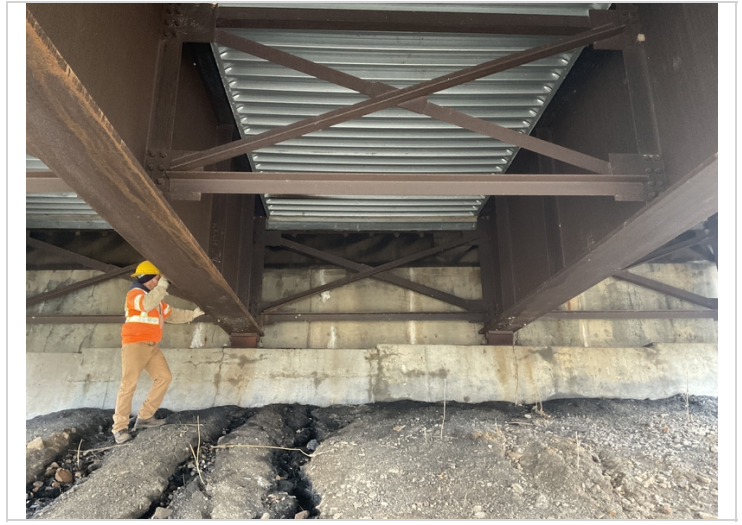
Abutment # 1 cracking typical.

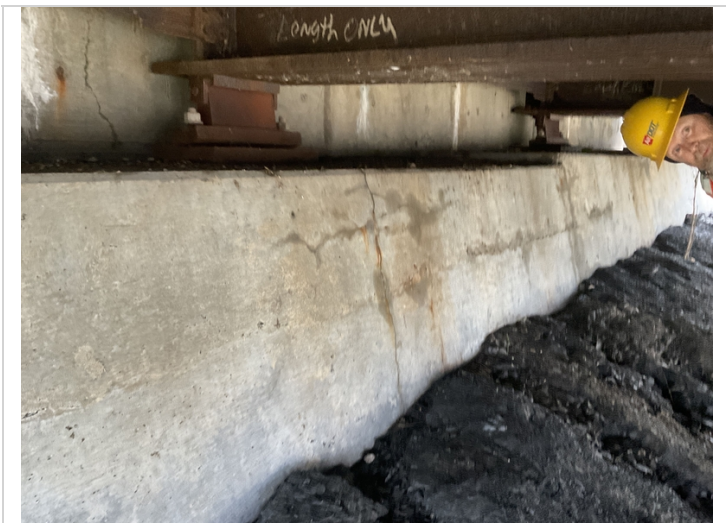
Abutment # 1 cap vertical and horizontal moderate width cracking.

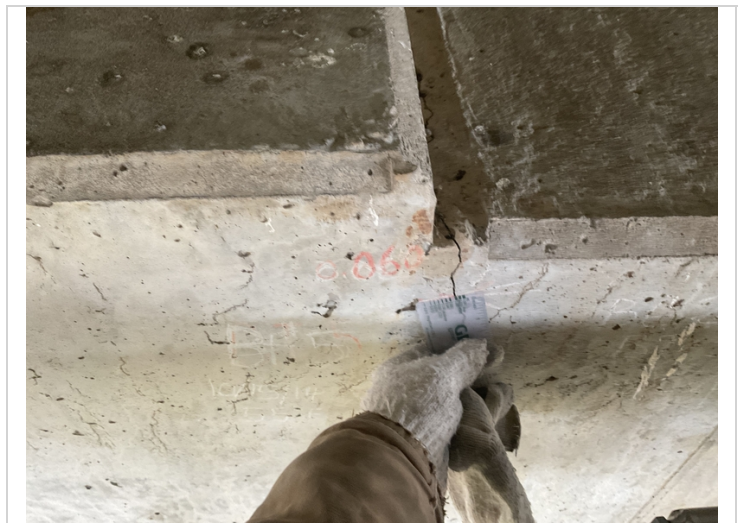
Bent # 5 vertical cracking at the centerline. 0.060" wide crack.

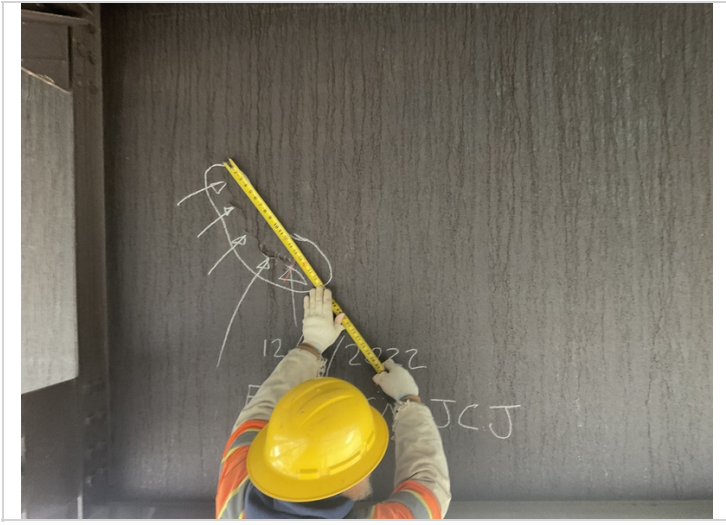
Span # 2 beam #3 laminar delamination in the web adjacent to diaphragm # 5 from bent #3.

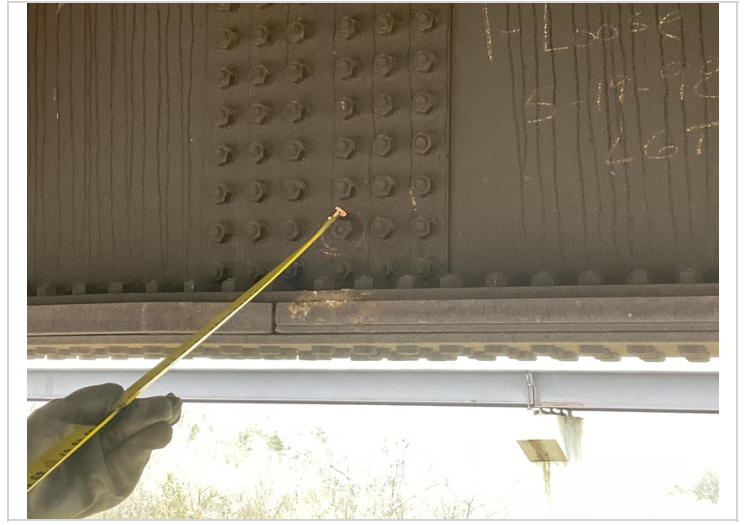
Span #3 girder #1 loose bolt in the splice.

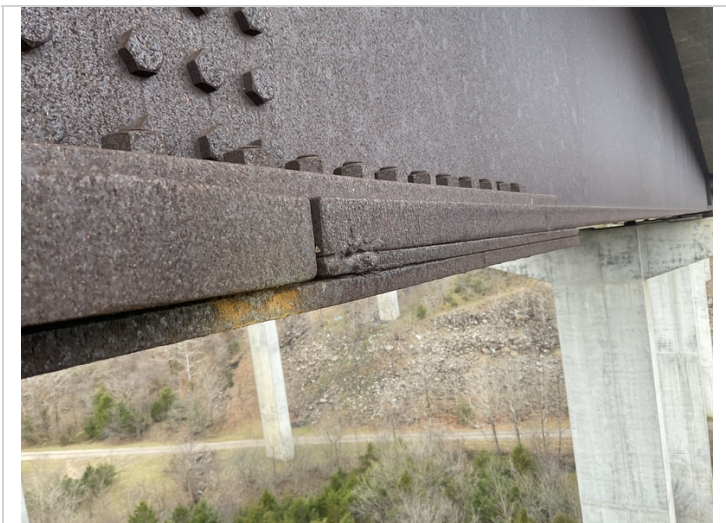
Span # 3 beam #4 tack weld on the splice spacer plate of the bottom flange.

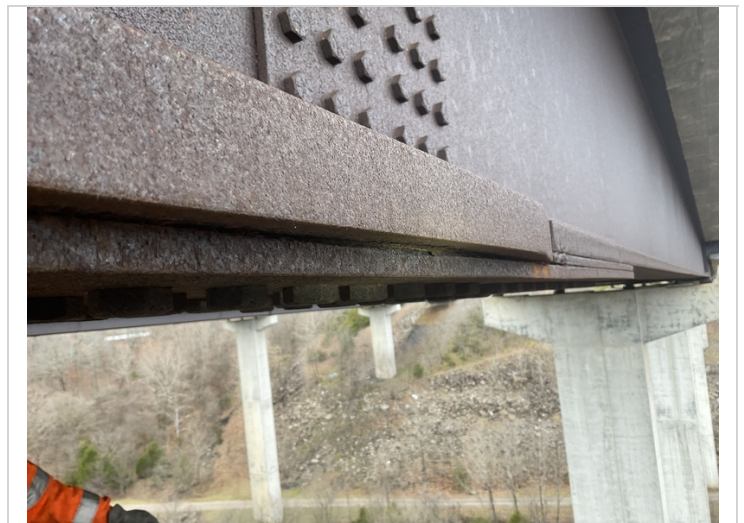
Span # 3 beam #4 pack rust between the splice plates.

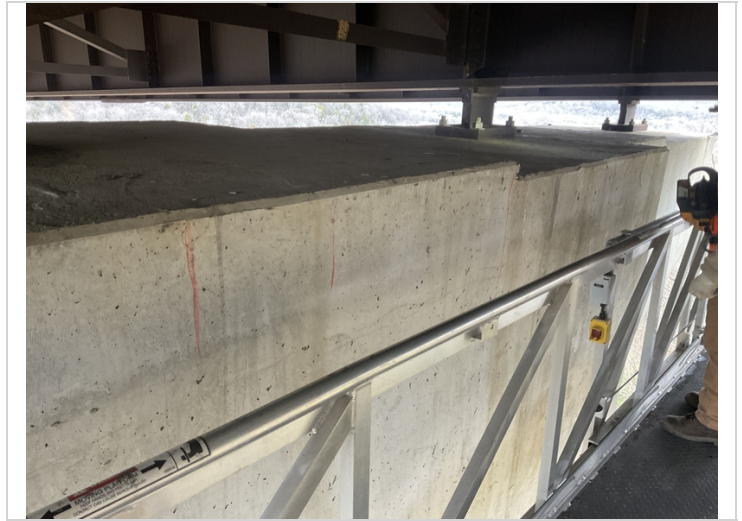
Bent #2 typical cracking.

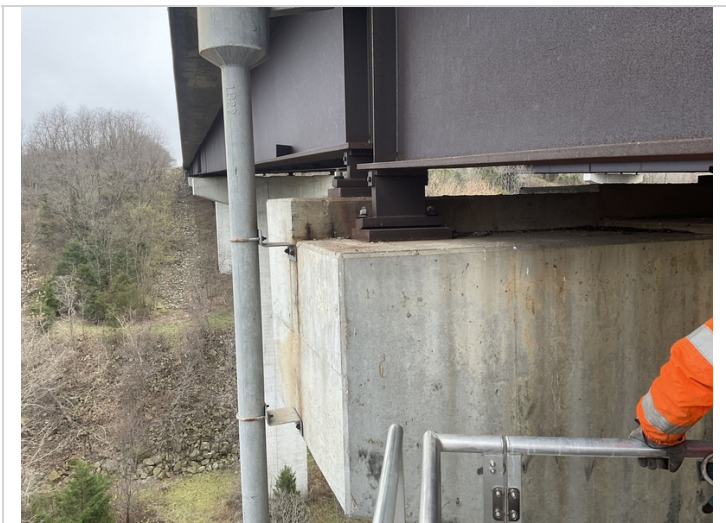
Bent # 4 Rt cap spalling with exposed reinforcing steel in the step of the cap.

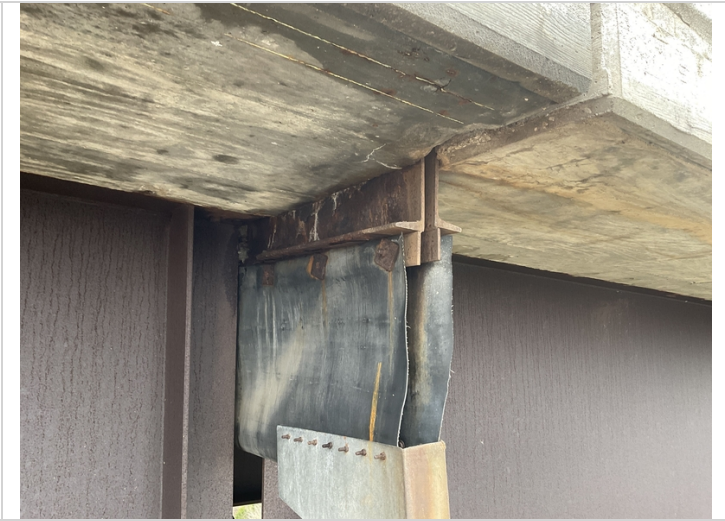
Bent # 4 expansion joint active corrosion with pack rust.

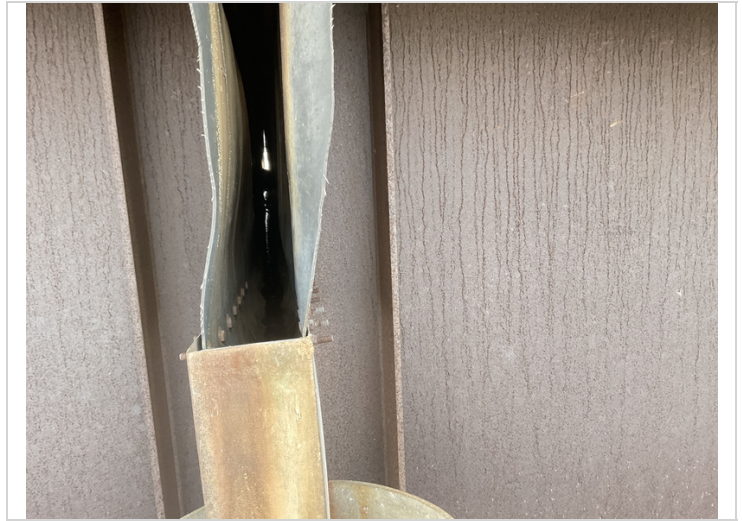
Bent # 4 expansion joint trough has minor debris accumulation.

Bent # 4 minor debris accumulation in the trough.

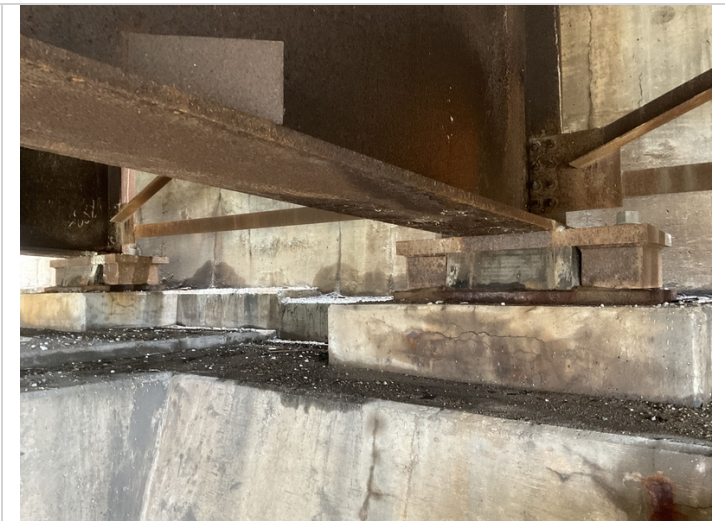
Abutment # 2 girders # 2 & 3 active corrosion with pack rust and section loss.

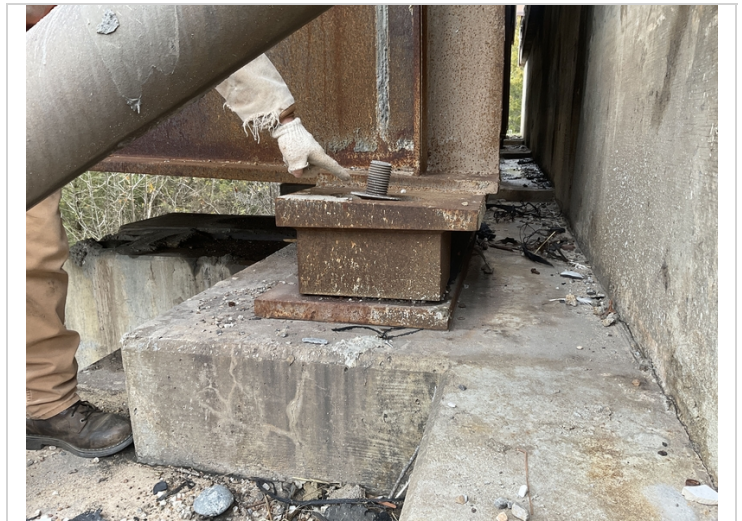
Abutment # 2 girder #4 missing anchor bolt nut.

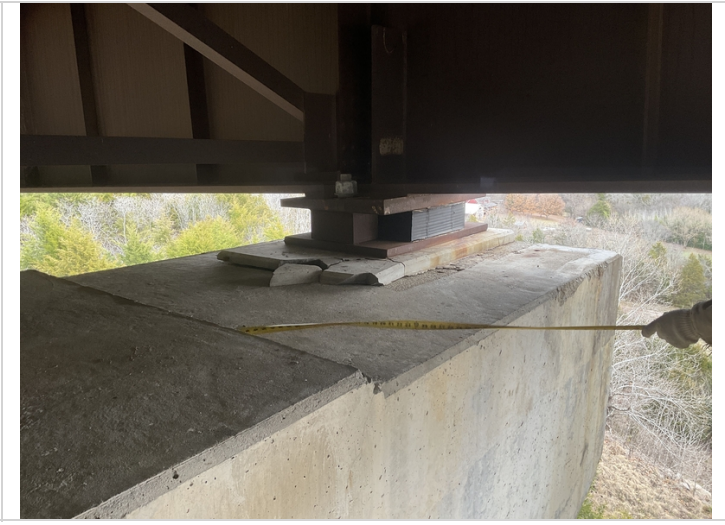
Bent # 7 bearing #4 fractured pedestal under the bearing.

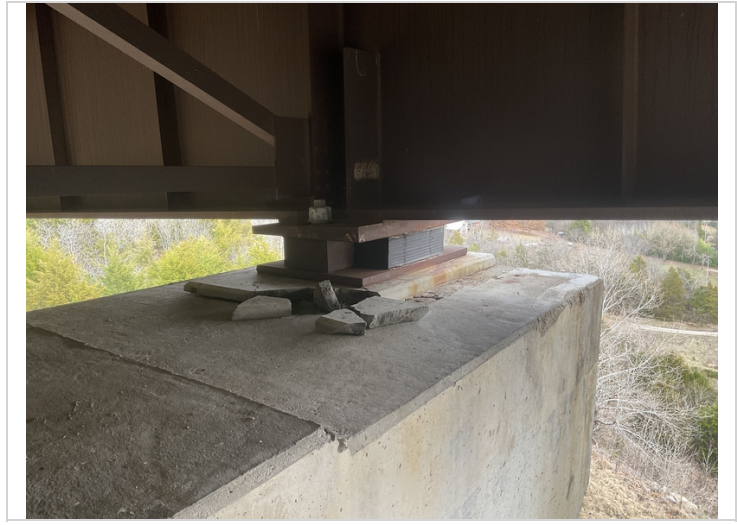
Bent # 7 bearing #4 fractured pedestal under the bearing.

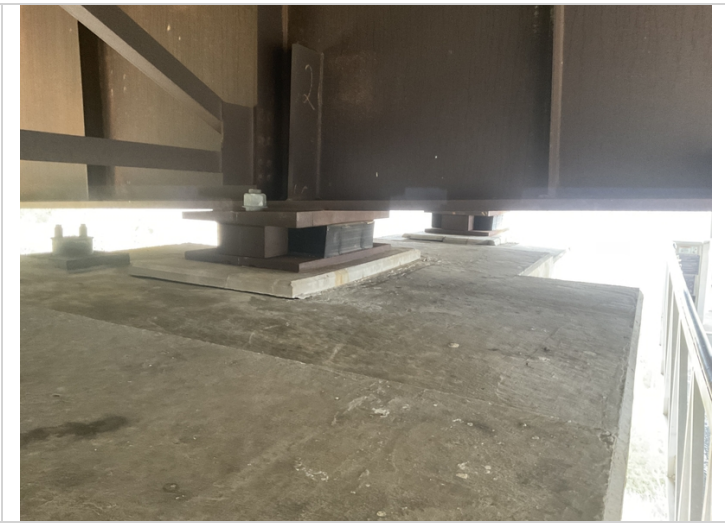
Bent # 7 bearing #3 elastomeric pad delaminated from the external load plate.

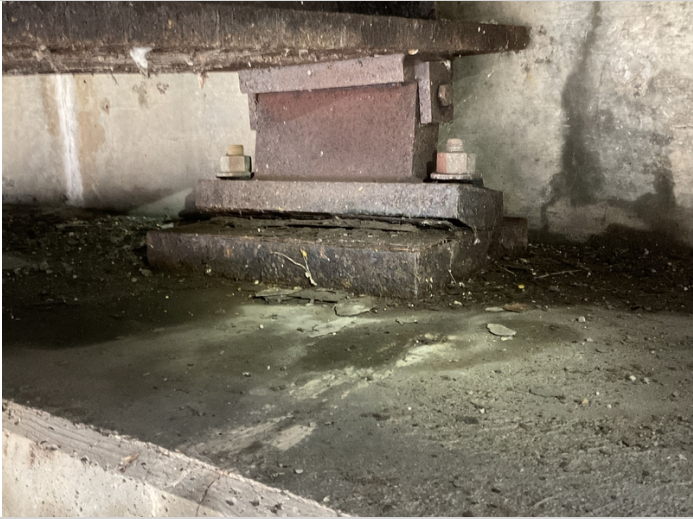
Abutment # 1 bearing #2 active corrosion with pack rust.

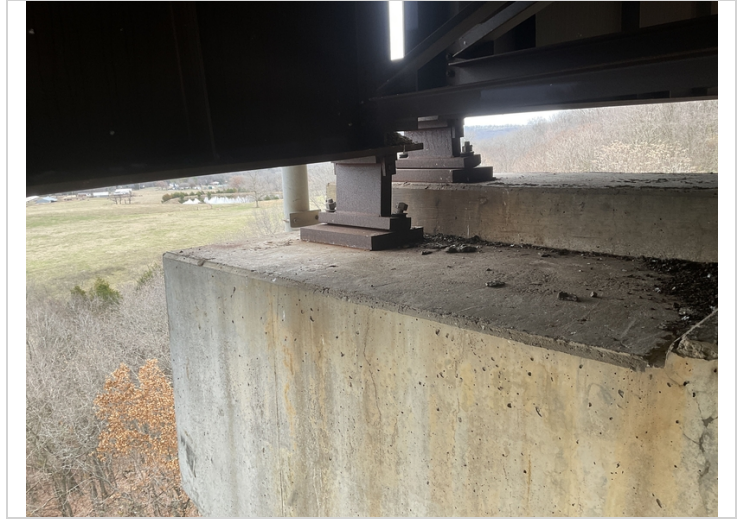
Bent # 4 Span #4 bearing #4 fractured anchor bolts.

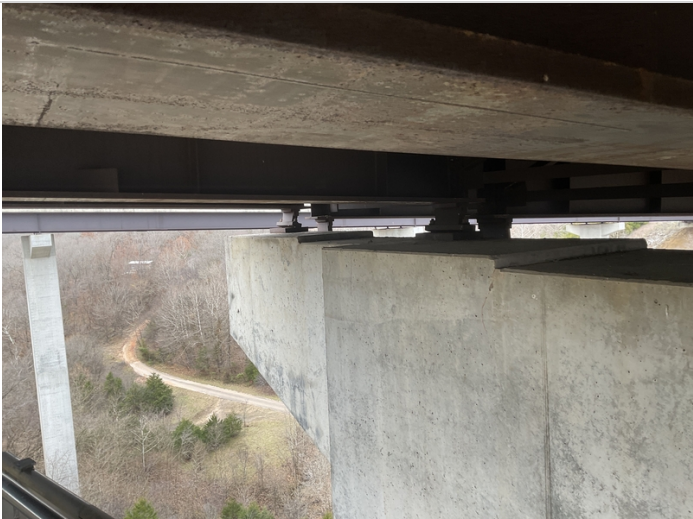
Bent # 4 bearings in the expanded position.

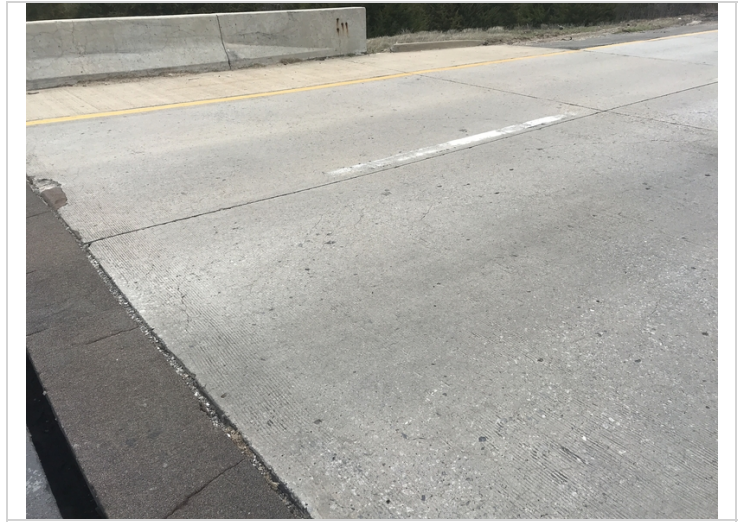
North approach slab. Sealable map cracking.

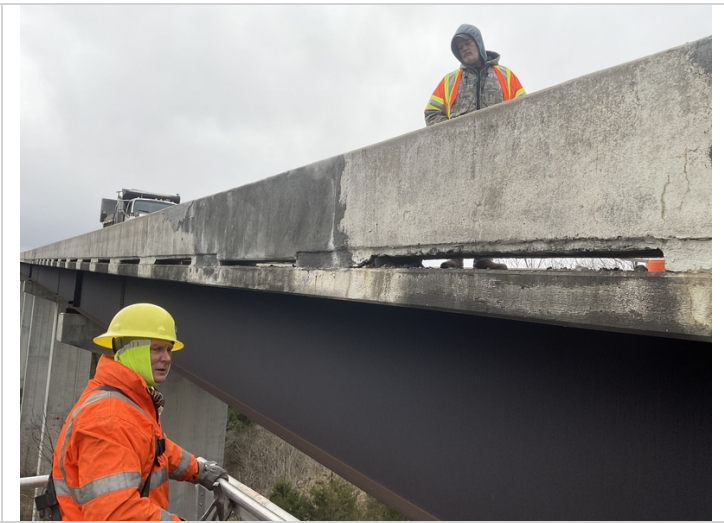
Span # 7 Rt exposed reinforcing steel in the base of the bridge rail.

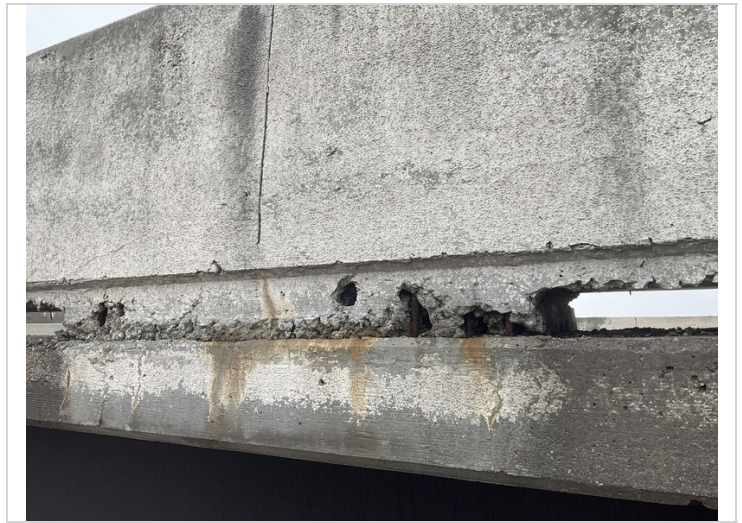
Span # 3 Rt bridge rail honeycomb with exposed reinforcing steel with active corrosion and pack rust.

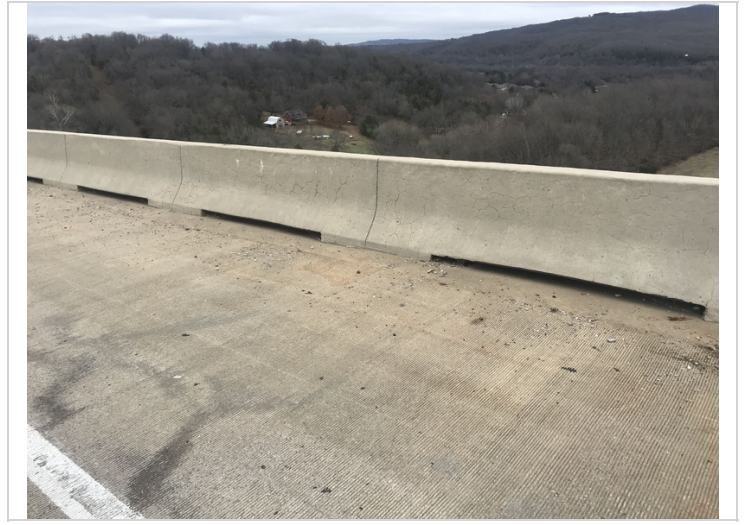
Heavy map cracking in the right parapet. Span 4.

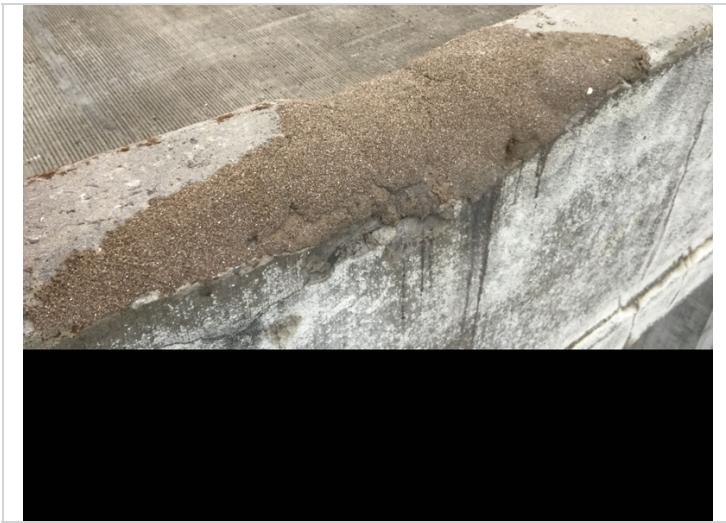
Epoxy and sand repair to a spall in span 5. Right.

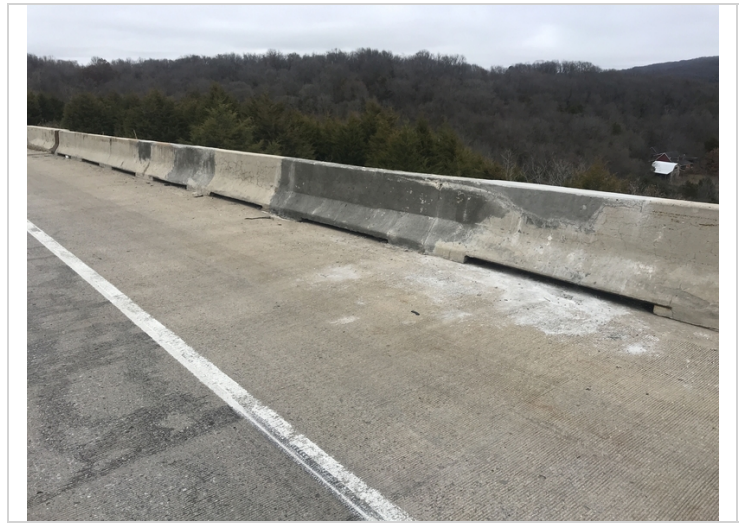
Concrete repairs. Span 7. Right.

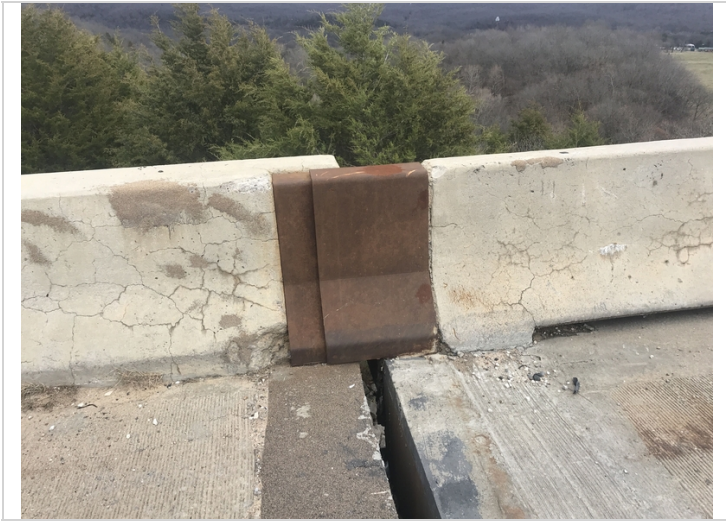
Maintenance forces have reattached the sliding plate to the right parapet at abutment 2 since the last inspection. The repair seems to be holding during this inspection.

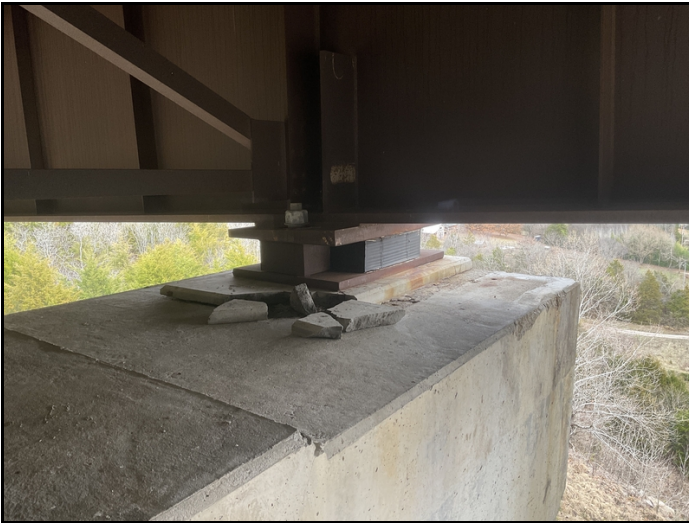
Concrete pedestals have random cracking with up to 1" separation from the cap along the edges. Southeast corner of the concrete pedestal for bearing # 1 at bent # 7 is fractured in an area approximately 12" long x 8" wide with a portion of the fractured area that extends under the interior side of the masonry plate approximately 1-1/4". Bent # 7 bearing #4 fractured pedestal under the bearing.

Bent # 7 bearing #4 fractured pedestal under the bearing.

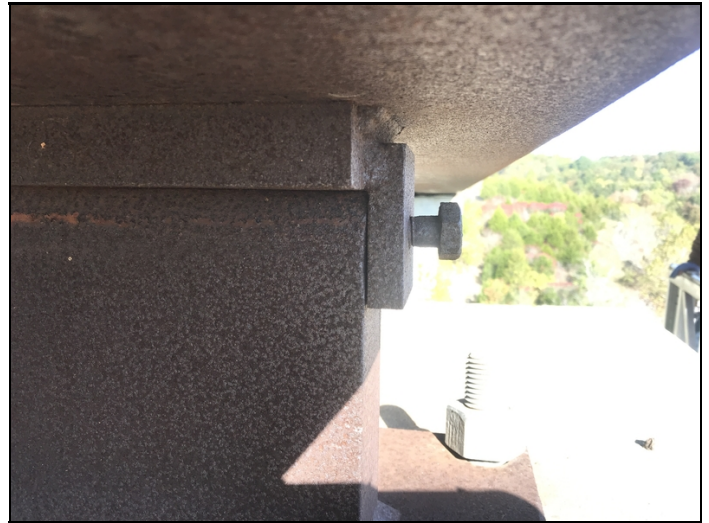
Fixed bearing # 5 at bent # 5 has one bolt that attaches the girder to the bearing device that is working out.

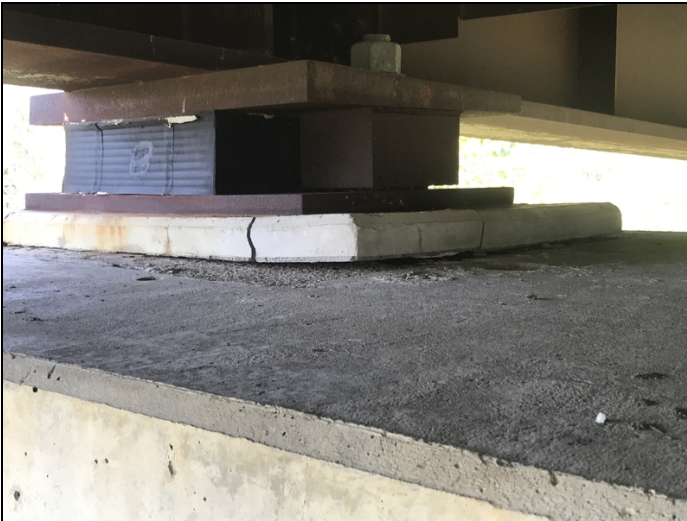
Southeast corner of the concrete pedestal for bearing # 1 is fractured in an area approximately 12" long x 8" wide with a portion of the fractured area that extends under the interior side of the masonry plate approximately 1-1/4".

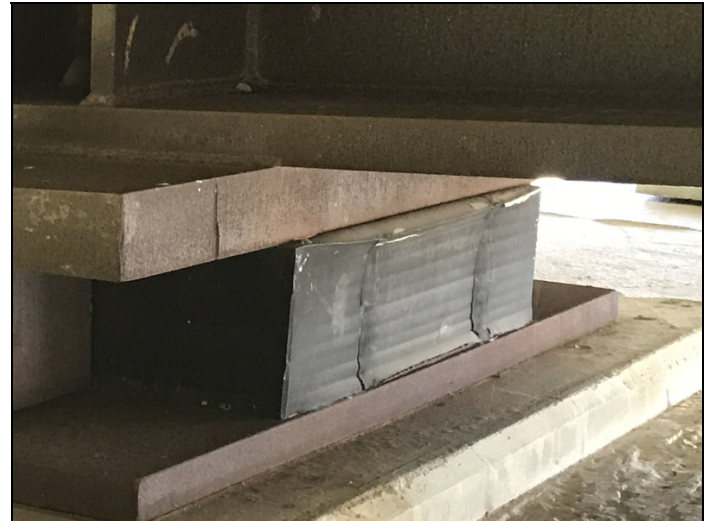
Elastomeric bearing pad for Girder # 3 at bent # 7 has adhesion failure. The bearing pad has worked out from under the sole plate approximately 7/8" during this inspection.

Bent # 7, Girder # 3 pad is de-bonded from the sole plate and protrudes 7/8" past the edge of the Sole plate.

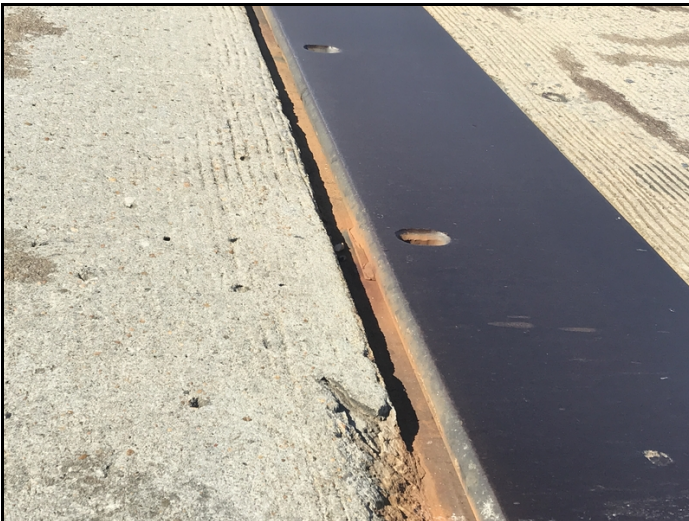
The steel shims at bent # 4 sliding plate assembly that are welded between the sliding plate anchorage and the sliding plate have cracked welds and section loss from wear caused by thermal expansion, the sliding plate is noisy when impacted by traffic.

The sliding plate has metal shims welded to the top cover plate to reduce movement during live load impacts. The shims have wear with some fretting. The welds that attach the shims have cracks in some locations.

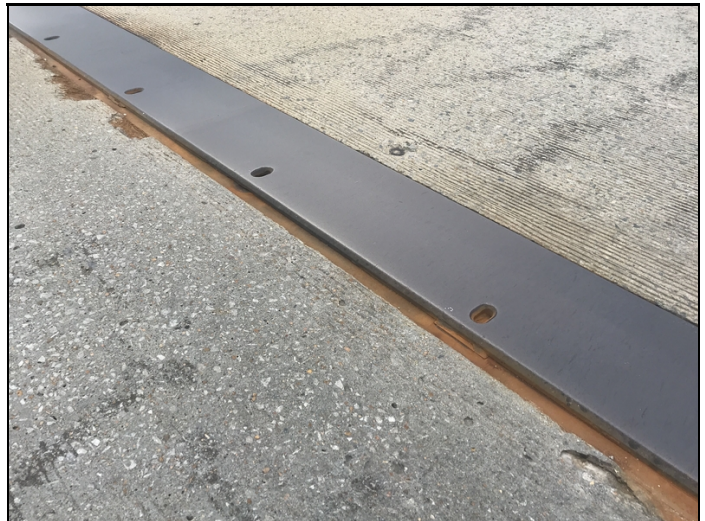
Sliding plate over Bent 4. Cracked welds in the shims.

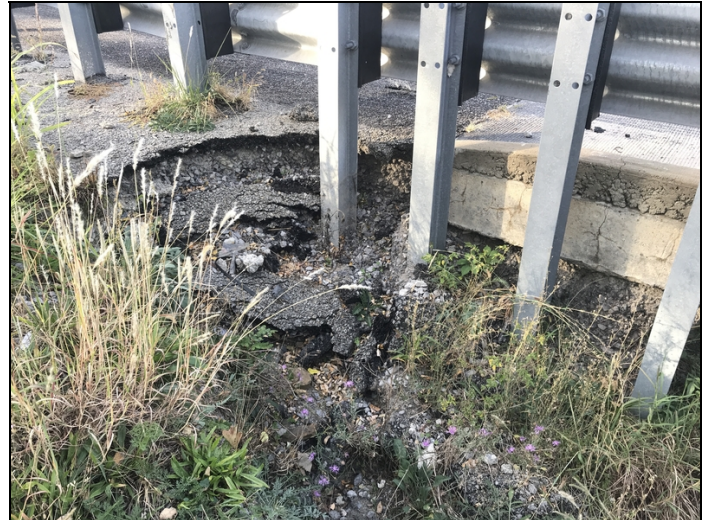
The slope on the right side of the South abutment has an area of erosion adjacent to the approach railing that has caused a loss of cover to the approach railing posts.

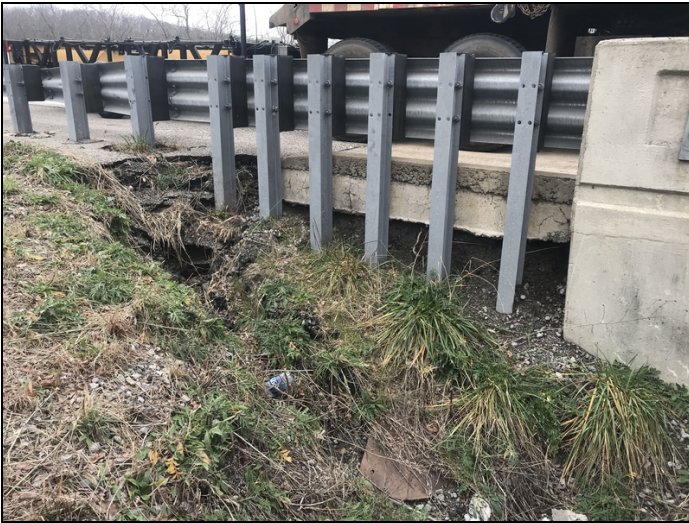
Right embankment at the south abutment has erosion with loss of cover to the approach railing and is beginning to undermine the approach gutter.

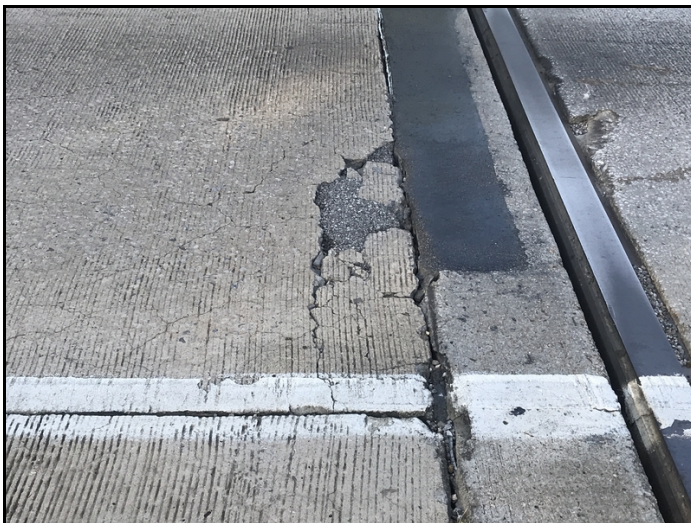
South approach slab, left lane-Spalling.

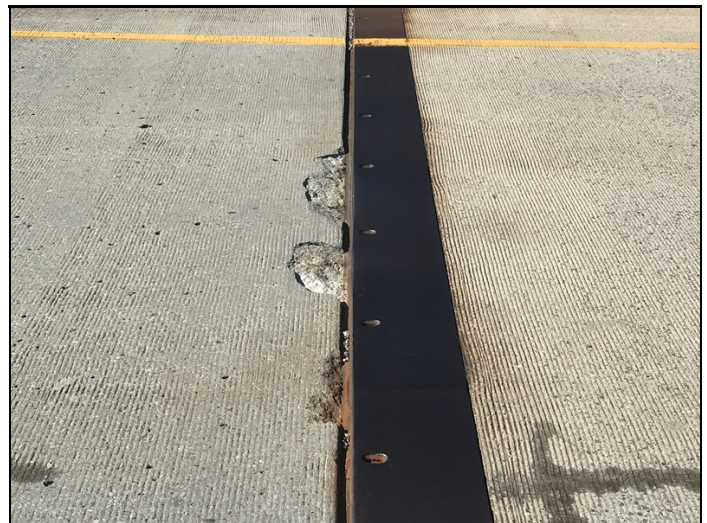
Span # 3 has areas of moderate sized spalling adjacent to bent # 4 sliding plate assembly.

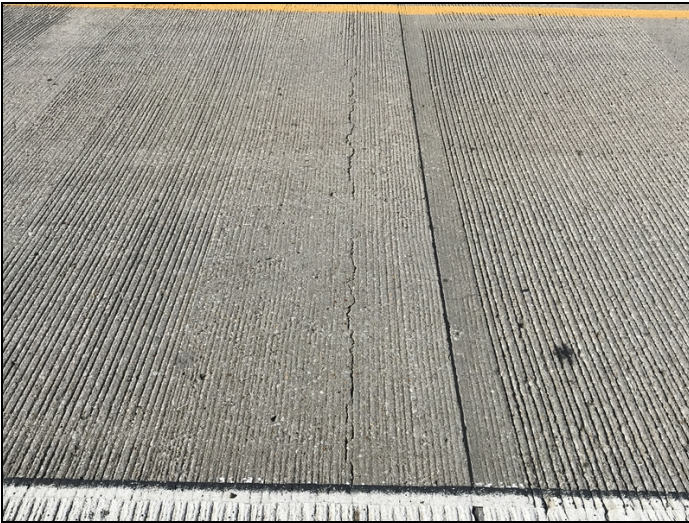
Span 3, left lane-Transverse crack.

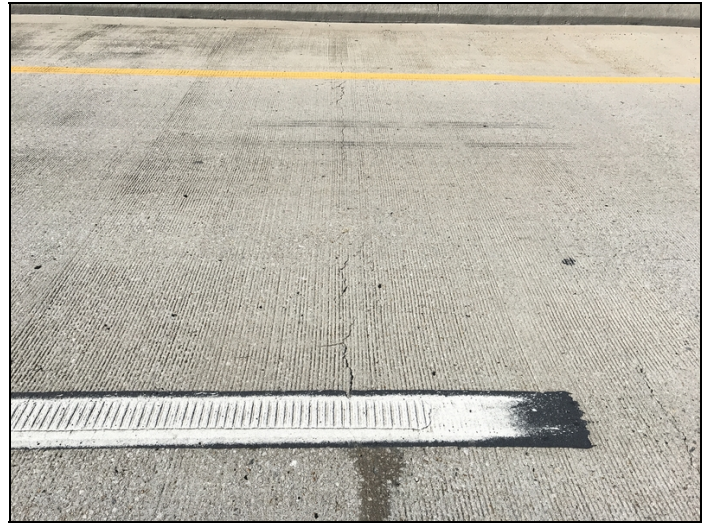
Transverse deck cracking.

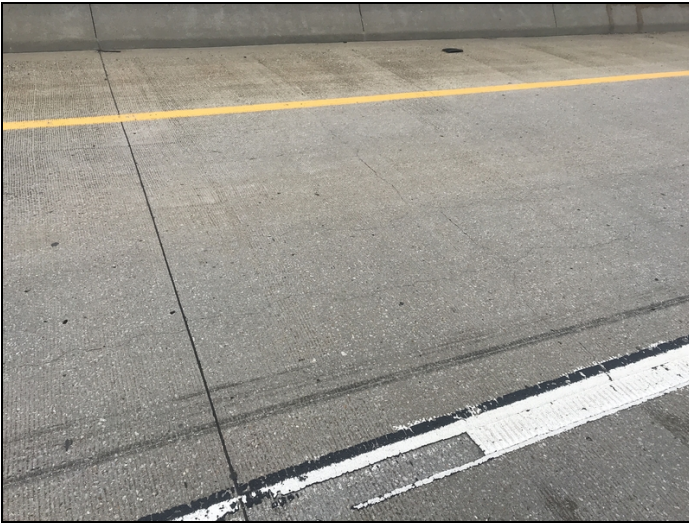
Sealable transverse cracking. Driving surface of the deck.

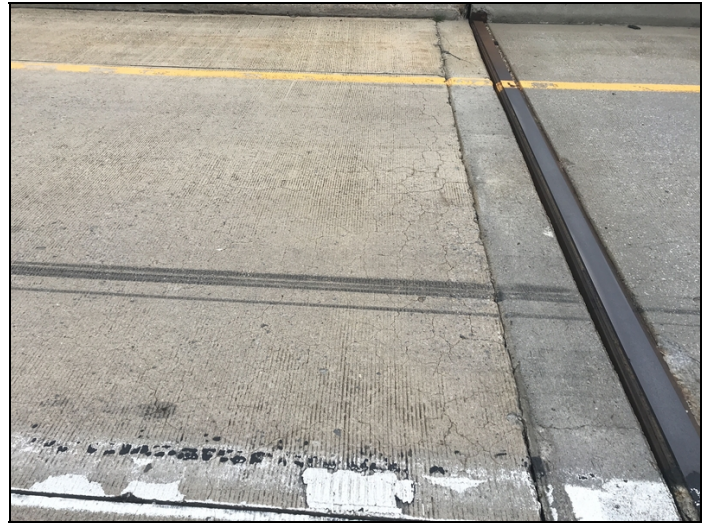
Sealable map cracking in the south approach slab.

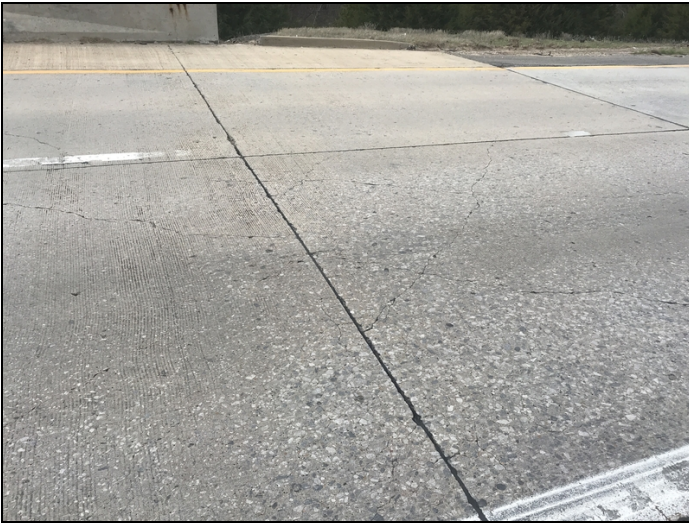
Wide diagonal cracks in the north approach slab.

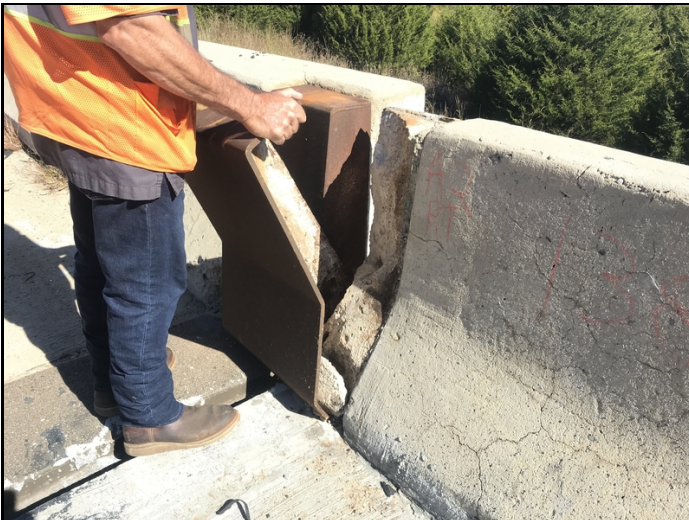
The portion of the steel sliding plate assembly on the right parapet at abutment # 2 is broken loose from the parapet leaving a spalled area in the parapet and the blunt end of the transition parapet exposed. The portion of the sliding plate was removed from the structure at time of inspection as a safety precaution.

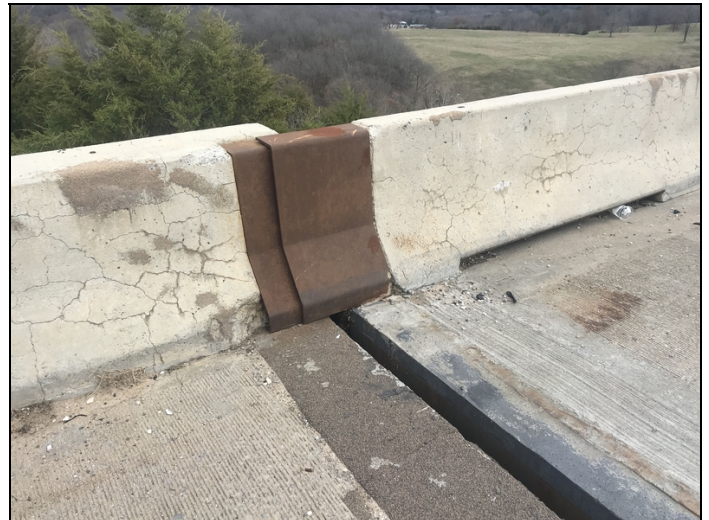
Maintenance forces have reattached the sliding plate to the right parapet at abutment 2 since the last inspection. The repair seems to be holding during this inspection.

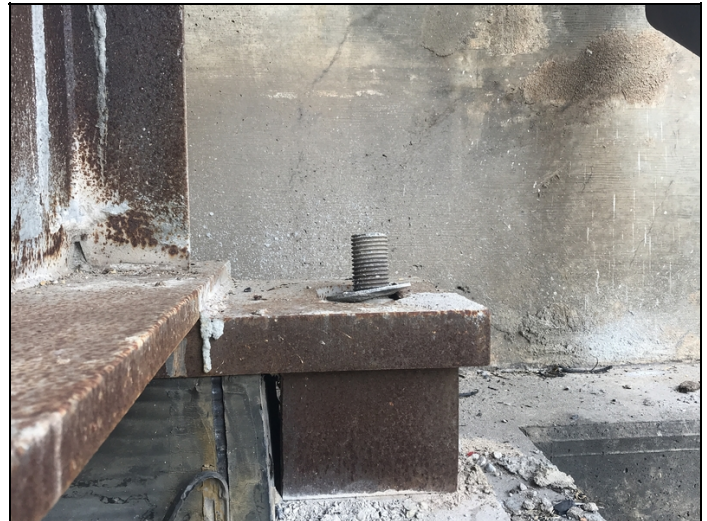
Abutment # 2, bearing # 4 has a missing anchor bolt nut.

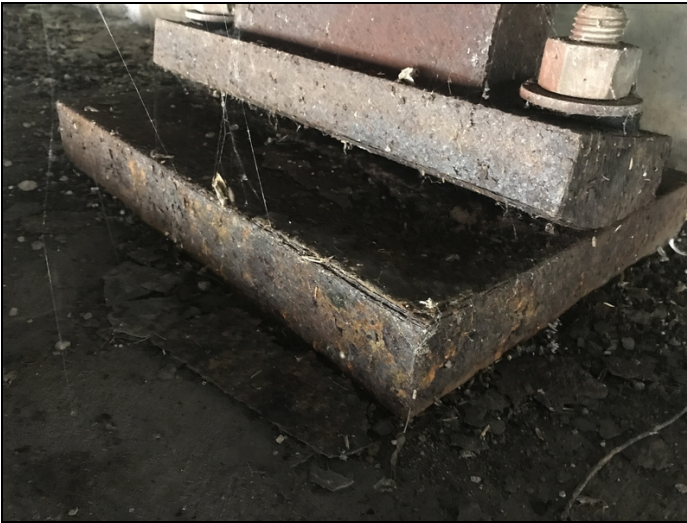
Abutment 1, bearing 3-Corrosion.

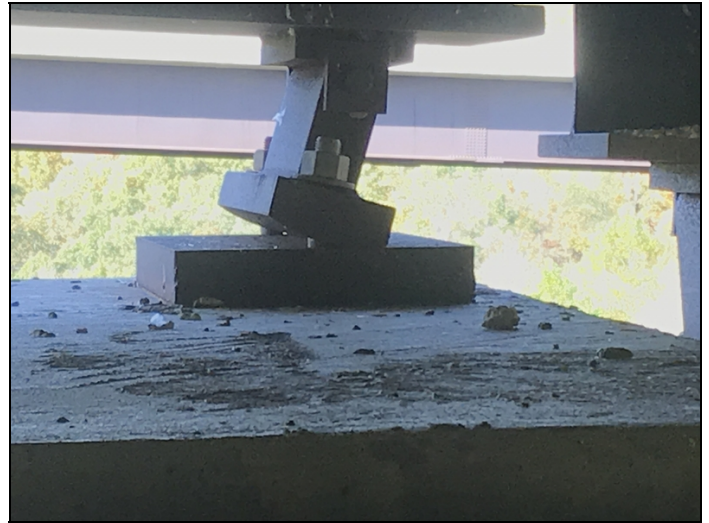
Span # 3, bearing 1 at bent # 4 appears to be fully expanded at this inspection. Ambient temperature at time of inspection is approximately 68 degrees Fahrenheit.

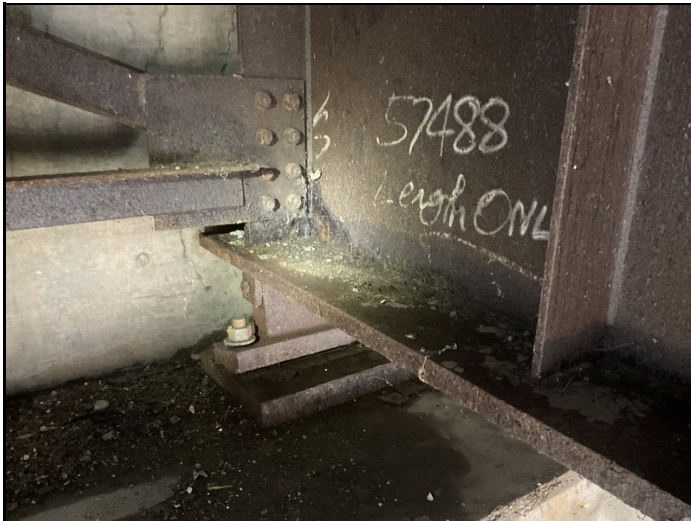
Abutment # 1 girder #2 active corrosion with pack rust over the bearing.

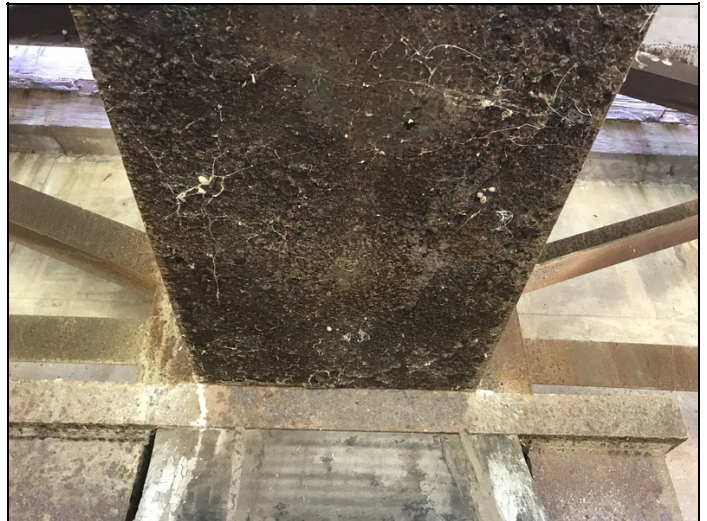
Abutment 2, girder 3-Abnormal weathering in bottom flange undersurface.

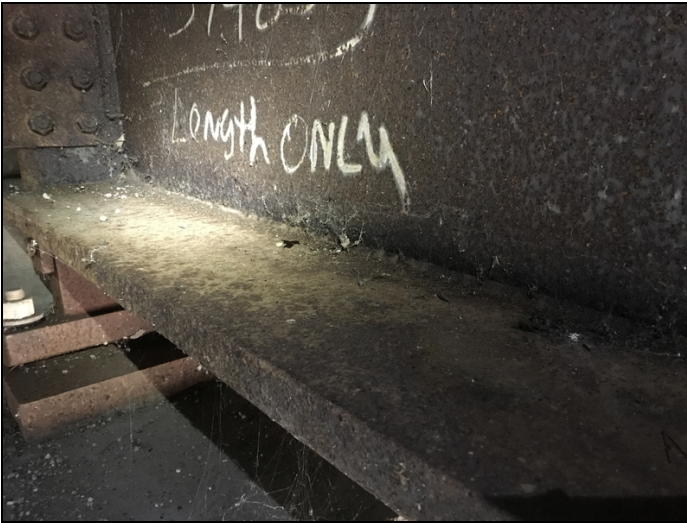
Span 1, girder # 3 at abutment # 1-Corrosion.
