**Asset #B6237** (Routine, Underwater type 2)  
**I-49 Northbound over Ravine-Washington Co.**

**Location: 11.4 N. OF WASH CO LINE**

**Team Lead: Eric West, Inspection Date: 12/12/2022**

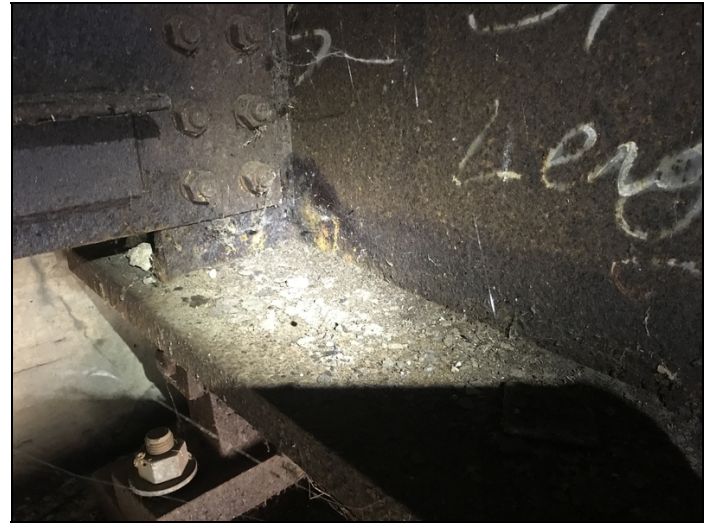
Span 1, girder # 2 at abutment # 1-Corrosion.

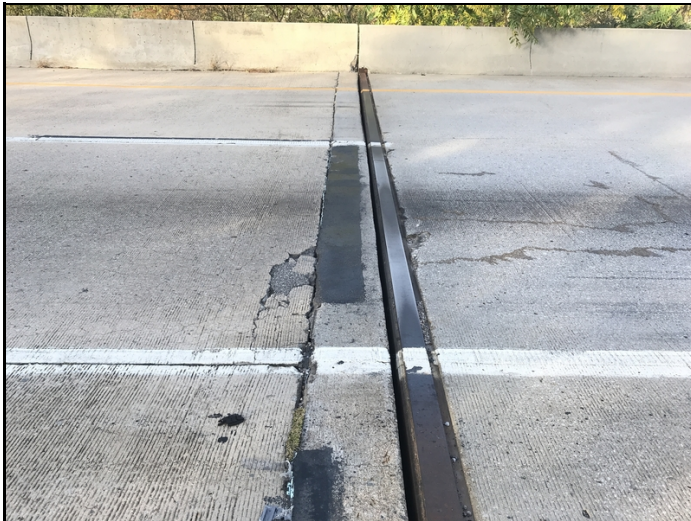
Abutment 1.

The expansion joints at both bridge ends have no seals allowing water, dirt and debris to leak onto the substructure and superstructure causing abnormal weathering / corrosion to the beam ends and bearing devices.

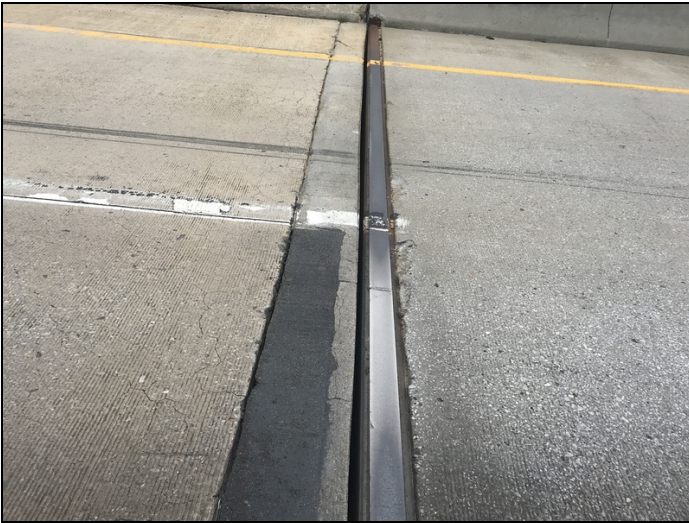
Missing expansion joint material at bent 1.

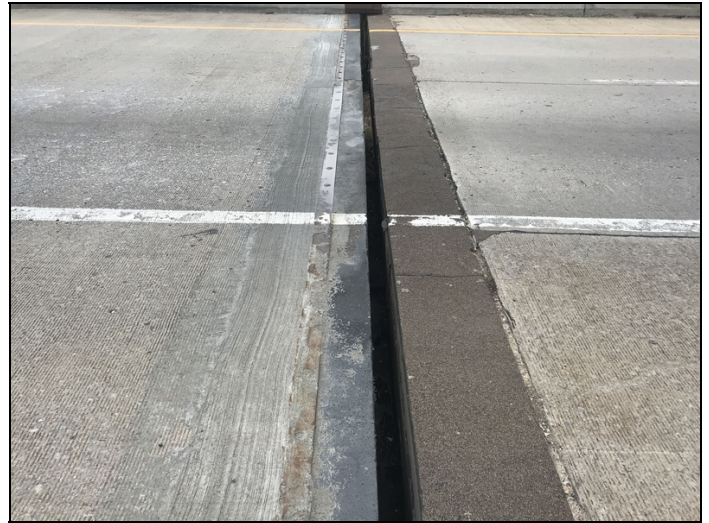
Open expansion joint at abutment 2.
