**Asset #A6239**(Routine, Underwater type 2)  
**I-49 Southbound over Farm Road - Wash. Co.**

**Location: 0.76 MI N EXIT 53**

**Team Lead: Eric West, Inspection Date: 04/05/2023**

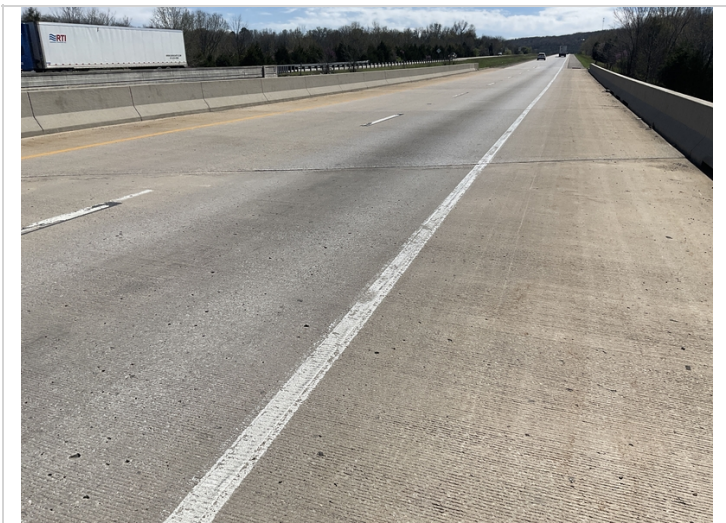
Typical driving surface of the deck.

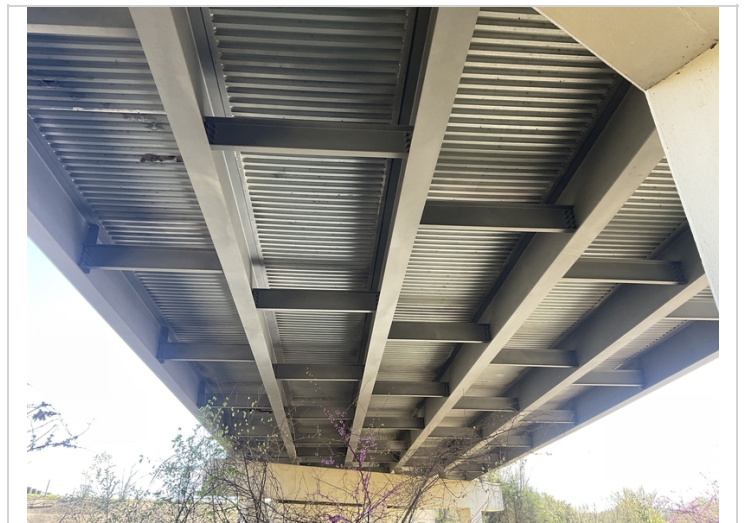
Typical undersurface of the deck.

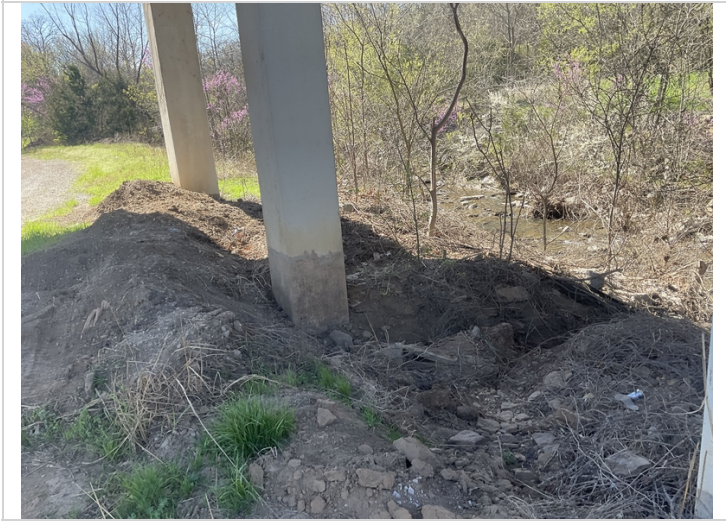
Comment: 04/05/2023 - EJW - Underwater Type II Inspection conducted on this date. No substructure in the water. Minor localized erosion at Bent # 3 Column # 2. Footings have cover at this inspection.

Bent #3 column # 2.

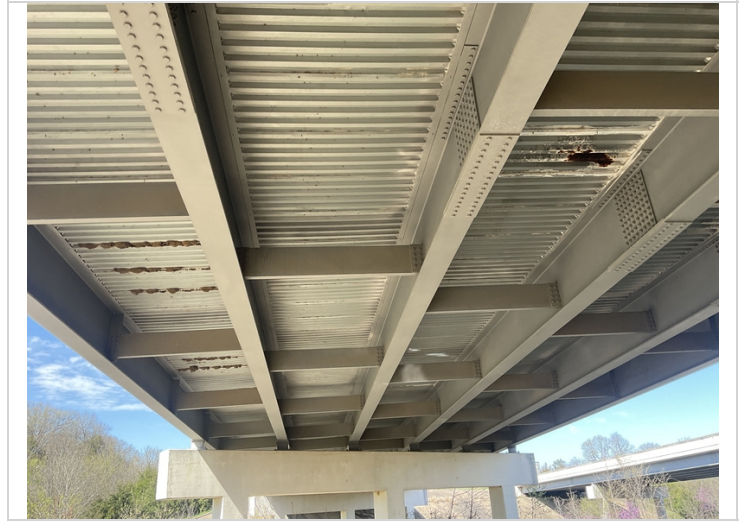
Span # 2 active corrosion in the deck pans.

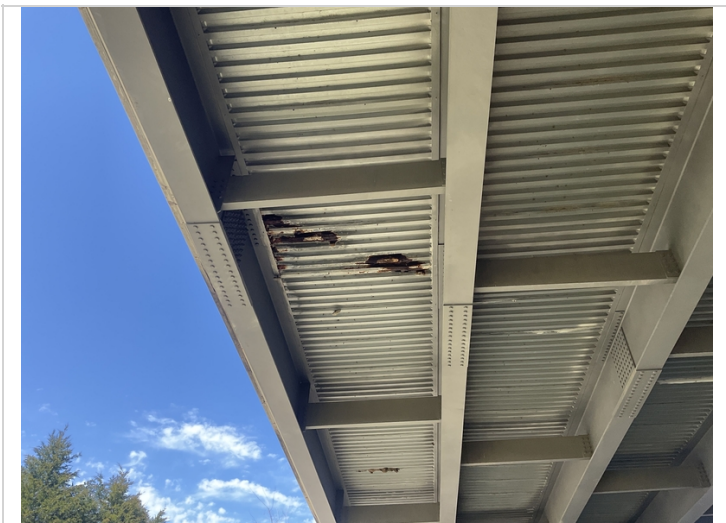
Span # 4 bay # 1 active corrosion in the deck pans.

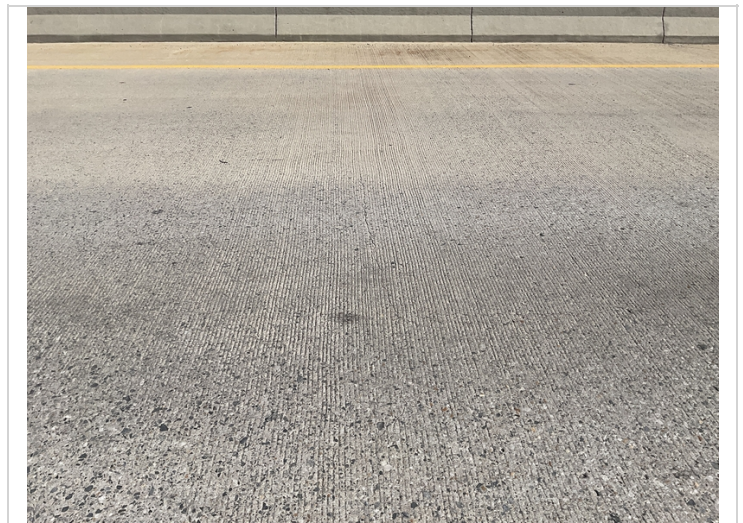
-The driving surface of the deck has sealable transverse and longitudinal cracking.

Sealable deck cracking.

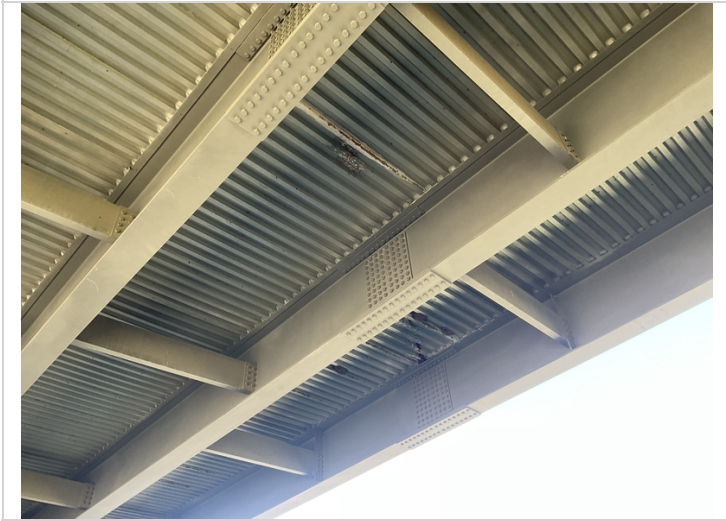
Span # 4 active corrosion in the deck pans.

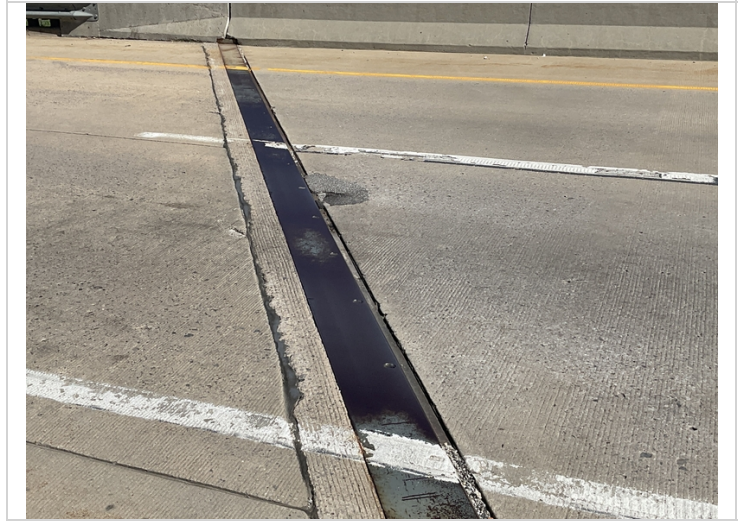
Span # 4 concrete spalling near the centerline at Abutment # 2.

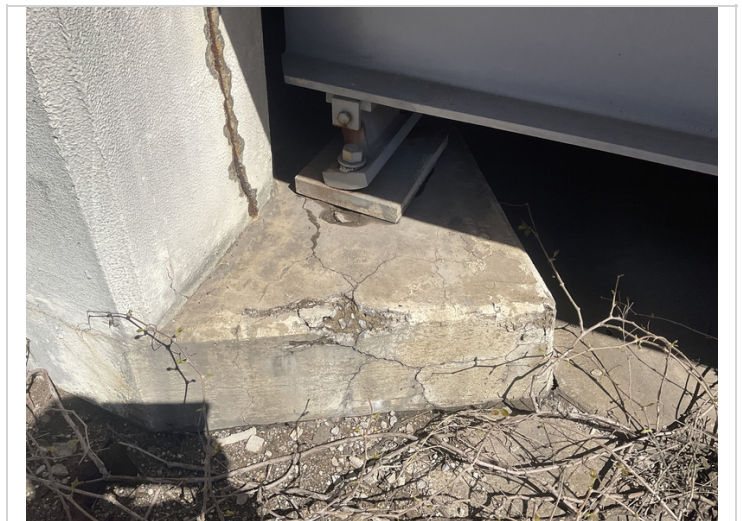
Abutment # 2 Lt end of the cap has concrete deterioration with up to 2" of section loss and map cracking in the bearing area.

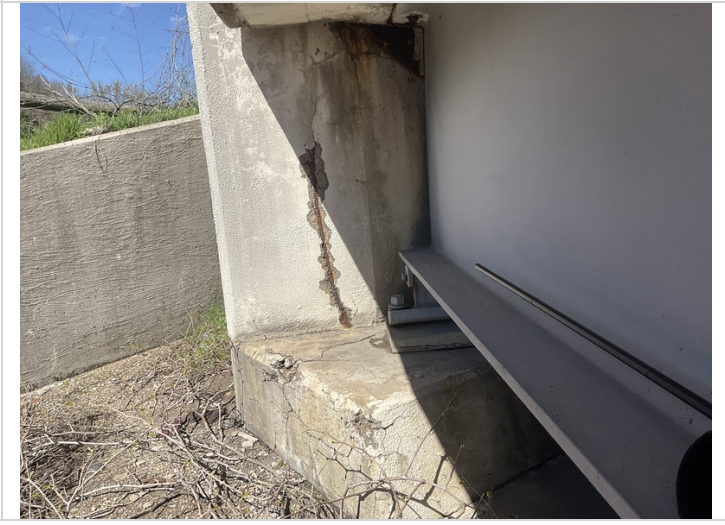
Abutment # 2 Lt back wall concrete spalling with exposed reinforcing steel.

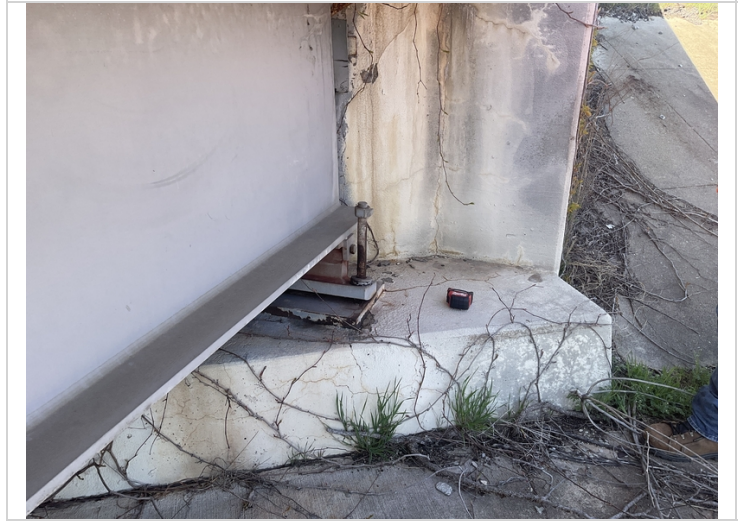
Abutment # 2 Lt map cracking at the end of the cap.

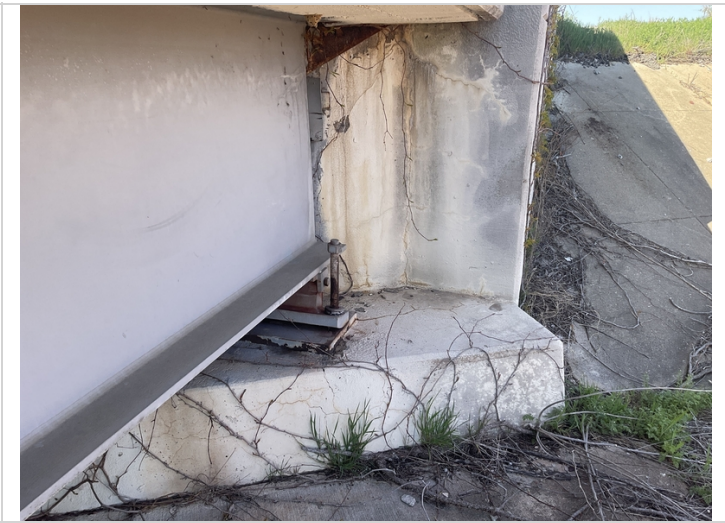
Abutment # 2 Rt end of the cap and back wall has map cracking with light efflorescence buildup.

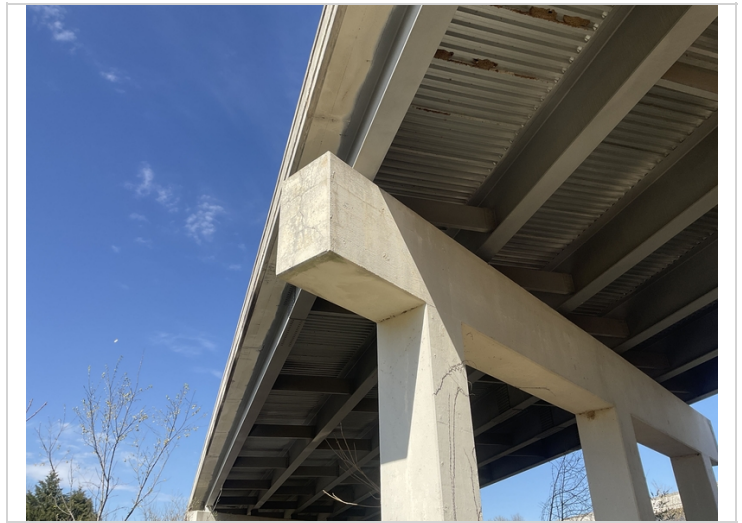
Bent # 3 Lt map cracking.

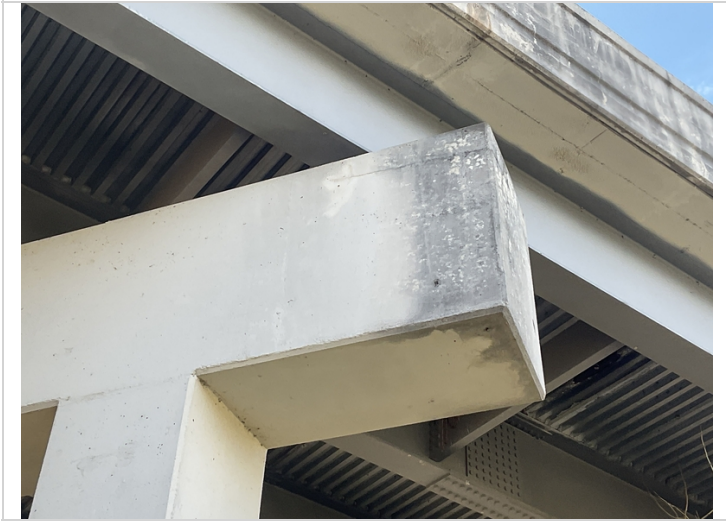
Bent # 3 Rt map cracking.

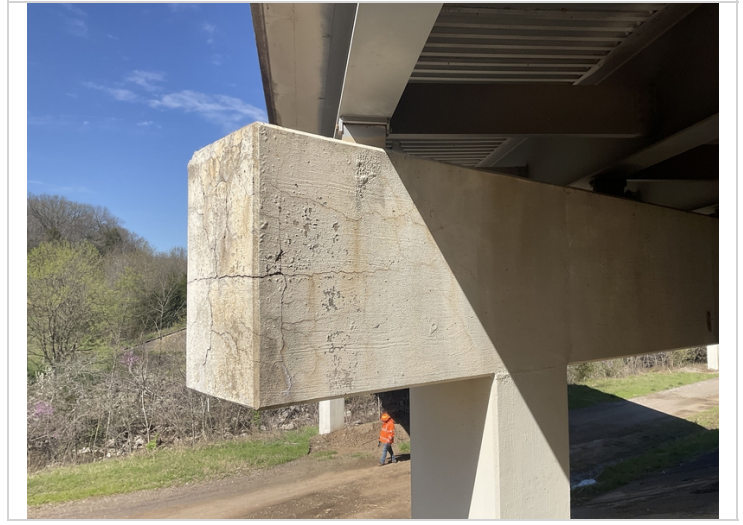
Bent # 2 Lt map cracking.

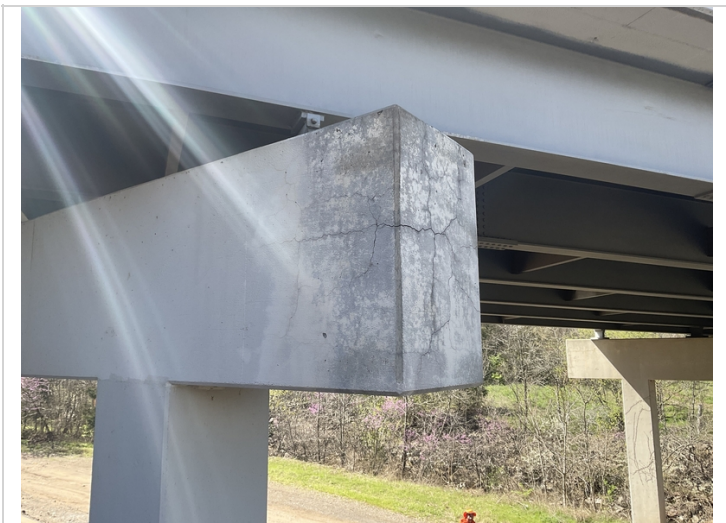
Bent # 2 Rt map cracking.

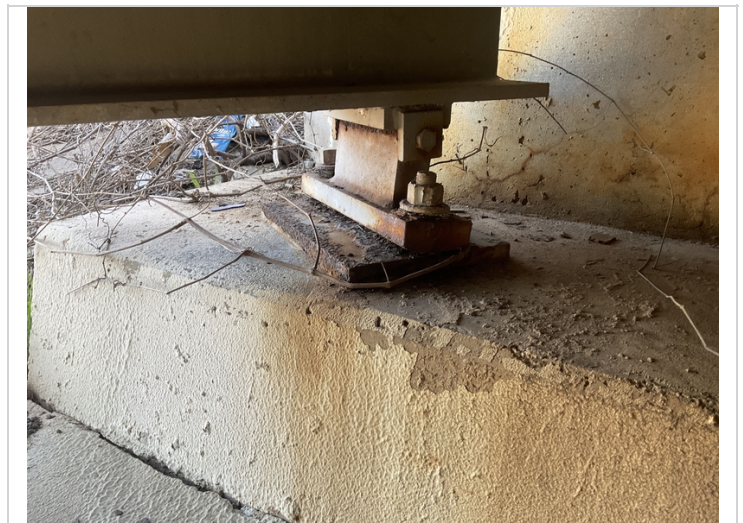
Abutment # 1 bearing # 6 active corrosion with flaking rust.

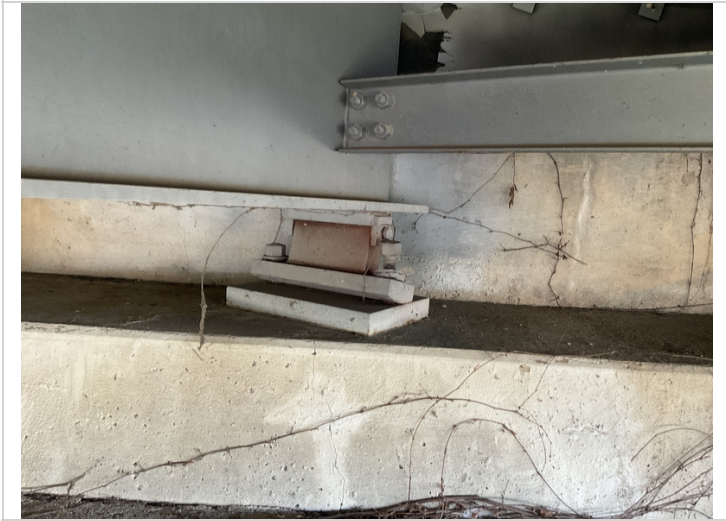
Abutment # 2 beam # 4 Rt bearing anchor bolt is working its way out of the cap.

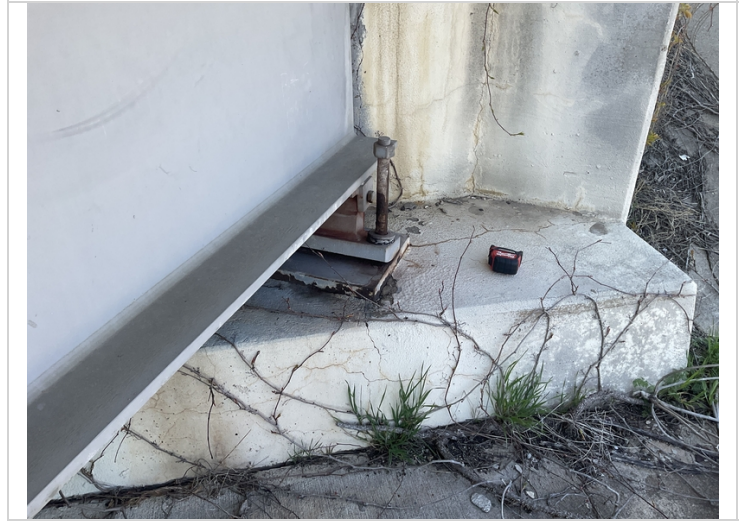
Abutment # 2 beam # 6 art anchor bolt working out of the cap.

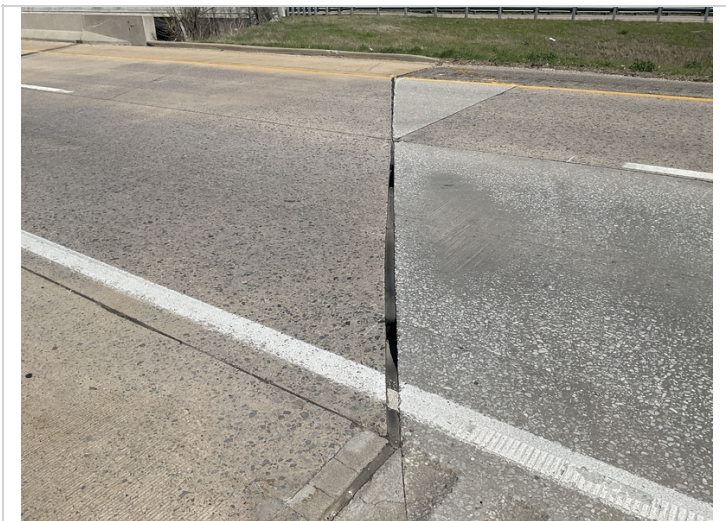
-The saw / construction joint sealant is deteriorated and completely missing in locations.

South approach slab missing joint seal.

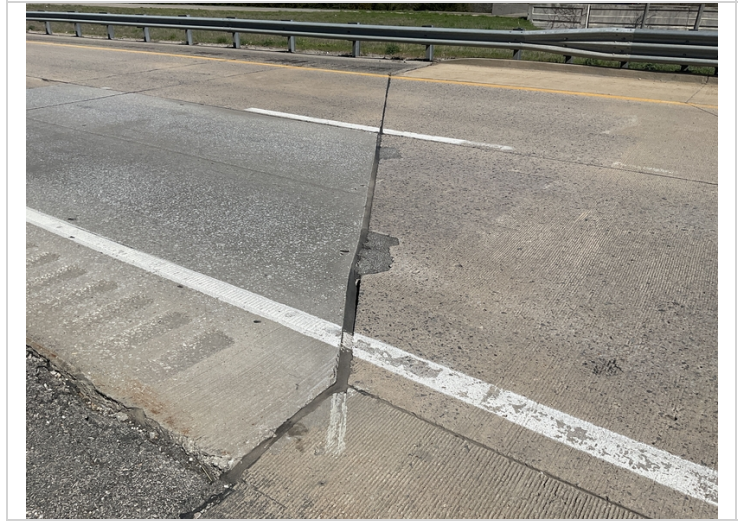
(321) -The approach slabs have sealable cracking. -The North approach slab has 2 fractured / spalled areas with a temporary asphalt patch in the North end of the slab. -The North approach slab has a few minor shallow spalls adjacent to the abutment back wall.

North approach slab spalling with temporary asphalt patches.

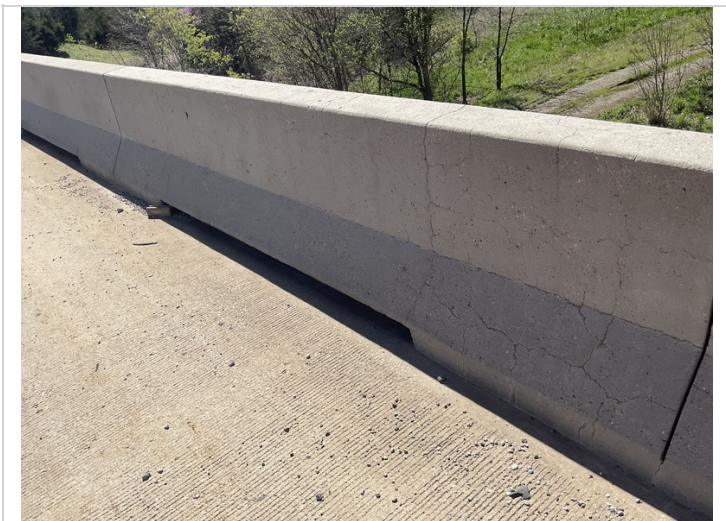
Bridge rail with wide vertical and map cracking.

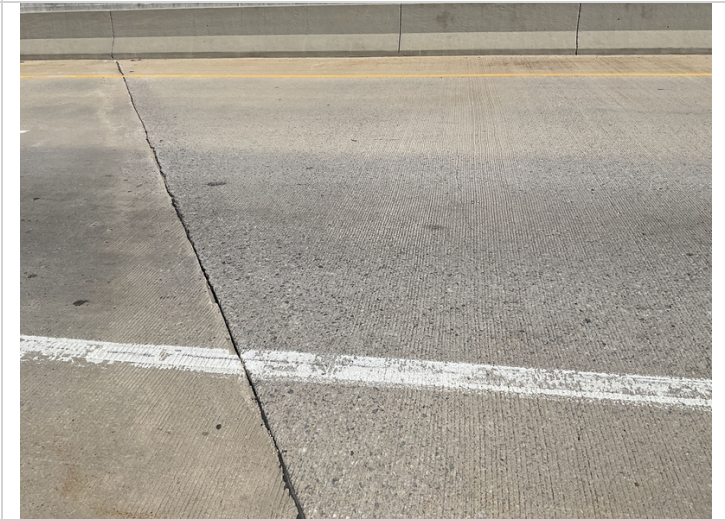
Sealable deck cracking.

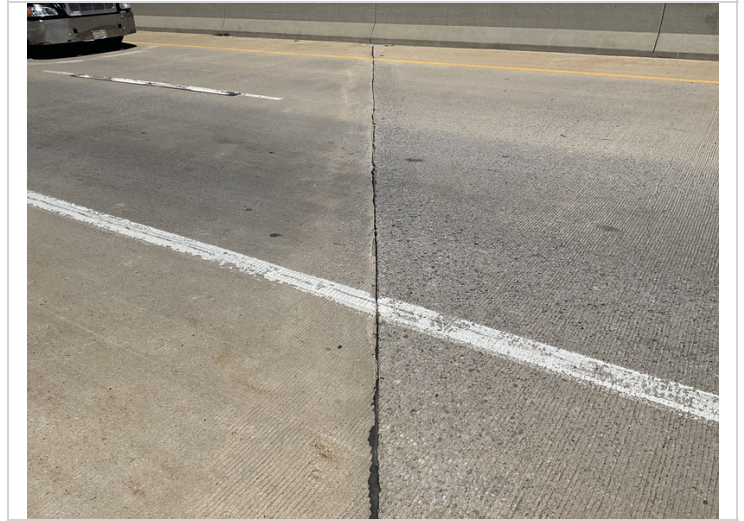
Span # 4 missing saw joint sealant.

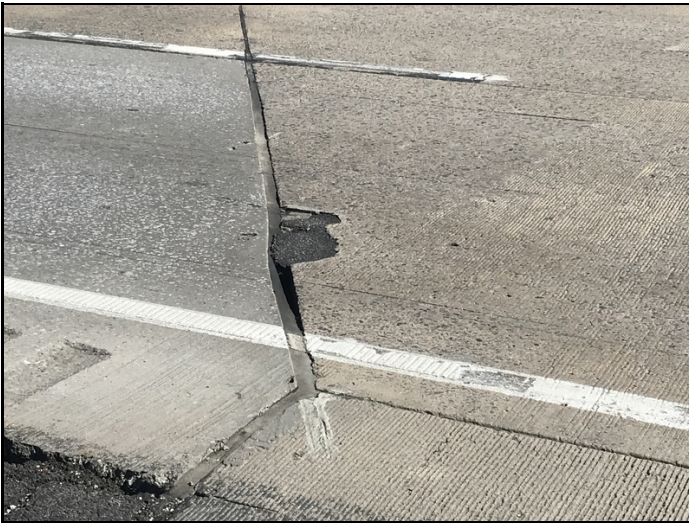
The North approach slab has an 8" X 2' fractured / spalled area with a temporary asphalt patch in the Northwest corner of the slab.

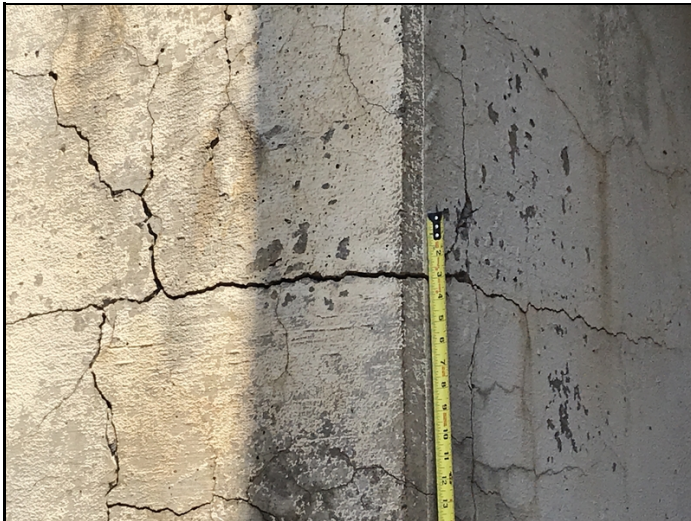
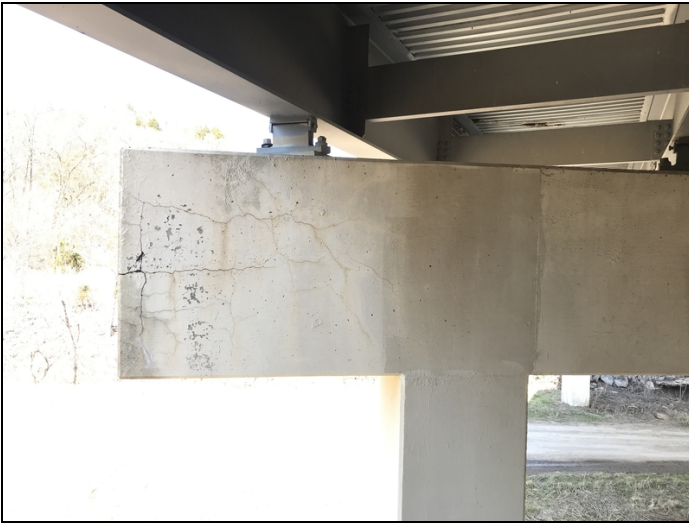
The left end of Bents # 2, 3, & 5 caps have open cracks. The ahead face of bent # 3 cap has a narrow diagonal shear type crack that propagates upward from exterior side of column # 1.

Left end of Bent # 2 cap.

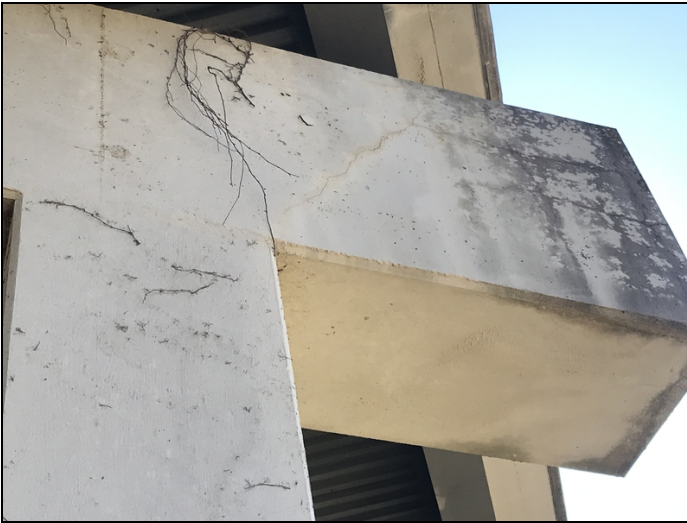
The ahead face of bent # 3 cap has a narrow diagonal shear type crack that propagates upward from exterior side of column # 1.

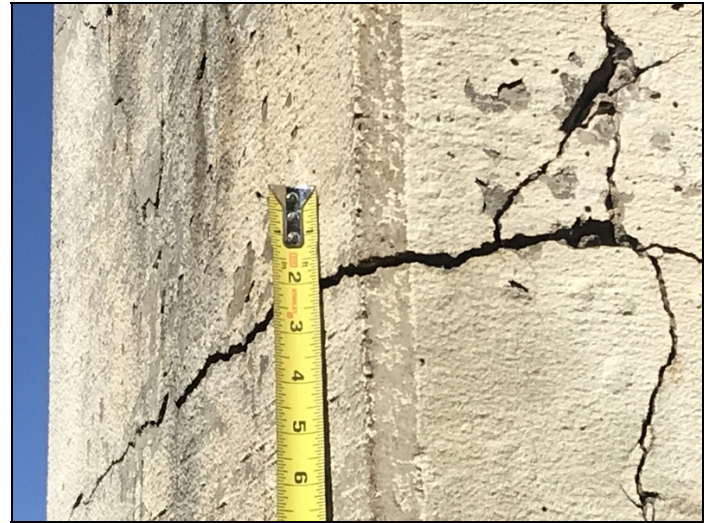
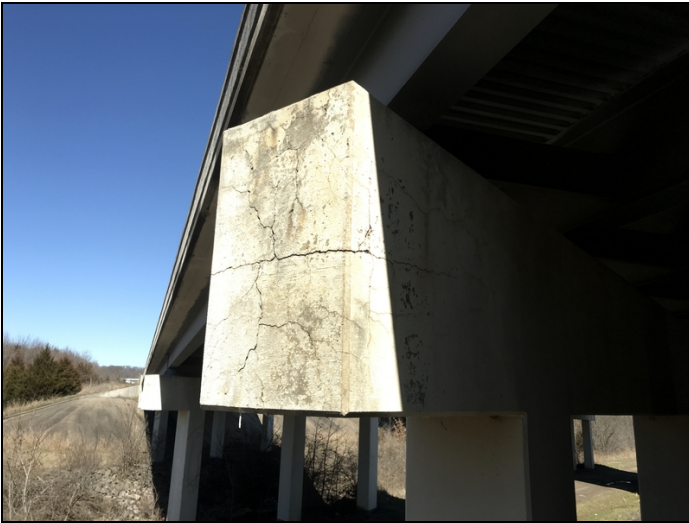
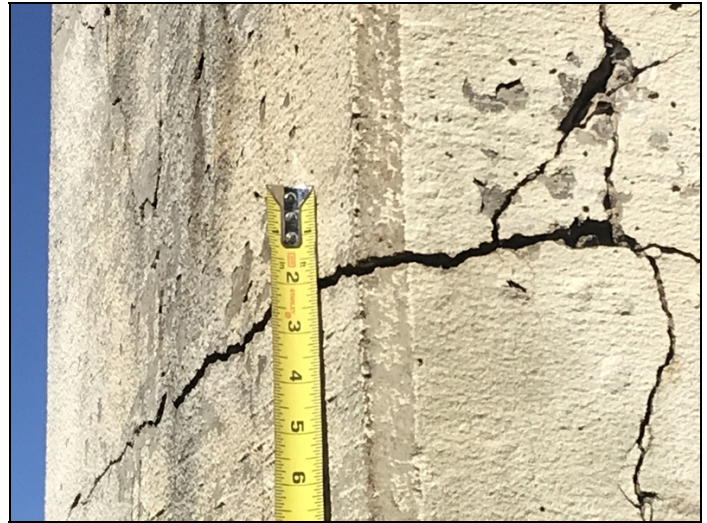
Bent 2 cap, left end-Wide mapcracking. Photo 1.

Bent 2 cap, left end-Wide mapcracking. Photo 2.

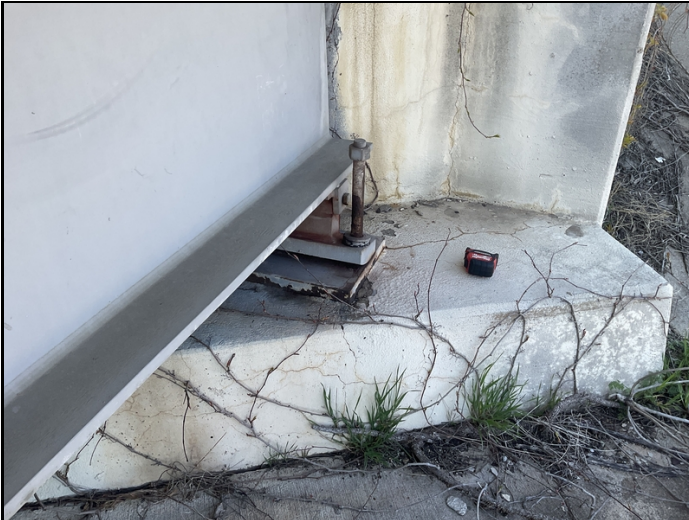
The Right anchor bolt for Beam # 6 at abutment # 2 appears to be working its way up out of the concrete abutment.

Abutment # 2 beam # 6 art anchor bolt working out of the cap.

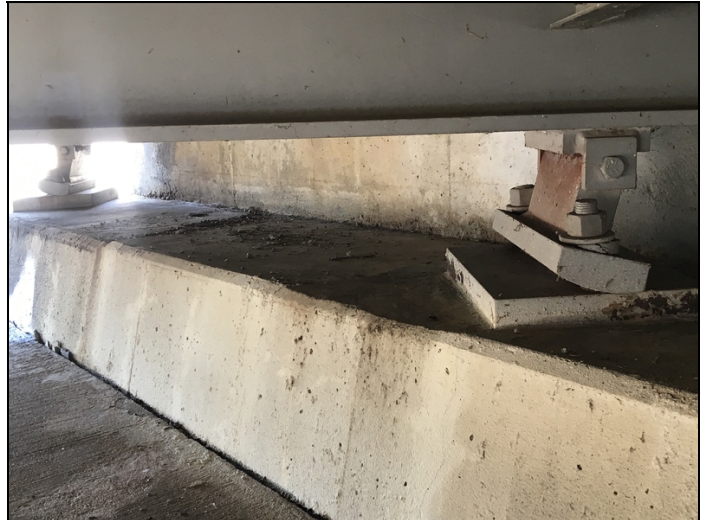
The Expansion bearings are fully expanded at approximately 50 degrees Fahrenheit.

Bearings # 1 & 2 at abutment # 2. Temperature is 60 degrees Fahrenheit.
