Asset #B6239(Routine, Underwater type 2)
I-49 Northbound over Farm Road - Wash. Co.

Location: 0.76 MI N OF EXIT 53

Team Lead: Eric West, Inspection Date: 04/05/2023

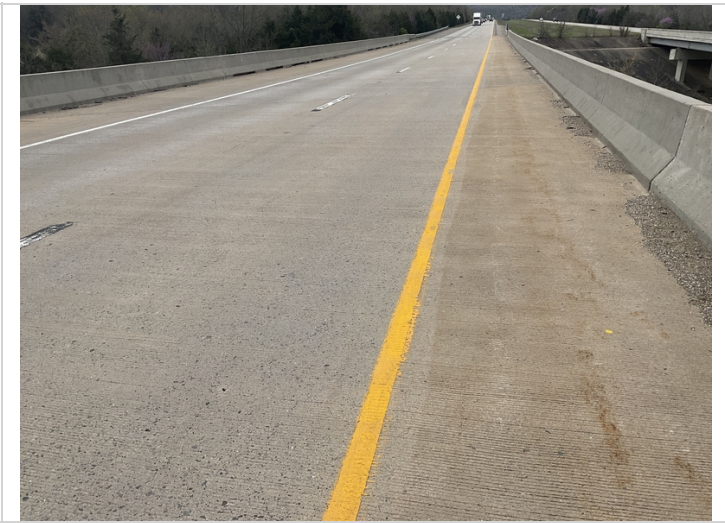
Typical driving surface of the deck.

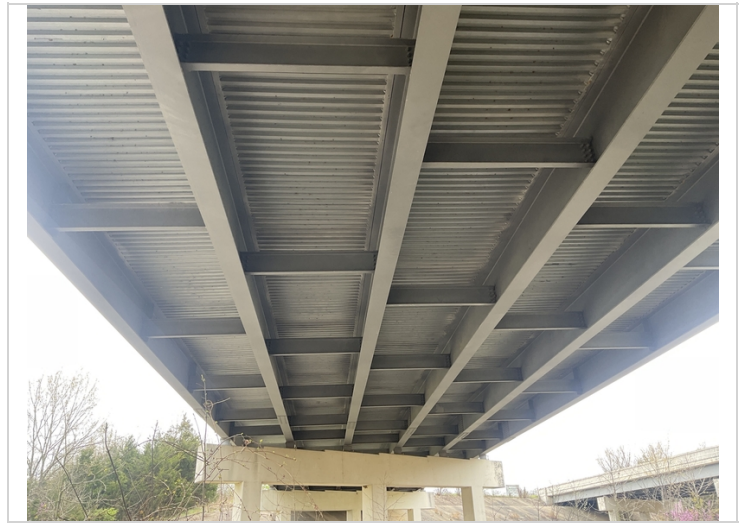
Typical undersurface of the deck.

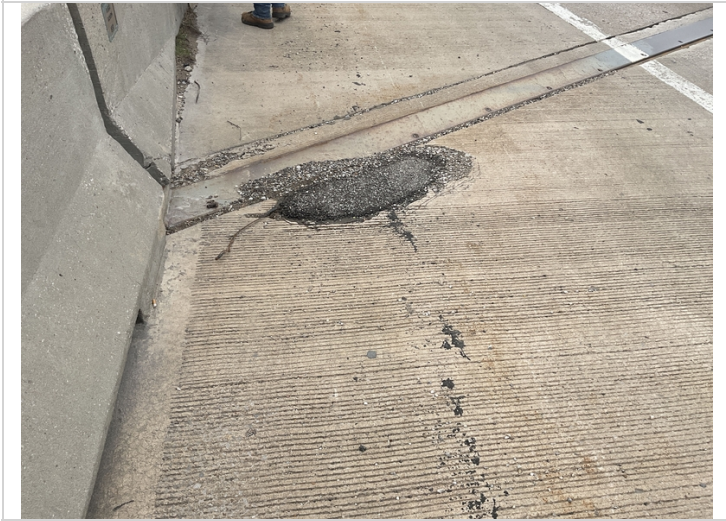
Span #1 Rt concrete deterioration with a failing temporary asphalt patch.

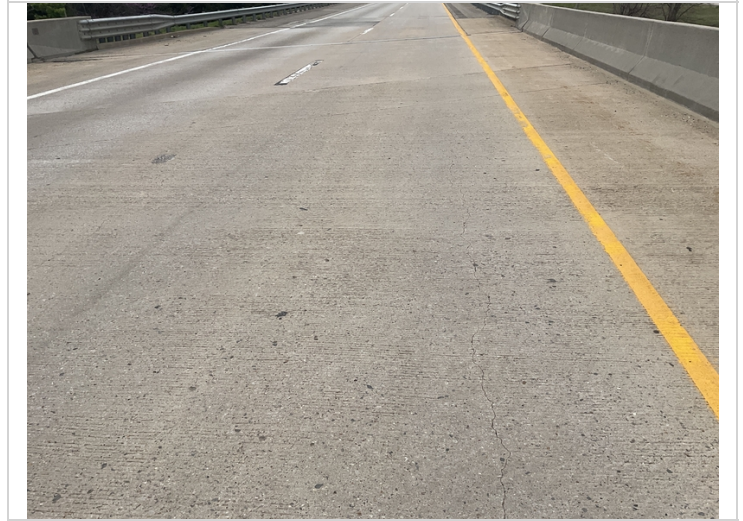
04/05/2023 - EJW - The driving surface of the deck has sealable transverse and longitudinal cracking.

Span #1 sealable deck cracking.

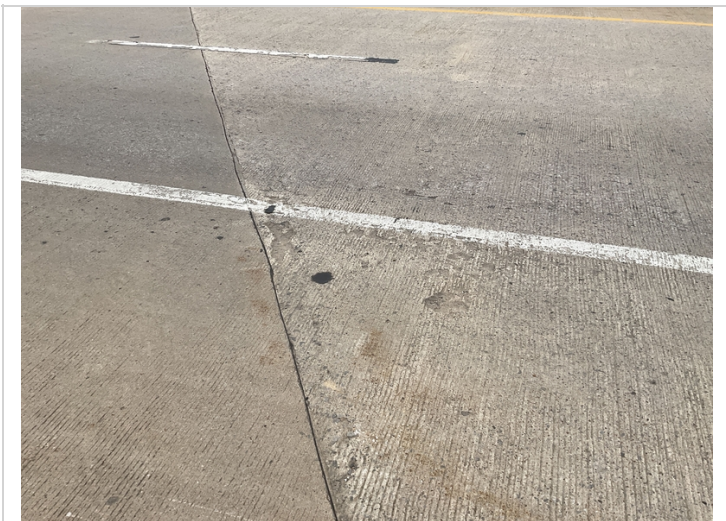
Span #3 Rt concrete deterioration and section loss.

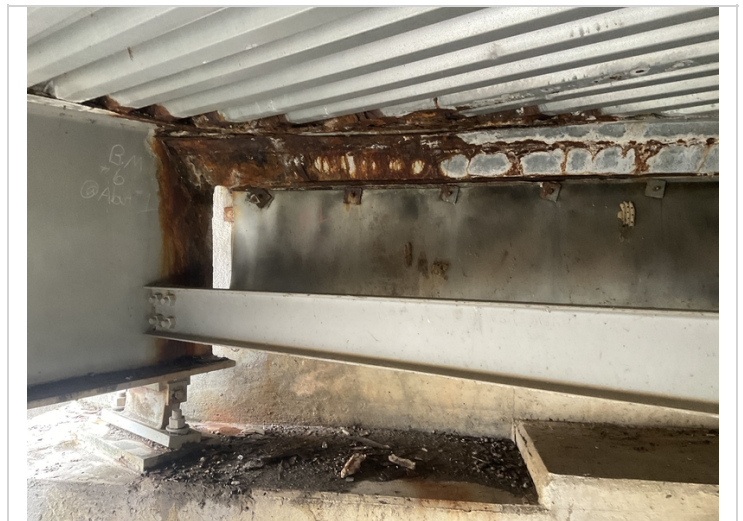
04/05/2023 - EJW - Active corrosion, flaking rust and minor section loss to the end of Beam # 6 at abutment # 1, and the end of Beam # 3 at abutment # 2.

Abutment # 1 Beam # 6 active corrosion with up to 1/8" section loss at the base of the expansion dam.

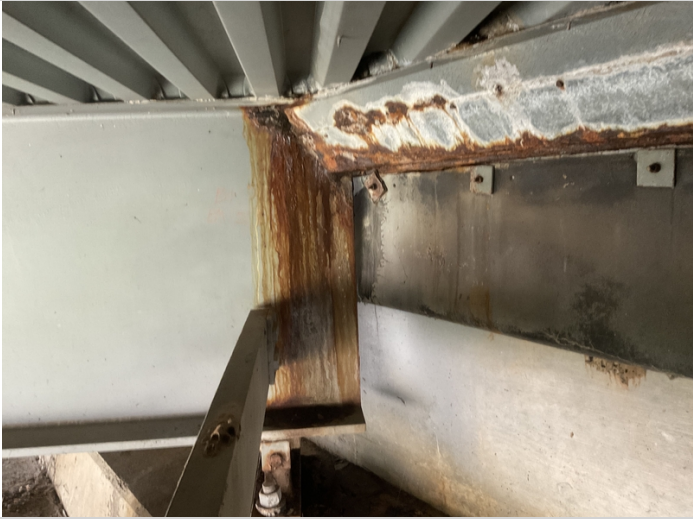
Abutment # 2 beam # 3 active corrosion with initial section loss at the expansion dam.

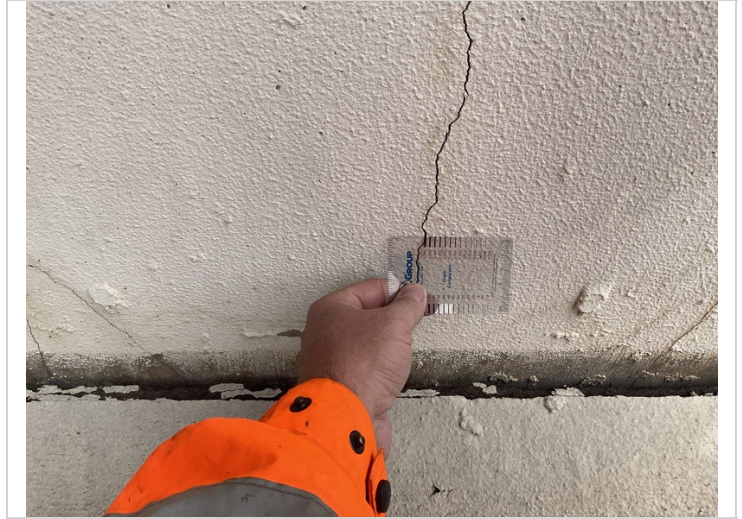
Bent # 2 column # 1 vertical cracking.

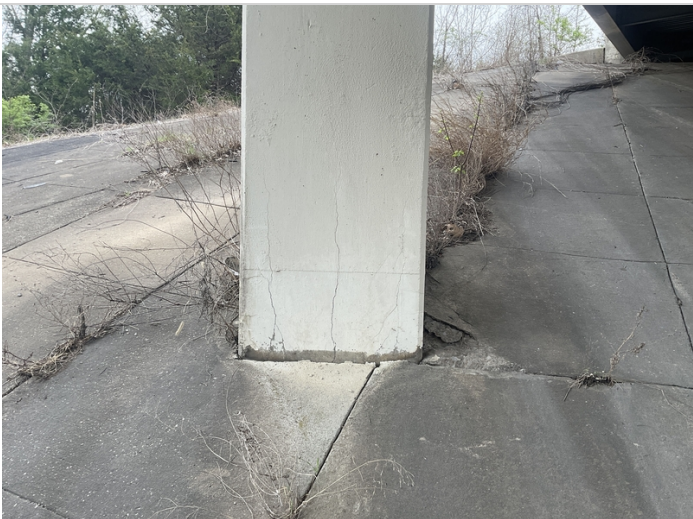
Bent # 2 Column #3 vertical cracks.

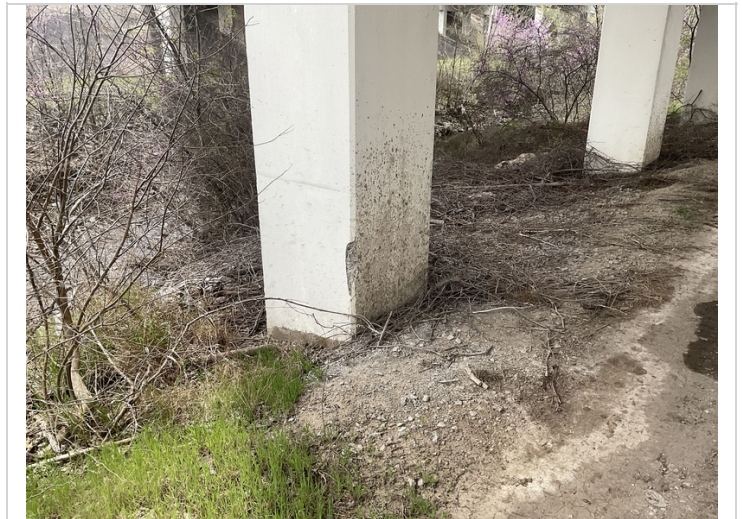
Bent # 4 column # 3 has a 5" spall in the corner of the column with no exposed reinforcing steel.

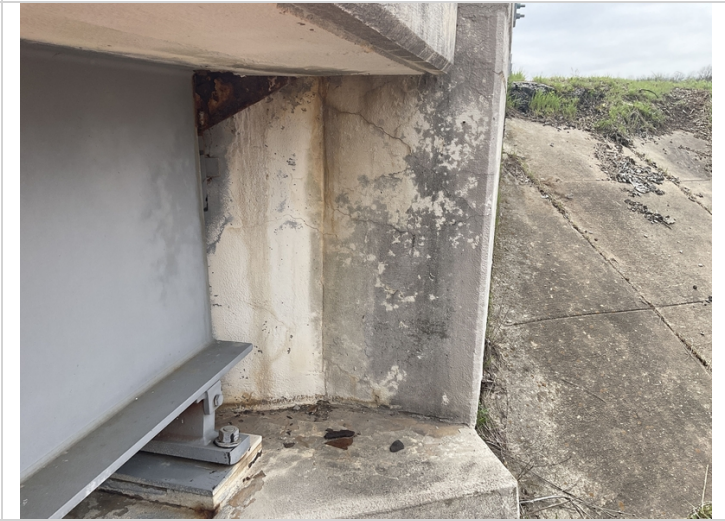
Abutment #1 Lt wing wall juncture map cracking.

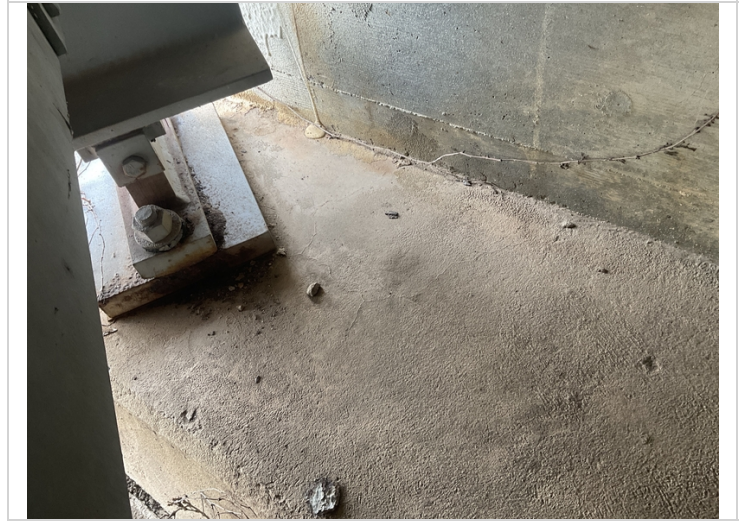
Abutment # 2 Lt map cracking at beam # 1.

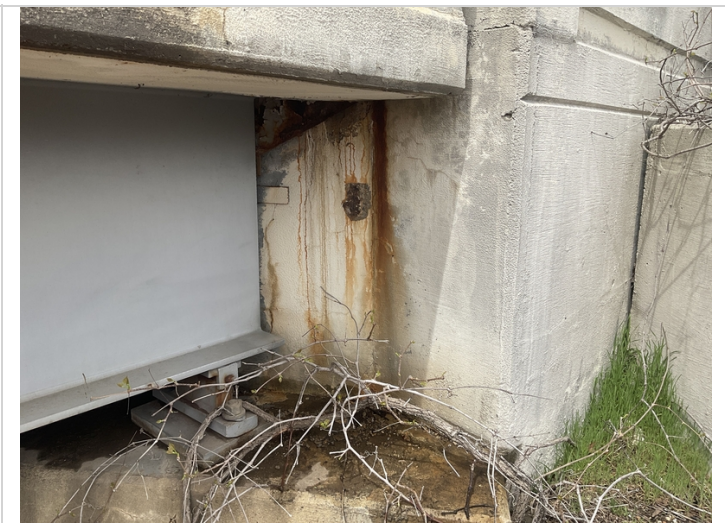
Abutment # 2 Rt concrete spalling with exposed reinforcing steel.

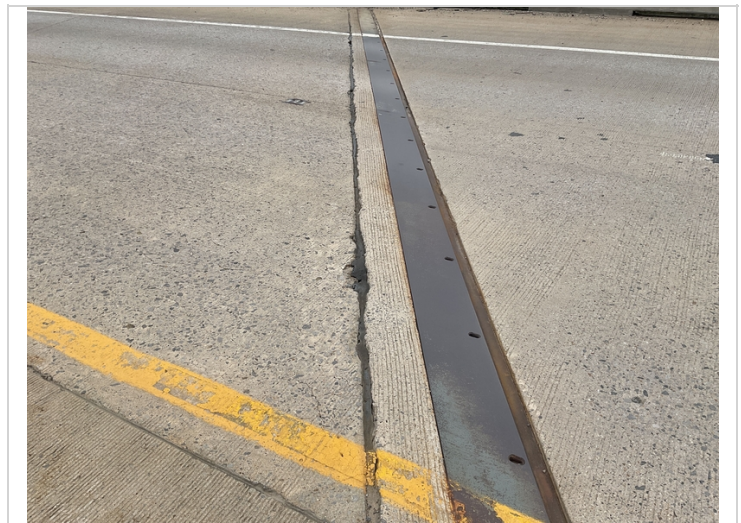
Abutment #2 top of the backwall transverse cracking with light wear.

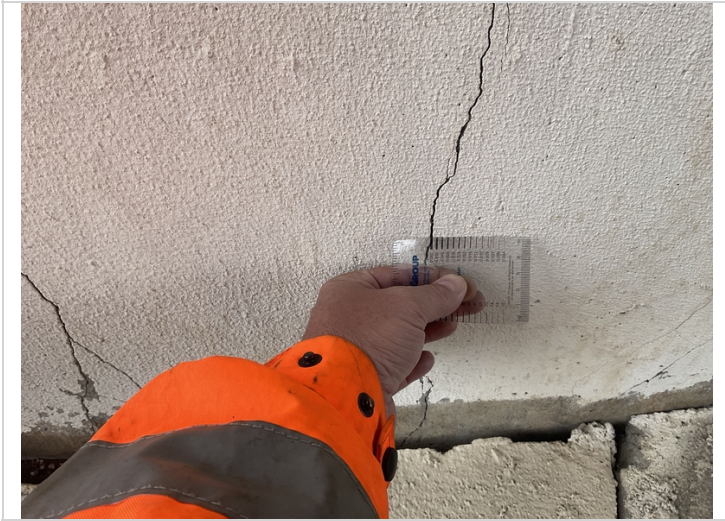
Bent # 2 Column #3 with 0.060" vertical cracks.

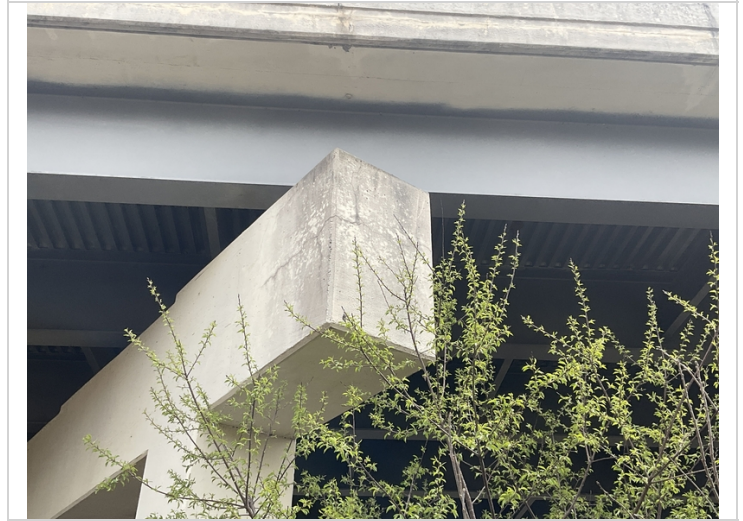
Bent #4 Lt map cracking.

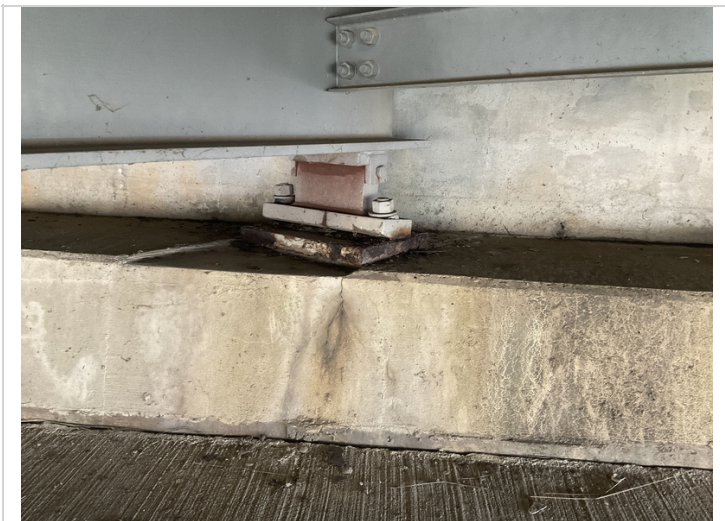
Abutment # 1 bearing #4 active corrosion with pack rust.

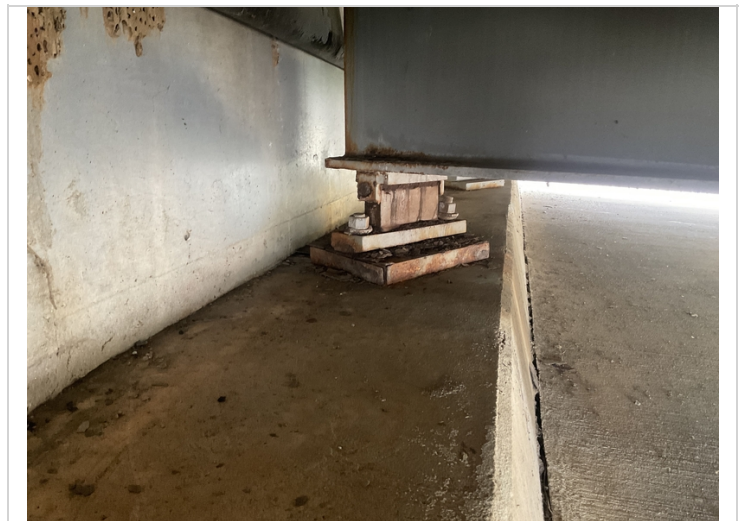
Abutment # 2 bearing # 3 active corrosion with pack rust.

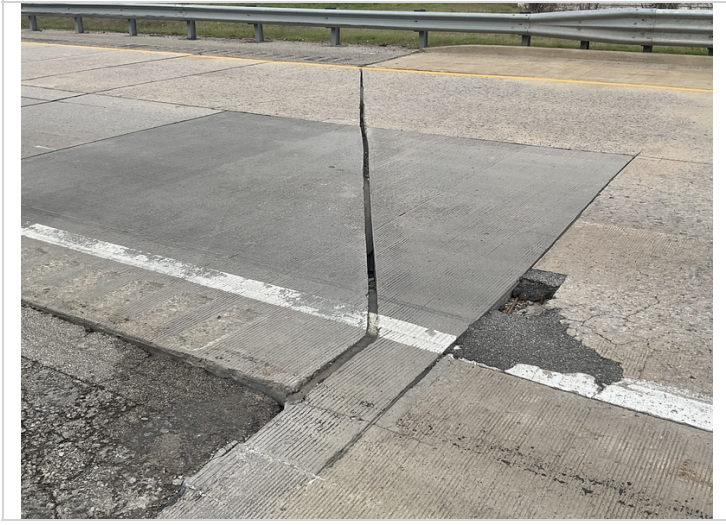
South approach slab joint seal missing.

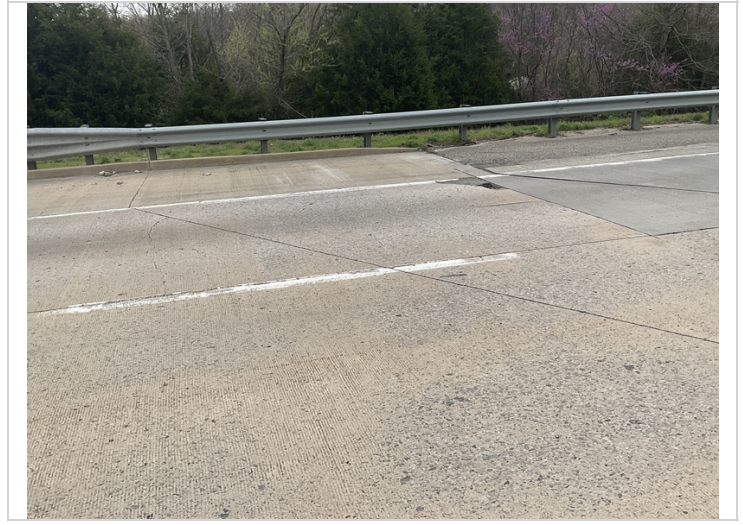
South approach slab concrete spalling and wide transverse cracking.

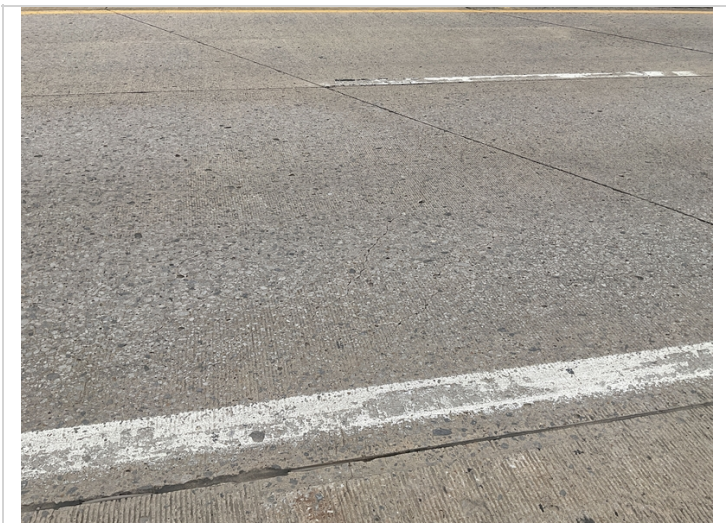
North approach slab cracking.

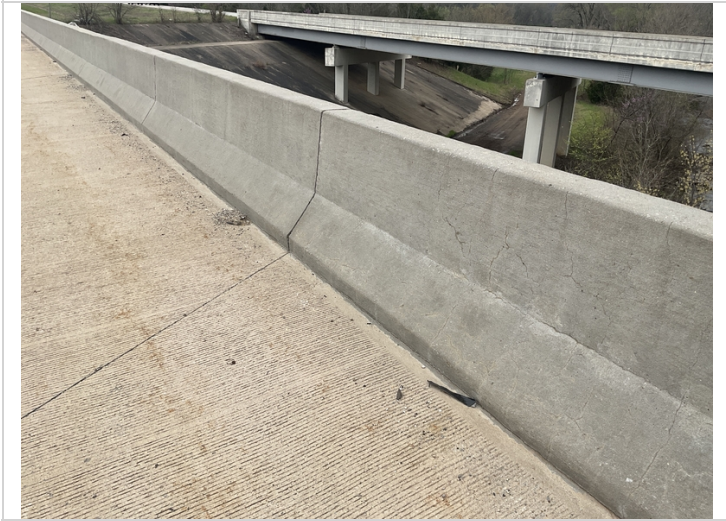
Typical bridge rail cracking.

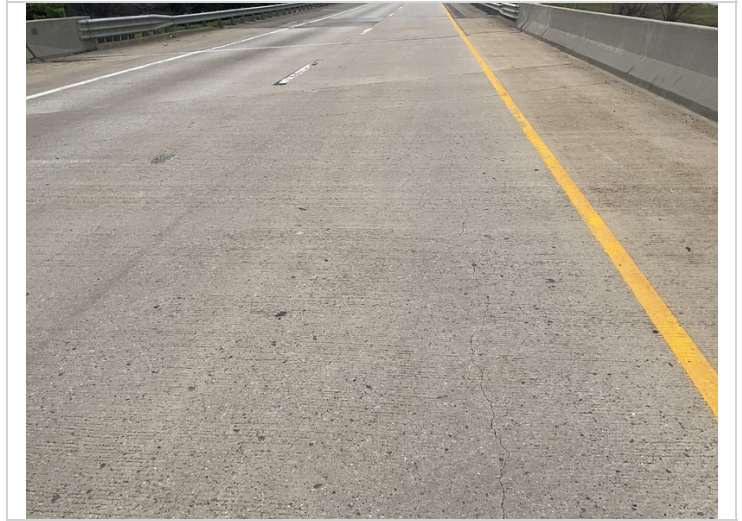
Span #1 sealable deck cracking.

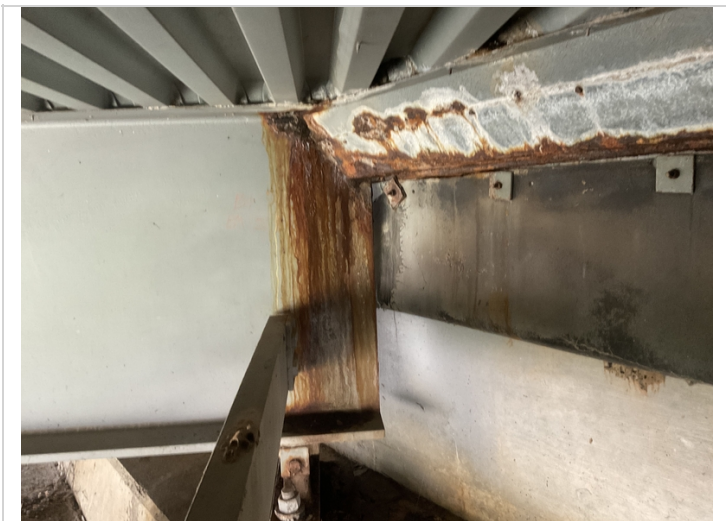
Abutment # 2 beam # 3 active corrosion with initial section loss at the expansion dam.

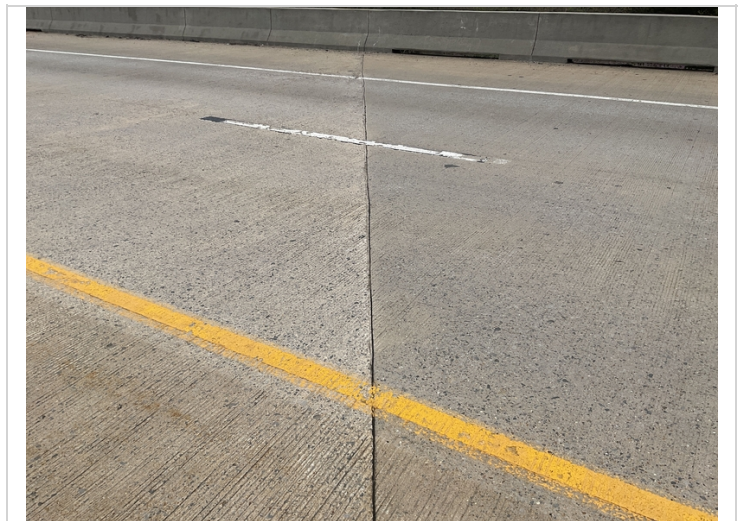
04/05/2023 - EJW - Saw joint sealant is deteriorating and missing in areas.

Failing saw joint sealant.

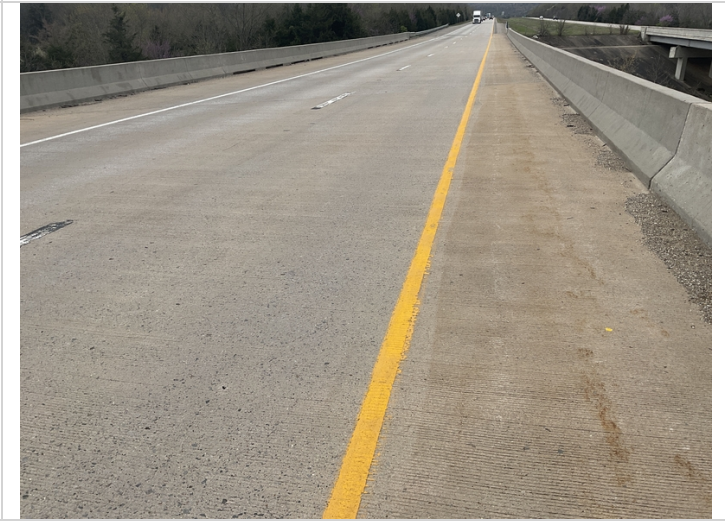
Typical driving surface of the deck.

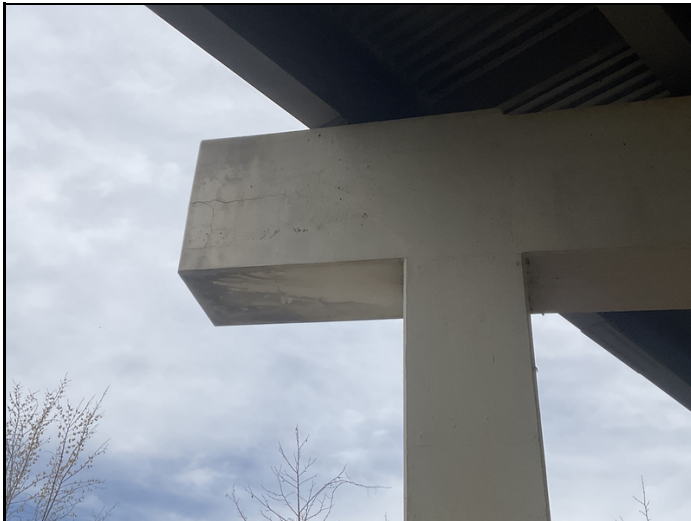
The right side of Bent # 2 cap and the left side of Bent # 3 cap has map cracking with a hairline diagonal shear type crack visible on both sides of cap that propagates from the area of mapcracking.

Bent 3 cap, left side-Wide cracking.

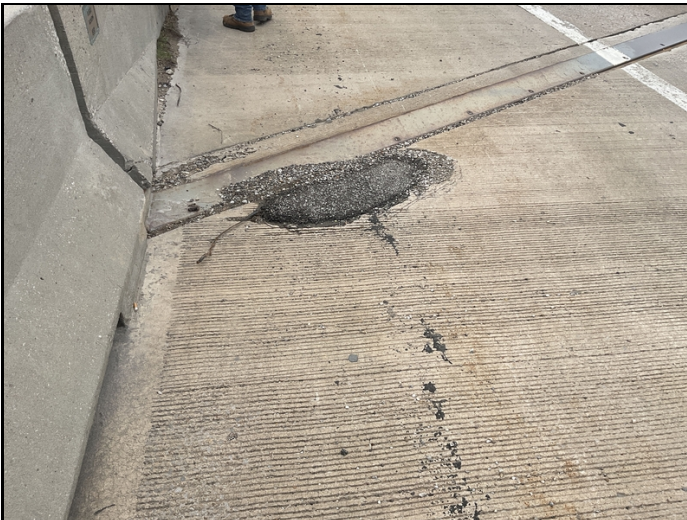
Deck -
The Southeast corner of Span # 1 has a 2' area with soft deteriorated concrete.

Span #1 Rt concrete deterioration with a failing temporary asphalt patch.

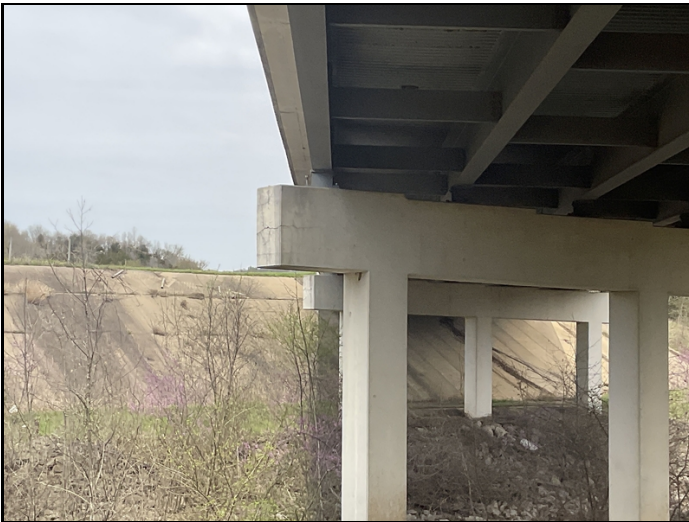
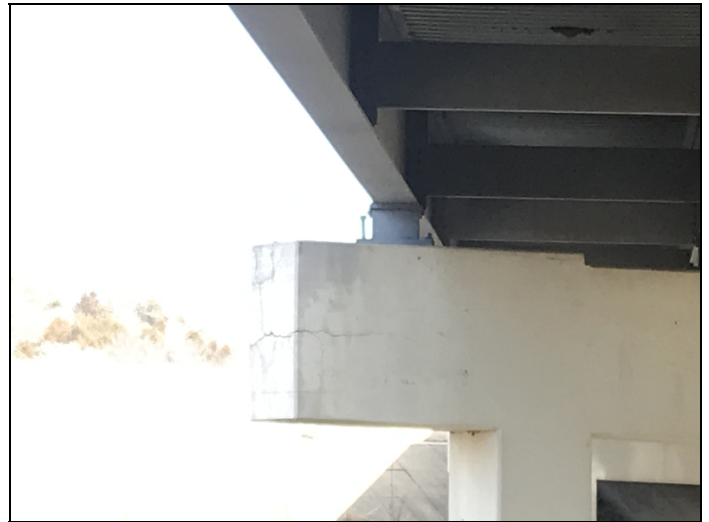
The exterior anchor bolt at Bent # 3 Beam # 1 is working out of the bent cap.

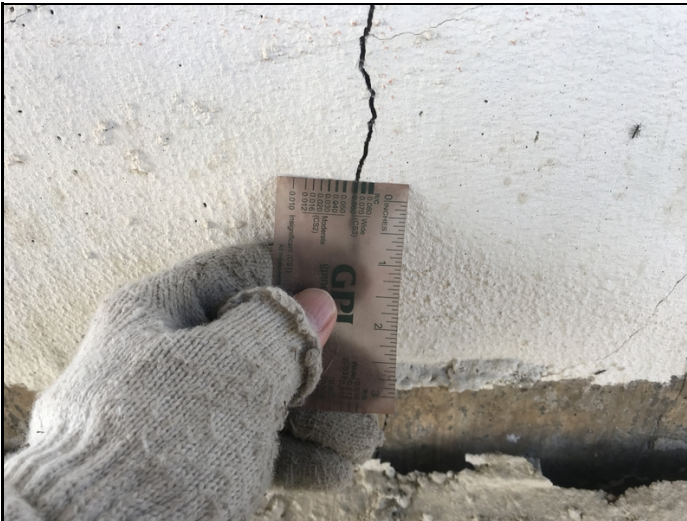
There is vertical cracking at the base of the columns at Bents # 2 & 3.

Cracking at Bent # 2 measures up to 0.060" in width.

Bent # 2, column # 2 vertical cracks measure up to 0.060" in width during this inspection.
