Asset #A6242(Routine)

I 49 SB LNS over W Wilson St -Washington

Location: JCT I 49 & CO RD 26

Team Lead: Eric West, Inspection Date: 07/19/2022

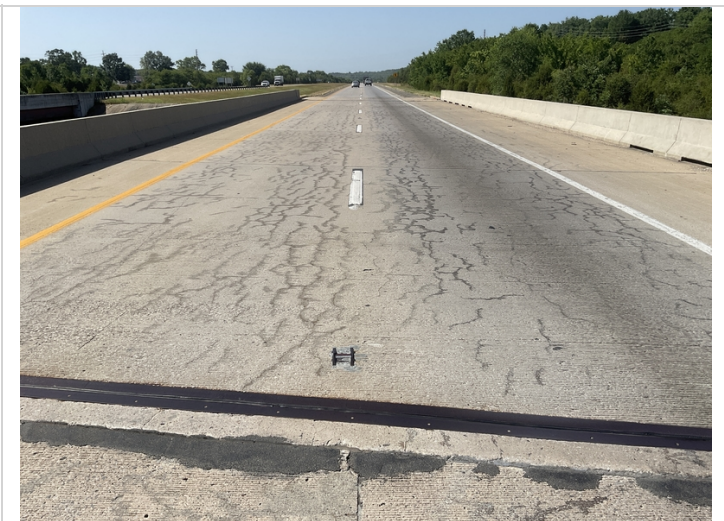
Typical driving surface of the deck.

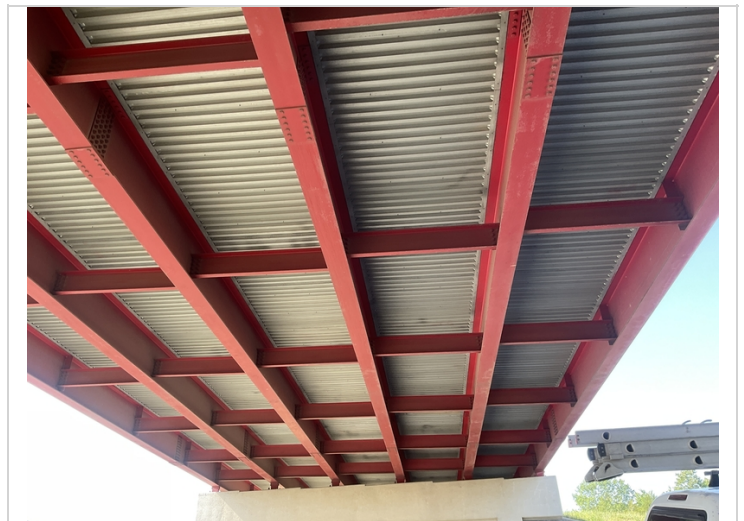
Span #2 typical undersurface of the deck.

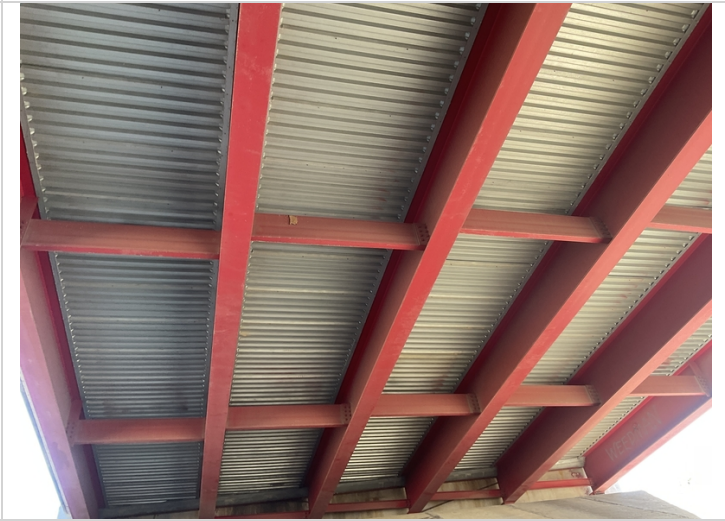
Span #3 typical undersurface of the deck.

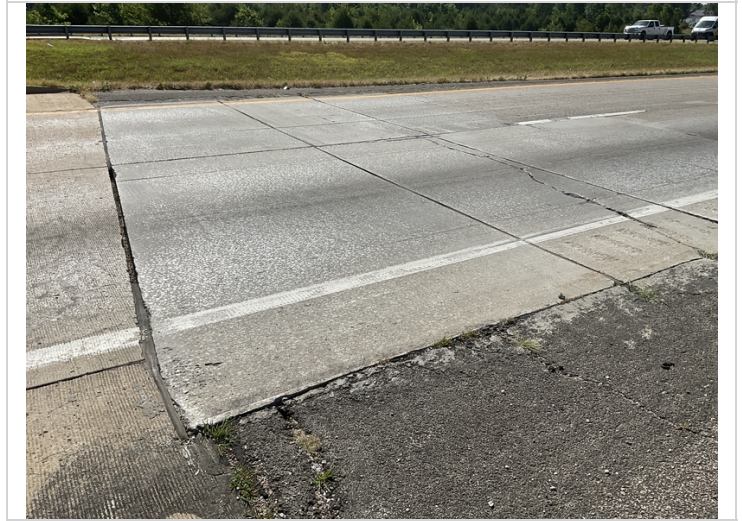
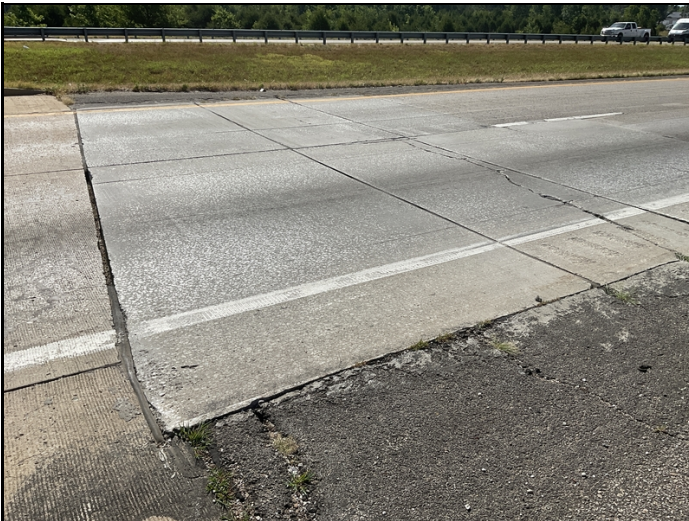
South approach roadway joint seal missing and fractured concrete slabs.

The south approach roadway has joint sealant missing between the approach slab and the roadway slabs.

The approach roadway concrete slabs are cracking and settling.

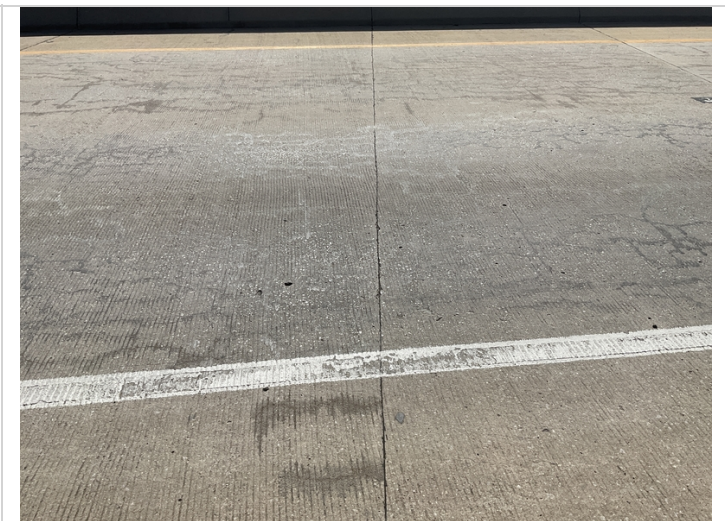
Failing saw joint sealant.

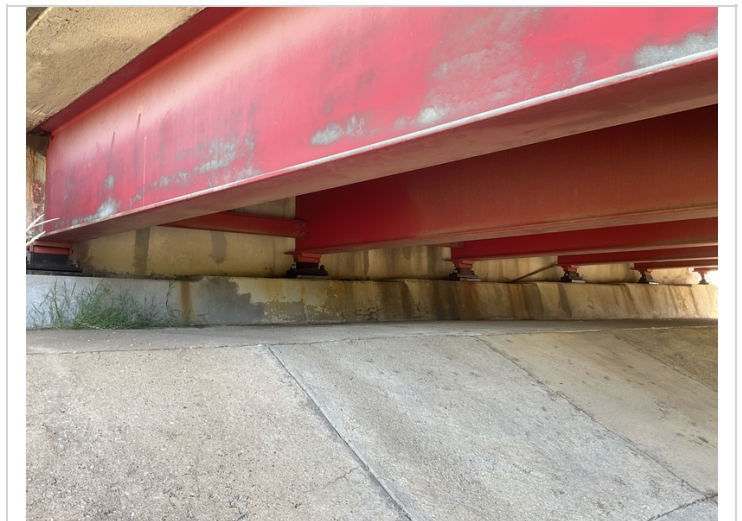
Abutment #2 typical.

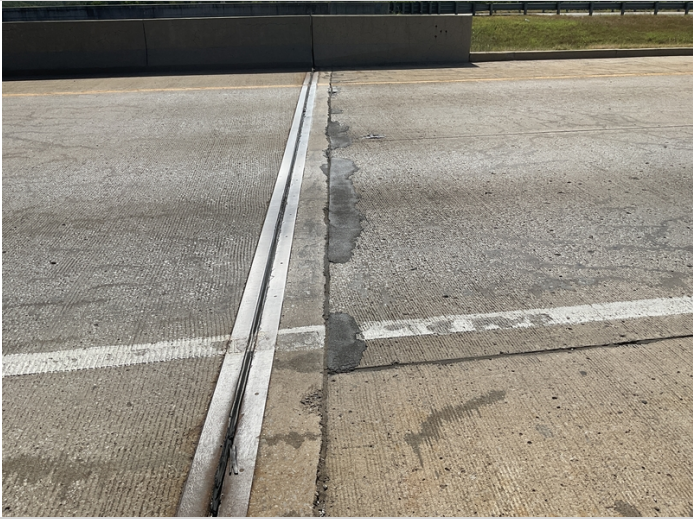
Abutment #1 top of back wall cracks sealed.

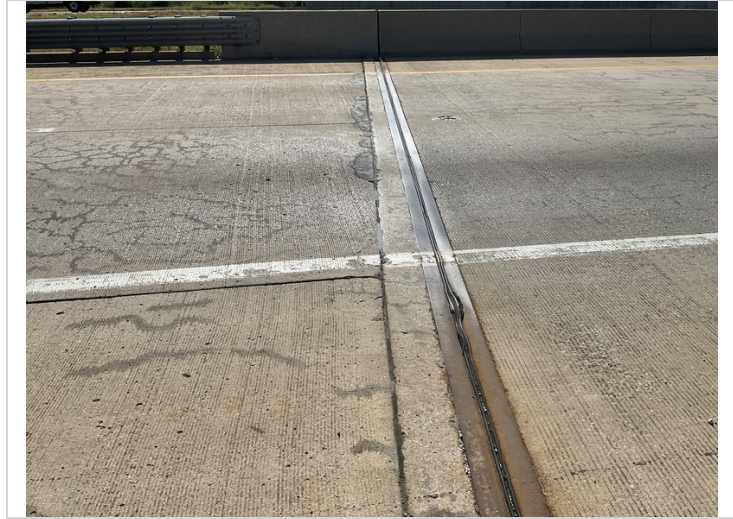
Abutment #2 top of back wall cracks sealed.

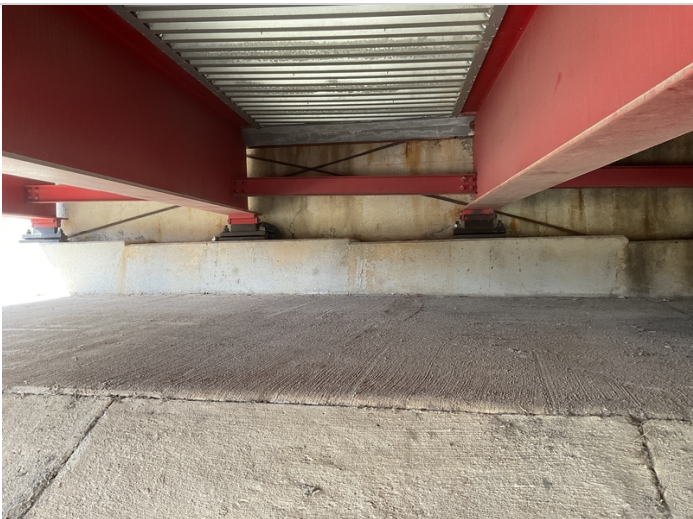
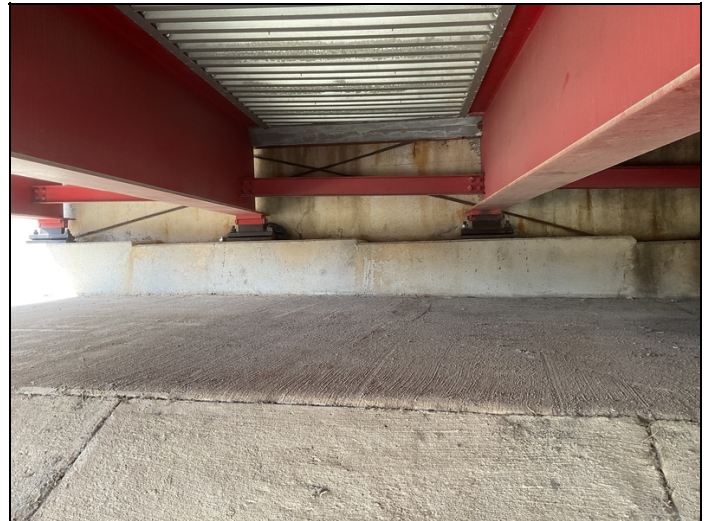
Abutment #1 road iron compression joint seal support fractured loose and dropped down out of position.

The expansion joints have sections of metal that help support the compression joint seal that have fractured and dropped out of position from inside the joint.

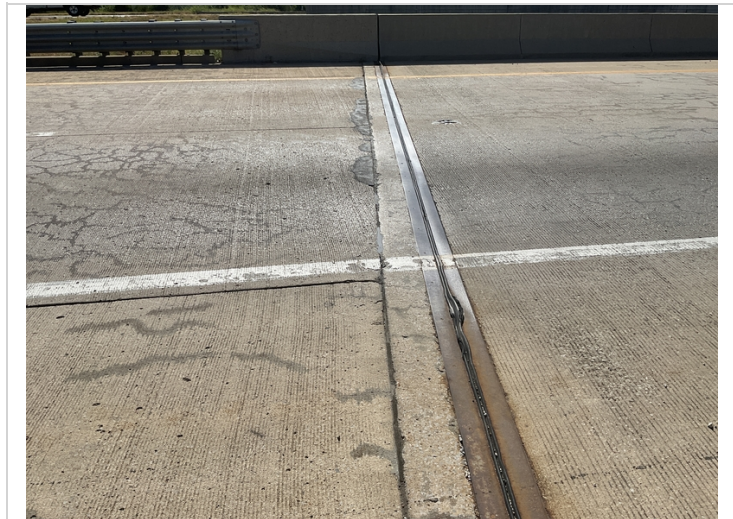
Abutment #2 compression joint seal.

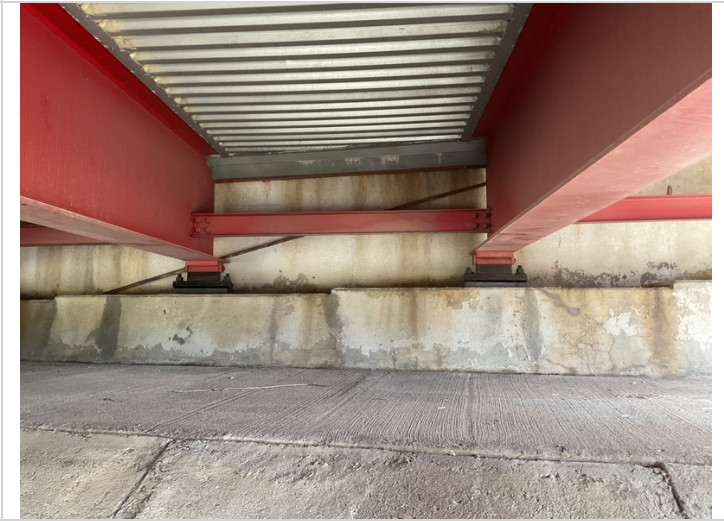
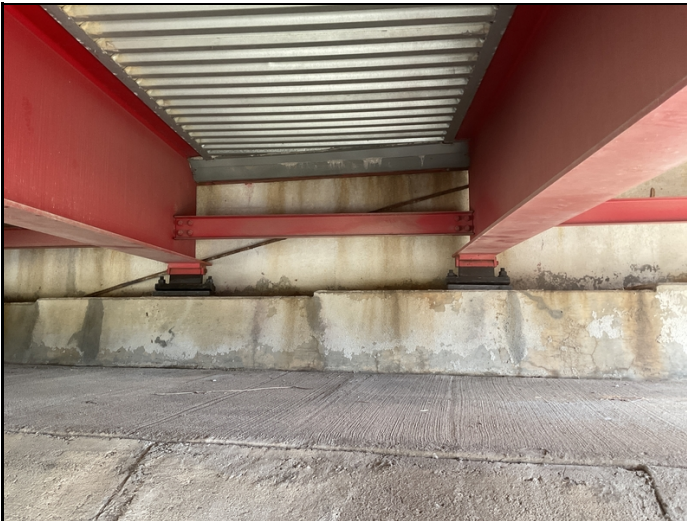
Abutment #2 road iron compression joint seal support fractured loose and dropped down out of position.

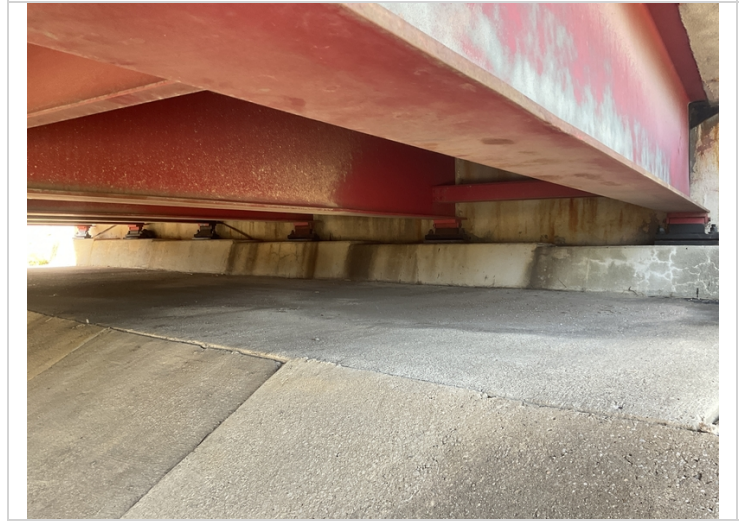
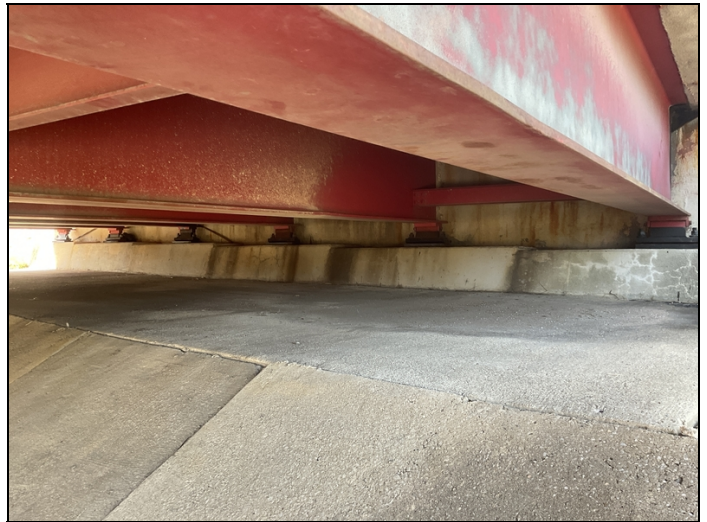
Abutment #1 bearings have been painted.

07/19/2022 - EJW - maintenance forces have painted the bearings and masonry plates.

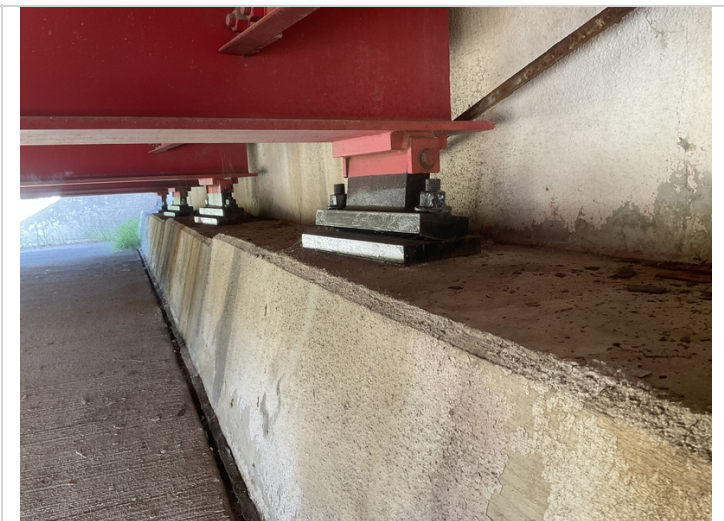
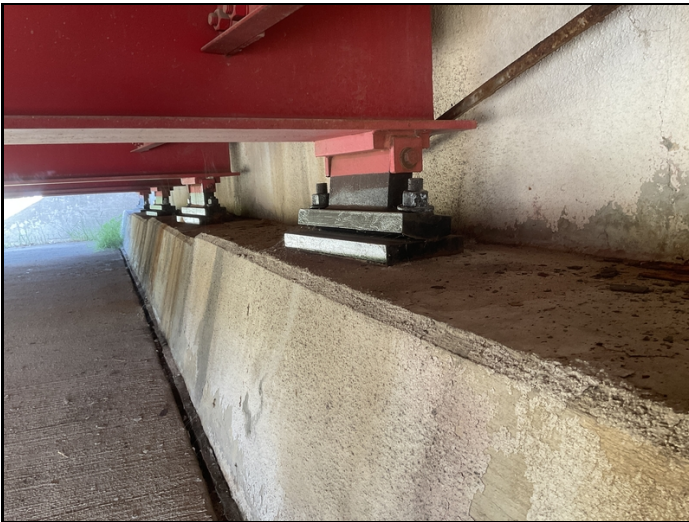
Abutment #2 bearings mostly painted

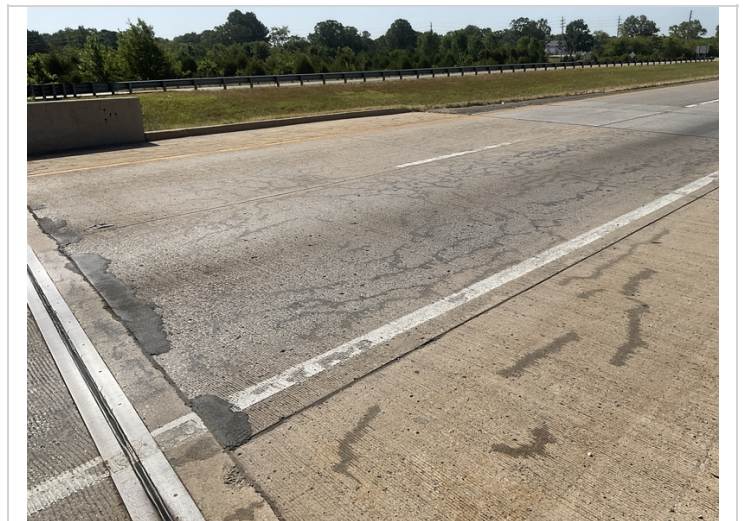
Abutment #1 approach slab cracks sealed.

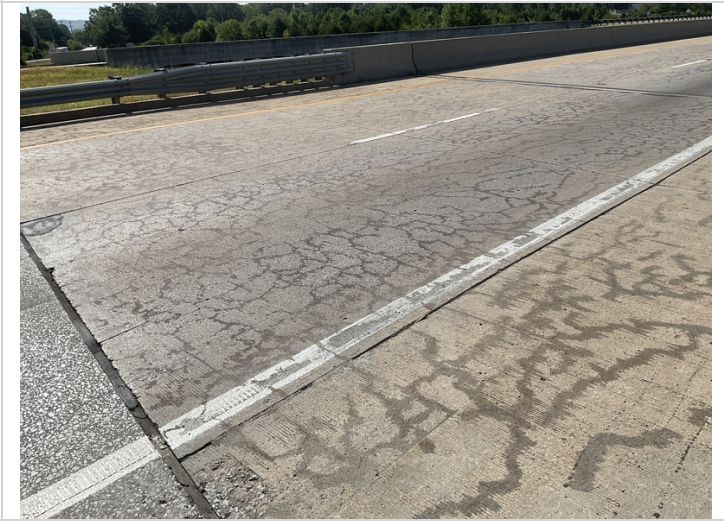
North approach slab cracking sealed.

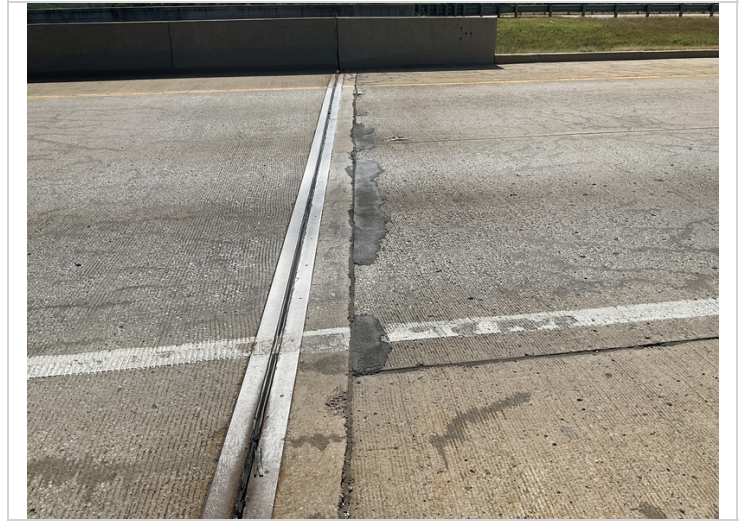
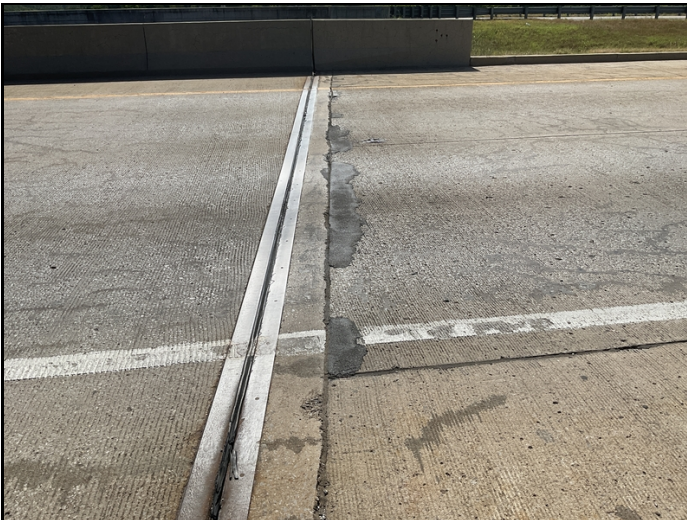
Abutment #1 approach slab repairs.

07/19/2022 - EJW - Maintenance forces have made epoxy repairs to the spalling.

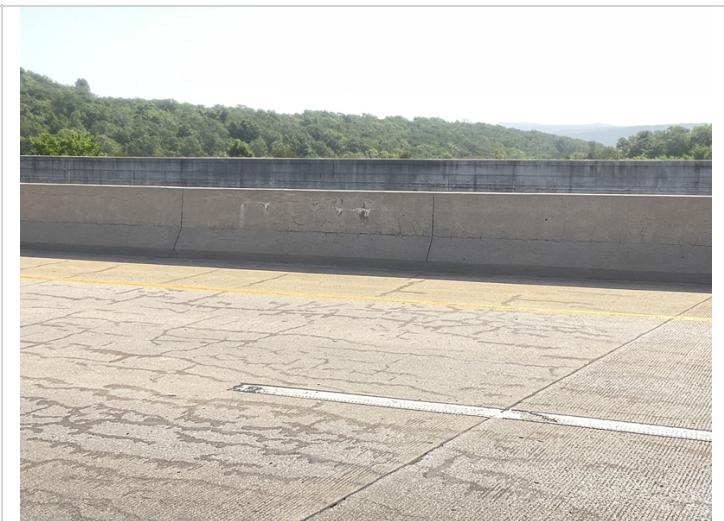
Rt bridge rail cracking with efflorescence buildup.

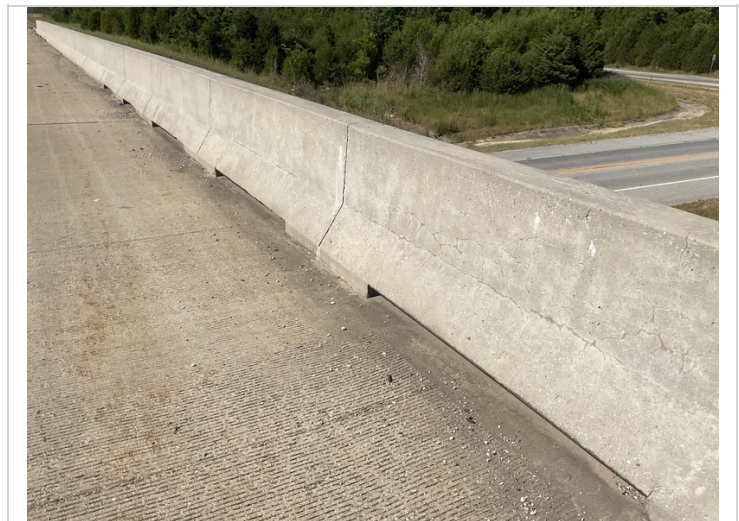
Typical concrete bridge rail.

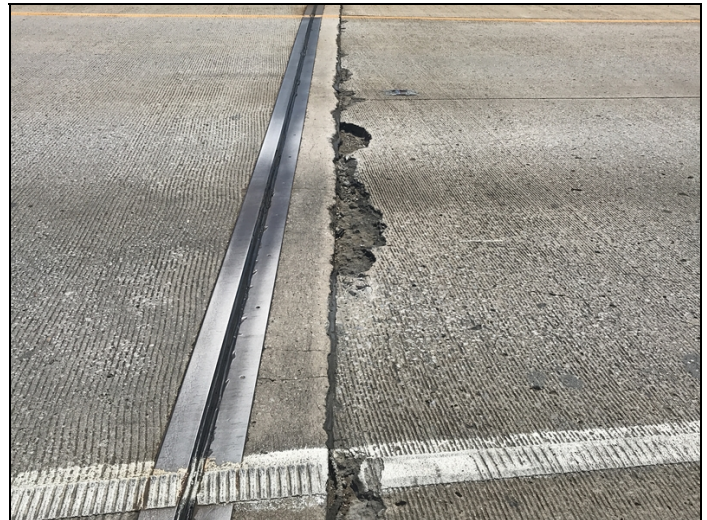
The South approach slab has several large spalls adjacent to the abutment backwall. The most extreme area is in the outside lane with a 7' long x 10" wide spall.

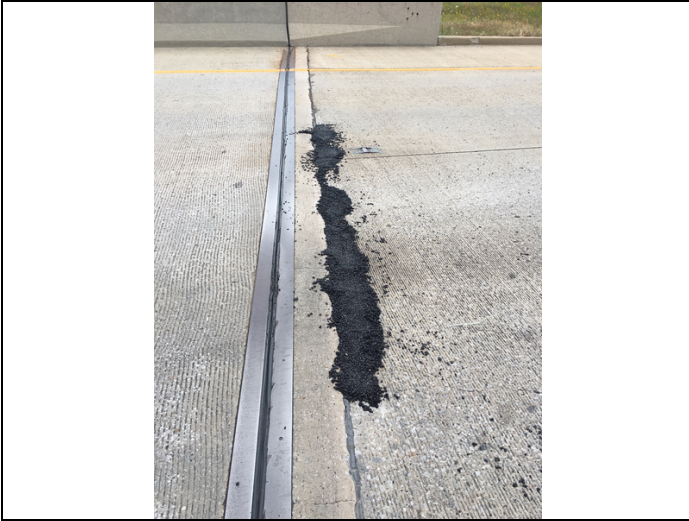
The South approach slab spall temporarily patched with HPM 7/1/20.

7/1/2020 - CD - Temporary patched with HPM by crew 04172. Priority lowered from an A to a B.

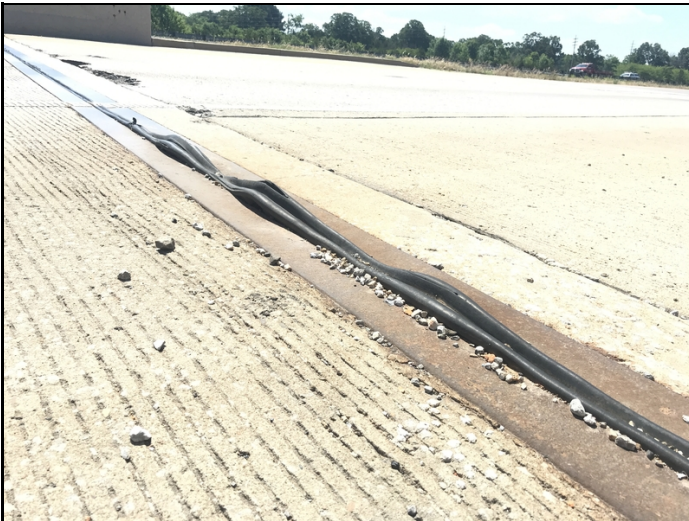
The expansion joint seals at both abutments are protruding above the bridge deck. The joint seals have areas that are torn. Staining on the abutments indicate the joint seals leak.

Abutment 1 expansion joint seal in left shoulder protruding above assembly.

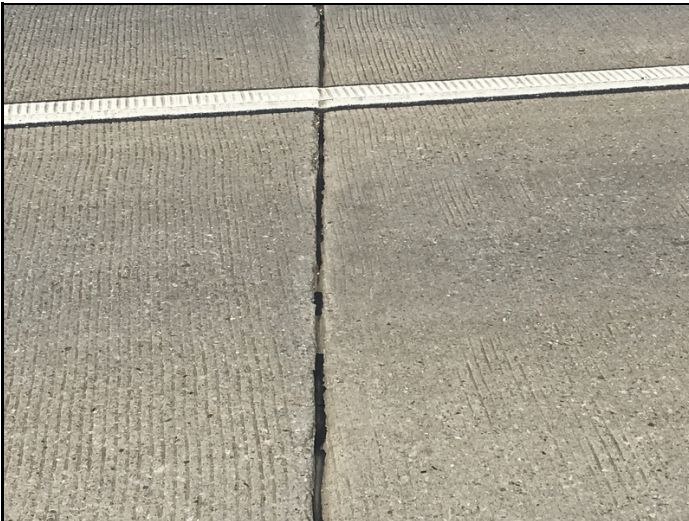
The transverse saw joints in the deck have areas where the sealant is missing.

Sawn joint sealant missing.

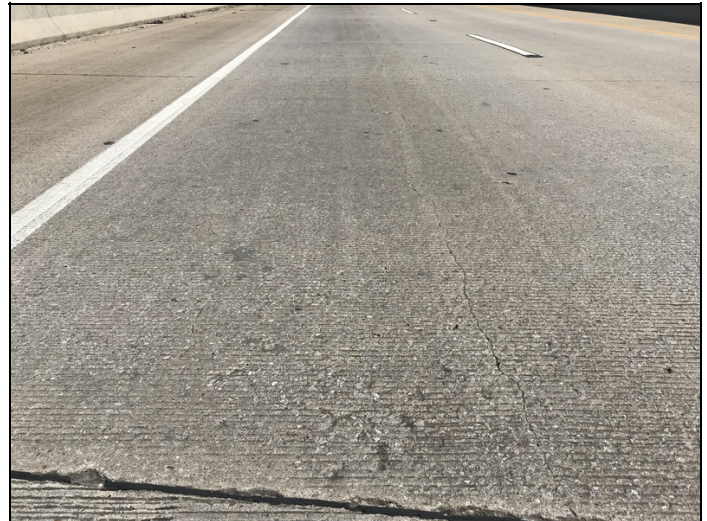
Span 1, left lane-Longitudinal cracking.

07/19/2022 - EJW - maintenance forces have sealed the cracking in the travel lanes. Deficiency description updated to reflect current conditions.

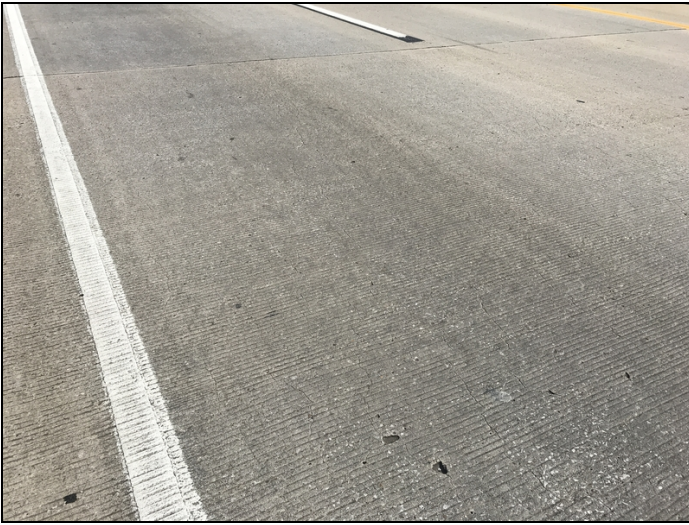
Span 3, left lane-Mapcracking.

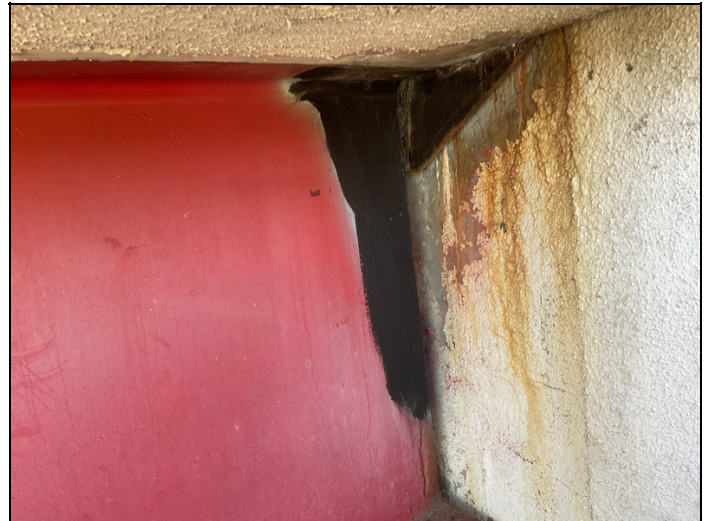
There is minor active corrosion at the ends of the beams where the expansion joint seals at the abutments leak.

Abutment #1 beam #1 rust inhibitors applied to areas of active corrosion.

07/19/2022 - EJW - maintenance forces have applied rust inhibitor to the corrosion at the beam ends.

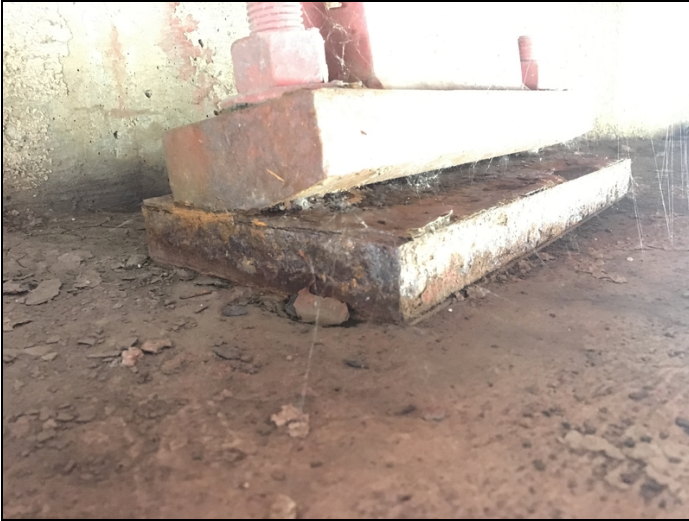
Some of the bearings at the abutments have active corrosion between the rocker and the masonry plate.

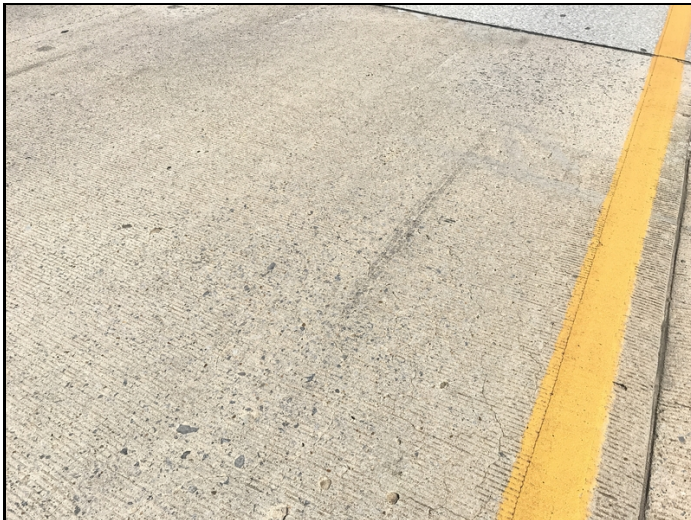
The approach slabs have sealable cracking .

07/19/2022 - EJW - maintenance forces have sealed the cracks in the approach slabs.
