Asset #B6242(Routine)

I 49 NB LANES over W. Wilson Street - Wash.

Location: JCT I 49 & CO RD 26

Team Lead: Eric West, Inspection Date: 07/19/2022

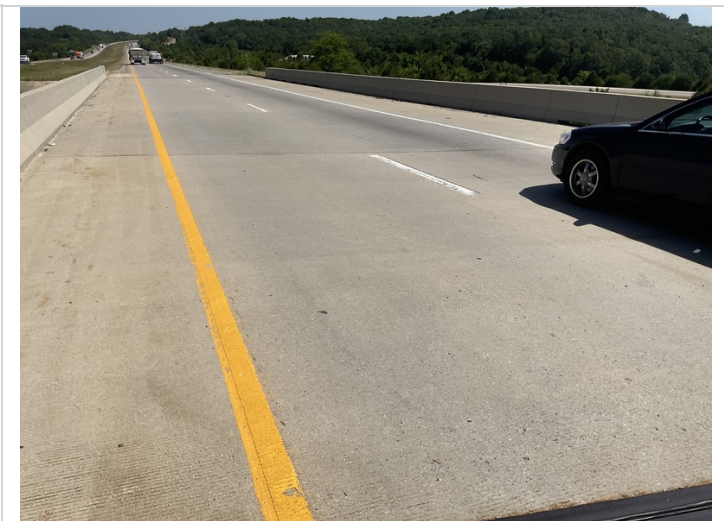
Typical driving surface of the deck.

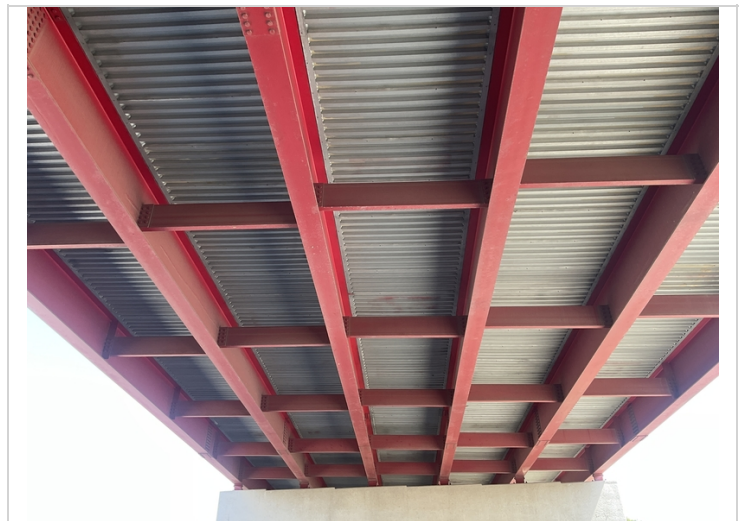
Span #2 typical undersurface of the deck.

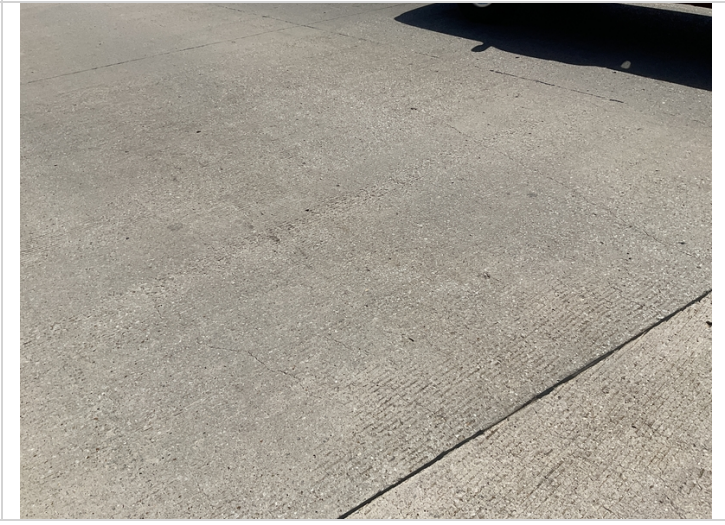
(12) -There is sealable longitudinal, transverse, and map cracking on the driving surface of the deck. -Map cracking appears to be most excessive in the outside lane. -The transverse saw joints in the deck have deteriorated sealant.							
107	Steel Open Girder/Beam	LF	948	627	320	1	0
1000	Corrosion	LF	321	0	320	1	0
515	Steel Protective Coating	SF	9795	8995	400	400	0
3410	Chalking (Steel Protective Coatings)	LF	400	0	400	0	0
3440	Effectiveness (Steel Protective Coatings)	LF	400	0	0	400	0

Sealable deck cracking.

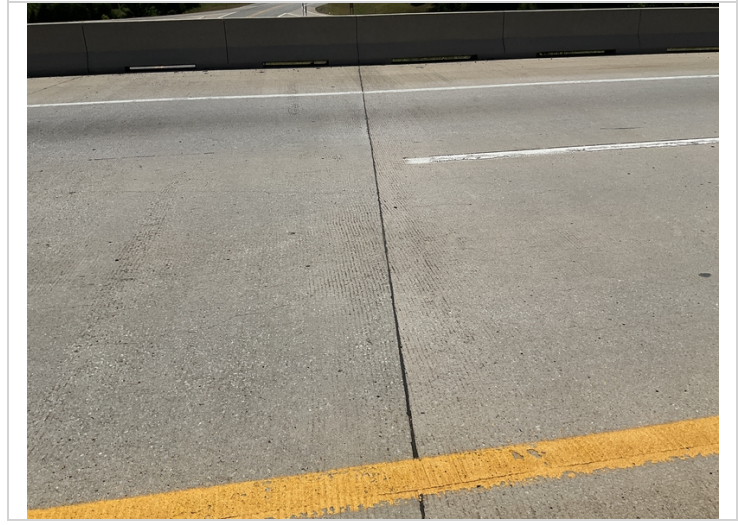
Failing saw joint sealant.

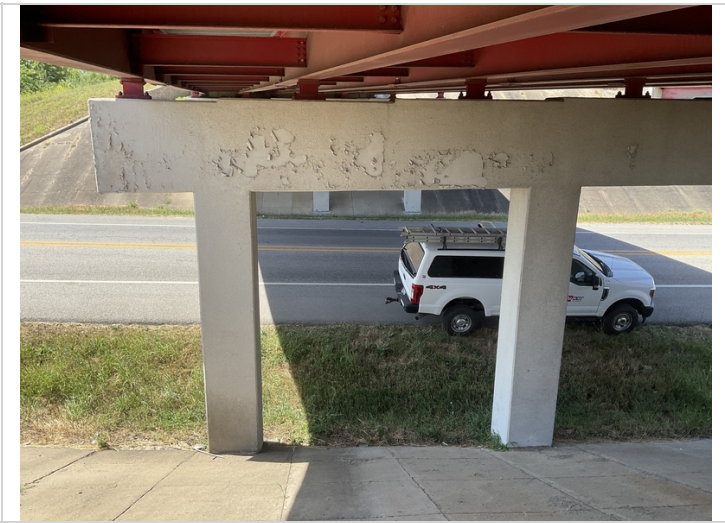
(234) -There is hairline map cracking in the Left end of Bent # 2 cap and the Right end of Bent # 3 cap. -The texicoat is peeling on Bent # 3 cap.

Bent #3 texicoat peeling.

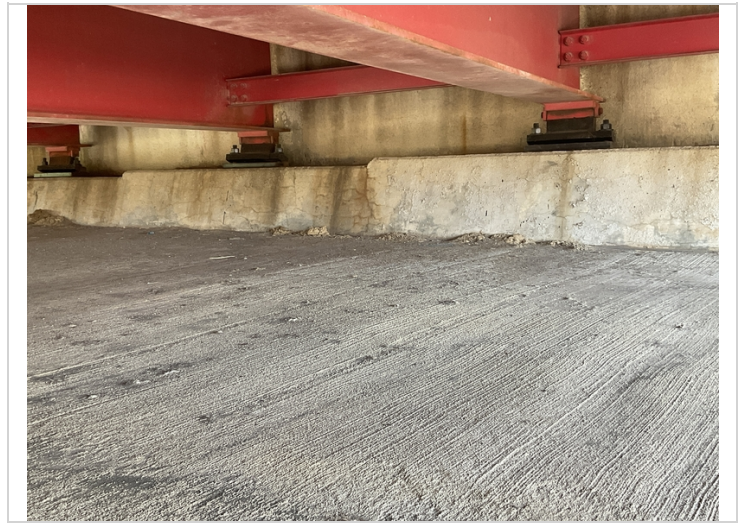
(215) -Map cracking in both ends of abutments # 1 and # 2 with areas horizontal cracking in random locations in the backwall. -Maintenance forces have filled the cracks in the Left end of abutment # 2 with caulking and have painted both ends of both abutments as a type of repair. -Rust stains from leaking deck joint seals are apparent in both abutments. -Abutment # 1 has map cracking for the majority of the length of the abutment stem. -Abutment # 2 has a few minor spalls with no exposed reinforcing steel visible from the driving surface of the deck. -Abutment # 2 backwall has transverse, longitudinal, and map cracks visible from the driving surface of the deck.							
234	Reinforced Concrete Pier Cap	LF	83	77	6	0	0
1130	Cracking (RC and Other)	LF	6	0	6	0	0

Abutment #1 typical map cracking.

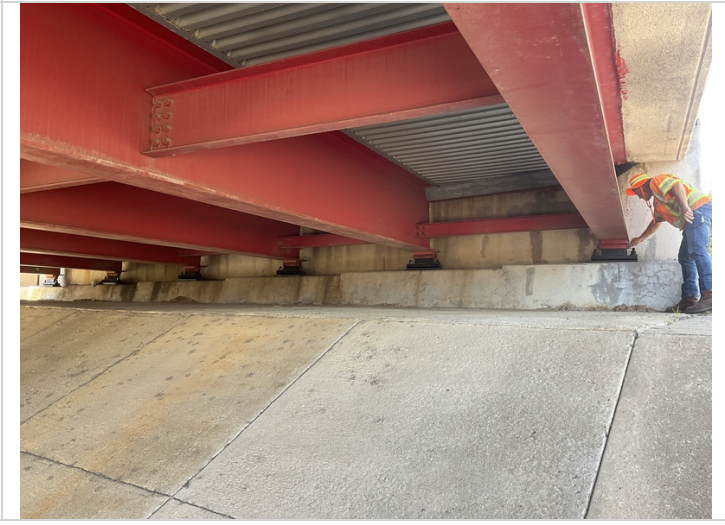
Abutment #1 typical.

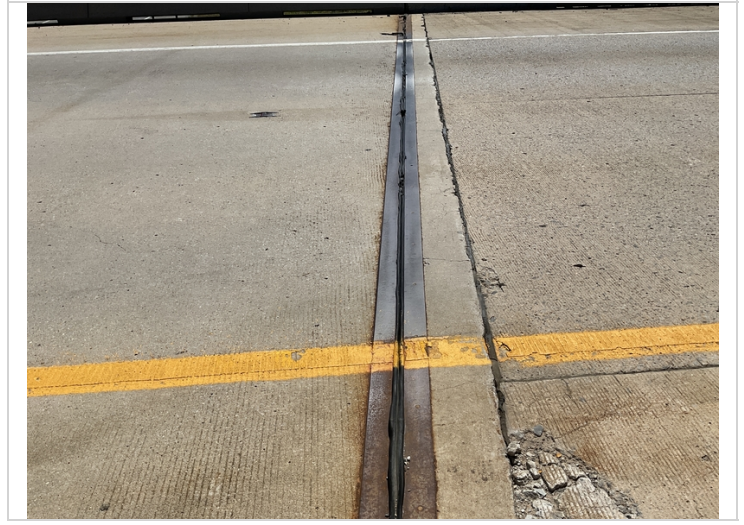
Abutment #1 compression joint seal.

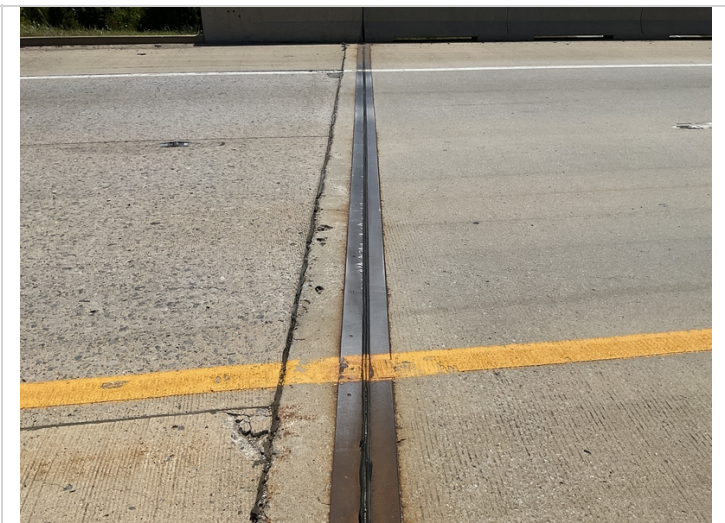
Abutment #2 typical joint seal.

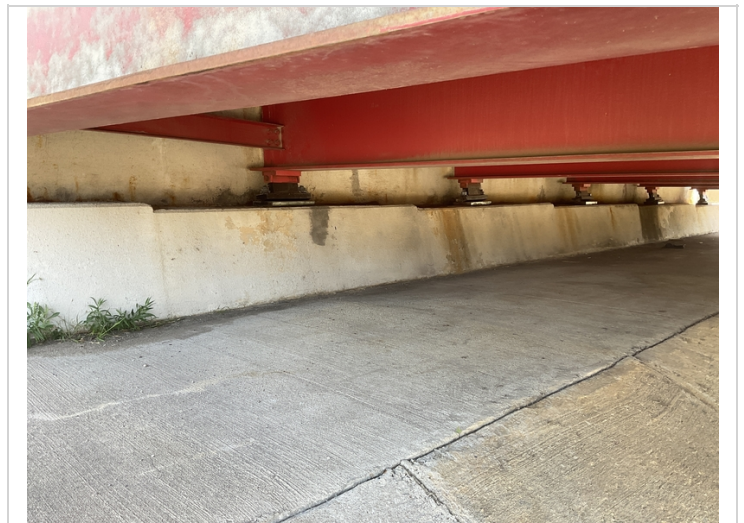
Abutment #2 bearings typical.

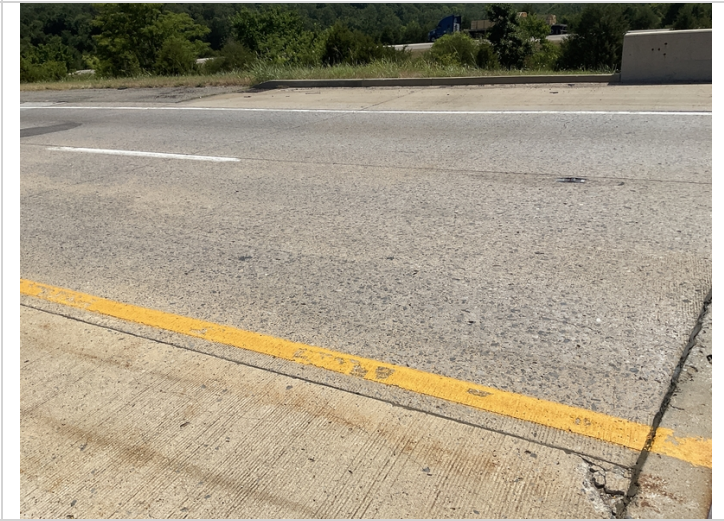
Abutment #2 approach slab typical.

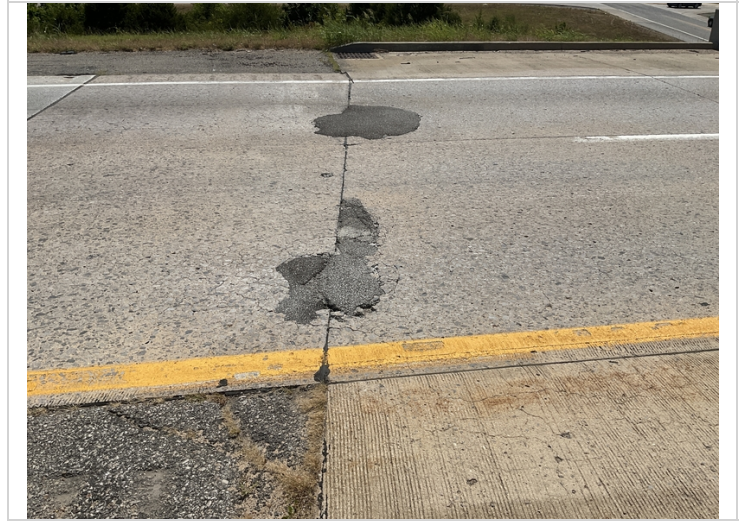
(321) -Both approach slabs have map, transverse, and diagonal cracking. -The South approach slab has a 4' spall with a temporary asphalt patch adjacent to the PCCP. The North approach slab. -There is one 3" deep spall at the Northeast bridge end adjacent to the Back wall of abutment # 2. -There is one 3' spall and one 4' spall with temporary asphalt patches in the North approach slab adjacent to the PCCP. The temporary asphalt patches are failing in locations allowing potholes to form.							
331	Reinforced Concrete Bridge Railing	LF	316	30	3	283	0
1090	Exposed Rebar	LF	5	0	0	5	0
1120	Efflorescence/Rust Staining	LF	3	0	3	0	0
1130	Cracking (RC and Other)	LF	278	0	0	278	0
1234	ASR	LF	1	1	0	0	0

Abutment #2 approach slab spalling with temporary asphalt patches.

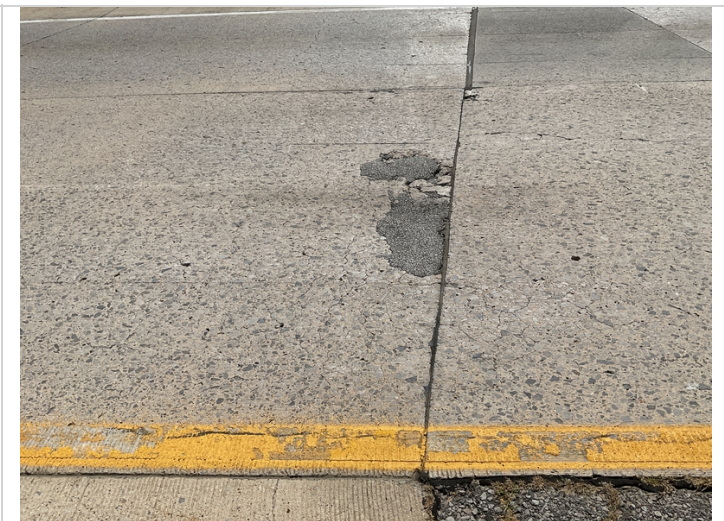
Abutment #1 approach slab spalling.

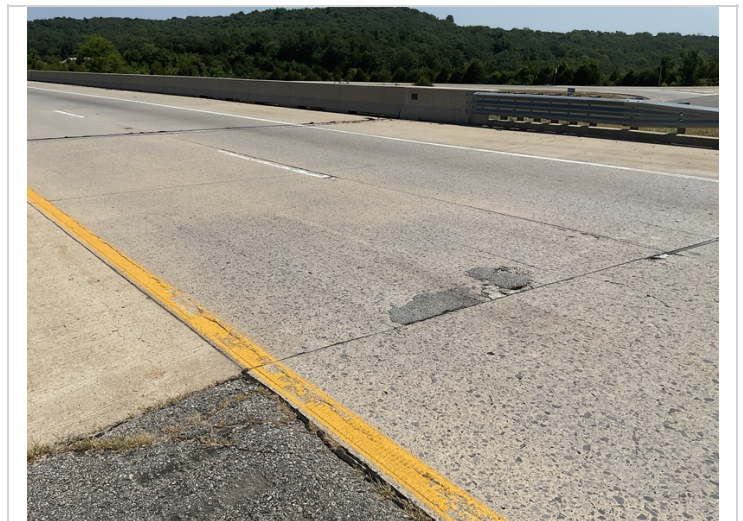
Abutment #1 approach slab typical.

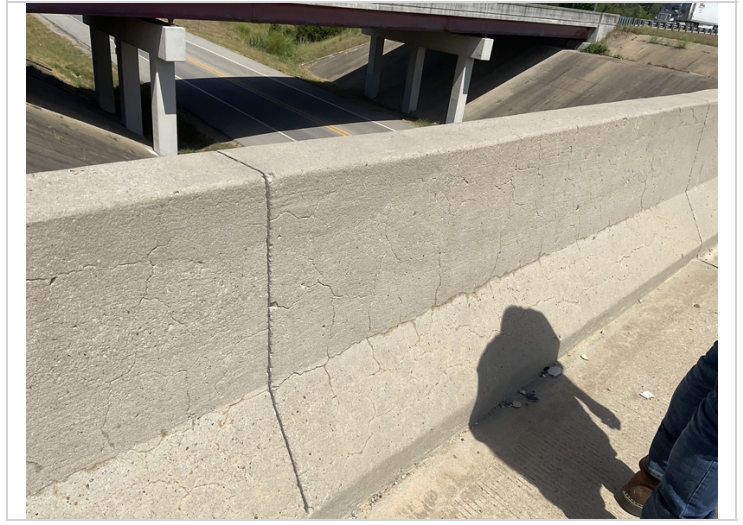
Bridge rail.

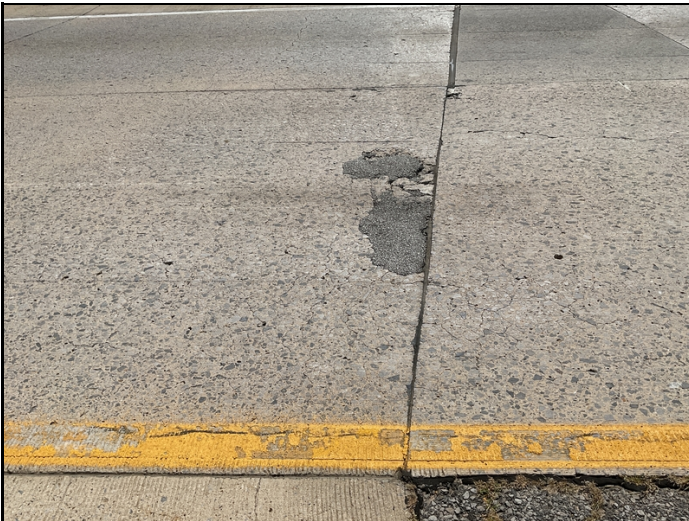
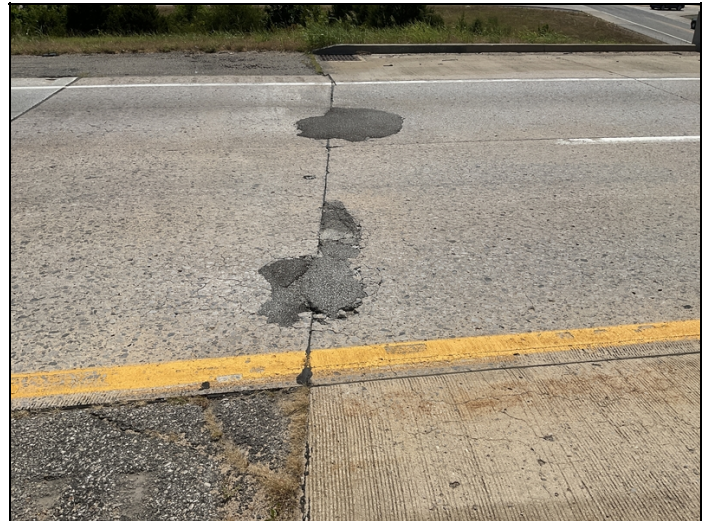
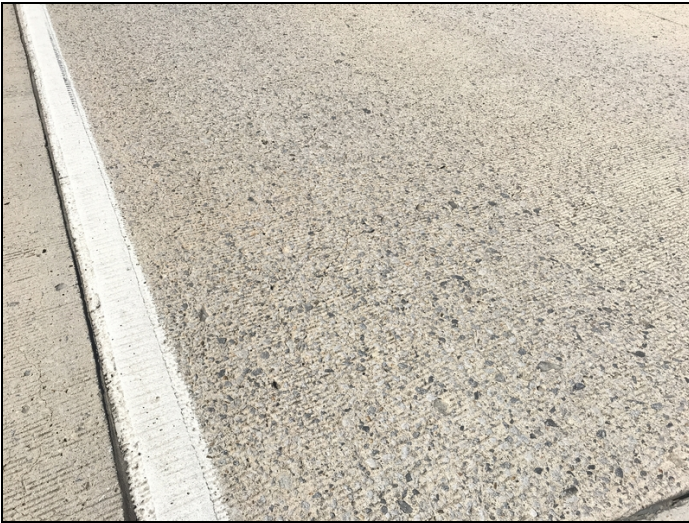
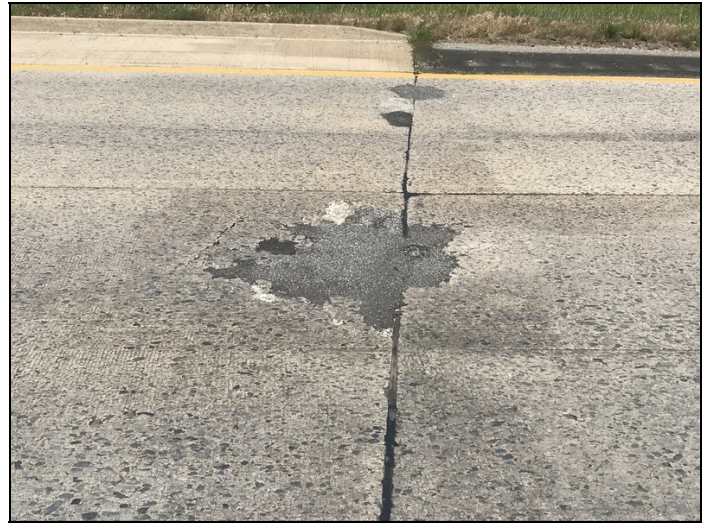
Both approach slabs have large spalls with temporary asphalt patches. Both approach slabs have moderate width sealable cracking.

Abutment #1 approach slab spalling.

Abutment #2 approach slab spalling with temporary asphalt patches.

Approach slab-Mapcracking.

The North approach slab has a 4' x 4' area of settlement / spalling with failing asphalt repairs in the outside lane at the juncture of the approach roadway.

Type of Work: Repair (General)

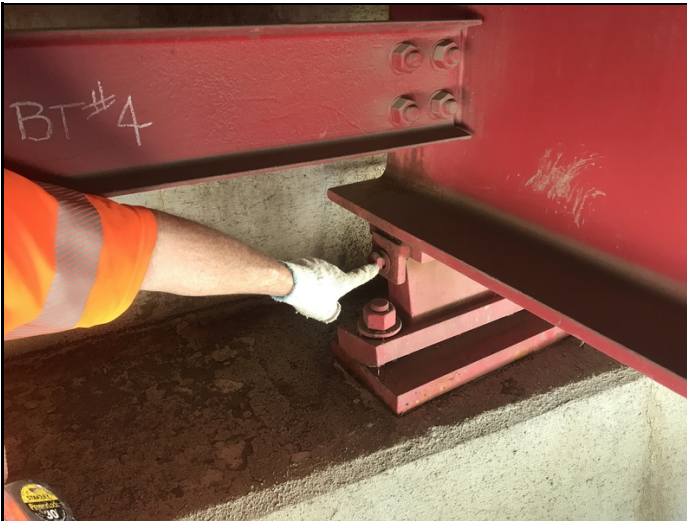
Bearing # 5 at abutment # 1, and bearing # 4 at abutment # 2 have a bolt that attaches the beam to the bearing device that is not fully seated and appears to be working out.

Bearing # 5 at abutment # 1, and bearing # 4 at abutment # 2 have a bolt that attach the beam to the bearing device that is not fully seated and appears to be working out.

Type of Work: Repair (General)

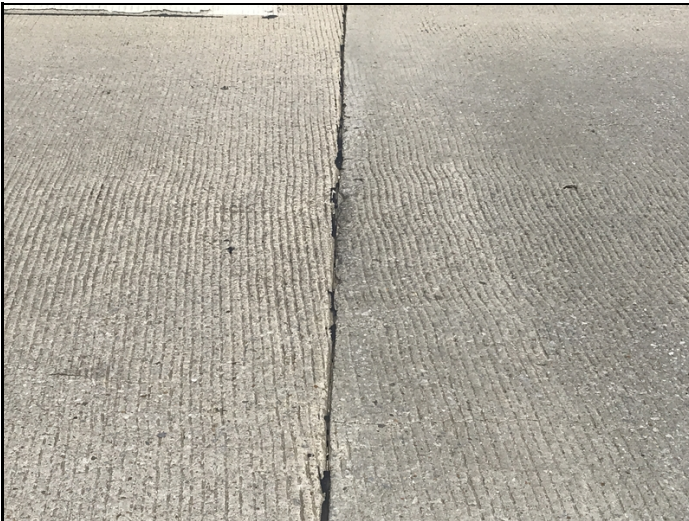
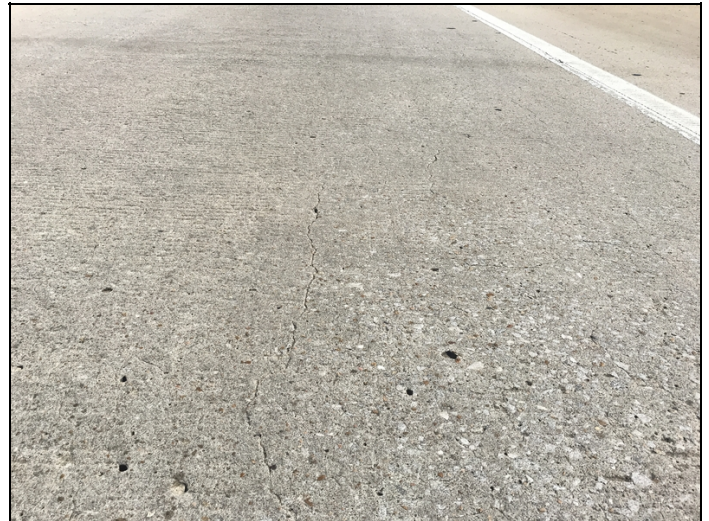
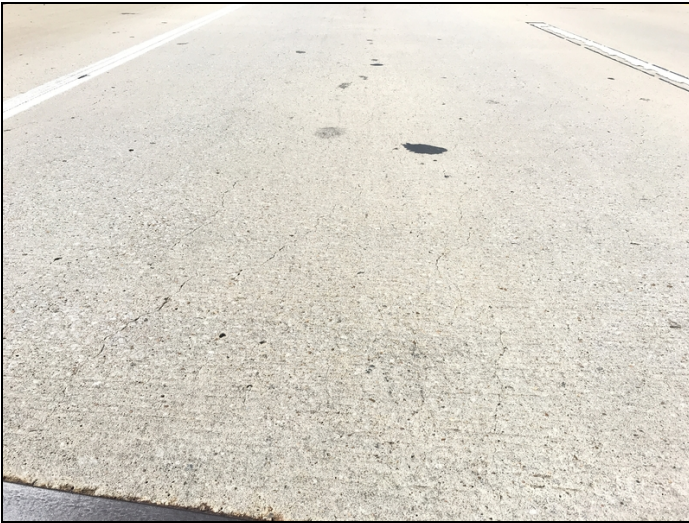
There is sealable longitudinal and map cracking on the driving surface of deck. The transverse saw joints in the deck have deteriorated sealant.

Sawn joint sealant missing.

Span 1, right lane-Mapcracking.

Span 3, right lane-Mapcracking.

Type of Work: Repair (General)

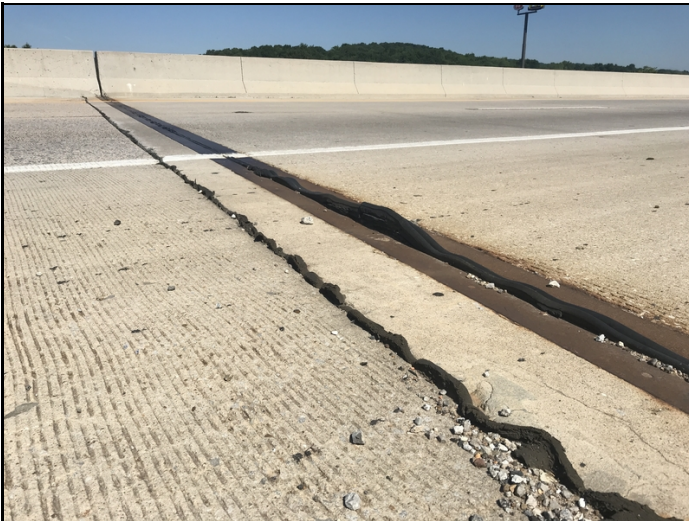
The compression joint seals at both abutments leak. The compression joint seal at abutment # 1 protrudes above the assembly and has several rips and tears.

Abutment 1 expansion joint seal.

Type of Work: Repair (General)

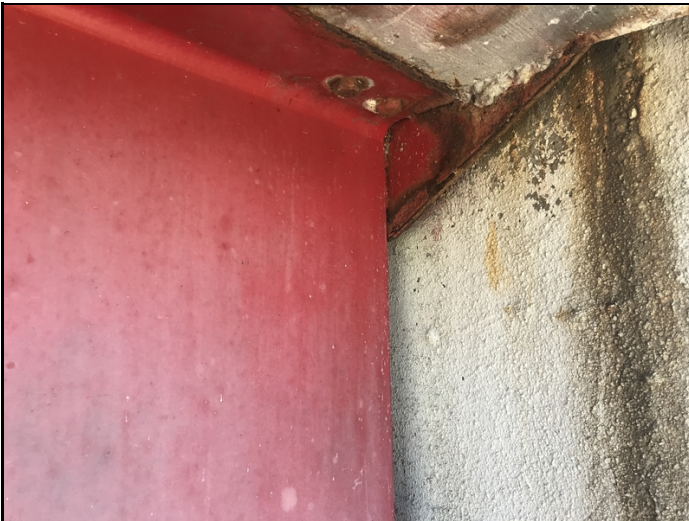
Beam # 6 has corrosion with initial section loss to the exterior side of the top flange over abutment # 2.

Type of Work: Repair (General)

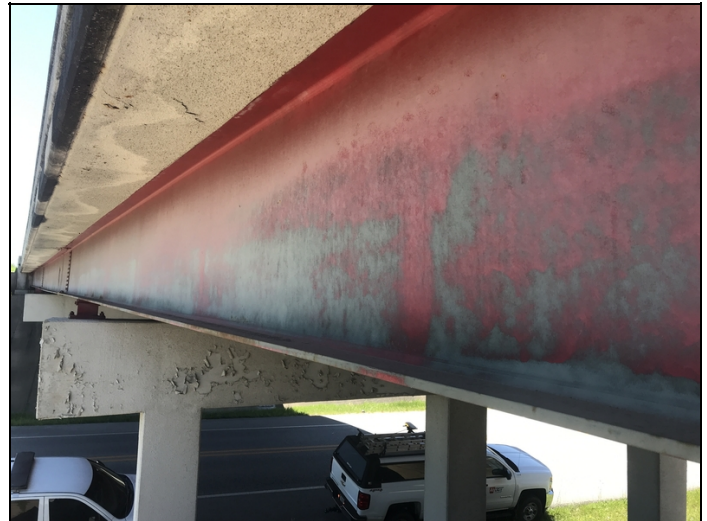
The superstructure paint system has chalking paint with exposed primer on the exterior beams.

Paint system failing on exterior beams.

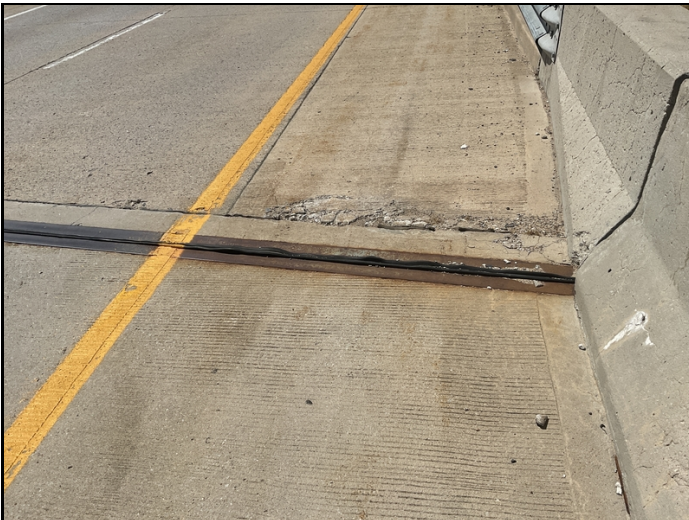
Abutment # 1 Lt approach gutter has a large concrete delamination adjacent to the abutment.

Abutment #1 Lt gutter spalling.

Type of Work: Repair (General)
