Asset #A6243(Routine)

I-49 SB LNS over State Highway 265

Team Lead: Eric West, Inspection Date: 07/18/2022

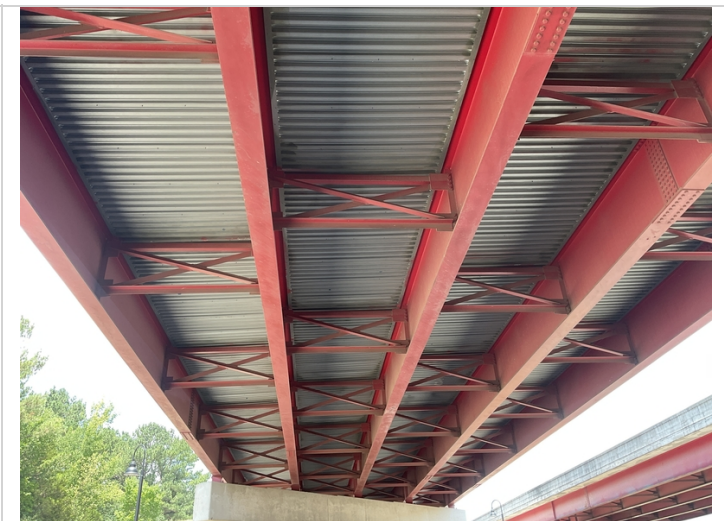
Typical undersurface of the deck.

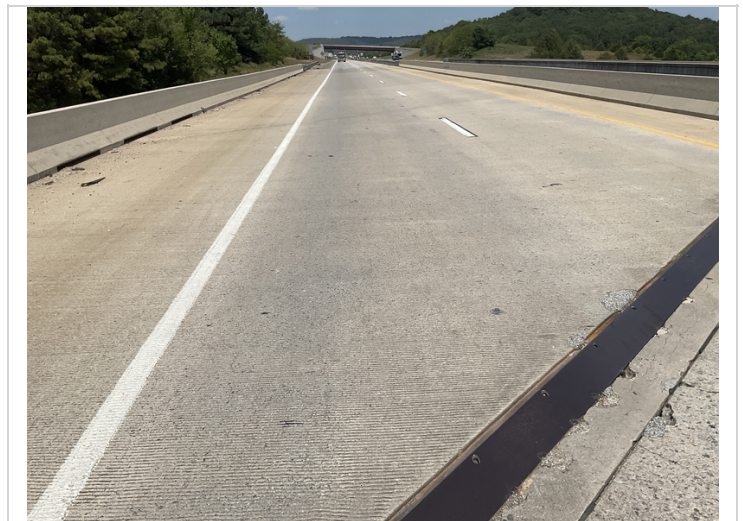
Typical driving surface of the deck.

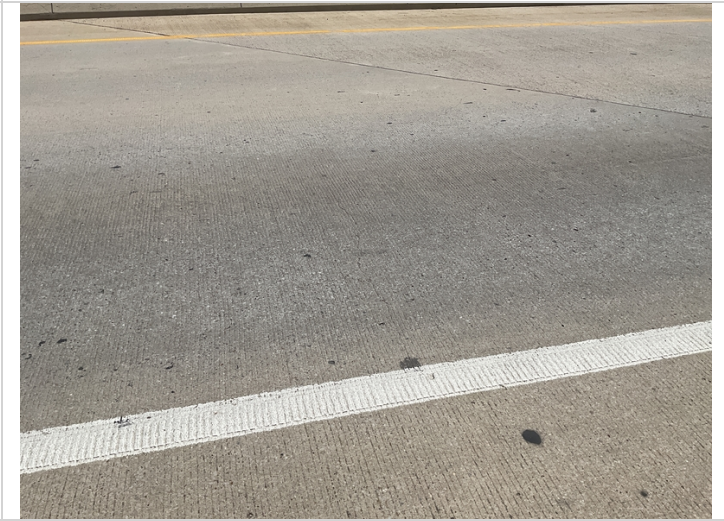
(12) -The driving surface of the deck has sealable transverse, longitudinal, and map cracking in all spans. -There are a couple of softball sized spalls with temporary asphalt patches adjacent to the expansion joint at abutment # 1.							
107	Steel Open Girder/Beam	LF	1200	712	486	2	0
1000	Corrosion	LF	488	0	486	2	0
515	Steel Protective Coating	SF	17195	15237	0	1928	30
3410	Chalking (Steel Protective Coatings)	LF	1928	0	0	1928	0
3420	Peeling/Bubbling/Cracking	LF	30	0	0	0	30

Sealable deck cracking.

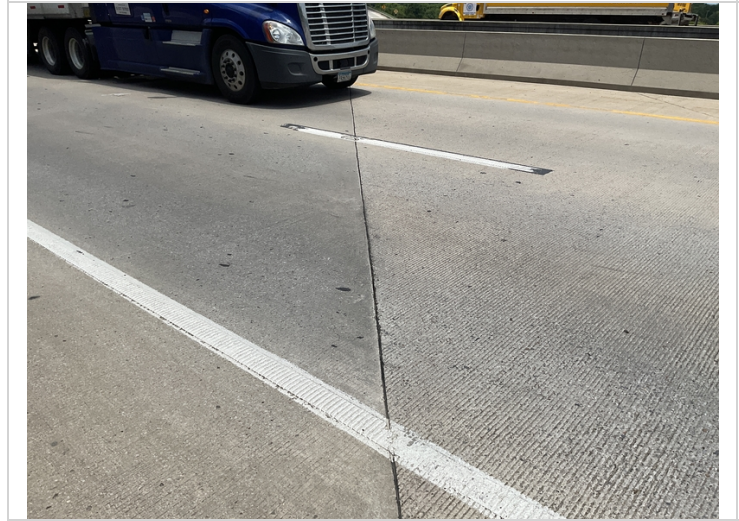
Failed saw joint sealant.

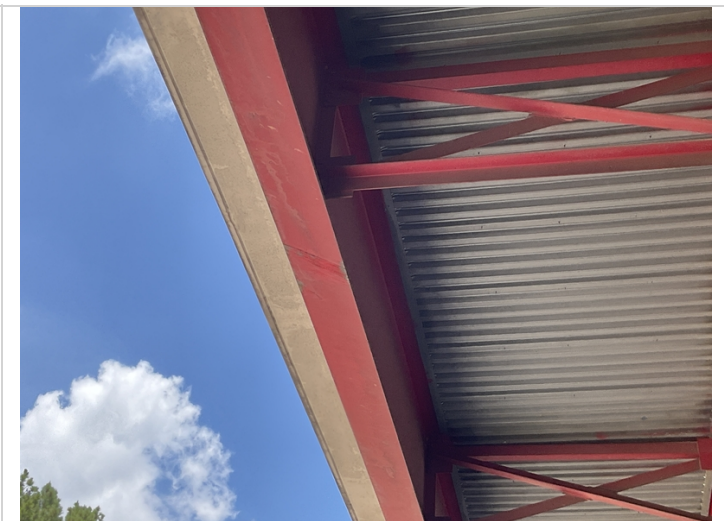
Span #2 beam #1 scrape marks on the undersurface of the bottom flange with no visible cracks.

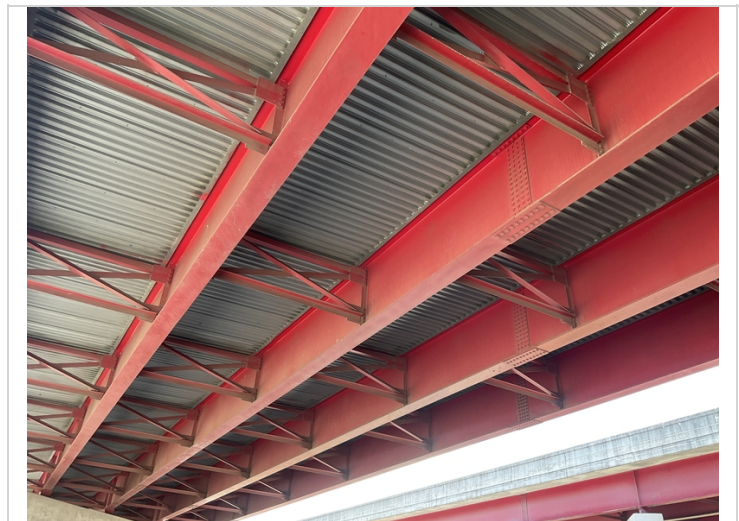
(107) -The exterior surface of beam # 1 paint system is chalking in areas that expose the primer undercoat. -There is minor rust at the ends of the beams adjacent to the backwalls and along the bottom flanges of the exterior beams. The most extreme case is Beam # 2 of Span # 1 at abutment # 1 which has corrosion with flaking rust to the upper portion of web behind bearing area. -Abutment # 1 backwall appears to have been constructed with a bulge in the concrete behind Beam # 4 (Appears to be poor alignment in the construction formwork). Beam # 4 makes contact with the backwall in the bulged area. There is no apparent spalling or cracking at the point of contact. -Span # 2 Beam # 1 over Eastbound lane has an insignificant scrape marks to undersurface of bottom flange. -Span # 3 Beam # 1 bottom flange has insignificant scrape marks. -No visible cracks in the steel beams.							
205	Reinforced Concrete Column	EA	8	3	5	0	0

Chalked paint system.

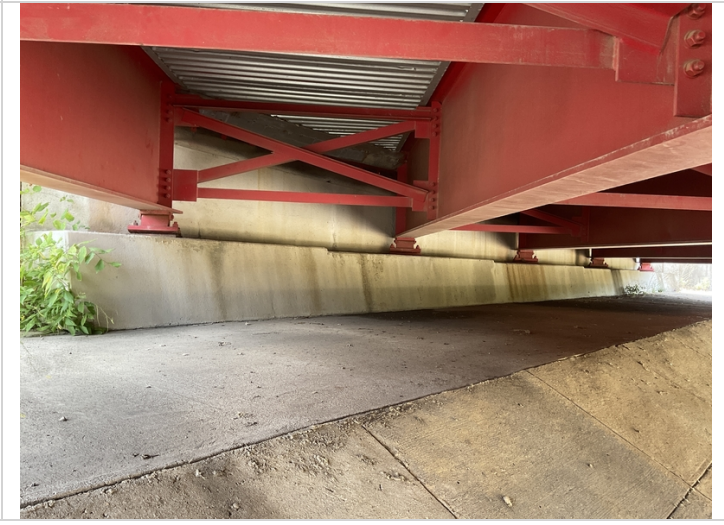
Abutment # 1 typical.

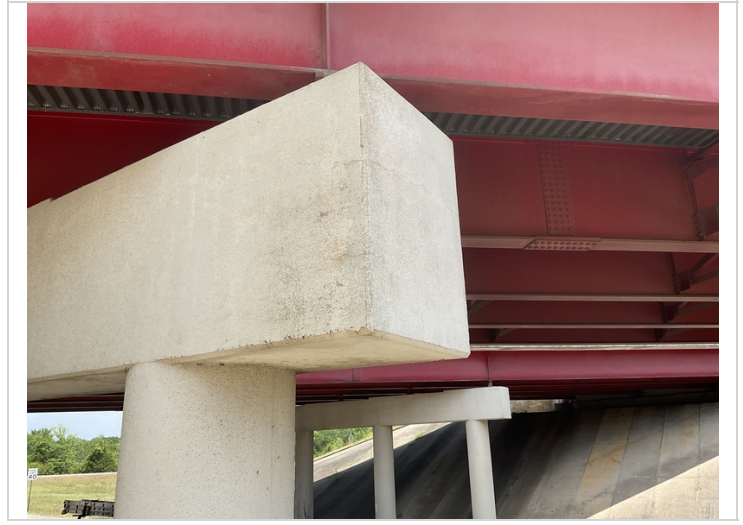
(234) Bent # 2 - -Bent #2 cap has map cracking in both ends of the cap. -Bent #2 cap has a longitudinal hairline crack visible from the undersurface of the cap between Columns # 2 & 3. Bent # 3 - -Bent #3 has a 3" spall and map cracking in the Left end of the cap.							
305	Assembly Joint without Seal	LF	114	114	0	0	0

Bent #3 Lt cap map cracking.

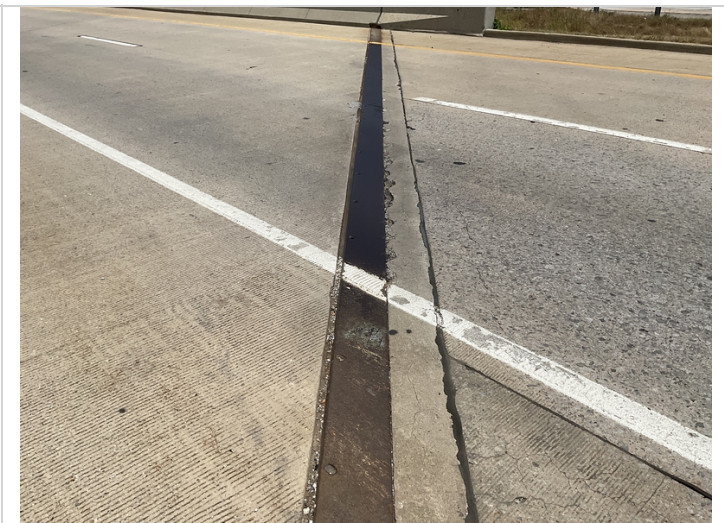
(305) -Stains on abutment # 1 indicate that the drainage trough leaks. -There are spalls that expose the anchorage adjacent to the sliding plate in the abutment # 1 backwall. -Sliding plate repairs appear to be holding at this inspection and appear to sound normal when impacted by traffic during this inspection.							
311	Movable Bearing	EA	10	0	5	5	0
1000	Corrosion	EA	9	0	4	5	0
1020	Connection	EA	1	0	1	0	0
515	Steel Protective Coating	SF	40	21	2	2	15
3440	Effectiveness (Steel Protective Coatings)	EA	19	0	2	2	15

Abutment #1 sliding plate.

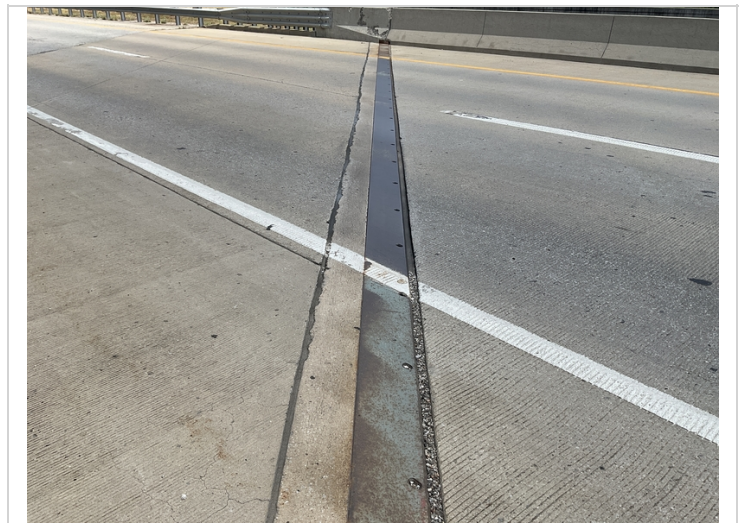
Abutment #2 sliding plate.

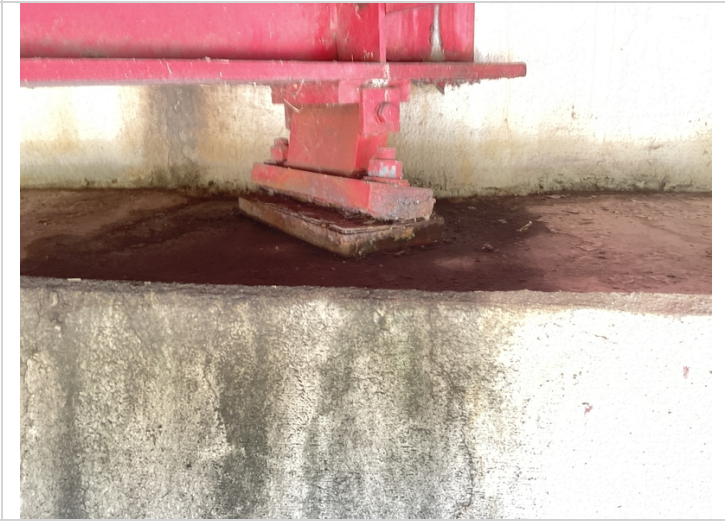
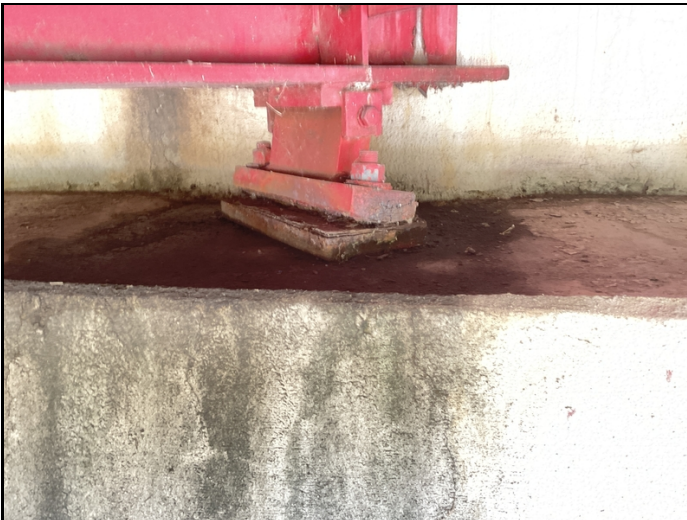
Abutment #1 bearing #2 active corrosion with pack rust.

The bearings at the abutments have active corrosion with pack rust.

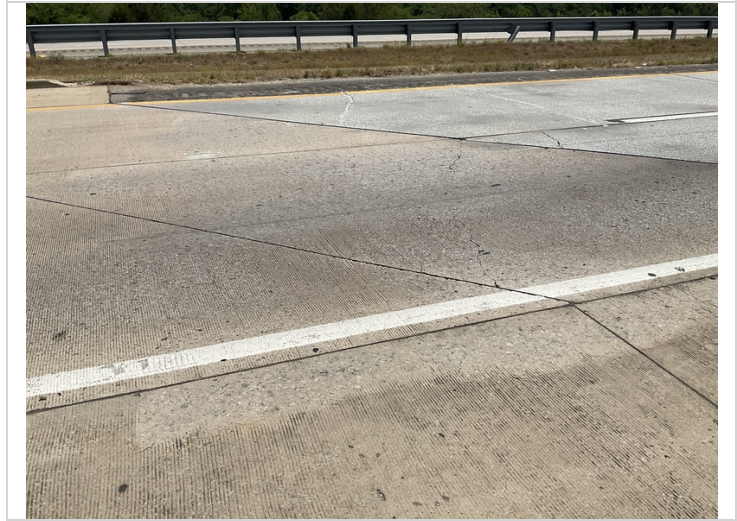
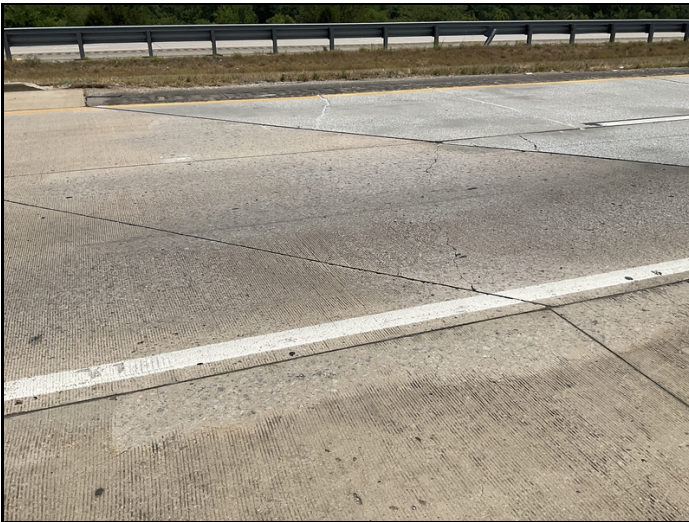
(321) -Sealable map cracking typical in both approach slabs. -Approach slabs have areas of wide transverse cracks.							
331	Reinforced Concrete Bridge Railing	LF	480	1	62	417	0
1130	Cracking (RC and Other)	LF	479	0	62	417	0
1234	ASR	LF	1	1	0	0	0

South approach slab wide transverse cracks.

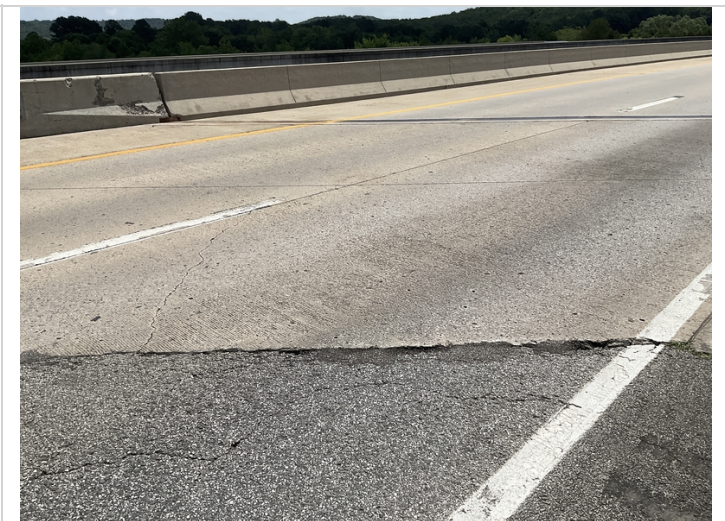
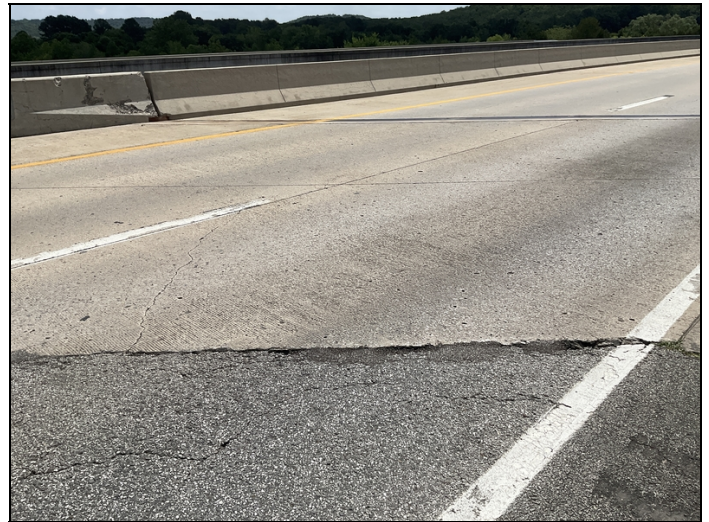
North approach slab cracking.

R.C. Approach Slabs-
The approach slabs have sealable cracking.

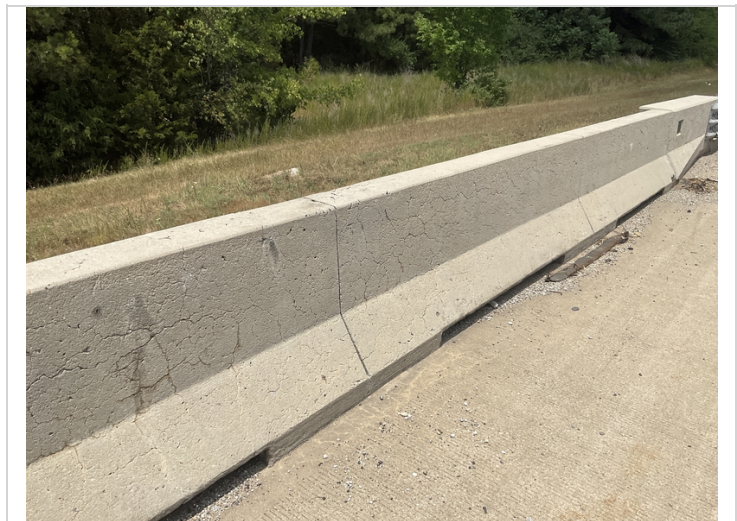
Typical bridge rail map cracking.

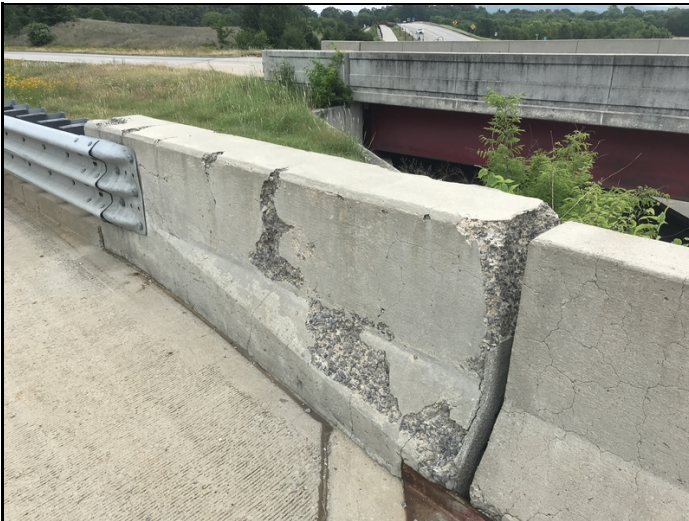
The Northeast transition parapet appears to be constructed with poor quality concrete. The parapet has soft deteriorated concrete with numerous areas of spalling.

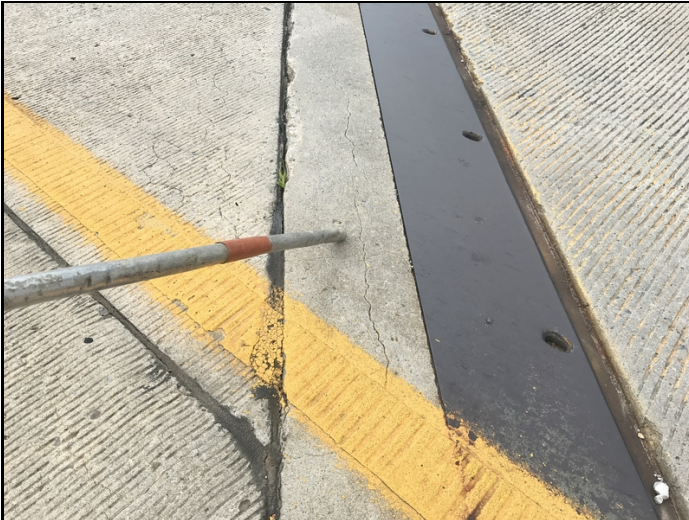
The top of both abutment backwalls have longitudinal cracking.

Abutment 1-Longitudinal cracking in top of backwall.

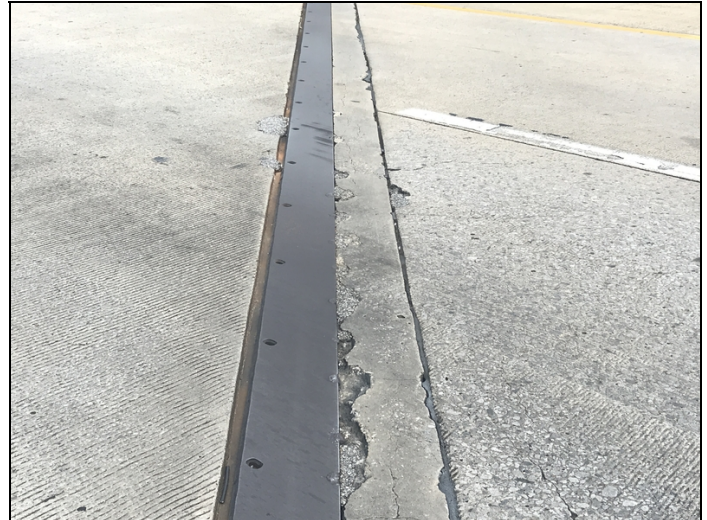
There are shallow spalls with temporary patches in the top of abutment # 1 backwall adjacent to the sliding plate anchorage where maintenance forces have made repairs in the past.

Abutment 1 backwall-Spalling with longitudinal cracking.

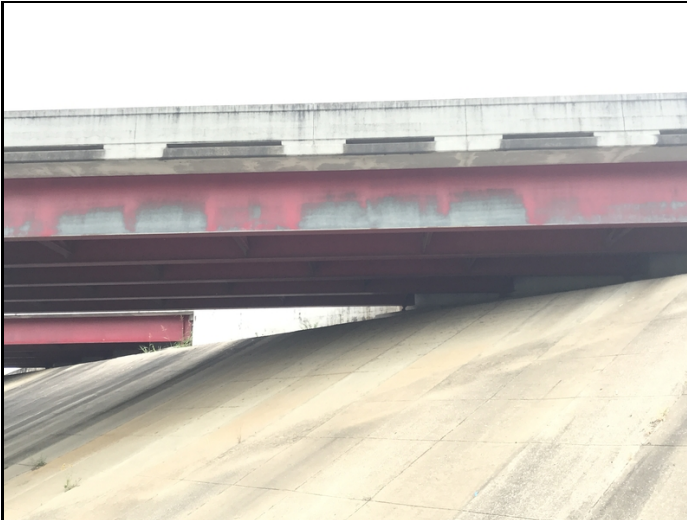
The paint system on the exterior beams is chalking in areas that expose the primer undercoat.

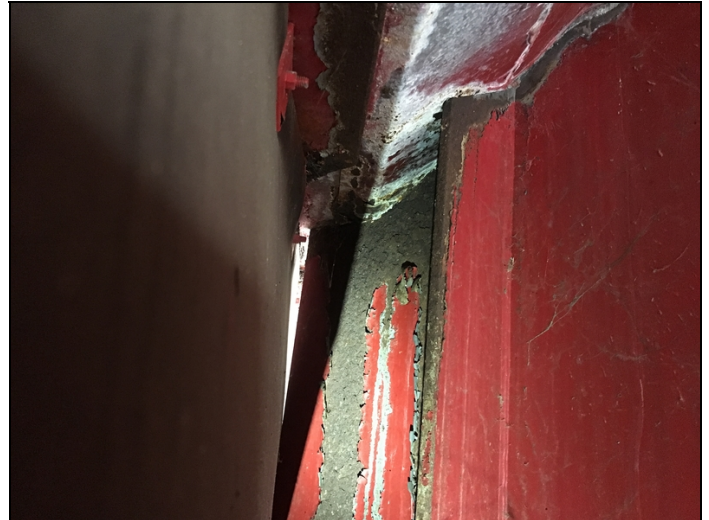
Span 1, Beam # 2 at abutment # 1 has corrosion with flaking rust to the upper portion of web behind bearing area.

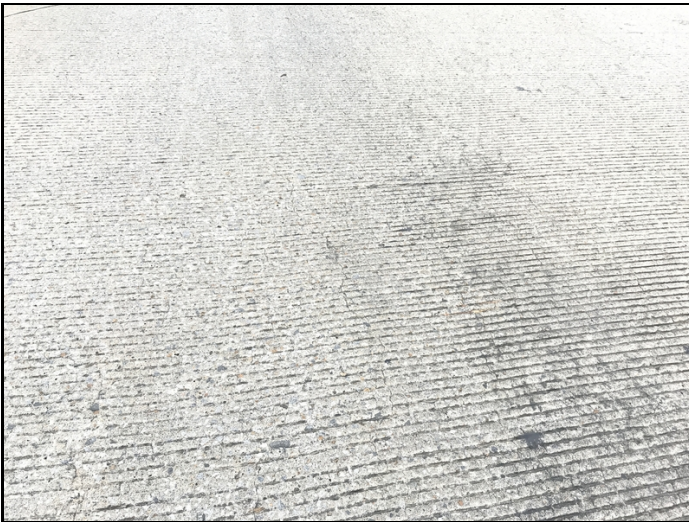
The driving surface of the deck has sealable cracking in all spans.

Span 1-Cracking in wheel path.

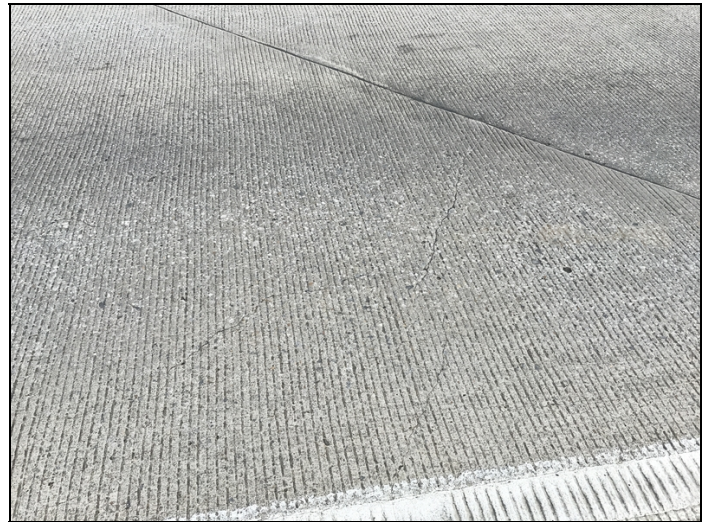
Span 1, left lane-Transverse cracking.
