Asset #B6243(Routine)

Interstate 49 NB over State Highway 265

Location: JCT I 49& SH 265

Team Lead: Eric West, Inspection Date: 07/18/2022

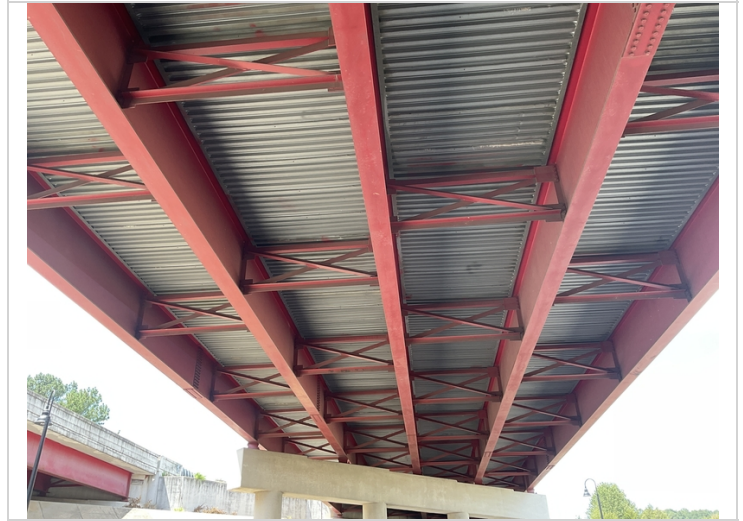
Typical undersurface of the deck.

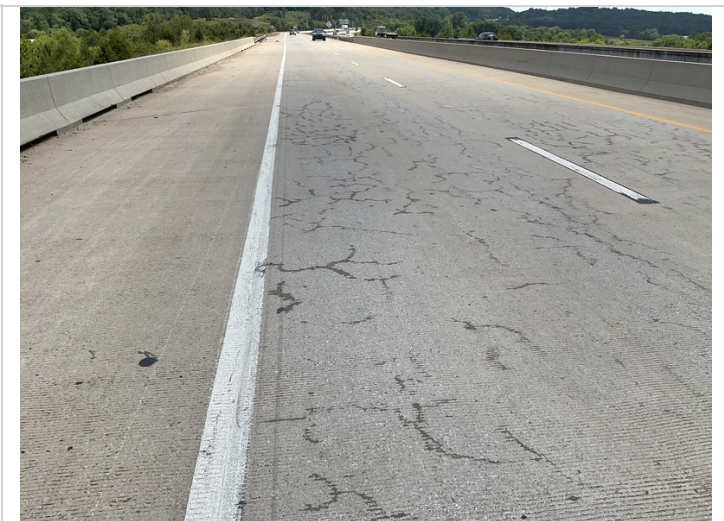
Typical driving surface of the deck.

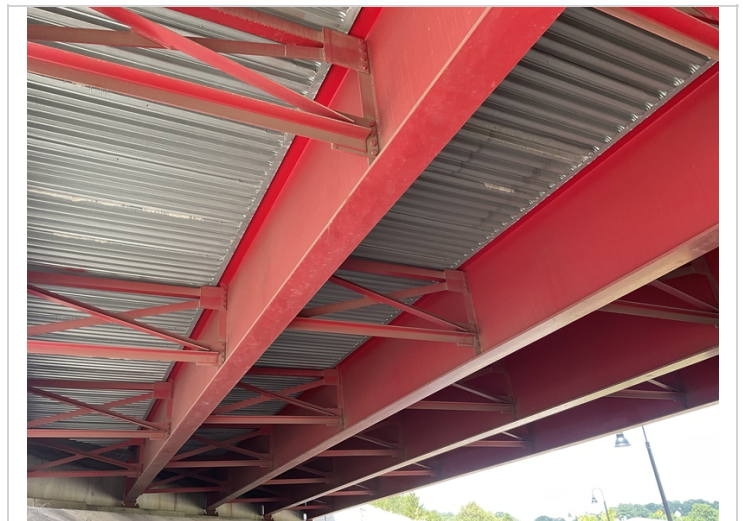
Span #3 typical undersurface of the cap.

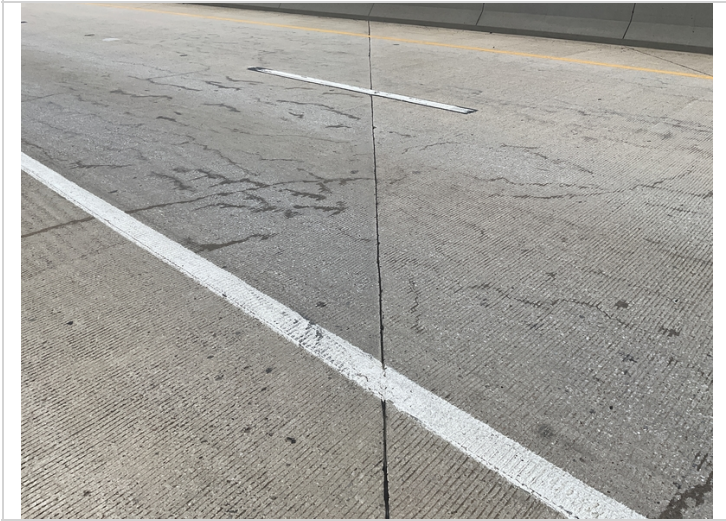
Failing saw joint sealant.

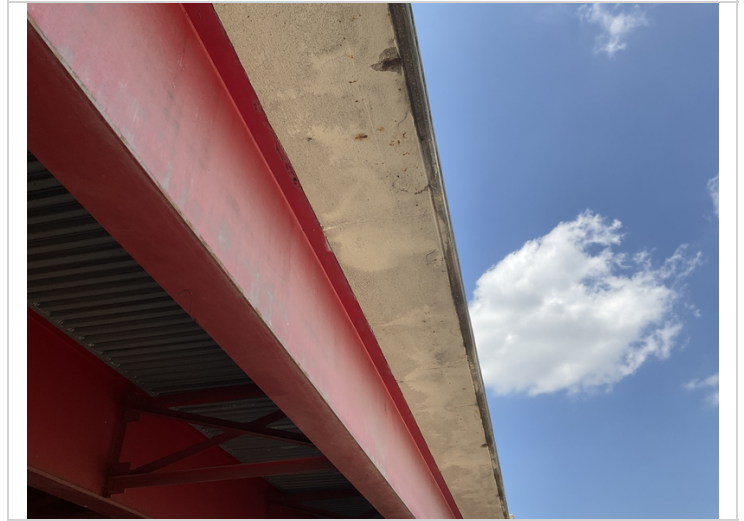
(12) -There are a few delaminated areas and spalls with exposed reinforcing steel visible from the Right overhang of the deck. -Maintenance forces have sealed the majority of the transverse, map, and longitudinal cracks on the driving surface of the deck since last inspection.							
107	Steel Open Girder/Beam	LF	1200	748	452	0	0
1000	Corrosion	LF	452	0	452	0	0
515	Steel Protective Coating	SF	17195	15237	0	1928	30
3410	Chalking (Steel Protective Coatings)	LF	1928	0	0	1928	0
3440	Effectiveness (Steel Protective Coatings)	LF	30	0	0	0	30

Span #3 Rt concrete delamination and spalling with exposed reinforcing steel.

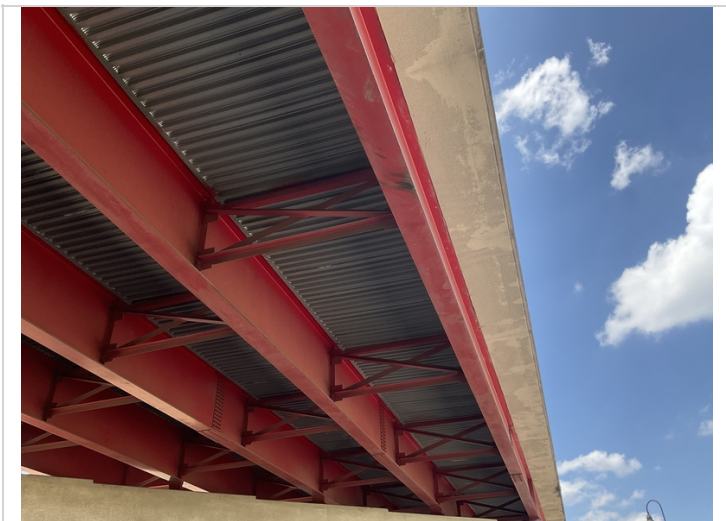
Span #2 beam #7 scrape marks.

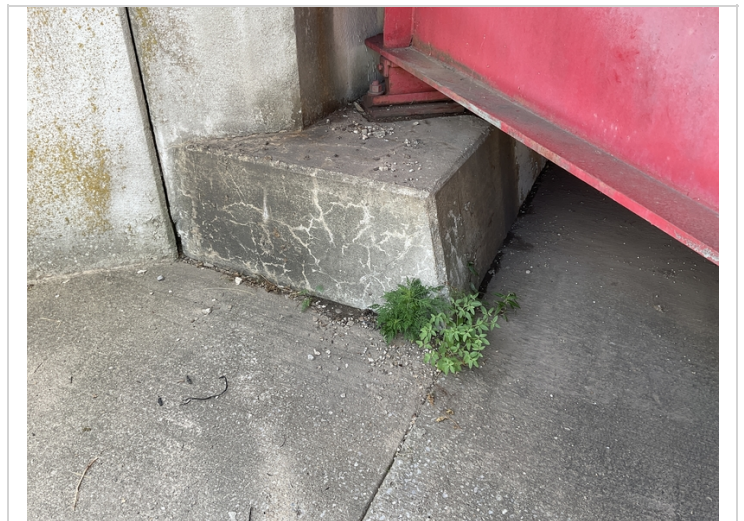
(215) Abutment # 1 - -Abutment # 1 has 34' of hairline map cracking in the abutment cap. -Vertical hairline cracks in the backwall of abutment # 1. -There are no apparent spalls or delaminated areas where the ends of the beams make contact with the backwall during high ambient temperatures. Abutment # 2 - -The top of abutment # 2 backwall is spalled at the expansion joint anchorage. Maintenance forces have made repairs to the spalls in the back wall of abutment #2. -Abutment # 2 has map cracking in the Right side of abutment.							
234	Reinforced Concrete Pier Cap	LF	112	107	5	0	0
1080	Delamination/Spall/Patched Area	LF	1	0	1	0	0
1130	Cracking (RC and Other)	LF	4	0	4	0	0

Abutment #1 Rt map cracking.

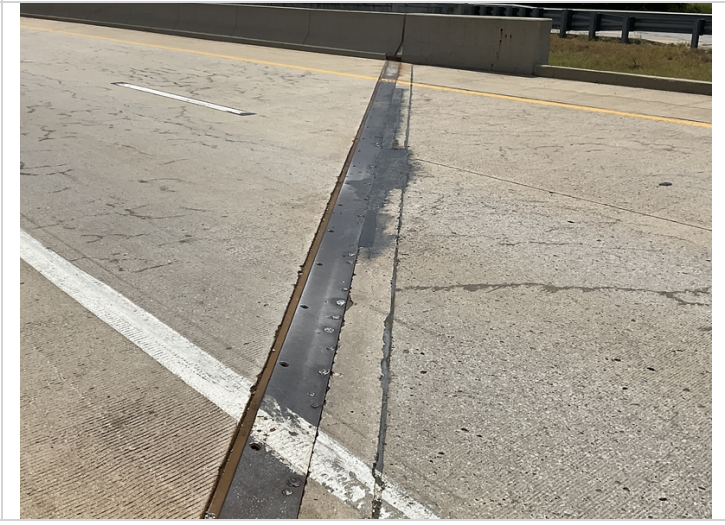
Abutment #2 top of backwall repair.

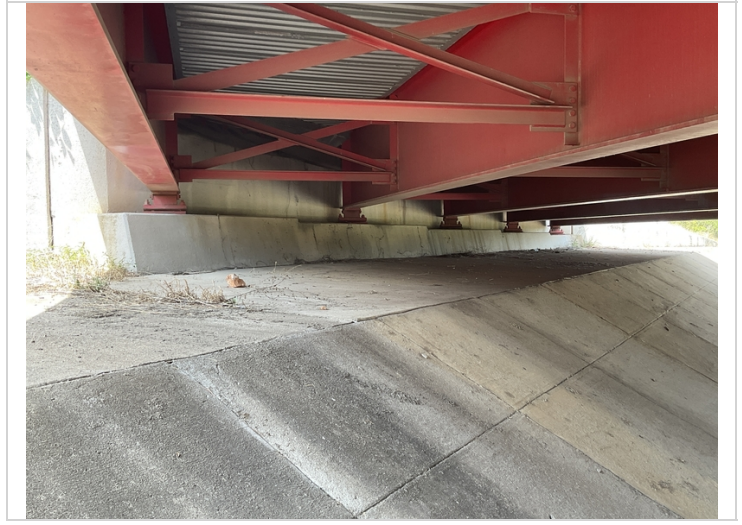
Abutment #2 typical.

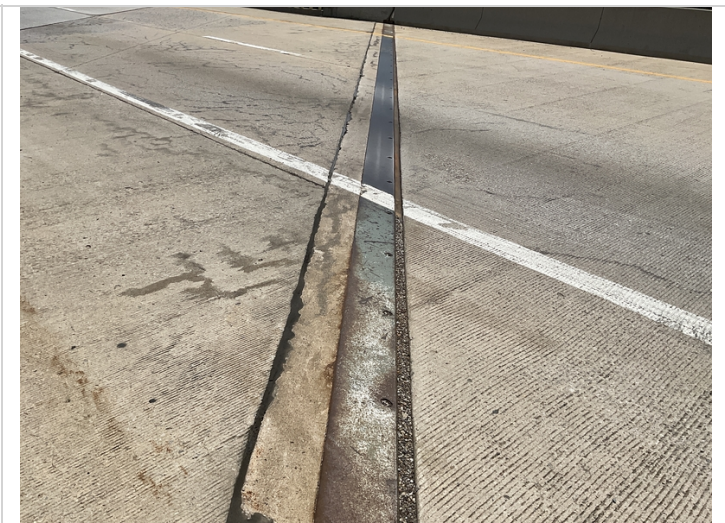
Abutment #1 sliding plate.

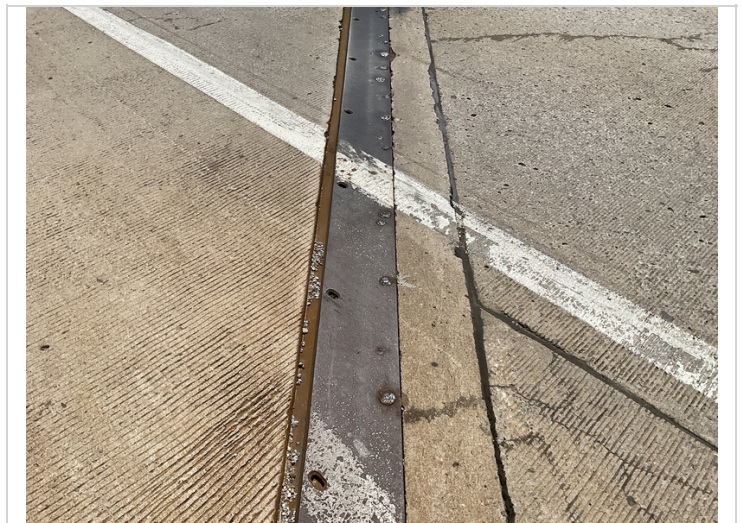
Abutment #2 new anchorage welds.

07/18/2022 - EJW - Maintenance forces have repaired the noisy sliding plate since the last inspection.

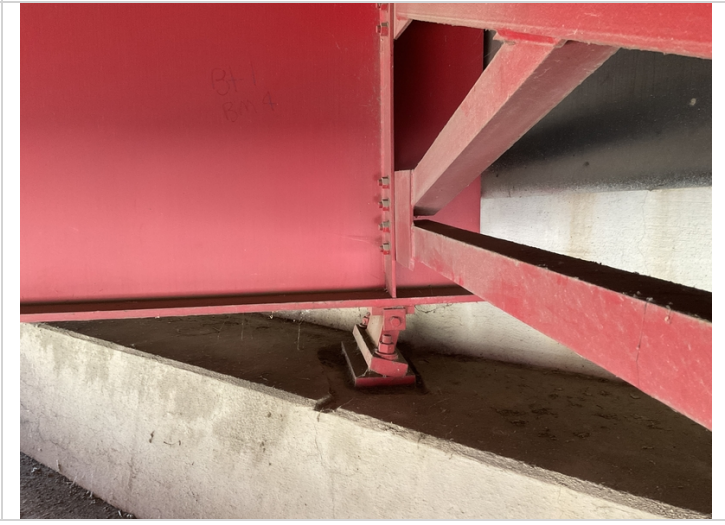
(311) -Some bearings have minor corrosion on the masonry plates. -Bearings do not appear to be installed in accordance with the design. See History. -Rocker bearings at abutments # 1 and # 2 are near fully expanded with ambient temperature approximately 78 degrees Fahrenheit at time of inspection.							
313	Fixed Bearing	EA	10	9	1	0	0
1000	Corrosion	EA	1	0	1	0	0
515	Steel Protective Coating	SF	1000	996	0	4	0
3440	Effectiveness (Steel Protective Coatings)	EA	4	0	0	4	0

Abutment #1 bearings nearly fully expanded.

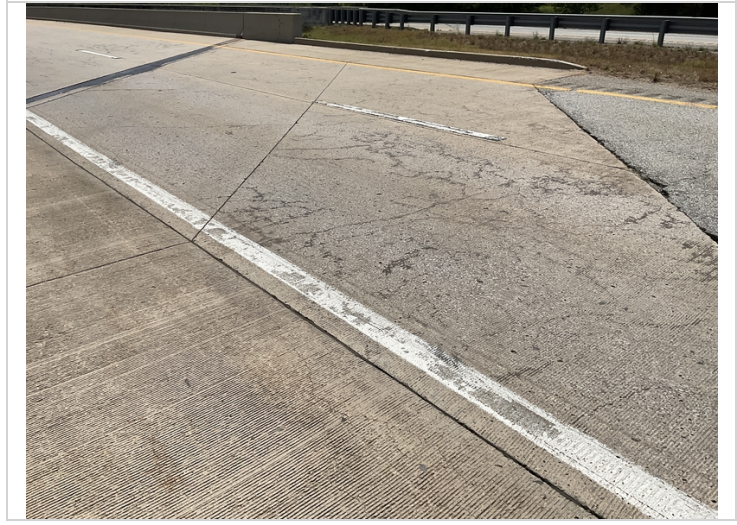
ELEMENTS	DESCRIPTION	UNITS	TOTAL	CS1	CS2	CS3	CS4
(321) -Sealable diagonal and map cracking is typical in the approach slabs at this inspection. Maintenance forces have sealed a majority of the cracks in the past.							
331	Reinforced Concrete Bridge Railing	LF	480	127	349	4	0
1080	Delamination/Spall/Patched Area	LF	2	0	2	0	0
1120	Efflorescence/Rust Staining	LF	2	0	2	0	0
1130	Cracking (RC and Other)	LF	349	0	345	4	0
1234	ASR	LF	1	1	0	0	0
(331) -Previous documentation indicates that the parapet walls have been sand blasted and sealed under contract in the past but open mapcracking is visible throughout the parapets on the left and right sides of structure. -Parapets have minor shallow spalling adjacent to the sliding plate assemblies.							
Approach railing: -Southeast approach railing has light collision damage.

North approach slab cracking.

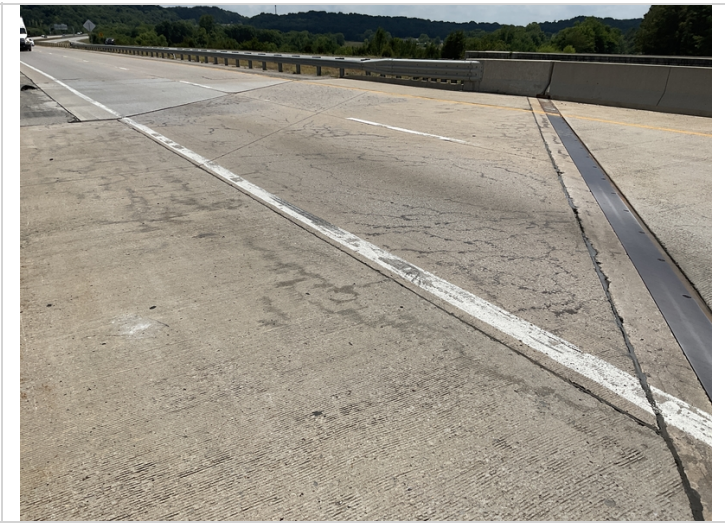
South approach slab cracking.

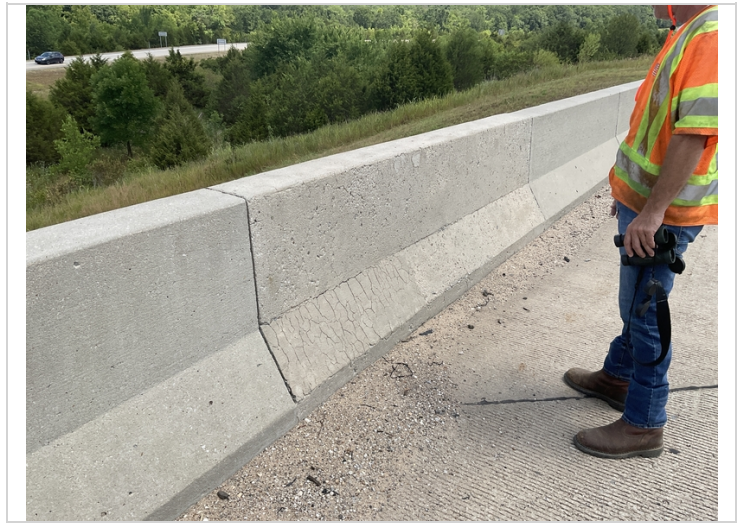
Possible ASR.

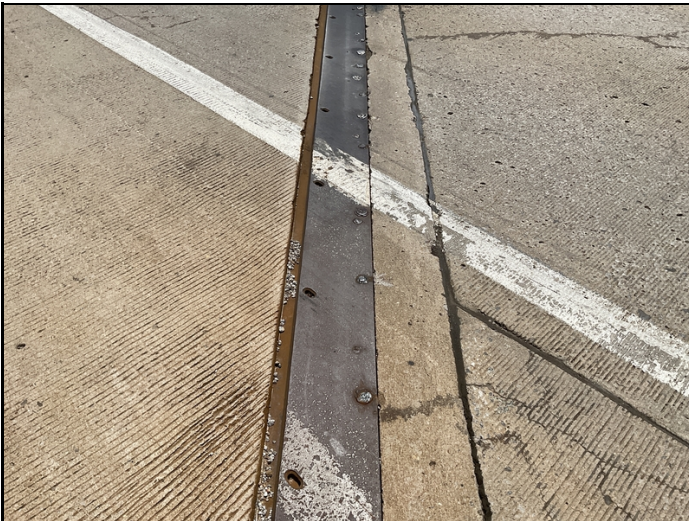
Abutment #2 new anchorage welds.

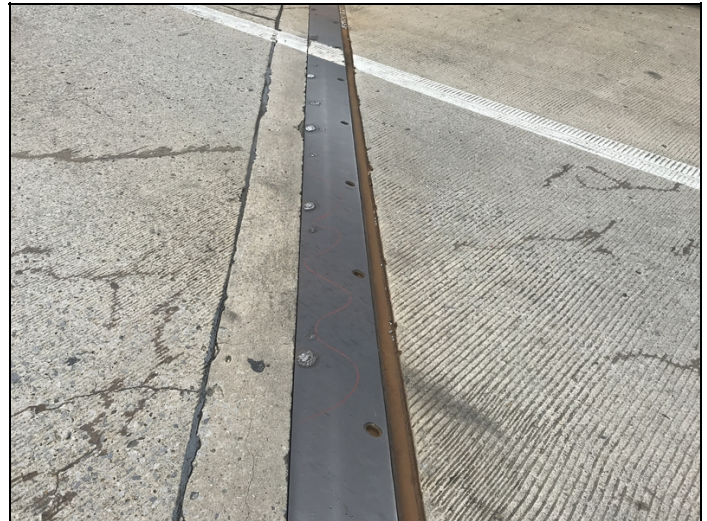
Abutment # 2 Sliding Plate Assembly is noisy in the right lane when impacted by traffic. Sounding indicates that approximately 15' of the assembly in the right lane is not securely anchored.

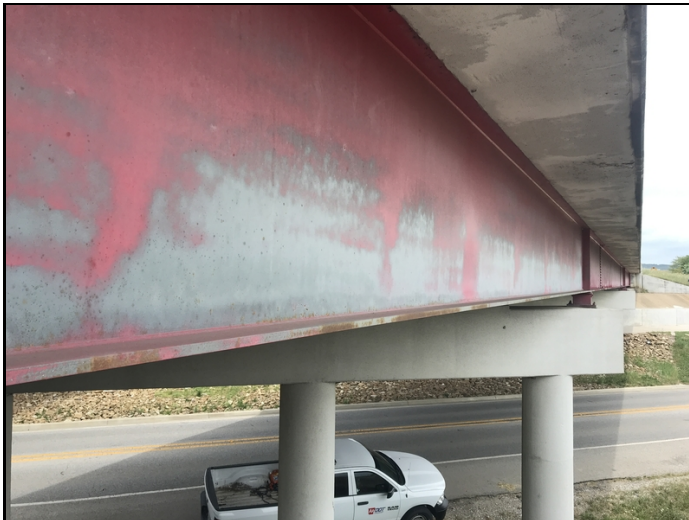
Right side

The exterior beams paint system is chalking in areas that expose the primer undercoat.
