Asset #A6479(Routine)

I 49 SB LNS over BLACKBURN CREEK

Location: .5 MI N OF HOPPER TUNNEL

Team Lead: Lee Swan, Inspection Date: 04/14/2022

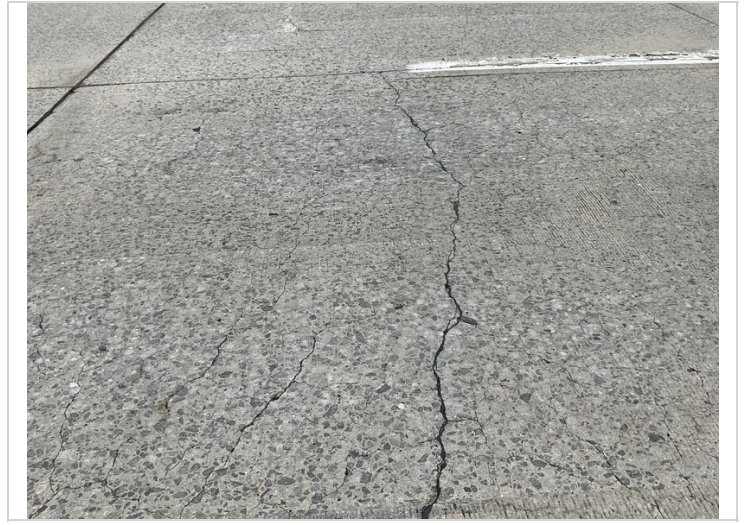
(321) 04/21/2022-RLS & ADC - Both slabs have cracks and spalls.							
331	Reinforced Concrete Bridge Railing	LF	3024	1459	1564	1	0
1080	Delamination/Spall/Patched Area	LF	1	0	0	1	0
1120	Efflorescence/Rust Staining	LF	16	0	16	0	0
1130	Cracking (RC and Other)	LF	1520	0	1520	0	0
7000	Damage	LF	28	0	28	0	0

North side approach slab, large cracks.

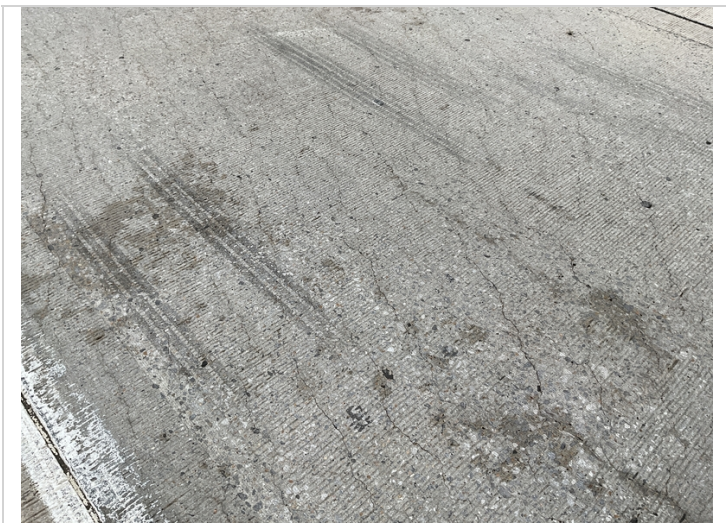
North side approach slab, cracking.

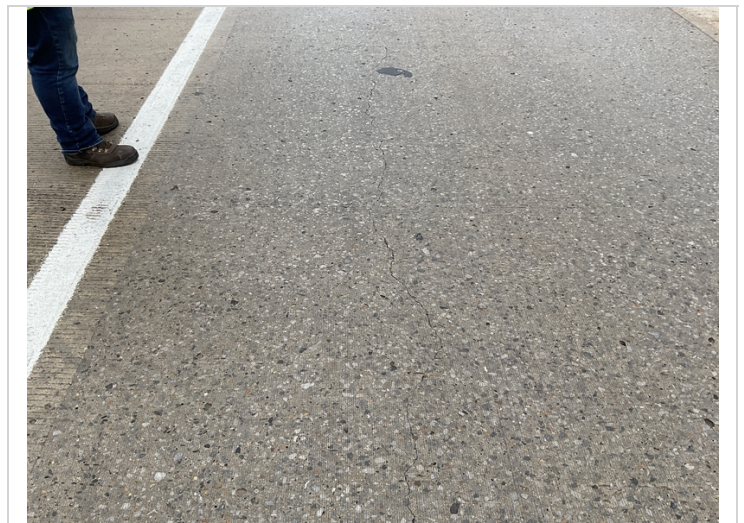
(12) 04/21/2022-RLS & ADC - Large longitudinal and transverse cracks with the past seal failed. Scattered minor spalls.							
107	Steel Open Girder/Beam	LF	6048	6012	36	0	0
1000	Corrosion	LF	24	0	24	0	0
1020	Connection	LF	12	0	12	0	0
515	Steel Protective Coating	SF	96180	94668	1512	0	0
3430	Oxide Film Degradation Color/Texture Adherence(Steel Protective Coatings)	LF	1512	0	1512	0	0

Span 8, large longitudinal crack.

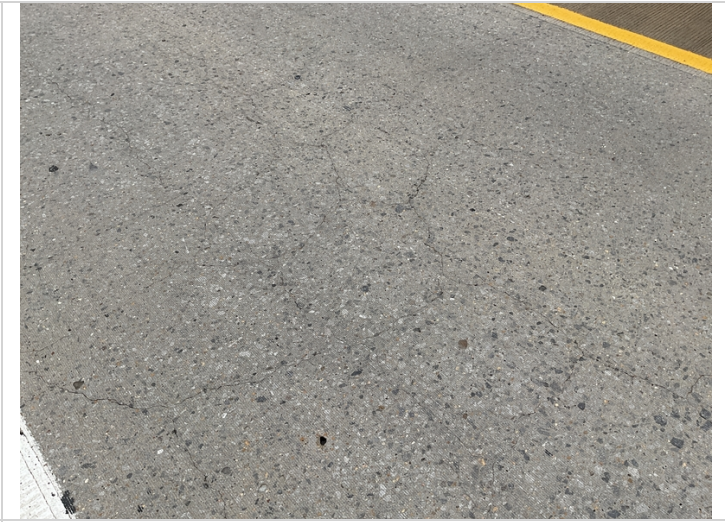
Span 6, large cracks.

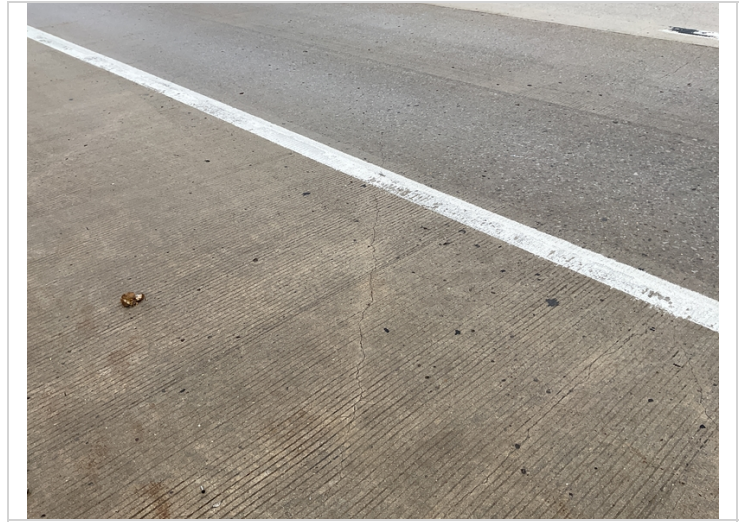
Span 6, large diagonal crack.

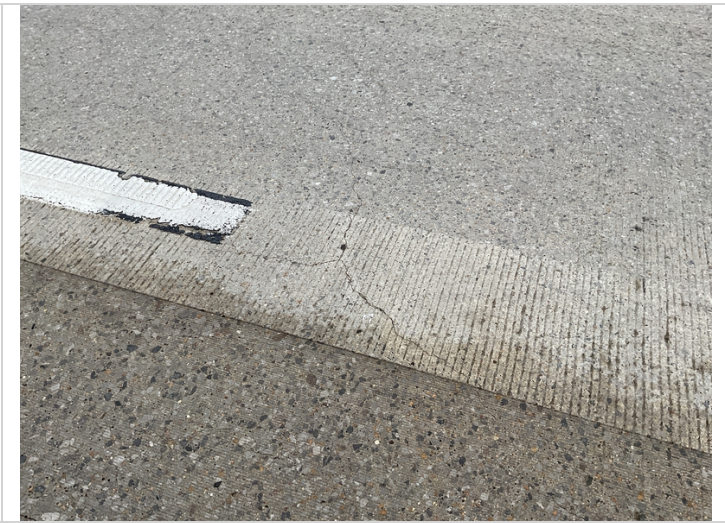
Span 6, large cracks at centerline.

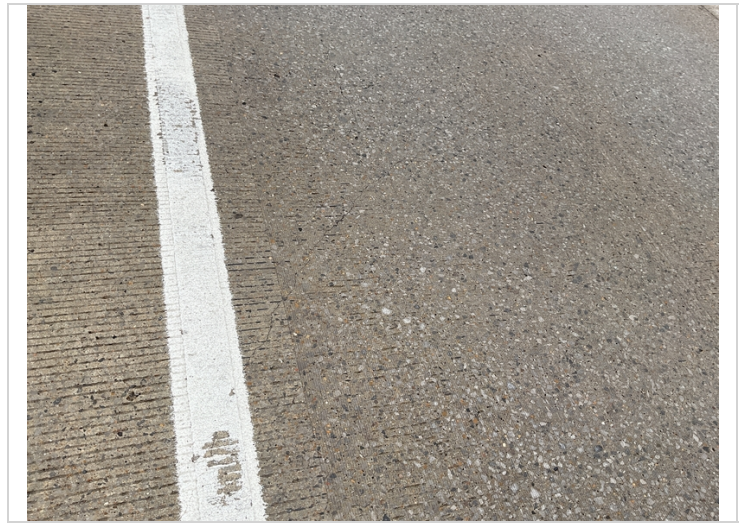
Span 6 diagonal cracks

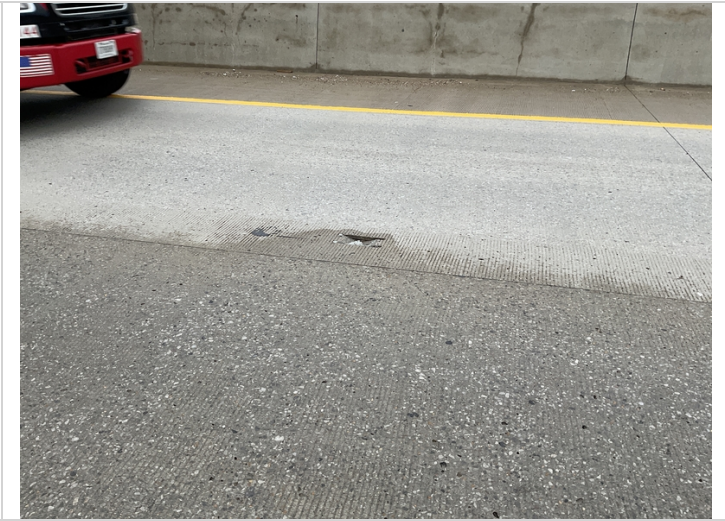
Span 5, missing plowable marker.

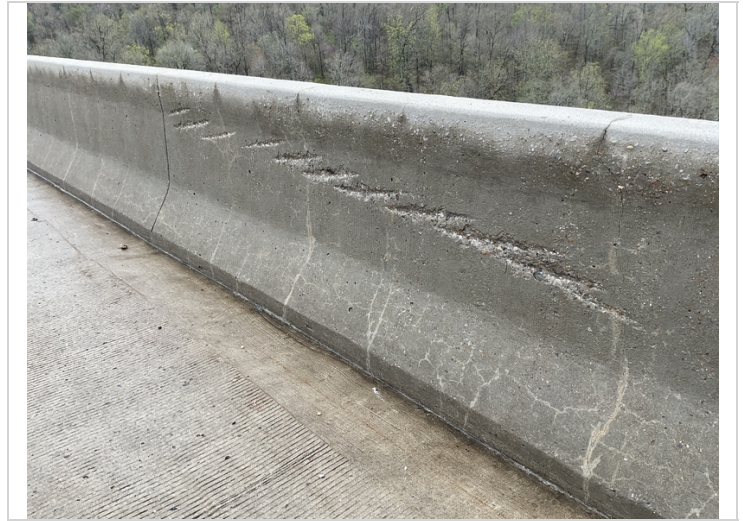
Left bridge rail span 4, 10' damage.

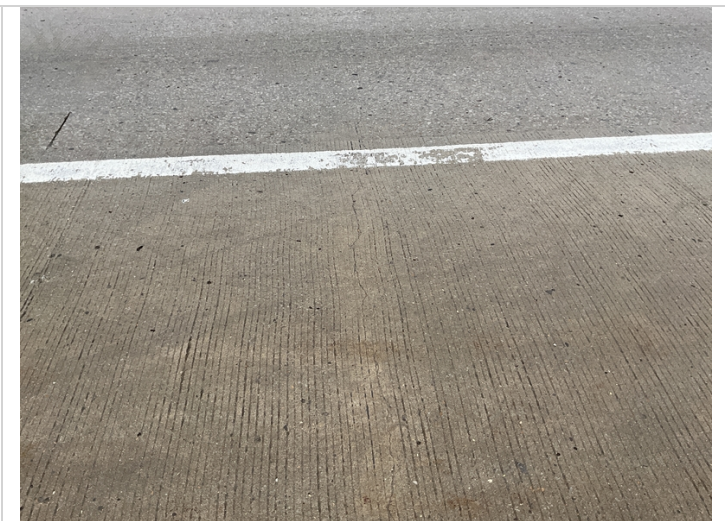
Span 4, large transverse crack.

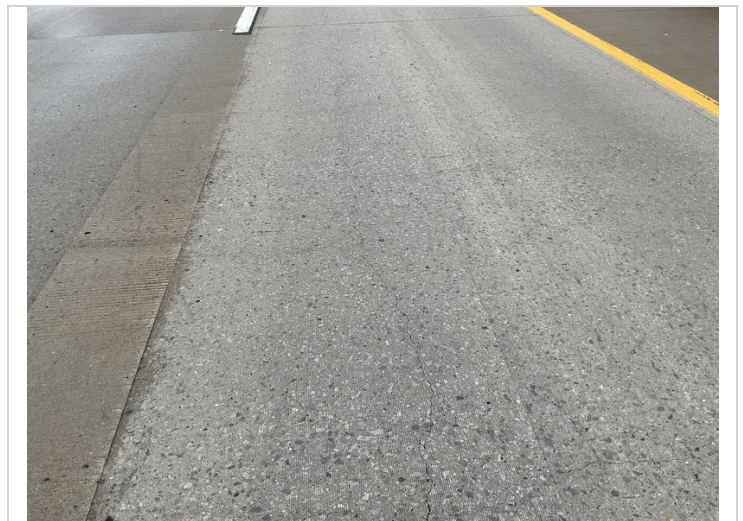
Span 3, large longitudinal crack

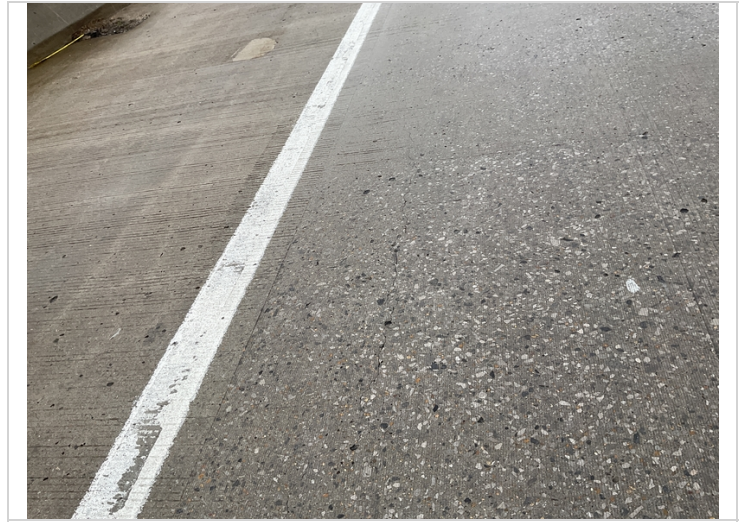
Span 3, large longitudinal crack.

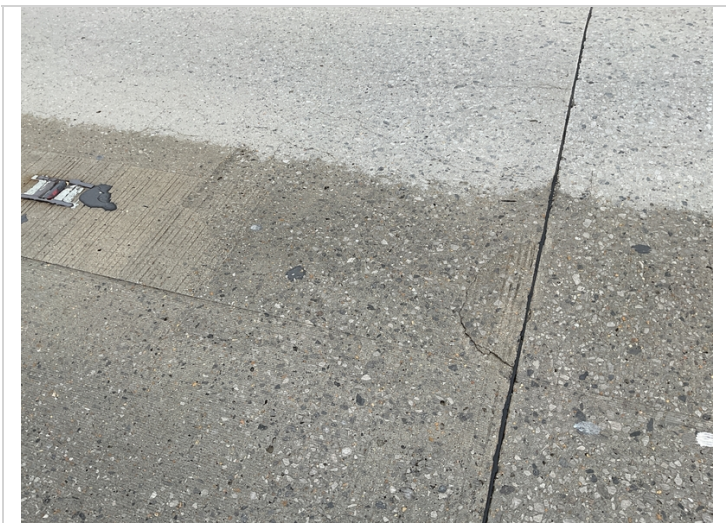
Span 3, delam at centerline.

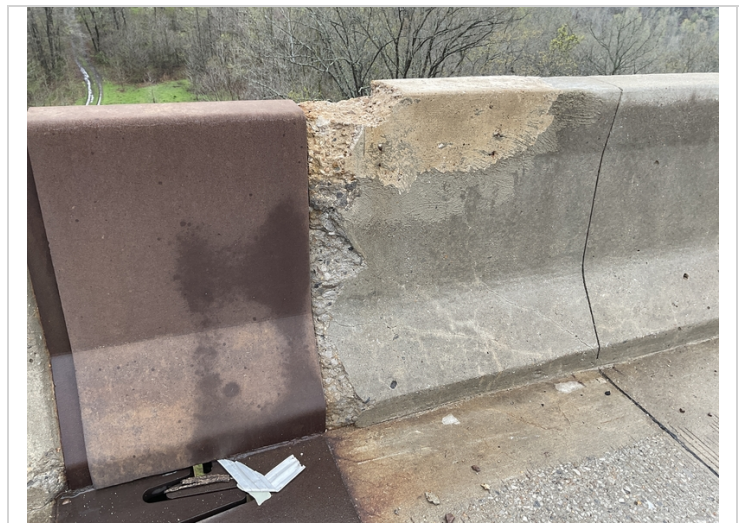
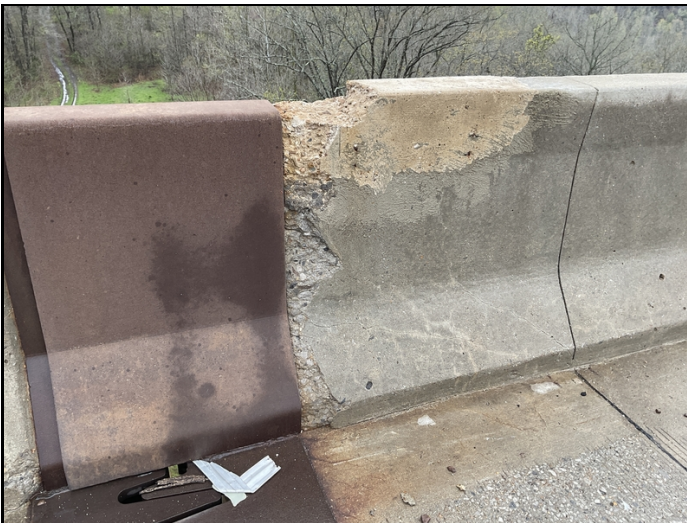
(331) 04/21/2022-RLS & ADC - Both walls have cracks. Bent 3, large spall in bridge rail. Minor damage in the left rail.

Bent 3, large spall in bridge rail.

RLS & ADC- 04/21/2020- Cracks, map cracking and efflorescence throughout. Bent 3, large spall at the expansion joint.

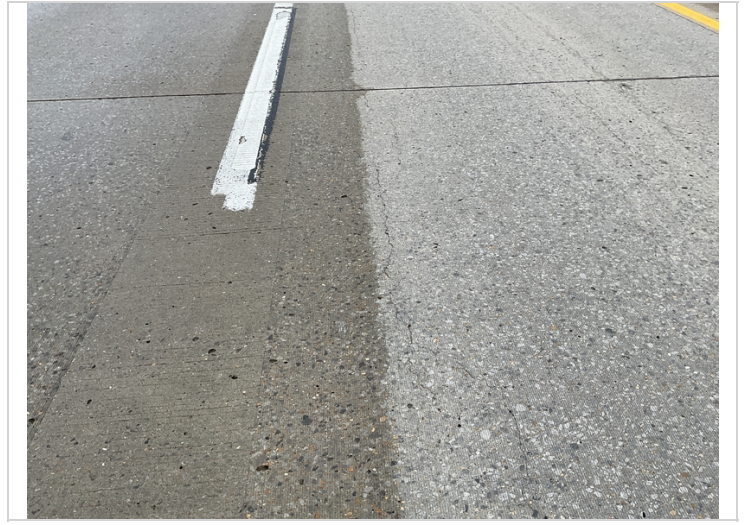
Span 2, large longitudinal crack.

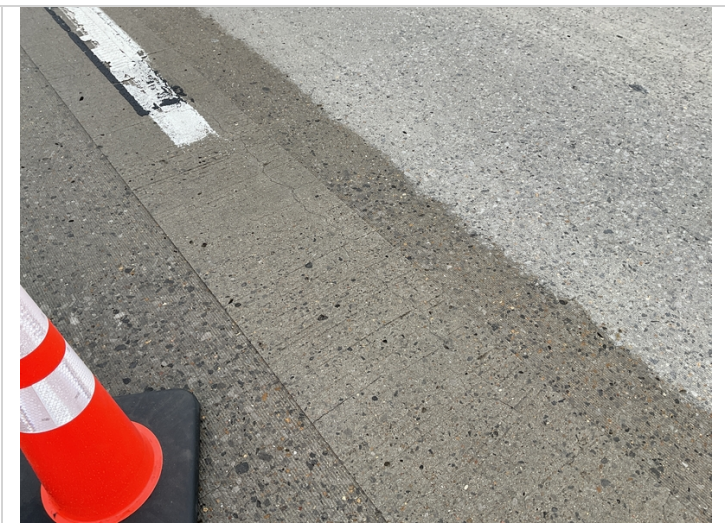
Span 1, cracking in the deck

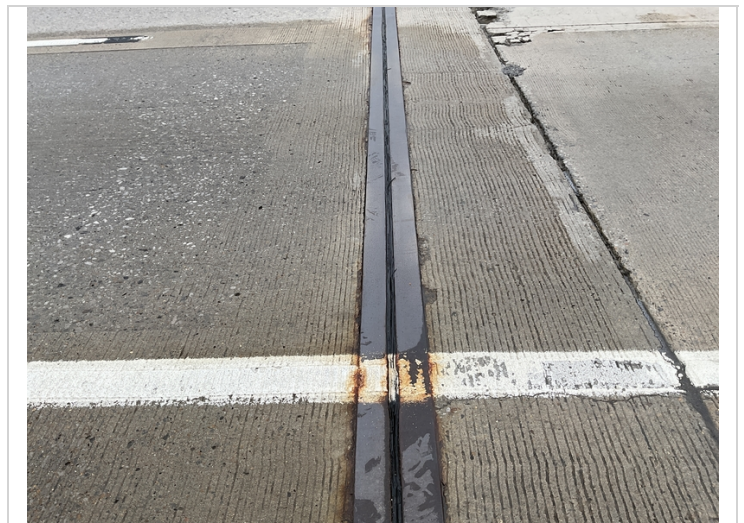
(302) 04/21/2022-RLS & ADC - Joints are leaking and have damage.							
303	Assembly Joint with Seal	LF	83	73	10	0	0
2350	Debris Impaction	LF	10	0	10	0	0

Bent 1 joint, damage.

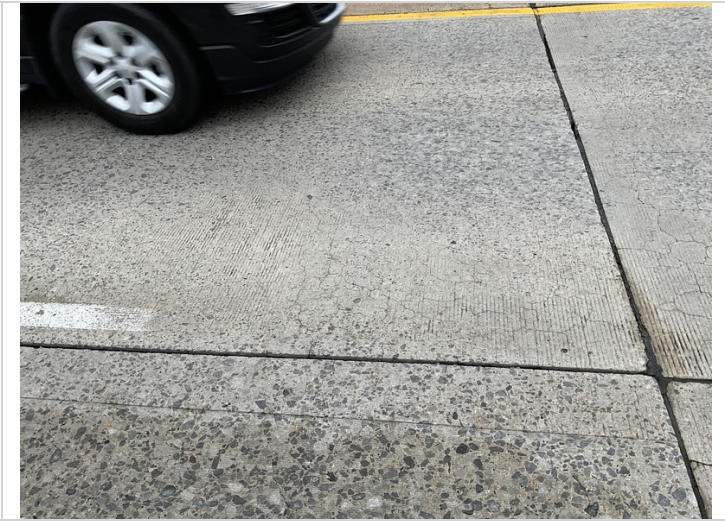
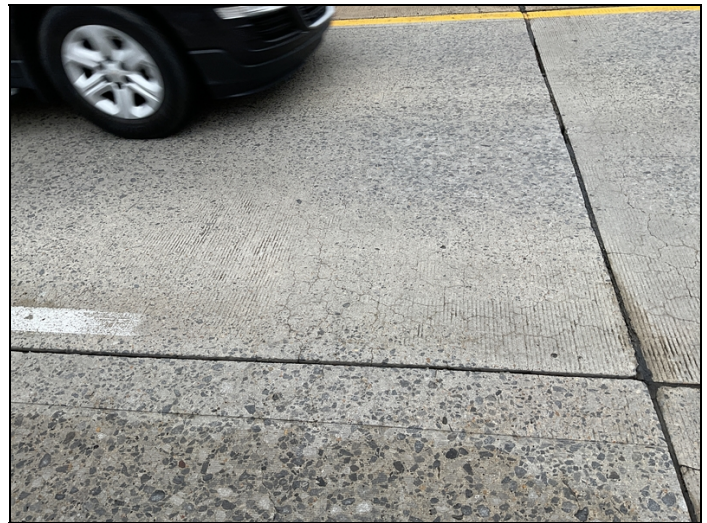
Map cracking southern approach slab.

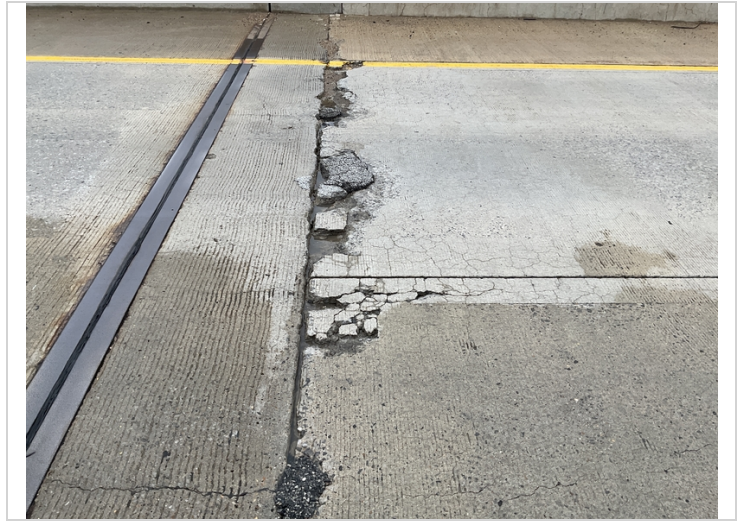
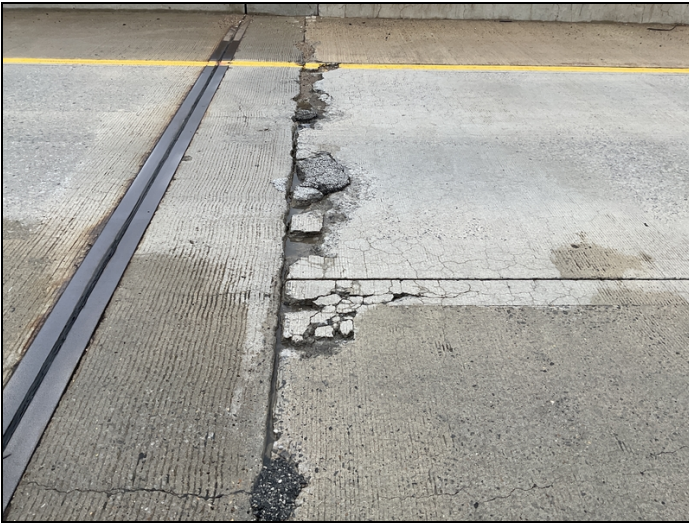
Left lane of southern approach slab, large spalls.

RLS & ADC-04/20/2022- Numbers large spall and failing patches in the south approach slab. Change priority from "D" to "C".

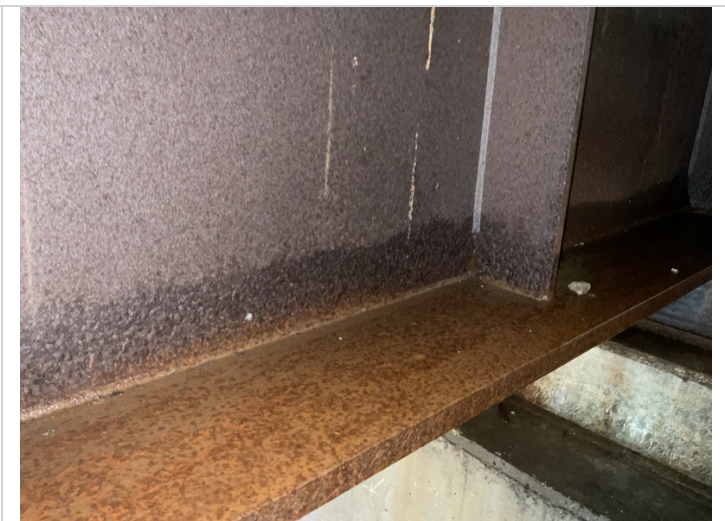
(107) 04/21/2022-RLS & ADC - Girder ends at joints are beginning to corrode due to failure of the protective coating.							
(515-107) 04/21/2022-RLS & ADC - There is a granular texture on the bottom of the bottom flanges.							
210	Reinforced Concrete Pier Wall	LF	126	112	14	0	0
1130	Cracking (RC and Other)	LF	14	0	14	0	0

Span 3 girder 3 at bent 3, protective coating failing.

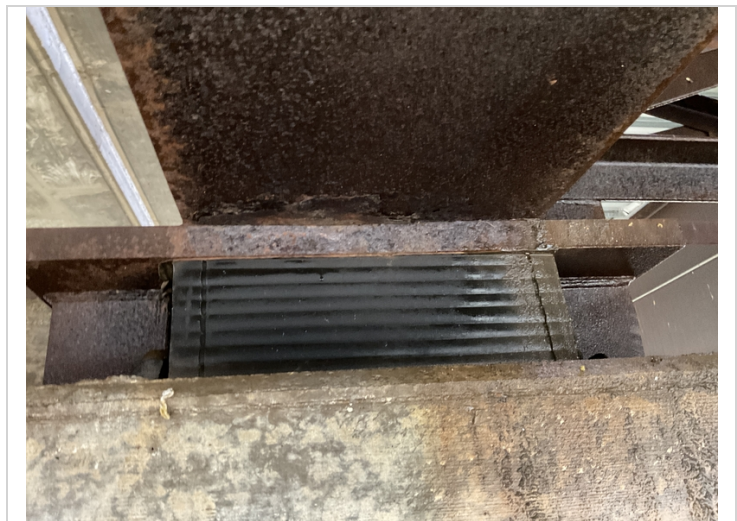
Bent 3 span 3 girder 4, failure of the protective coating.

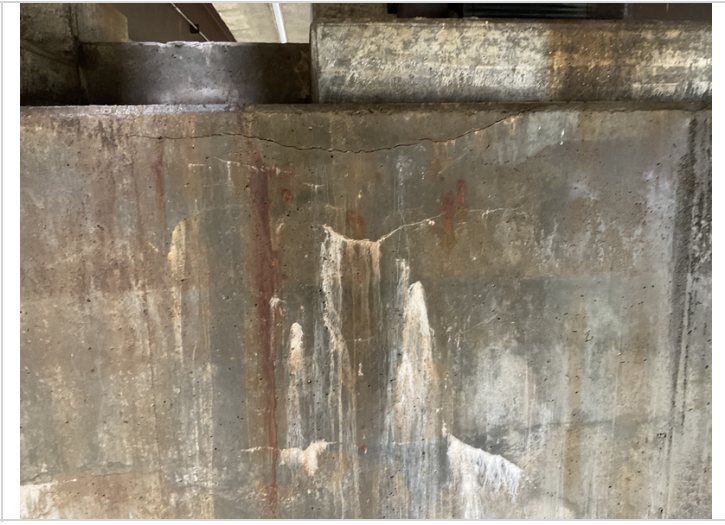
Bent 3 ahead side near girder 4, large horizontal cracks, rust staining and efflorescence.

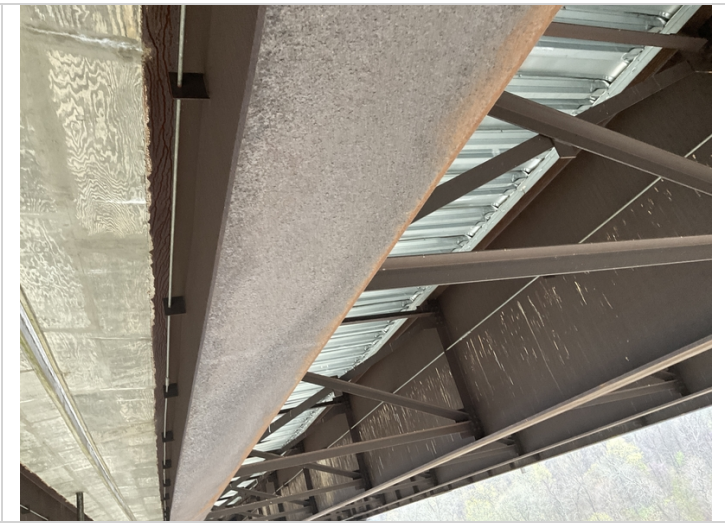
Span 6 girder 4, flaking in the protective coating.

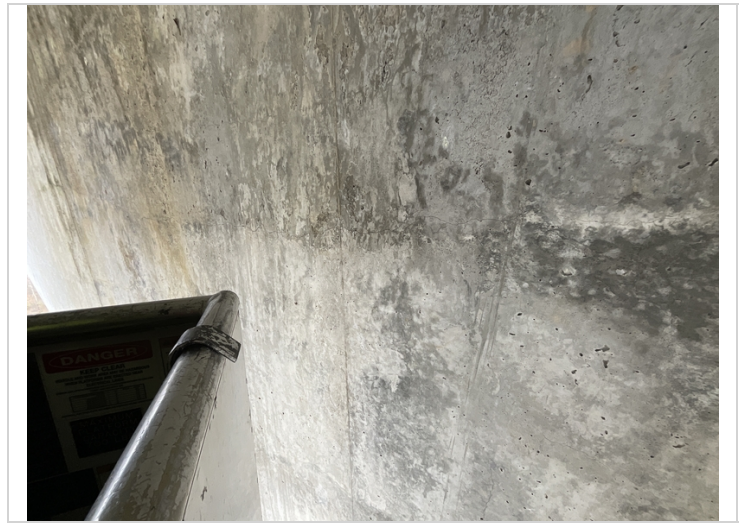
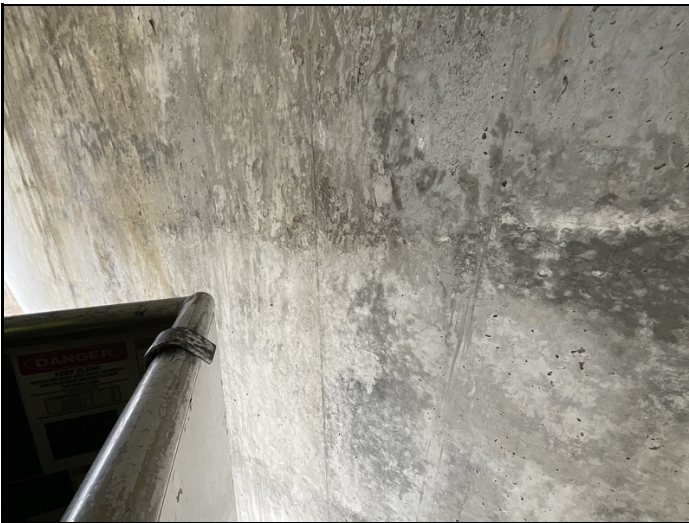
Bent 6 backside face of cap, long horizontal crack from left edge to middle of bay 3.

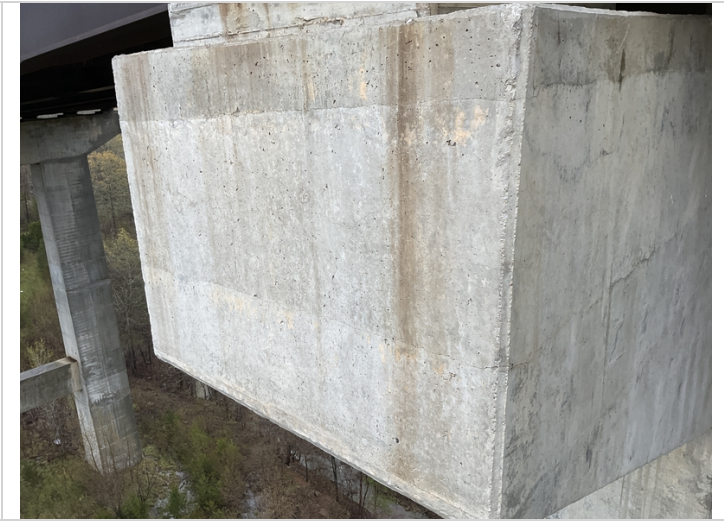
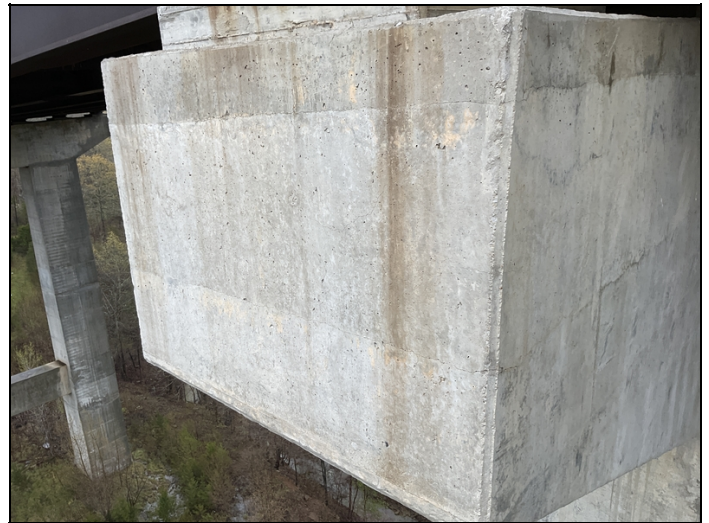
Left end of bent 6, cracking.

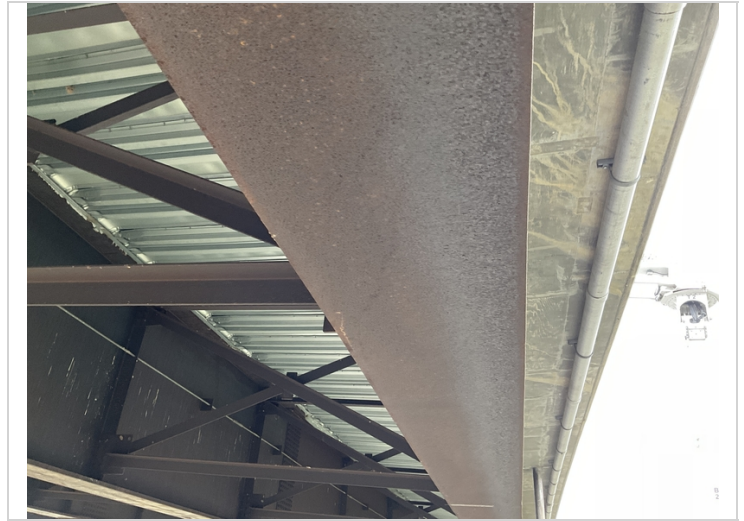
Span 6, typical condition of the protective coating on the bottom of the bottom flange.

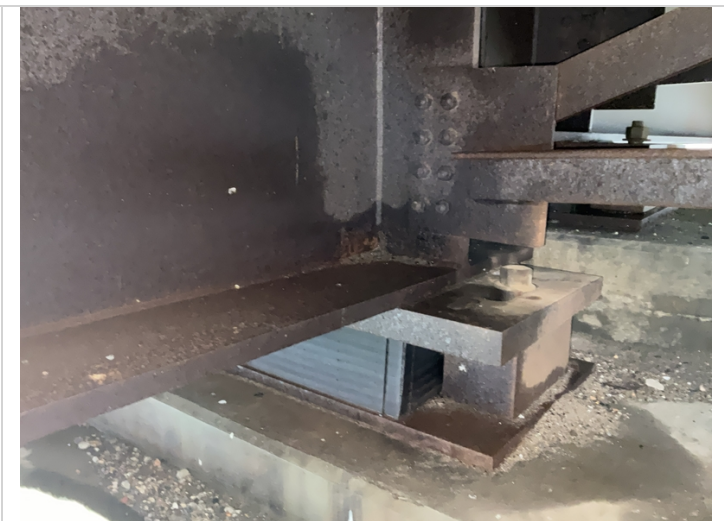
Span 7, bent 8 girder 3, protective coating has failed and there is minor section loss to the lower web.

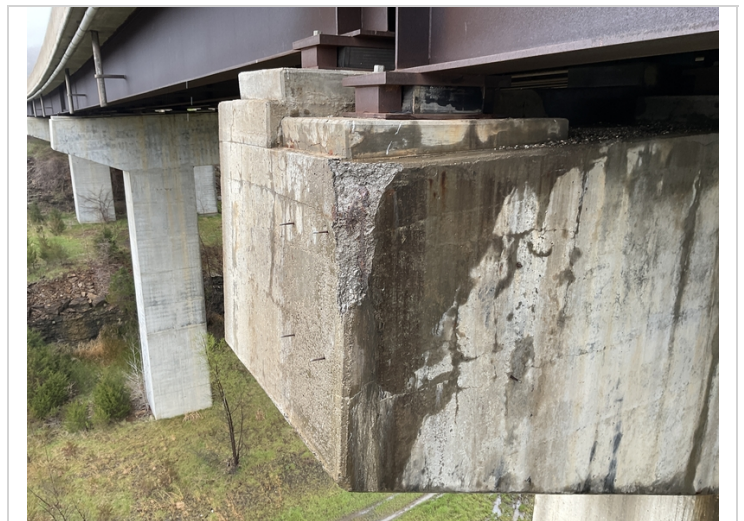
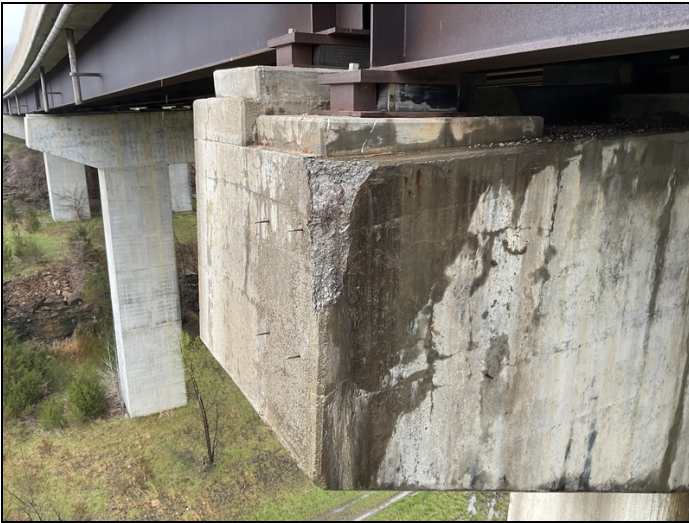
(234) 04/21/2022-RLS & ADC - All caps have vertical cracks. Bent 7 has a horizontal crack on the left, ahead side. Bent 8, efflorescence, spall with exposed rebar.

Bent 8 left side, large spall with exposed rebar with section loss.

RLS & ADC-04/20/2020- Bent 8 has a large spall with exposed rebar.

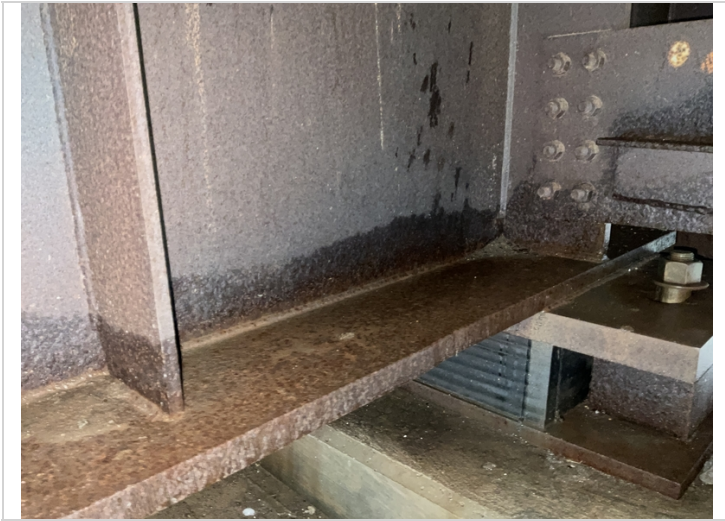
Bent 8 girder 3, corrosion.

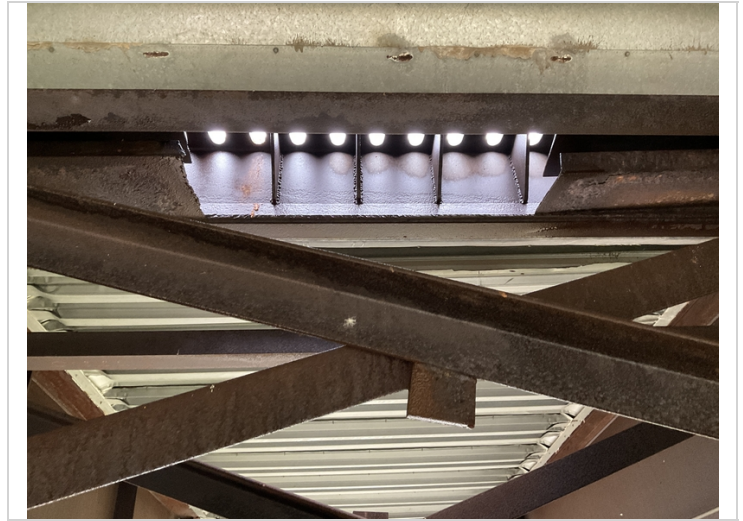
(303) 04/21/2022-RLS & ADC - Minor debris impaction on the ends of the joints. Maintenance has cut out part of the bottom of the joints in the bays to reinforce the joints.							
310	Elastomeric Bearing	EA	52	50	2	0	0
2220	Alignment	EA	2	0	2	0	0

Bent 8 bay 3, 4' of the trough for the assembly joint has been removed by maintenance forces to reinforce the finger joint. Common.

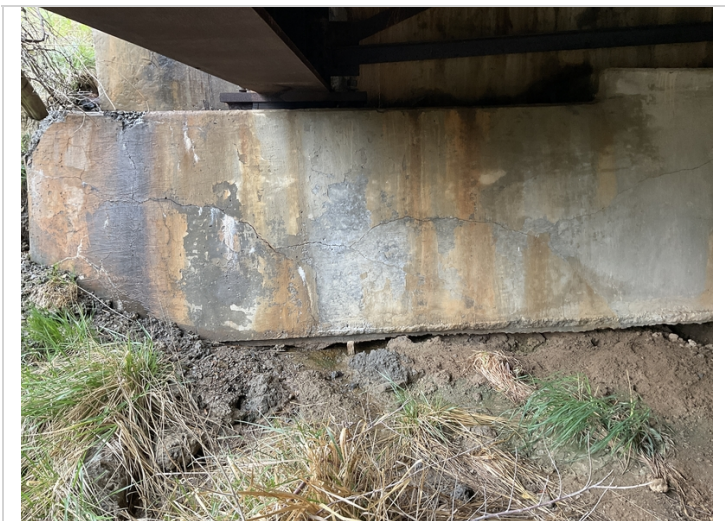
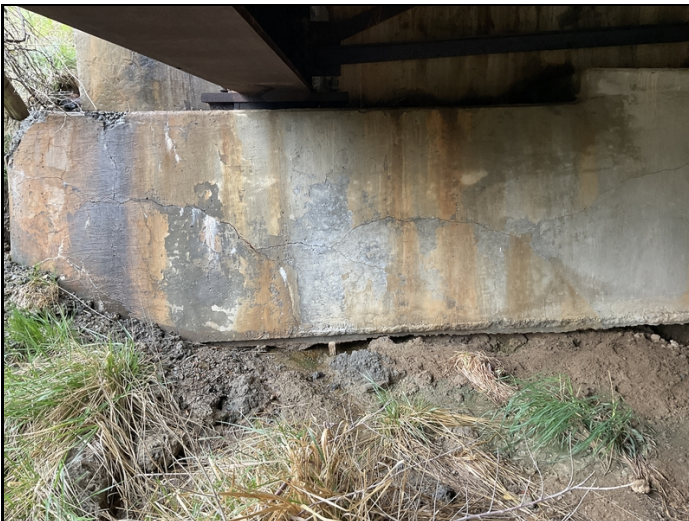
(215) 04/21/2022-RLS & ADC - Bent 11, 2 large spalls, on left side. Large horizontal cracks across the face of the bridge seat.							
234	Reinforced Concrete Pier Cap	LF	387	304	74	9	0
1080	Delamination/Spall/Patched Area	LF	2	0	0	2	0
1090	Exposed Rebar	LF	1	0	0	1	0
1120	Efflorescence/Rust Staining	LF	14	0	11	3	0
1130	Cracking (RC and Other)	LF	66	0	63	3	0

Bent 11 , large horizontal cracks in the face of the bridge seat.

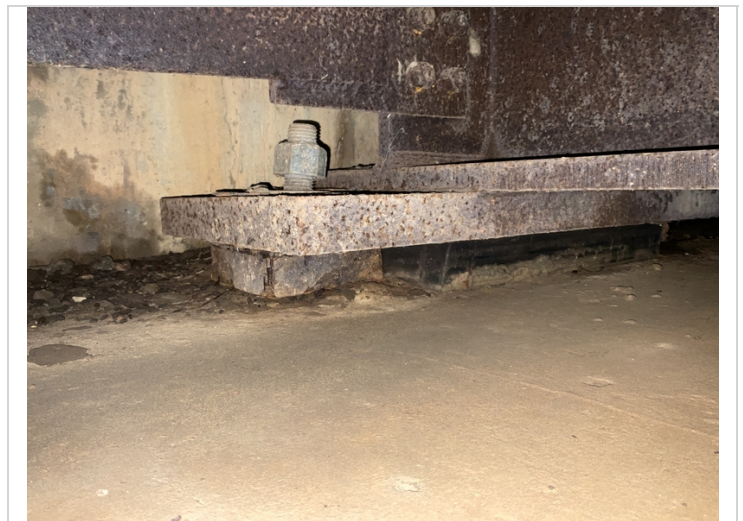
Bent 11 bearing 2, protective coating failing.

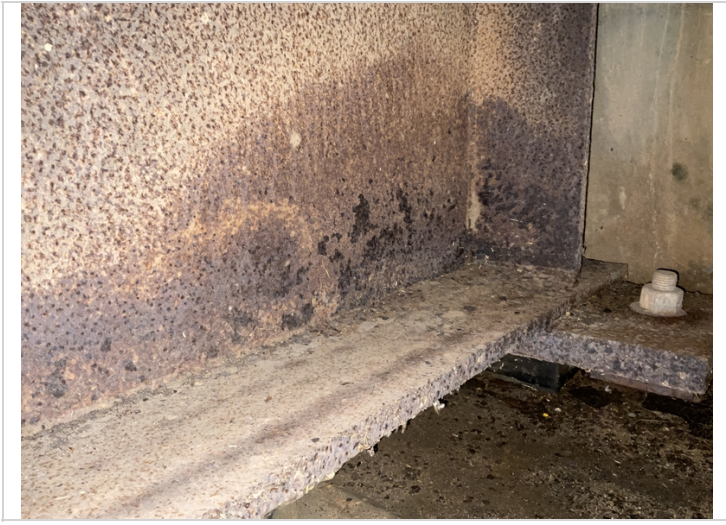
Bent 11 girder 4, the protective coating is failing and there is minor pitting in the lower web.

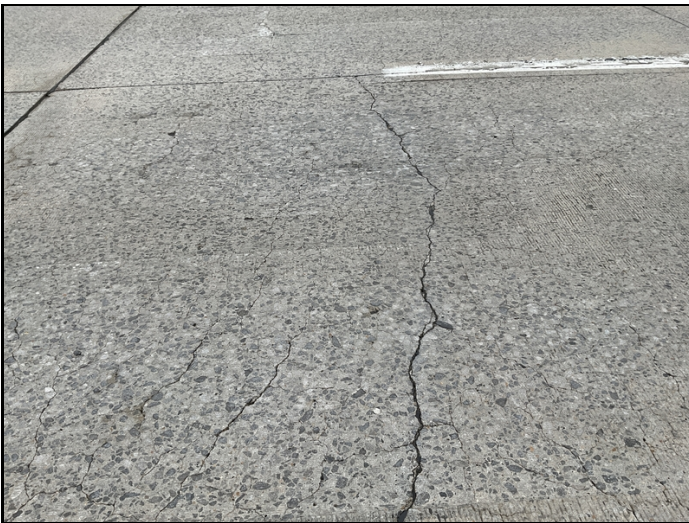
North side approach slab, large cracks.

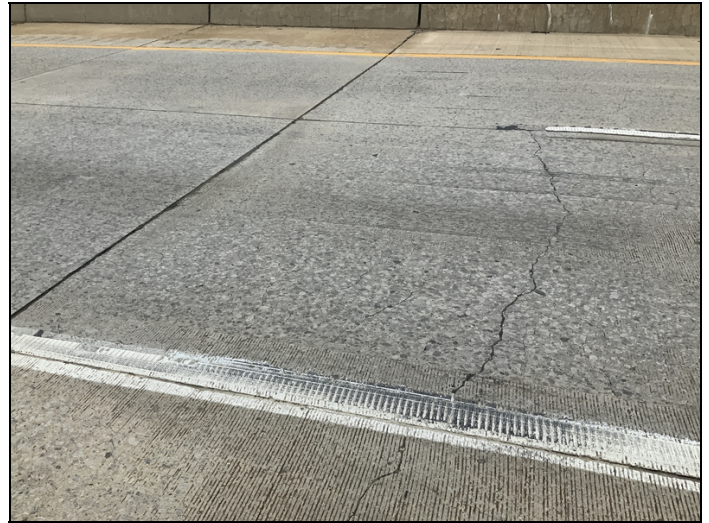
North approach right lane approximately 1" settlement
with 20' CS-3 cracking.

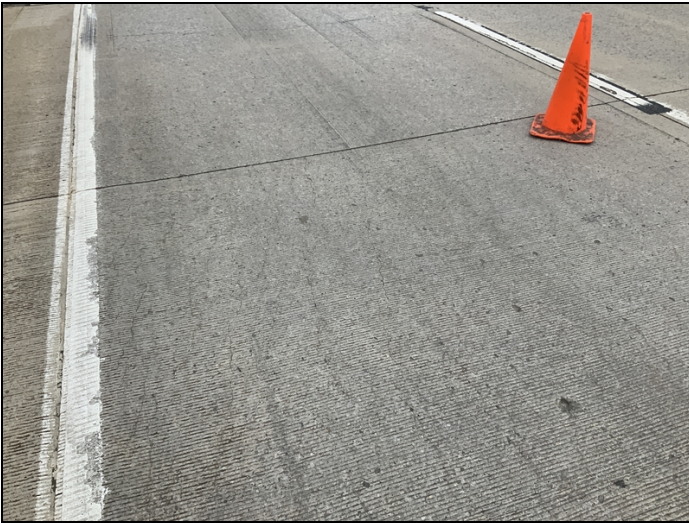
North approach sealable cracking.

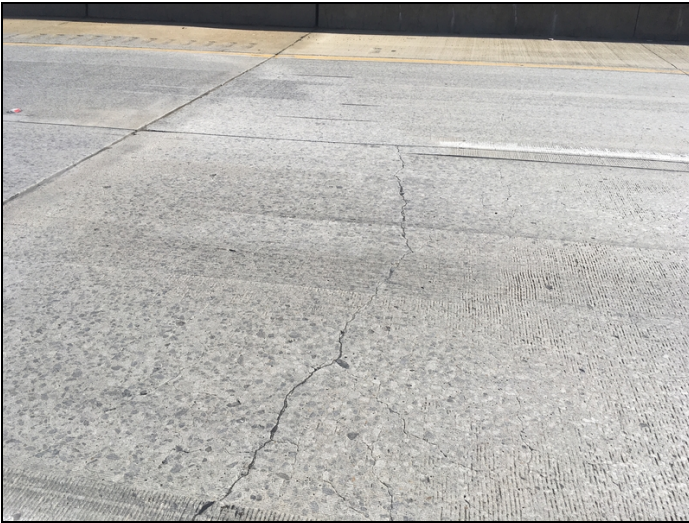
North approach slab sealed cracks.

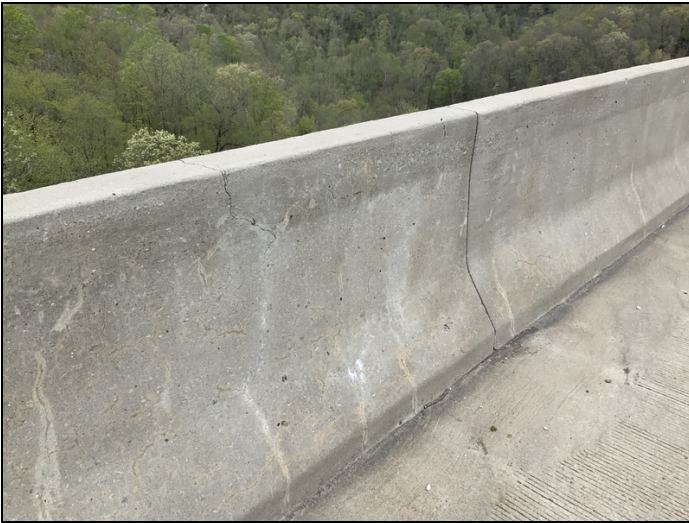
Typical cracking throughout barrier walls.

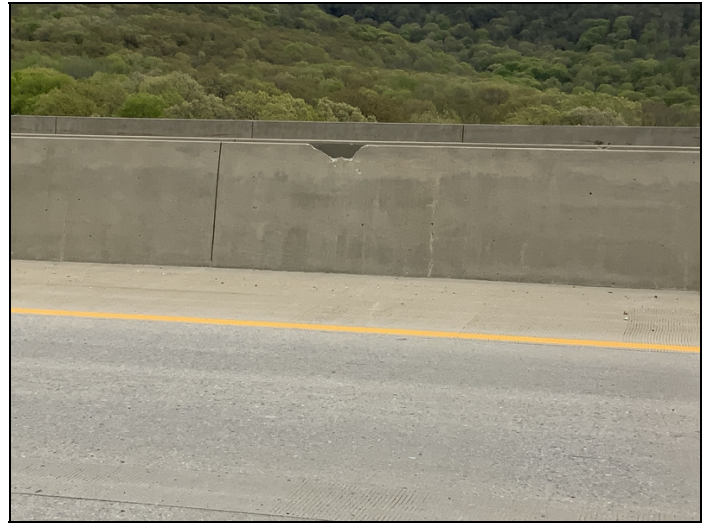
Span 6 center barrier wall collision damage.

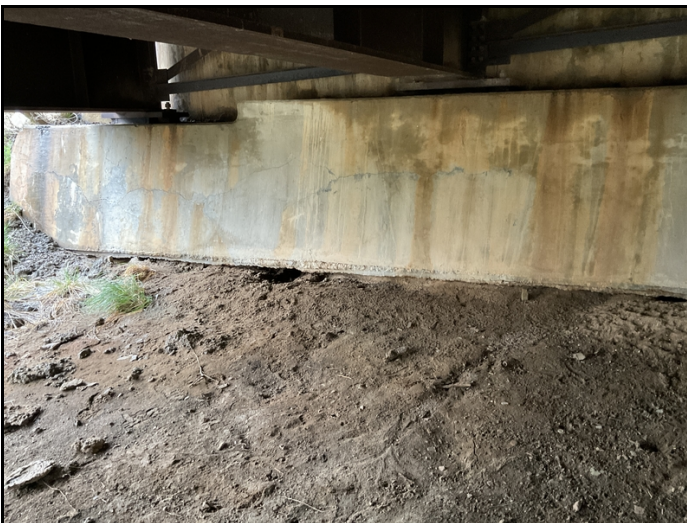
Bent 11, cracks and embankment settlement.

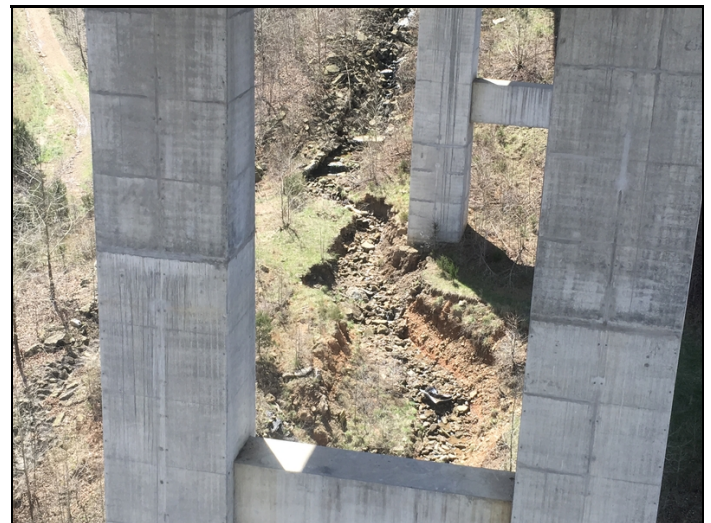
Heavy erosion was occurring to the Rt. of Span 2 and 3 and along the centerline at Span 3 and 4.

Bent 2 - 4 embankment erosion

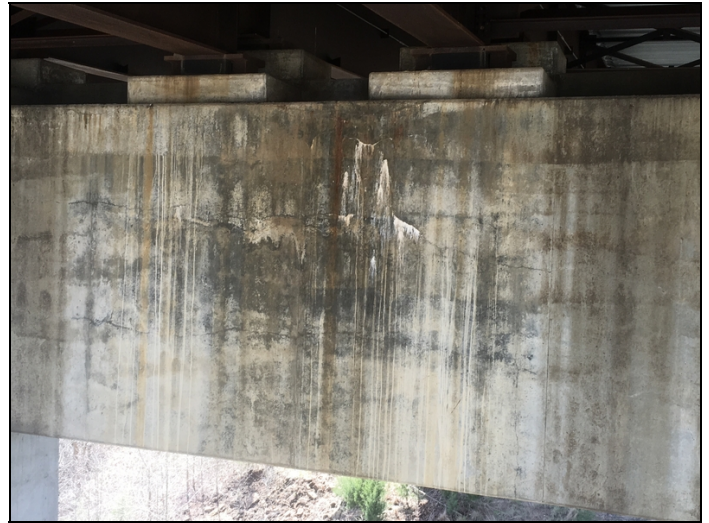
Bent 2 and map Cracking with efflorescence in face of cap.

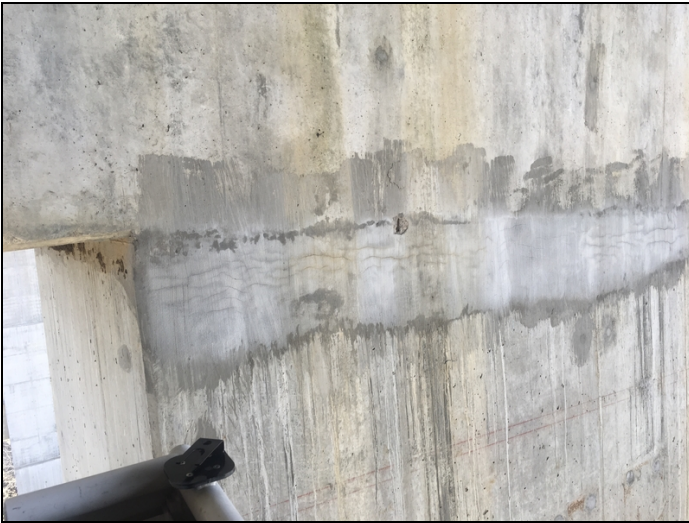
Bent 6 and left pier wall Spall with exposed reinforcing steel.

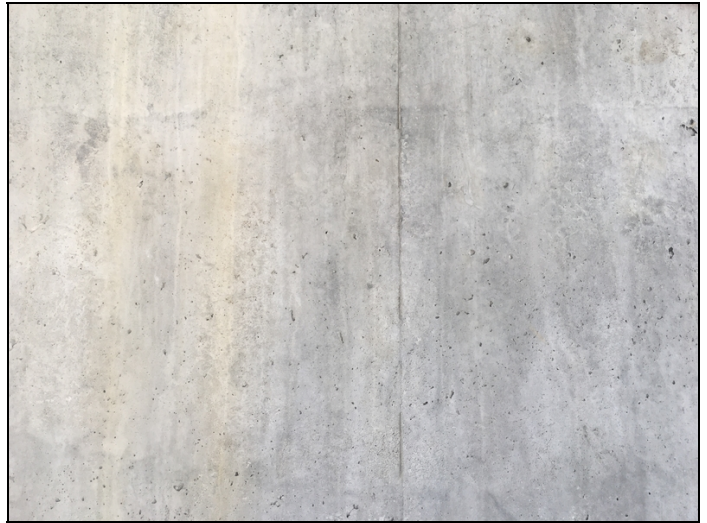
Bent 3 Hairline Cracking in face of cap.

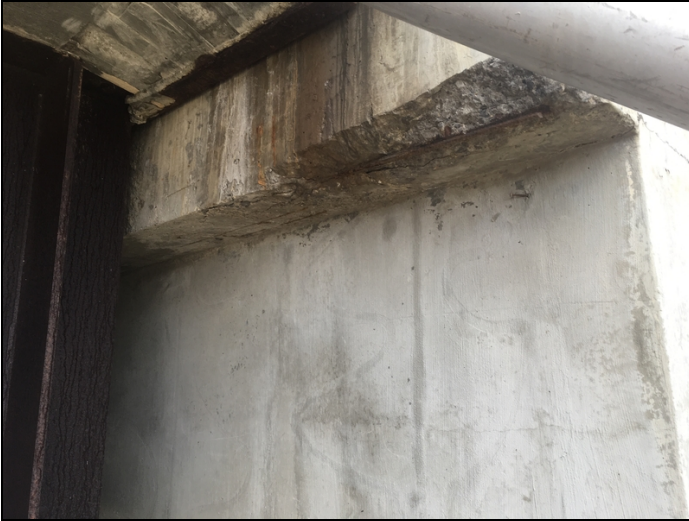
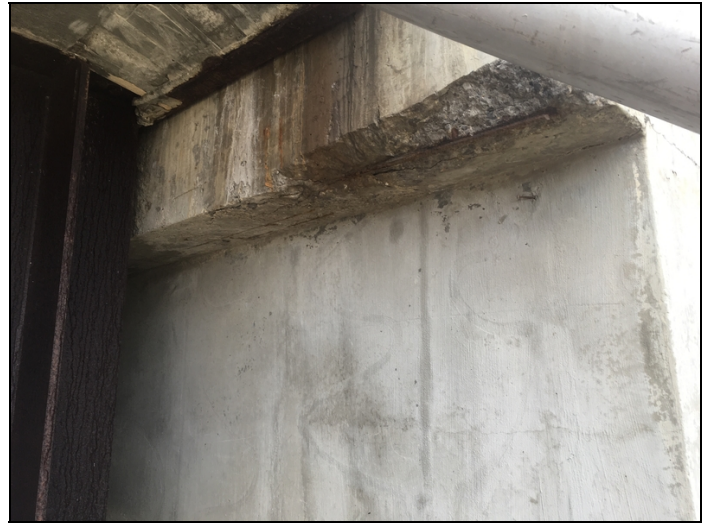
South Abutment left spall with exposed reinforcing steel.

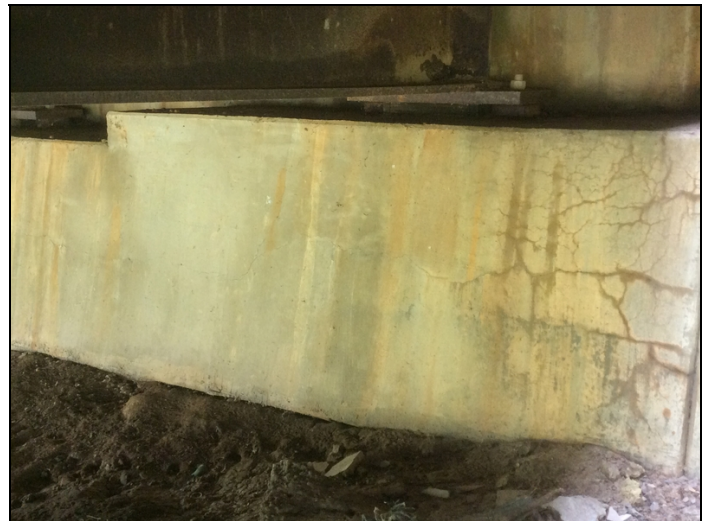
Bent 11 right side (abutment): map cracking and horizontal crack

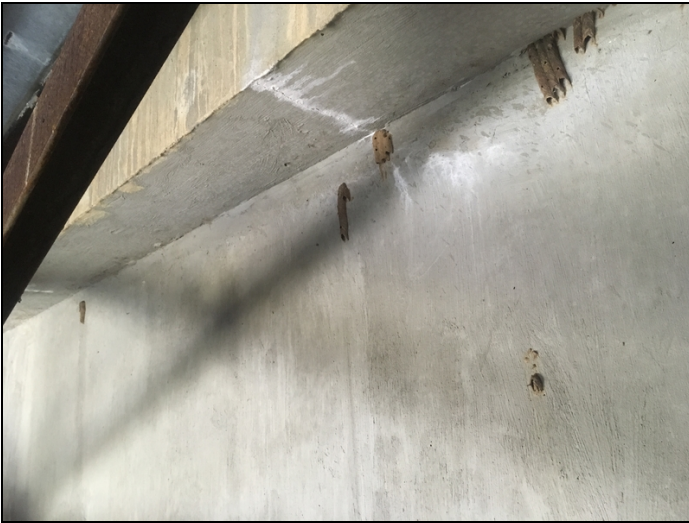
South Abutment Cracking in back wall with efflorescence.

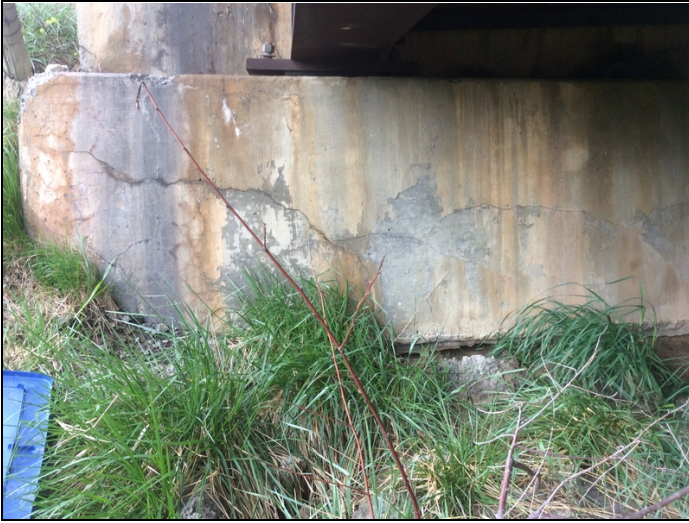
Bent 11 left side: horizontal and map cracking.
