Asset #B6479(Routine)

I 49 NB LNS over BLACKBURN CREEK

Location: .5 MI N OF HOPPER TUNNEL

Team Lead: Lee Swan, Inspection Date: 04/14/2022

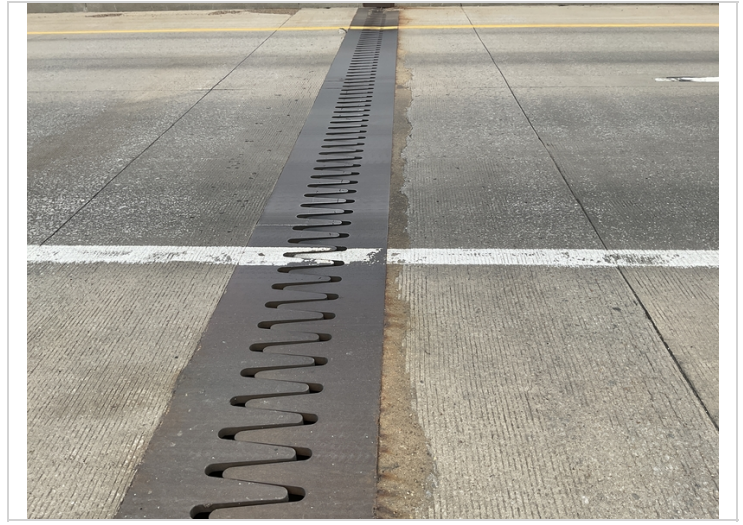
(303) 04/21/2022-RLS & ADC - Spalling and repaired areas adjacent to joints. Debris in joints with areas completely compacted. Maintenance has cut out part of the bottom of the joints in each bay to reinforce the finger joints.							
310	Elastomeric Bearing	EA	52	37	5	10	0
1000	Corrosion	EA	4	0	3	1	0
1020	Connection	EA	7	0	0	7	0
2220	Alignment	EA	4	0	2	2	0

Bent 3, patching and spall adjacent to the assembly joint.

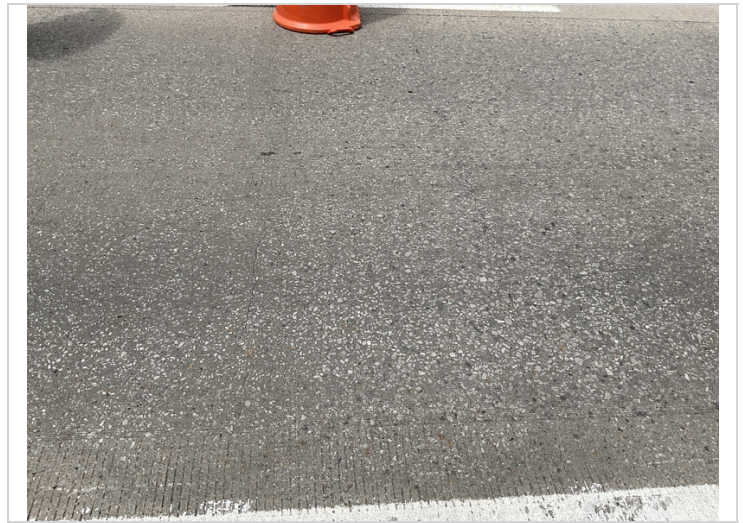
Span 4, large transverse cracks.

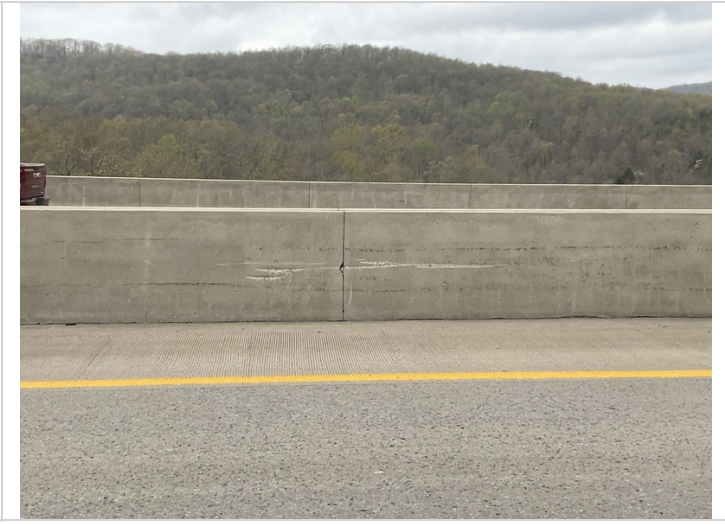
Minor collision damage on the left bridge rail in span 5.

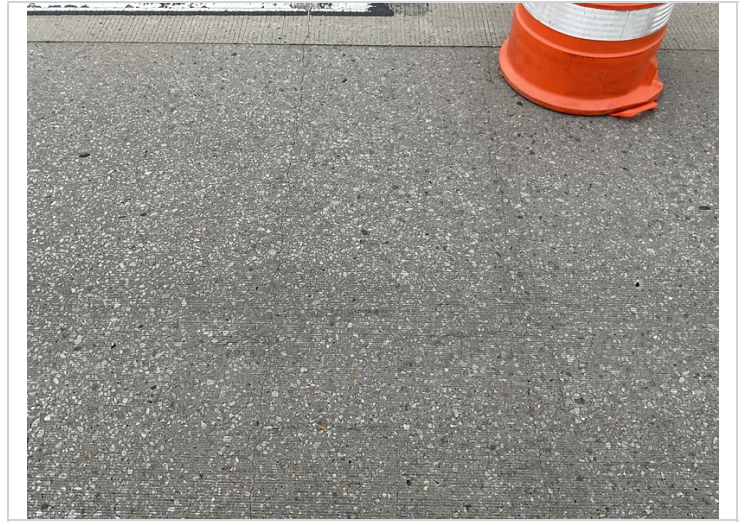
Span 6, large transverse cracks.

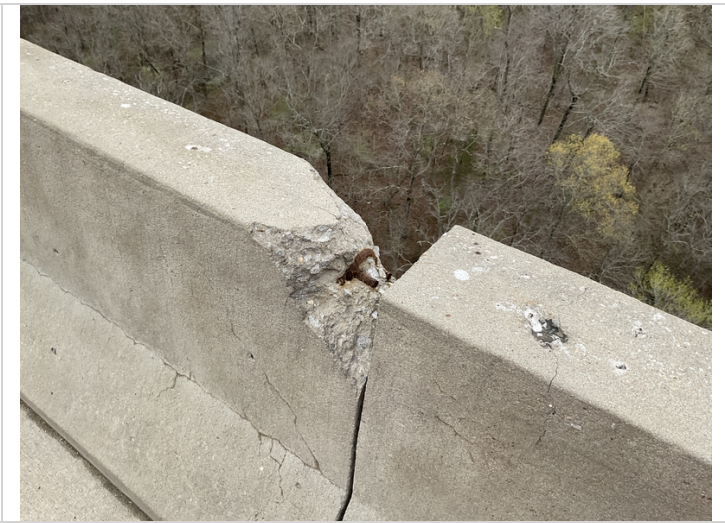
Span 6, right bridge rail, large spall with exposed rebar.

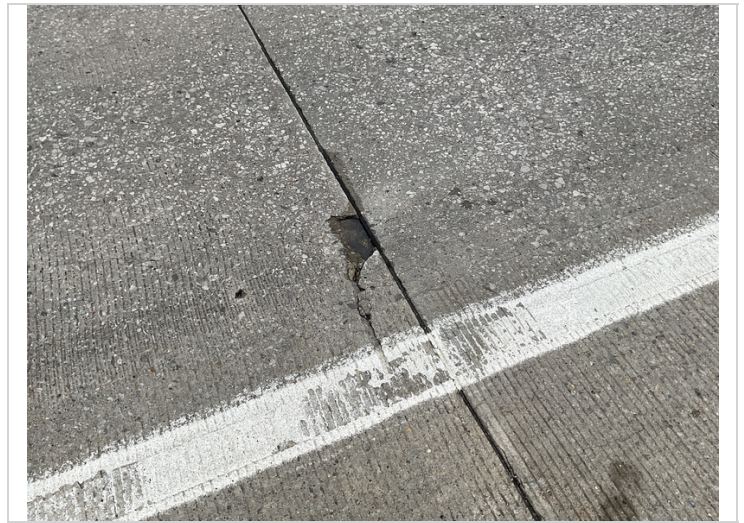
Span 7, deep spall in the right lane

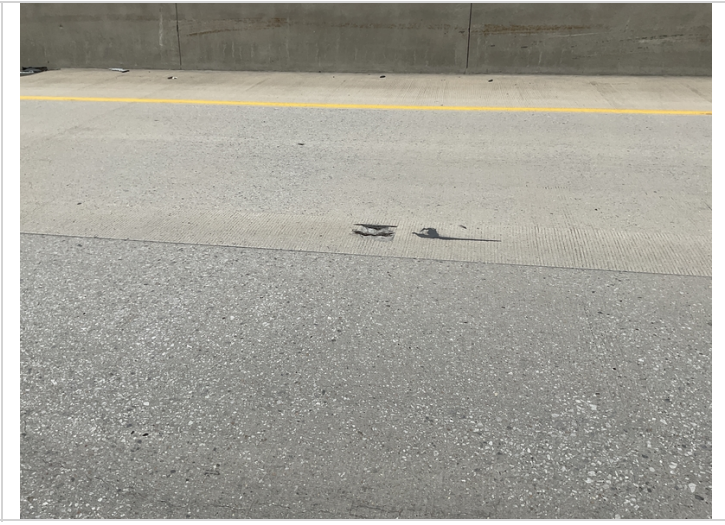
Span 7, missing plowable marker.

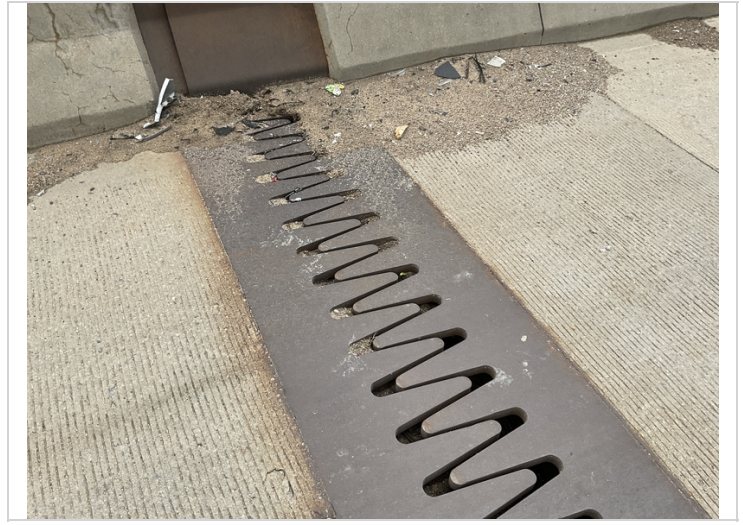
Bent 8, debris impact in assembly joint.

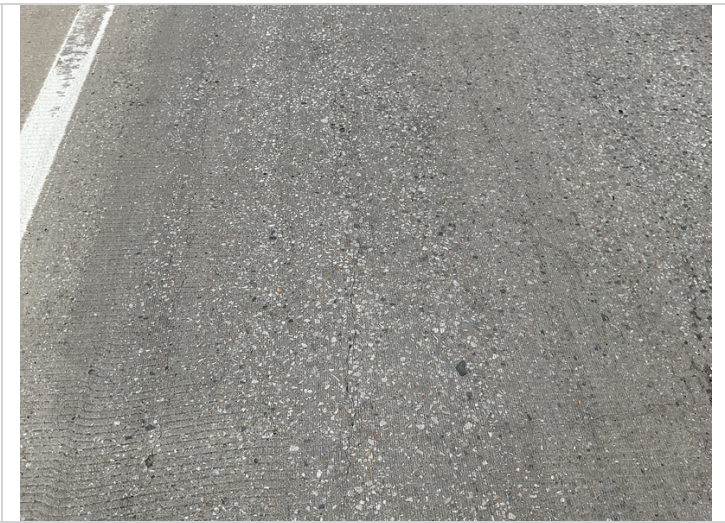
Span 9, longitudinal cracks.

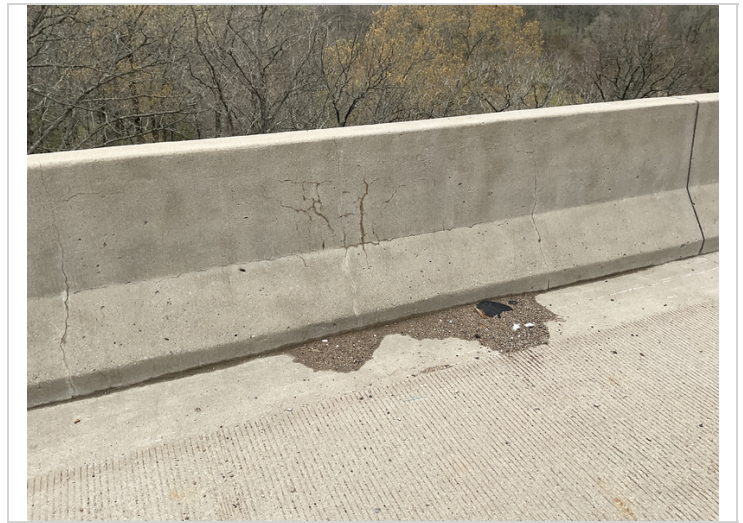
Typical cracks in concrete bridge rail

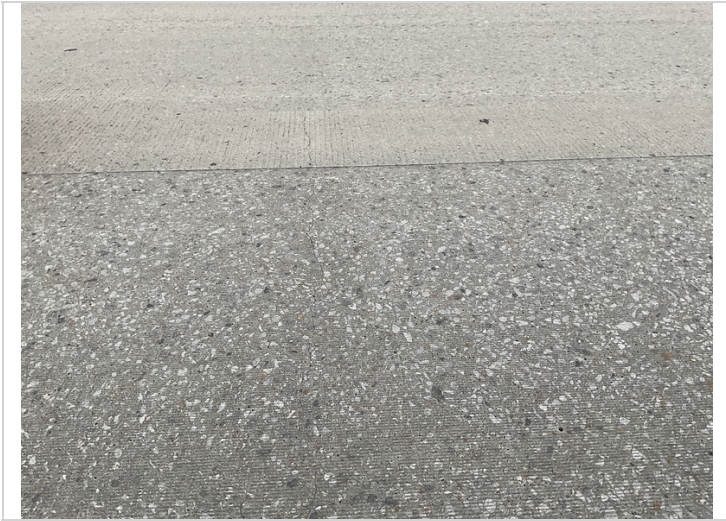
Span 10, large transverse cracks.

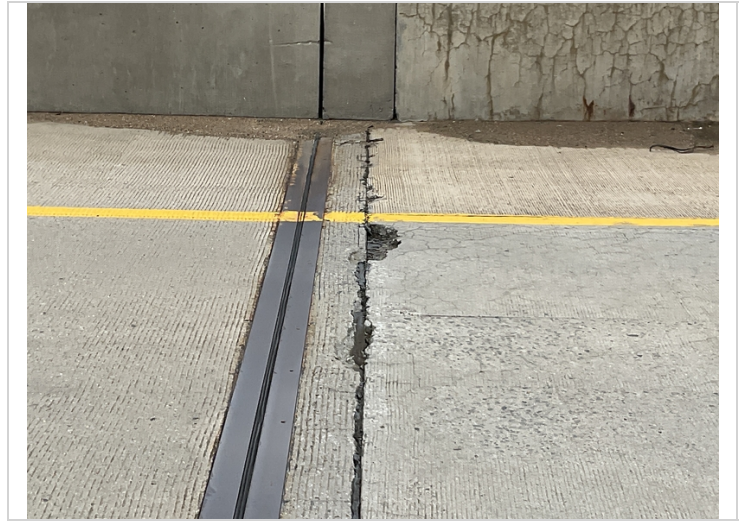
Large spall in northern approach slab.

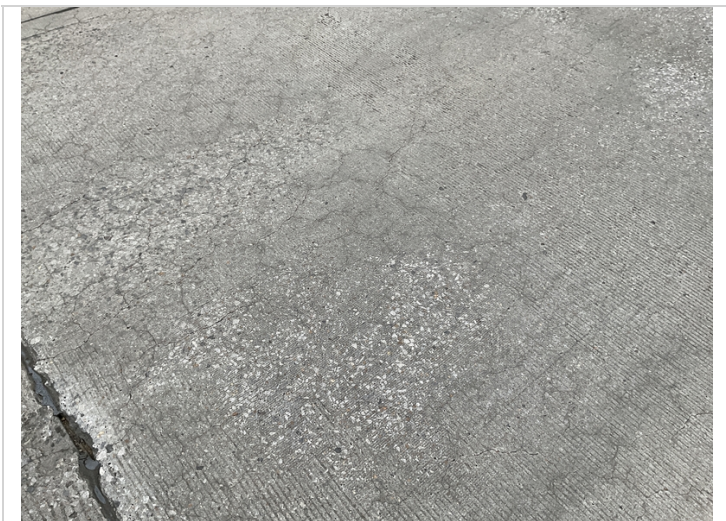
Map cracking in northern approach slab.

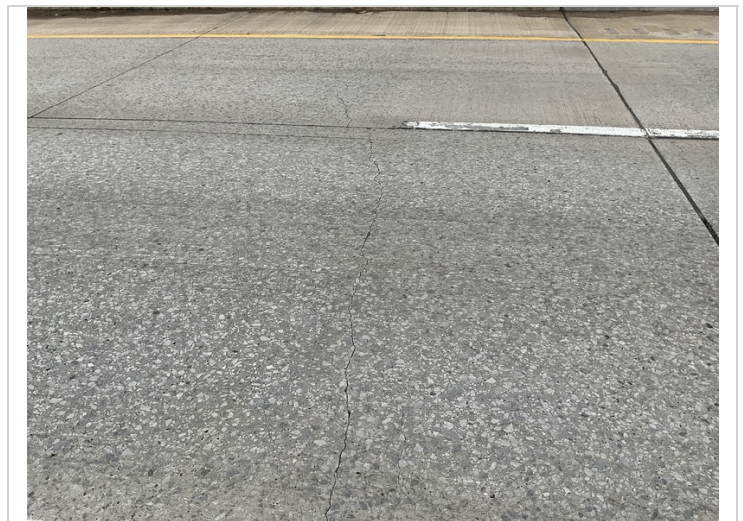
Large transverse cracks in northern approach slab.

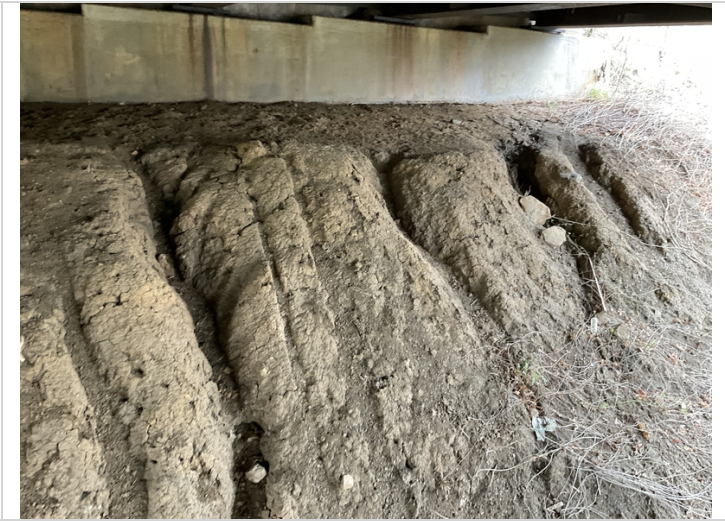
Erosion at bent 11,

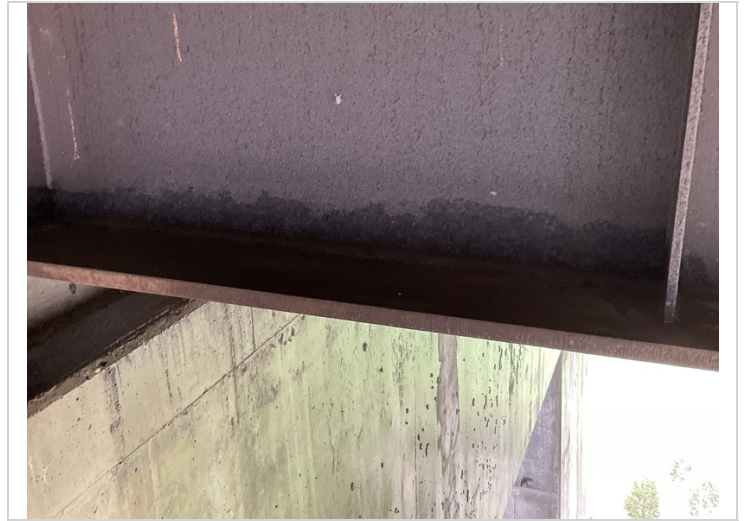
Span 8 girder 1, corrosion in lower web

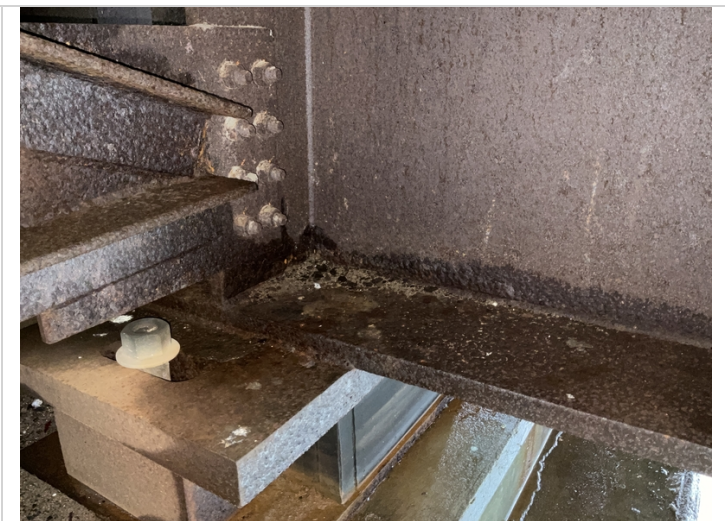
Span 7 girder 2, corrosion on bottom flange.

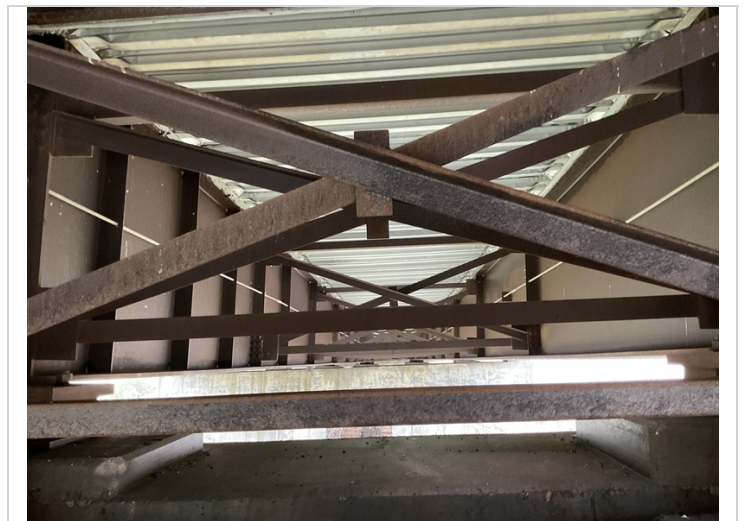
Span 7, bent 8, corrosion on diaphragm.

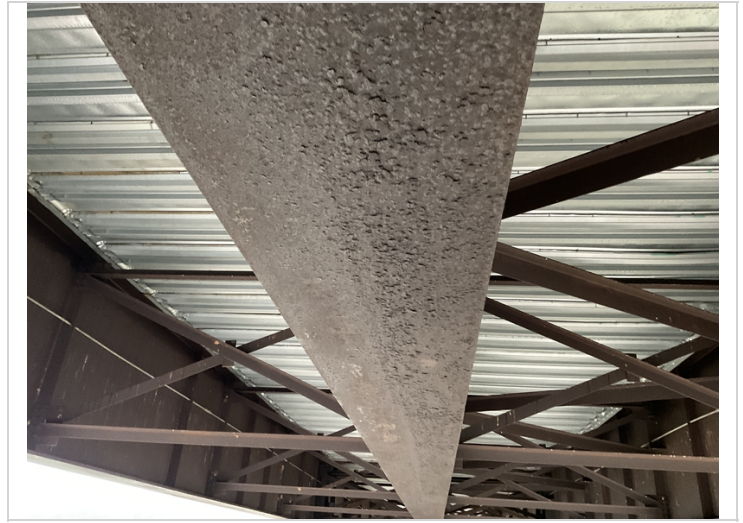
Span 3 girder 3, protective coating is failing.

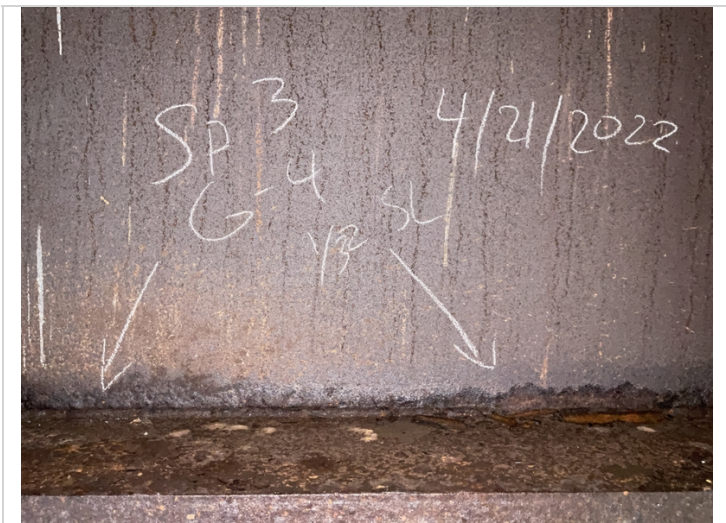
Span 3 girder 4, 1/32 section loss to lower web and bottom flange.

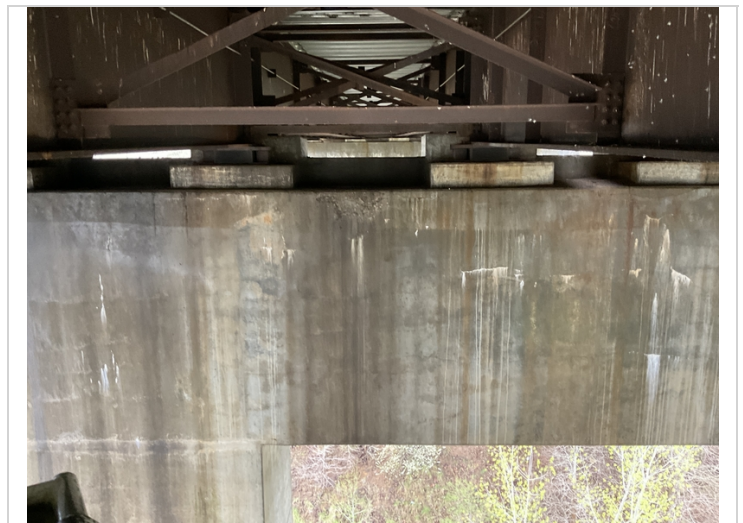
Bent 3 ahead side, large spall, horizontal cracking and efflorescence with build up.

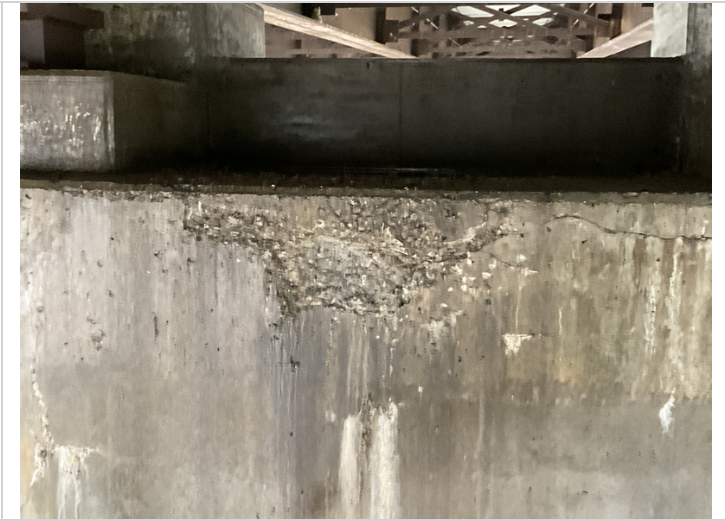
Bent 3, large spall on the ahead side.

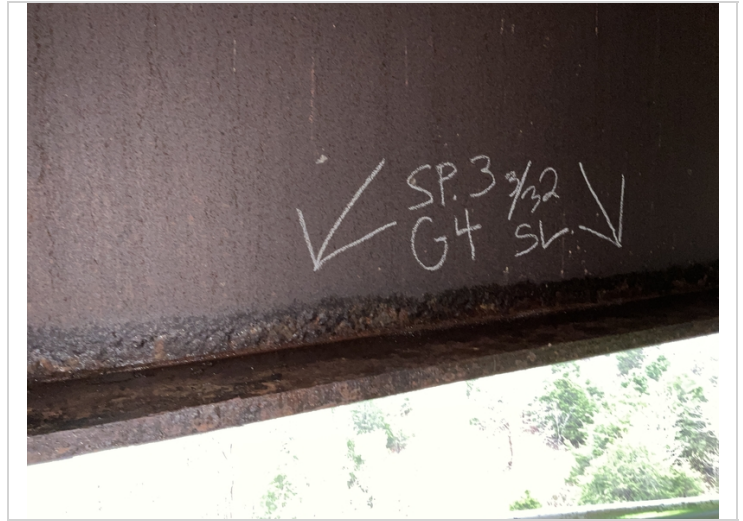
Span 3 girder 4, 3/32ths section loss to bottom flange. 1 3/8 is the thickness without section loss.

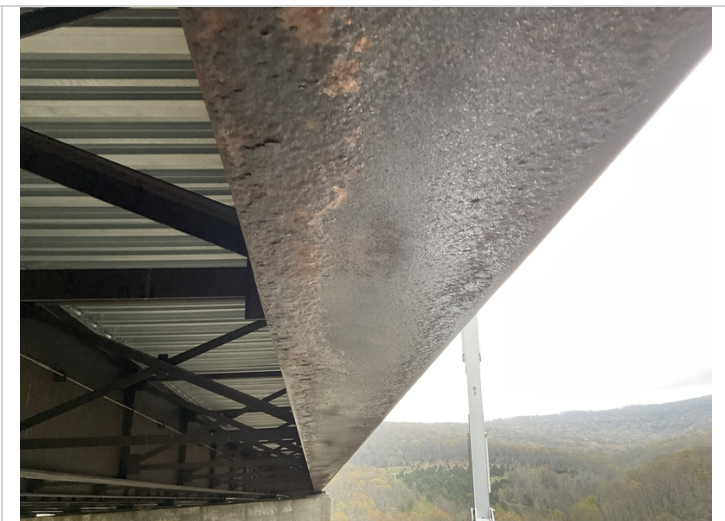
Span 3 girder 4, large flakes in the protective coating.

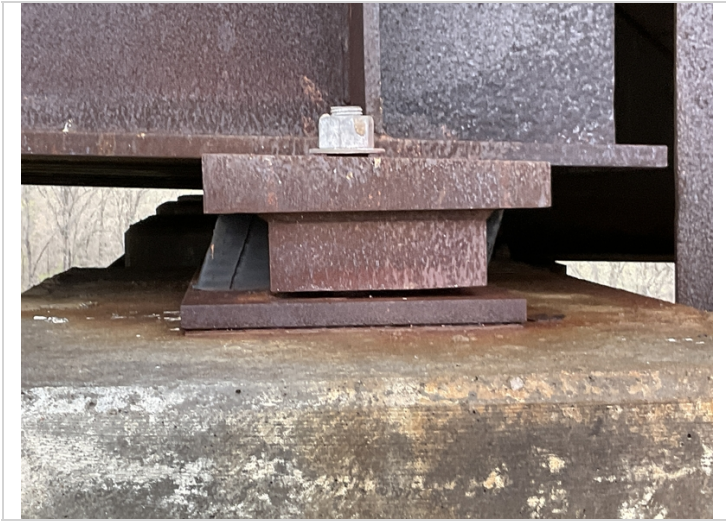
Span 2 Bent 3 bearing 4,

(310) 04/21/2022-RLS & ADC - Bent 3, backside bearings 1-4 are pushed forward with 3 and 4 being the worst. Bent 3, broken anchor bolts on the bearings on the ahead side. Bearings at bent 11 have corrosion.							
321	Reinforced Concrete Approach Slab	SF	2739	2569	130	40	0
1080	Delamination/Spall/Patched Area	SF	4	0	0	4	0
1130	Cracking (RC and Other)	SF	166	0	130	36	0

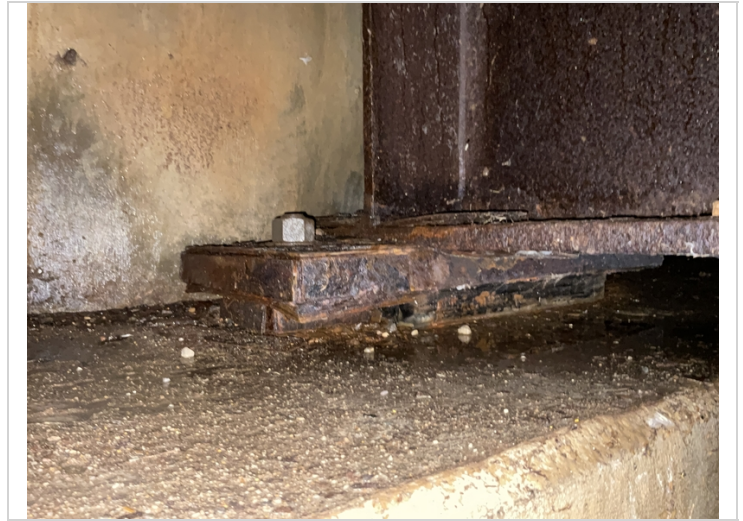
Bent 11 girder 1, laminating rust in girder and bearing.

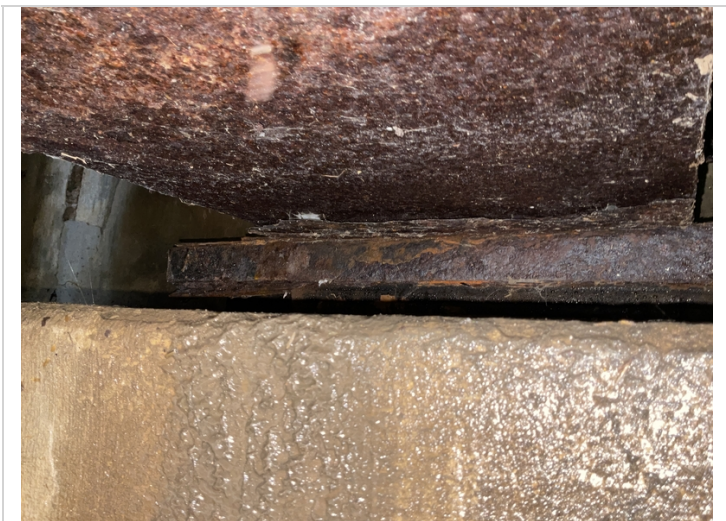
Bent 11 bearing 1, laminating rust

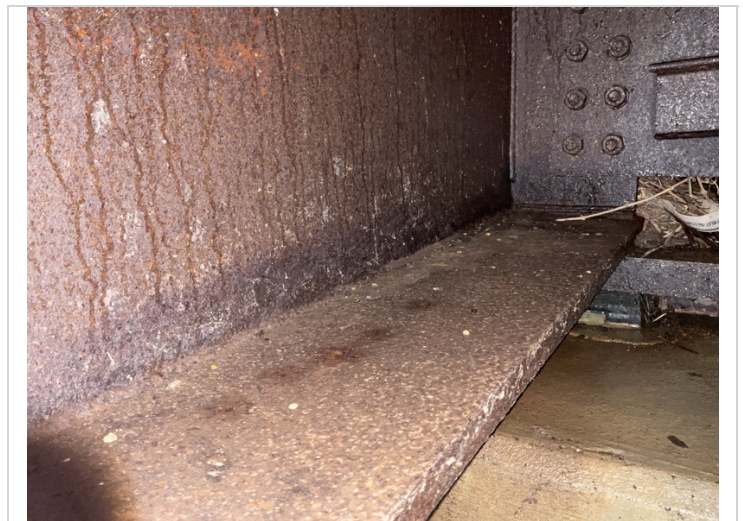
Bent 11 girder 3, protective coating is failing.

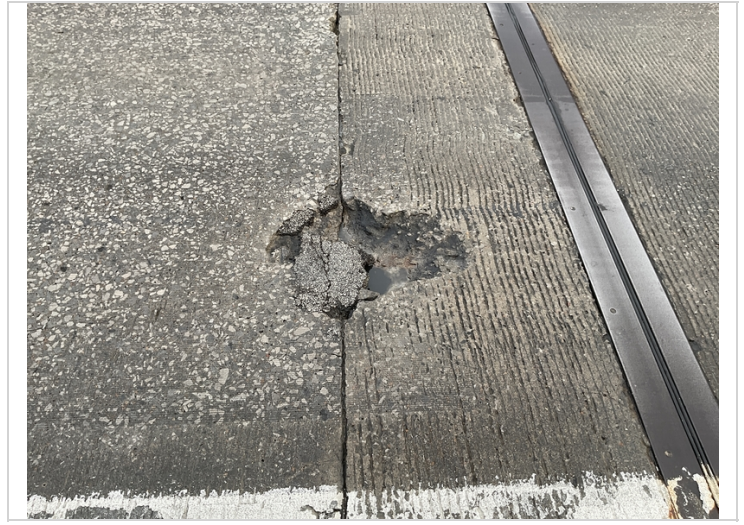
Large spall in the top of the backwall bent 1.

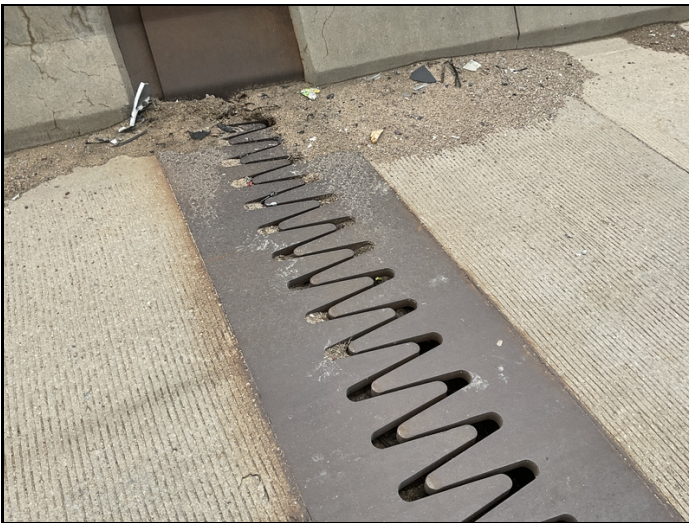
RLS & ADC- 04/21/2022- Finger joints have debris impaction on the ends.

Bent 8, debris impaction in assembly joint.

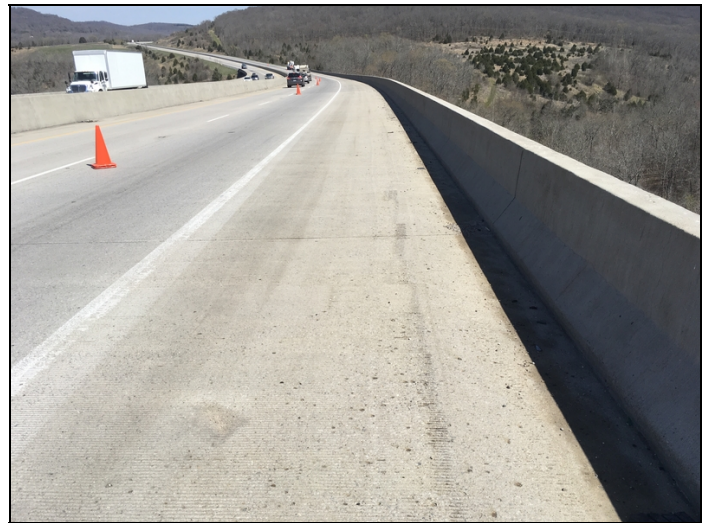
Minor dirt and debris in gutter areas.

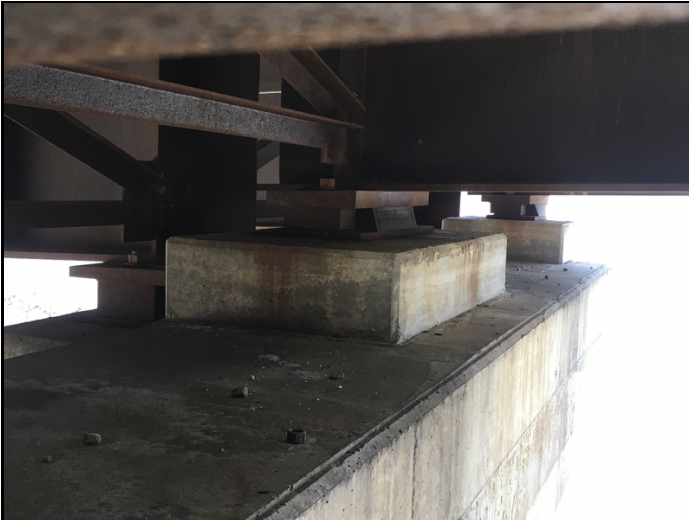
Bent 2 anchor bolt broken Bearing like 1" being fully extended.

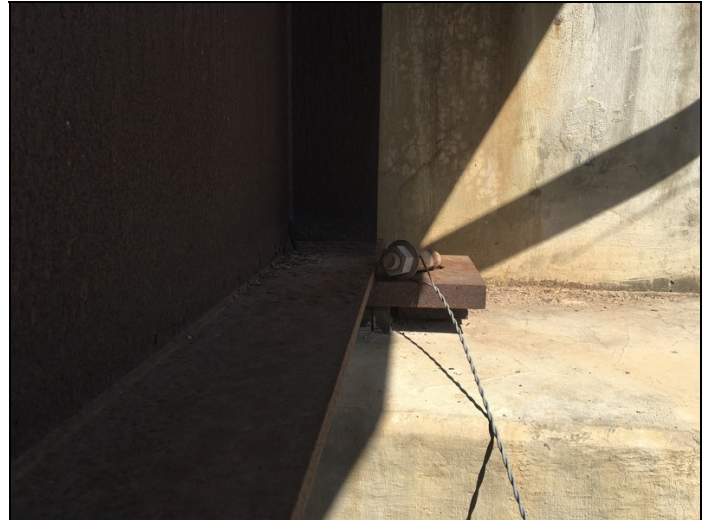
North Abutment Girder 4 broken anchor bolt.

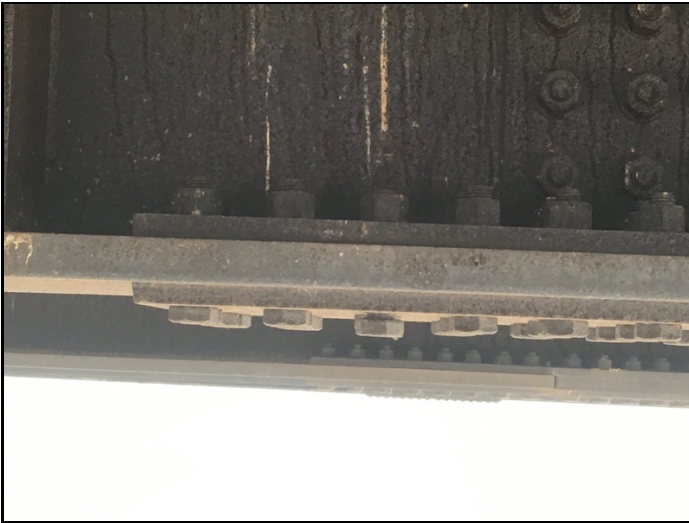
Span 4 Girder 1 first splice plate and loose bolt bottom flange.

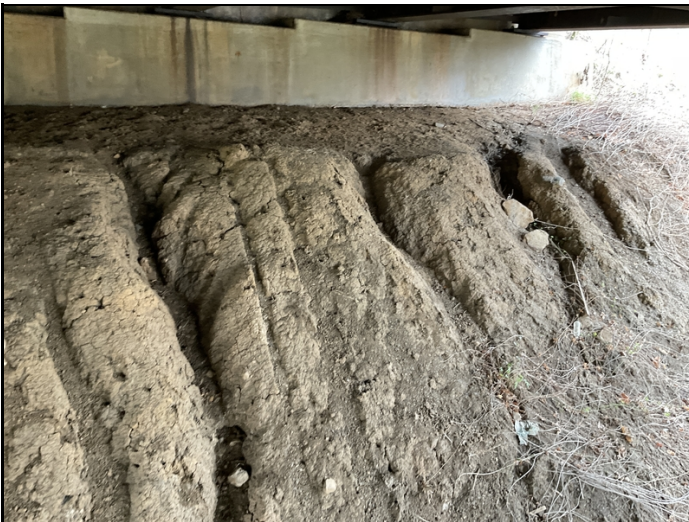
Erosion at bent 11,

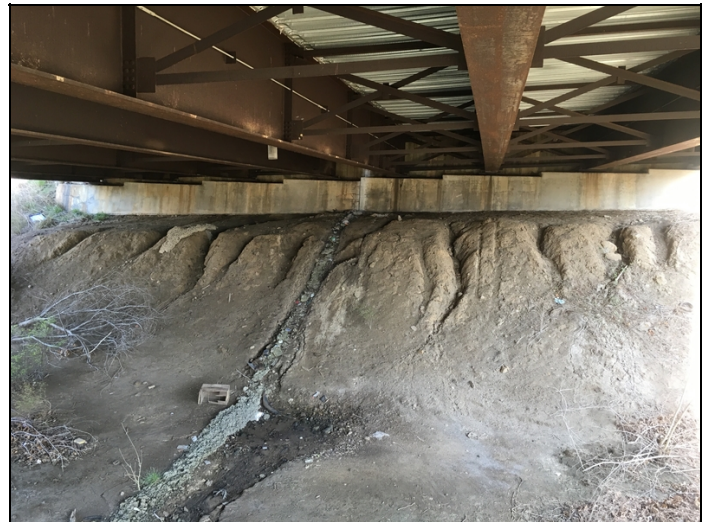
North Abutment embankment erosion.

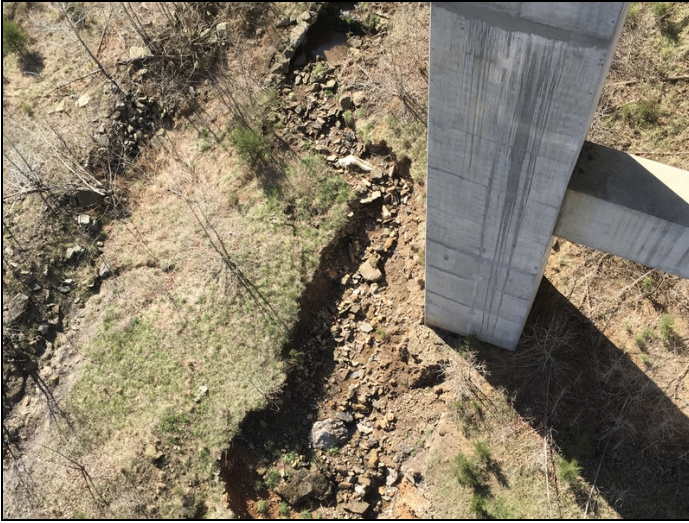
Bent 3 erosion .

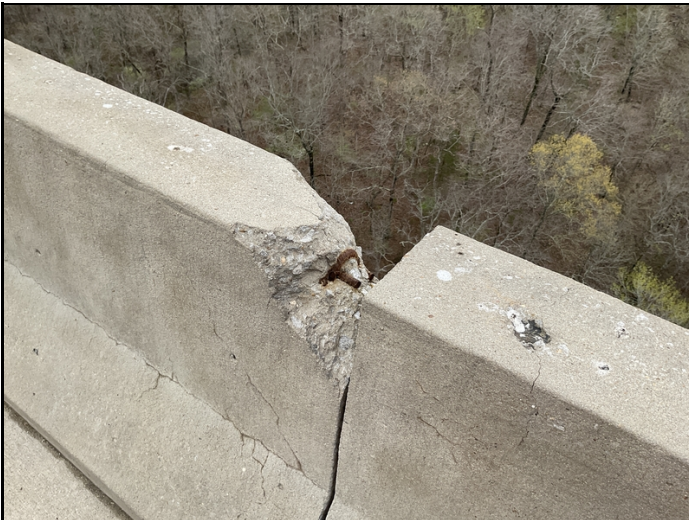
Span 6, right bridge rail, large spall with exposed rebar.

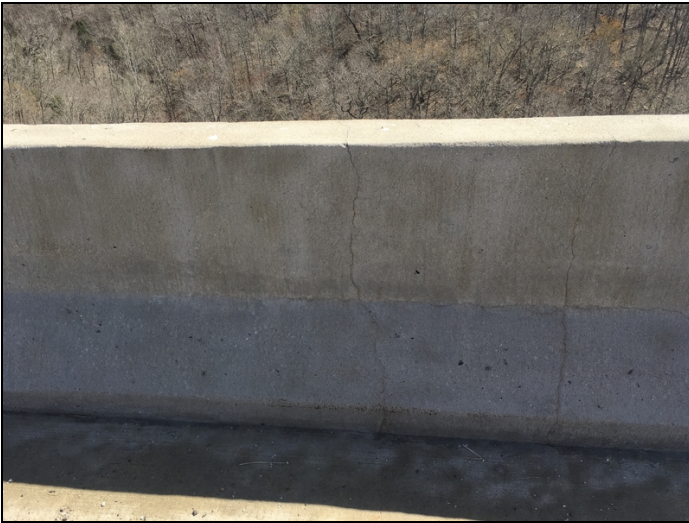
Vertical cracking in parapet wall typical throughout.

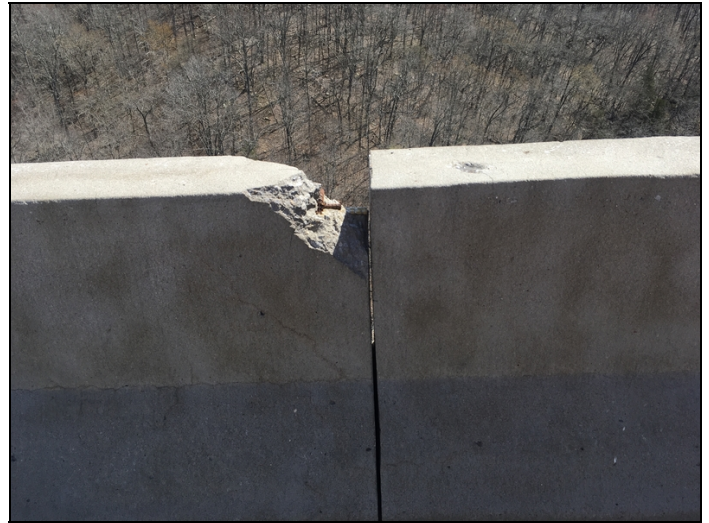
Span 5 Collision damage.

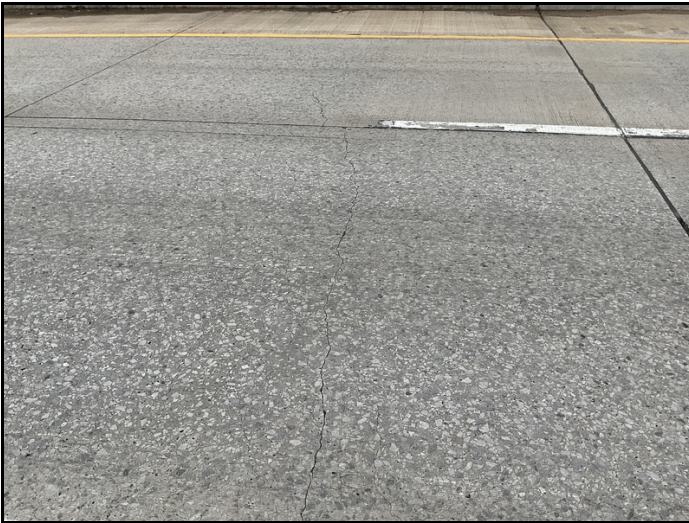
Large transverse cracks in northern approach slab.

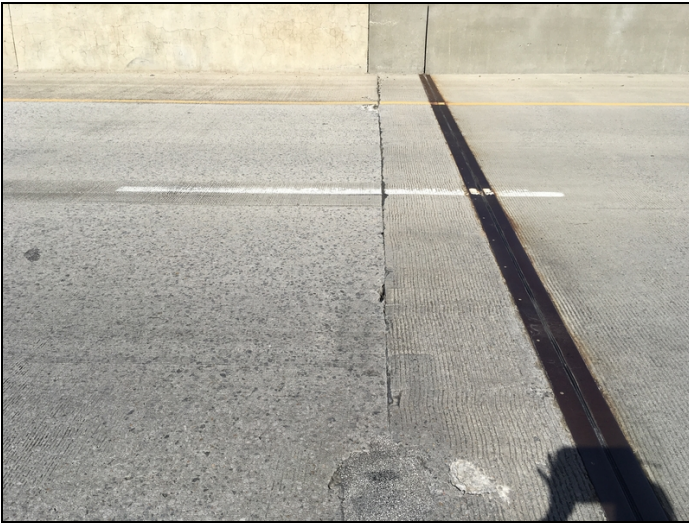
South Abutment Joint sealant has abraded.

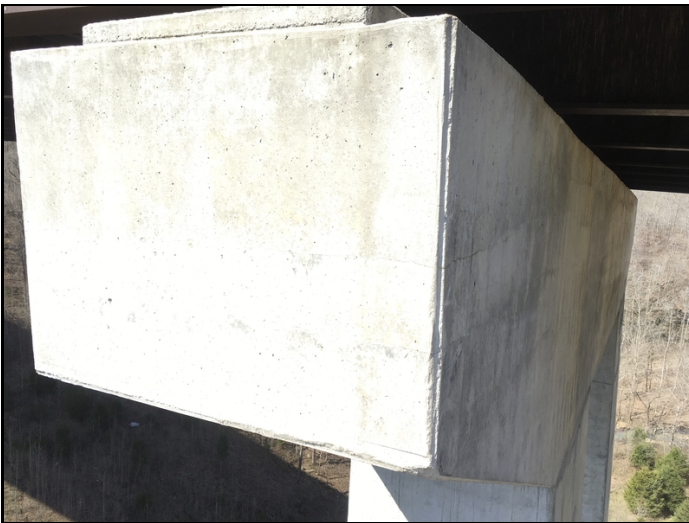
Bent 5 upstream end of cap map Cracking.

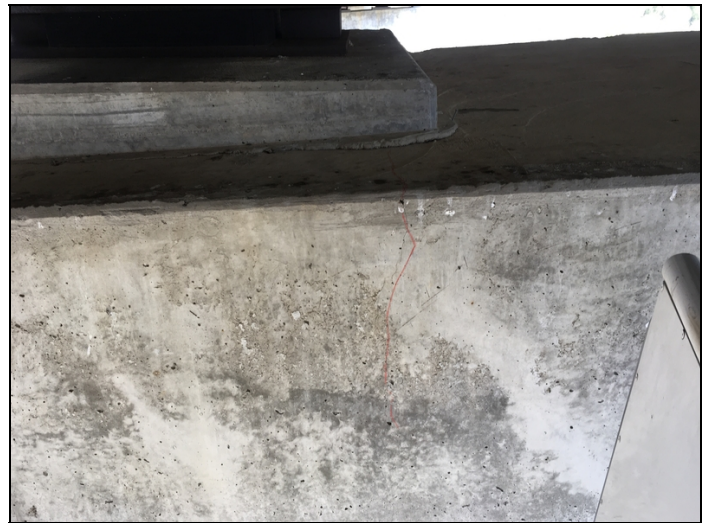
Bent 5 Hairline Cracking in face of cap.

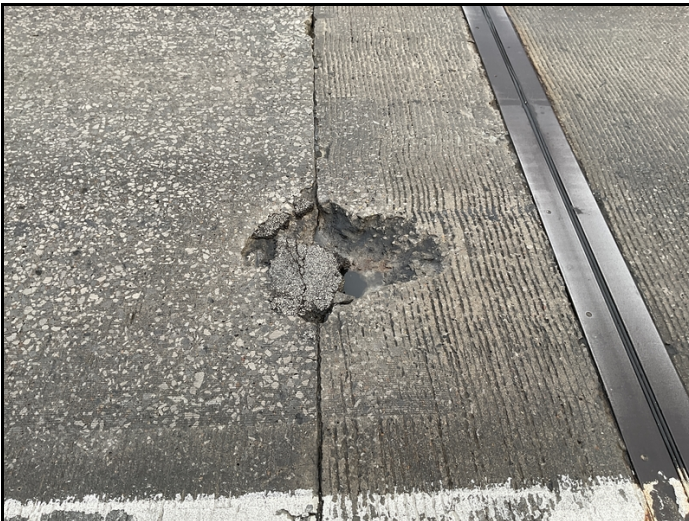
Large spall in the top of the backwall bent 1.

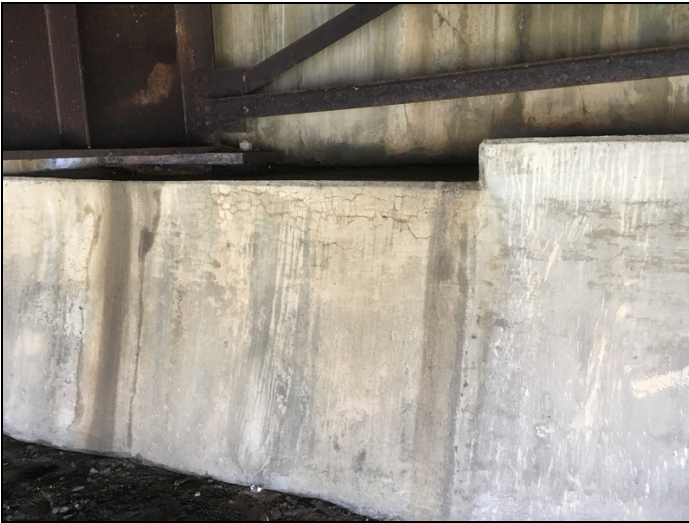
North Abutment map Cracking under Girders 1 and 2.

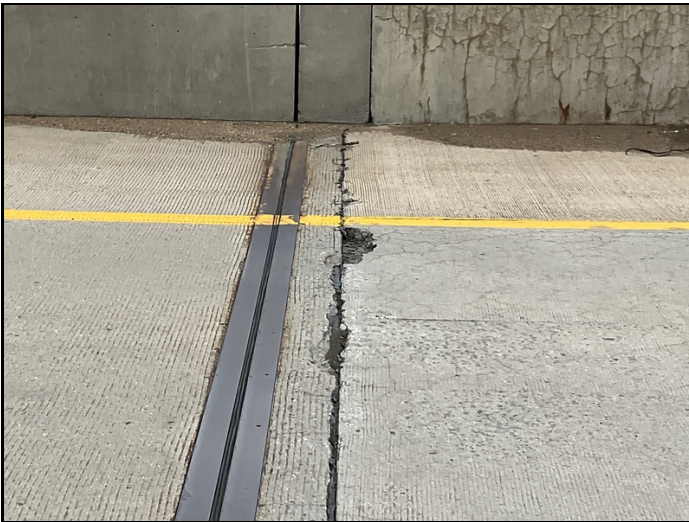
Large spall in northern approach slab.

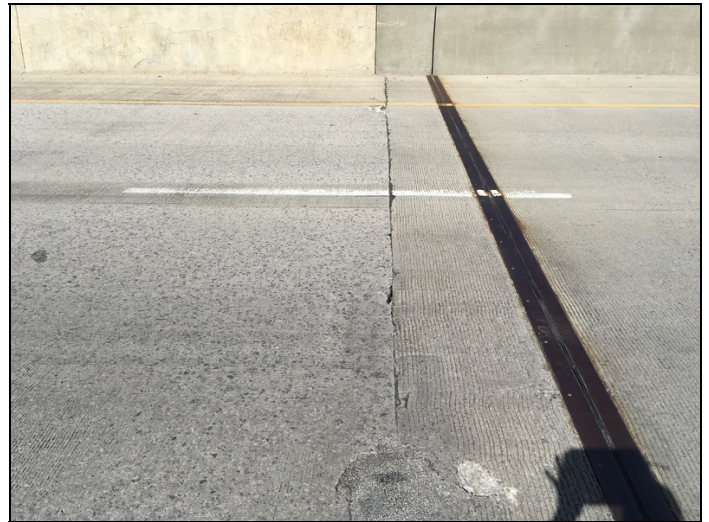
South Abutment Joint sealant has abraded.

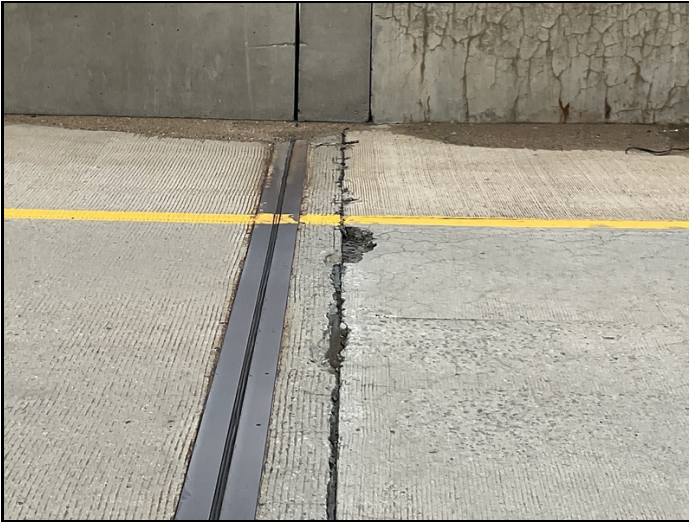
Large spall in northern approach slab.

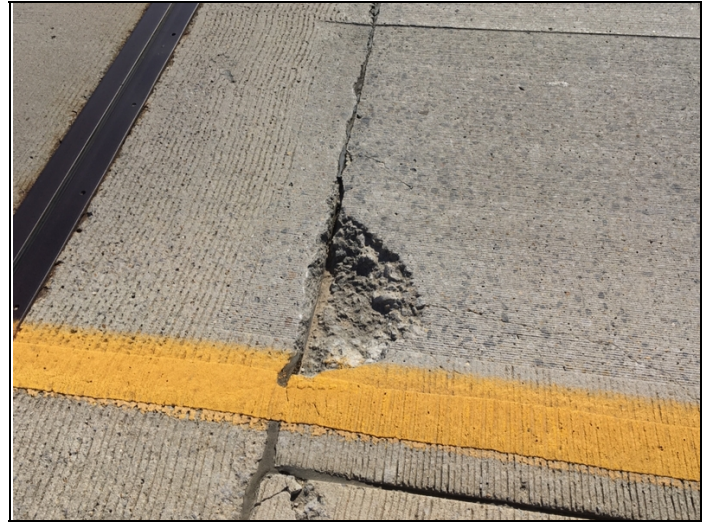
Approach 1: Spalling.

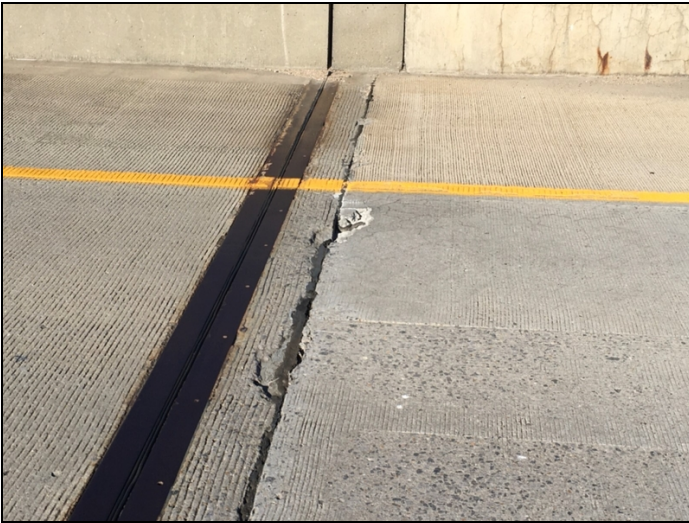
Approach 2: Spalling.

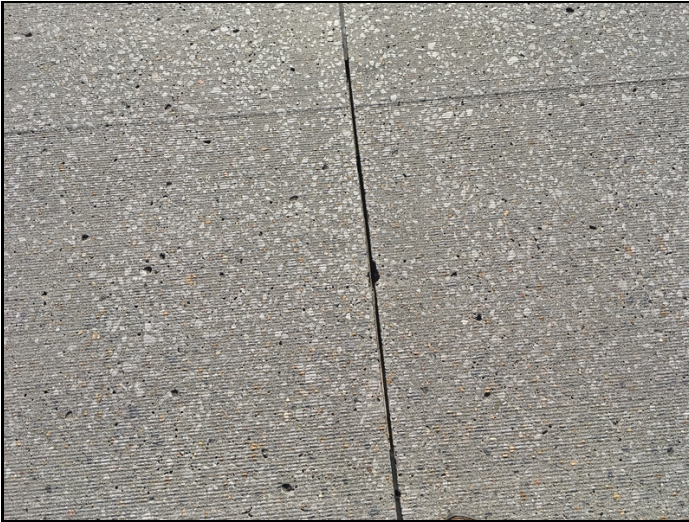
Saw Joint Seals: Missing. Scattered locations.

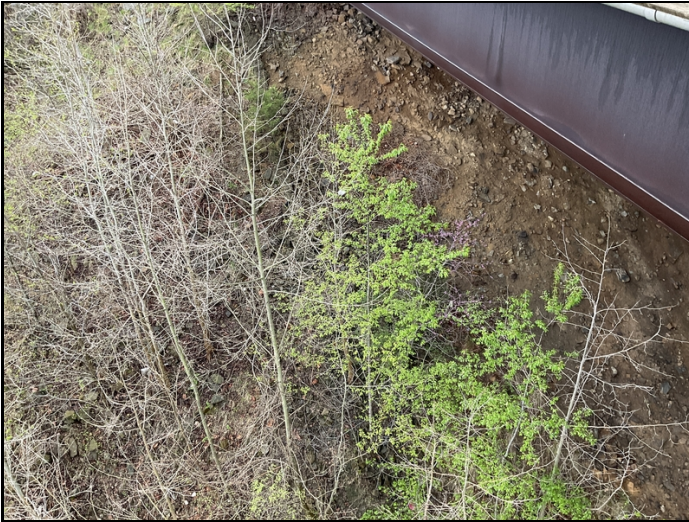
Small trees are restricting the use of the under bridge inspection vehicle on spans 1, 2, 9 and 10.

Span 1, trees restricting use of the under bridge inspection vehicle
