Bridge Inspection Report

02800

**SH 36 White County
over
EAST HOG THIEF CREEK**

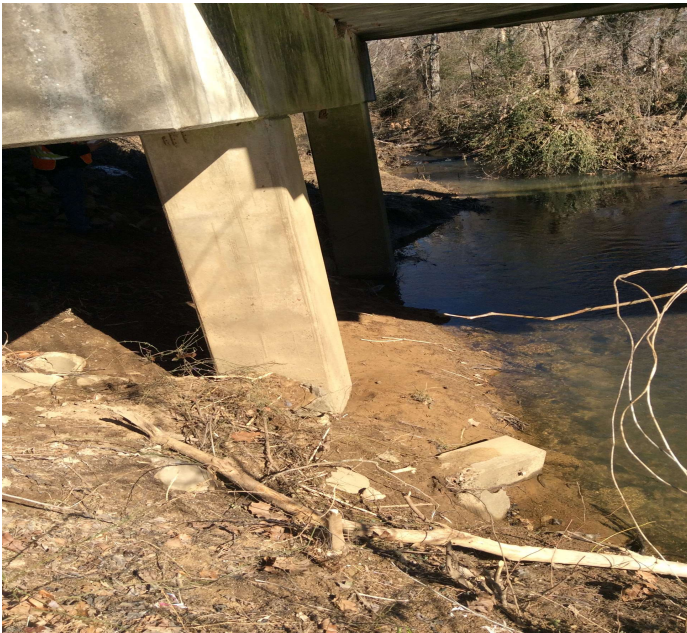
Scour @ Bent 1 & 2.

PHOTO 1 Description Scour @ Bent 1.

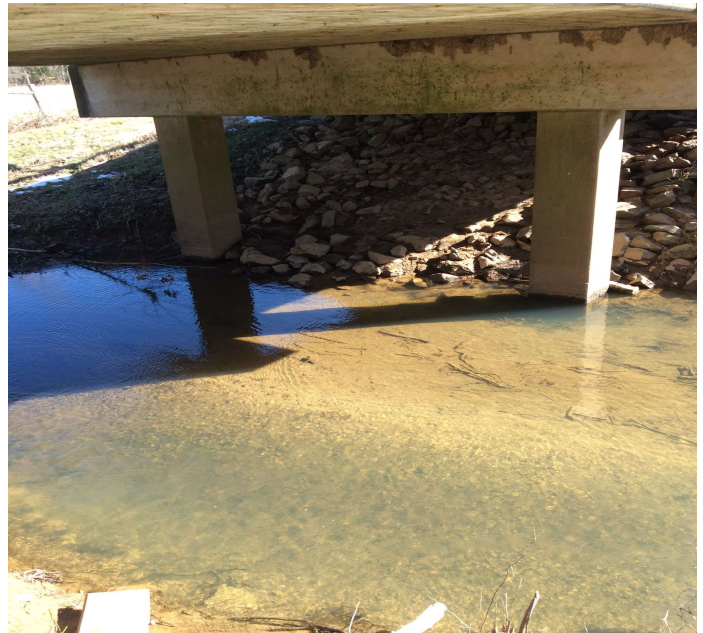
PHOTO 2 Description Scour @ Bent 2.

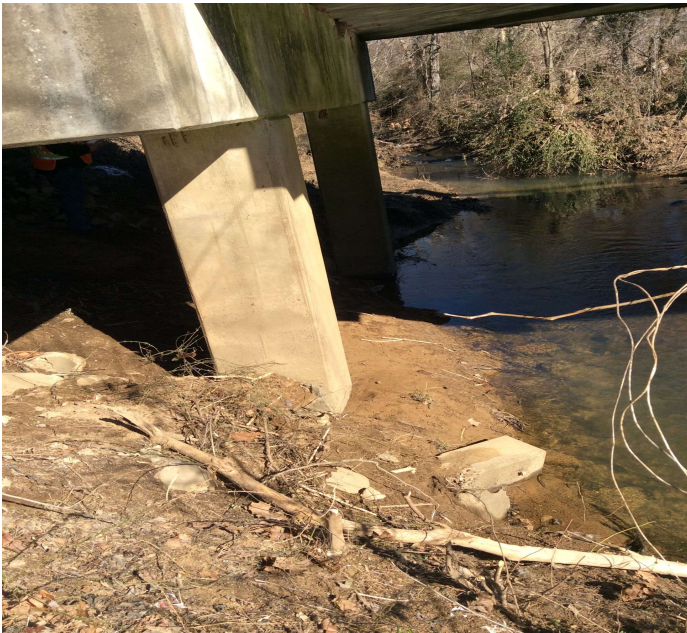
Erosion to embankment @ Abutment 1 & 2.

PHOTO 1 Description Scour @ Bent 1.

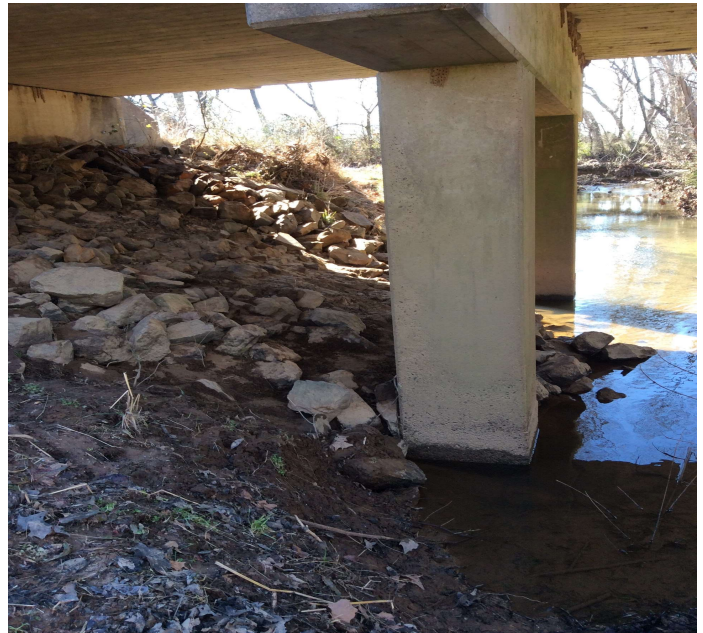
PHOTO 2 Description Erosion to embankment @ Abutment 2.
