Bridge Inspection Report

02803

**SH 36 White County
over
WEST HOG THIEF CREEK**

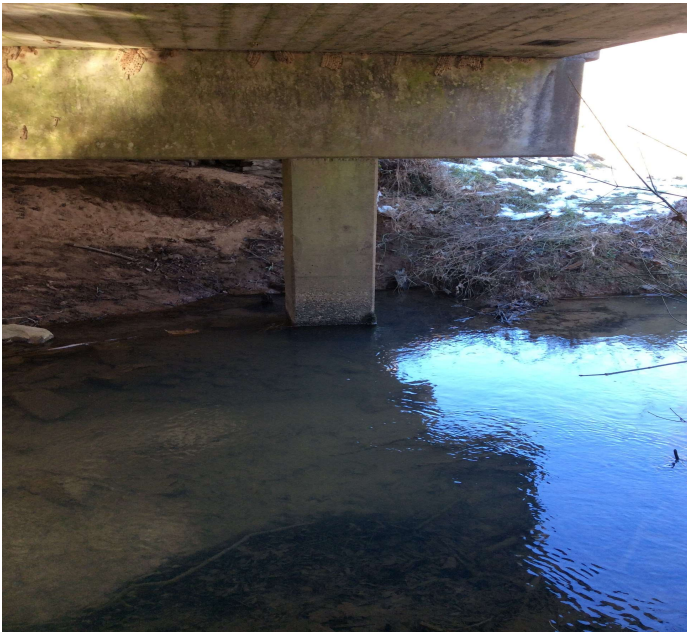
Environment	Total Quantity	Units	Condition State 1	Condition State 2	Condition State 3	Condition State 4
38 - Reinforced Concrete Slab	1- Ben.	1749	sq. ft.	0	1568	181	0
	Spalls with rebar exposed to deck @ Spans 1 & 2 & soffit @ Span 2. 4' of delaminated areas to soffit @ Span 2. Longitudinal & transverse cracks to deck Span 2 - Full width transverse efflorescent crack (construction joint) to soffit @ midspan. Minor to moderate abrasion to entire surface of deck. Deep scaling to Right gutter line @ Spans 1 & 2. Patched area to deck in Right lane @ Span 3.						
1080 - Delamination/Spall/Patched Area		12		0	12	0	0
1090 - Exposed Rebar		7		0	0	7	0
1120 - Efflorescence/Rust Staining		20		0	20	0	0
1130 - Cracking (RC and Other)		274		0	200	74	0
1190 - Abrasion/Wear (PSC/RC)		1436		0	1336	100	0
205 - Reinforced Concrete Column	1- Ben.	4	each	0	4	0	0
	Bent 1 - Scour to Left column. Bent 2 - Scour to Right column. Abrasion to bottom of all columns.

Scour to Left column at Bent 1.
Scour to Right column at Bent 2.

PHOTO 1 Description Scour to Left column at Bent 1.

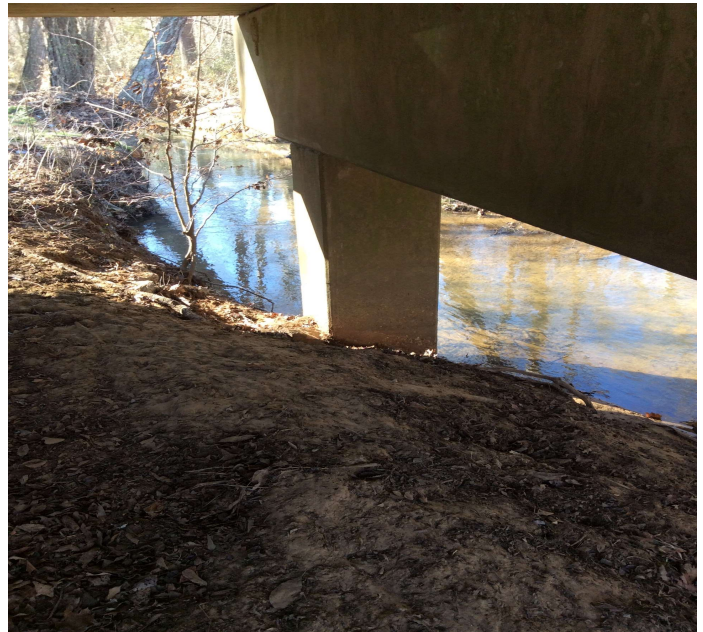
PHOTO 2 Description Scour to Right column at Bent 2.

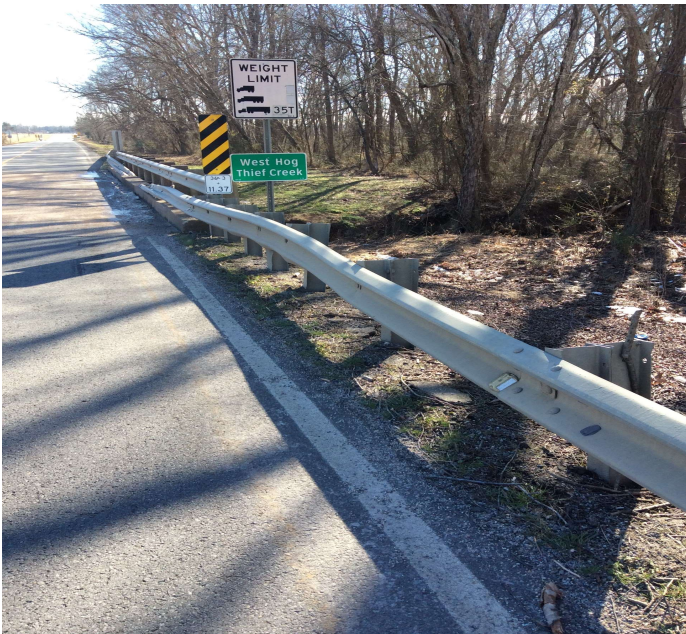
Impact damage to Right approach guardrail at Abutment 1.

PHOTO 1 Description 14' guard rail bent on Right at approach at Abutment 1.

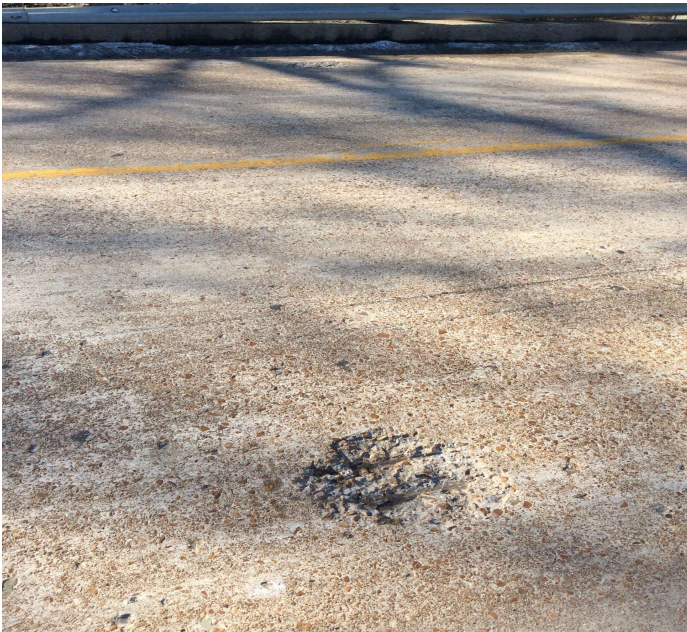
Spalls with 3' rebar exp. to deck at Span 1.
Spalls with 3' rebar exp. to deck at Span 2.

PHOTO 1 Description Spalls to deck with rebar exposed @
Span 1 & 2.
