BRIDGE INSPECTION REPORT									
FORM IIIB									
Insp.	WRR/KBM/MSY/RRJ								
Date	6/16/2010								
Dist.	5	Co.	25 / Fulton	Rt.	289	Sec.	4	Log	16.29
		Br.	M2728

Bridge No. M2728	Dist. 5	Co. Fulton - 25
Log 16.29	Rt. 289	Sect/Zone - 4
Date Drawn 6/16/10 By RRJ

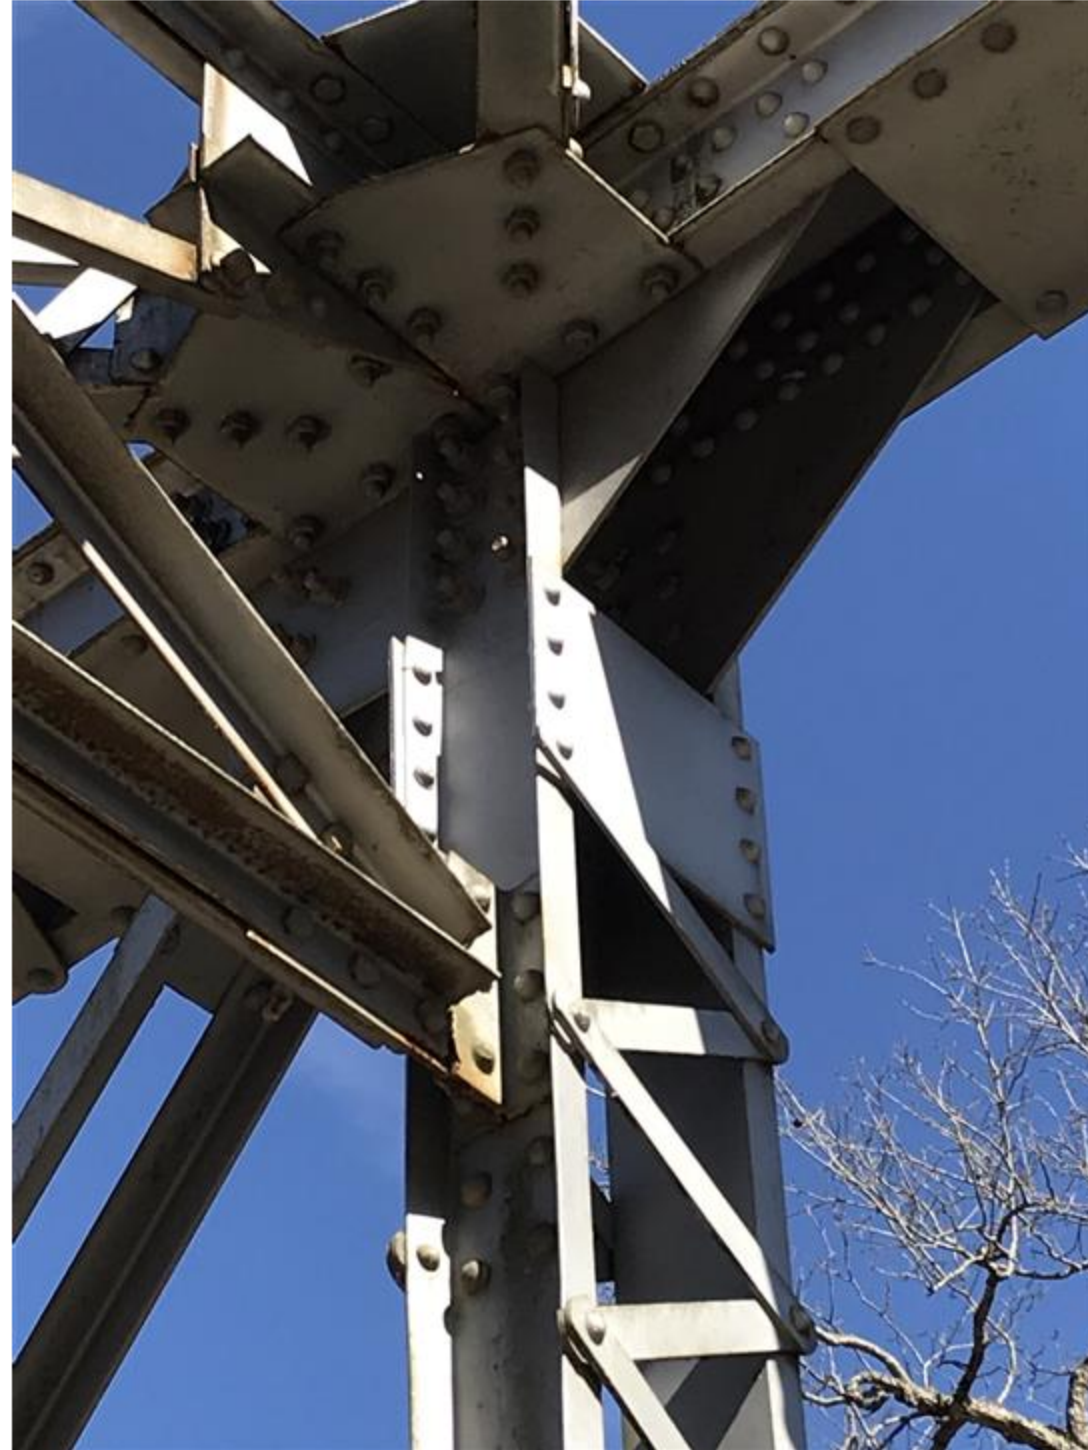
Photo 16

Span 2 - (Truss) Interior channels of verticals are cracked below sway bracing at U2 Right.

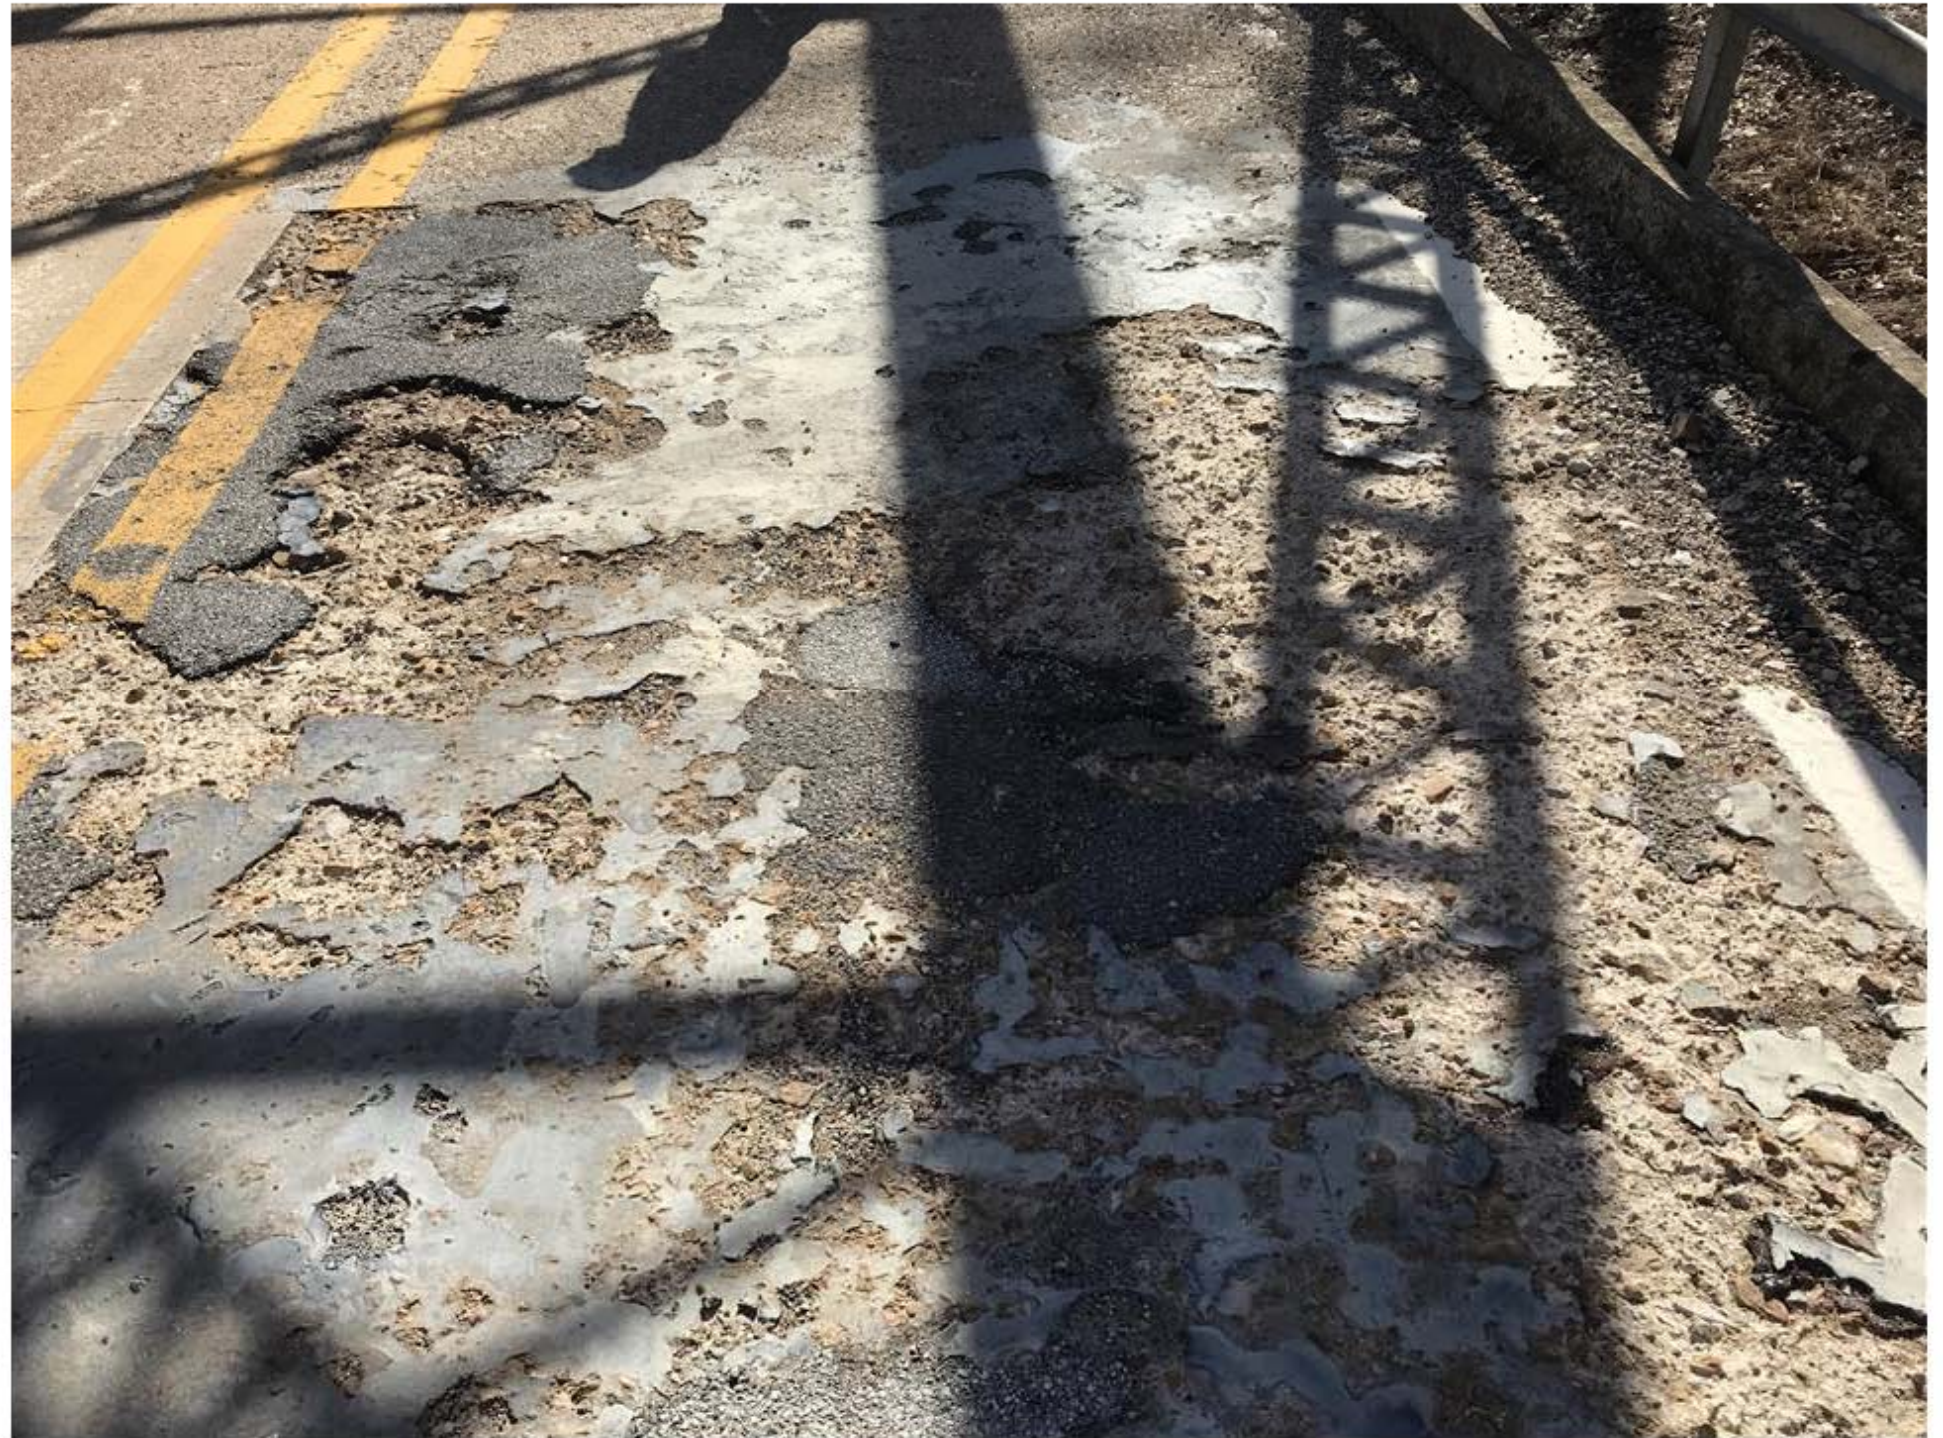
Photo 18

Span 2 - Heavy scaling & deep Spalls to deck in Left Lane.

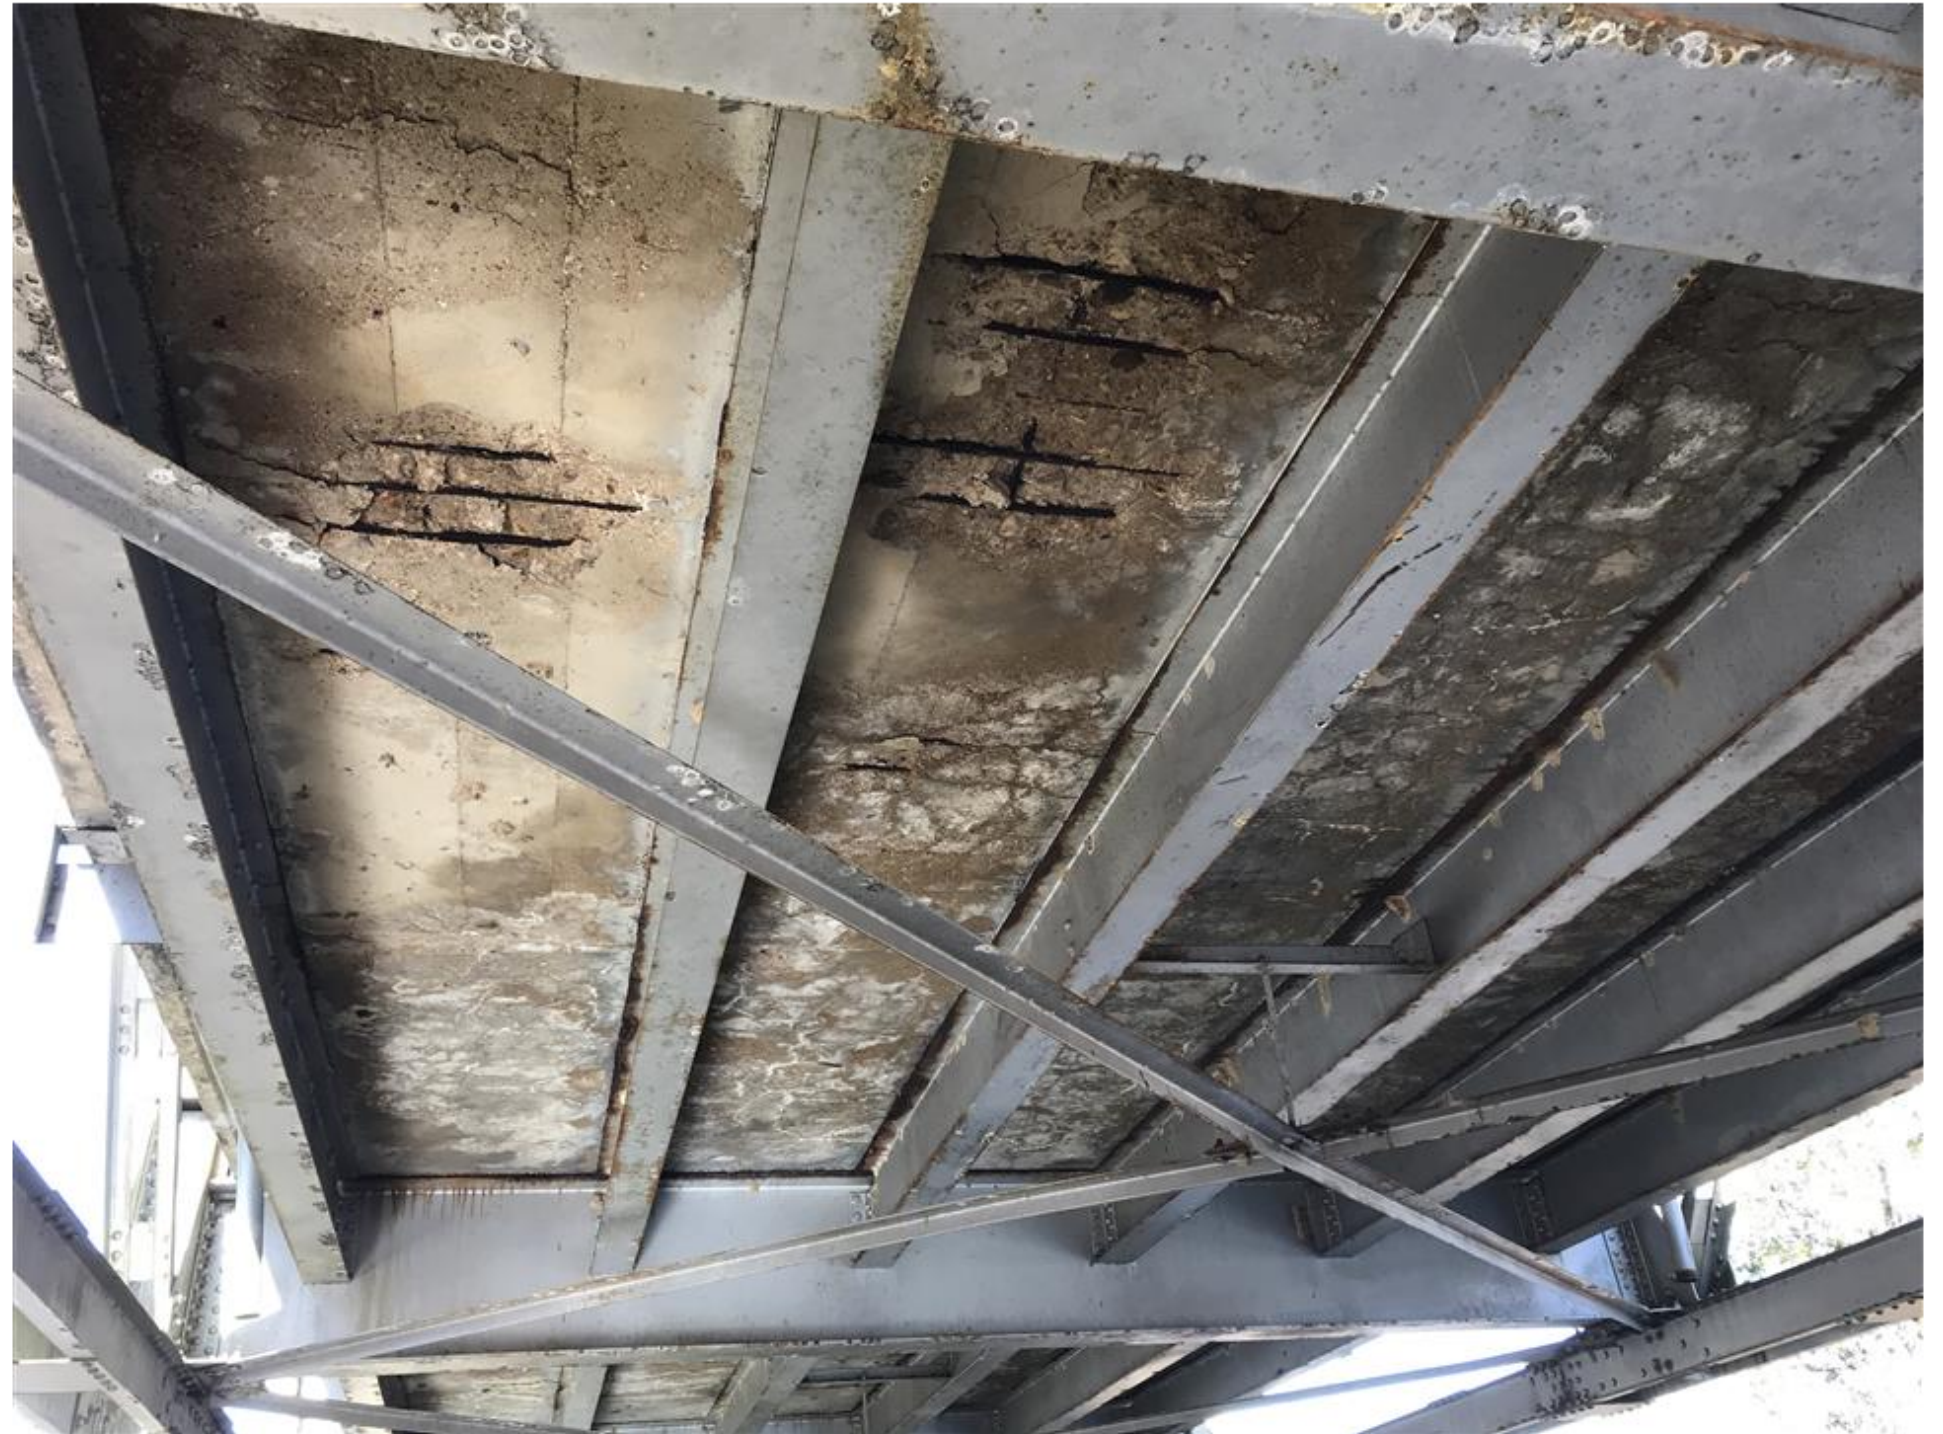
Photo 28

Large spall with 18" rebar exposed between Floorbeams 4 and 5 between Stringers 1, 2 and 3.

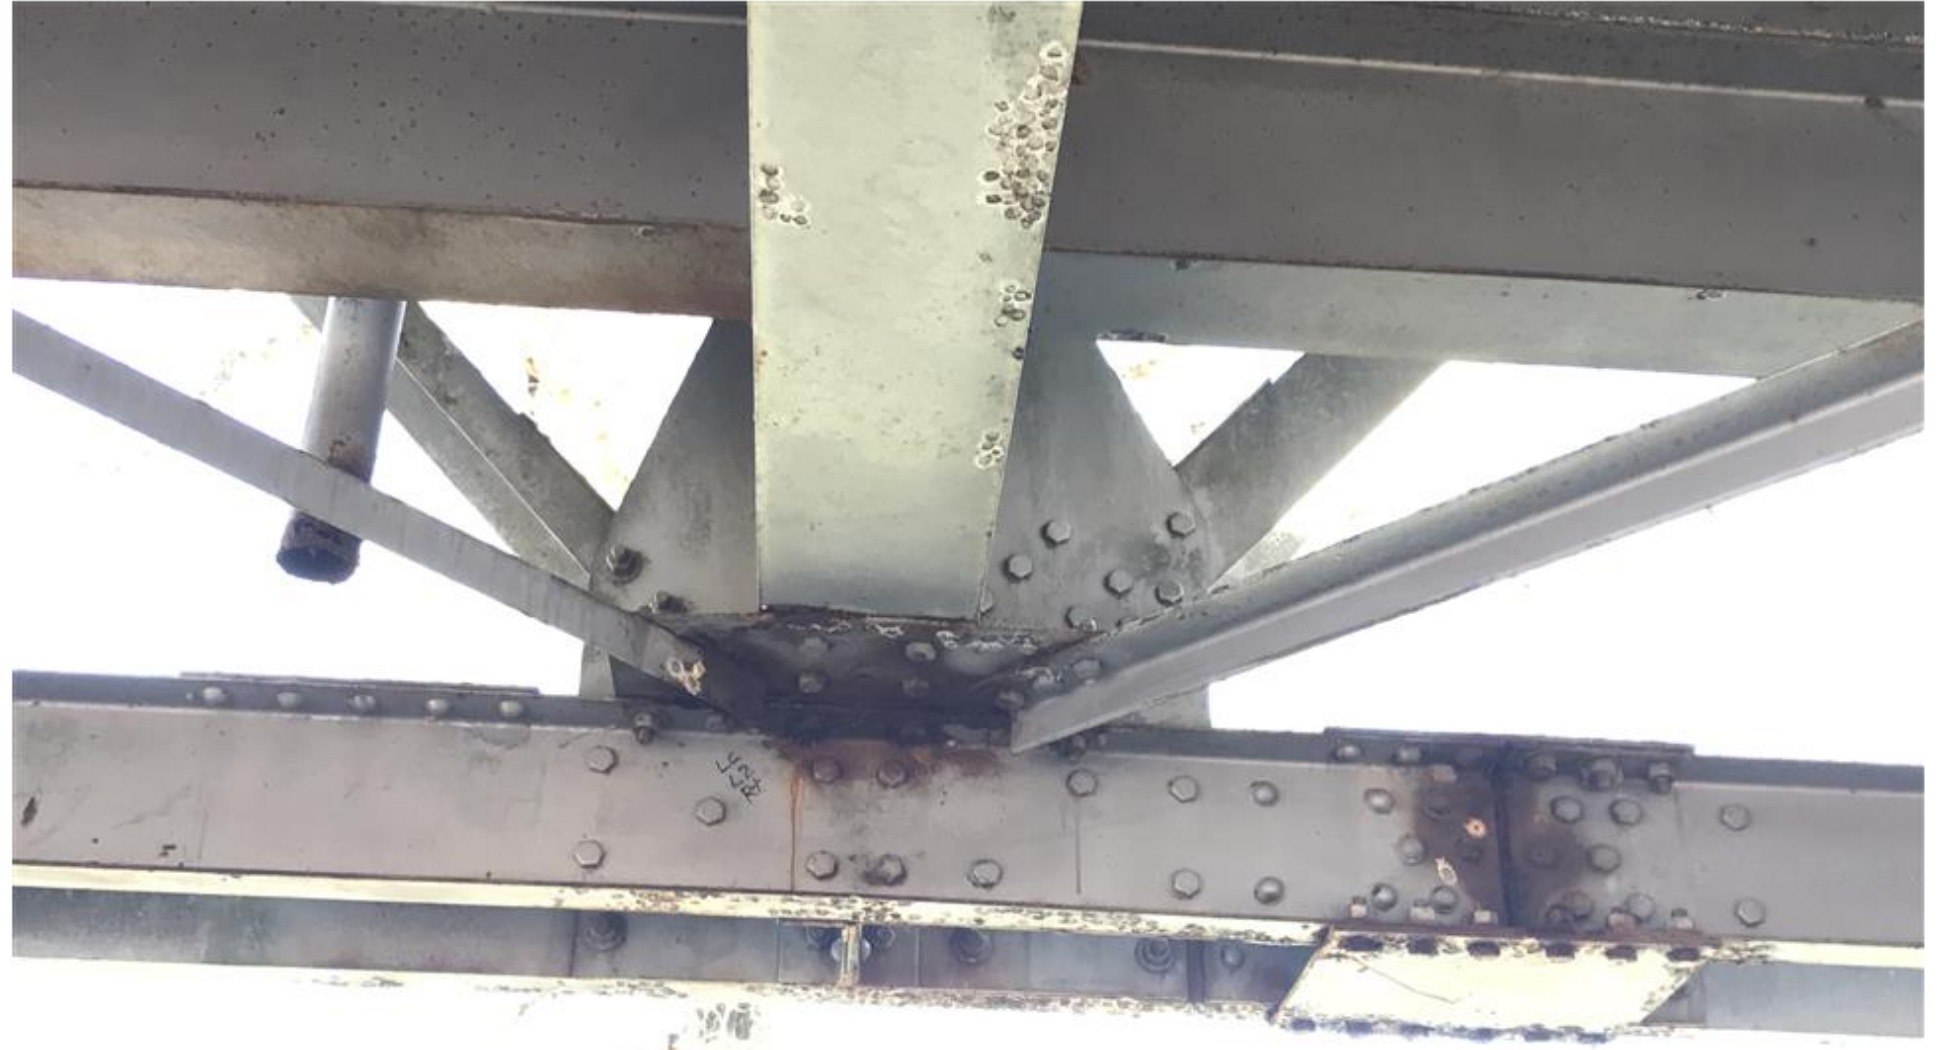
Photo 30

Typical Rust to ends of floor beams & connection plates.
