Bridge Inspection Report

01451
SH 367 WHITE
over
DESARC BAYOU RELIEF

Structure Number: 01451

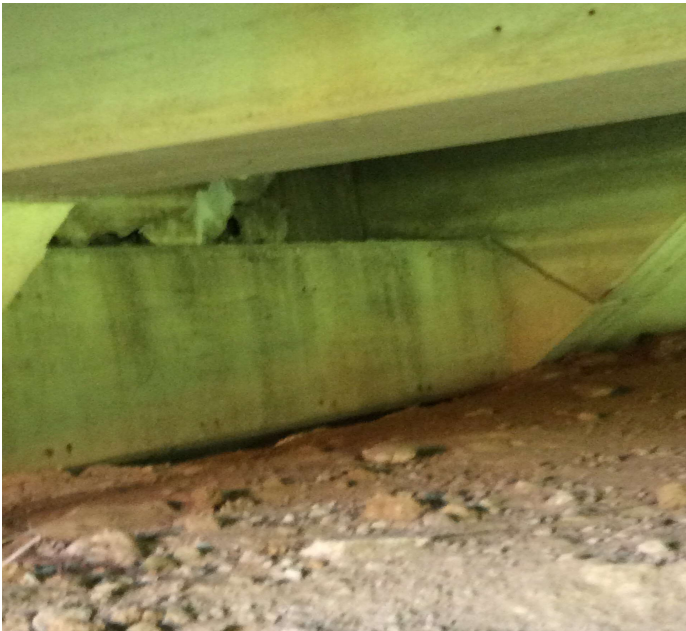
1090 - Exposed Rebar		1		0	0	1	0
1120 - Efflorescence/Rust Staining		3		0	3	0	0
1130 - Cracking (RC and Other)		48		0	48	0	0
205 - Reinforced Concrete Column	1- Ben.	6	each	0	5	1	0
	Bent 2 - Spall to Left column. Abrasion along bottom of all columns.						
1080 - Delamination/Spall/Patched Area		1		0	0	1	0
1190 - Abrasion/Wear (PSC/RC)		5		0	5	0	0
210 - Reinforced Concrete Pier Wall	1- Ben.	43	ft.	0	43	0	0
	1 vertical crack to Concrete Pier Walls @ Bents 1 & 2. Abrasion to bottom of Concrete Pier Walls & Bents 1 & 2.						
1130 - Cracking (RC and Other)		2		0	2	0	0
1190 - Abrasion/Wear (PSC/RC)		41		0	41	0	0
215 - Reinforced Concrete Abutment	1- Ben.	66	ft.	48	10	8	0
	Abutment 1 - Diagonal efflorescent cracks to backwall between Girders 1 -2, 3 & 4. Diagonal cracking to backwall between Girders 2 & 3 @ Abutment 1. Abutment 2 - Large slab spall to backwall between Girder 2 & 3.						
1080 - Delamination/Spall/Patched Area		8		0	0	8	0

Large slab spall w/efflor. & rust stains to backwall between girders 2 & 3 at Abutment 2.

PHOTO 1 Description Large slab spall w/t efflorescence & rust stains to backwall between girders 2 & 3 at Abutment 2.

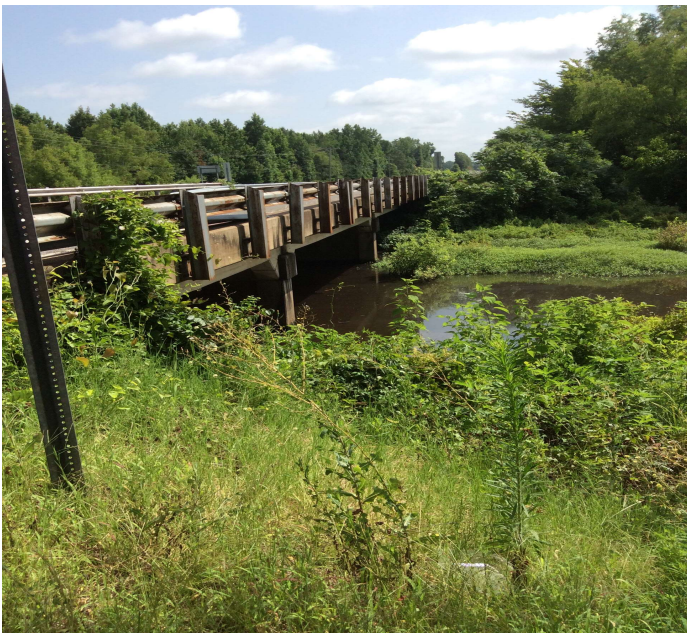
Heavy vegetation to left & right sides at Spans 1 & 3

PHOTO 1 Description Heavy vegetation to Left & Right sides of Span 1 & 3.
