# Bridge Inspection Report

01452  
SH 367 White Co.  
over  
DESARC BAYOU

Structure Number: 01452

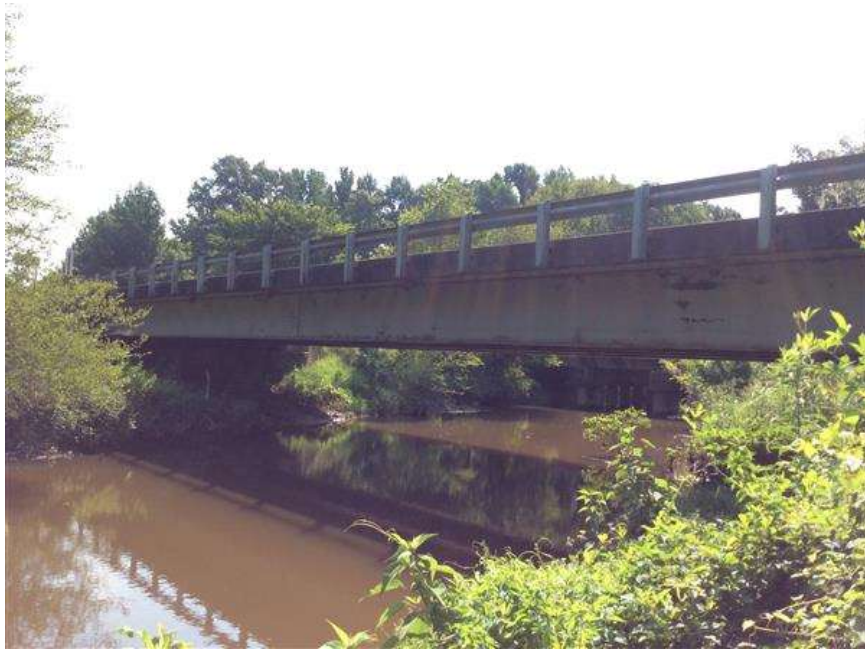
Roadway looking Northeast.

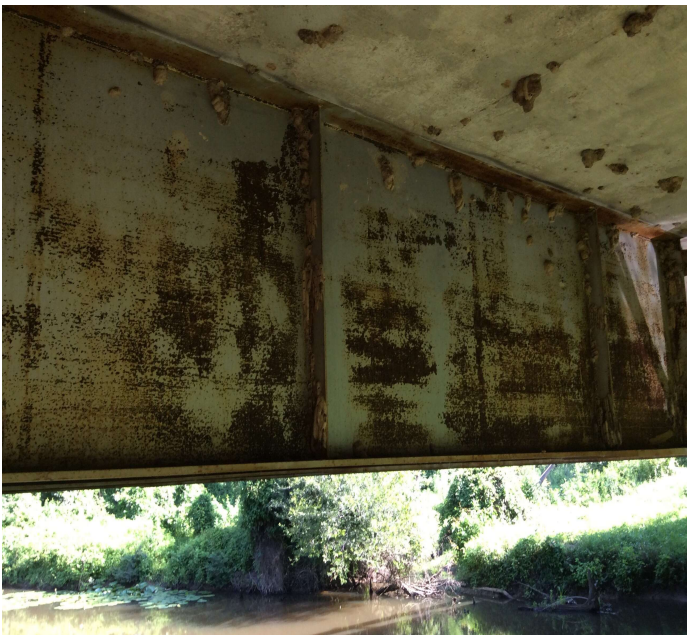
Paint system failing, surface rust present to all girders.							
1000 - Corrosion		408			400	8	
515 - Steel Protective Coating		4684	sq. ft.	4634	0	50	0
3420 - Peeling/Bubbling/Cracking (Steel Protective Coatings)		50				50	
<b>215 - Reinforced Concrete Abutment</b>	1- Ben.	106	ft.	80	22	4	0
1 Vertical crack to Abutment 1. Full height vertical efflorescent crack with leaching & rust stains @ Abutment 2. Vertical efflorescent cracking to backwalls @ Abutments 1 & 2.							
1120 - Efflorescence/Rust Staining		25			22	3	
1130 - Cracking (RC and Other)		1				1	
<b>303 - Assembly Joint with Seal</b>	1- Ben.	56	ft.	0		56	
Joints are closed.							
<b>311 - Movable Bearing</b>	1- Ben.	4	each	0	0	4	0
Rust, pack rust, & minor section loss to bearings.							
1000 - Corrosion		4				4	
515 - Steel Protective Coating		16	sq. ft.	0	6	0	10
3440 - Effectiveness (Steel Protective Coatings)		16			6		10
<b>313 - Fixed Bearing</b>	1- Ben.	4	each	0	0	4	0

Paint flaking and surface rust to girders.

PHOTO 1      Description      Paint flaking and surface rust to girders.

Work Code: Repair

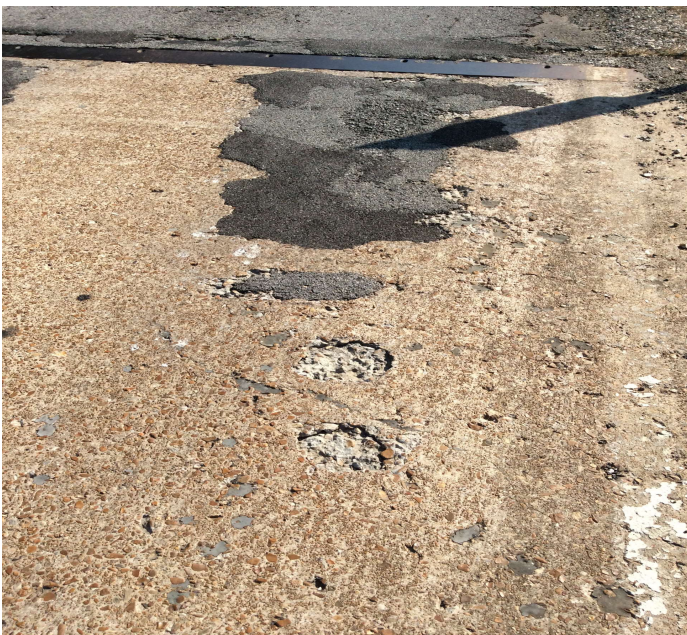
Environment	Total Quantity	Units	Condition State 1	Condition State 2	Condition State 3	Condition State 4
<b>12 - Reinforced Concrete Deck</b>	1- Ben.	3214	sq. ft.	0	2534	680	0
Unsealed cracks to deck. Delaminated areas & areas of light to moderate scaling to deck. Several spalled areas. (some filled with asphalt patch) Areas of delamination & spall with 8' rebar exposed to soffit between Girders 1 & 2 near end of span. Transverse efflorescent cracks & minor spalls to Left & Right overhangs. Light efflorescent cracking to soffit between Girders 3 & 4 near end of span. Spalls with 2' rebar exposed @ Right overhang @ end of span.							
1080 - Delamination/Spall/Patched Area		1171			1071	100	
1090 - Exposed Rebar		10				10	
1120 - Efflorescence/Rust Staining		20			20		
1130 - Cracking (RC and Other)		370				370	
1190 - Abrasion/Wear (PSC/RC)		1643			1443	200	
<b>107 - Steel Open Girder/Beam</b>	1- Ben.	408	ft.	0	400	8	0

Several spalls and delaminated areas to deck.  
Unsealed cracks to deck.

PHOTO 1	Description	Several spalls and delaminated areas to deck. Unsealed cracks to deck.
---------	-------------	---

Work Code: Repair

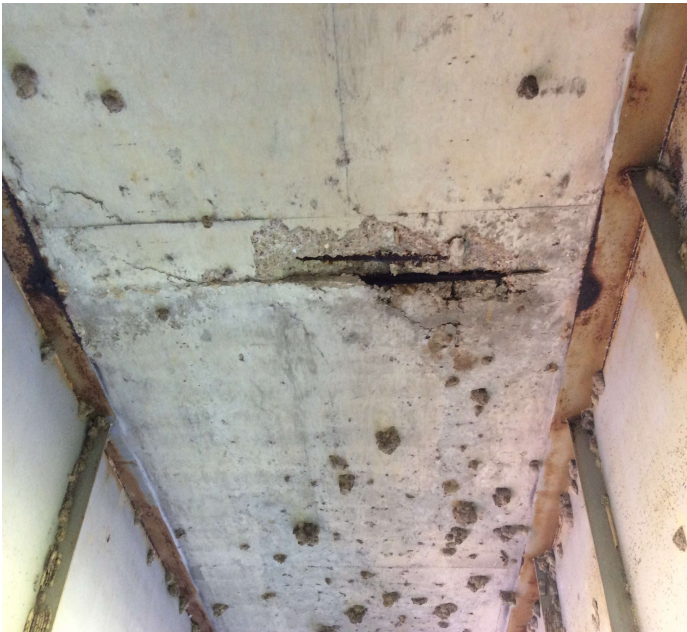
Spall with 3' of rebar exposed to soffit between Girder's 1 & 2 near end of span.

PHOTO 1      Description      Spall with 3' of rebar exposed to soffit between Girders 1 and 2.

Work Code: Repair

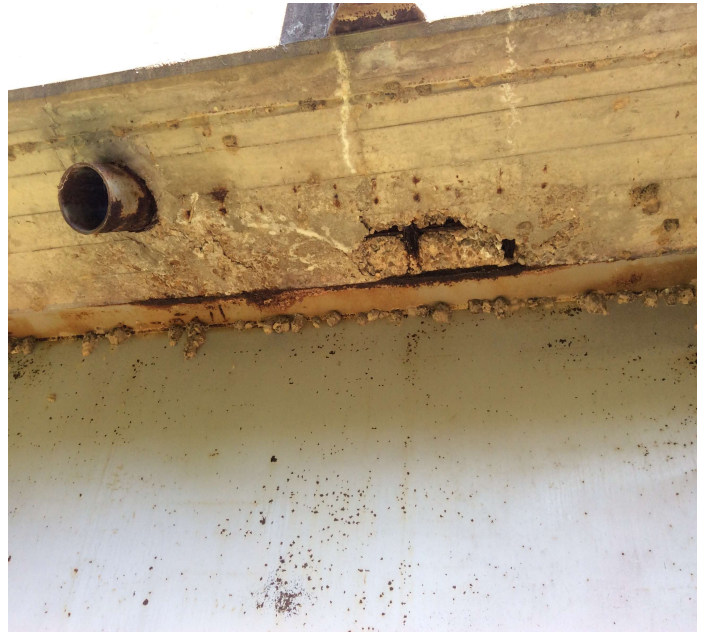
Spall with 2' of rebar exposed to Right overhang at end of span.

PHOTO 2      Description      Spall with 2' of rebar exposed to Right overhang at end of span.

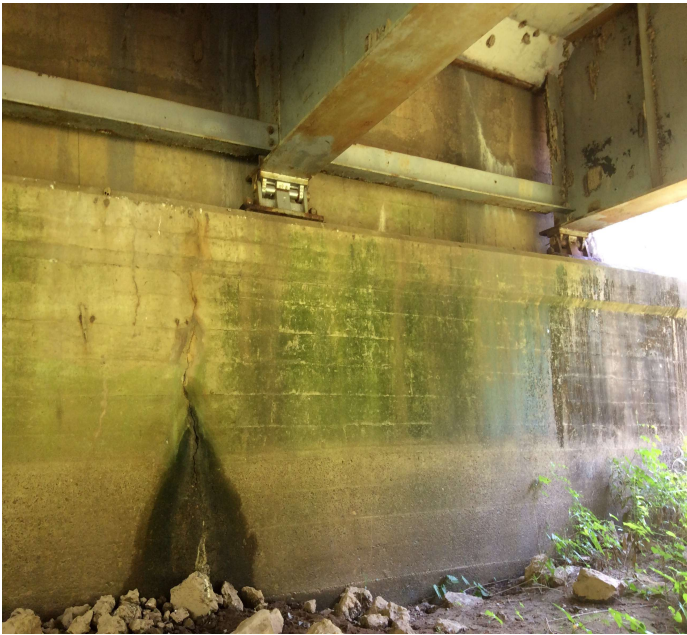
Full height vertical efflor. crack & diag. crack to backwall.

Full height vertical efflor. cracks with leaching and rust stains at Abutment 2

PHOTO 1      Description      Full height vertical efflorescent cracks with leaching and rust stains at Abutment 2.

Work Code: Repair

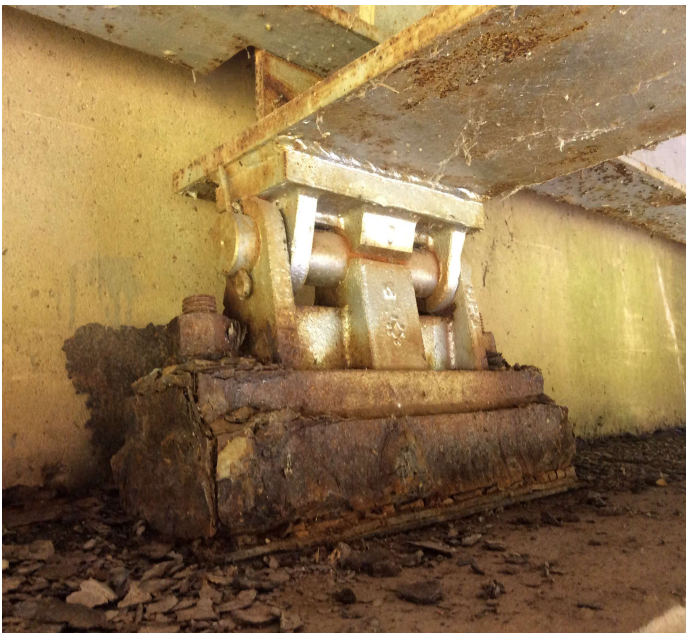
Rust, pack rust, & minor section loss to bearings.

Rust, pack rust, and section loss to bearings.

PHOTO 1      Description      Rust, pack rust, and section loss to bearings.

Work Code: Repair
