Bridge Inspection Report

01159

**SH 367/Jackson Co.
over
GRIZZLE ROAD ZONE E**

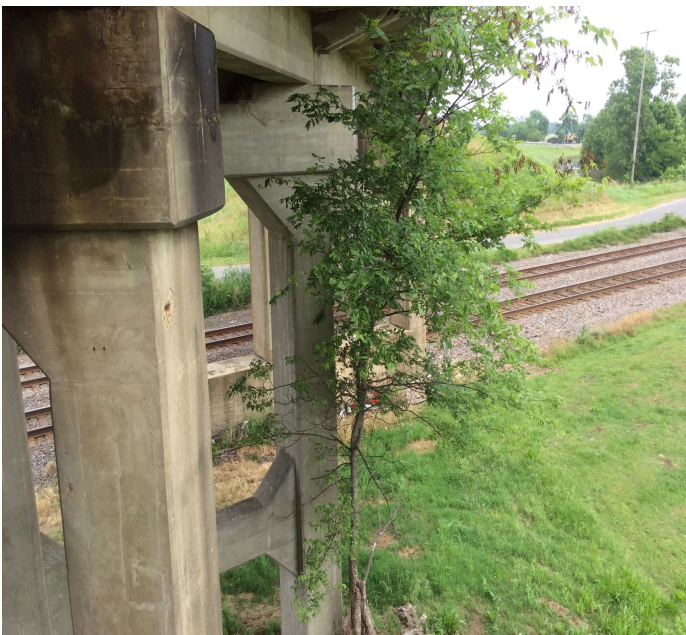
Spans 1 and 5

Vegetation & minor erosion to embankment under spans.

PHOTO 1 Description Vegetation @ Span 1.

Cut vegetation

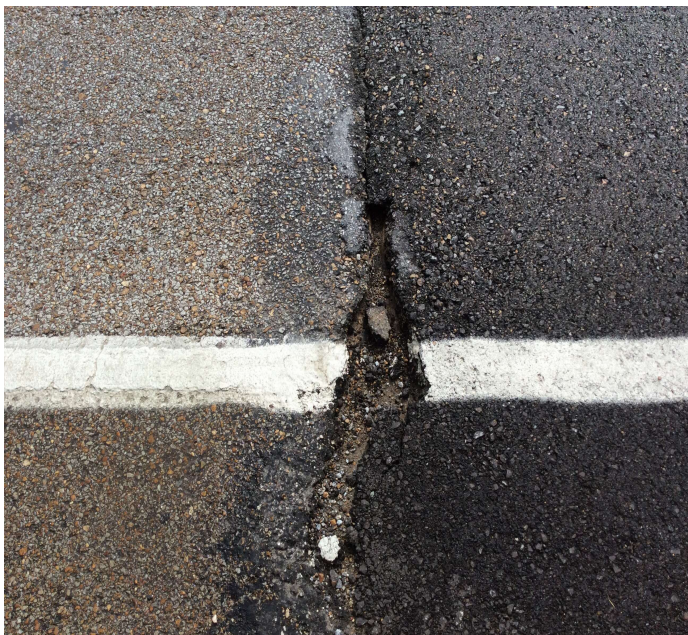
Potholes in asphalt wearing surface in main lanes and at all joints

PHOTO 1 Description Pothole in deck in Left lane over Bent 1.

Potholes filled with premix

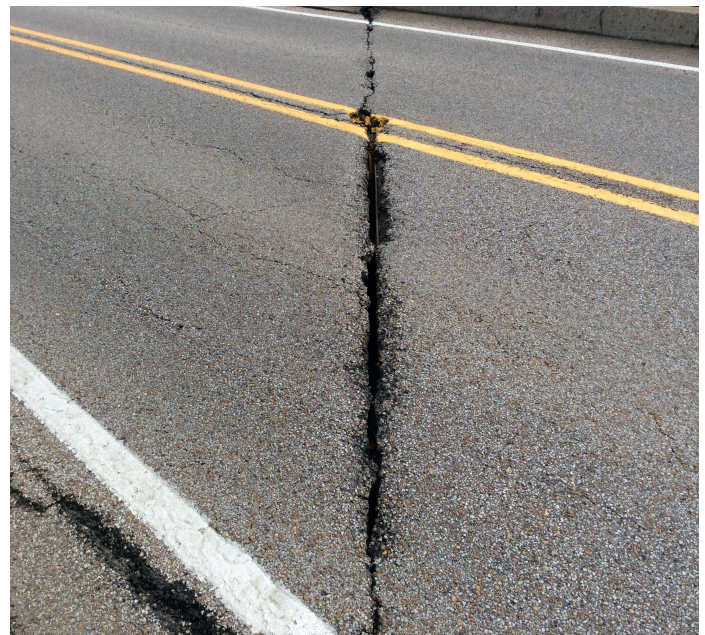
PHOTO 2 Description Spalls in asphalt @ joint @ end of Span 2.

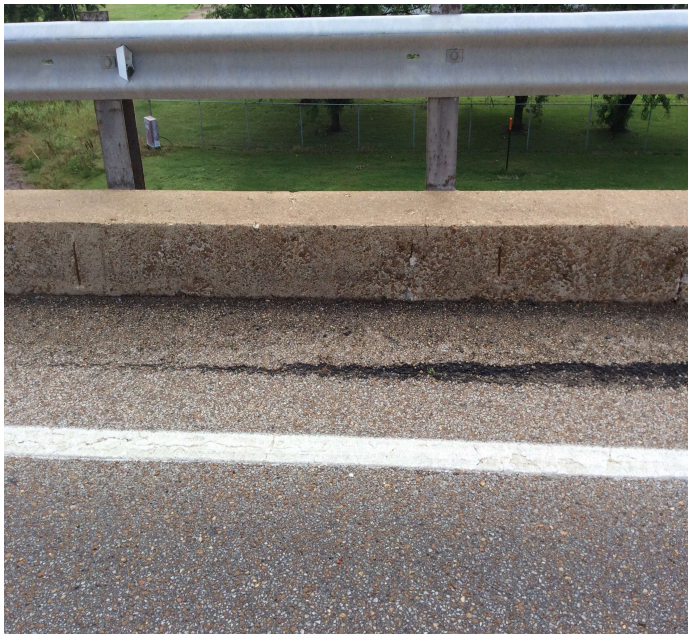
Spalls with rebar exposed to curbs at Span 3.

PHOTO 1 Description Spalls with rebar exposed to Right curb @ Span 3.

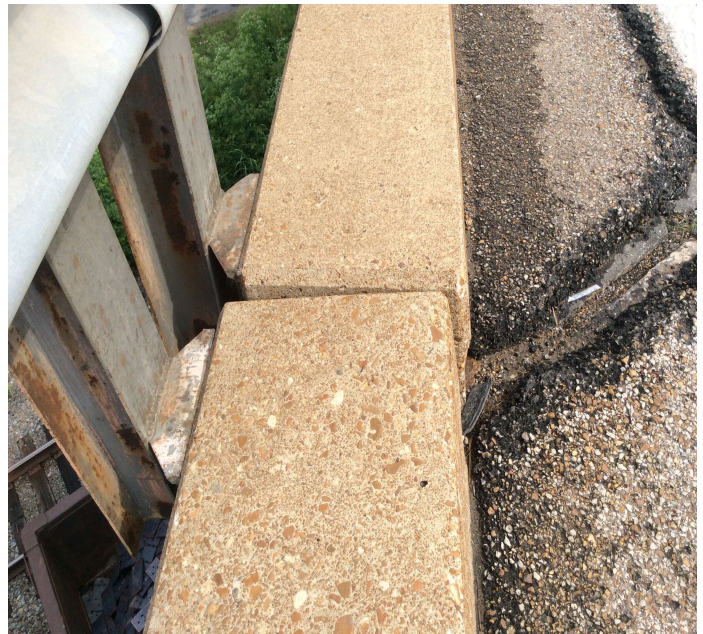
Left curb at Span 2 is out of alignment 1.5"

PHOTO 2 Description Left curb at Span 2 is out of alignment 1.5"

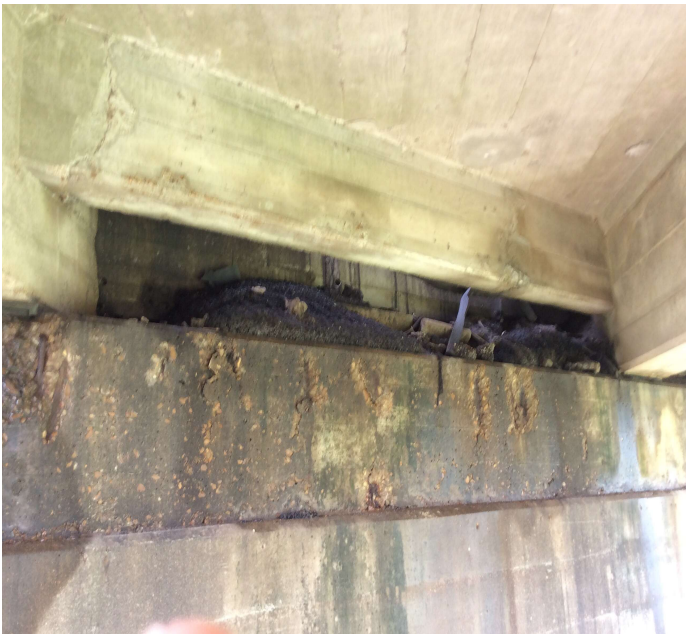
Bent 2
Joint material has failed.
Heavy debris on cap.

PHOTO 1 Description Debris on top of Cap @ Bent 2.

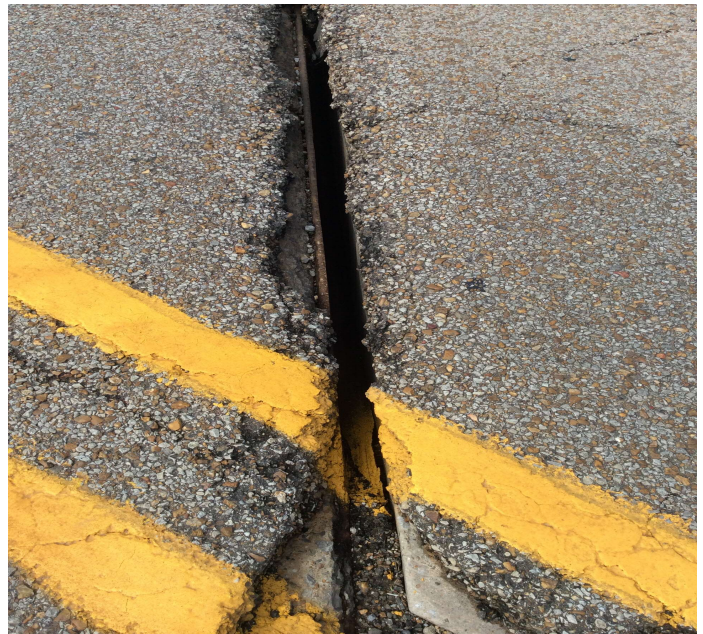
PHOTO 2 Description Joint seal over Bent 2.

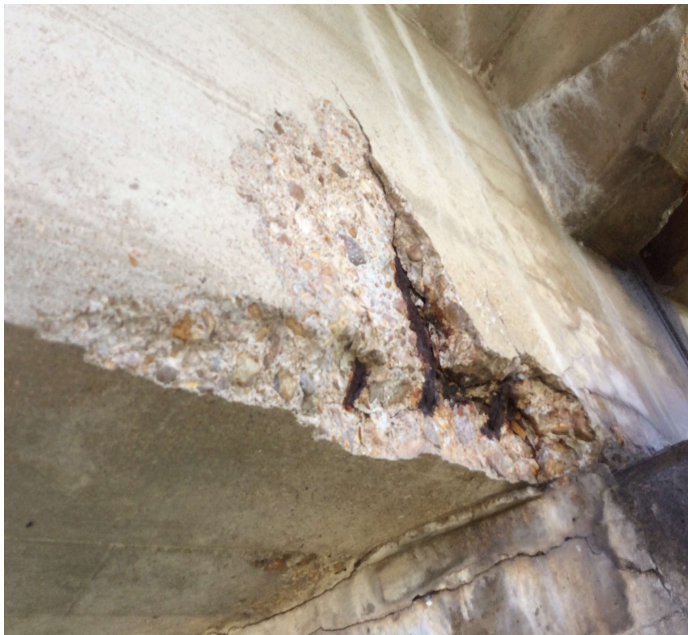
Spalls with corroded rebar exposed to end of girders.

PHOTO 1 Description Spalls with rebar exposed to Girder 1
@ beginning of Span 2.

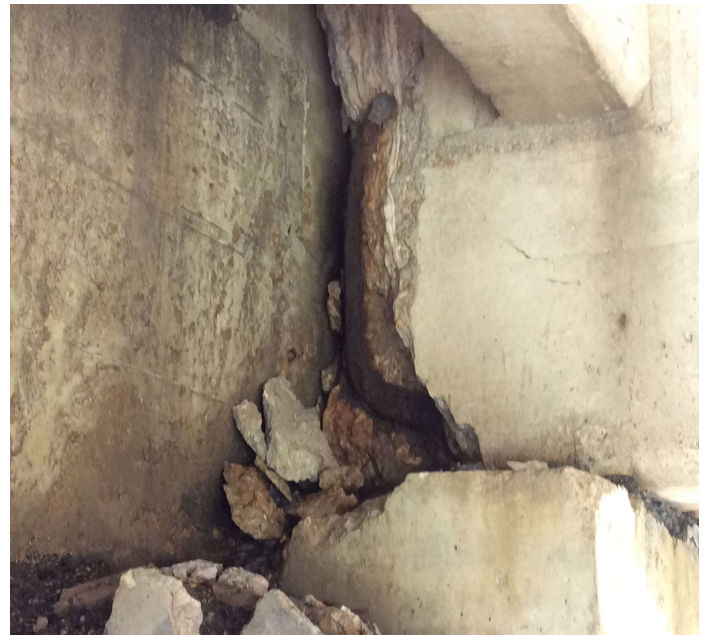
PHOTO 2 Description Spalls with rebar exposed to Girder 2
@ beginning of Span 5.

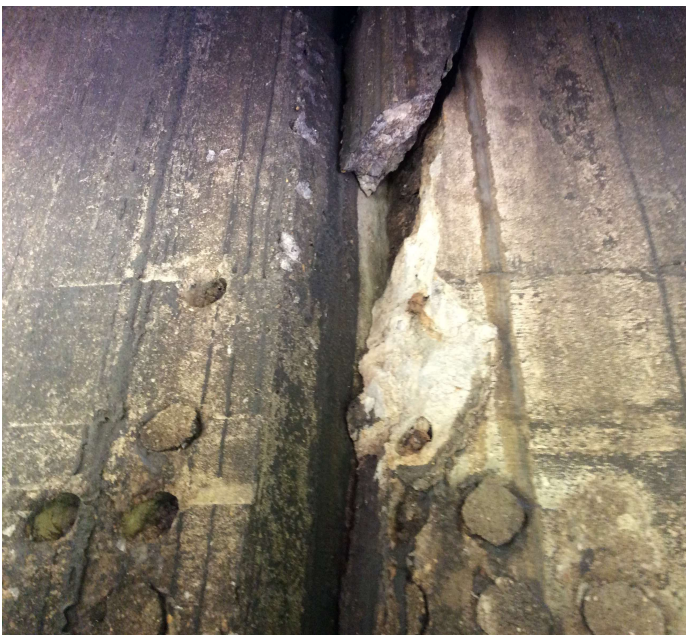
Cracks, delaminated areas, and spalls with rebar exposed to girders.

PHOTO 1 Description Deep spall to end of Unit 6 @ Bent 3.

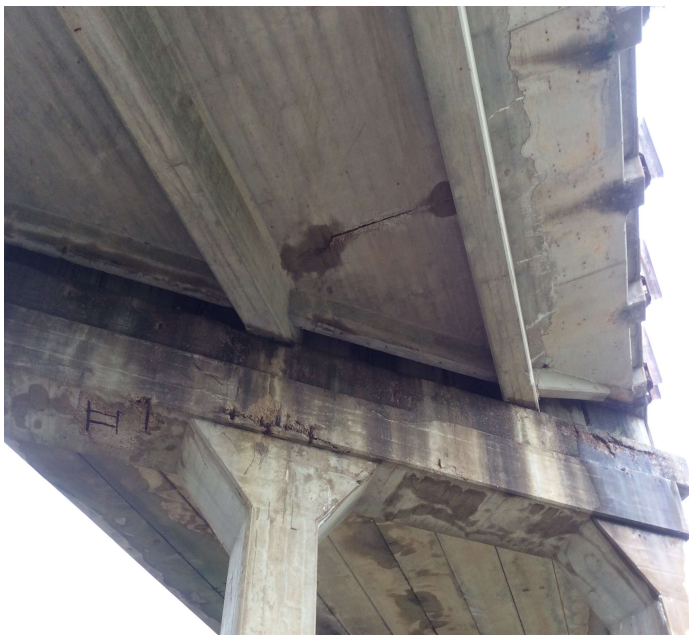
Spalls with rebar exposed to columns and caps

PHOTO 1 Description Spalls with rebar exposed to Cap @ Bent 3.

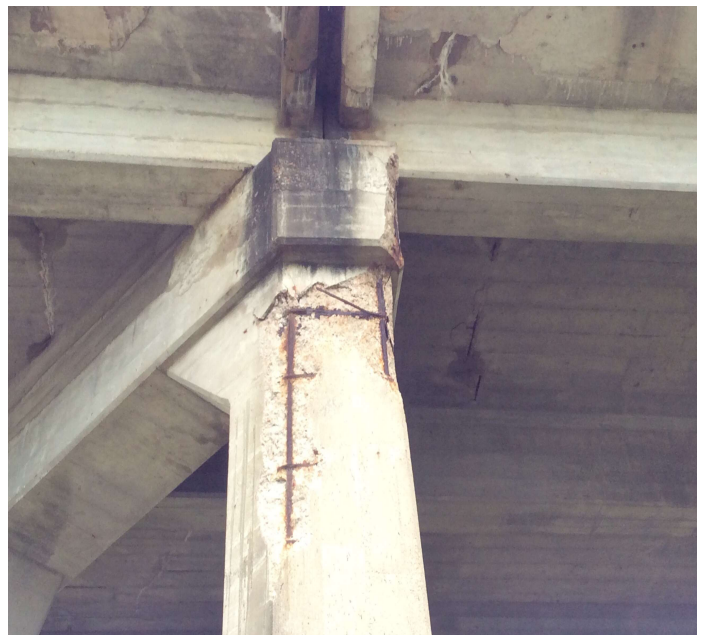
PHOTO 2 Description Spalls with rebar exposed to Column 3 @ Bent 4A.

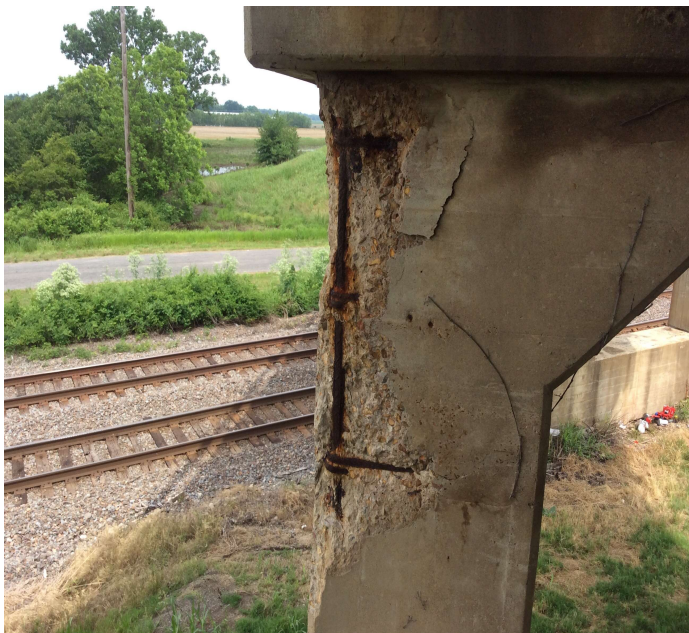
PHOTO 3 Description Spalls with rebar exposed to Column 1
@ Bent 1.
