Bridge Inspection Report

05537
SH 385 WHITE CO.
over
US 67-SEC 13

Structure Number: 05537

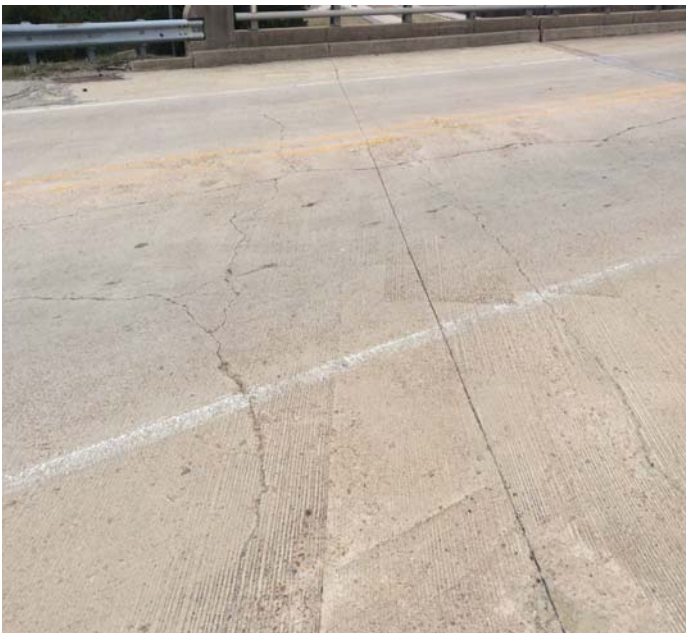
Unsealed cracks to approach slabs @ Abutment 1 & 2.

PHOTO 1 Description Unsealed cracks to approach slabs @
Abutment 1 & 2.

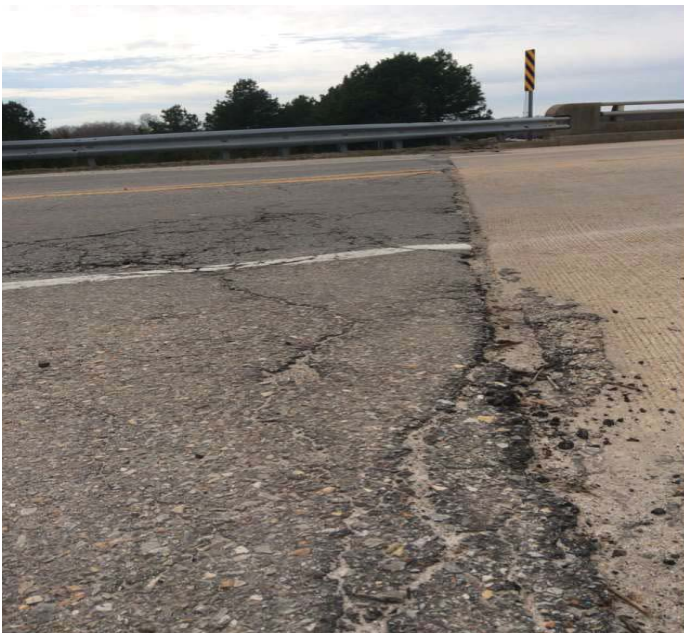
Visible settlement & potholes to Roadway @ Abutment 1.

PHOTO 1 Description Visible settlement & potholes to
Roadway @ Abutment 1.

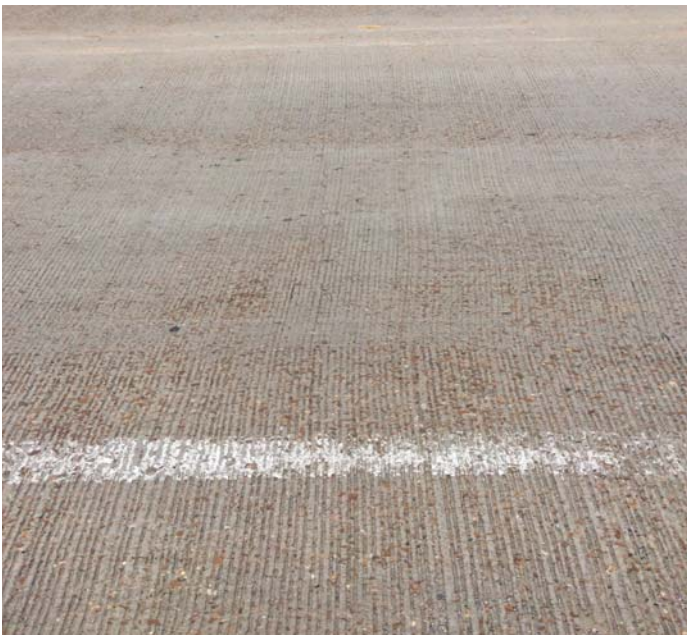
Unsealed cracks to deck @ all Spans.

PHOTO 1 Description Unsealed cracks to deck @ all Spans.

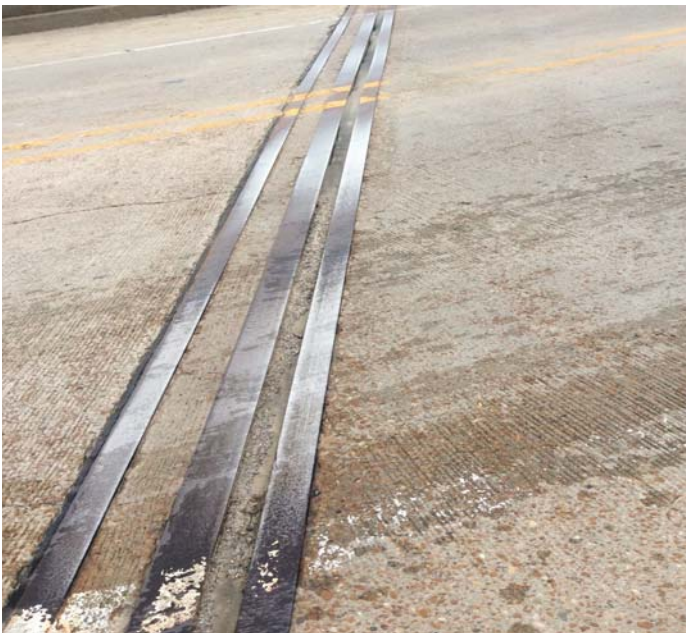
18' of Joint seal has separated & leak @ Abutment 1 & 2

PHOTO 1 Description 18' of Joint seal has separated & leak
@ Abutment 1 & 2.
