Bridge Inspection Report

06992

SH 367/Jackson Co.

Drainage Ditch #10

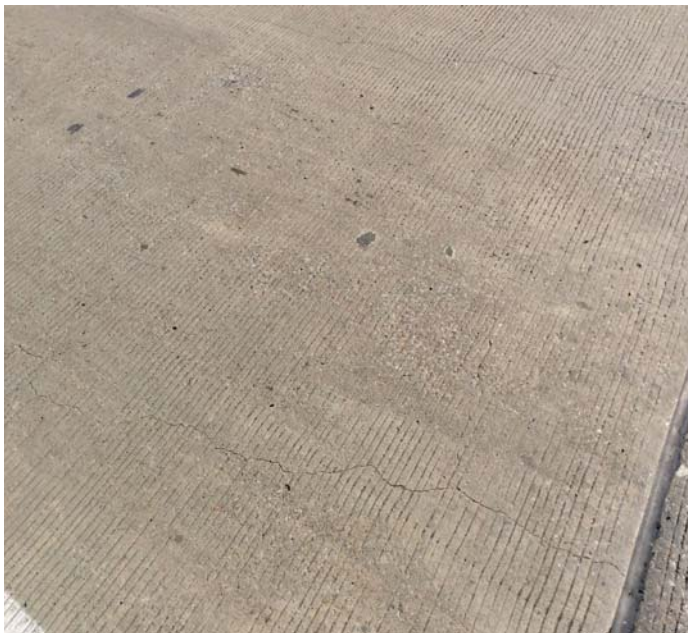
Unsealed cracks to deck @ all spans.

PHOTO 1 Description Unsealed cracks to deck @ all spans.

Work Code: Repair

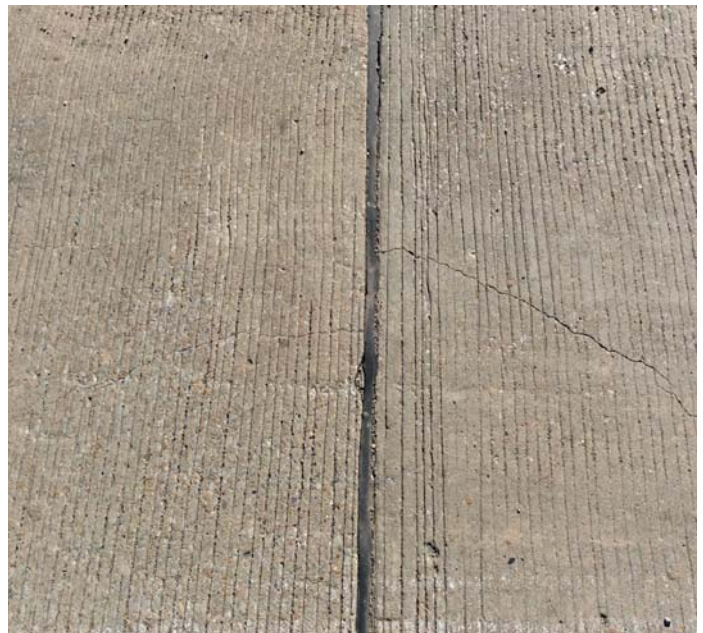
PHOTO 2 Description Unsealed cracks to deck @ all spans.

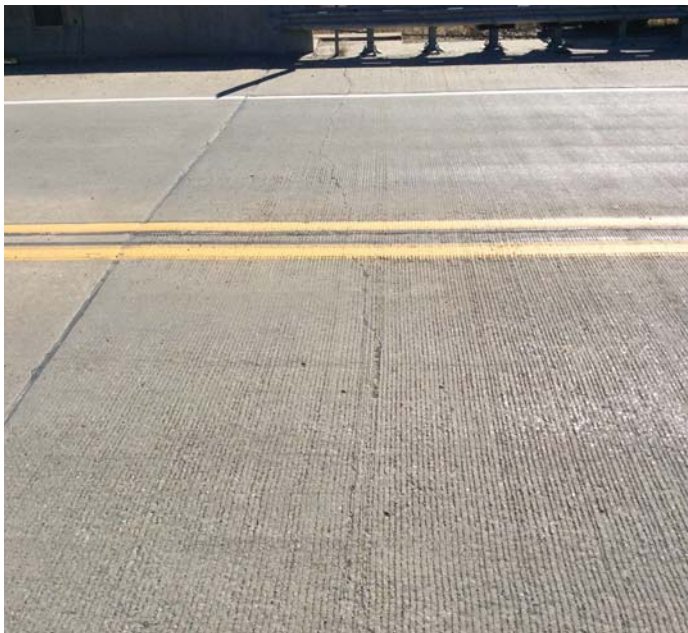
Approach slabs @ Abutments 1 & 2 have unsealed transverse cracks.

PHOTO 1 Description Approach slabs @ Abutments 1 & 2 have unsealed transverse cracks.

Work Code: Repair

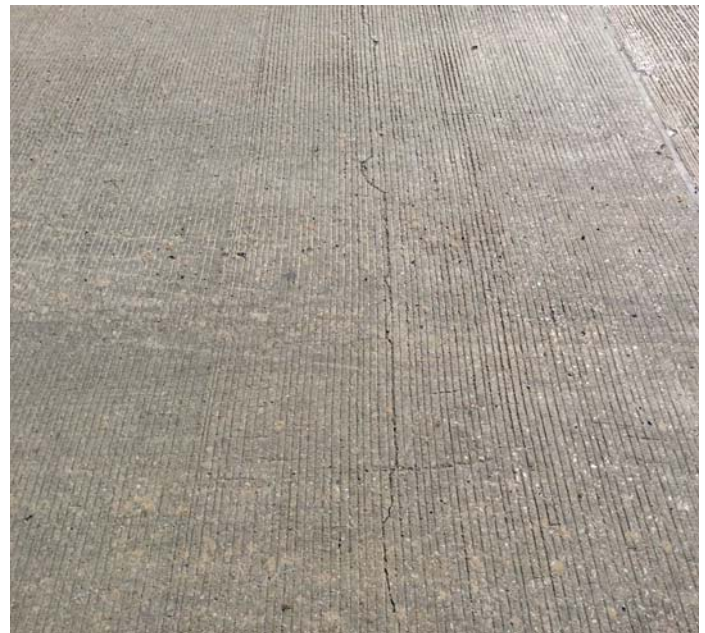
PHOTO 2 Description Approach slab @ Abutment 2 cracking.
