Bridge Inspection Report

05449

SH 367 Sec16 WHITE

US 67-SEC 12

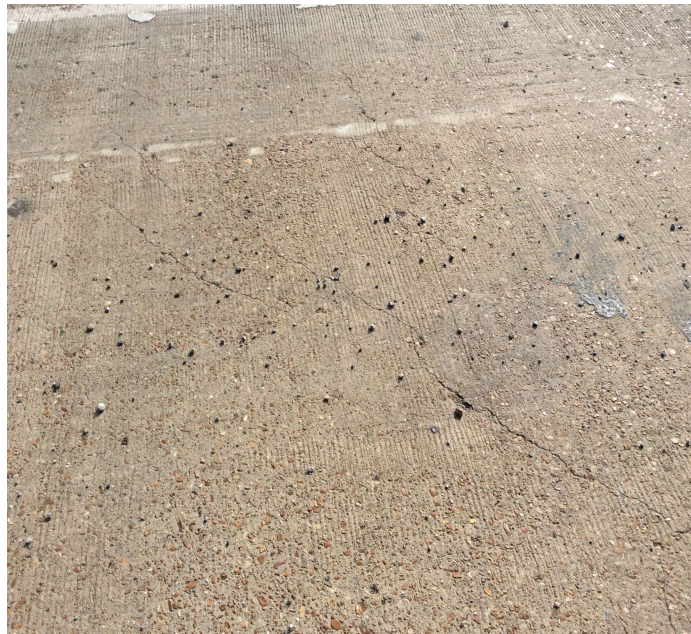
Unsealed cracks in deck at Spans 1 & 2.

PHOTO 1 Description Unsealed cracks in deck at Spans 1 & 2.

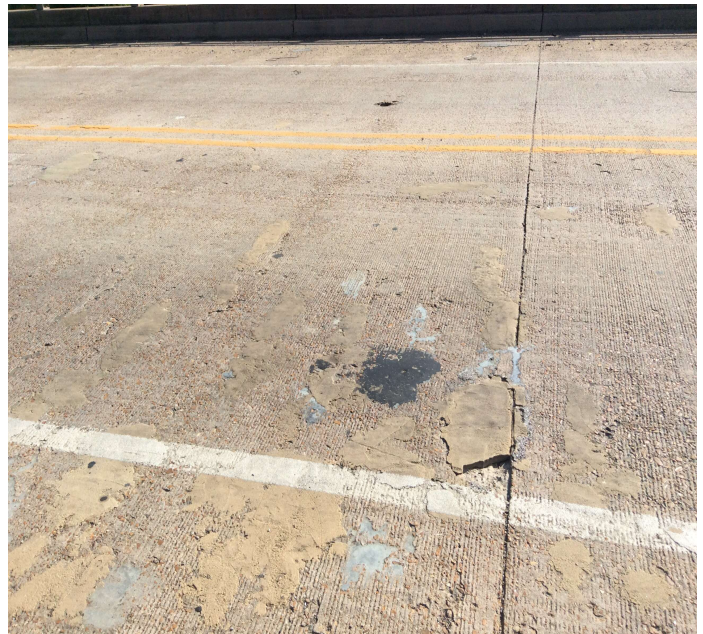
Spalls with no rebar exposed to deck at Spans 1 & 2.

PHOTO 2 Description Spalls with no rebar exposed to deck at Spans 1 & 2.

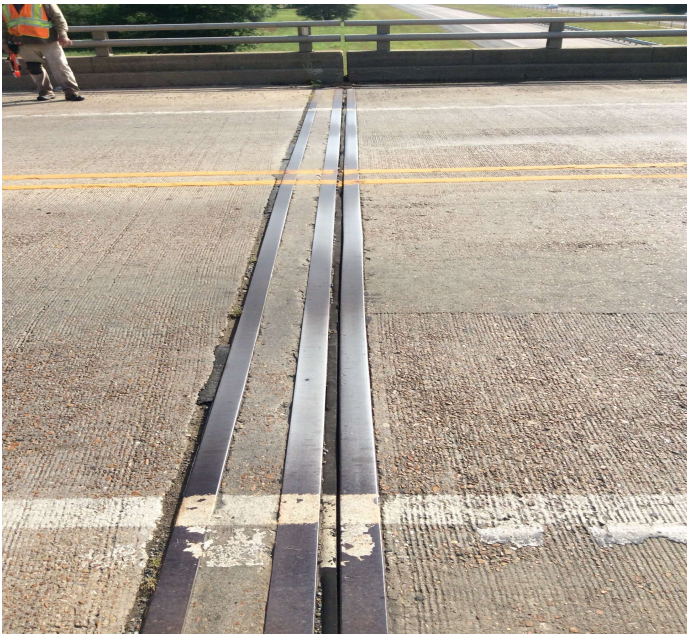
Adhesion failure to joint seal at Abutment 1.

PHOTO 1 Description Adhesion failure to joint seal at Abutment 1.

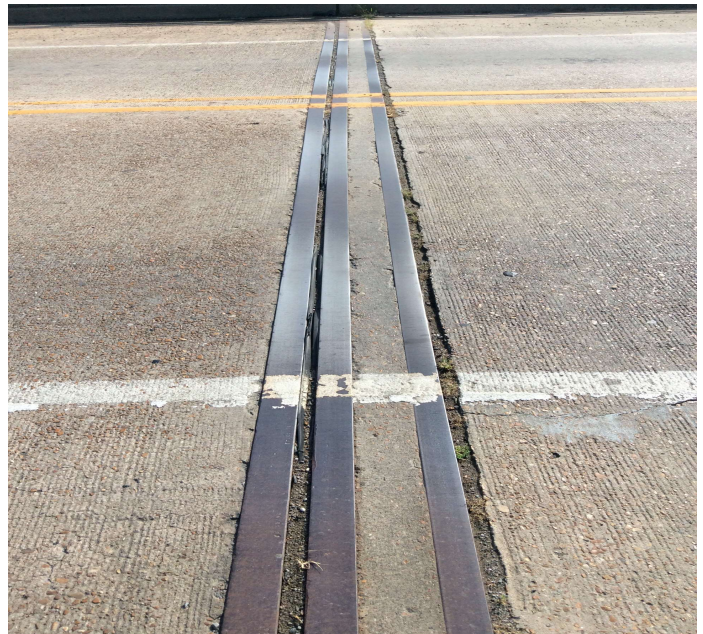
302 - Compression Joint Seal	1- Ben.	46	ft.	0	0	43	3
Joint Seal is cracked and deteriorated at Abutment 2 with some adhesion failure.							
2320 - Seal Adhesion		3		0	0	0	3
2340 - Seal Cracking		43		0	0	43	0
311 - Movable Bearing	1- Ben.	12	each	0	2	10	0
Pads have been welded and painted at Abutments 1 & 2. Bearing assemblies at Abutment 1 & 2 have rust & section loss.							
1000 - Corrosion		12		0	2	10	0
515 - Steel Protective Coating		24	sq. ft.	0	0	4	20
3440 - Effectiveness (Steel Protective Coatings)		24		0	0	4	20
313 - Fixed Bearing	1- Ben.	6	each	6	0	0	0
515 - Steel Protective Coating		10	sq. ft.	10	0	0	0
321 - Reinforced Concrete Approach Slab	1- Ben.	3010	sq. ft.	2610	0	400	0
Large cracks to Approach Slabs at Abutments 1 & 2.							
1130 - Cracking (RC and Other)		400		0	0	400	0
330 - Metal Bridge Railing	1- Ben.	416	ft.	416	0	0	0
10' of left approach rail is bent at Abutment 2.							
331 - Reinforced Concrete Bridge Railing	1- Ben.	416	ft.	367	49	0	0

Joint seal is cracked & deteriorated at Abutment 2..

PHOTO 2 Description Joint seal is cracked & deteriorated at Abutment 2.

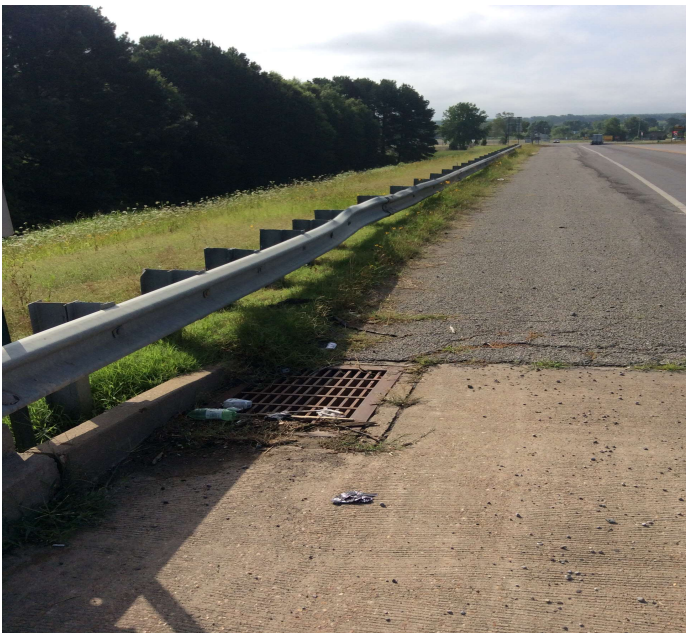
10' of left approach rail is bent at Abutment 2.

PHOTO 1 Description 10' of left approach rail is bent at Abutment 2.

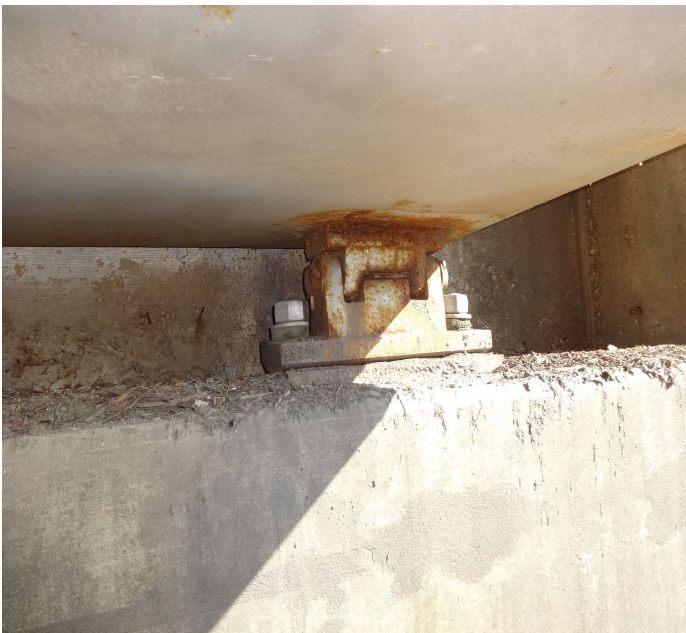
Rust bearing assemblies & to outside bottom of all girders at Bearing assemblies at Abutments 1 & 2.

PHOTO 1 Description Rust on bearing assemblies & to outside bottom of all girders at Bearing assemblies at Abutment 1 & 2.

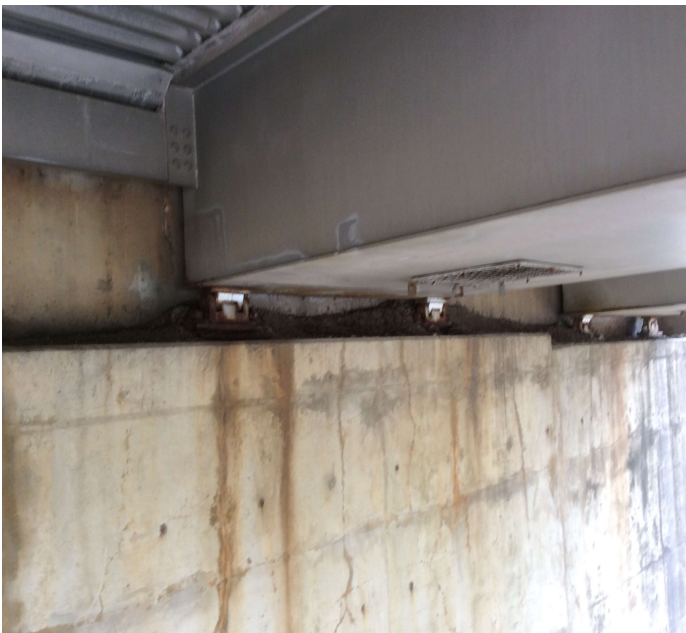
Debris on cap @ Abutment 1.

PHOTO 1 Description Debris on cap @ Abutment 1.

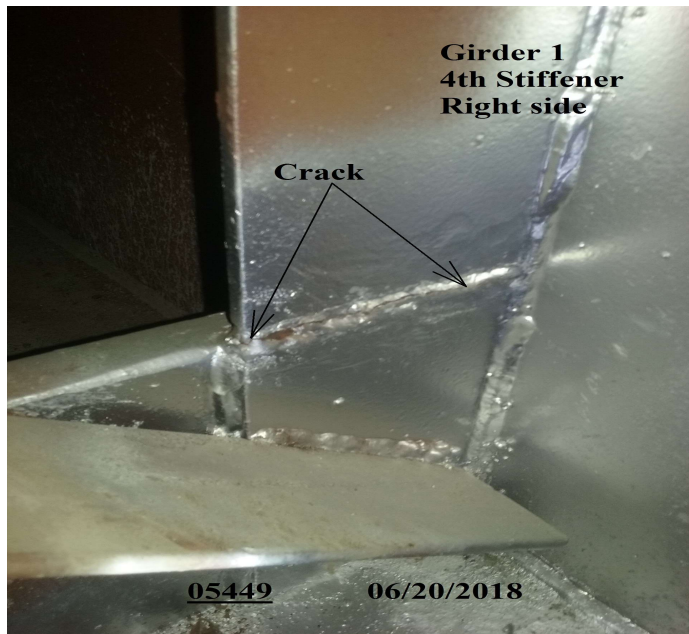
PHOTO 1 Description

Girder 1, 4th Stiffener ahead of Abutment 1, Right Side has large crack near bottom.

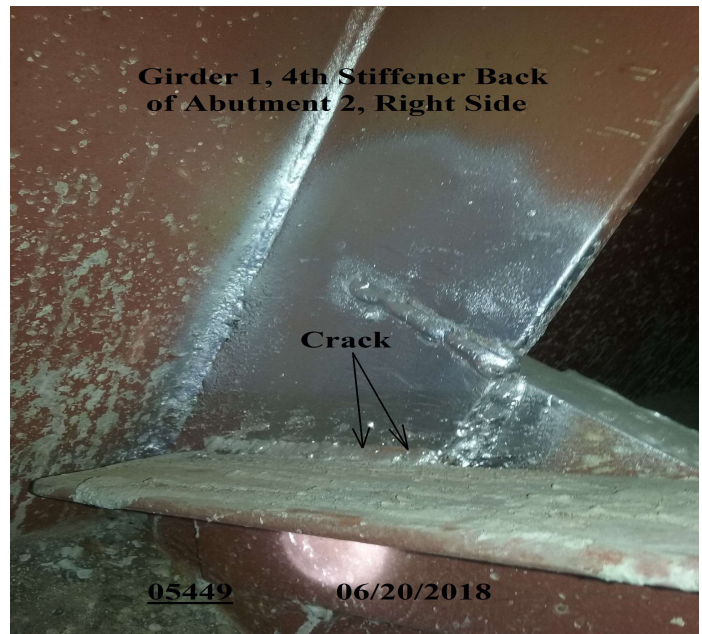
PHOTO 2 Description

Girder 1, 4th Stiffener back of Abutment 2, Right Side has large crack near bottom.
