# Bridge Inspection Report

**03581**  
**SH 5 WHITE COUNTY**  
**over**  
**CEDAR CREEK**

## Bridge Inspection Report

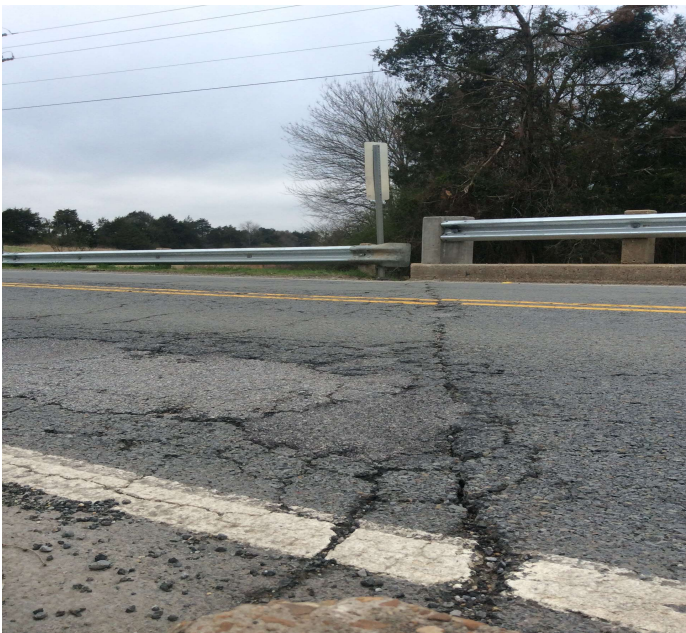
Visible settlement to roadway @ Abutment 1 & 2.

PHOTO 1      Description      Visible settlement to Roadway @  
Abutment 1 & 2.

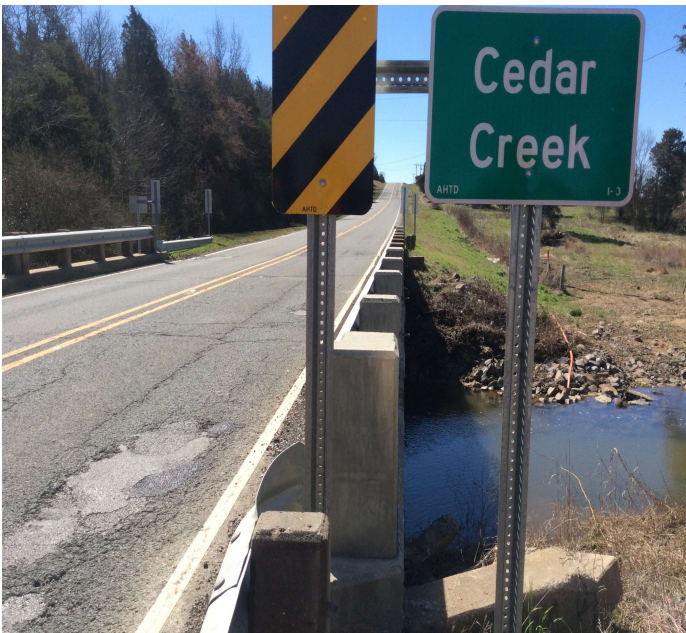
Log Mile sign is missing @ Abutment 2. Should read 14.47.

PHOTO 1      Description      Log Mile sign is missing @ Abutment 2.  
Should read 14.47.

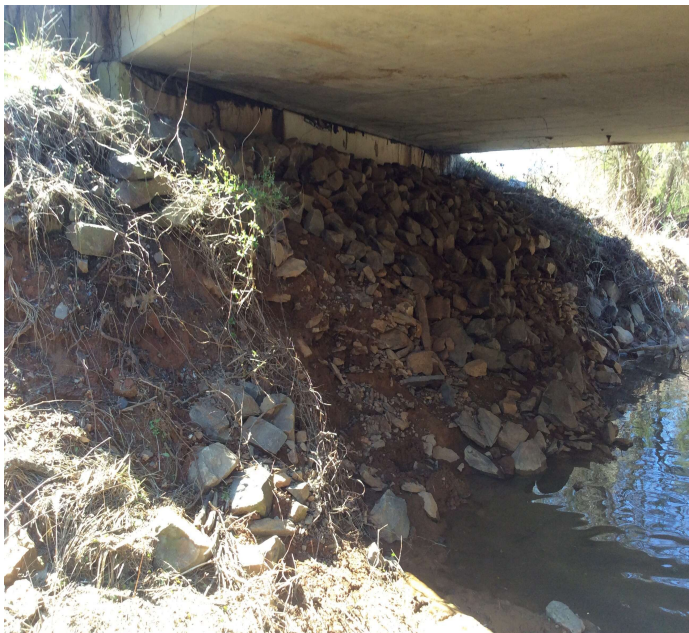
Severe erosion to Slope @ Abutment 1.

PHOTO 1      Description      Severe erosion to Slope @ Abutment 1.

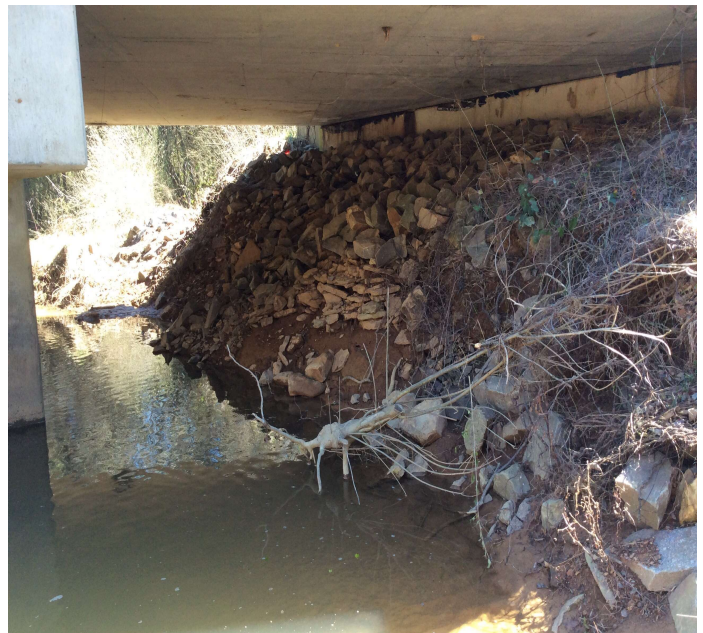
PHOTO 2      Description      Severe erosion to Slope @ Abutment 1.

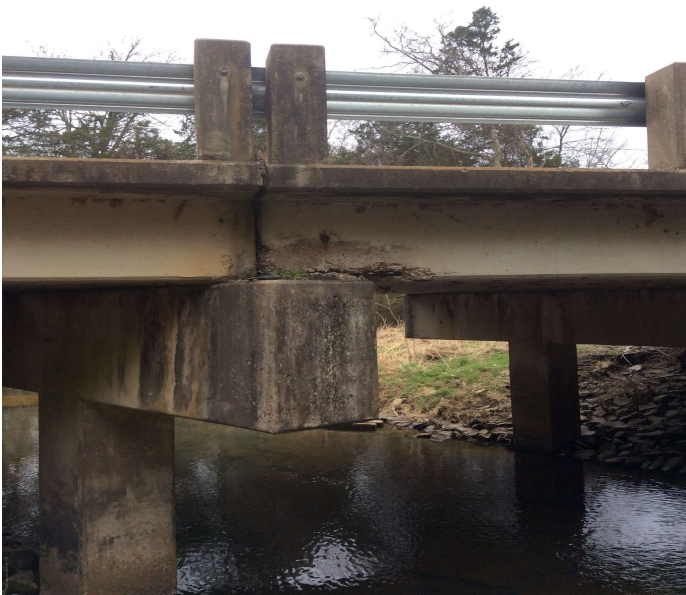
Spall with 1' rebar exposed to outside edge of deck on Right side of Span 2.

PHOTO 1      Description      Spall with 1' rebar exposed to outside edge of deck on Right side of Span 2.

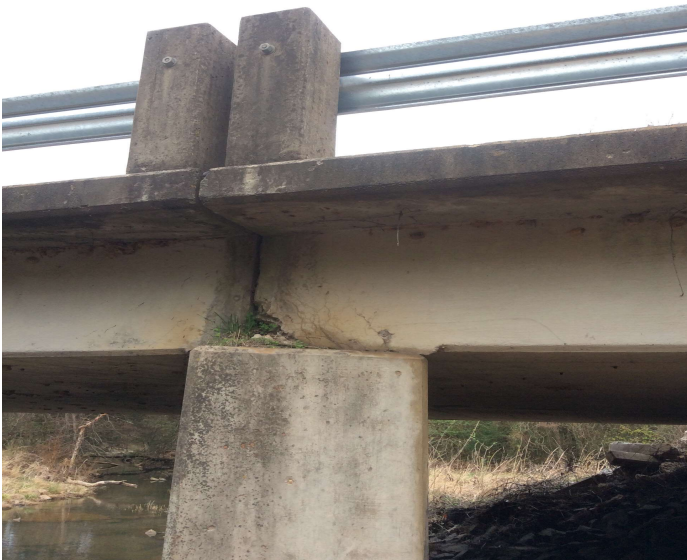
Cracks to outside edge of deck over Bents 1 & 2.

PHOTO 1      Description      Cracks to outside edge of deck over  
Bents 1 & 2.
