Bridge Inspection Report

05844
SH 87 OP White Co.
over
US 67-SEC 13

Structure Number: 05844

Facility Carried: SH 87 OP White
Co.

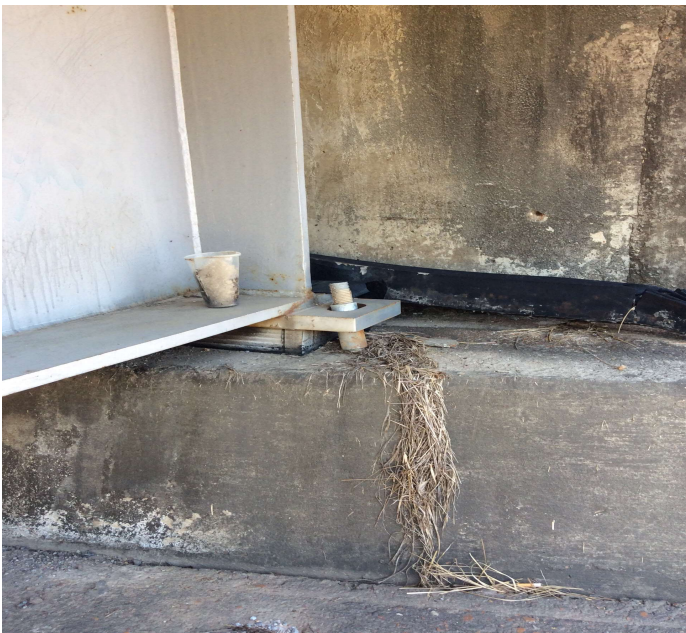
Anchor Nut missing @ Girder 5 @ Abutment 2

PHOTO 1 Description Anchor Nut missing @ Girder 5 @
Abutment 2.

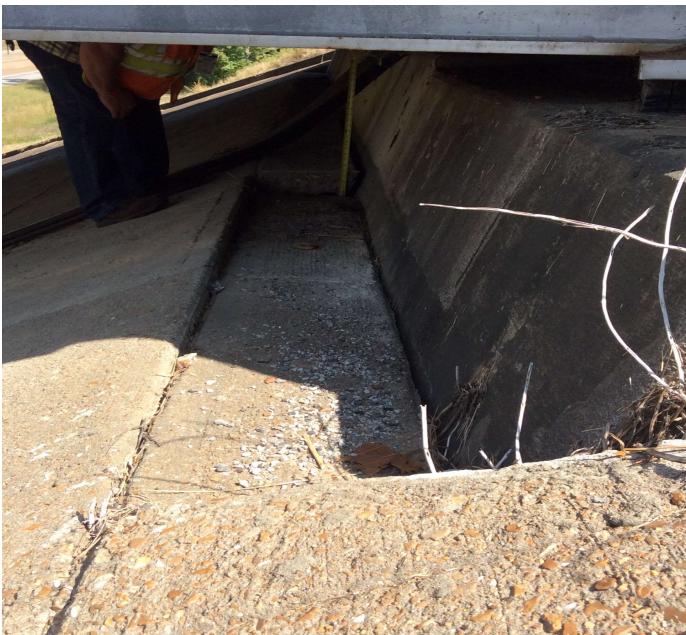
Concrete Rip Rap settled 4 1/2" @ Left side of Abutment 1.

PHOTO 1 Description Concrete Rip Rap settled 4 1/2" @ Left
side of Abutment 1.

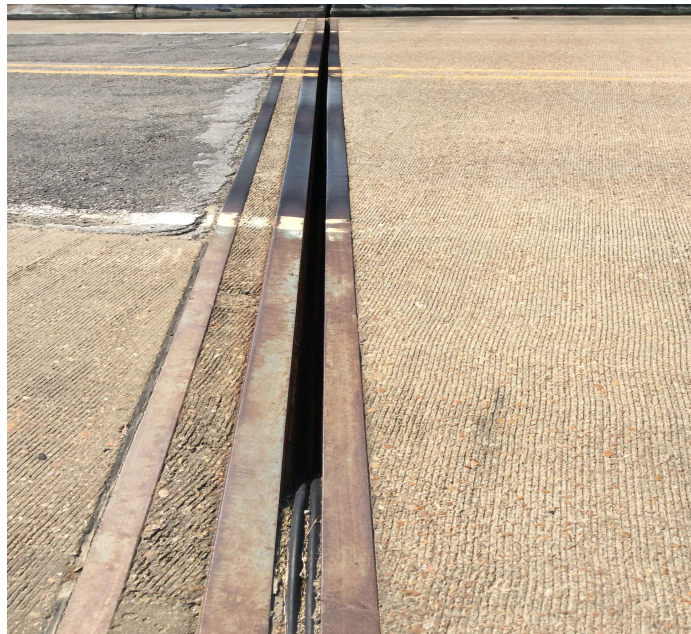
37' of Joint Seal failed & debris buildup on Cap @ Abutment 1.

PHOTO 1 Description Abutment 1 - 37' of Joint Seal failed & debris buildup on Cap.

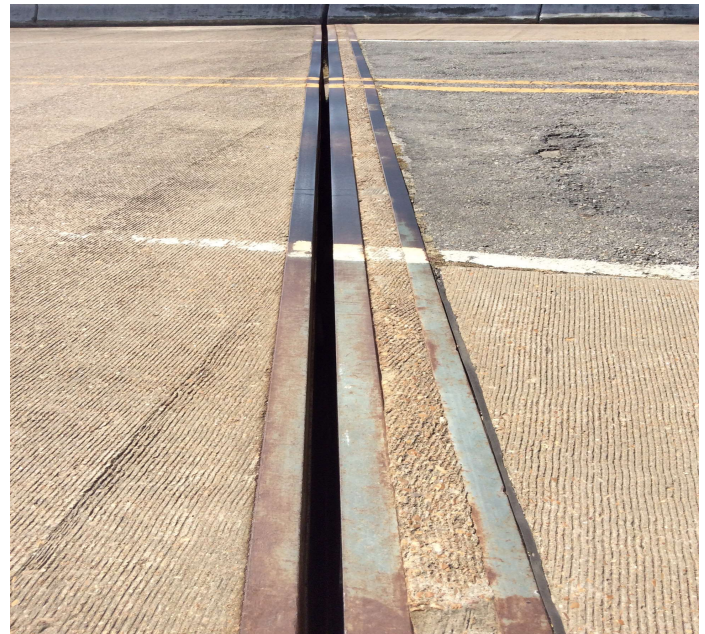
44' of Joint Seal failed & debris buildup on Cap @ Abutment 2.

PHOTO 2 Description Abutment 2 - 44' of Joint Seal failed & debris buildup on Cap.

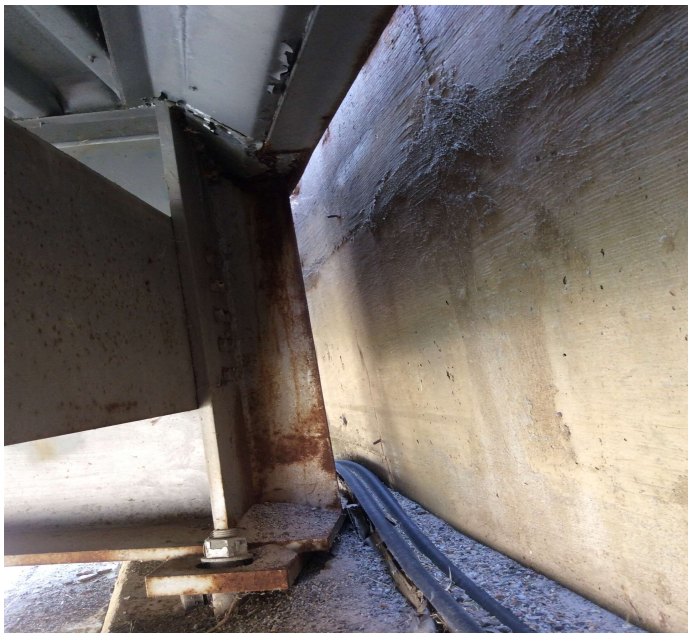
PHOTO 1 Description Abutment 2 has corrosion to bottom of Road Irons & to ends of Girders.

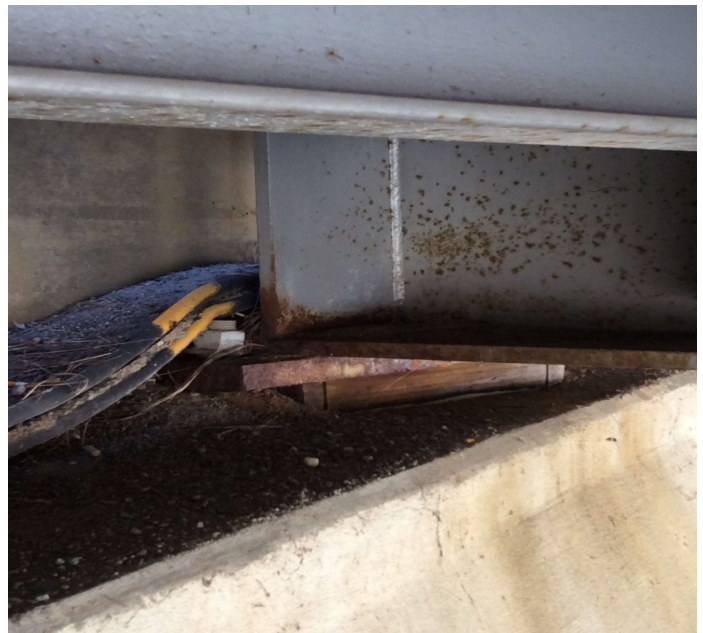
Typical corrosion to bottom of Road Irons & to ends of Girders @ Abutment 1 & 2.

PHOTO 2 Description Typical corrosion to bottom of Road Irons & to ends of Girders @ Abutment 1 & 2.
