# Bridge Inspection Report

**05849**

**SH 9/Fulton County  
over  
STRAWBERRY RIVER**

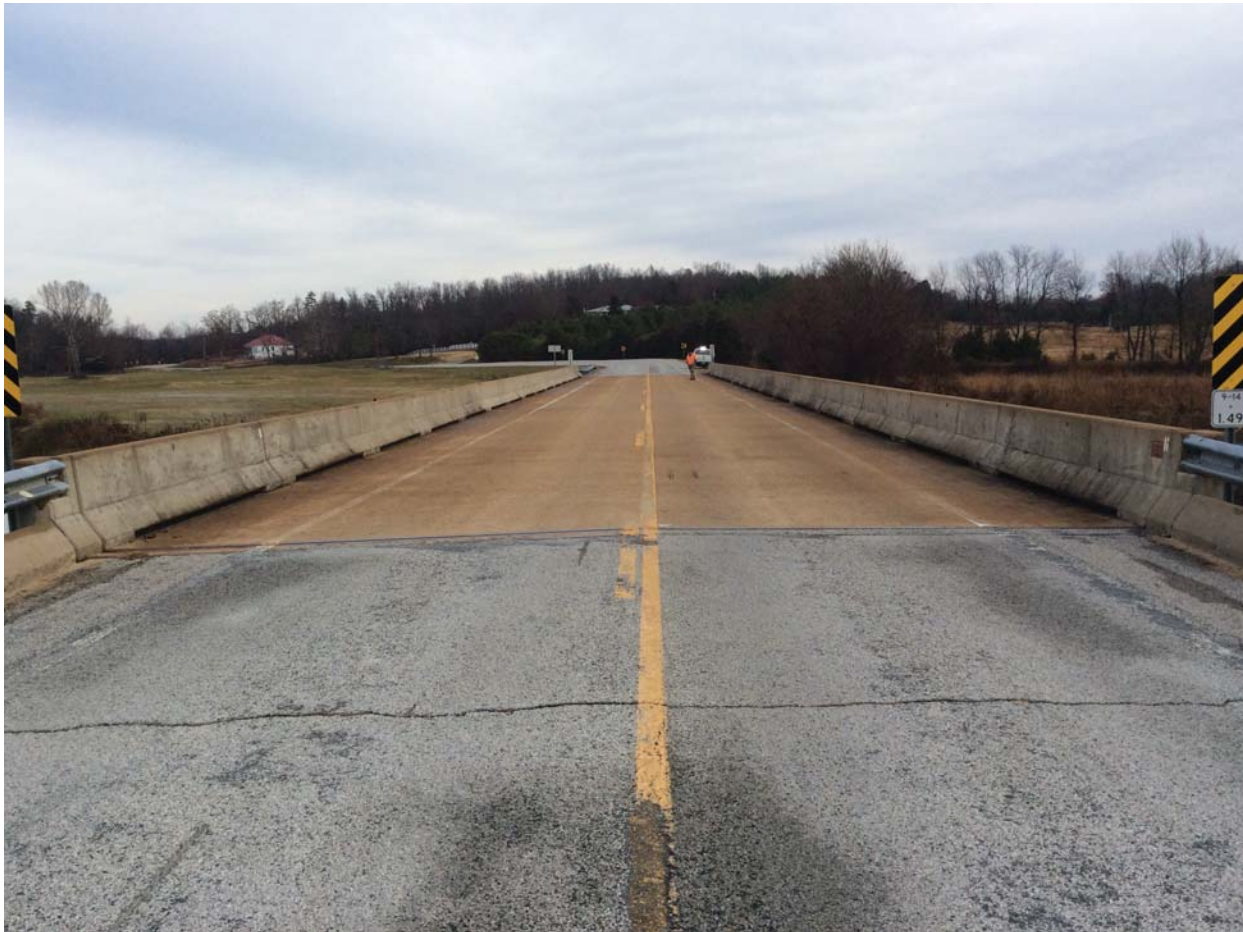
No overlay on the bridge

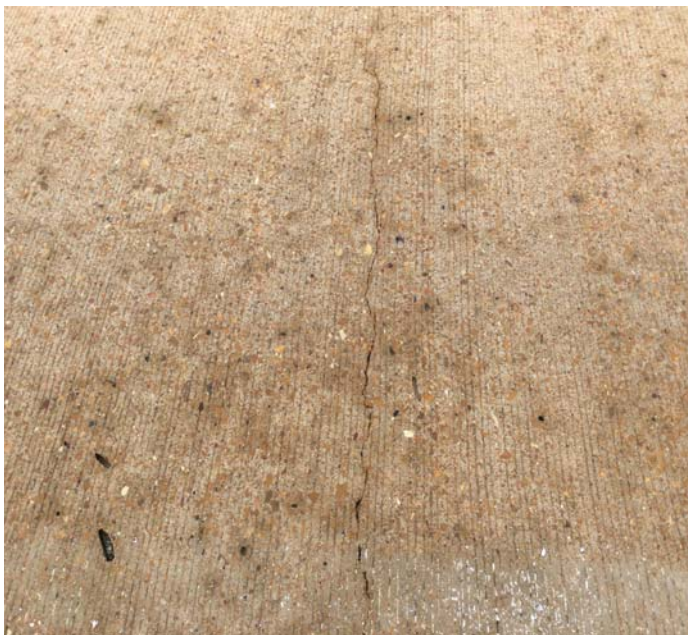
Deck at all spans

Minor transverse unsealed cracks

PHOTO 1      Description      Transverse cracking to deck @ Span 3. Right lane.

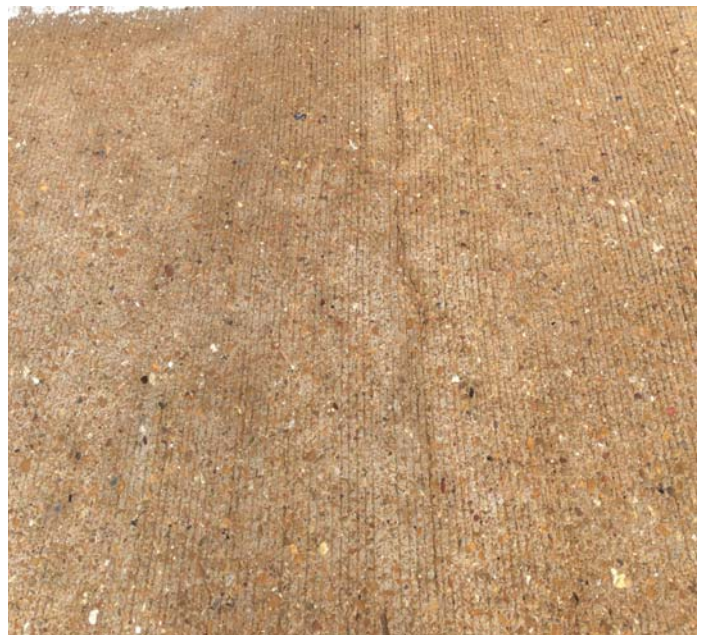
PHOTO 2      Description      Transverse cracking to deck @ Span 2. Left lane.

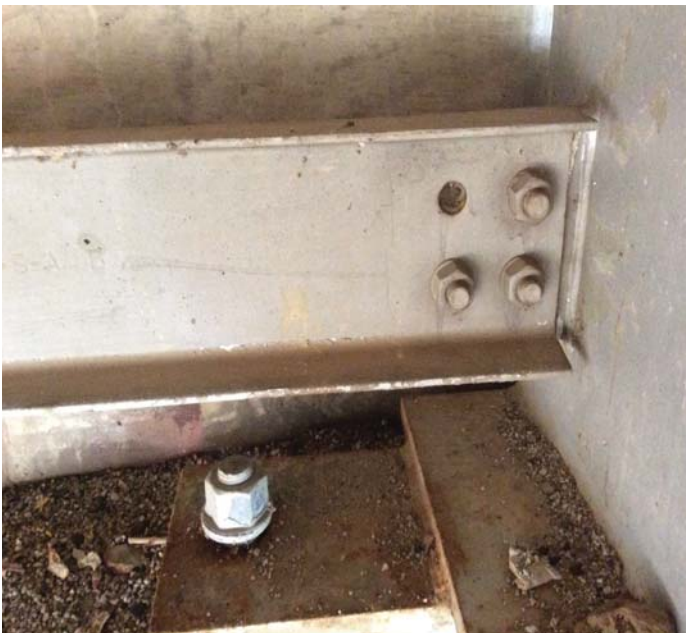
Diaphragm @ Right side of Girder 3 @ Abutment 1 has 1 bolt missing.

PHOTO 1      Description      Diaphragm @ Right side of Girder 3 @  
Abutment 1 has 1 bolt missing.
