Bridge Inspection Report

M0284
SH 9/Fulton County
over
HARKLE ROAD CREEK

Structure Number: M0284

Facility Carried: SH 9/Fulton County

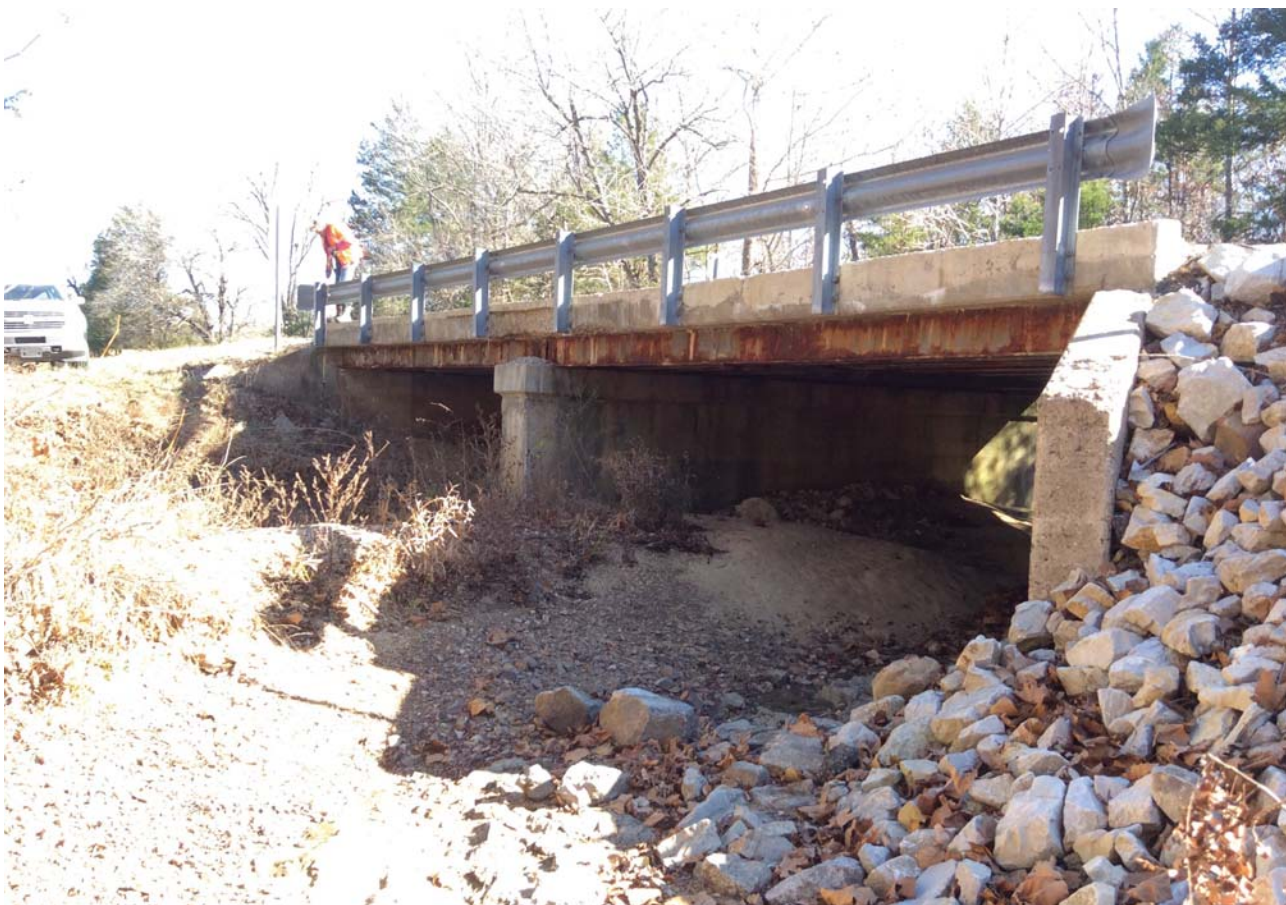
2 1/2 inches of asphalt wearing surface

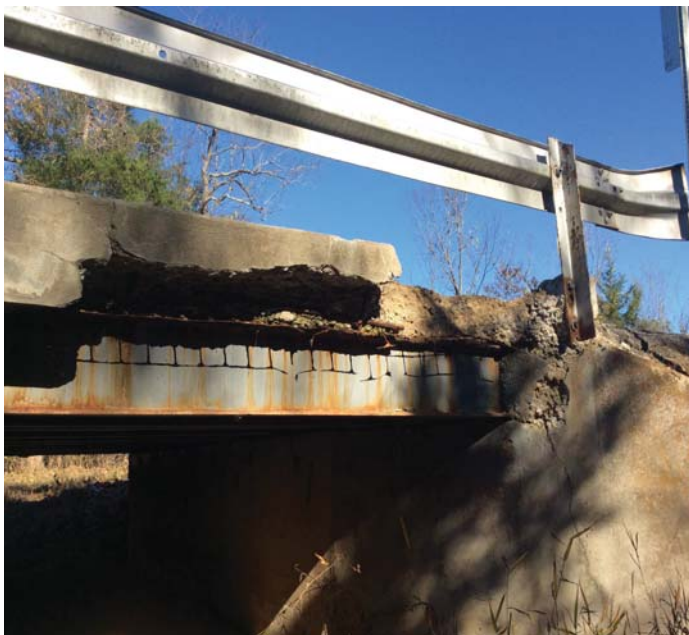
Deck at Abutment 2 Spalled with 1.5' x 4' hole in Deck at right edge with bridge rail post broken loose.
Deck at Abutment 1 right edge spalled with bridge rail post broken loose.

PHOTO 1 Description Deck at Abutment 2 Spalled with 1.5' x 3.5' hole in Deck at Right edge.

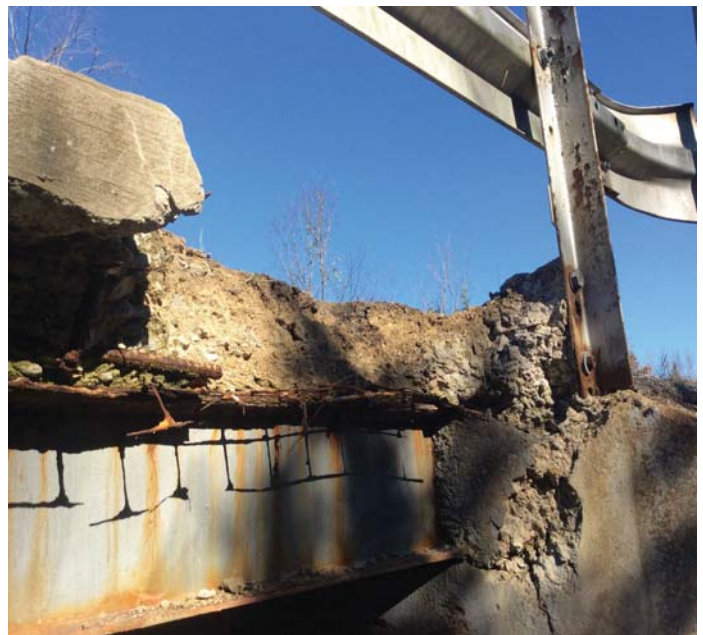
PHOTO 2 Description Deck at Abutment 2 Spalled with 1.5' x 3.5' hole in Deck at Right edge.

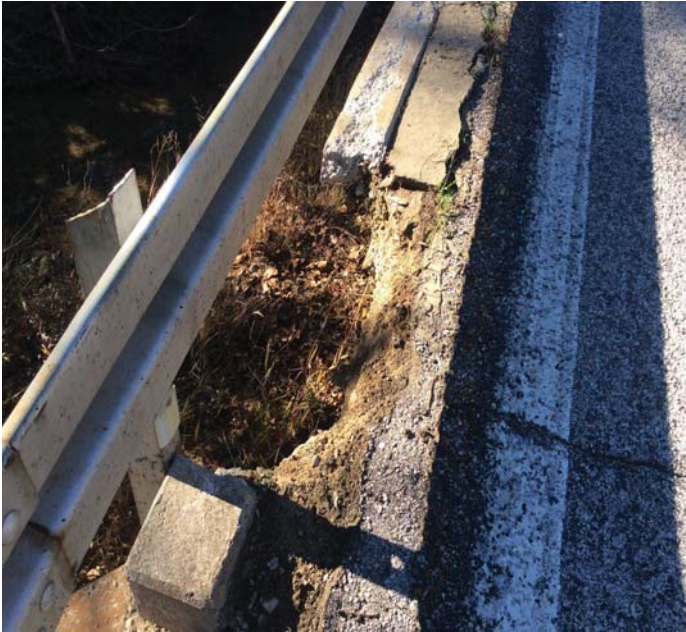
PHOTO 3 Description Deck at Abutment 2 Spalled with 1.5' x 3.5' hole in Deck at Right edge.

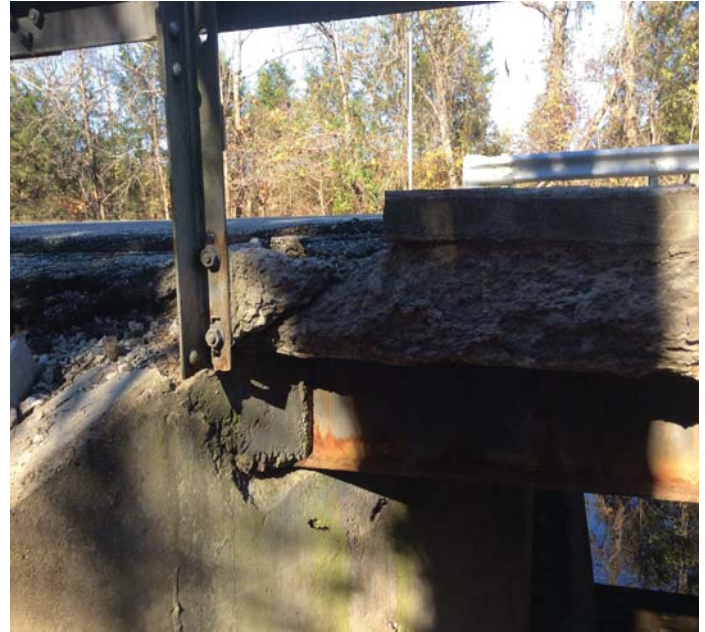
PHOTO 5 Description Deck at Abutment 1 Right.

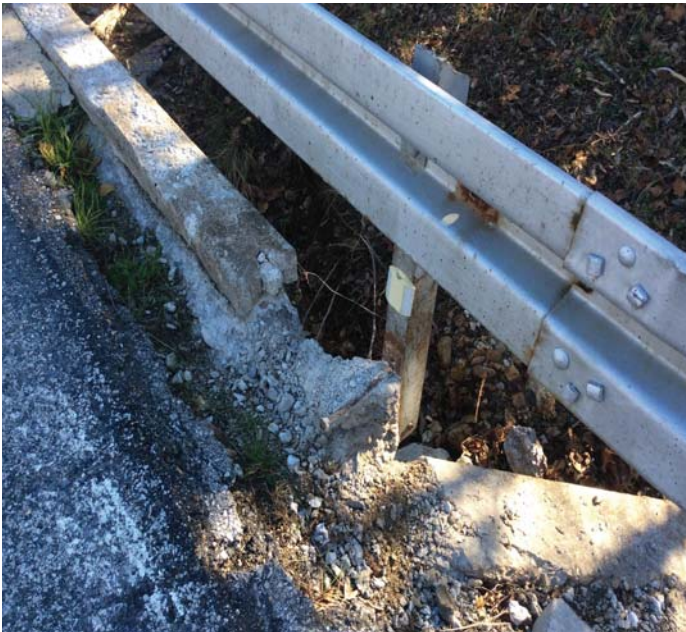
PHOTO 4 Description Deck at Abutment 1 Right.

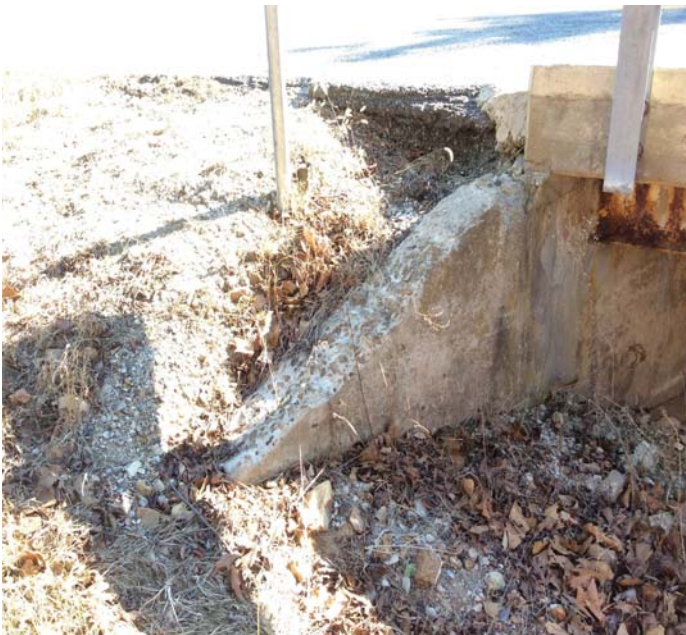
PHOTO 1 Description Erosion to slope behind Left Wing at Abutment 2 beginning to undermine roadway.

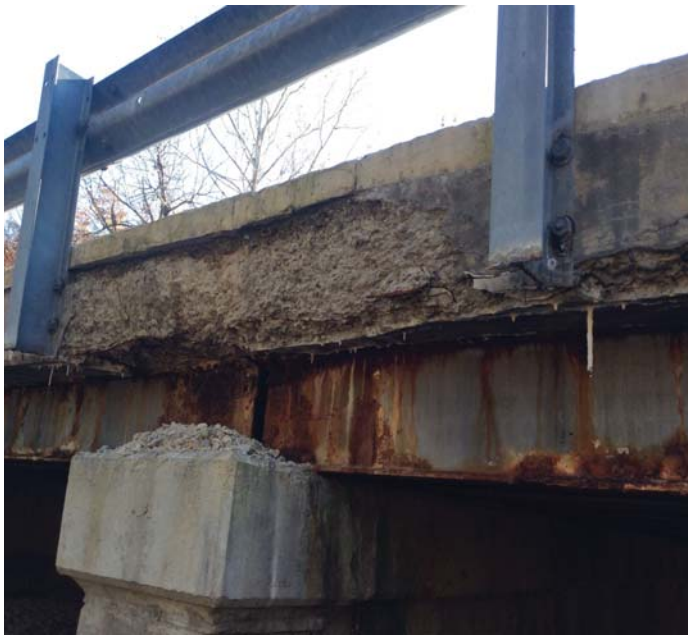
Heavy deterioration and spalls with rebar exposed to Left & Right side of deck of Spans 1 & 2.

PHOTO 1 Description Left side of Deck over Bent 1.

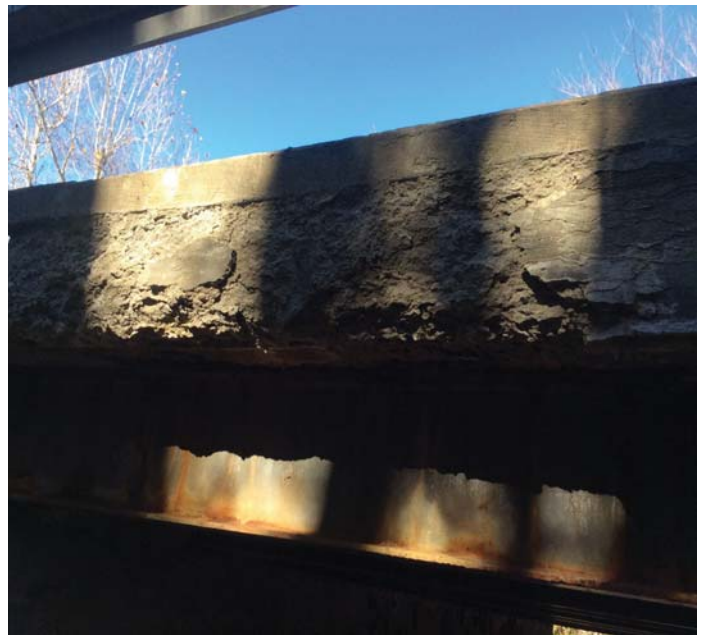
PHOTO 2 Description Right edge of Deck at Span 1.

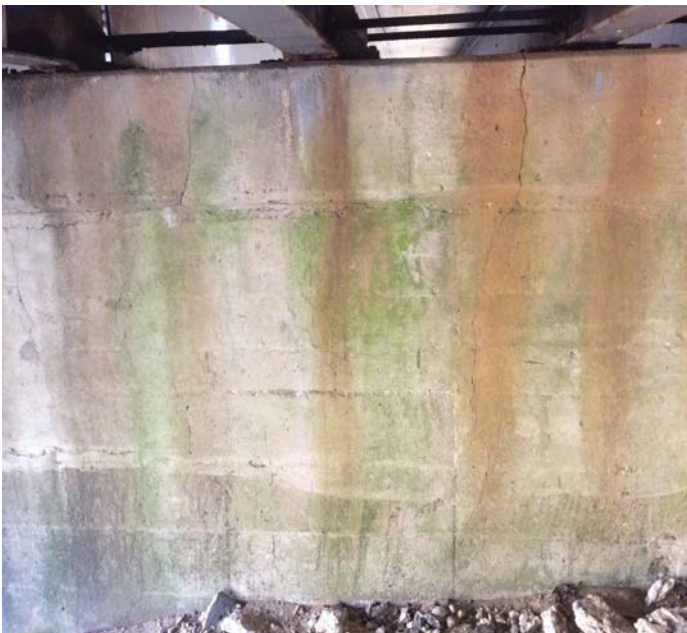
PHOTO 1 Description Moderate vertical cracks to Bent 1.

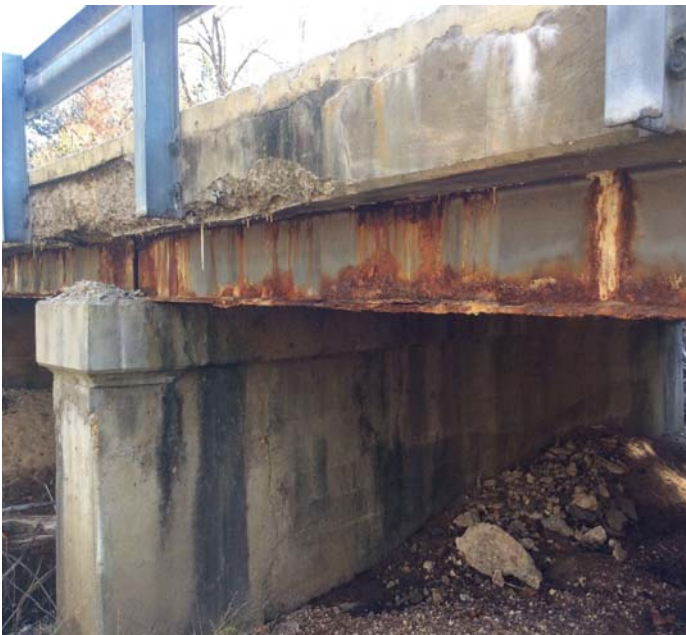
Rust and some areas of severe section loss with knife edge areas to Girders 1 - 12 @ Spans 1 & 2.

PHOTO 1 Description Girder 1.

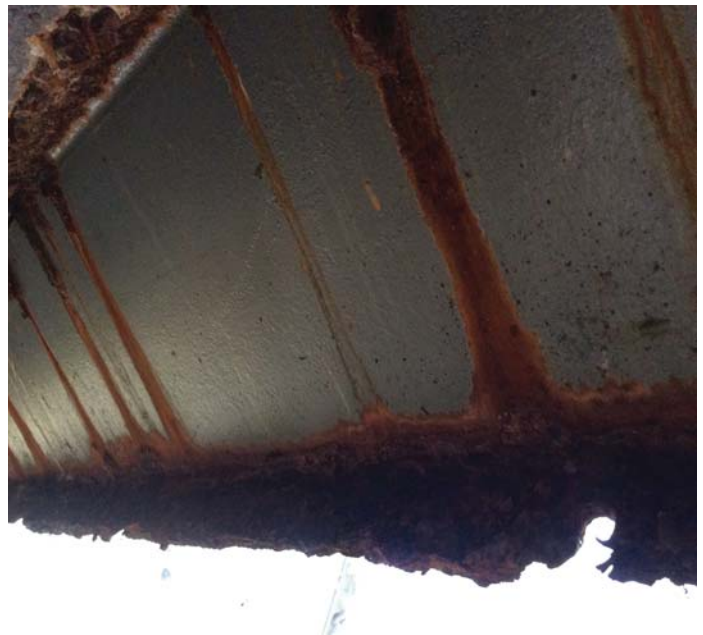
PHOTO 2 Description Bottom flange of Girder 1 at Span 1.

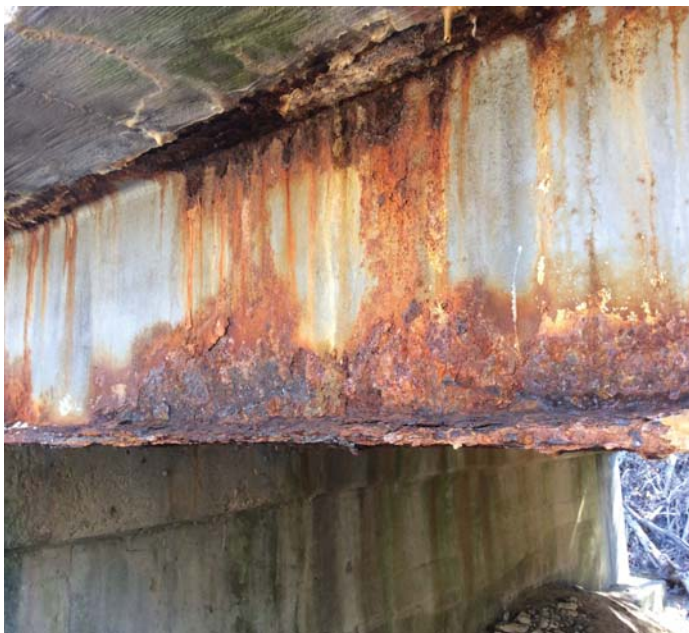
PHOTO 3 Description Bottom flange of Girder 1 at Span 1.

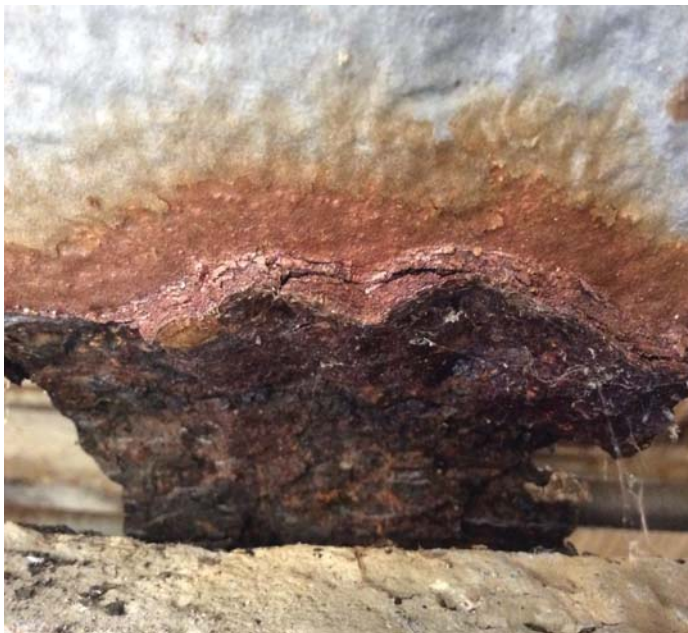
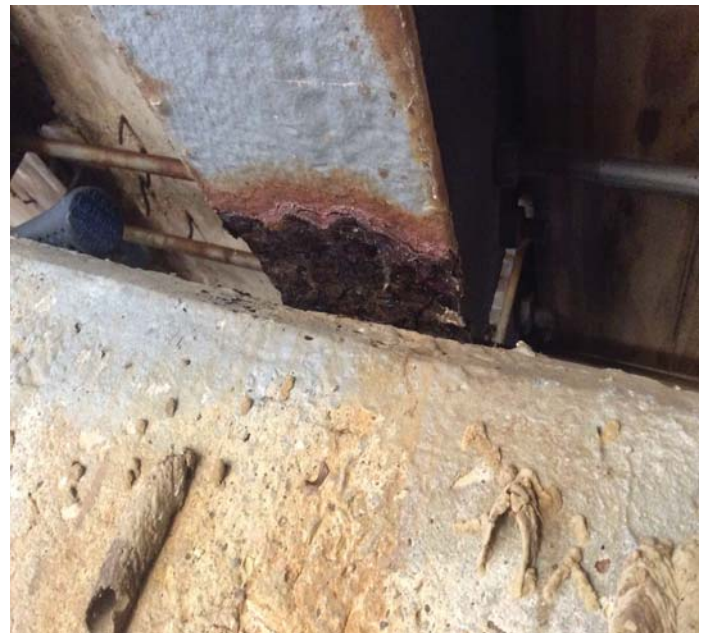
Severe section loss to bottom flange of Girder 7 at over Bent 1.

PHOTO 1 Description Girder 7 at beginning of Span 2.

PHOTO 2 Description Girder 7 at beginning of Span 2.

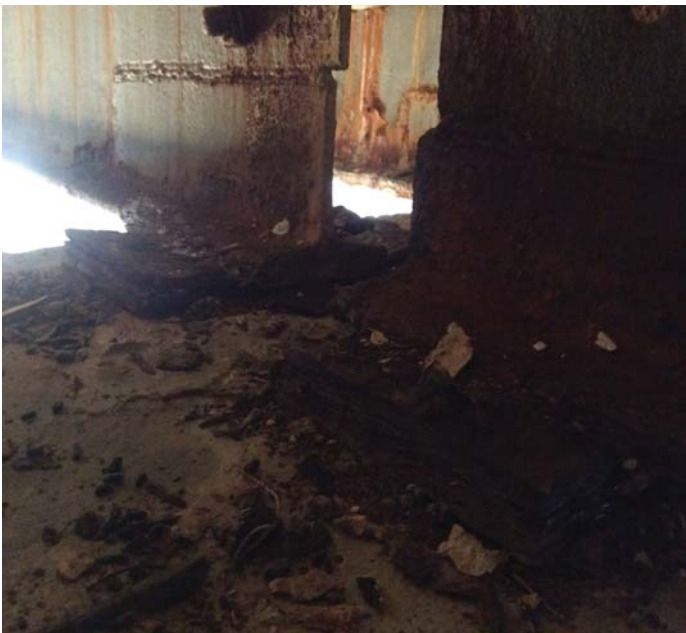
All masonry plates are rusted and corroded over Bent 1.

PHOTO 1 Description Bearings at Girder 10 (typical).

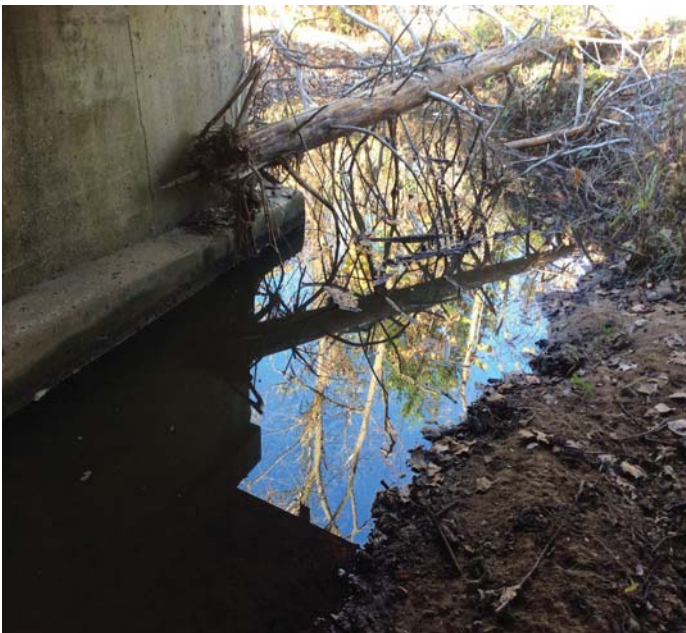
PHOTO 1 Description Scour @ Left end of Bent 1.

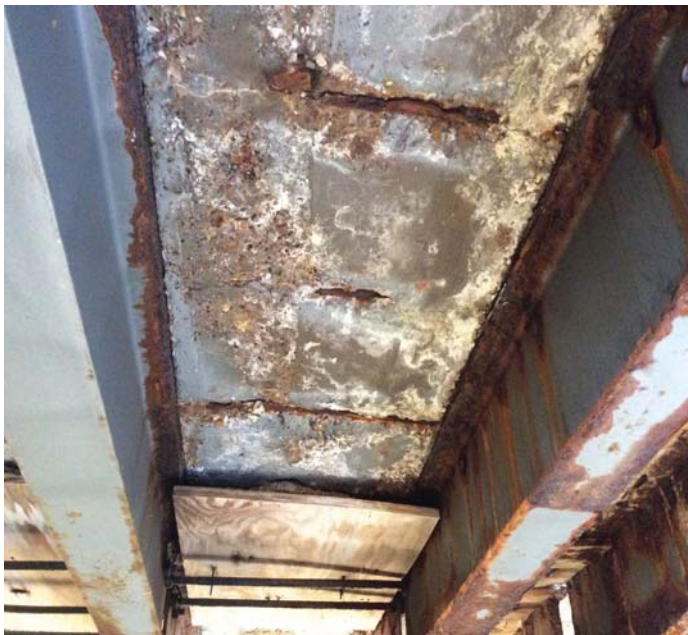
Heavy scaling & spalling with rebar exposed to soffit @ Spans 1 & 2.

PHOTO 1 Description Span 1 between Girders 9 & 10 (typical).

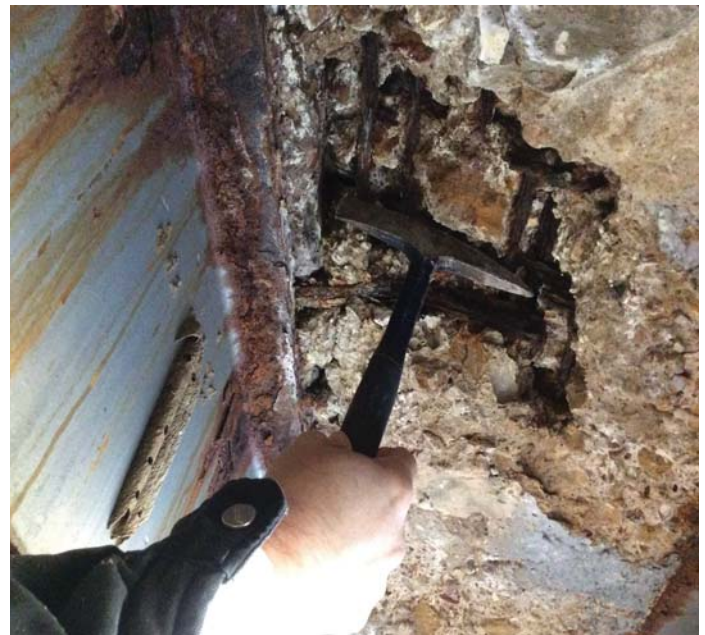
PHOTO 2 Description Deck between Girders 2 & 3 at Span 1 has deep spall with exposed rebar with 100% section loss.
