# Bridge Inspection Report

**M0285**  
**SH 9/Fulton County**  
**over**  
**CREEK**

Structure Number: M0285

Facility Carried: SH 9/Fulton County

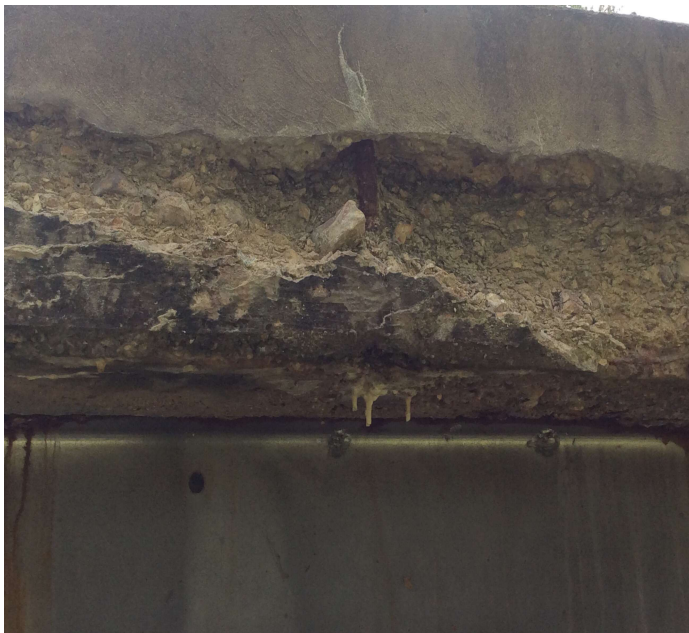
Right outside edge of deck has heavy efflorescent cracking, spalling and exposed rebar.

PHOTO 1      Description      Right outside edge of deck spalled with 4" of exposed rebar.

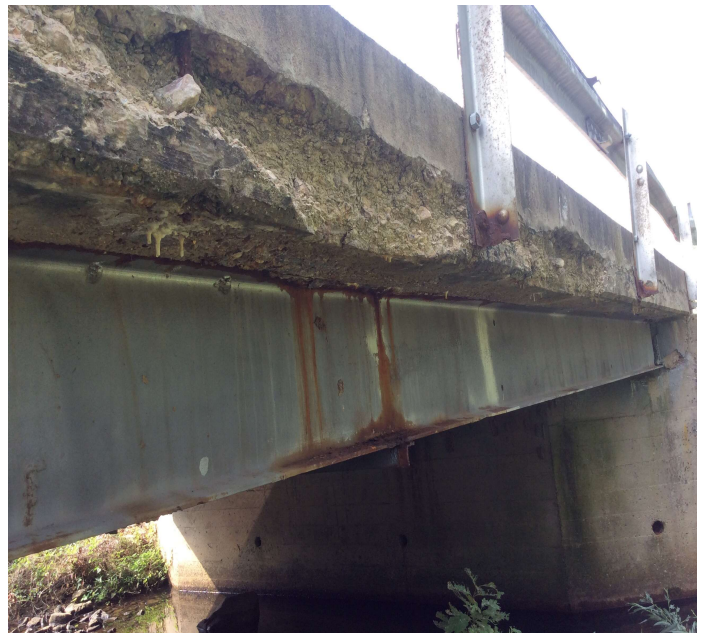
PHOTO 2      Description      Right edge of deck.

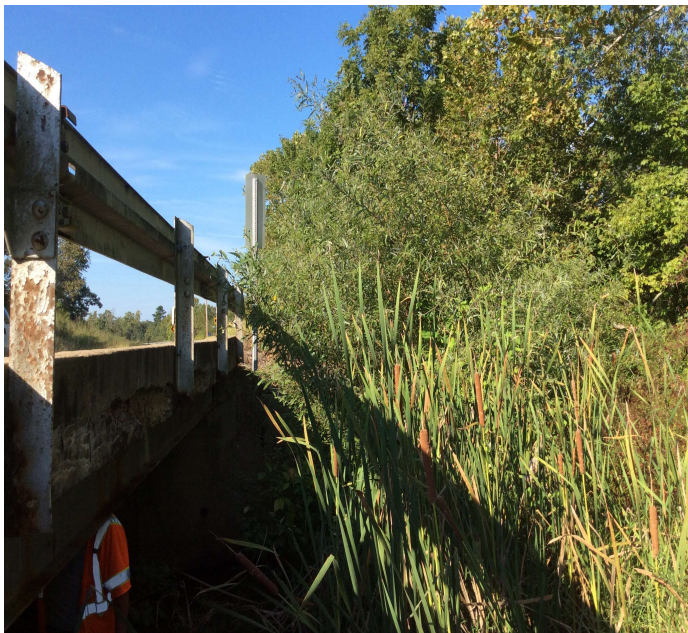
Vegetation on Left & Right side of bridge.

PHOTO 1 Description Vegetation on Left side of bridge.

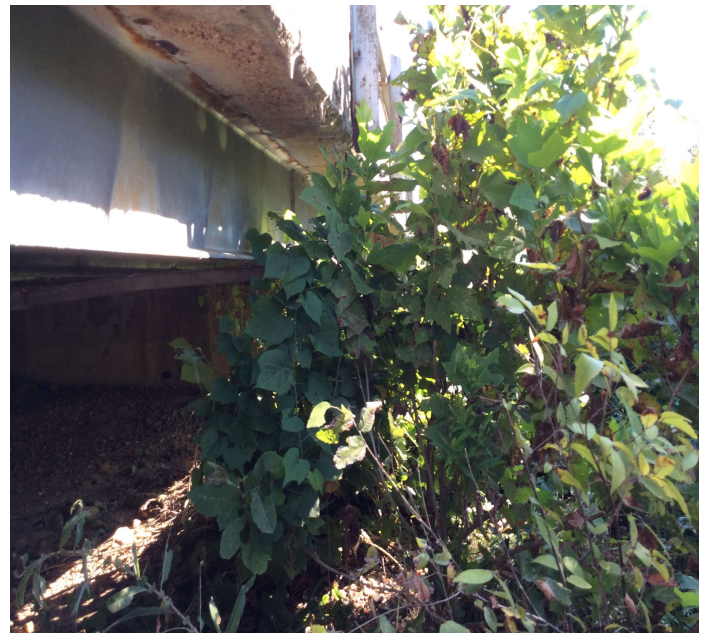
PHOTO 2 Description Vegetation on Right side of bridge.

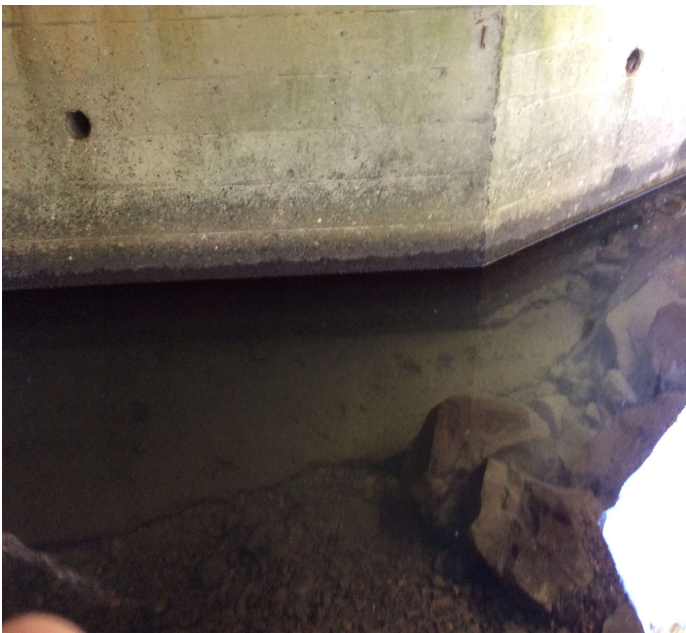
PHOTO 1      Description      Footing @ Abutment 1 is exposed.

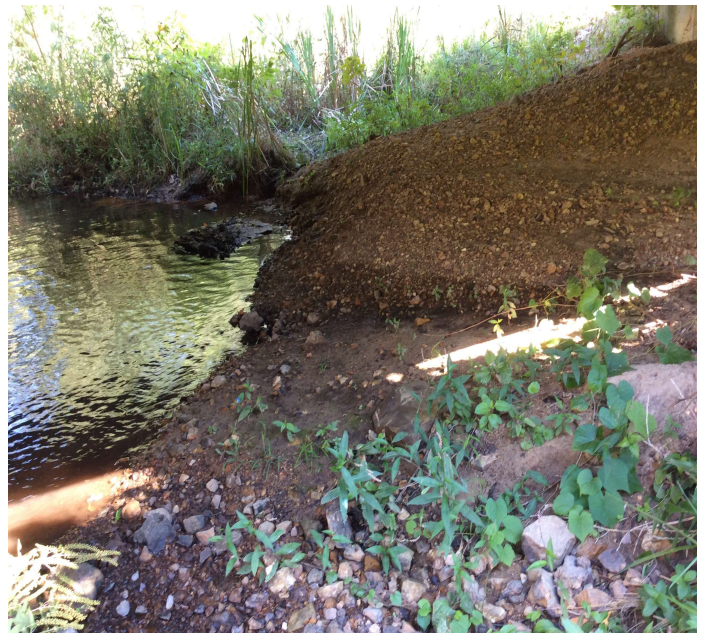
Channel has Realigned to Abutment 1 with scour developing.

PHOTO 2      Description      Channel has realigned to Abutment 1 with scour developing.

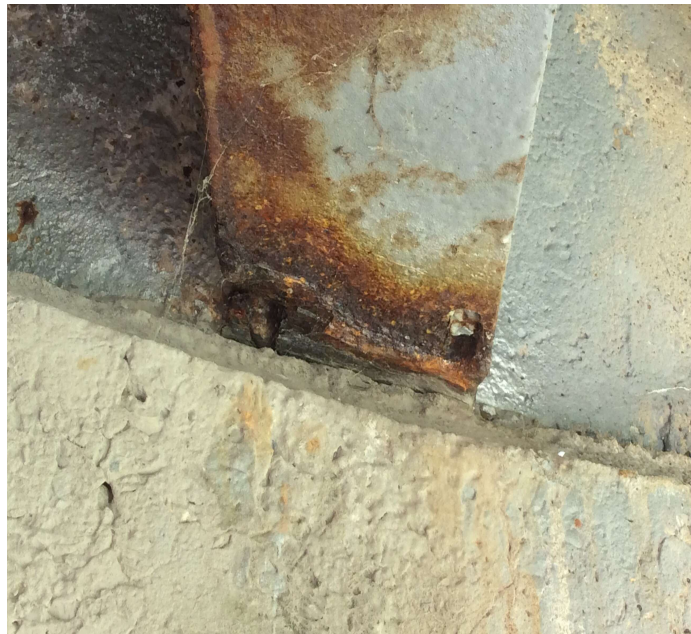
Girder 11 at end of span has heavy section loss to bottom flange at bearing with holes in flange.

PHOTO 1      Description      Bottom flange of Girder 11 at end of Span.

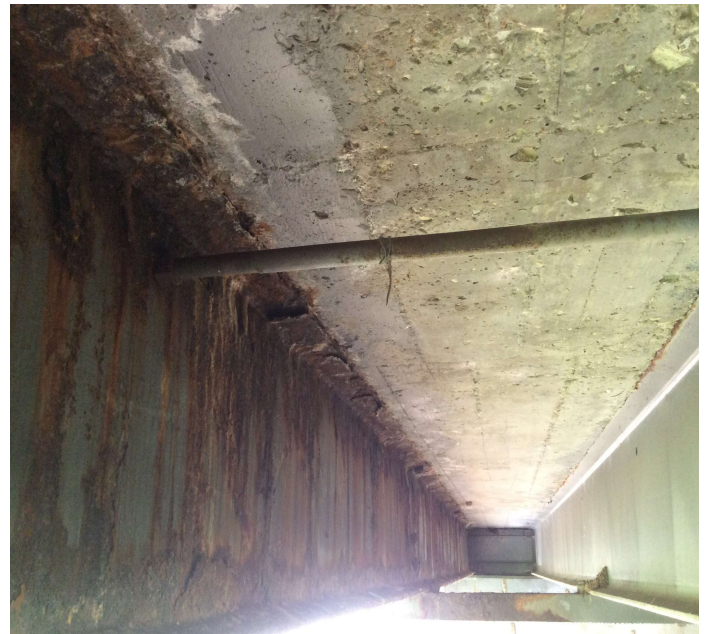
PHOTO 2      Description      Girder 10

Girders 3 & 10 have rust & moderate section loss through out.
