# Bridge Inspection Report

**M0286**  
**SH 9/Fulton County**  
**over**  
**Little Strawberry Creek**

## Bridge Inspection Report

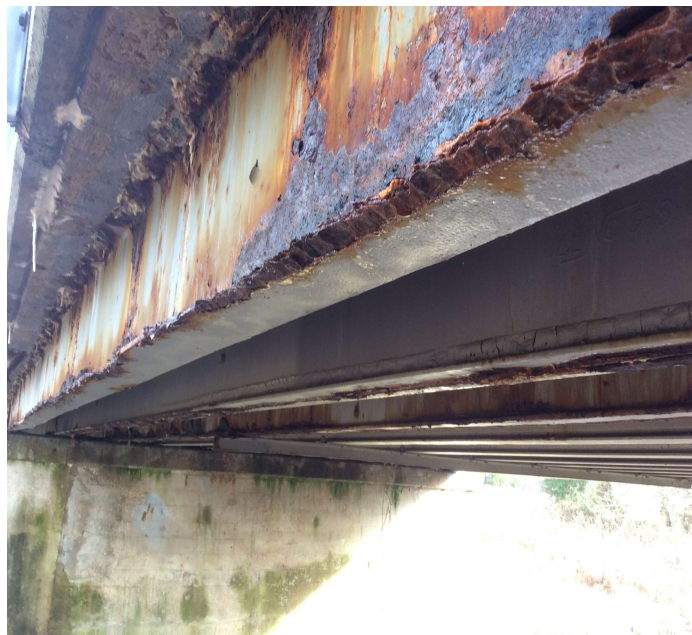
Rust, corrosion & section loss to Girders 1 thru 3 & 9 thru 12 at Spans 1 & 2.

PHOTO 1      Description      Rust & section loss to Girders 1 - 3 @ Span 1.

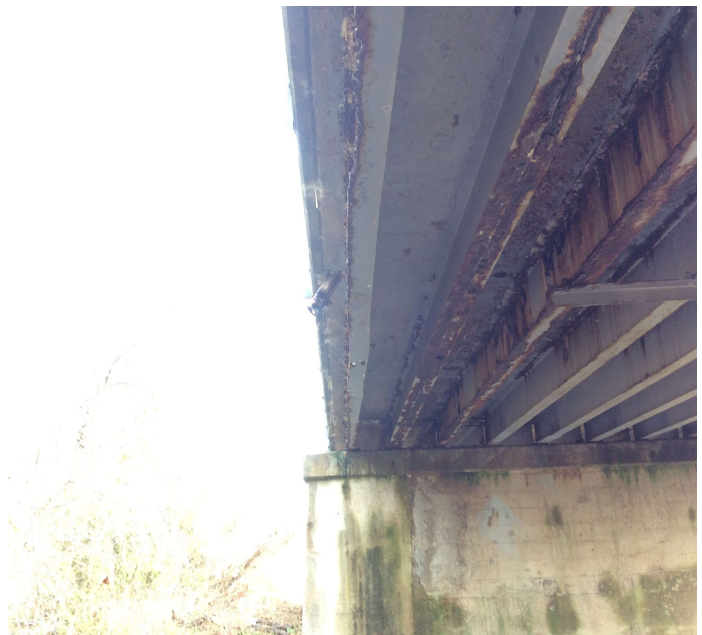
PHOTO 2      Description      Distortion to Girder 1 @ Span 1.

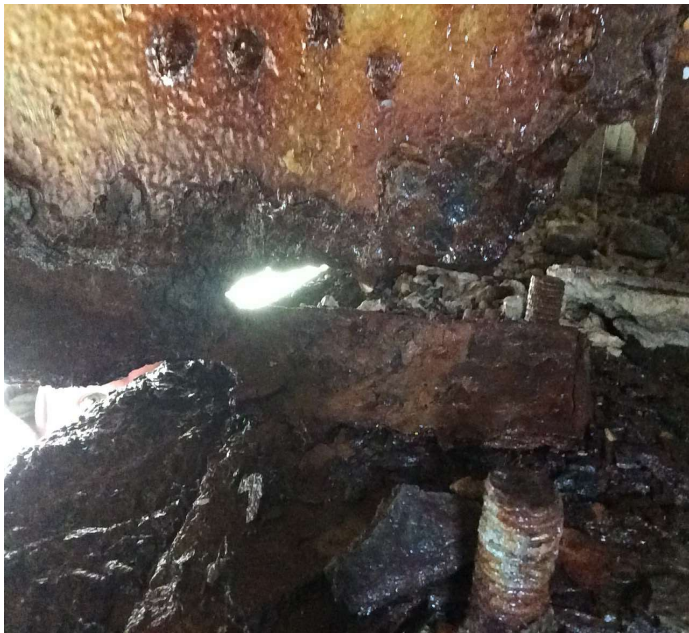
Rust with heavy section loss to web & bottom flange (holes / knife edged) of Girder 1 at beginning & end of Span 1  
Girder 2 at Beginning of Span 2 has severe section loss to bottom of web and bottom flange with large hole in bottom of web and is beginning to crush.

PHOTO 3      Description      Girder 2 at Beginning of Span 2 has severe section loss to bottom of web and bottom flange with large hole in bottom of web and is beginning to crush.

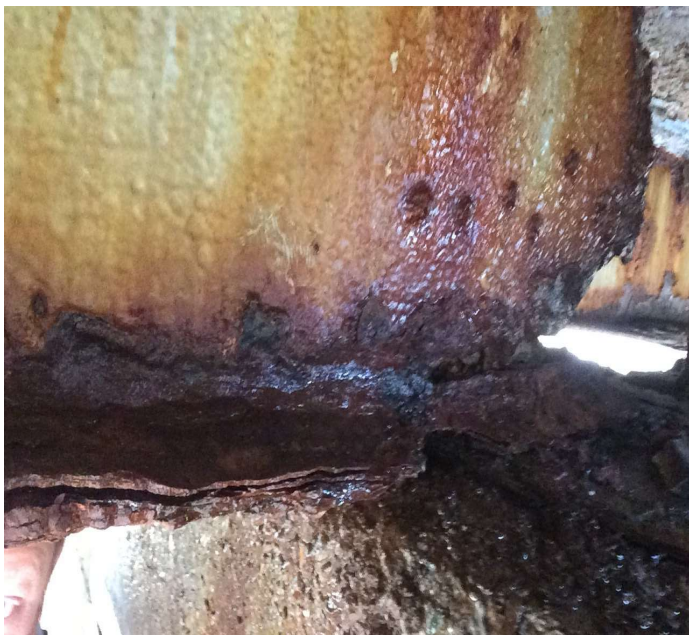
PHOTO 4      Description      Girder 2 at Beginning of Span 2 has severe section loss to bottom of web and bottom flange with large hole in bottom of web and is beginning to crush.

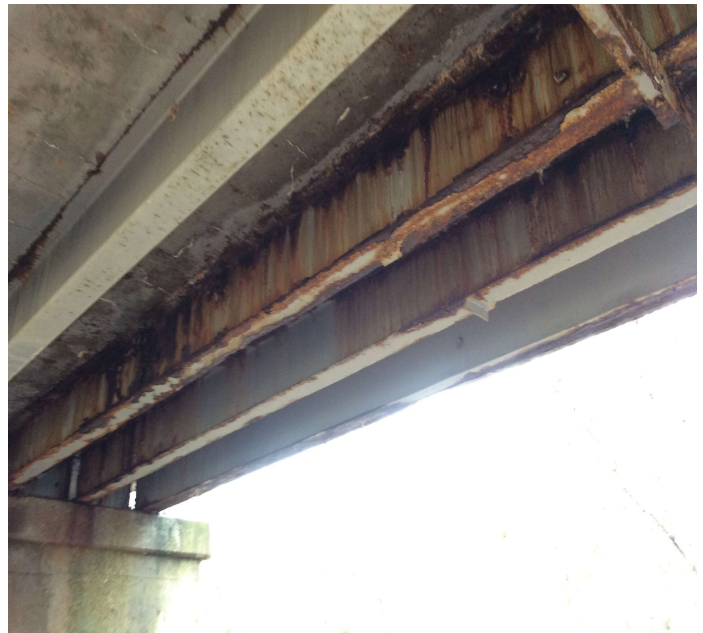
PHOTO 5      Description      Rust & section loss to Girders 1 - 3 @ Span 2.

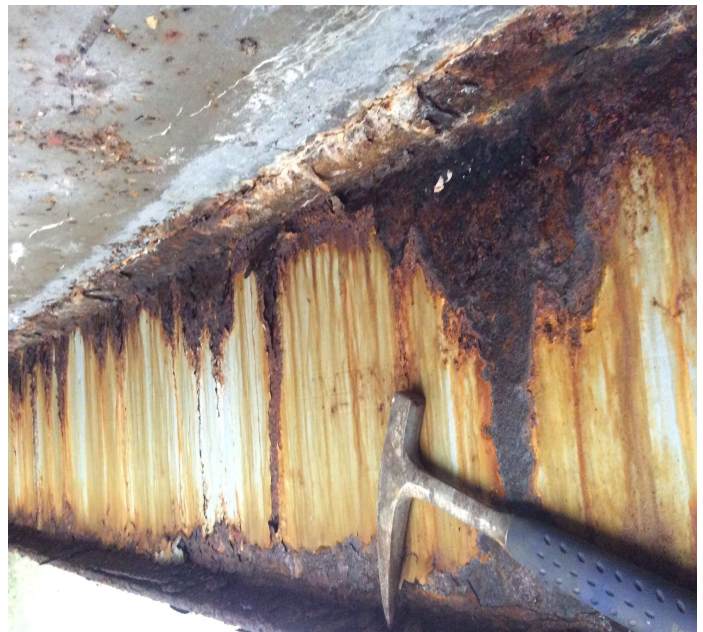
Girder 3 has holes in top of web near 1/4 point & midspan @ Span 2.

PHOTO 6      Description      Girder 3 has hole in top of web near midspan @ Span 2.

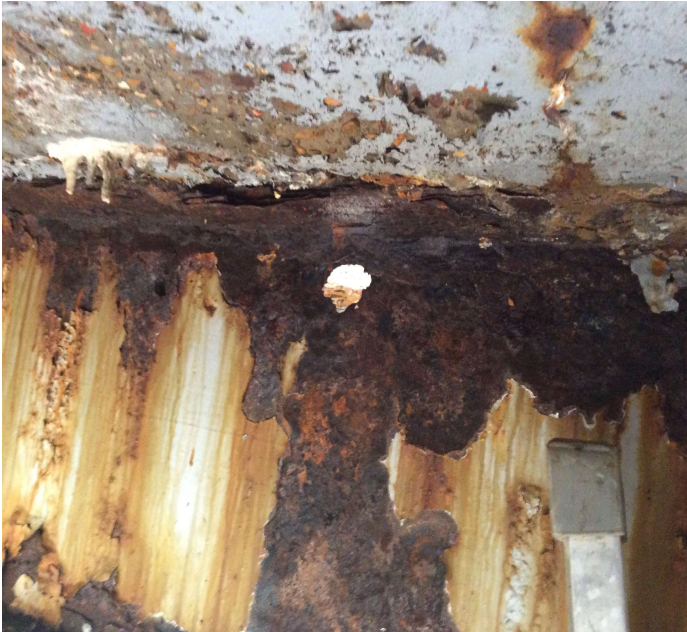
PHOTO 7      Description      Girder 3 has hole in top of web near 1/4 point @ Span 2.

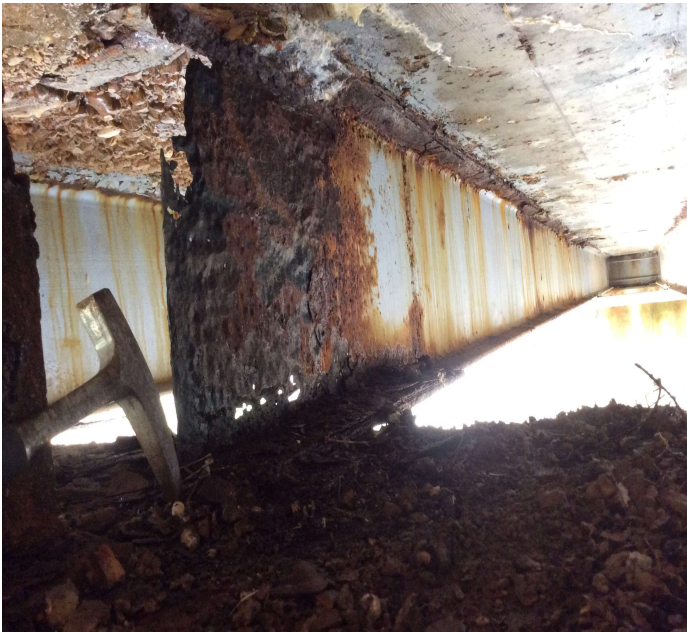
Girder 10 at End of Span 1 has severe section loss to end of web with holes at end of Girder.

PHOTO 8      Description      Girder 10 at End of Span 1 has severe section loss to end of web with hole at end of Girder.

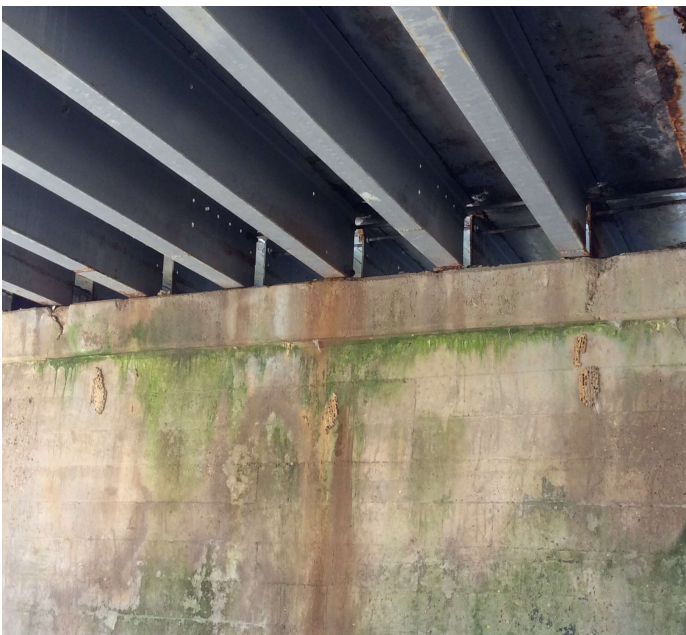
Cap @ Bent 1 & Abutment 2  
Spalls under girders.

PHOTO 1      Description      Spalls to Cap on ahead side of Bent 1.

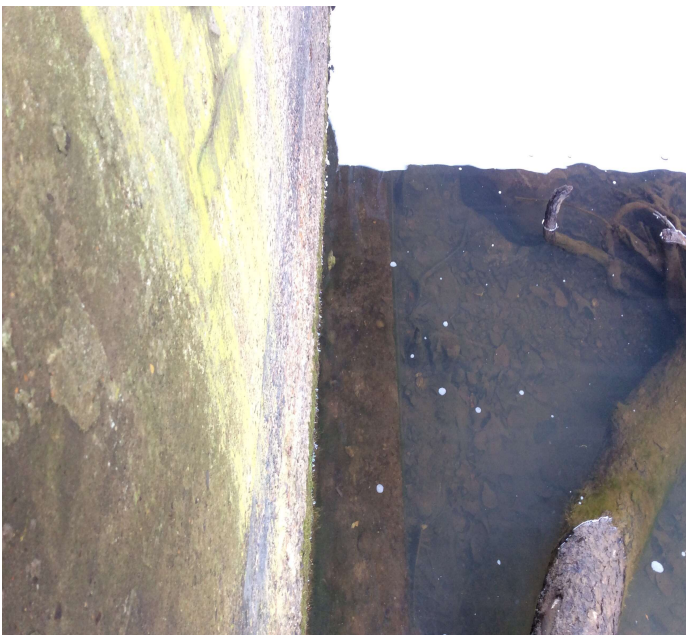
Scour to Bent 1 footing exposed.  
Channel has realigned to Span 1.

PHOTO 1      Description      Scoured 1' below top of footing @ Bent 1.

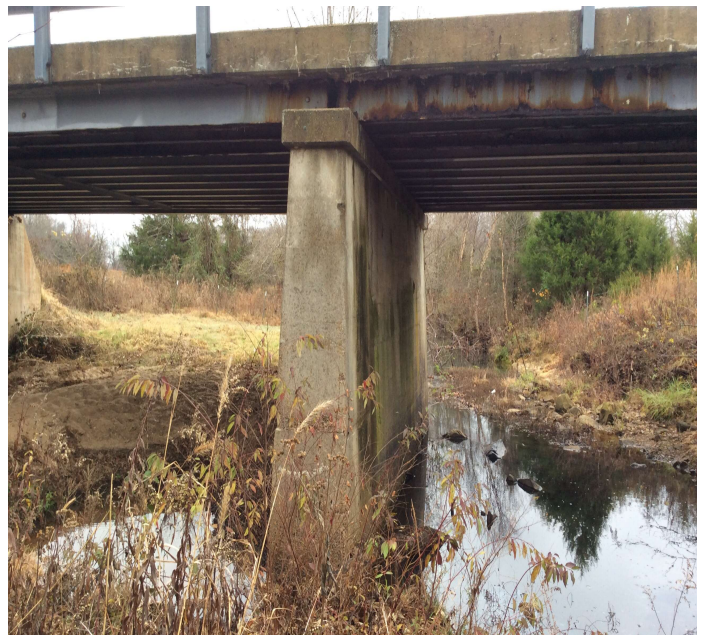
PHOTO 2      Description      Channel has realigned to Abutment 1.
