# Bridge Inspection Report

**M0287**  
**SH 9/Fulton County**  
**over**  
**CREEK**

## Bridge Inspection Report

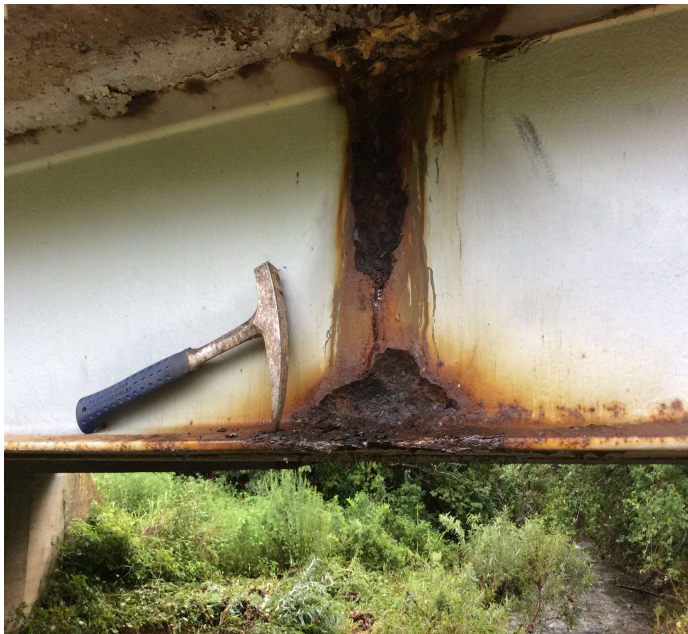
Rust and section loss to Girders 1 through 3 & 10 through 12 with Girders 1, 3, 11 & 12 having areas being knife edged to bottom flange.

PHOTO 1 Description Girder 1. Areas of rust with heavy section loss to web & knife edge to bottom flange.

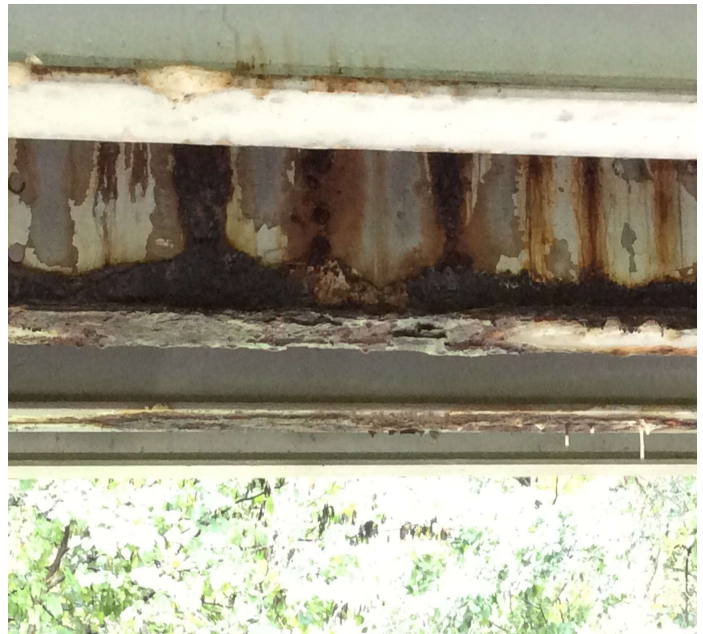
PHOTO 2 Description Girder 10 has areas of rust and section loss with knife edge to bottom flange.

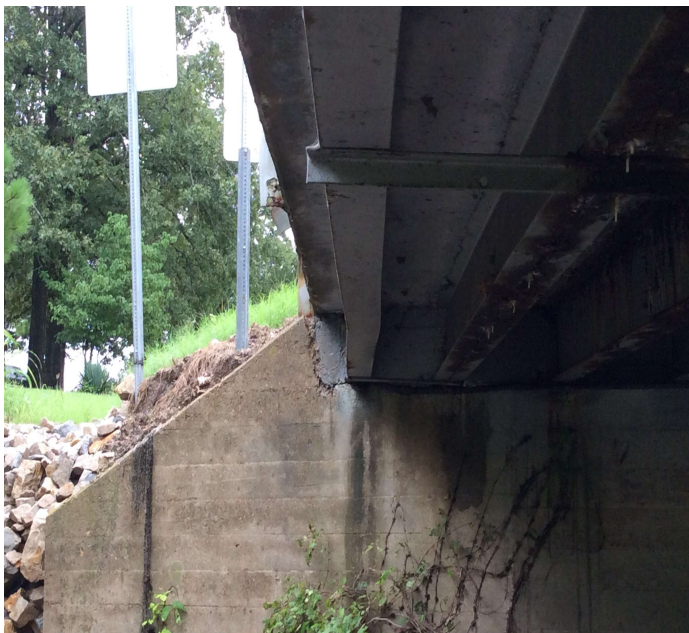
Girder 12 is bowed inward near Abutment 1.

PHOTO 3	Description	Girder 12 is bowed inward near Abutment 1.
---------	-------------	--

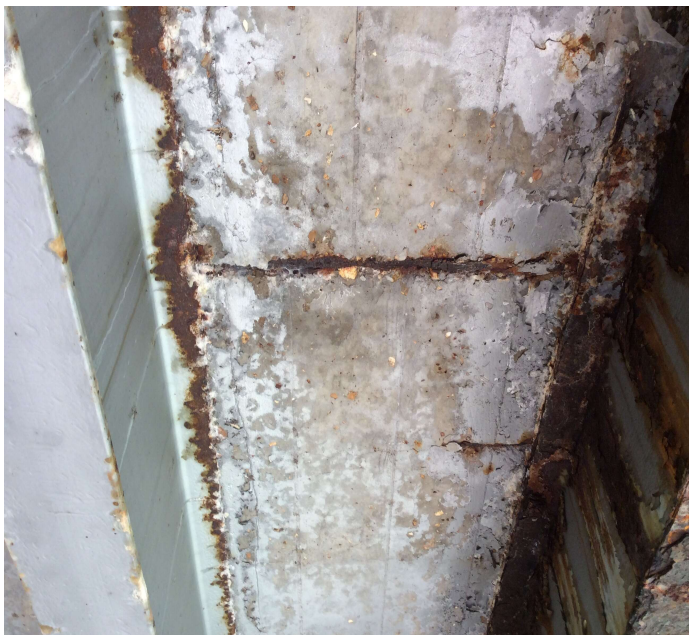
Soffit is Spalled w/ rebar exposed to deck below between Girders 2 & 3 and 9 through 11.  
Heavy efflorescent map cracking to Left and Right outside edge of deck.

PHOTO 1      Description      Soffit between Girders 10 & 11.

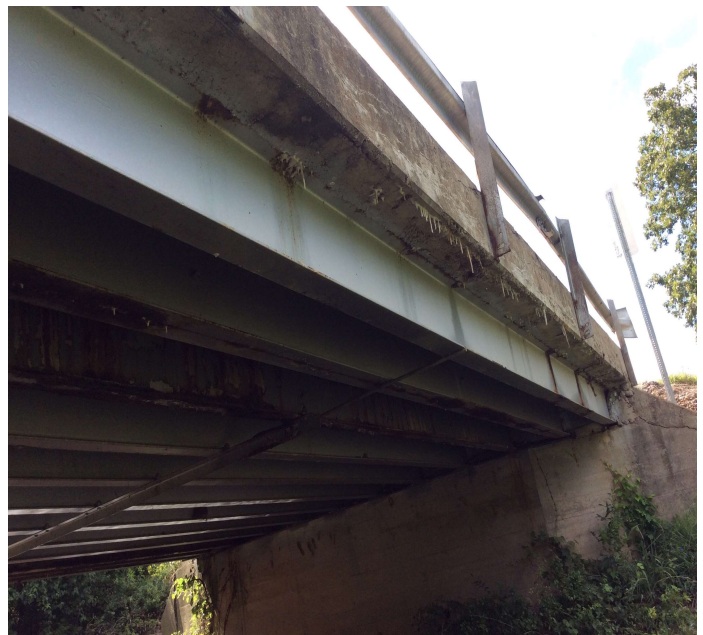
PHOTO 2      Description      Left overhang efflorescent cracks.

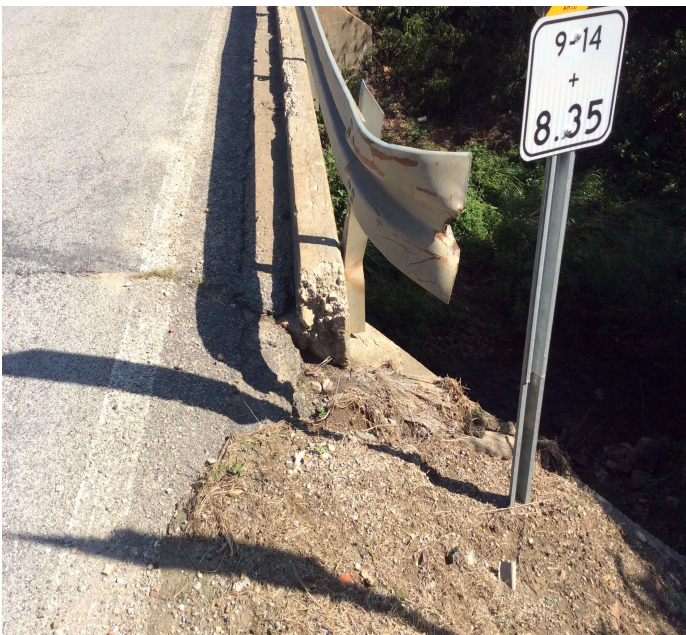
First post on Right side is bent at Abutment 1.

PHOTO 1      Description      Bridge Rail  
First post on Right side is bent at  
Abutment 1.

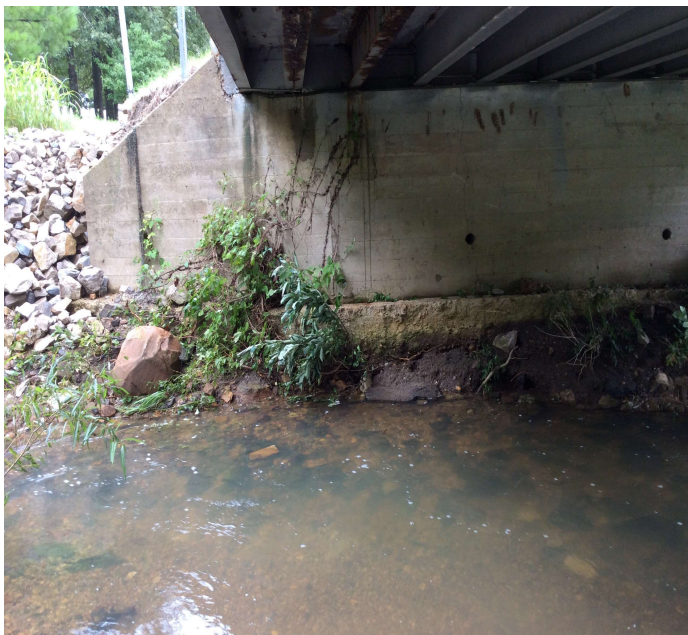
Channel is Scoured 3' below footing at Abutment 1 Right side.  
Channel has realigned towards Abutment 1.

PHOTO 1 Description Channel is Scoured 3' below footing at Abutment 1 Right side.

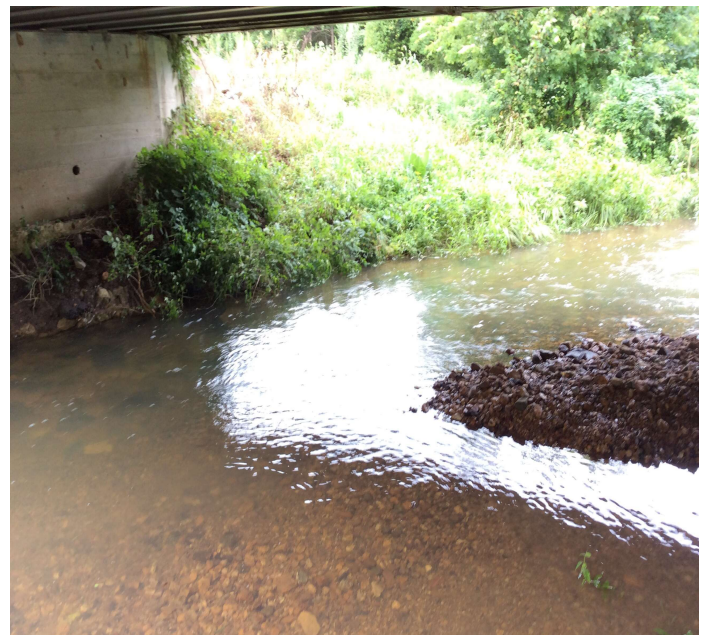
PHOTO 2 Description Channel has realigned towards Abutment 1.
