# Bridge Inspection Report

02056

US 62 Sharp County  
over  
SH 342, Spring River

Special Inspection is for SH 342 Underclearance.

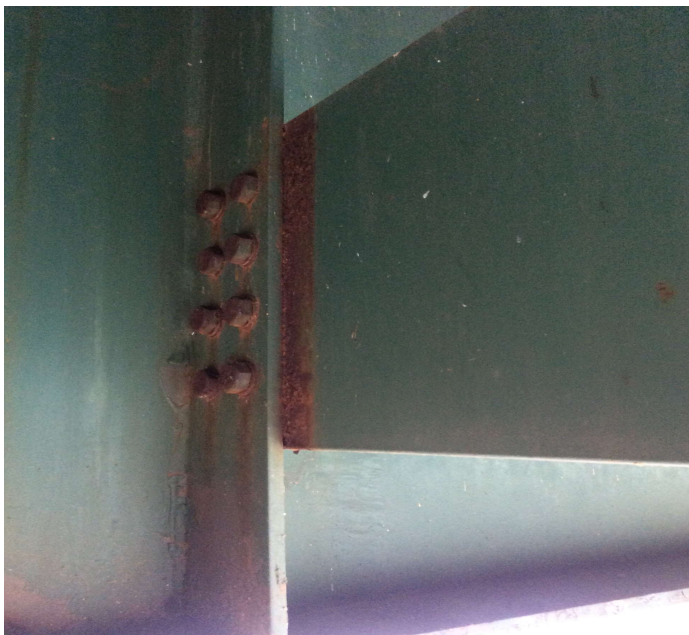
Spans 1 - 8 have pack rust between Diaphragms & Vertical Stiffeners to Girders 1 - 4 @ Pin & Hanger Assemblies with some stiffeners bent.

PHOTO 1 Description Typical rust to Vertical Stiffeners @ Diaphragm Connections.

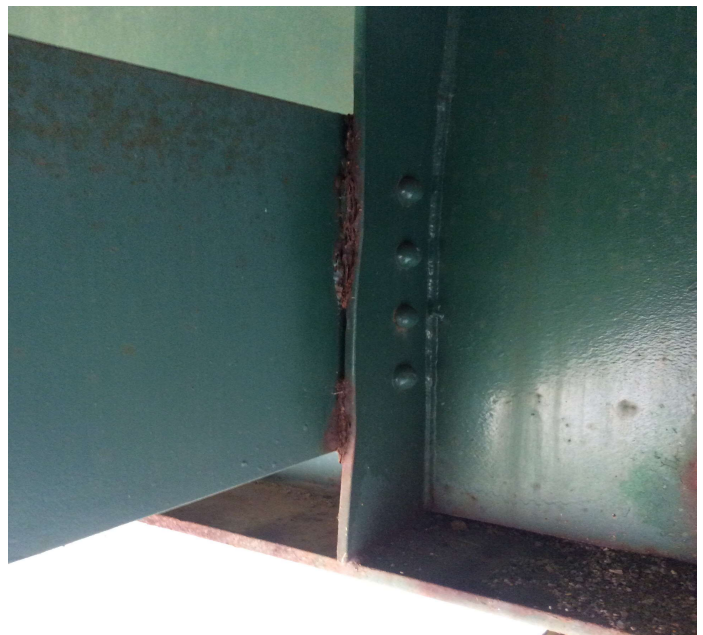
PHOTO 2 Description Typical pack rust @ Diaphragm & Vertical Stiffener Connection @ random areas.

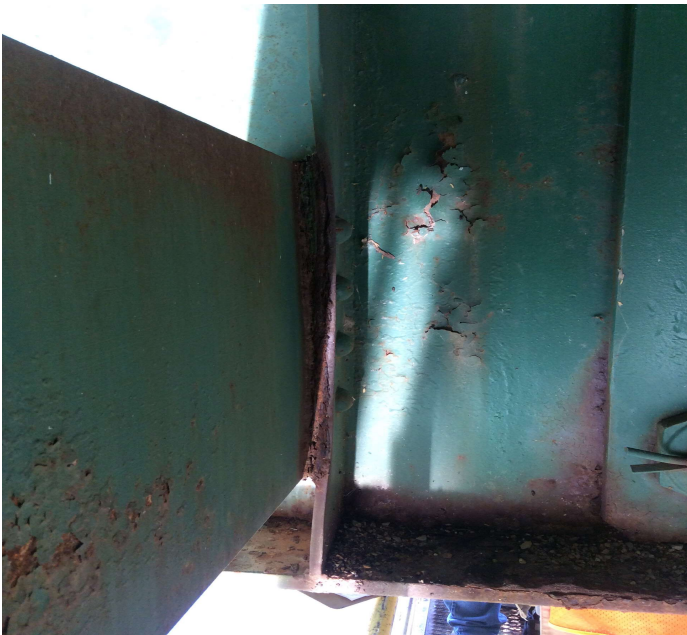
PHOTO 3      Description      Span 4. Pack rust to Stiffener back of Pin & Hanger Assembly @ Girder 3.

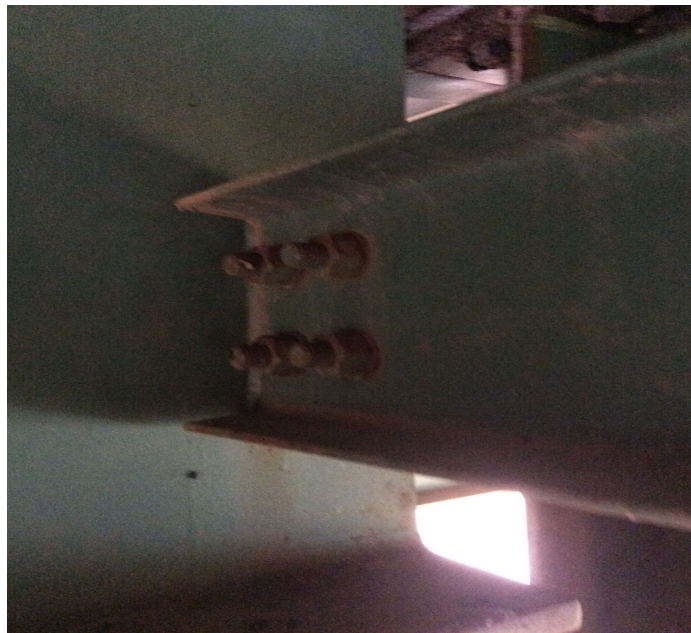
Typical loose bolts to Diaphragm connections between Girders 4 & 5 @ Spans 4 - 10.

PHOTO 1      Description      Loose bolts to Diaphragm Connection between Girders 4 & 5 Bent 1. Typical condition @ Spans 4 - 10.

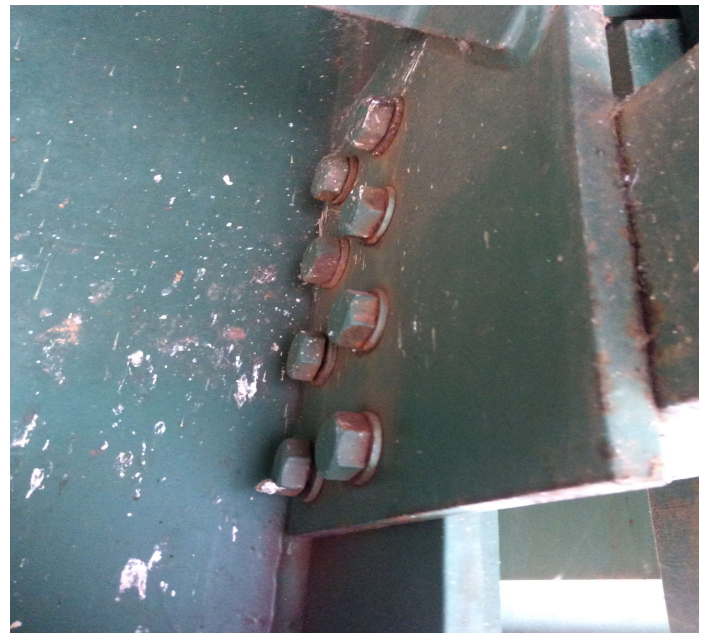
PHOTO 2      Description      Loose bolts 1st Diaphragm Connection ahead of Pin & Hanger Assembly between Girder 4 & 5. Typical @ several Spans.

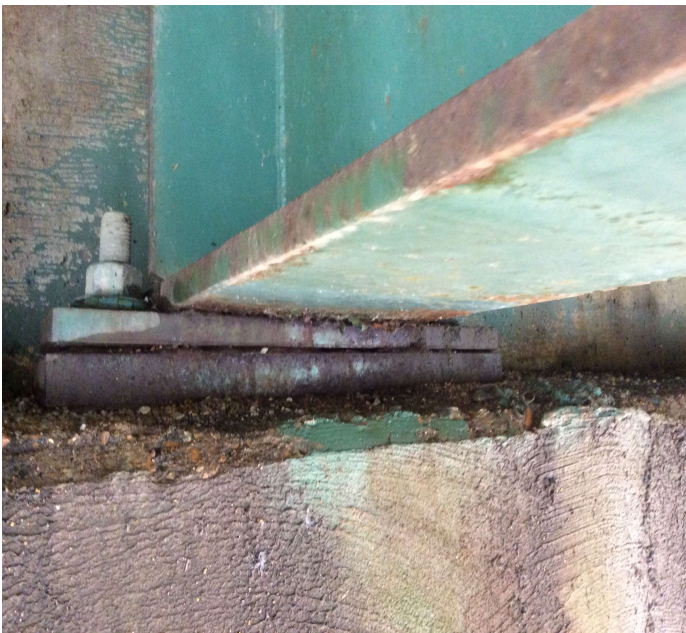
Rust &/or pack rust to Bearings 1 - 8 @ Bents 1 - 10.

PHOTO 1      Description      Typical rust & corrosion to Bearing Assemblies @ all Spans.

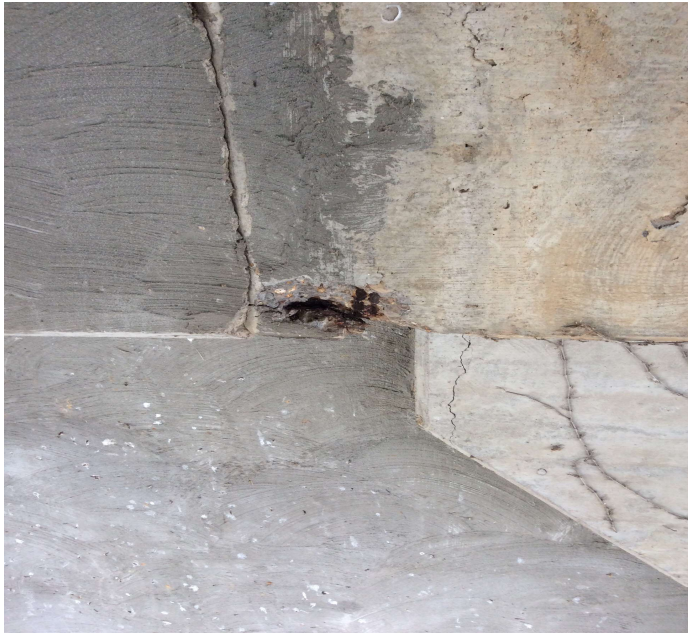
Cracks, delaminated areas &/or spalls with Rebar to Cap

PHOTO 1      Description      Typical Spall with Rebar Exposed to Concrete Caps @ random areas.

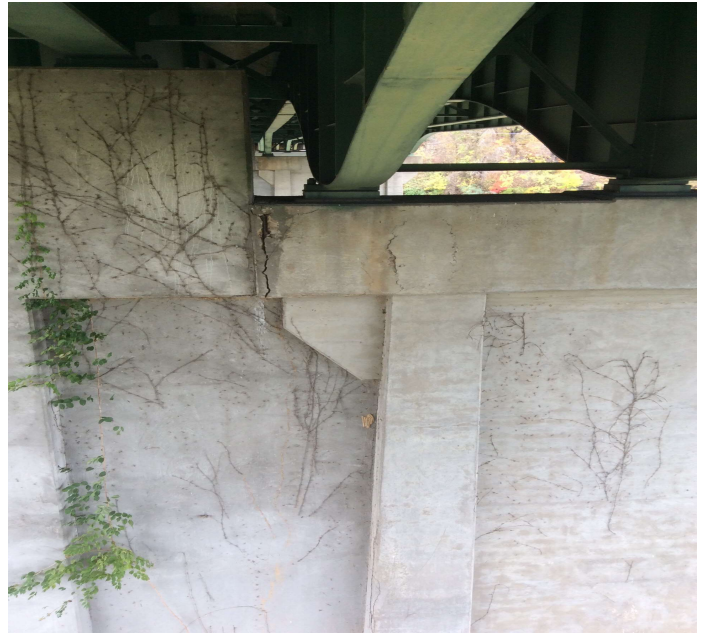
PHOTO 2      Description      Spall with Rebar Exposed to Bent 5 on ahead side. Typical of random areas @ other Bents.

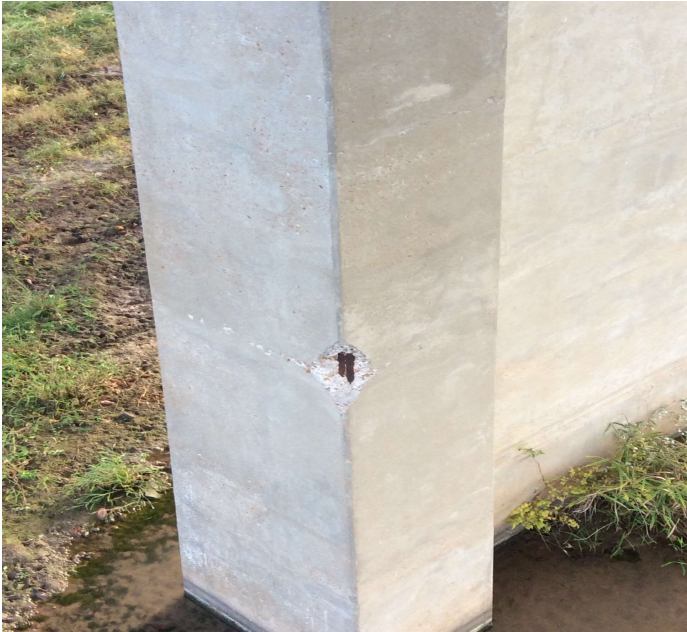
Cracks, delaminated areas &/or spalls with Rebar to Columns.

PHOTO 3      Description      Typical Spall to Concrete Column 1 @ Bent 8.

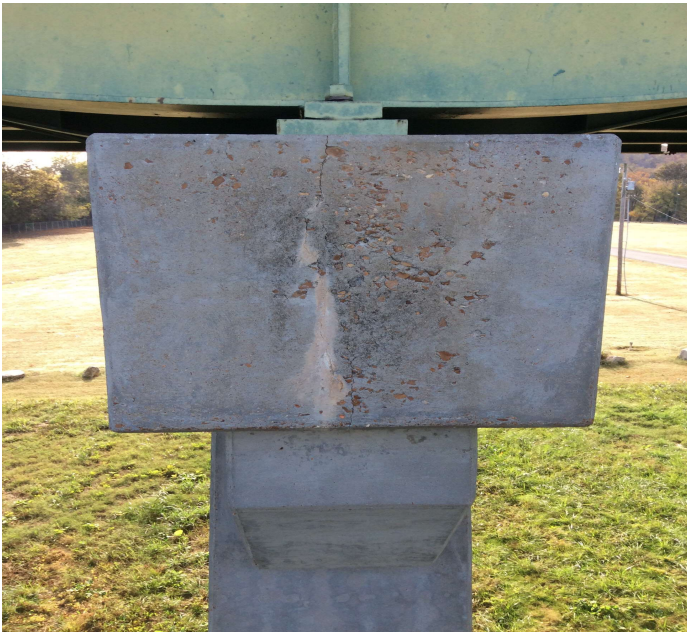
PHOTO 4      Description      Efflorescent crack to Left end of Cap at Bent 7.

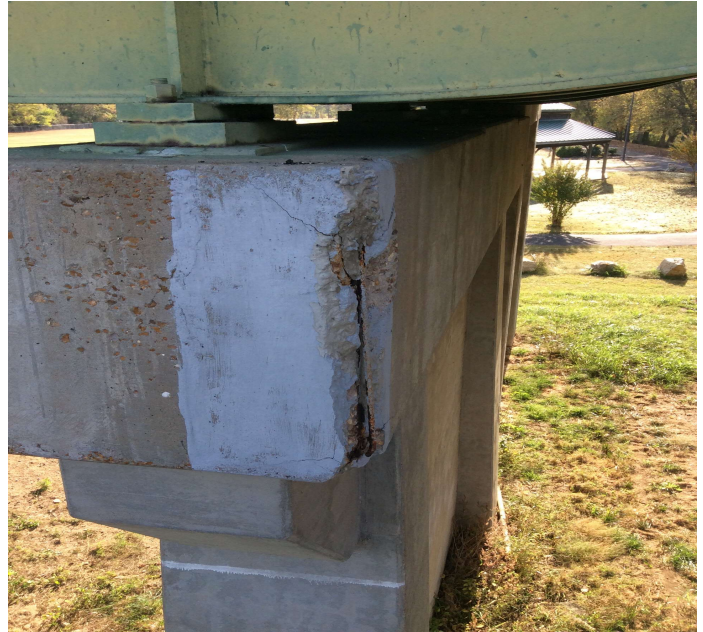
PHOTO 5      Description      Left end of Cap @ Bent 5 Spall with 2' Rebar Exposed with 100% Section Loss.

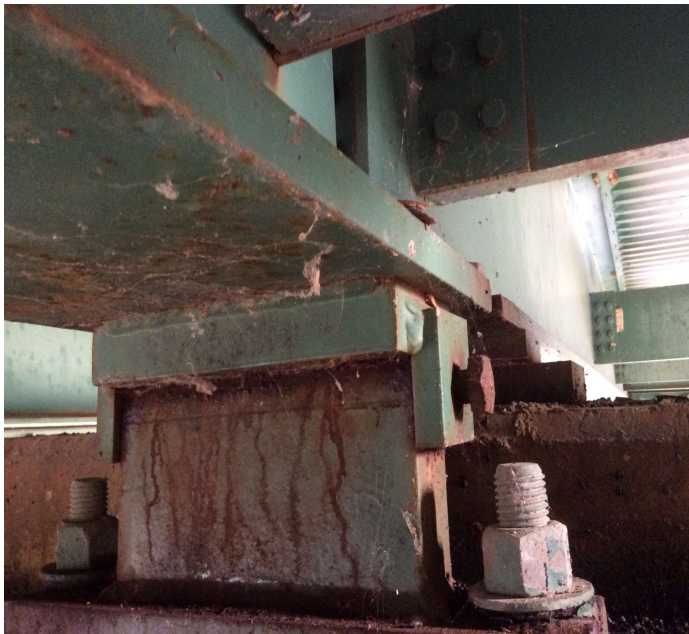
Bearing @ Bent 1 - Bolt has backed out 1" to rocker Bearing @ Girder 7

PHOTO 1      Description      Bolts have backed out on Left & Right sides of Bearing Assembly 7 @ Bent 1.

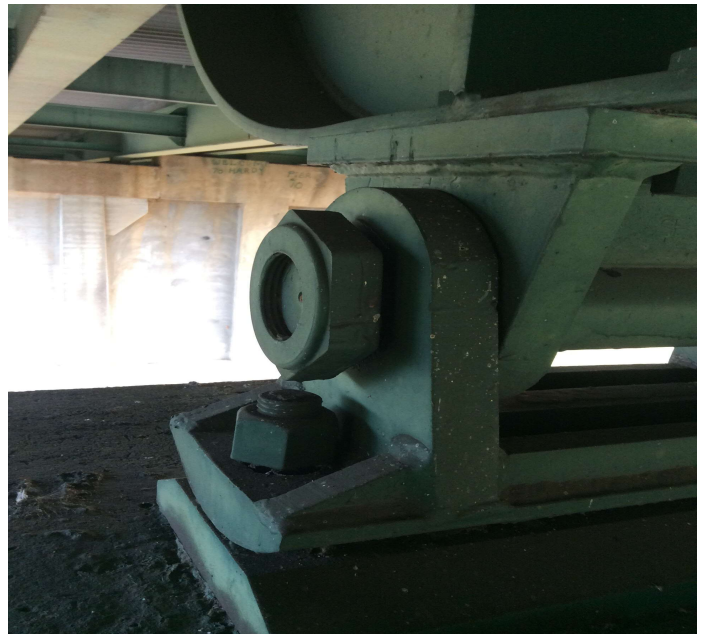
Bearing @ Bent 9 - Nut has back off 1/2 the threads to Bearing @ Girder 3

PHOTO 2      Description      Nut is backed off at Bearing Assembly @ Girder 3 Bent 9.

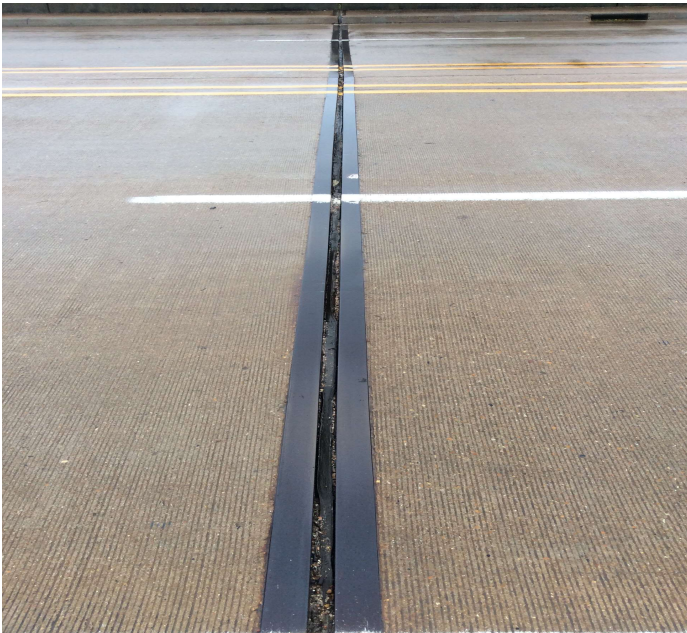
Expansion material is deteriorated, pulling away from Road Irons & leaks @ Bents 1 - 10.

PHOTO 1      Description      Typical condition of Joint Seals @ all Spans.

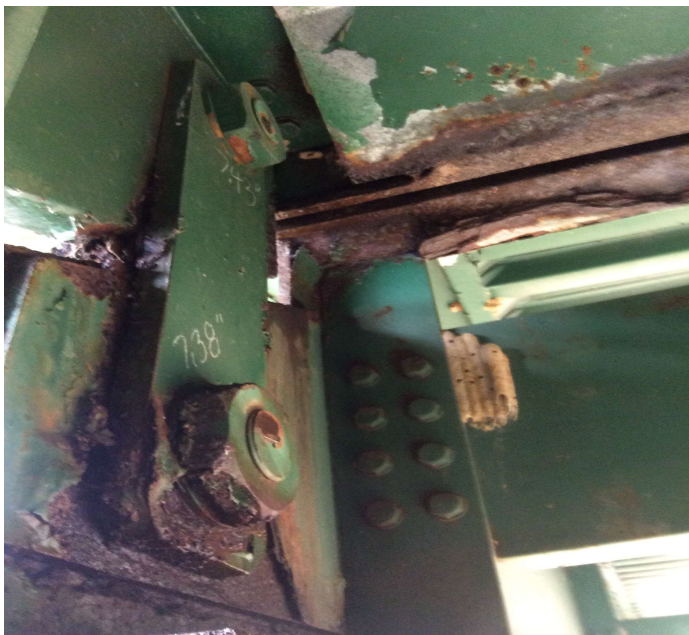
Pack rust forming between lower hanger & web.  
Rust to webs & bottom flanges some with section loss.

PHOTO 1 Description Typical rust, pack rust & Section Loss to Pin & Hanger Assemblies @ Girders 1 - 8 Spans 2 - 10.

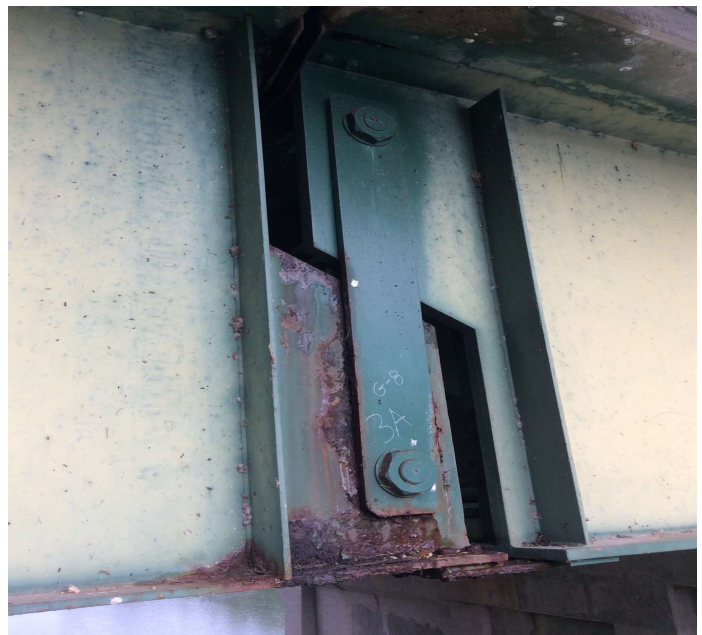
PHOTO 2 Description Typical pack rust & Section Loss to Pin & Hanger Assembly, Web of Girder, Vertical Stiffener & bottom Flange @ Span 3 Girder 8.

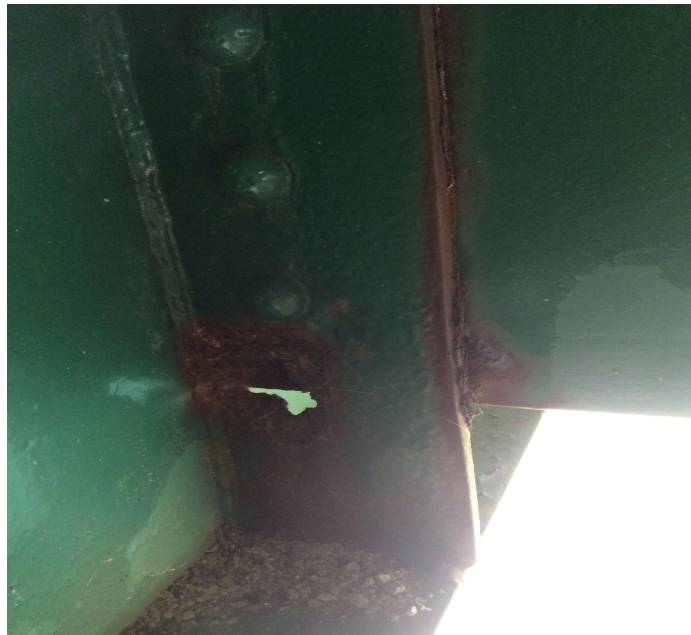
2" x 2" hole in 1st Stiffener back from Pin & Hanger Assembly @ Girder 3.

PHOTO 1      Description      Hole in 1st Stiffener back of Pin & Hanger Assembly at Girder 3 @ Span 6.

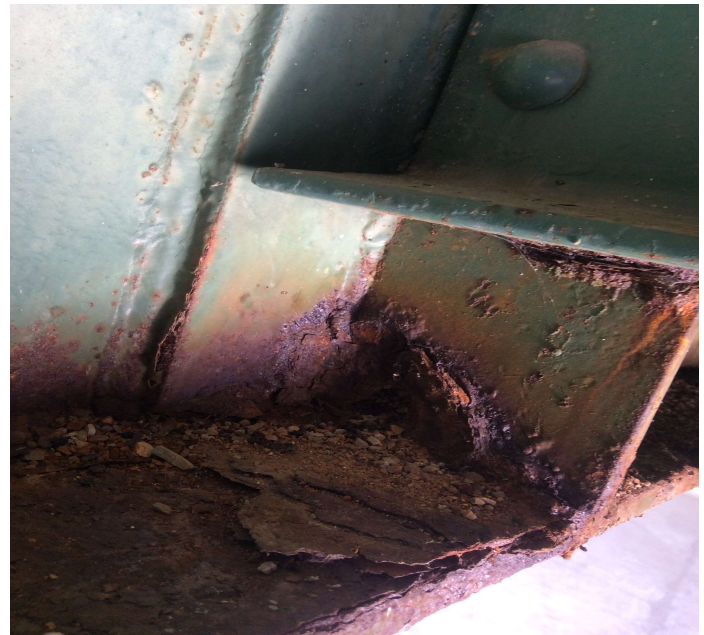
1" hole in 1st Stiffener back from Pin & Hanger Assembly @ Girder 3.

PHOTO 2      Description      Span 4 Girder 3 Hole in 1st stiffener back of Pin & Hanger Assembly.

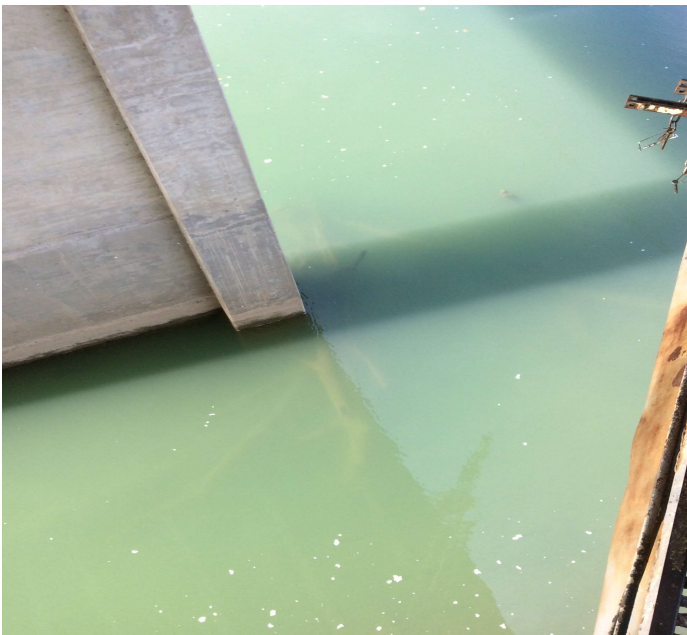
Drift on Left side of Bents 4.

PHOTO 1    Description    Drift @ Bent 4.

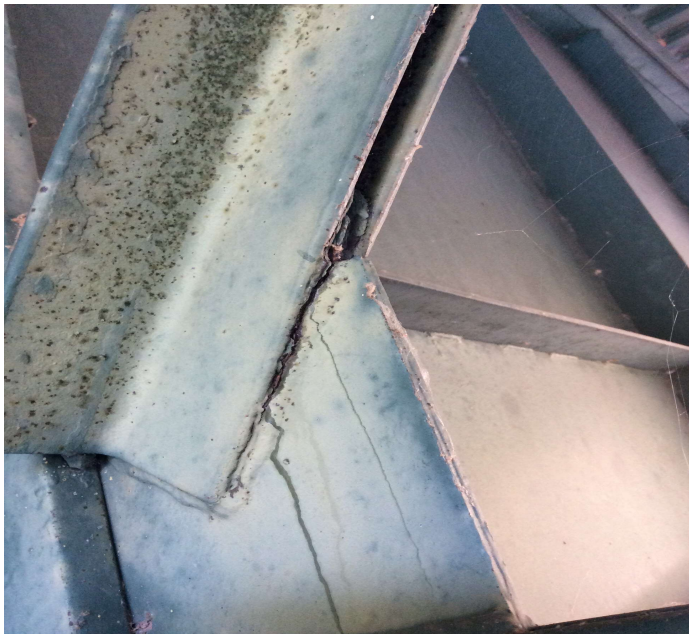
Bent 2 - 2" crack in weld to Diaphragms between Girders 1 - 2 & 2 - 3

PHOTO 1      Description      Diaphragm between Girder 1 & 2 @ Bent 2. Cracked weld to Diaphragm on ahead side.

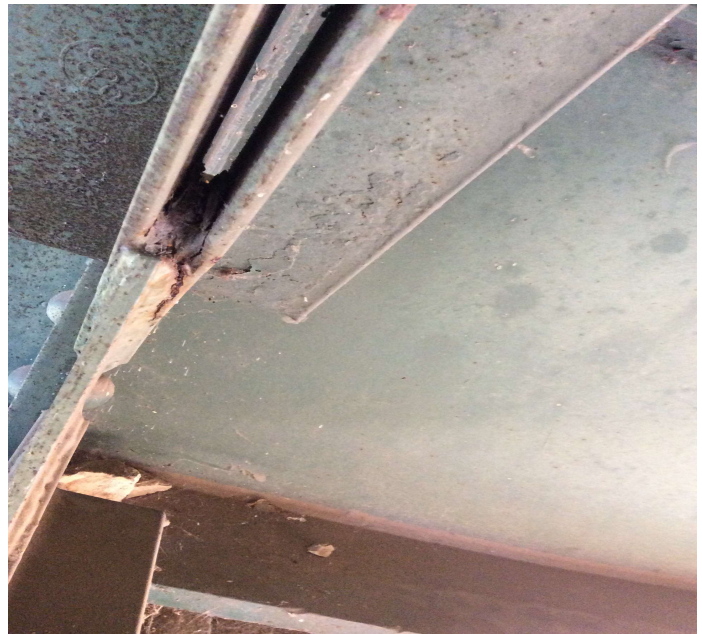
PHOTO 2      Description      Diaphragm between Girder 2 & 3 @ Bent 2. Cracked weld to Diaphragm on back side.

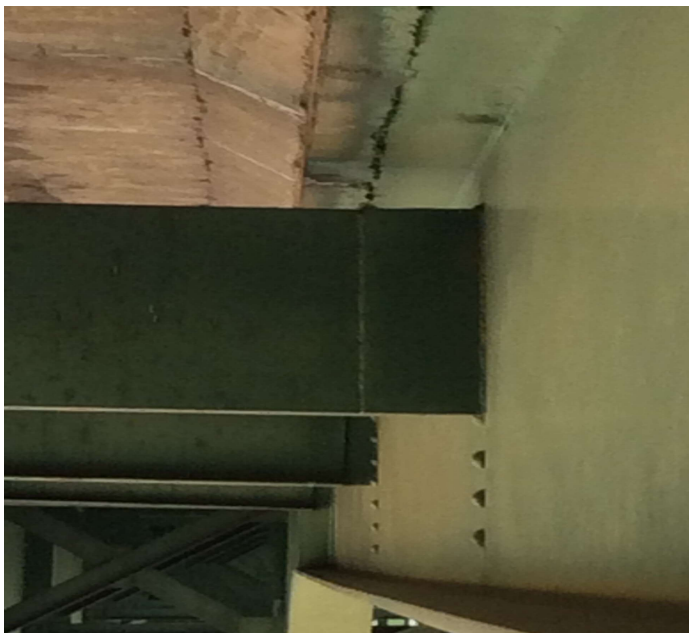
Span 10 - 2" crack to weld to left end of 3rd Diaphragm between Girders 4 - 5

PHOTO 3      Description      Cracked weld to 3rd Diaphragm ahead of Bent 9 on Left side between Girder 4 & 5 @ Span 10.

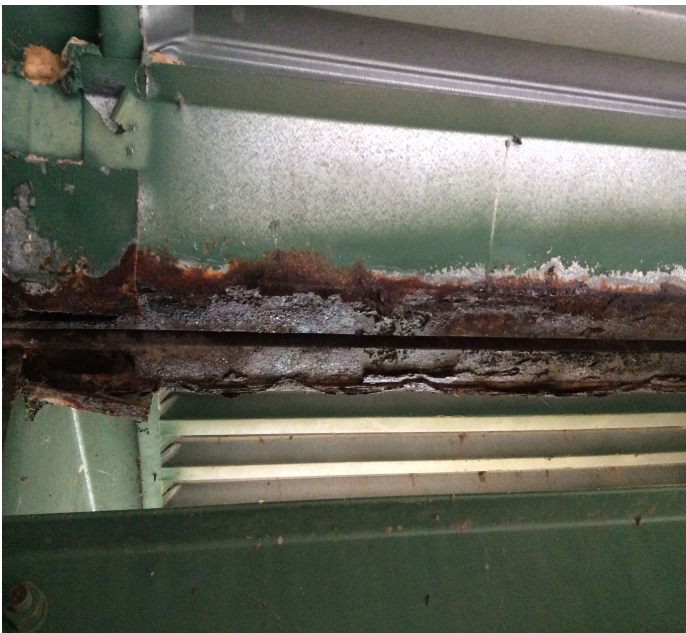
Bents 1 - 4 has flaking rust to bottom of Road Irons

PHOTO 1      Description      Heavy rust to Road Iron/Paving Haunch Assembly @ Bent 1.

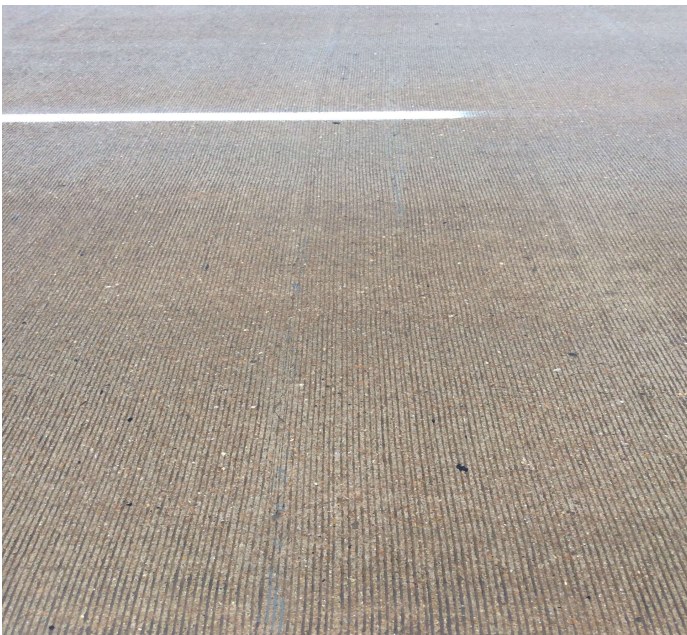
Unsealed cracks to Deck @ all Spans.

PHOTO 1    Description    Typical Deck @ all Spans

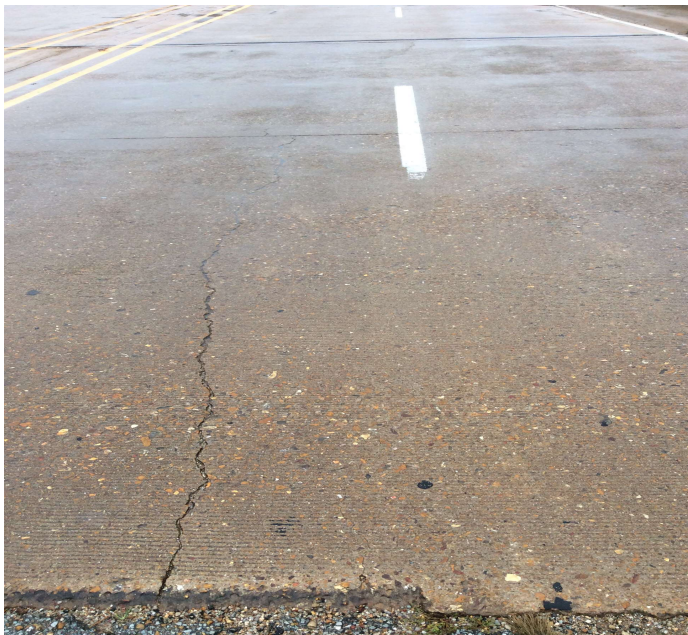
Moderate unsealed cracks in South lanes @ Abutments 1 & 2.

PHOTO 1    Description    Moderate unsealed cracks in South lanes @ Abutments 2.

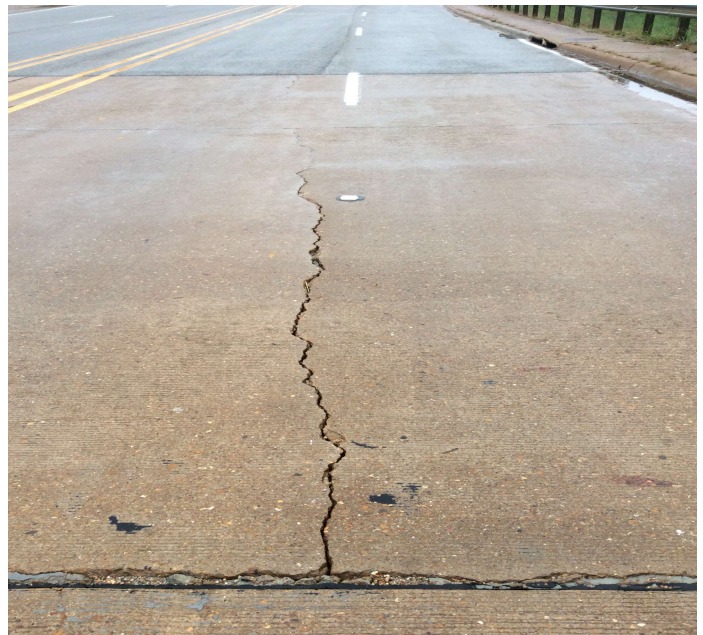
PHOTO 2    Description    Moderate unsealed cracks in South lanes @ Abutment 1

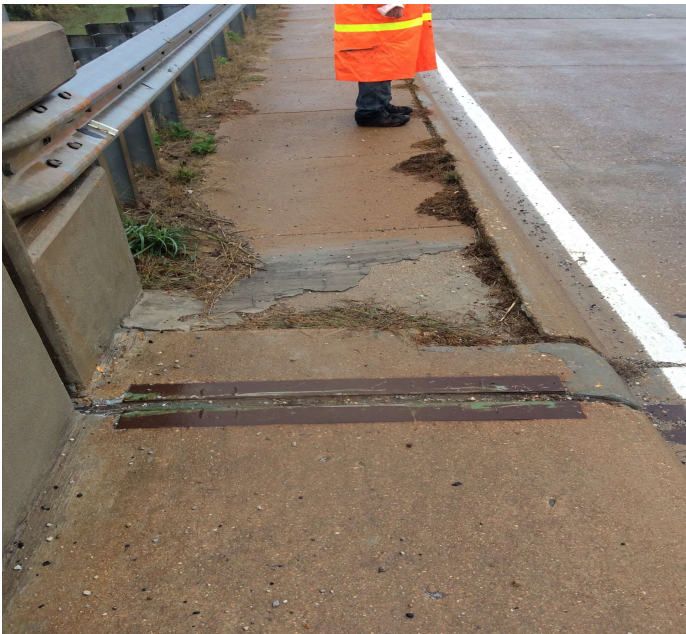
Side walks on Left & Right sides have settled.

PHOTO 1 Description Sidewalk settled @ Abutment 2 on left.

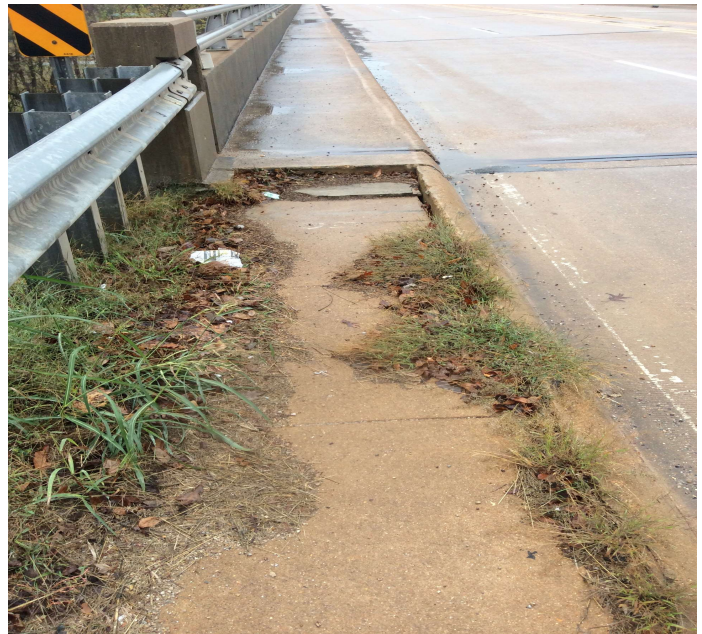
PHOTO 2 Description Settlement to sidewalk @ Abutment 2 on Right.

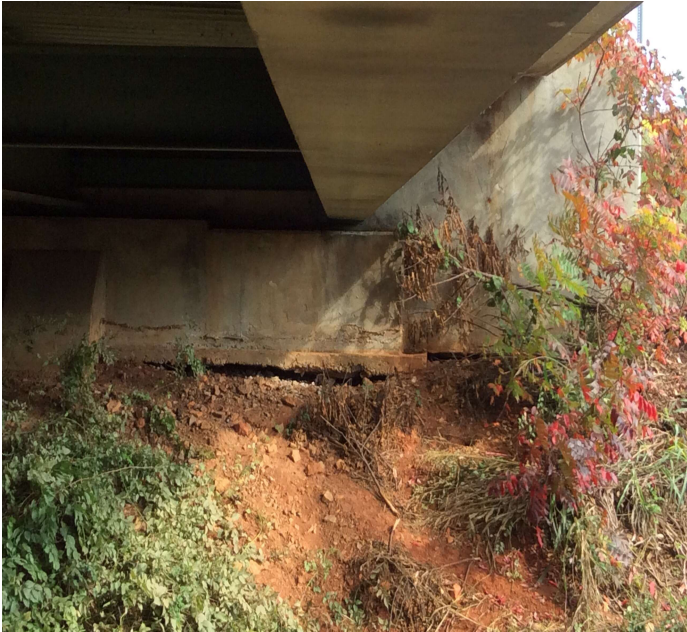
Abutment 2 is settled/undermined with 3 Piles exposed.

PHOTO 3      Description      Erosion & Undermining to Right end of Abutment 2 with 1 Pile exposed.

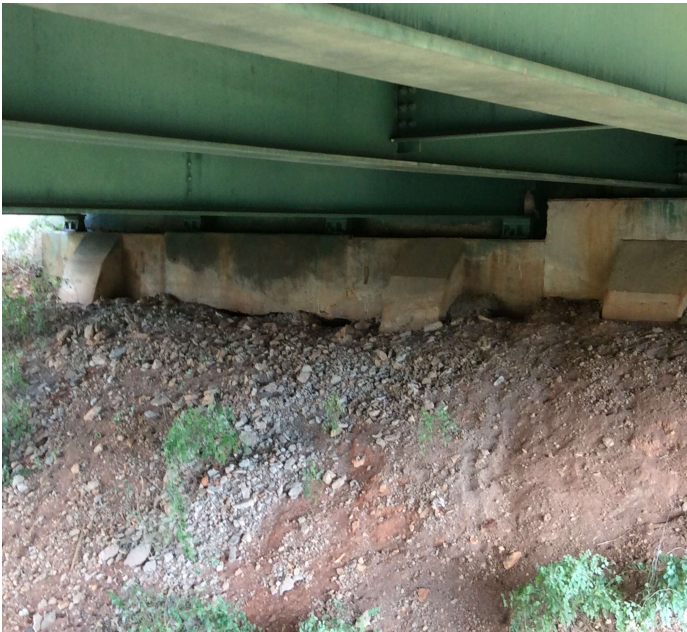
PHOTO 4      Description      Erosion & Undermining to Left end of Abutment 2 with 2 Piles Exposed.
