Bridge Inspection Report

06498

US 62 Sharp County
over
HACKNEY CREEK

IDENTIFICATION		INSPECTIONS	
(1) STATE CODE	056 - Arkansas	(90) INSPECTION DATE	01/02/2019
(8) STRUCTURE NUMBER	06498	(91) DESIGNATED INSPECTION FREQUENCY	24

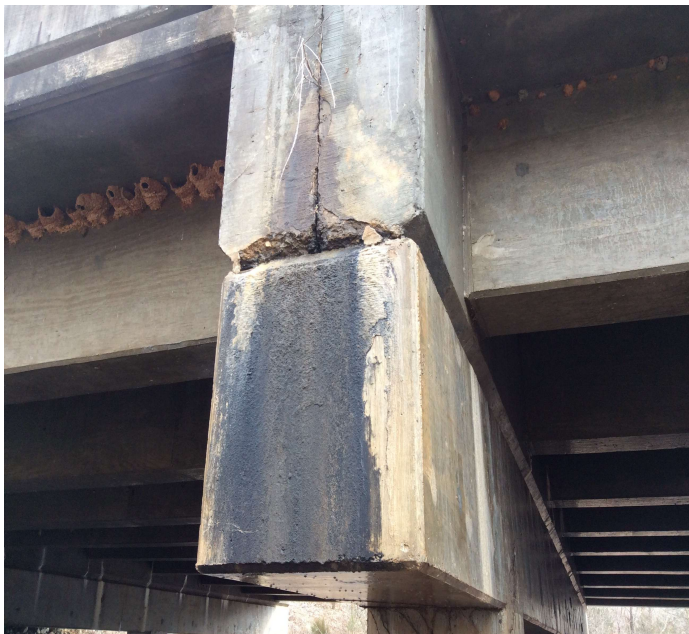
Environment	Total Quantity	Units	Condition State 1	Condition State 2	Condition State 3	Condition State 4
16 - Reinforced Concrete Top Flange	1- Ben.	7434	sq. ft.	5220	1510	704	0
	Unsealed cracks to deck. Spall to Left outside edge of deck over Bent 1 with light rust. Longitudinal & diagonal cracks with efflorescence & rust to soffit @ all spans.						
1120 - Efflorescence/Rust Staining		1066		0	962	104	0
1130 - Cracking (RC and Other)		1148		0	548	600	0
110 - Reinforced Concrete Open Girder/Beam	1- Ben.	945	ft.	945	0	0	0
205 - Reinforced Concrete Column	1- Ben.	8	each	8	0	0	0
215 - Reinforced Concrete Abutment	1- Ben.	136	ft.	102	29	5	0
	Abutment 1 - Vertical efflorescent cracking, some with rust stains to Abutment 1. Abutment 2 -Vertical & horizontal efflorescent cracking, some with rust stains to Abutment 2.						
1120 - Efflorescence/Rust Staining		34		0	29	5	0
234 - Reinforced Concrete Pier Cap	1- Ben.	142	ft.	139	3	0	0

Spall to Left outside edge of deck at Bent 1.

PHOTO 1 Description Spall to Left outside edge of deck at Bent 1.

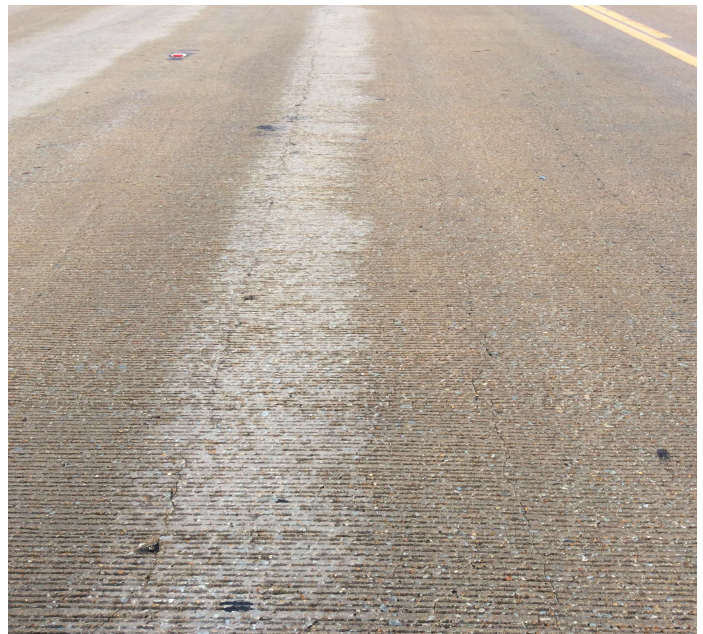
Unsealed cracks to deck at all spans

PHOTO 2 Description Typical unsealed cracks to deck at all spans.

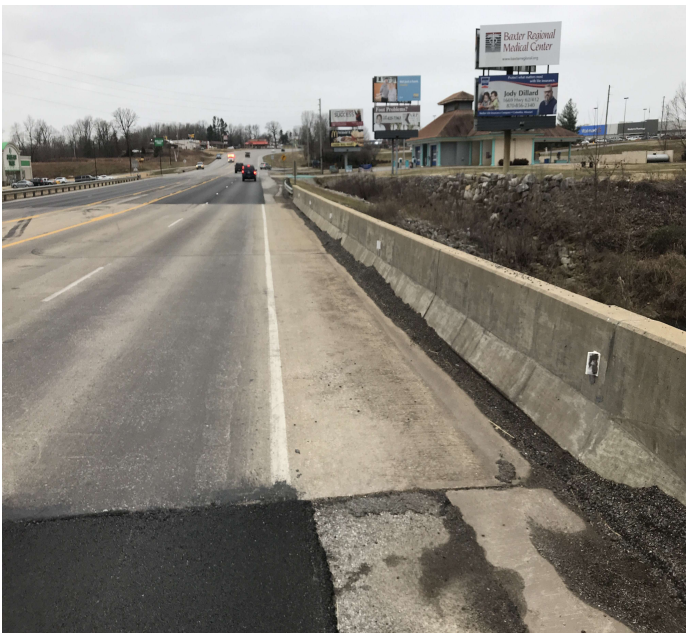
Debris in Left & Right gutter lines

PHOTO 1 Description Debris in Left gutter line.
