Bridge Inspection Report

M2957
SH 356/Cleburne Co
over
CADRON CREEK

Structure Number: M2957

Facility Carried: SH 356/Cleburne
Co

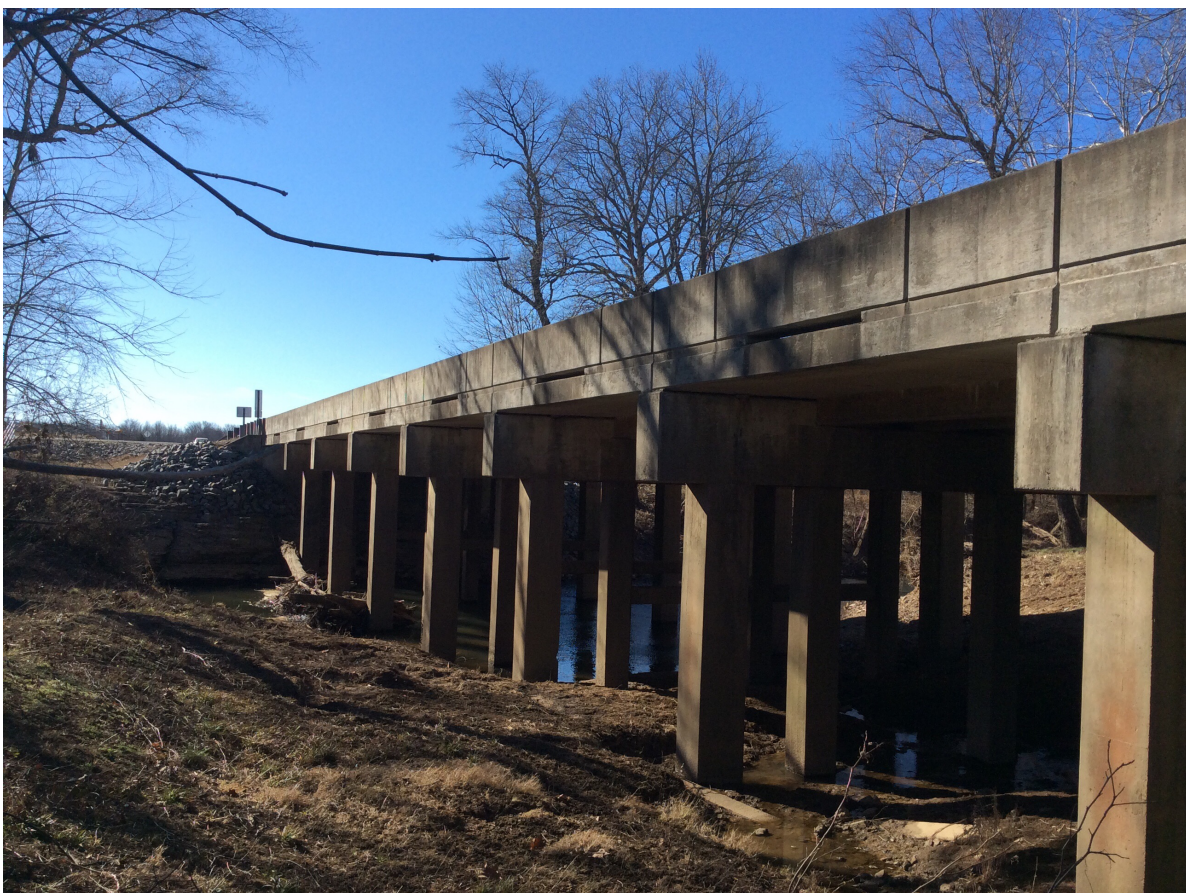
No asphalt overlay on the deck.

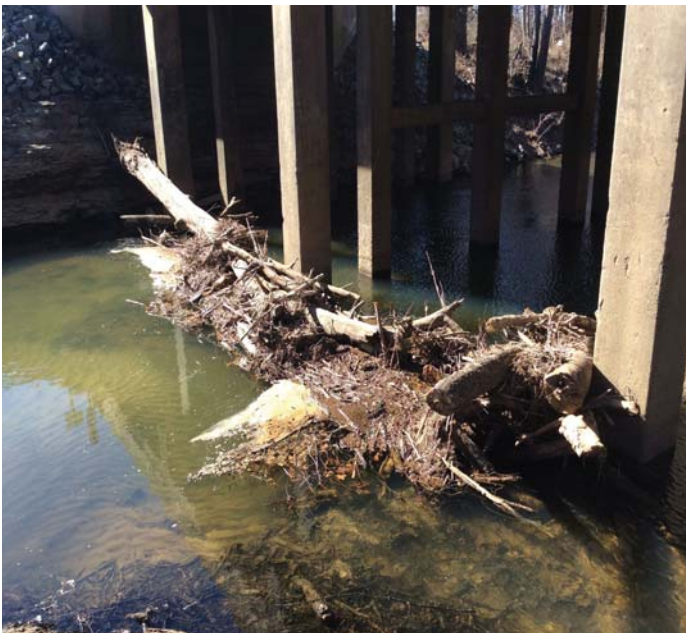
Drift @ Spans 6 & 7 restricting flow, creating scour at Spans 4, 5 & 6.

PHOTO 1 Description Drift @ Spans 6 & 7 restricting flow,
creating scour at Spans 4, 5 & 6.

Work Code: Clean

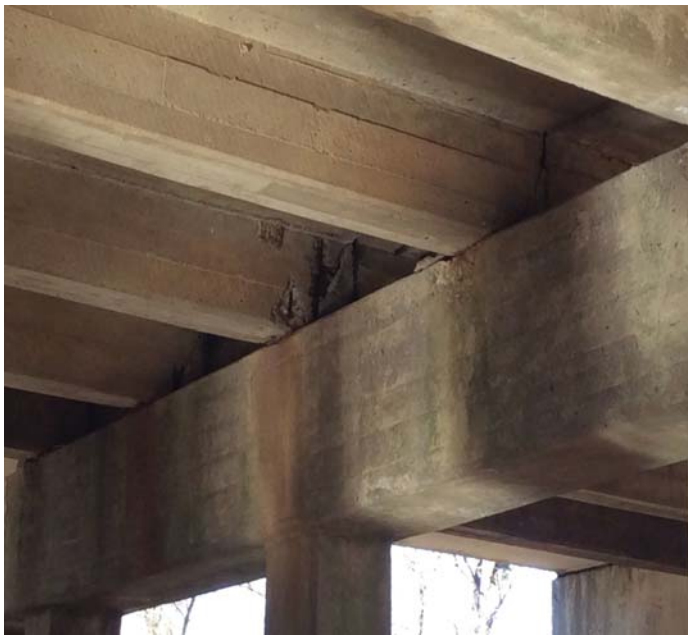
Full height vertical cracks to Girders 2, 3 & 4 @ beginning of Span 4, and Girder 3 @ beginning of Span 8.

PHOTO 1 Description Full height vertical cracks to Girders 2, 3 & 4 @ beginning of Span 4.

Work Code: Repair

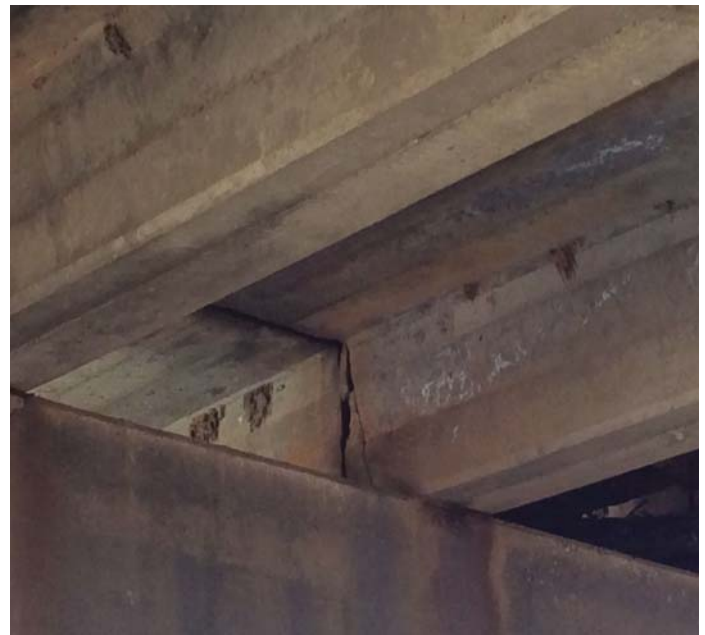
PHOTO 2 Description Girder 3 @ beginning of Span 8.

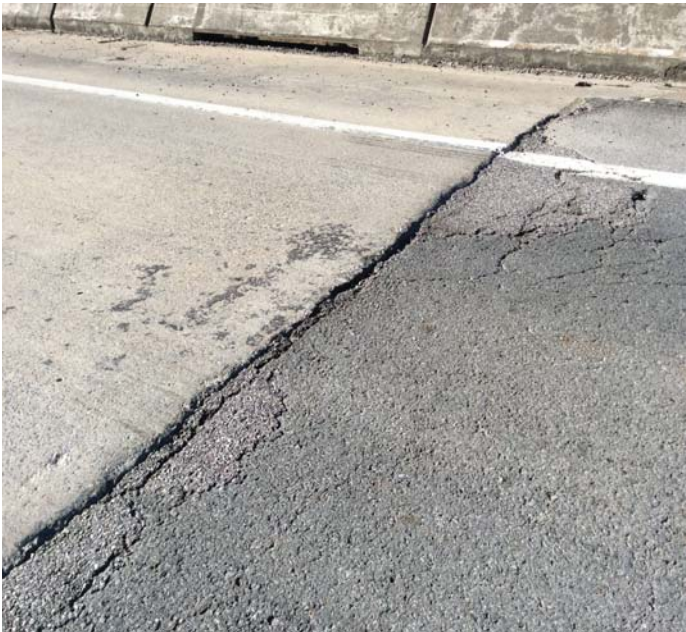
Abutments 1 & 2
Roadway settlement.

PHOTO 1 Description Roadway settlement @ Abutment 1.

Work Code: Repair

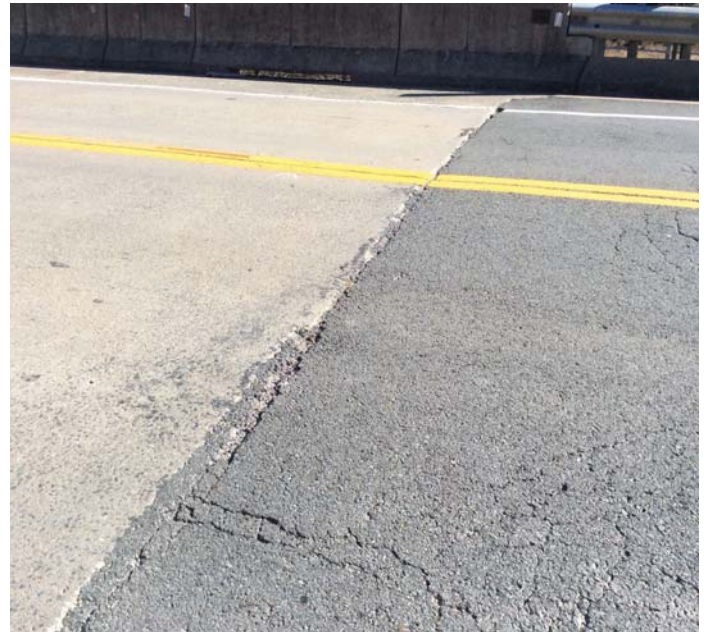
PHOTO 2 Description Roadway settlement @ Abutment 2.
