Bridge Inspection Report

05644

**US 167/Indepen. Co
over
WHITE RIVER RELIEF**

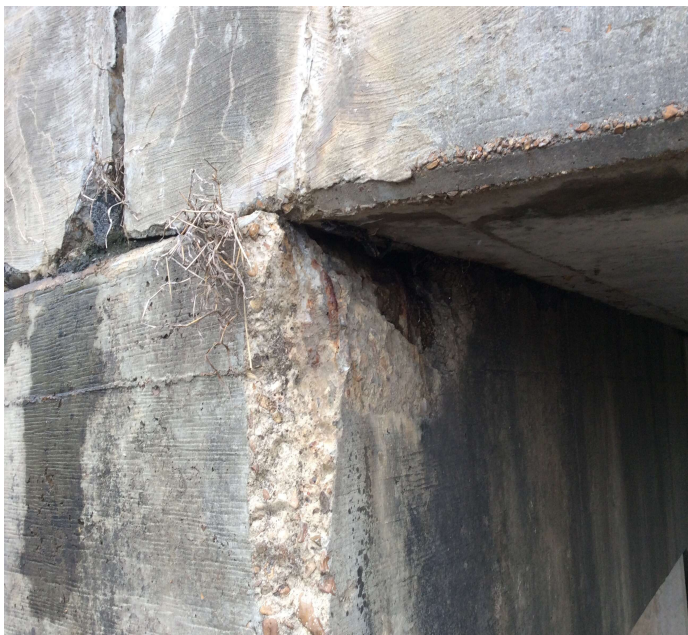
Spalls with rebar exposed to caps at Bents 1, 2, 10, 11, 17-24, 26, 27,30-33.
Spalls with rebar exposed to Abutments 1 & 2.

PHOTO 1 Description Bent 1 right end of Cap spall with exposed rebar.

Work Code: Repair

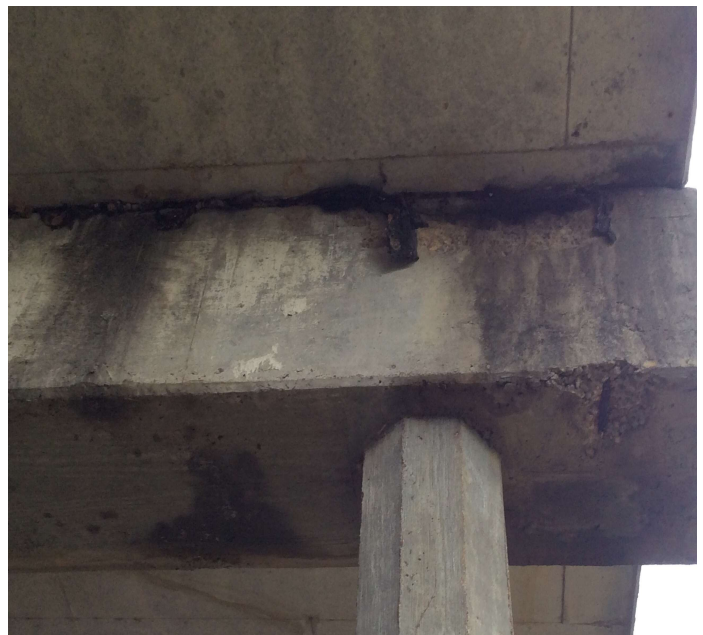
PHOTO 2 Description Bent 2 at Pile 1 spall with 6" of exposed rebar and spall with no exposed rebar at Bridge Seat on ahead side.

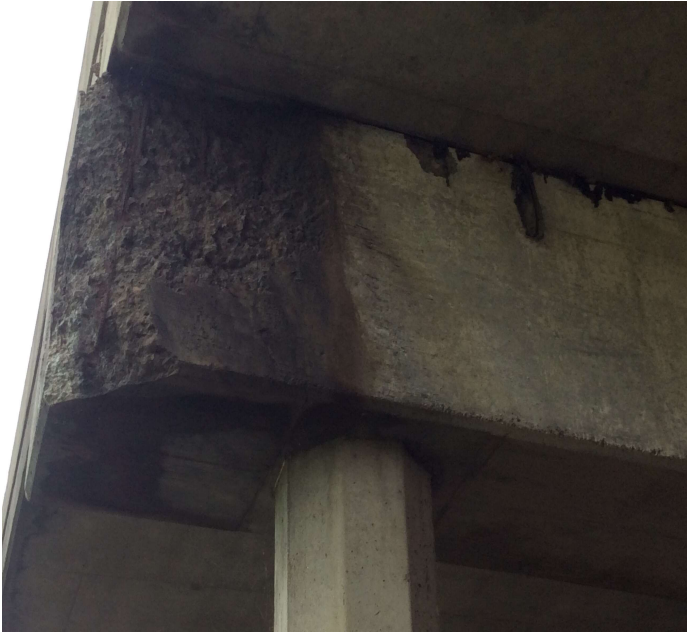
PHOTO 3 Description Left end of Cap at Bent 22.

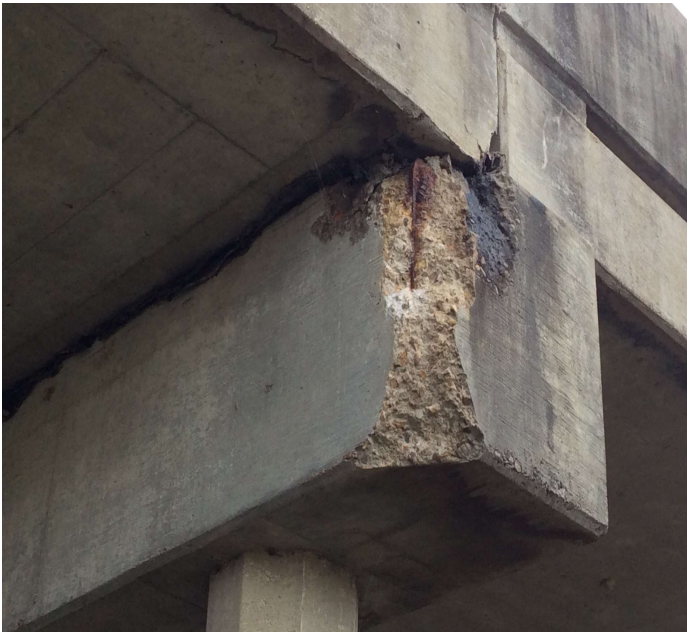
PHOTO 4 Description Right end of Cap at Bent 22.

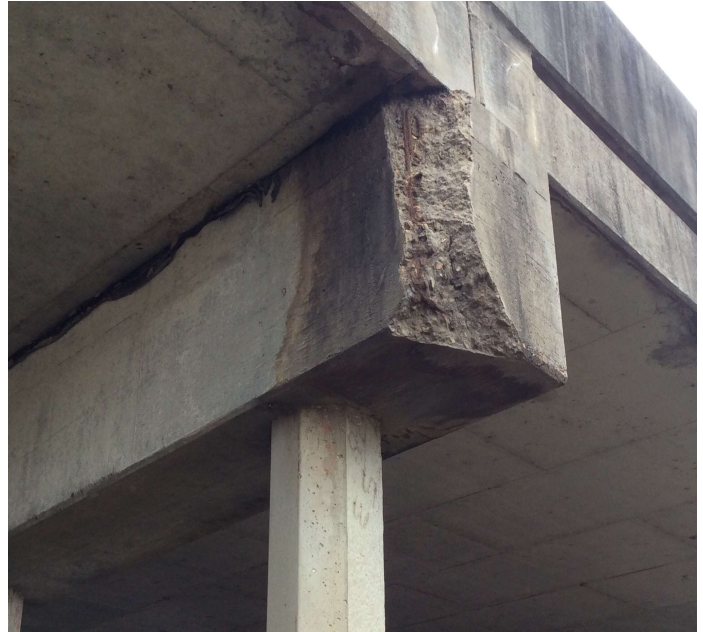
PHOTO 5 Description Right end of Cap at Bent 23.

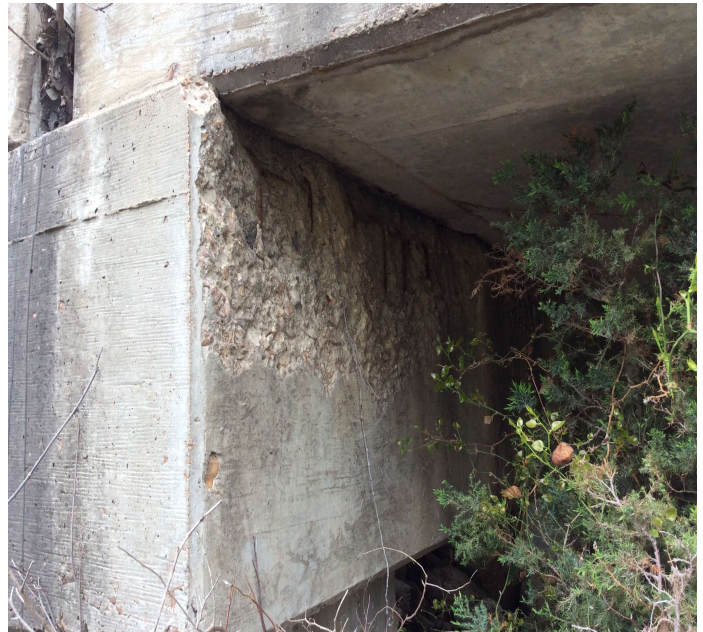
PHOTO 6 Description Left end of Cap at Bent 33.

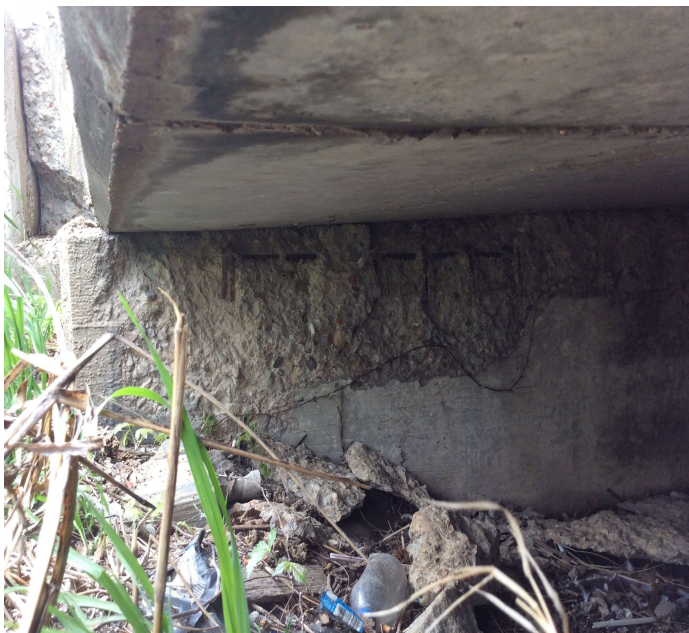
PHOTO 7 Description Left end of Abutment 2

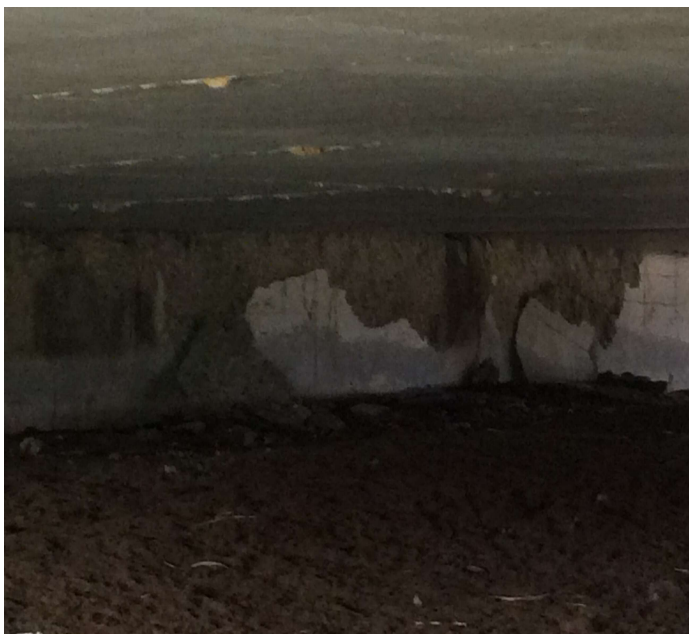
PHOTO 8 Description Face of Abutment 2 near Centerline.

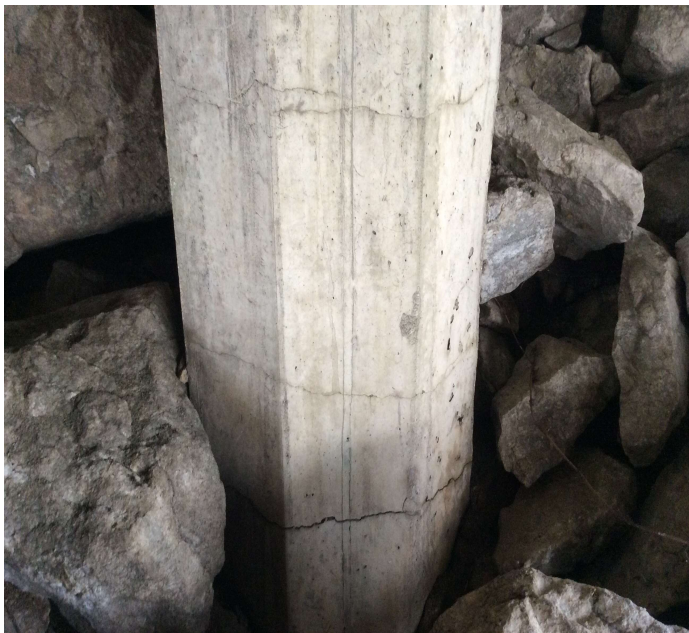
Hairline to 1/8" wide horizontal cracks to piles, located \pm 5' below bottom of cap, at Bents 1, 32 & 33.

PHOTO 1 Description Pile 3 at Bent 1

Work Code: Repair

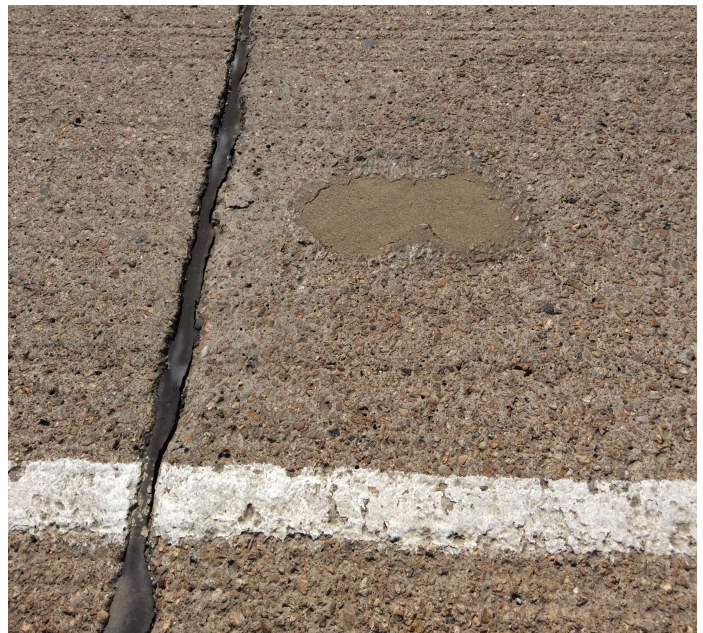
PHOTO 2 Description Spall in right lane at Span 32 with 16" of exposed rebar. Repaired.

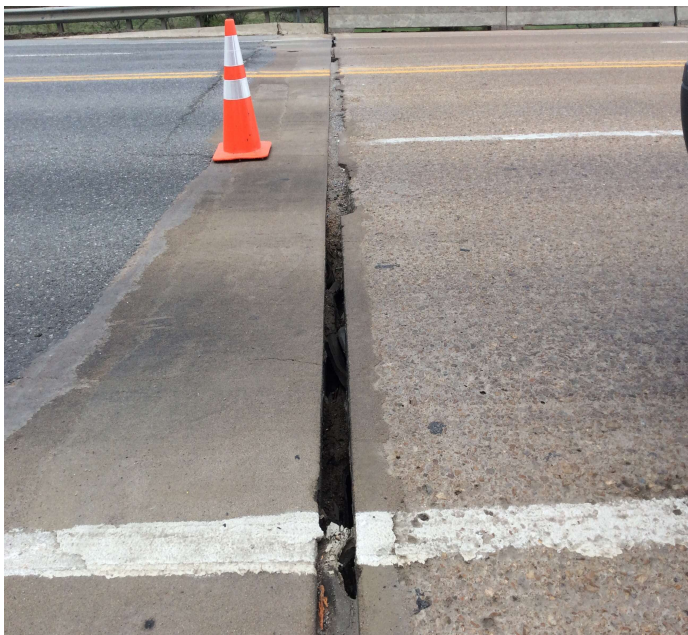
Deck joints at Abutment 1 & 2 are deteriorated with most sections missing.
Deck joints at Spans 1 - 34 are deteriorated & filled with debris.

PHOTO 1 Description Joint at Abutment 1

Work Code: Repair

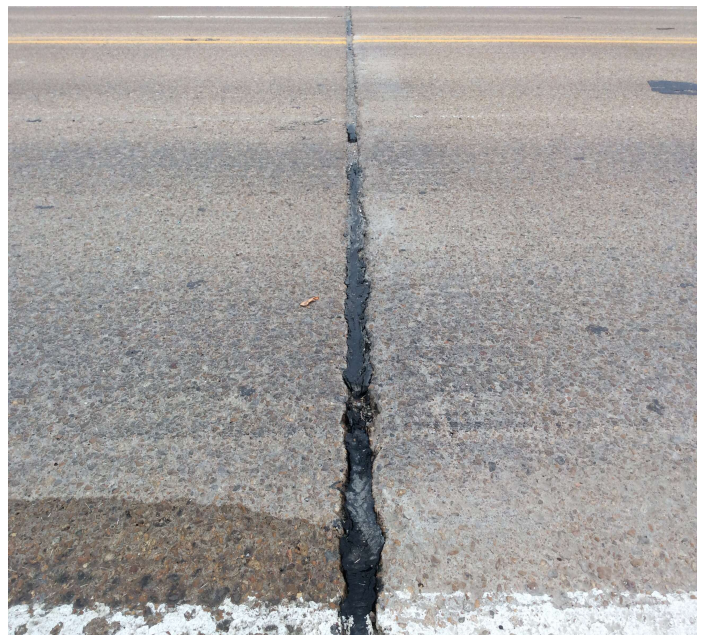
PHOTO 2 Description Bent 1 Joint

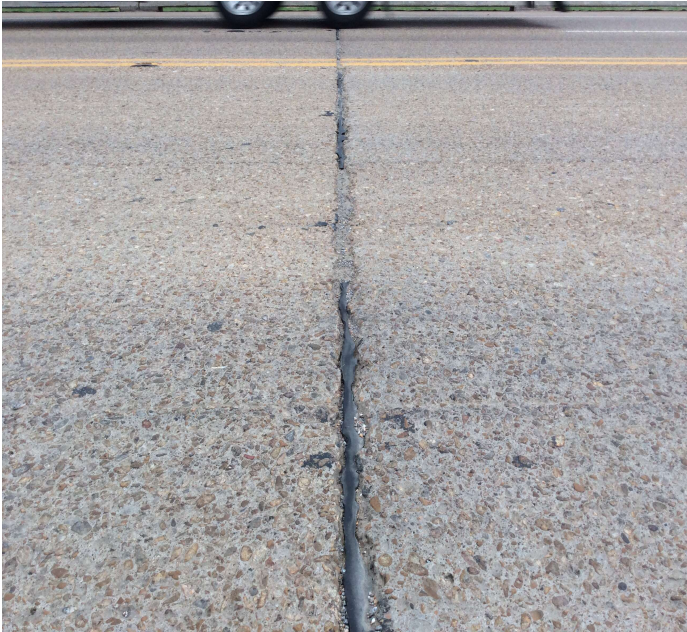
PHOTO 3 Description Bent 23 joint.

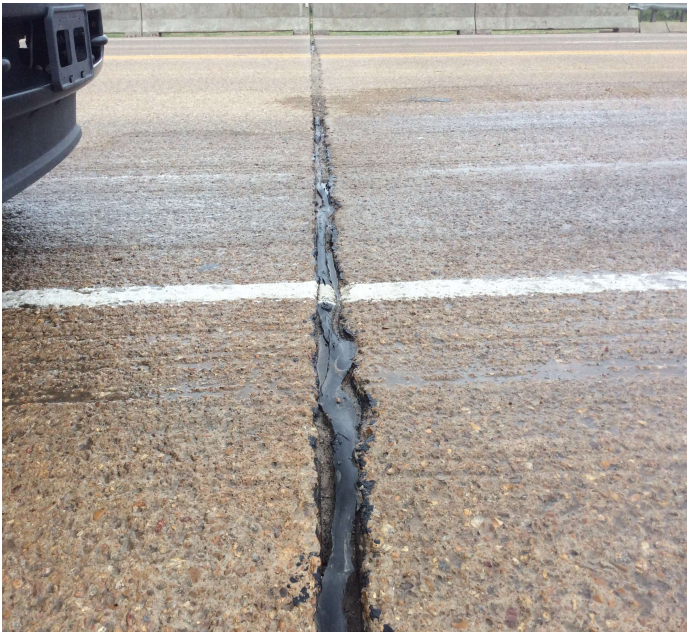
PHOTO 4 Description Bent 33 joint

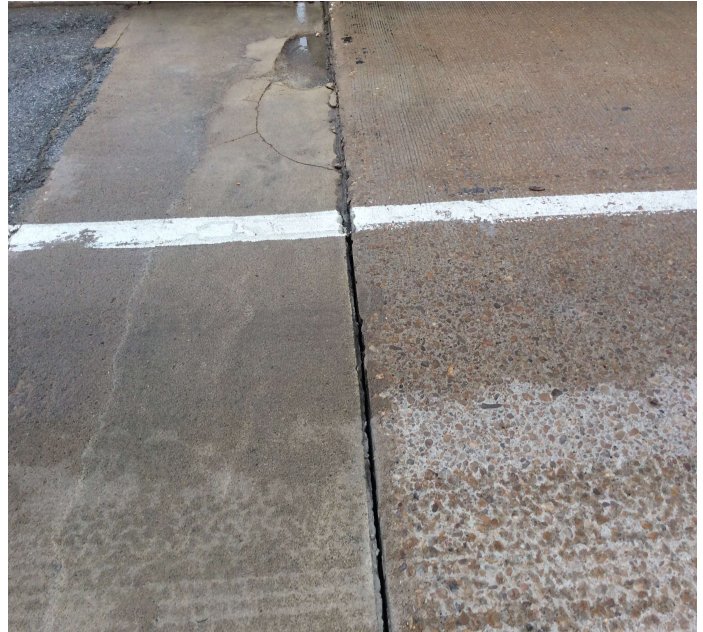
PHOTO 5 Description Abutment 2 right shoulder spalled patch and joint condition.

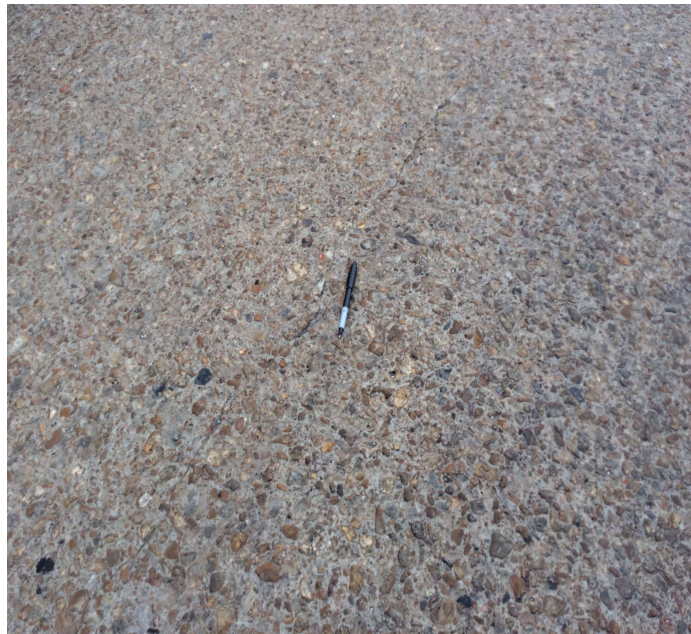
Unsealed cracks to deck at all spans.

PHOTO 1 Description Span 7 unsealed crack.

Work Code: Repair

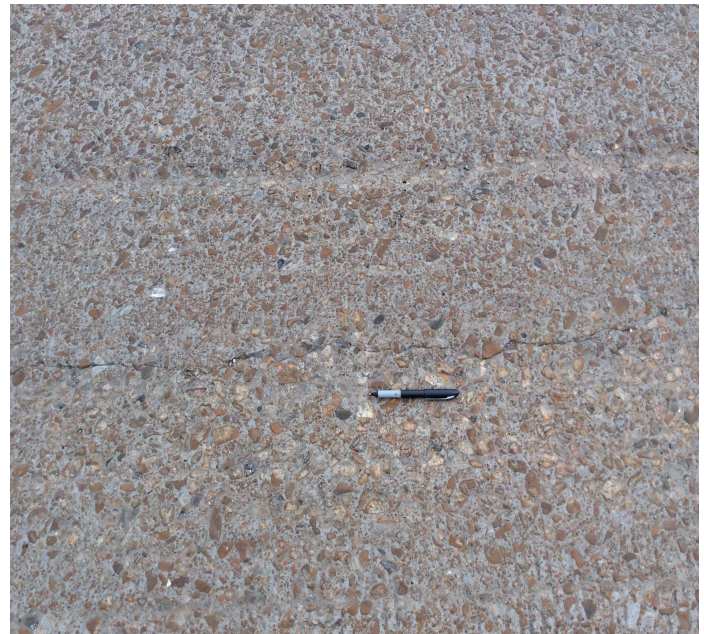
PHOTO 2 Description Span 20 unsealed crack.

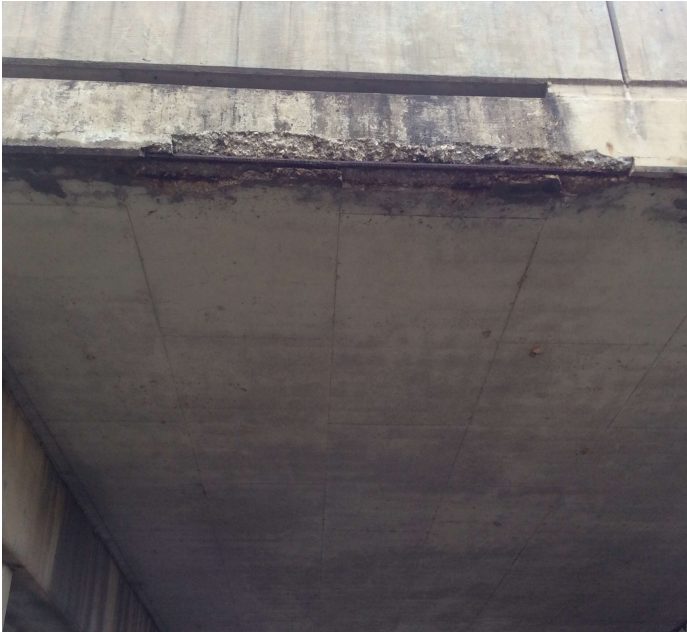
Right edge of Deck below at Spans 8, 9, 11, 12, 13, 20, 28, 29 have Spalls with exposed rebar.

PHOTO 3 Description Span 12 right edge of Deck.

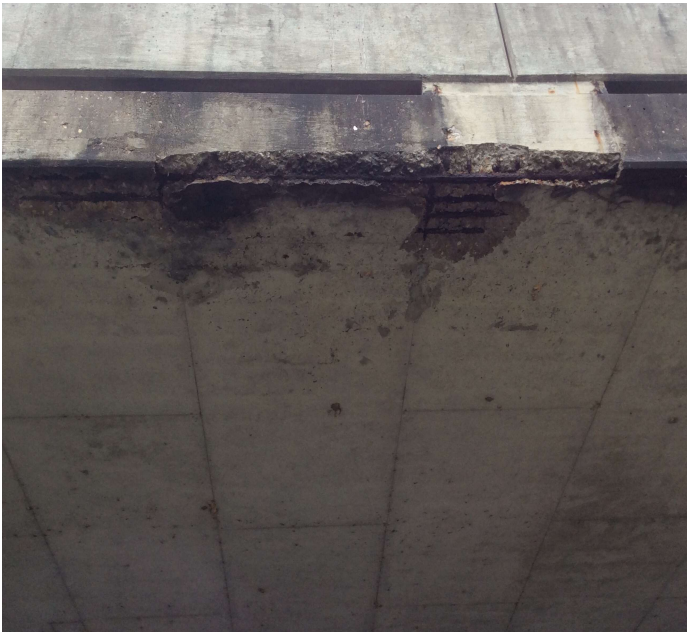
PHOTO 4 Description Right edge of Deck at Span 29.

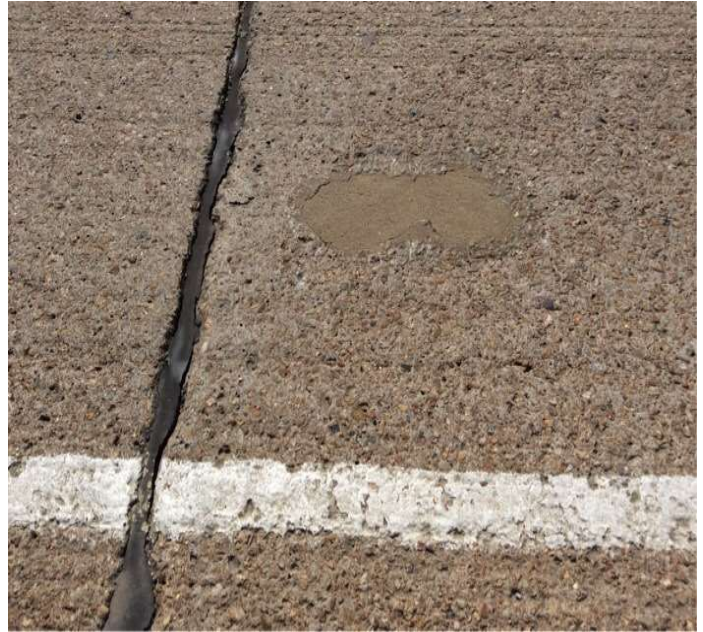
Spall in right lane at Span 32 with 16" of exposed rebar.

PHOTO 5 Description Spall in right lane at Span 32 with 16" of exposed rebar.
Deck spalls Repaired.

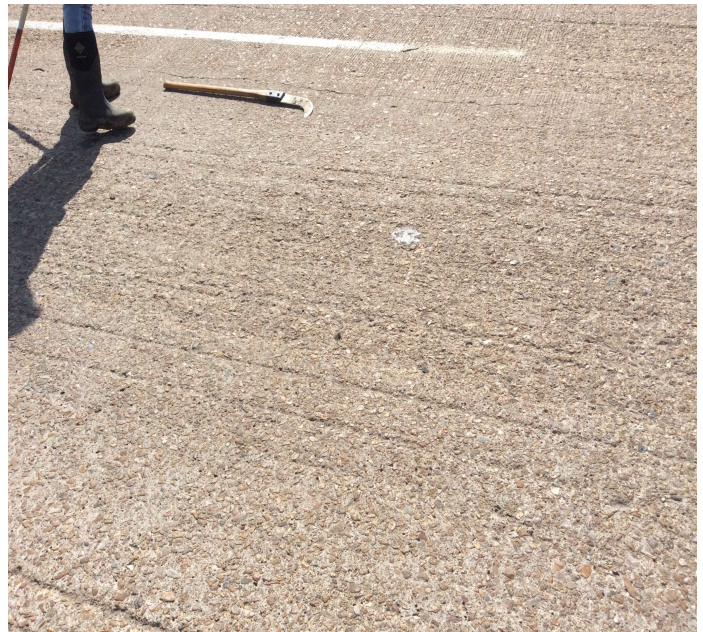
PHOTO 6 Description Typical of Longitudinal cracks to deck @ several spans.

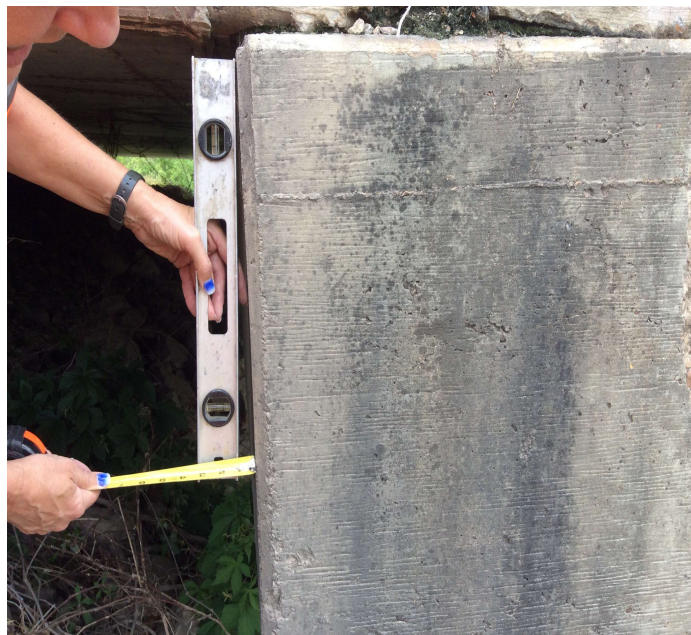
Bent 1 has rotated back 7/8" in 18".
Bent 2 has rotated back 1/2" in 18".
Bent 3, 4 & 5 have minor rotation back.
Bent 31 has minor rotation ahead.
Bent 32 has rotated ahead 1/2" in 18".
Bent 33 has rotated ahead 3/4" in 18"

PHOTO 1 Description Bent 1 has rotated back 7/8" in 18".

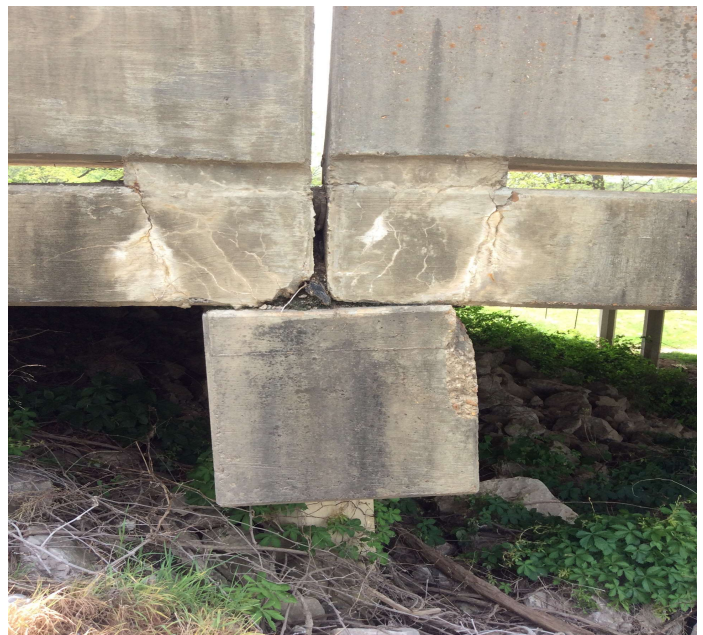
PHOTO 2 Description Bent 1 has rotated back.

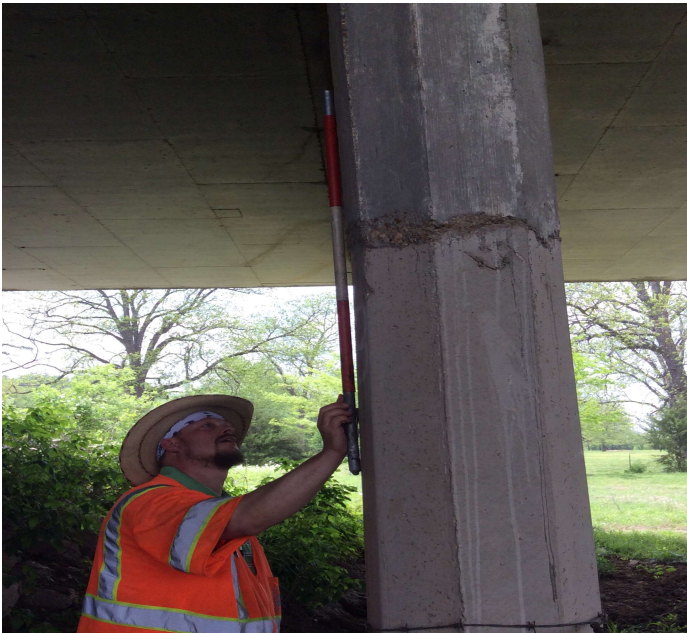
Bent 2 - Piles 4, 5 & 6 are bowed & leaning back at cracks (cold joints).

PHOTO 1 Description Bent 1 - Piles 4, 5, & 6 are bowed & leaning back at cracks (cold joints).
